Visual Site Inspection Report

Project Name	H-600 Pipeline Spread H	AFE	124300138	Spread	H-600 Pipeline Spread H
Contractor	Precision			Report #	8570
Inspector	Dustin Lyons			Date/Time	2/24/2020 3:22 PM
Permit #	TBD	Inspection Type	VA SWPP	Station Begin	12443+00
State	VA	Inspection Area	Partial	Station End	12544+50
County	Montgomery	Ground	Wet	Temperature (°F)	45.00
Municipality	N/A	Weather	Cloudy	Rain Gauge (in)	0.00
				Rain Accumulation Time (days)	3.00

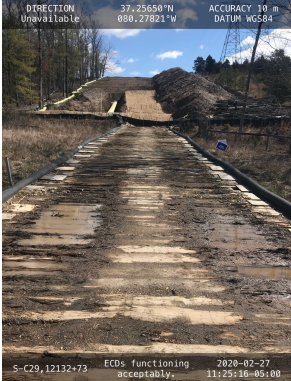
GPS Location	See GPS for location		GPS Location	See GPS for location	
Field Station#	12132+73		Field Station#	12200+00	
Pic 7 Desc.	ECDs were in place at this stream and functioning properly.		Pic 8 Desc.	Erosion blanket, SSF, sumps, and end treatments are in place and functioning properly.

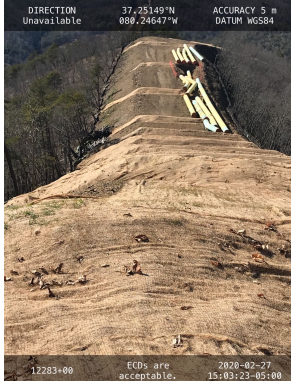
GPS Location	See GPS for location		GPS Location		
Field Station#	12283+00		Field Station#		
Pic 9 Desc.	. Erosion blanket, SSF, sumps, and end treatments are in place and functioning properly.		Pic 10 Desc.		
Insert image here		Insert image here			
GPS Location			GPS Location		
Field Station#			Field Station#		
Pic 11 Desc.			Pic 12 Desc.

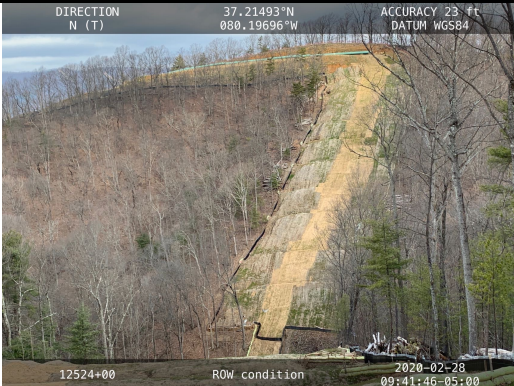
Field Station#	12524+00		Field Station#	12519+75	
Pic 5 Desc.	Photo shows the ROW condition from about 12513+00 to 12524+00. No environmental issues were observed.		Pic 6 Desc.	Photo shows the bridge over stream S-EF19. No environmental issues were observed.
