## Visual Site Inspection Report

<b>Project Name</b>	H-600 Pipeline Spread H	<b>AFE</b>	124300138	<b>Spread</b>	H-600 Pipeline Spread H
<b>Contractor</b>	Precision			<b>Report #</b>	8777
<b>Inspector</b>	Tammy Kruizenga			<b>Date/Time</b>	3/3/2020 6:32 AM
<b>Permit #</b>	TBD	<b>Inspection Type</b>	VA SWPP	<b>Station Begin</b>	12005+00
<b>State</b>	VA	<b>Inspection Area</b>	Partial	<b>Station End</b>	12119+17
<b>County</b>	Montgomery	<b>Ground</b>	Wet	<b>Temperature (°F)</b>	59.00
<b>Municipality</b>	N/A	<b>Weather</b>	Light Rain	<b>Rain Gauge (in)</b>	0.20
				<b>Rain Accumulation Time (days)</b>	1.00

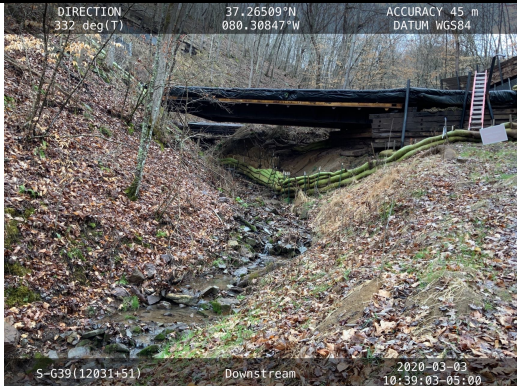
<p style="text-align: center;">Insert image here</p>			
<b>GPS Location</b>	See GPS for location	<b>GPS Location</b>			
<b>Field Station#</b>	12031+51	<b>Field Station#</b>			
<b>Pic 9 Desc.</b>	No sediment impact to stream.	<b>Pic 10 Desc.</b>			
<p style="text-align: center;">Insert image here</p>		<p style="text-align: center;">Insert image here</p>			
<b>GPS Location</b>		<b>GPS Location</b>			
<b>Field Station#</b>		<b>Field Station#</b>			
<b>Pic 11 Desc.</b>		<b>Pic 12 Desc.</b>

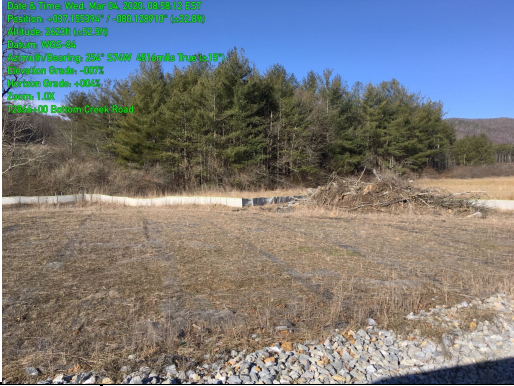
<p>Date &amp; Time: Wed, Mar 04, 2020, 08:50:13 EST Position: +037.135297° / -080.128779° (±16.4M) Altitude: 25279 (±26.2M) Datum: WGS-84 Azimuth/Bearing: 254° 57'4W 4014mils True (±15°) Elevation Grade: -007% Horizon Grade: +004% Zoom: 1.0X 12866+00 Bottom Creek Road</p>

<p>Date &amp; Time: Wed, Mar 04, 2020, 08:50:58 EST Position: +037.135344° / -080.128779° (±16.4M) Altitude: 25279 (±26.2M) Datum: WGS-84 Azimuth/Bearing: 254° 57'4W 3858mils True (±15°) Elevation Grade: -004% Horizon Grade: +004% Zoom: 1.0X 12866+00 Bottom Creek Road</p>			
<b>GPS Location</b>	See pic for GPS location		<b>GPS Location</b>	See pic for GPS location	
<b>Field Station#</b>	12866+00		<b>Field Station#</b>	12866+00	
<b>Pic 1 Desc.</b>	CIS of the Bottom Creek Road crossing.		<b>Pic 2 Desc.</b>	GAS of the Bottom Creek Road Crossing

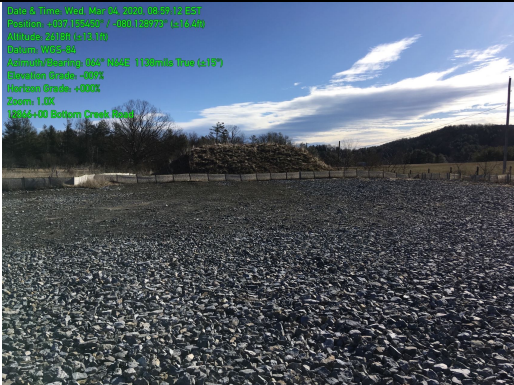
<p>Date &amp; Time: Wed, Mar 04, 2020, 09:25:13 EST Position: +037.135297° / -080.128779° (±16.4M) Altitude: 25279 (±26.2M) Datum: WGS-84 Azimuth/Bearing: 254° 57'4W 1138mils True (±15°) Elevation Grade: -007% Horizon Grade: +000% Zoom: 1.0X 12866+00 Bottom Creek Road</p>

<p>Date &amp; Time: Wed, Mar 04, 2020, 10:19:15 EST Position: +037.135297° / -080.134398° (±16.4M) Altitude: 25779 (±26.2M) Datum: WGS-84 Azimuth/Bearing: 004° 00'4E 0107mils True (±38°) Elevation Grade: -011% Horizon Grade: +004% Zoom: 1.0X 12957+30 RO-287</p>			
<b>GPS Location</b>	See pic for GPS location		<b>GPS Location</b>	See pic for GPS location	
<b>Field Station#</b>	12866+00		<b>Field Station#</b>	12957+30	
<b>Pic 3 Desc.</b>	Topsoil stock pile in ATWS at Bottom Creek Road.		<b>Pic 4 Desc.</b>	North side of Stream S-Z17 on access road RO-287.

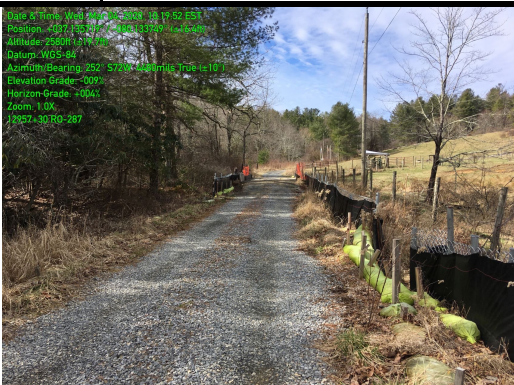
<b>GPS Location</b>	See pic for GPS location		<b>GPS Location</b>	See pic for GPS location	
<b>Field Station#</b>	12957+30		<b>Field Station#</b>	12957+30	
<b>Pic 5 Desc.</b>	South side of Stream S-Z17 on access road RO-287.		<b>Pic 6 Desc.</b>	North side of Stream S-Z16 on access road RO-287.

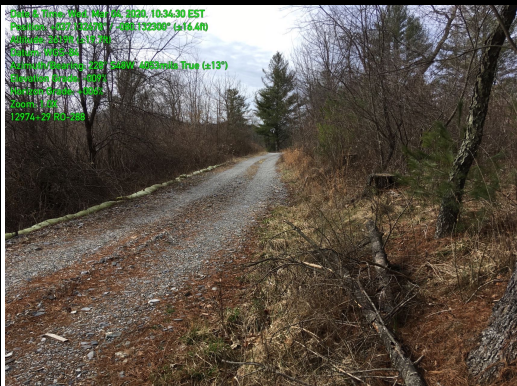
GPS Location		See pic for GPS location						GPS Location		See pic for GPS location	
Field Station#		12974+29						Field Station#		12974+29	
Pic 9 Desc.		Access road RO-288 no issues or impacts were observed.						Pic 10 Desc.		Access road RO-288 from US-221.

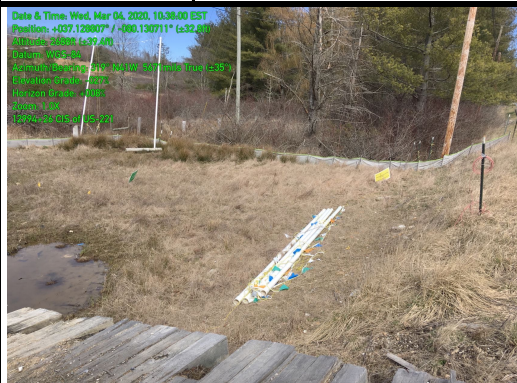
GPS Location		See pic for GPS location						GPS Location		See pic for GPS location	
Field Station#		12994+26						Field Station#		12994+26	
Pic 11 Desc.		CIS of the US-221 road crossing.						Pic 12 Desc.		GAS of US-221 road crossing.

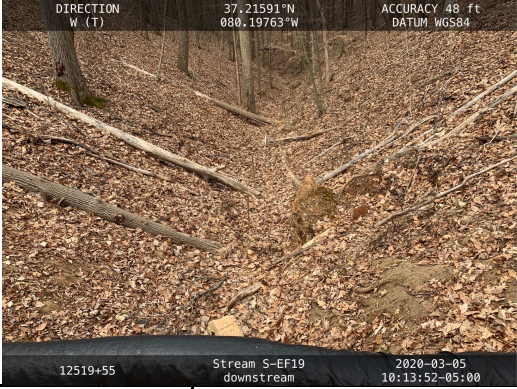
<p>DIRECTION W (T) 37.21591°N 080.19763°W ACCURACY 48 ft DATUM WGS84</p> <p>12519+55 Stream S-EF19 downstream 2020-03-05 10:13:52-05:00</p>

<p>DIRECTION NW (T) 37.21785°N 080.19956°W ACCURACY 39 ft DATUM WGS84</p> <p>12506+00 ROW condition 2020-03-05 10:30:10-05:00</p>			
<b>GPS Location</b>	See photo for gps location data.		<b>GPS Location</b>	See photo for gps location data.	
<b>Field Station#</b>	12519+55		<b>Field Station#</b>	12506+00	
<b>Pic 7 Desc.</b>	Photo shows stream S-EF19 downstream from the ROW. No environmental issues were observed.		<b>Pic 8 Desc.</b>	Photo shows the ROW condition from about 12502+00 to 12506+00. No environmental issues were observed.

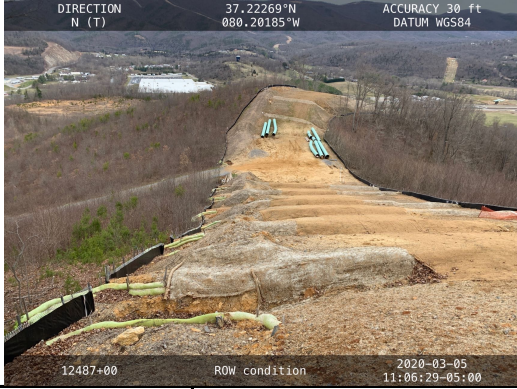
<p>DIRECTION N (T) 37.22269°N 080.20185°W ACCURACY 30 ft DATUM WGS84</p> <p>12487+00 ROW condition 2020-03-05 11:06:29-05:00</p>

<b>GPS Location</b>	See photo for gps location data.		<b>GPS Location</b>	See photo for gps location data.	
<b>Field Station#</b>	12487+00		<b>Field Station#</b>	12455+21	
<b>Pic 9 Desc.</b>	Photo shows the ROW condition from about 12485+00 to 12487+00. No environmental issues were observed.		<b>Pic 10 Desc.</b>	Photo shows the bridge over stream S-CD12b. No environmental issues were observed.	
Insert image here			Insert image here		
<b>GPS Location</b>			<b>GPS Location</b>		
<b>Field Station#</b>			<b>Field Station#</b>		
<b>Pic 11 Desc.</b>			<b>Pic 12 Desc.</b>
