Visual Site Inspection Report

Project Name	H-600 Pipeline Spread H	AFE	124300138	Spread	H-600 Pipeline Spread H
Contractor	Precision			Report #	9415
Inspector	John Brcic			Date/Time	3/23/2020 11:20 AM
Permit #	TBD	Inspection Type	VA SWPP	Station Begin	12443+75
State	VA	Inspection Area	Partial	Station End	12544+06
County	Montgomery	Ground	Damp	Temperature (°F)	41.00
Municipality	N/A	Weather	Light Rain	Rain Gauge (in)	0.50
				Rain Accumulation Time (days)	3.00

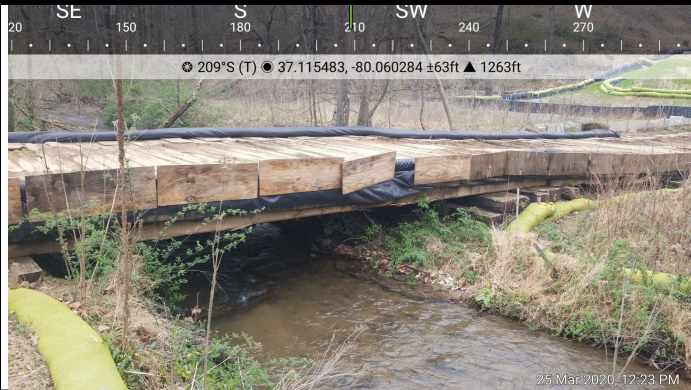
GPS Location	See photo for coordinates.		GPS Location	See photo for coordinates.	
Field Station#	13260+60		Field Station#	13258+00

Pic 5 Desc.	S-II4, upstream side of equipment bridge, no changes or environmental issues noted.		Pic 6 Desc.	Good vegetative cover across LOD, permanent waterbars stable.

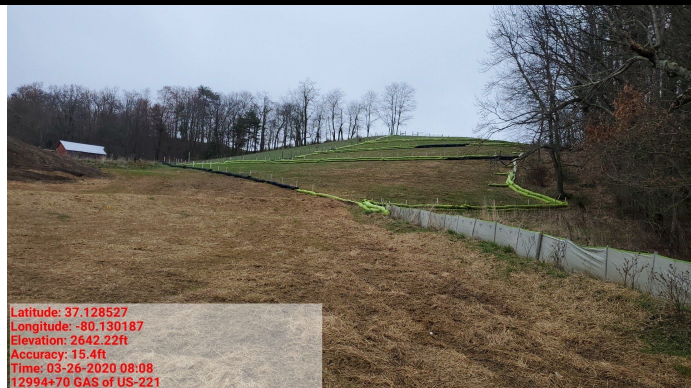
<p>Latitude: 37.128527 Longitude: -80.130187 Elevation: 2642.22ft Accuracy: 15.4ft Time: 03-26-2020 08:08 12994+70 GAS of US-221</p>			  <p>Latitude: 37.12591 Longitude: -80.12531 Elevation: 2700.46ft Accuracy: 12.5ft Time: 03-26-2020 08:10 13012+63 CIS of the BRP motorway</p>		
GPS Location	See pic for GPS location		GPS Location	See pic for GPS location	
Field Station#	12994+70		Field Station#	13012+63	
Pic 5 Desc.	Permanent and temporary stabilization in good condition on GAS of US-221.		Pic 6 Desc.	No maintenance issues or impacts found on the BRP.
