Visual Site Inspection Report

Project Name	H-600 Pipeline Spread H	AFE	124300138	Spread	H-600 Pipeline Spread H
Contractor	Precision			Report #	8972
Inspector	Tammy Kruizenga			Date/Time	3/9/2020 6:53 AM
Permit #	TBD	Inspection Type	VA SWPP	Station Begin	12005+00
State	VA	Inspection Area	Partial	Station End	12119+17
County	Montgomery	Ground	Dry	Temperature (°F)	65.00
Municipality	N/A	Weather	Sunny	Rain Gauge (in)	0.00
				Rain Accumulation Time (days)	1.00

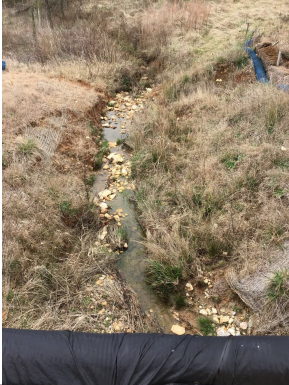
GPS Location	0000	GPS Location	0000		
Field Station#	13666+27	Field Station#	13666+27		
Pic 3 Desc.	Stream crossing photo facing downstream	Pic 4 Desc.	Stream crossing photo facing upstream		
Insert image here			Insert image here		
GPS Location		GPS Location			
Field Station#		Field Station#			
Pic 5 Desc.		Pic 6 Desc.

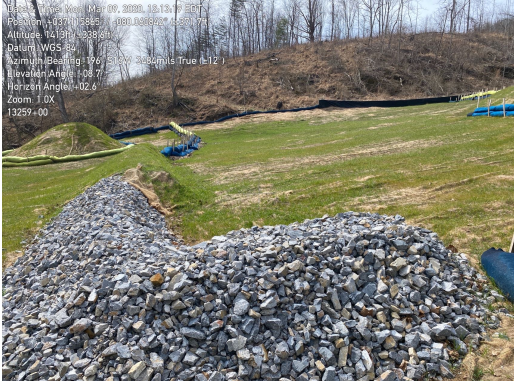
GPS Location	See photo for coordinates.		GPS Location	See photo for coordinates.	
Field Station#	13259+00		Field Station#	13314+00	
Pic 3 Desc.	Permanent waterbars stable, moderate to good vegetative cover noted across LOD.		Pic 4 Desc.	Moderate vegetative cover noted across LOD, perimeter controls functioning acceptably.	
<p> <small> Date & Time: Mon, Mar 9, 2020, 12:15:13 PM Position: +437.10344° / +460.04233° (±1.0147 m) Altitude: 1450 ft (±100.4 ft) Datum: WGS-84 Azimuth/Bearing: 276° NBW 4907mils True (±1.6°) Elevation Angle: -07.2° Horizon Angle: +02.5° Zoom: 1.0X 13276+00 </small> </p>

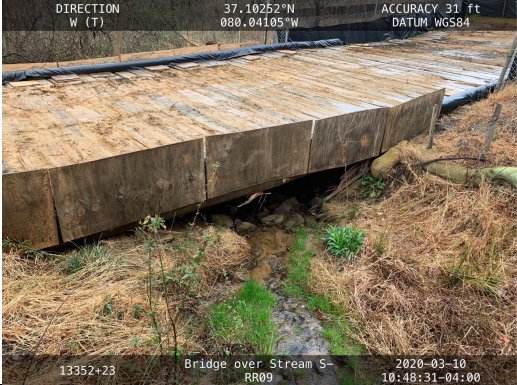
GPS Location	See photo for gps data.		GPS Location	See photo for gps data.	
Field Station#	13352+30		Field Station#	13358+70	
Pic 7 Desc.	Photo shows the bridge over stream S-RR09.		Pic 8 Desc.	Photo shows the bridge over stream S-RR11.

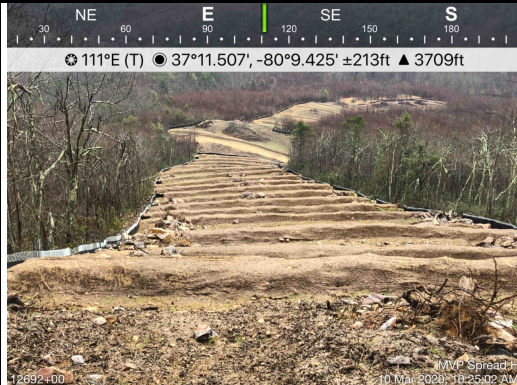
Pic 11 Desc.	ROW on GAS of Honeysuckle remains well stabilized with matting, and no accelerated erosion was observed.		Pic 12 Desc.	Access road MVP-RO-280 is in good condition.

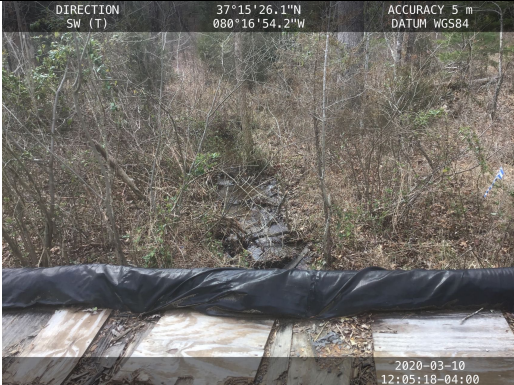
GPS Location	See photo		GPS Location	See photo	
Field Station#	12121+33		Field Station#	12121+83	
Pic 1 Desc.	Stream S-C33, facing southwest, downstream		Pic 2 Desc.	Stream S-C36, facing southwest, downstream

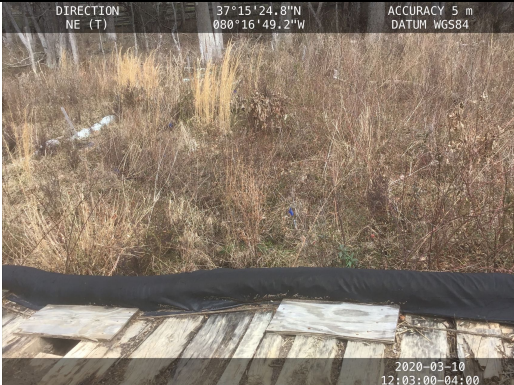
GPS Location	See photo		GPS Location	See photo	
Field Station#	12125+65		Field Station#	12132+73	
Pic 3 Desc.	Stream S-MM31, facing northeast, upstream		Pic 4 Desc.	Stream S-C29, facing northwest

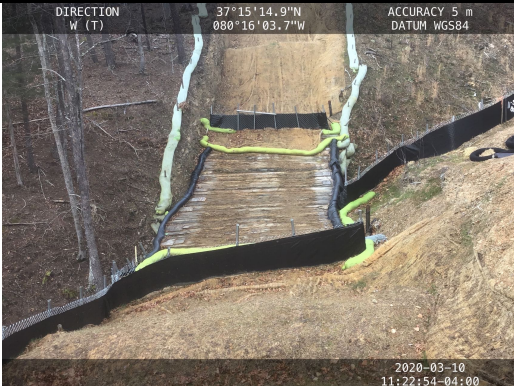
GPS Location	See photo		GPS Location	See photo	
Field Station#	12163+05		Field Station#	12166+47	
Pic 5 Desc.	Stream S-C25, facing west		Pic 6 Desc.	Stream S-C24, facing west

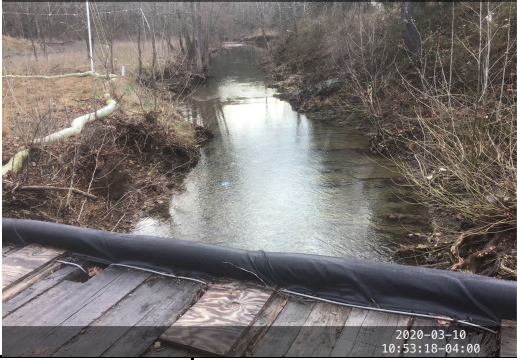
<small>2020-03-10 10:49:01-04:00</small>			
GPS Location	See photo	GPS Location	See photo		
Field Station#	12192+50	Field Station#	12197+37		
Pic 7 Desc.	Stream S-C21, facing south, downstream	Pic 8 Desc.	Stream S-OO11, facing northwest, downstream		
<small>DIRECTION E (T) 37.25311°N 080.25411°W ACCURACY 32 m DATUM WGS84</small>

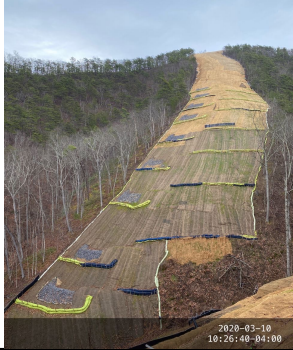
<small>2020-03-10 10:26:40-04:00</small>		<div style="text-align: center;">Insert image here</div>			
GPS Location	See photo	GPS Location			
Field Station#	12215+25	Field Station#			
Pic 9 Desc.	Permanent restoration remains intact and stable below the switchback on Reese Mountain.	Pic 10 Desc.

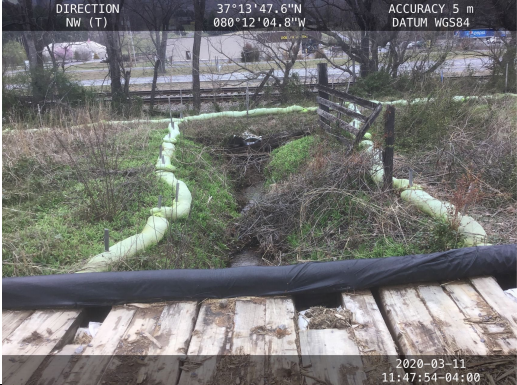
Insert image here			
GPS Location	See photo		GPS Location		
Field Station#	12464+98		Field Station#		
Pic 7 Desc.	Stream S-CD12, facing northwest, downstream		Pic 8 Desc.		
Insert image here			Insert image here		
GPS Location			GPS Location		
Field Station#			Field Station#		
Pic 9 Desc.			Pic 10 Desc.		
Insert image here			Insert image here		
GPS Location			GPS Location		
Field Station#			Field Station#		
Pic 11 Desc.			Pic 12 Desc.

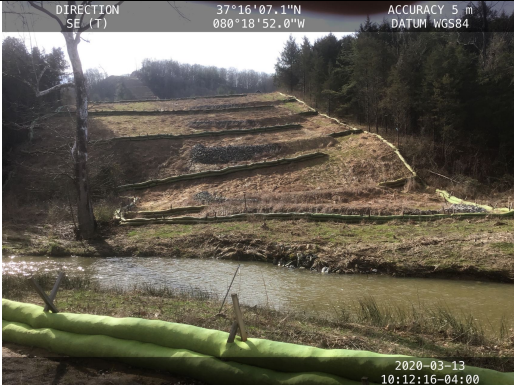
GPS Location	See photo		GPS Location	See photo	
Field Station#	12008+53		Field Station#	12015+84	
Pic 1 Desc.	Stream S-G36, facing southeast		Pic 2 Desc.	Stream S-G38, facing south

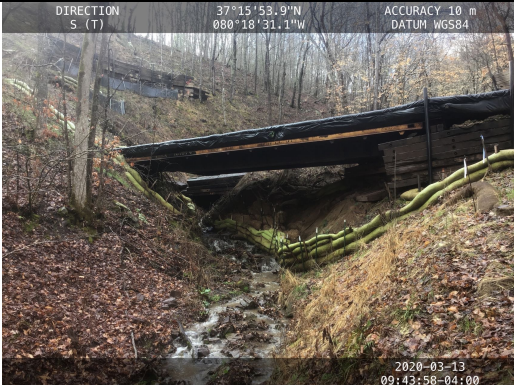
GPS Location	See photo		GPS Location	See photo	
Field Station#	12031+51		Field Station#	12035+75	
Pic 3 Desc.	Stream S-G36, facing south, upstream		Pic 4 Desc.	Stream S-PP23, facing northeast

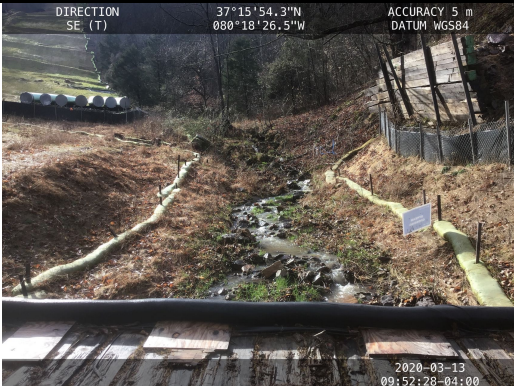
GPS Location	See photo		GPS Location	See photo	
Field Station#	12035+11		Field Station#	12096+95	
Pic 5 Desc.	Stream S-G40, facing southeast, upstream		Pic 6 Desc.	Stream S-MM15, facing northeast

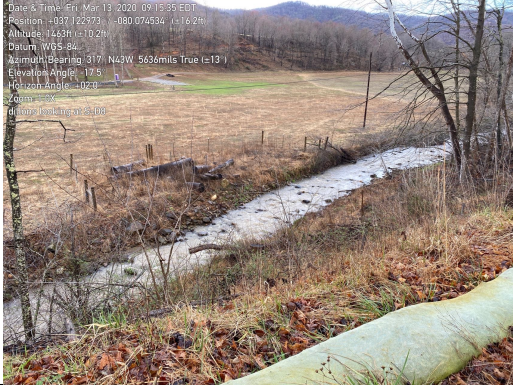
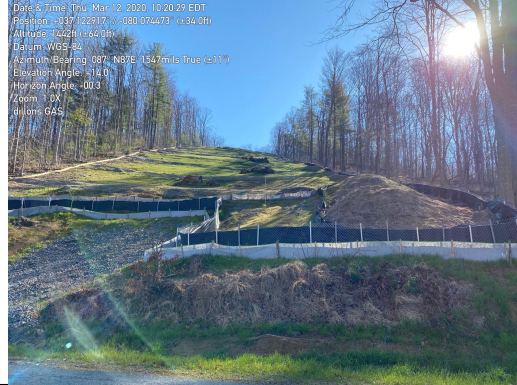
<p>Date & Time: Fri, Mar 13, 2020 09:15:35 EDT Position: +037.125372, -080.074534, +16.2m Altitude: 1453ft (+10.2m) Datum: WGS 84 Azimuth: Bearing: 317, N43W, 563mils True (+13) Elevation Angle: -17.5 Horizon Angle: -02.9 Zoom: 1.0X S-GH7 upstream</p>			<p>Date & Time: Thu, Mar 12, 2020 10:20:29 EDT Position: +037.125372, -080.074473, +15.4m Altitude: 1453ft (+10.2m) Datum: WGS 84 Azimuth: Bearing: 087, N87E, 1547mils True (+14) Elevation Angle: -16.0 Horizon Angle: -00.3 Zoom: 1.0X S-GH7</p>			
GPS Location			See photo for coordinates.			
Field Station#			13197+40			
Pic 1 Desc.			S-D8, looking towards undisturbed ROW, no environmental concerns noted.

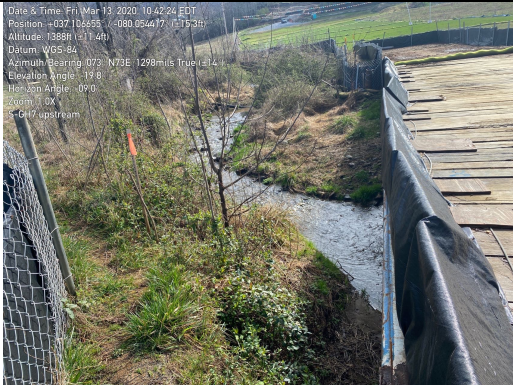
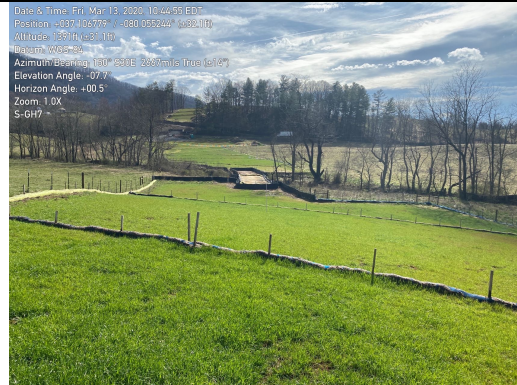
GPS Location			See photo for coordinates.			
Field Station#			13309+09			
Pic 3 Desc.			S-GH7, upstream side of equipment bridge, bridge in good condition, not environmental issues noted at crossing.
