# Visual Site Inspection Report

<b>Project Name</b>	H-600 Pipeline Spread H	<b>AFE</b>	124300138	<b>Spread</b>	H-600 Pipeline Spread H
<b>Contractor</b>	Precision			<b>Report #</b>	10254
<b>Inspector</b>	John Brcic			<b>Date/Time</b>	4/20/2020 8:27 PM
<b>Permit #</b>	TBD	<b>Inspection Type</b>	VA SWPP	<b>Station Begin</b>	12433+75
<b>State</b>	VA	<b>Inspection Area</b>	Partial	<b>Station End</b>	12544+06
<b>County</b>	Montgomery	<b>Ground</b>	Damp	<b>Temperature (°F)</b>	58.00
<b>Municipality</b>	N/A	<b>Weather</b>	Heavy Rain	<b>Rain Gauge (in)</b>	0.60
				<b>Rain Accumulation Time (days)</b>	3.00

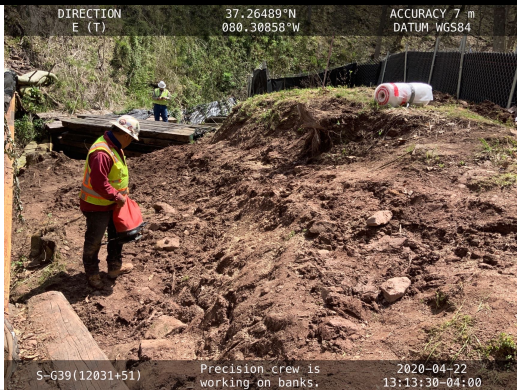
<p style="text-align: center;">Insert image here</p>			
<b>GPS Location</b>	See photo GPS for location		<b>GPS Location</b>		
<b>Field Station#</b>	12031+51		<b>Field Station#</b>		
<b>Pic 9 Desc.</b>	Precision working on bank erosion. Work is in progress.		<b>Pic 10 Desc.</b>		
<p style="text-align: center;">Insert image here</p>			<p style="text-align: center;">Insert image here</p>		
<b>GPS Location</b>			<b>GPS Location</b>		
<b>Field Station#</b>			<b>Field Station#</b>		
<b>Pic 11 Desc.</b>			<b>Pic 12 Desc.</b>

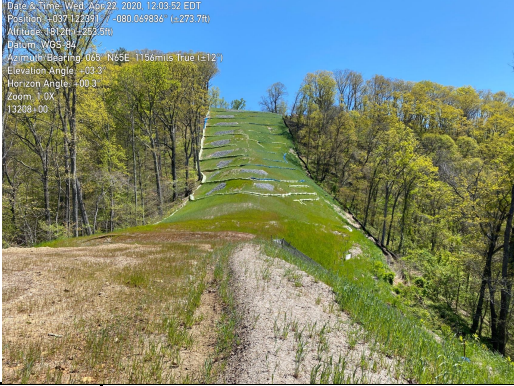
<p>Date &amp; Time: Wed, Apr 22, 2020 12:03:52 EDT Position: 43°37'12.51"N / -88°06'49.38"W (1273.7m) Altitude: 1820ft (554.9m) Datum: WGS 84 Azimuth Bearing: 121° 59'E 215mils True (±12°) Elevation Angle: -21.2° Horizon Angle: -03.0° Zoom: 1.0x S-114 13210+00</p>

<p>Date &amp; Time: Wed, Apr 22, 2020 12:30:41 EDT Position: 43°37'12.02"N / -88°06'52.28"W (1616.3m) Altitude: 1820ft (554.9m) Datum: WGS 84 Azimuth Bearing: 121° 59'E 215mils True (±12°) Elevation Angle: -21.2° Horizon Angle: -03.0° Zoom: 1.0x S-114 13221+00</p>			
<b>GPS Location</b>	See photo for coordinates.		<b>GPS Location</b>	See photo for coordinates.	
<b>Field Station#</b>	13210+00		<b>Field Station#</b>	13221+00	
<b>Pic 1 Desc.</b>	Permanently restored ROW, good vegetative cover noted across LOD.		<b>Pic 2 Desc.</b>	Slip noted along LOD, triple stack CFS perimeter control collapsed, further investigation in process.

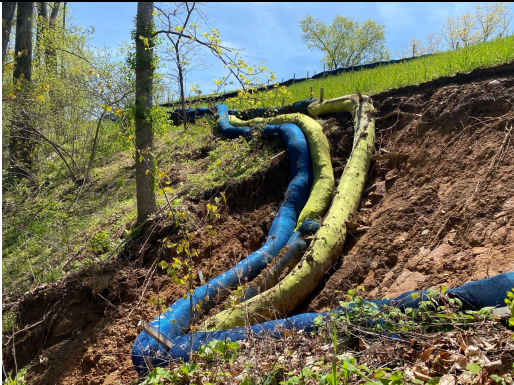
<p>Date &amp; Time: Wed, Apr 22, 2020 13:14:45 EDT Position: 43°37'13.24"N / -88°06'53.27"W (1616.3m) Altitude: 1820ft (554.9m) Datum: WGS 84 Azimuth Bearing: 121° 59'E 215mils True (±12°) Elevation Angle: -21.2° Horizon Angle: -03.0° Zoom: 1.0x S-114 13221+00</p>			
<b>GPS Location</b>	See photo for coordinates.		<b>GPS Location</b>	See photo for coordinates.	
<b>Field Station#</b>	13221+00		<b>Field Station#</b>	13227+00	
<b>Pic 3 Desc.</b>	Slip noted along LOD, triple stack CFS perimeter control collapsed, further investigation in process.		<b>Pic 4 Desc.</b>	Permanently restored ROW, good vegetative cover noted across LOD.

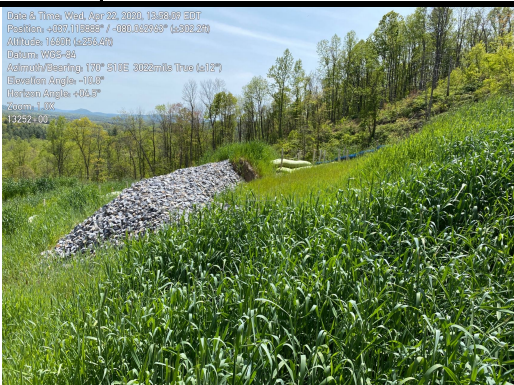
<p>Date &amp; Time: Wed, Apr 22, 2020 13:56:07 EDT Position: 43°37'13.55"N / -88°06'53.47"W (1616.3m) Altitude: 1820ft (554.9m) Datum: WGS 84 Azimuth Bearing: 121° 59'E 215mils True (±12°) Elevation Angle: -21.2° Horizon Angle: -03.0° Zoom: 1.0x S-114 13252+00</p>

<p>Date &amp; Time: Wed, Apr 22, 2020 14:24:24 EDT Position: 43°37'14.55"N / -88°06'53.47"W (1616.3m) Altitude: 1820ft (554.9m) Datum: WGS 84 Azimuth Bearing: 121° 59'E 215mils True (±12°) Elevation Angle: -21.2° Horizon Angle: -03.0° Zoom: 1.0x S-114 13258+00</p>			
<b>GPS Location</b>	See photo for coordinates.		<b>GPS Location</b>	See photo for coordinates.	
<b>Field Station#</b>	13252+00		<b>Field Station#</b>	13258+00	
<b>Pic 5 Desc.</b>	Permanent waterbar stable, good vegetative cover across LOD.		<b>Pic 6 Desc.</b>	CIS S-II4, ECDs along stream functioning acceptably, bridge in acceptable condition.

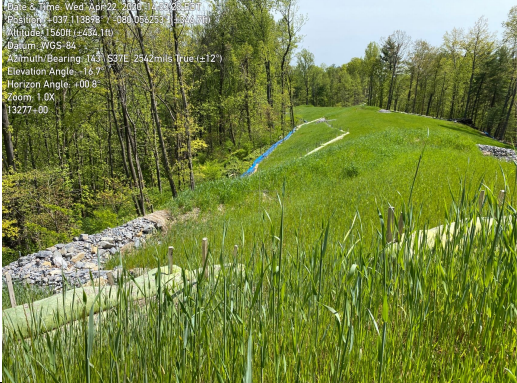
<p>Photo 7 Time: Wed Apr 22 2020 7:33:01 PM Position: +38° 11' 38.8" N / -88° 05' 02.1" W Altitude: 1560 ft (476.1 m) Datum: WGS-84 Magnetic Bearing: 103° 50' E 2342 mls True (±12°) Elevation Angle: +16.7° Horizon Angle: +100.8° Zoom: 1.0X 13277+00</p>

<p>Photo 8 Time: Wed Apr 22 2020 7:33:01 PM Position: +38° 11' 38.8" N / -88° 05' 02.1" W Altitude: 1560 ft (476.1 m) Datum: WGS-84 Magnetic Bearing: 103° 50' E 2342 mls True (±12°) Elevation Angle: +16.7° Horizon Angle: +100.8° Zoom: 1.0X 13301+00</p>			
<b>GPS Location</b>	See photo for coordinates.	<b>GPS Location</b>	See photo for coordinates.		
<b>Field Station#</b>	13277+00	<b>Field Station#</b>	13301+00		
<b>Pic 7 Desc.</b>	Permanent waterbars stable, CFS perimeters functioning acceptably.	<b>Pic 8 Desc.</b>	ROW restored, good vegetative cover noted across LOD.
