Visual Site Inspection Report

Project Name	H-600 Pipeline Spread H	AFE	124300138	Spread	H-600 Pipeline Spread H
Contractor	Precision			Report #	10488
Inspector	Logan Box			Date/Time	4/28/2020 7:00 PM
Permit #	TBD	Inspection Type	VA SWPP	Station Begin	13415+51
State	VA	Inspection Area	Partial	Station End	13670+00
County	Franklin	Ground	Damp	Temperature (°F)	72.00
Municipality	N/A	Weather	Cloudy	Rain Gauge (in)	1.50
				Rain Accumulation Time (days)	6.00

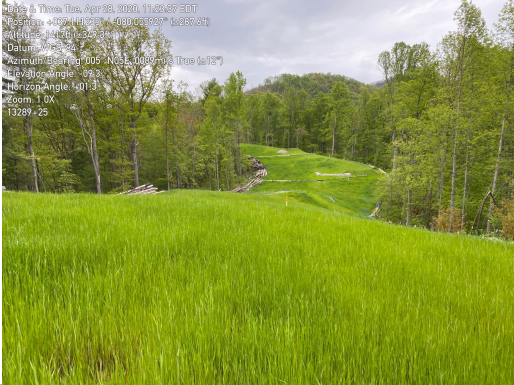
<p>Date & Time: Tue, Apr 28, 2020, 11:45:30 EDT Position: +037.118210° / -080.054455° (+30.10) Altitude: 1420ft (+36.20) Datum: WGS-84 Azimuth/Bearing: 282° N28W 5013mils True (+12°) Elevation Angle: +09.8° Horizon Angle: +01.3° Zoom: 1.0X 13289+25</p>

<p>Date & Time: Tue, Apr 28, 2020, 11:45:30 EDT Position: +037.118210° / -080.054455° (+30.10) Altitude: 1420ft (+36.20) Datum: WGS-84 Azimuth/Bearing: 282° N28W 5013mils True (+12°) Elevation Angle: +09.8° Horizon Angle: +02.5° Zoom: 1.0X 13273+50</p>			
GPS Location	See photo for coordinates.		GPS Location	See photo for coordinates.	
Field Station#	13289+25		Field Station#	13273+50	
Pic 3 Desc.	ROW stable, moderate to good vegetative cover noted across LOD, perimeter controls functioning acceptably.		Pic 4 Desc.	ROW stable, moderate to good vegetative cover noted across LOD, perimeter controls functioning acceptably.
