Visual Site Inspection Report

Project Name	H-600 Pipeline Spread H	AFE	124300138	Spread	H-600 Pipeline Spread H
Contractor	Precision			Report #	9138
Inspector	Tammy Kruizenga			Date/Time	4/6/2020 6:21 AM
Permit #	TBD	Inspection Type	VA SWPP	Station Begin	12005+00
State	VA	Inspection Area	Partial	Station End	12119+17
County	Montgomery	Ground	Wet	Temperature (°F)	70.00
Municipality	N/A	Weather	Light Rain	Rain Gauge (in)	0.00
				Rain Accumulation Time (days)	1.00

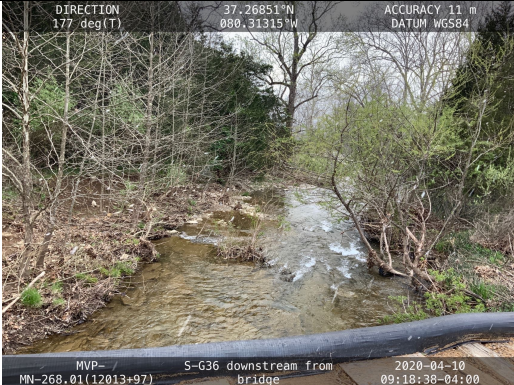
<p>DIRECTION 177 deg(T) 37.26851°N 080.31315°W ACCURACY 11 m DATUM WGS84</p> <p>MVP- MN-268.01(12013+97) S-G36 downstream from bridge 2020-04-10 09:18:38-04:00</p>

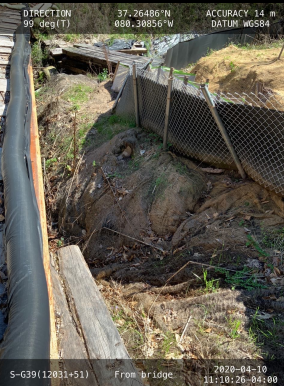
Field Station#	12031+51		Field Station#	12031+51	
Pic 3 Desc.	ECDs surrounding this stream are functioning adequately at this time.		Pic 4 Desc.	ECDs on the CIS of this stream are functioning adequately at this time.

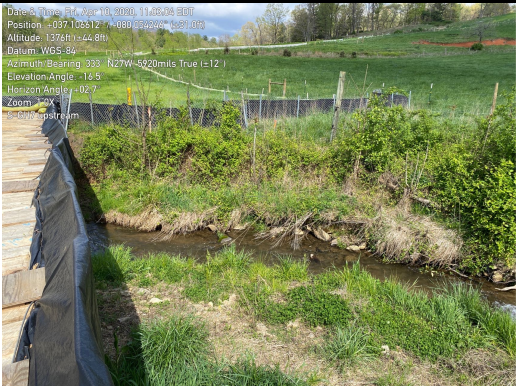
<p>Date & Time: Fri, Apr 10, 2020, 11:45:04 EDT Position: +037 102312 / -080 05594 (±18.9ft) Altitude: 1376ft (±4.6ft) Datum: WGS-84 Azimuth/Bearing: 333° N33W 5920mils True (±12°) Elevation Angle: -16.5° Horizon Angle: -02.7° Zoom: 1.0X 13309+09</p>

Field Station#	13309+09		Field Station#	13262+50	
Pic 5 Desc.	S-GH7, upstream side of equipment bridge, native stream material noted depositing under bridge on right descending bank.		Pic 6 Desc.	Flanders Road, ECDs functioning acceptably, road and RCE in acceptable condition.
