Visual Site Inspection Report

Project Name	H-600 Pipeline Spread I	AFE	124300139	Spread	H-600 Pipeline Spread I	
Contractor	Precision			Report #	6967	
Inspector	Glenn Mike Renfro			Date/Time	12/31/2019 7:08 PM	
Permit #	TBD	Inspection Type	VA SWPP	Station Begin	0000+00	
State	VA	Inspection Area	Full	Station End	0000+00	
County	Franklin	Ground	Wet	Temperature (°F)	58.00	
Municipality	N/A	Weather	Light Rain	Rain Gauge (in)	0.40	
				Rain Accumulation Time (days)	6.00

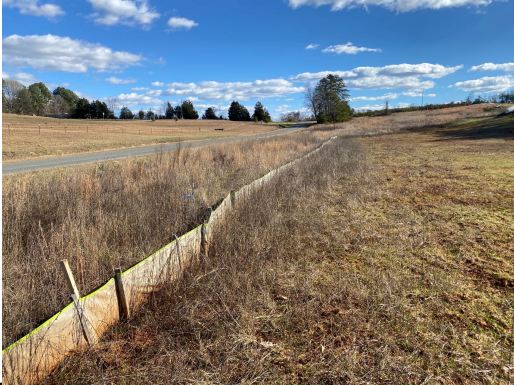
GPS Location	0	GPS Location	0		
Field Station#	15621+00	Field Station#	15629+00		
Pic 1 Desc.	Vegetation growing well along stabilized areas.	Pic 2 Desc.	CWD inlet in good working condition.

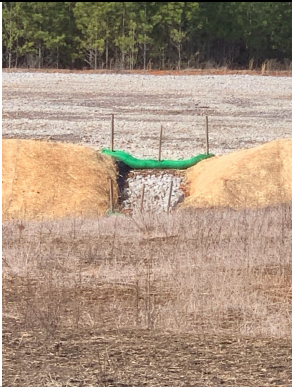
GPS Location	O	GPS Location	O		
Field Station#	00+00	Field Station#	00+00		
Pic 1 Desc.	Observing RCE.	Pic 2 Desc.	Observing outlet and outlet protection.
