Visual Site Inspection Report

Project Name	H-600 Pipeline Spread I	AFE	124300139	Spread	H-600 Pipeline Spread I
Contractor	Precision			Report #	9612
Inspector	Ben Davenport			Date/Time	3/31/2020 5:00 PM
Permit #	TBD	Inspection Type	VA SWPP	Station Begin	14928+52
State	VA	Inspection Area	Partial	Station End	15296+00
County	Franklin/Pittsylvania	Ground	Wet	Temperature (°F)	49.00
Municipality	Chatham	Weather	Heavy Rain	Rain Gauge (in)	0.00
				Rain Accumulation Time (days)	0.00

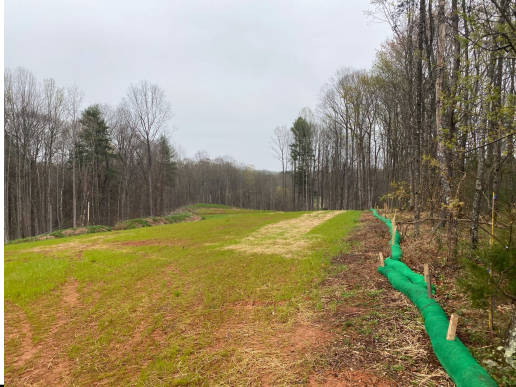
GPS Location	0	GPS Location	0		
Field Station#	14026+75	Field Station#	13855+00		
Pic 3 Desc.	Approximately 14026+75. Overview of ROW. ROW temporarily stabilized and has winter vegetation growing.		Pic 4 Desc.	Approximately 13855+00. Overview of ROW. ROW temporarily stabilized and has winter vegetation growing.	
Insert image here			Insert image here		
GPS Location		GPS Location			
Field Station#		Field Station#			
Pic 5 Desc.		Pic 6 Desc.
