Visual Site Inspection Report

Project Name	H-600 Pipeline Spread I	AFE	124300139	Spread	H-600 Pipeline Spread I
Contractor	Precision			Report #	9739
Inspector	Ben Davenport			Date/Time	4/6/2020 5:00 PM
Permit #	TBD	Inspection Type	VA SWPP	Station Begin	14928+55
State	VA	Inspection Area	Partial	Station End	15296+00
County	Franklin/Pittsylvania	Ground	Dry	Temperature (°F)	75.00
Municipality	Chatham	Weather	Sunny	Rain Gauge (in)	4.00
				Rain Accumulation Time (days)	0.90

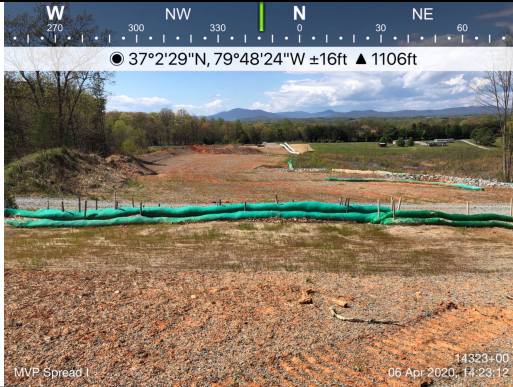
GPS Location	0	GPS Location	0		
Field Station#	14189+50	Field Station#	14189+50		
Pic 1 Desc.	Stake is broken on P1 silt fence	Pic 2 Desc.	P1 silt fence has holes in it .

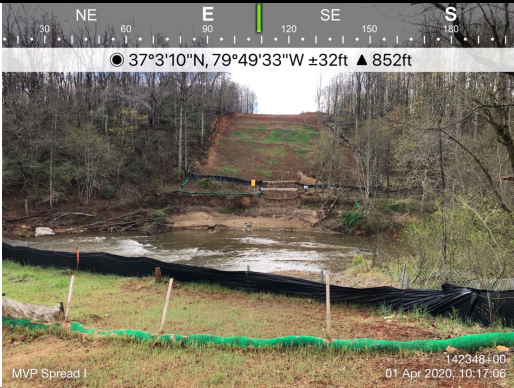
GPS Location	0	GPS Location	0		
Field Station#	14181+00	Field Station#	14323+00		
Pic 3 Desc.	Super silt fence has holes in it .	Pic 4 Desc.	CFS in acceptable condition

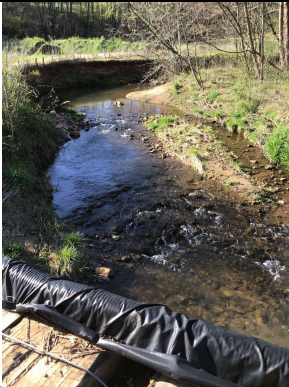
GPS Location	00000	GPS Location	00000		
Field Station#	13755+49	Field Station#	13755+49		
Pic 3 Desc.	Stream crossing photo facing upstream	Pic 4 Desc.	Stream crossing photo facing downstream		
Insert image here			Insert image here		
GPS Location		GPS Location			
Field Station#		Field Station#			
Pic 5 Desc.		Pic 6 Desc.

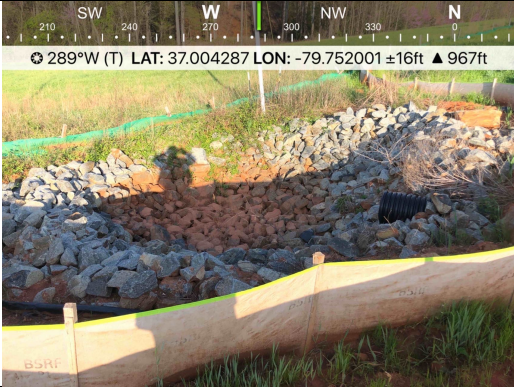
GPS Location	0	GPS Location	0		
Field Station#	14550+00	Field Station#	14568+10		
Pic 1 Desc.	Plunge pool functioning as intended	Pic 2 Desc.	Equipment bridge clean at stream S-E18

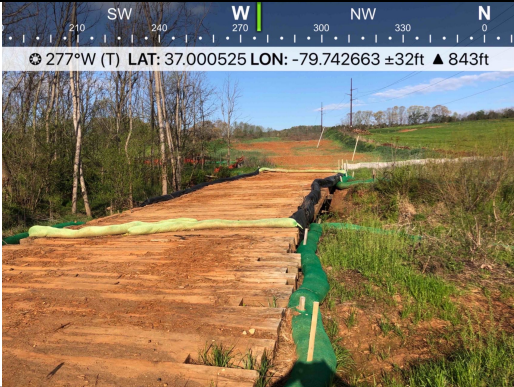
GPS Location	0	GPS Location	0		
Field Station#	14582+85	Field Station#	14585+00		
Pic 3 Desc.	Equipment bridge clean at stream S-E17	Pic 4 Desc.	Contractor seeded and mulched areas that were disturbed while installing perimeter fence

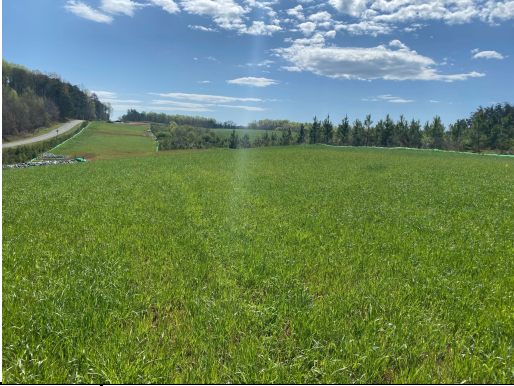
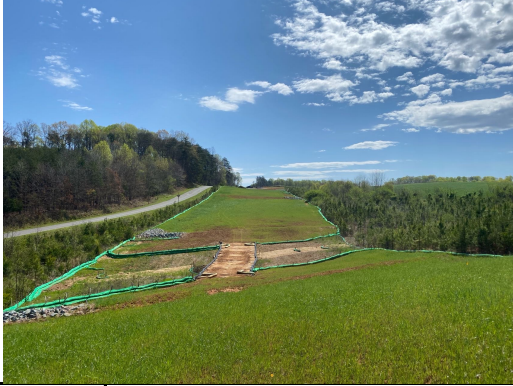
GPS Location	0	GPS Location	0		
Field Station#	15360+00	Field Station#	15365+00		
Pic 1 Desc.	Permanent vegetation.	Pic 2 Desc.	Permanent vegetation.

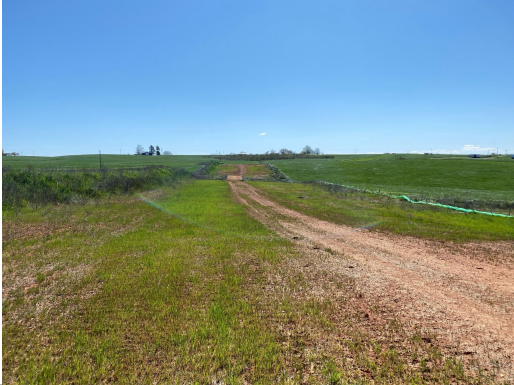
GPS Location	0	GPS Location	0		
Field Station#	15470+00	Field Station#	15353+00		
Pic 3 Desc.	Temporary vegetation along ROW.	Pic 4 Desc.	Temporary vegetation along spoil piles.

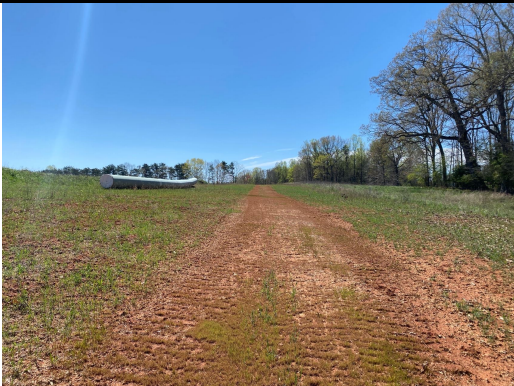
GPS Location	0	GPS Location	0		
Field Station#	15640+00	Field Station#	15346+87		
Pic 5 Desc.	Temporary vegetation.	Pic 6 Desc.	Stream crossing S-H13

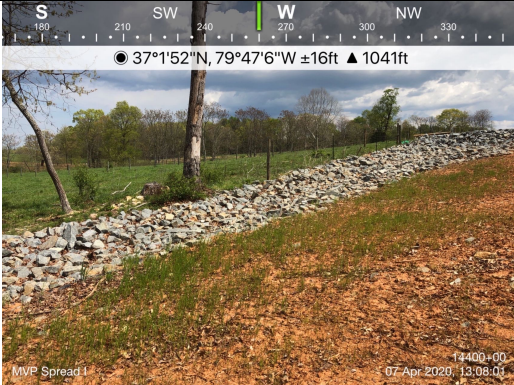
GPS Location	0	GPS Location	0		
Field Station#	14400+00	Field Station#	14496+64		
Pic 1 Desc.	Rock lined Channel in acceptable condition		Pic 2 Desc.	Equipment bridge in acceptable condition

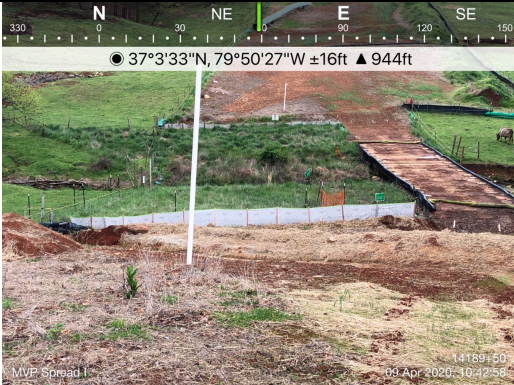
GPS Location	0	GPS Location	0		
Field Station#	14189+50	Field Station#	14531+58		
Pic 3 Desc.	P1 silt fence in acceptable condition		Pic 4 Desc.	Equipment bridge in acceptable condition

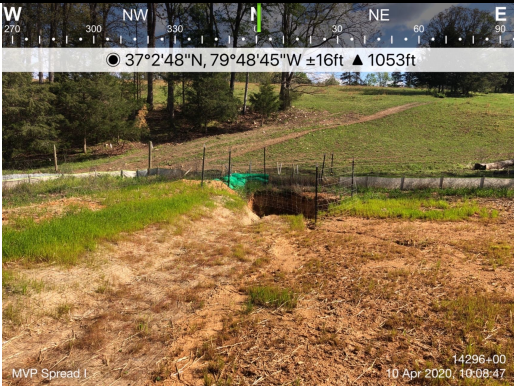
GPS Location	0	GPS Location	0		
Field Station#	14296+00	Field Station#	14278+50		
Pic 5 Desc.	Waterbar in acceptable condition		Pic 6 Desc.	Erosion control blanket in acceptable condition

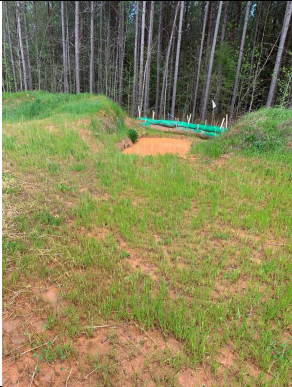
GPS Location	O	GPS Location	O		
Field Station#	15940+00	Field Station#	15936+00		
Pic 1 Desc.	Observing CFS that requires maintenance.	Pic 2 Desc.	Observing sump and end treatment.

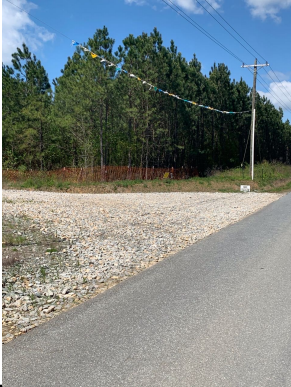
GPS Location	O	GPS Location	O		
Field Station#	00+00	Field Station#	15935+00		
Pic 3 Desc.	Observing RCE at Transco.	Pic 4 Desc.	Observing stabilized stock pile.		
Insert image here			Insert image here		
GPS Location		GPS Location			
Field Station#		Field Station#			
Pic 5 Desc.		Pic 6 Desc.

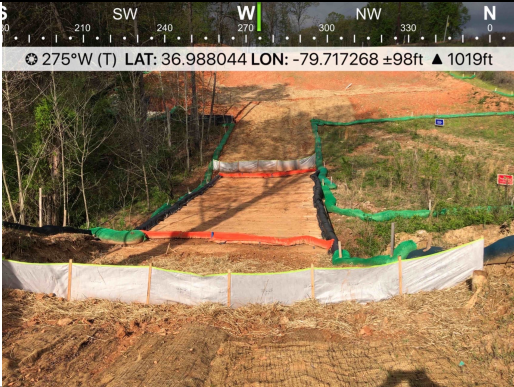
GPS Location	0	GPS Location	0		
Field Station#	14773+10	Field Station#	14722+60		
Pic 3 Desc.	Equipment bridge clean at stream S-H37		Pic 4 Desc.	Equipment bridge clean at stream S-A18

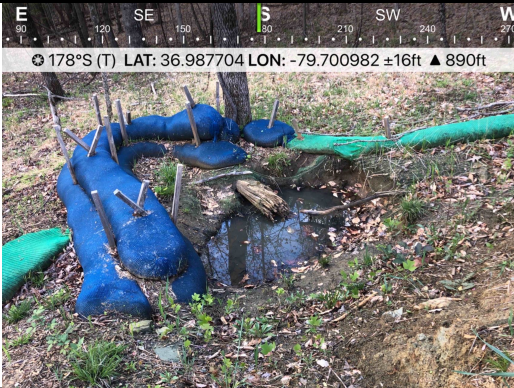
GPS Location	0	GPS Location	0		
Field Station#	14726+00	Field Station#	14727+62		
Pic 5 Desc.	Sump pit functioning as intended		Pic 6 Desc.	Equipment bridge clean at stream S-A19

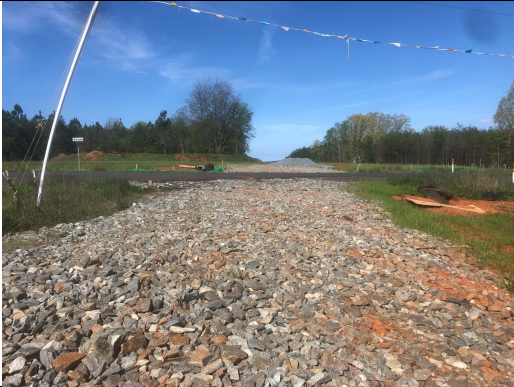
GPS Location	1	GPS Location	2		
Field Station#	14981+55	Field Station#	15113+00		
Pic 1 Desc.	RCE at Snow Creek Rd in good condition.	Pic 2 Desc.	RCE at Museville Rd in good condition.

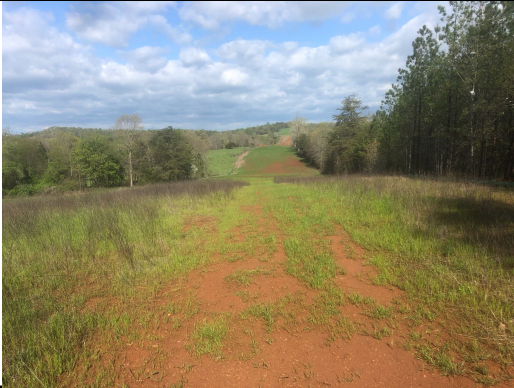
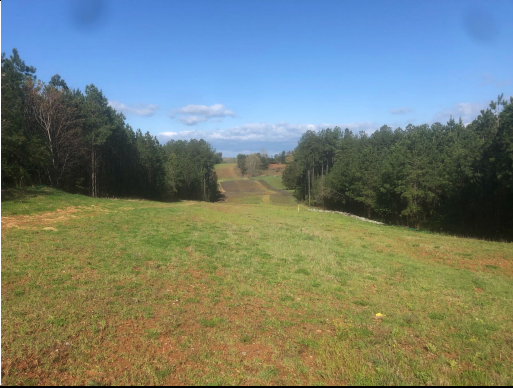
GPS Location	5	GPS Location	6		
Field Station#	15176+00	Field Station#	15207+00		
Pic 5 Desc.	Permanent vegetation area. Will continue to monitor growth during growing season.	Pic 6 Desc.	Permanent vegetation area. Will continue to monitor growth during growing season.

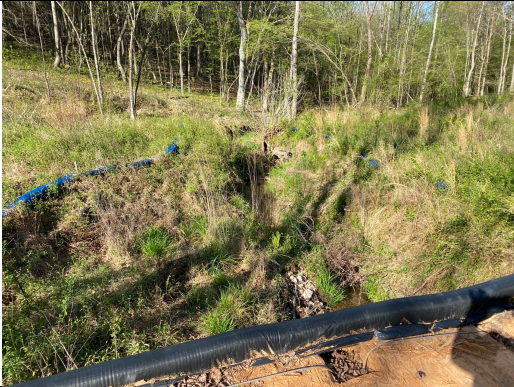
GPS Location	0	GPS Location	0		
Field Station#	15435+09	Field Station#	15448+00		
Pic 1 Desc.	Stream S-G3	Pic 2 Desc.	Stream S-CC16

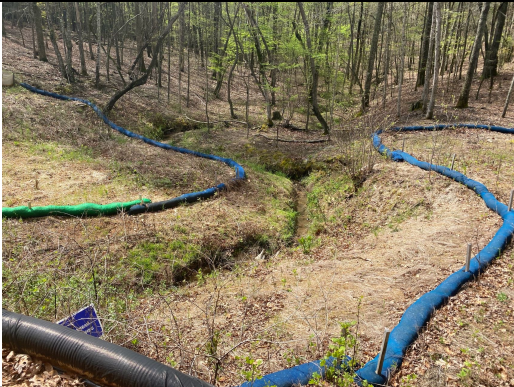
GPS Location	0	GPS Location	0		
Field Station#	15414+00	Field Station#	15463+00		
Pic 3 Desc.	Stream S-G5	Pic 4 Desc.	Stabilized spoil pile.		
 		Insert image here			
GPS Location	0	GPS Location			
Field Station#	15298+00	Field Station#			
Pic 5 Desc.	Stabilized spoil pile.	Pic 6 Desc.

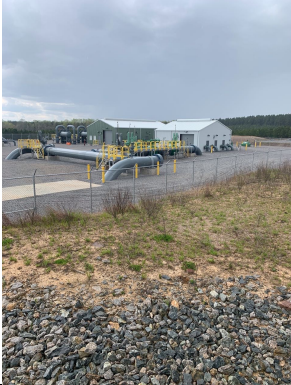
GPS Location	O	GPS Location	O		
Field Station#	00+00	Field Station#	00+00		
Pic 1 Desc.	Observing The Transco Facility.	Pic 2 Desc.	Observing ECD's performing as they should.

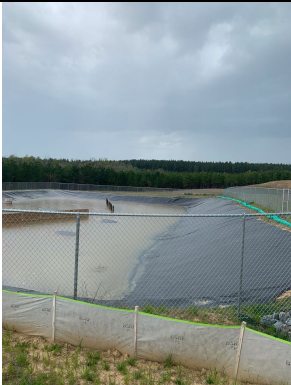
GPS Location	O	GPS Location	O		
Field Station#	00+00	Field Station#	00+00		
Pic 3 Desc.	Observing storm water pond.	Pic 4 Desc.	Observing ECD's performing as they should.		
Insert image here			Insert image here		
GPS Location		GPS Location			
Field Station#		Field Station#			
Pic 5 Desc.		Pic 6 Desc.
