## Visual Site Inspection Report

<b>Project Name</b>	H-600 Pipeline Spread G	<b>AFE</b>	124300137	<b>Spread</b>	H-600 Pipeline Spread G
<b>Contractor</b>	Precision			<b>Report #</b>	11860
<b>Inspector</b>	Jared Saunders			<b>Date/Time</b>	6/15/2020 2:41 PM
<b>Permit #</b>	TBD	<b>Inspection Type</b>	VA SWPP	<b>Station Begin</b>	12005+00
<b>State</b>	VA	<b>Inspection Area</b>	Partial	<b>Station End</b>	12005+00
<b>County</b>	Giles	<b>Ground</b>	Muddy	<b>Temperature (°F)</b>	60.00
<b>Municipality</b>	N/A	<b>Weather</b>	Light Rain	<b>Rain Gauge (in)</b>	1.20
				<b>Rain Accumulation Time (days)</b>	1.00

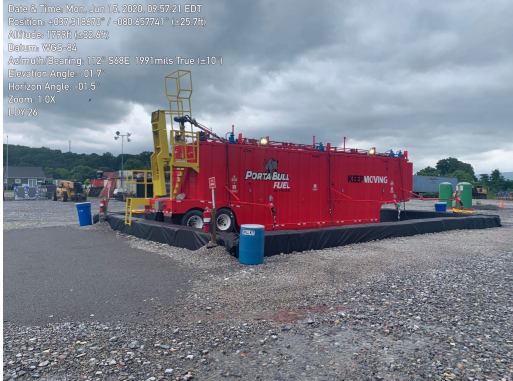
GPS Location	See photo for GPS location.		GPS Location	See photo for GPS location.	
Field Station#	12005+00		Field Station#	12005+00	
Pic 3 Desc.	Secondary containment in place under fuel cell.		Pic 4 Desc.	Rain gauge at Craig Creek Road reads 1.1 inches.

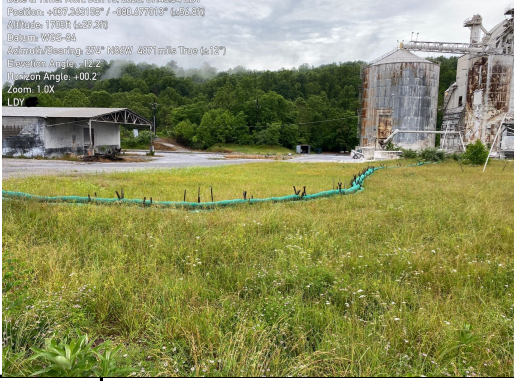
<b>GPS Location</b>	3	<b>GPS Location</b>	4		
<b>Field Station#</b>	12005+00	<b>Field Station#</b>	12005+00		
<b>Pic 3 Desc.</b>	Perimeter controls in the lower section of LDY 29 functional.		<b>Pic 4 Desc.</b>	Perimeter controls in the lower section of LDY 29 functional.

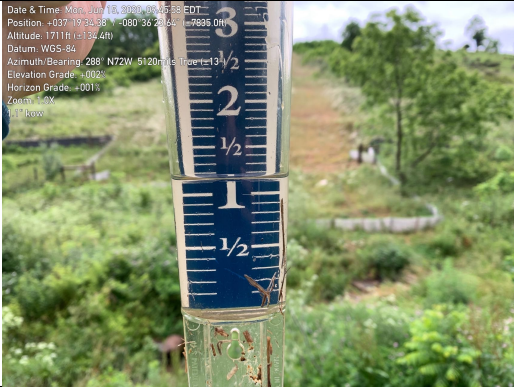
<b>GPS Location</b>	See picture above for GPS coordinates		<b>GPS Location</b>	See picture above for GPS coordinates	
<b>Field Station#</b>	+1		<b>Field Station#</b>	+2	
<b>Pic 1 Desc.</b>	1.1" of rain recorded @ Kow Camp		<b>Pic 2 Desc.</b>	.8" of rain recorded @ AR 244

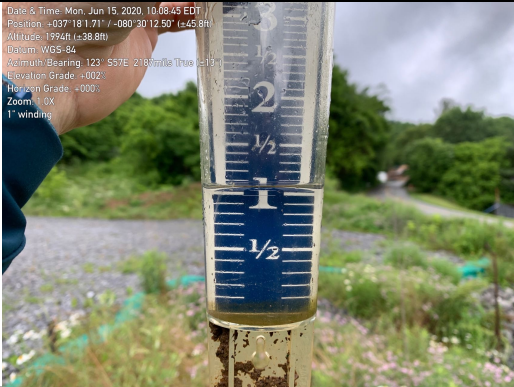
<b>GPS Location</b>	See picture above for GPS coordinates		<b>GPS Location</b>	See picture above for GPS coordinates	
<b>Field Station#</b>	+3		<b>Field Station#</b>	12005+00	
<b>Pic 3 Desc.</b>	1" of rain recorded @ Winding Way		<b>Pic 4 Desc.</b>	ECD's and row conditions

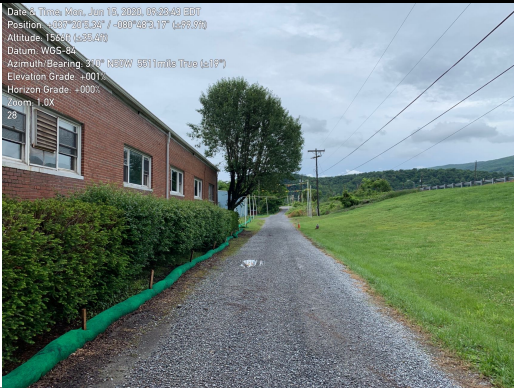
<b>GPS Location</b>	See picture above for GPS coordinates		<b>GPS Location</b>	See picture above for GPS coordinates	
<b>Field Station#</b>	12005+00		<b>Field Station#</b>	12005+00	
<b>Pic 5 Desc.</b>	ECD's and row conditions		<b>Pic 6 Desc.</b>	ECD's and row conditions

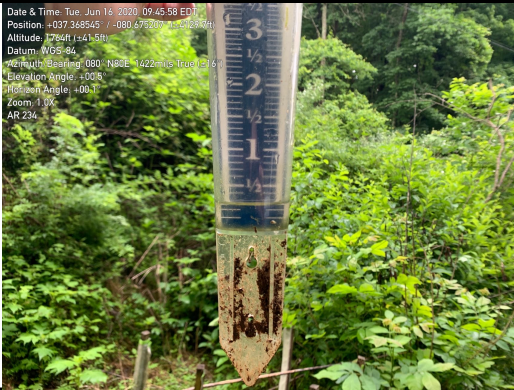
<b>GPS Location</b>	See photo for GPS location.		<b>GPS Location</b>	See photo for GPS location.	
<b>Field Station#</b>	12005+00		<b>Field Station#</b>	11696+00	
<b>Pic 5 Desc.</b>	Rain gauge at Access Road 234 reads 0.3 inches.		<b>Pic 6 Desc.</b>	RCE in place at Buffalo Anklets Road.

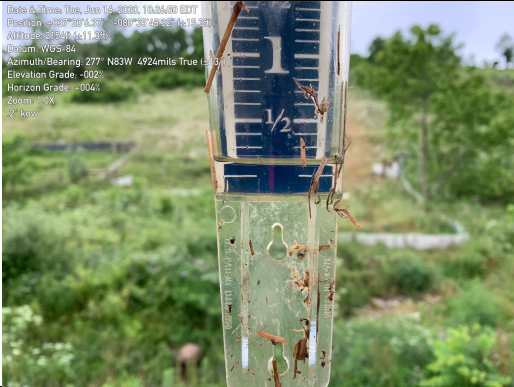
<b>GPS Location</b>	See picture above for GPS coordinates		<b>GPS Location</b>	See picture above for GPS coordinates	
<b>Field Station#</b>	+1		<b>Field Station#</b>	+1	
<b>Pic 1 Desc.</b>	.2" of rain recorded @ Kow Camp		<b>Pic 2 Desc.</b>	.25" of rain recorded @ Catawba

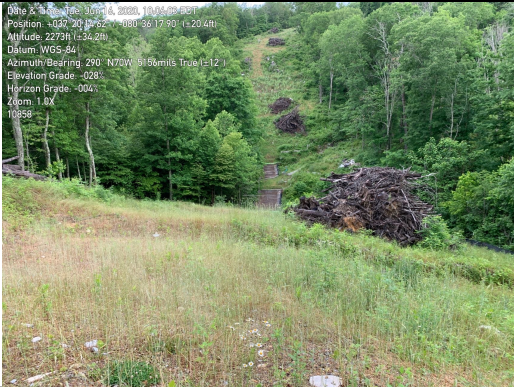
<b>GPS Location</b>	See picture above for GPS coordinates		<b>GPS Location</b>	See picture above for GPS coordinates	
<b>Field Station#</b>	10858+00		<b>Field Station#</b>	10875+00	
<b>Pic 3 Desc.</b>	ECD's and row conditions		<b>Pic 4 Desc.</b>	ECD's and row conditions

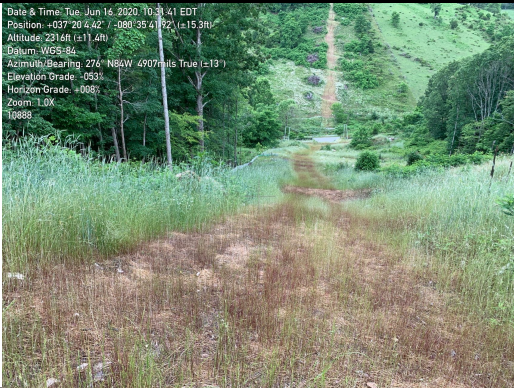
<b>GPS Location</b>	See picture above for GPS coordinates		<b>GPS Location</b>	See picture above for GPS coordinates	
<b>Field Station#</b>	10888+00		<b>Field Station#</b>	10898+00	
<b>Pic 5 Desc.</b>	ECD's and row conditions		<b>Pic 6 Desc.</b>	ECD's and row conditions

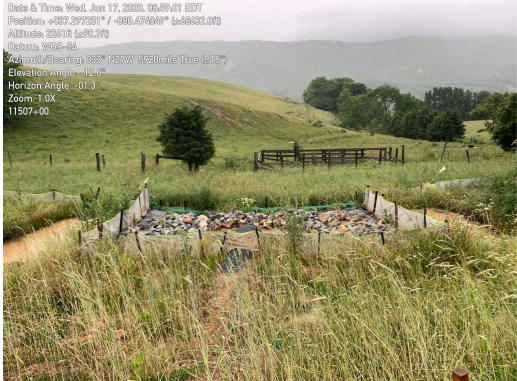
<p>Date &amp; Time: Wed, Jun 17, 2020, 08:58:00 EDT Position: +037.297281° / -080.43494° (±6632.0ft) Altitude: 2241ft (±683.2ft) Datum: WGS-84 Azimuth/Bearing: 335° N45°W 500mils True (±16°) Elevation Angle: -12.0° Horizon Angle: -01.3° Zoom: 1.0X 11489+00</p>			
GPS Location	See photo for GPS location.		GPS Location	See photo for GPS location.	
Field Station#	11507+00		Field Station#	11489+00	
Pic 1 Desc.	Clean water diversion pipe and plunge pool in place.		Pic 2 Desc.	RCE in place at Stevers Gap Road in place.

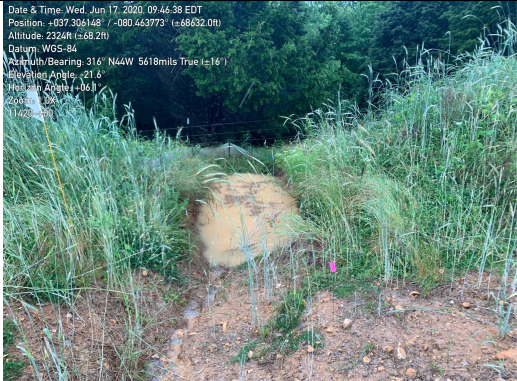
GPS Location	See photo for GPS location.		GPS Location	See photo for GPS location.	
Field Station#	11489+00		Field Station#	11428+00	
Pic 3 Desc.	Rain gauge at Stevers Gap Road reads 1.5 inches.		Pic 4 Desc.	Priority one silt fence stake broken at end treatment.

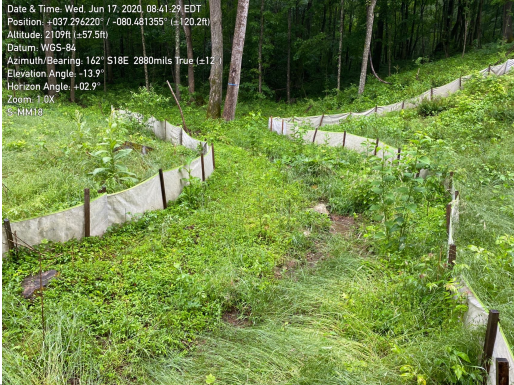
<b>GPS Location</b>	3	<b>GPS Location</b>	4		
<b>Field Station#</b>	11292+80	<b>Field Station#</b>	11327+85		
<b>Pic 3 Desc.</b>	S-MM18 and controls.		<b>Pic 4 Desc.</b>	S-NN12 and controls.

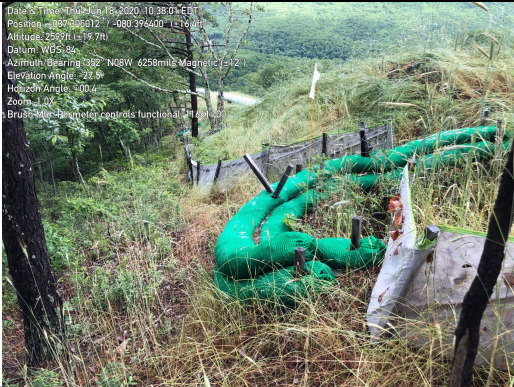
<b>GPS Location</b>	On photo	<b>GPS Location</b>	On photo		
<b>Field Station#</b>	11661+00	<b>Field Station#</b>	11646+00		
<b>Pic 3 Desc.</b>	End treatments and perimeter controls are in place and effective	<b>Pic 4 Desc.</b>	ROW stable. Slope breakers in place and functioning

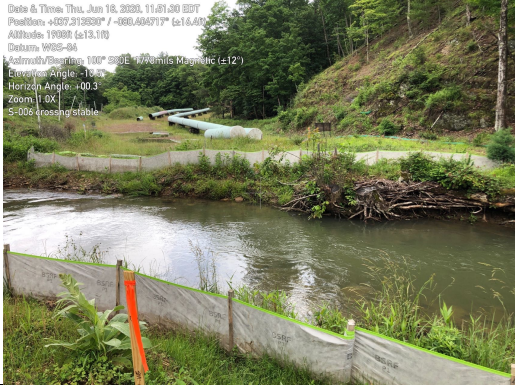
<p><small>Date &amp; Time: Thu, Jun 18, 2020, 11:49:00 EDT Position: +037.313530° / -080.404971° (±14.4ft) Altitude: 1908ft (±13.1ft) Datum: WGS-84 Azimuth/Bearing: 158° S27E 1970mils Magnetic (±12°) Elevation Angle: -16.3° Horizon Angle: +00.3° Zoom: 1.0X S-006 crossing stable</small></p>			
<b>GPS Location</b>	On photo	<b>GPS Location</b>	On photo		
<b>Field Station#</b>	11613+69	<b>Field Station#</b>	11607+81		
<b>Pic 7 Desc.</b>	S-RR13 crossing stable with environmental controls in place	<b>Pic 8 Desc.</b>	S-006 crossing stable with environmental controls in place

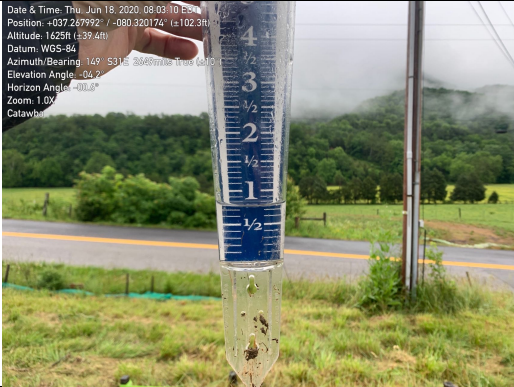
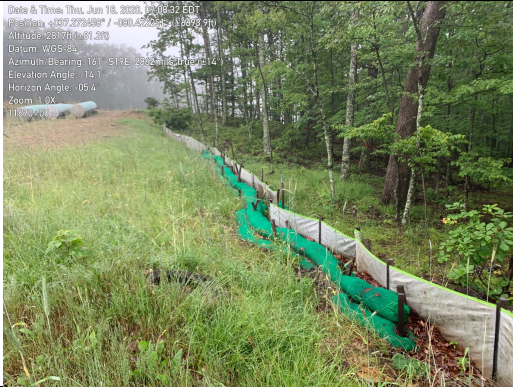
<b>GPS Location</b>	See photo for GPS location.		<b>GPS Location</b>	See photo for GPS location.	
<b>Field Station#</b>	11990+00		<b>Field Station#</b>	11670+00	
<b>Pic 1 Desc.</b>	Rain gauge at Catawba Road reads 0.8 inches.		<b>Pic 2 Desc.</b>	Triple stack compost filter sock and priority one silt fence in place along LOD.

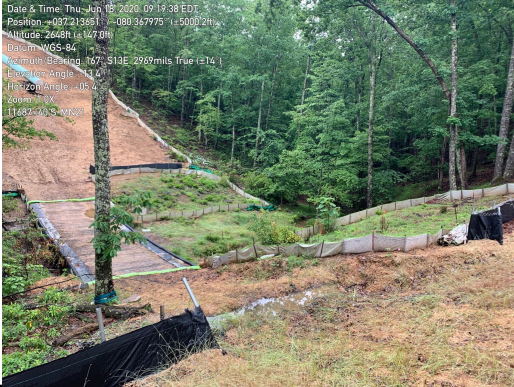
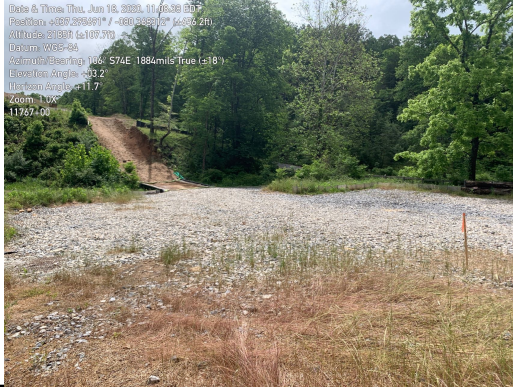
<b>GPS Location</b>	See photo for GPS location.		<b>GPS Location</b>	See photo for GPS location.	
<b>Field Station#</b>	11687+40		<b>Field Station#</b>	11767+00	
<b>Pic 3 Desc.</b>	Sensitive resource buffer in place at stream S-MN21.		<b>Pic 4 Desc.</b>	RCE in place at Main Line Valve 26.

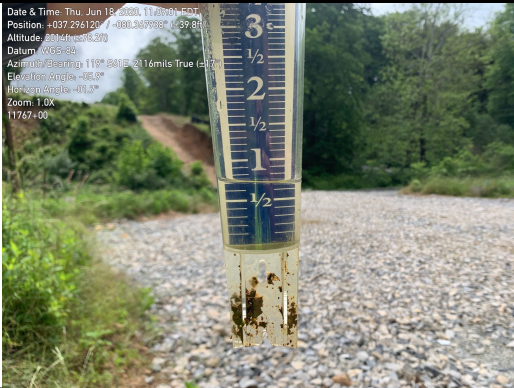
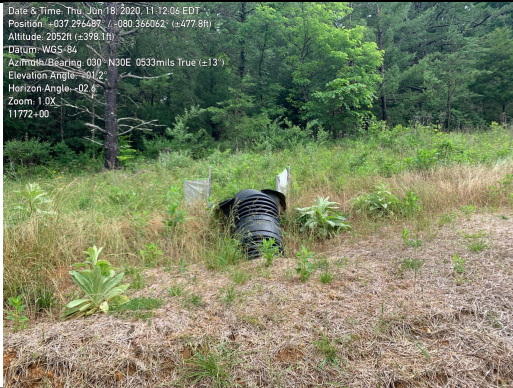
<b>Pic 5 Desc.</b>	Rain gauge at Mount Tabor Road reads 0.7 inches.		<b>Pic 6 Desc.</b>	Clean water diversion pipe inlet and clean water diversion berm in place.

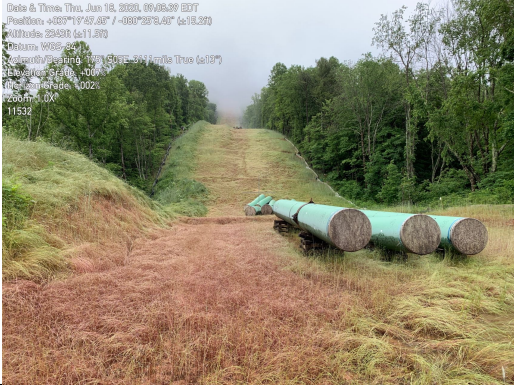
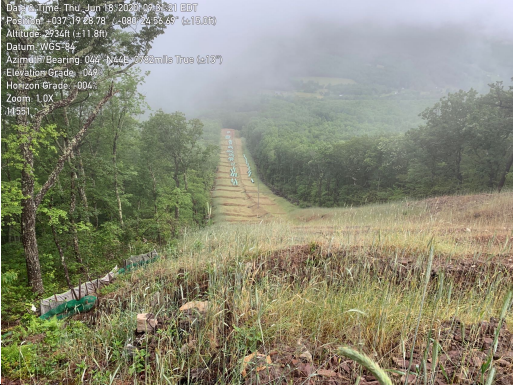
<b>GPS Location</b>	See picture above for GPS coordinates		<b>GPS Location</b>	See picture above for GPS coordinates	
<b>Field Station#</b>	11532+00		<b>Field Station#</b>	11551+00	
<b>Pic 1 Desc.</b>	ECD's and row conditions		<b>Pic 2 Desc.</b>	ECD's and row conditions

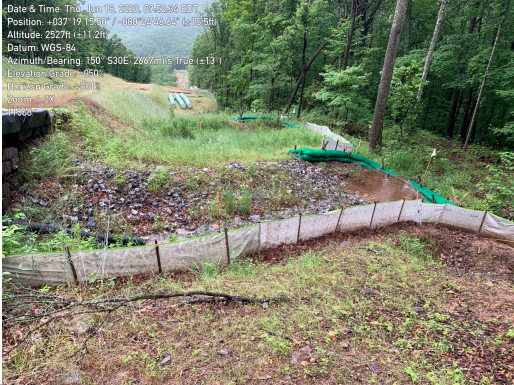
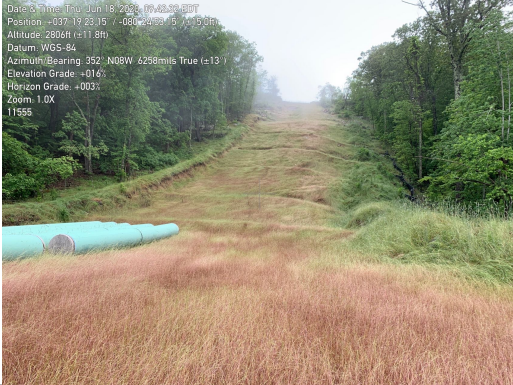
<b>GPS Location</b>	See picture above for GPS coordinates		<b>GPS Location</b>	See picture above for GPS coordinates	
<b>Field Station#</b>	11568+00		<b>Field Station#</b>	11555+00	
<b>Pic 3 Desc.</b>	ECD's and row conditions		<b>Pic 4 Desc.</b>	ECD's and row conditions

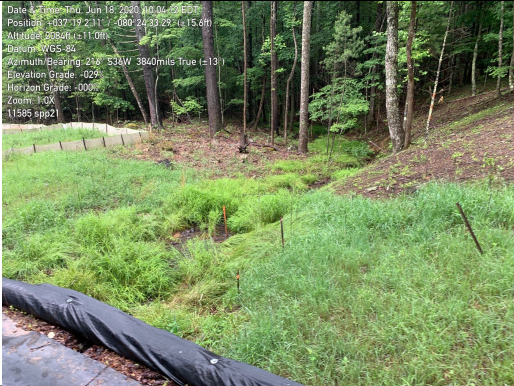
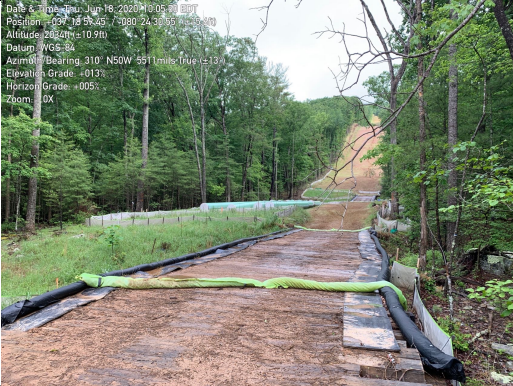
<b>GPS Location</b>	See picture above for GPS coordinates		<b>GPS Location</b>	See picture above for GPS coordinates	
<b>Field Station#</b>	11585+00		<b>Field Station#</b>	11589+00	
<b>Pic 5 Desc.</b>	ECD's and row conditions		<b>Pic 6 Desc.</b>	ECD's and row conditions

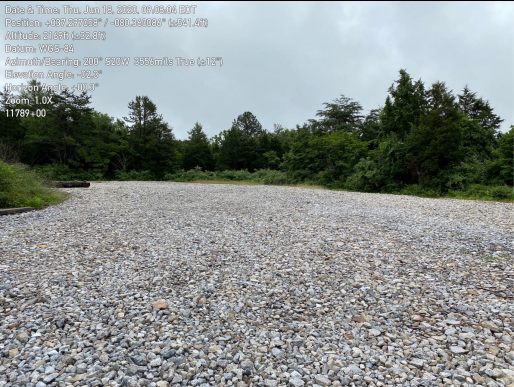
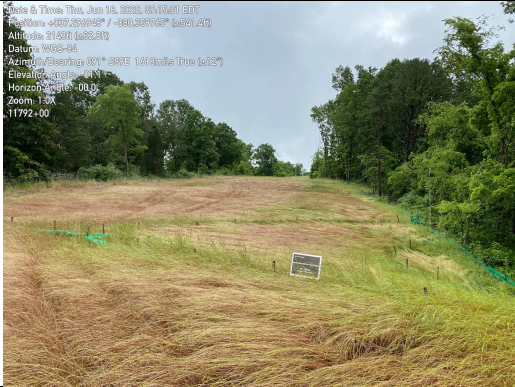
</div></div>			
GPS Location	1	GPS Location	2		
Field Station#	11789+00	Field Station#	11792+00		
Pic 1 Desc.	RCE on the South side of Mt Tabor Rd.		Pic 2 Desc.	Section of restored RoW showing conditions and controls.	
<div><div><div>Date &amp; Time: Thu, Jun 18, 2020, 05:45:44 EDT Position: +45° 29' 59.57" / -80.29999° (-801.47) Altitude: 22231 (+22.87) Datum: WGS-84 Adm/Br/Bearing: 161° 330W 330mils True (+12°) Elevation Angle: -0.3° Horizon Angle: -0.3° Zoom: 1.0X 11828+00</div>

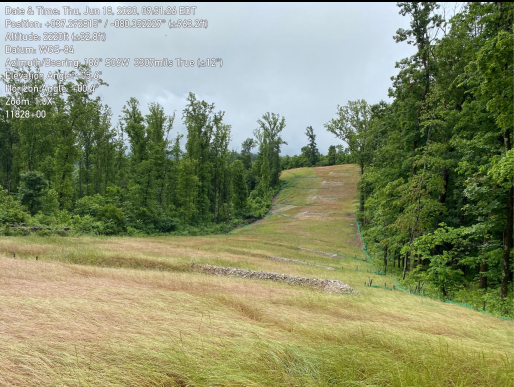
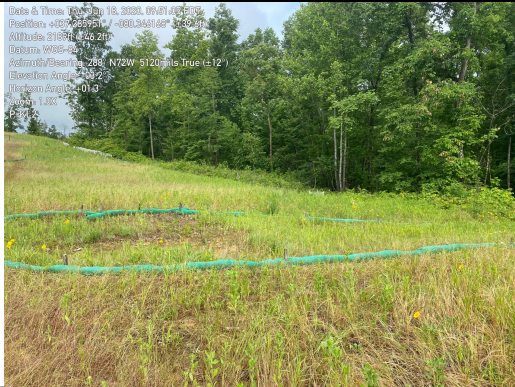
GPS Location	3	GPS Location	4		
Field Station#	11828+00	Field Station#	11863+65		
Pic 3 Desc.	Section of restored RoW showing conditions and controls.		Pic 4 Desc.	P-KL2 and controls.	
<div><div><div>Date &amp; Time: Thu, Jun 18, 2020, 10:16:12 EDT Position: +45° 29' 59.67" / -80.29999° (-801.47) Altitude: 22231 (+22.87) Datum: WGS-84 Adm/Br/Bearing: 161° 330W 330mils True (+12°) Elevation Angle: -0.3° Horizon Angle: -0.3° Zoom: 1.0X 11905+50</div>

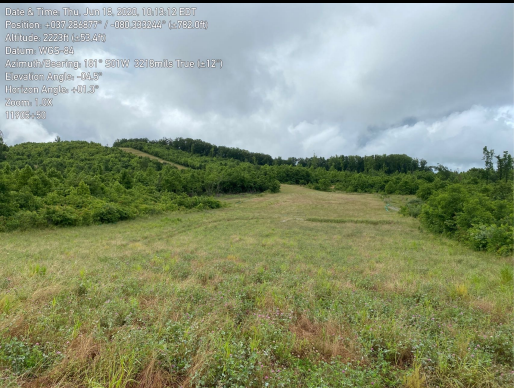
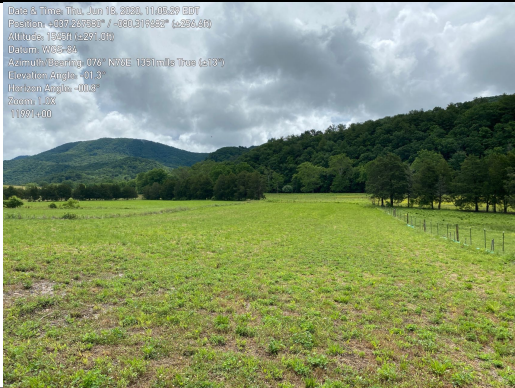
</div></div>			
GPS Location	5	GPS Location	6		
Field Station#	11905+50	Field Station#	11991+00		
Pic 5 Desc.	Section of partially restored RoW showing conditions and controls.		Pic 6 Desc.	Section of restored RoW showing conditions and controls.

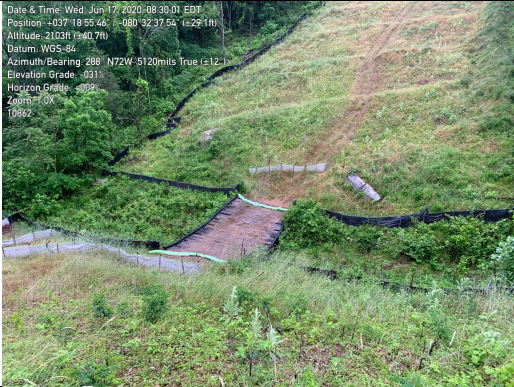
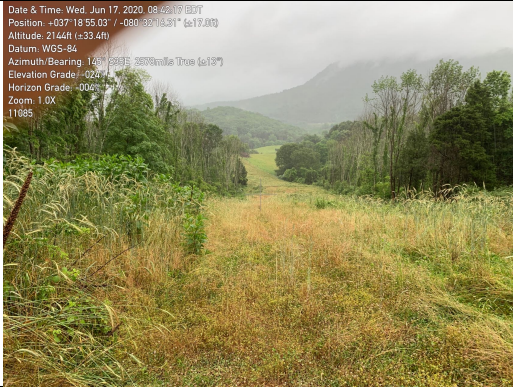
<b>GPS Location</b>	See picture above for GPS coordinates		<b>GPS Location</b>	See picture above for GPS coordinates	
<b>Field Station#</b>	10862+00		<b>Field Station#</b>	11085+00	
<b>Pic 1 Desc.</b>	ECD's and row conditions		<b>Pic 2 Desc.</b>	ECD's and row conditions

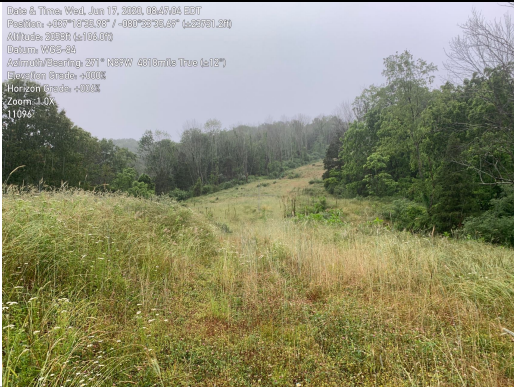
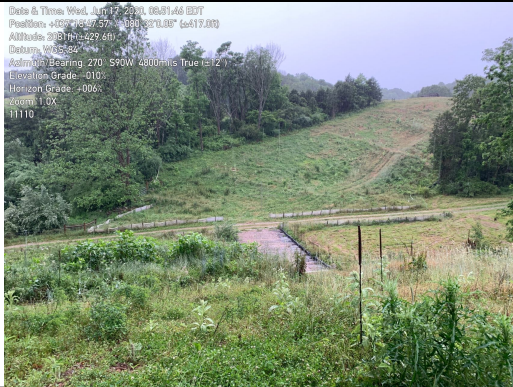
<b>GPS Location</b>	See picture above for GPS coordinates		<b>GPS Location</b>	See picture above for GPS coordinates	
<b>Field Station#</b>	11096+00		<b>Field Station#</b>	11110+00	
<b>Pic 3 Desc.</b>	ECD's and row conditions		<b>Pic 4 Desc.</b>	ECD's and row conditions	
<p>Date &amp; Time: Wed, Jun 17, 2020, 09:11:46 EDT  Position: +037°18'59.17" / -080°51'34.77" (+24°44.5N)  Altitude: 1930ft (+621ft)  Datum: WGS-84  Azimuth/Bearing: 274° N86W 4871mils True (+12°)  Elevation Grade: -031%  Horizon Grade: +00%  Zoom: 1.0X  11140</p>

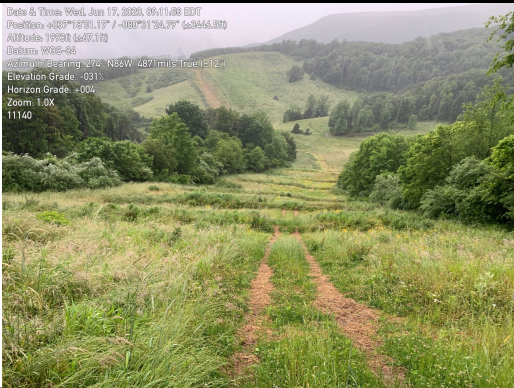
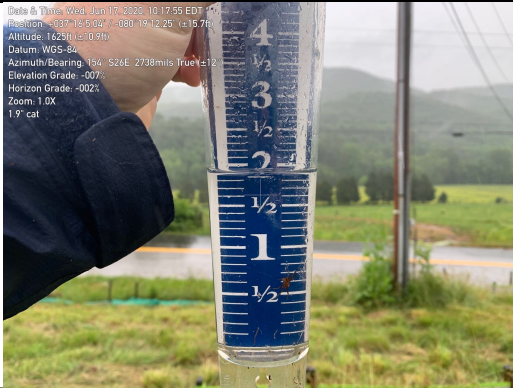
<b>GPS Location</b>	See picture above for GPS coordinates		<b>GPS Location</b>	See picture above for GPS coordinates	
<b>Field Station#</b>	11140+00		<b>Field Station#</b>	+1	
<b>Pic 5 Desc.</b>	ECD's and row conditions		<b>Pic 6 Desc.</b>	1.9" of rain recorded @ Catawba

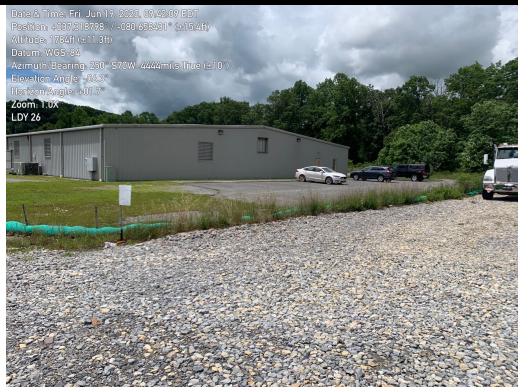
<p>Date &amp; Time: Fri, Jun 19, 2020, 09:28:09 EDT Position: +097°21'31.74" / +030°55'38.41" (NAD83) Altitude: 1787ft (±11.3m) Datum: WGS-84 Azimuth Bearing: 101.1° (SW) (172mils True (±10.1)) Elevation Angle: +31.6° Horizon Angle: -09.2° Zoom: 1.0X LDY 26</p>			
GPS Location	See photo for GPS location.		GPS Location	See photo for GPS location.	
Field Station#	12005+00		Field Station#	12005+00	
Pic 1 Desc.	Dumpsters being utilized for trash management.		Pic 2 Desc.	18 inch compost filter sock in place along LOD.

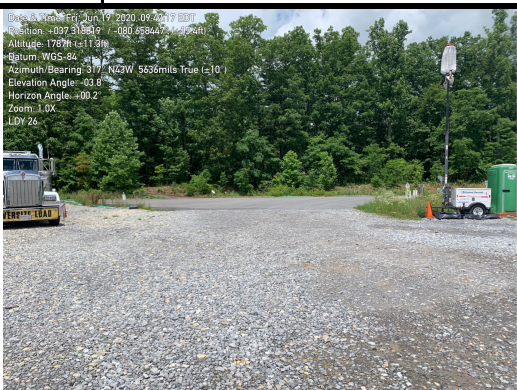
GPS Location	See photo for GPS location.		GPS Location	See photo for GPS location.	
Field Station#	12005+00		Field Station#	12005+00	
Pic 3 Desc.	RCE in place at LDY 26 entrance.		Pic 4 Desc.	Triple stack 12 inch compost filter sock in place along LOD.

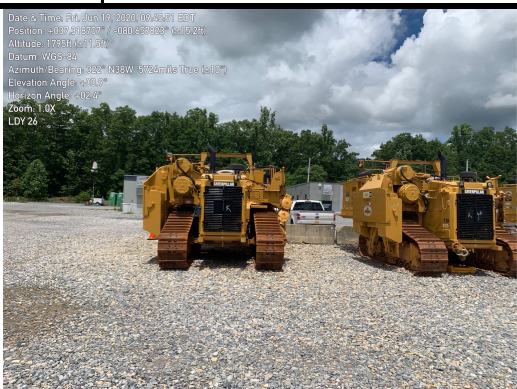
Pic 5 Desc.	Checked staged equipment for leaks.		Pic 6 Desc.	Secondary containment in place under fuel cell.

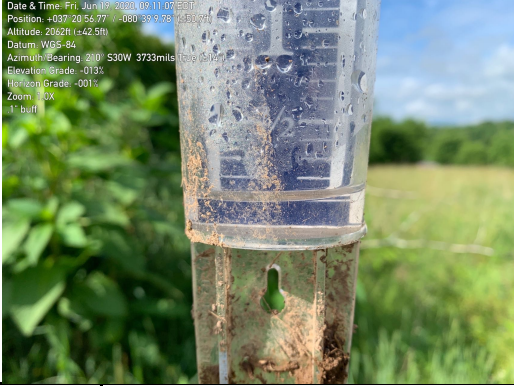
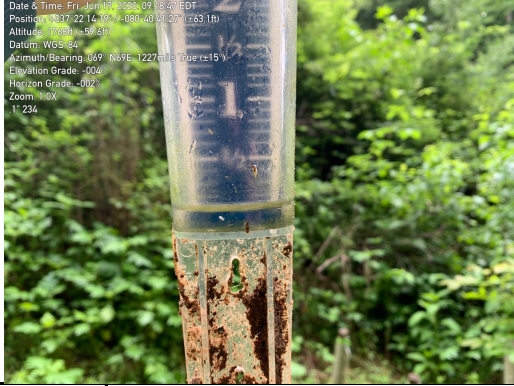
<b>GPS Location</b>	See picture above for GPS coordinates		<b>GPS Location</b>	See picture above for GPS coordinates	
<b>Field Station#</b>	+1		<b>Field Station#</b>	+2	
<b>Pic 1 Desc.</b>	.1" of rain recorded @ Buffalo Anklets		<b>Pic 2 Desc.</b>	.1" of rain recorded @ AR 234

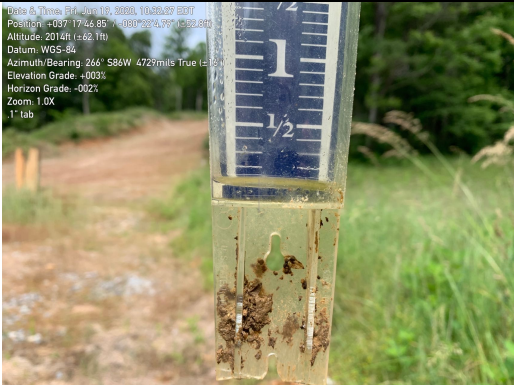
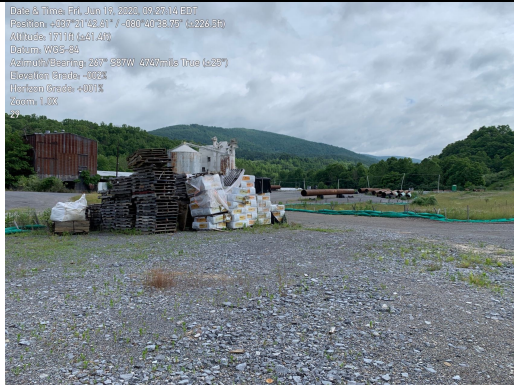
<b>GPS Location</b>	See picture above for GPS coordinates		<b>GPS Location</b>	See picture above for GPS coordinates	
<b>Field Station#</b>	+3		<b>Field Station#</b>	12005+00	
<b>Pic 3 Desc.</b>	.1" of rain recorded @ Tabor		<b>Pic 4 Desc.</b>	ECD's and row conditions LDY 29	
<p>Date &amp; Time: Fri Jun 19 2020 09:45:07 EDT  Position: +037°20'54.77" N -080°33'19.93" W (501.81ft)  Altitude: 1500ft (+45.7m)  Datum: WGS-84  Azimuth/Bearing: 264° S84W 5038mils True (±5°)  Elevation Grade: -004%  Horizon Grade: -001%  Zoom: 1.0X  1" = 1ft</p>

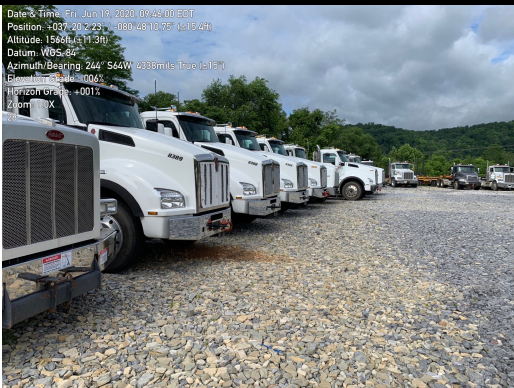
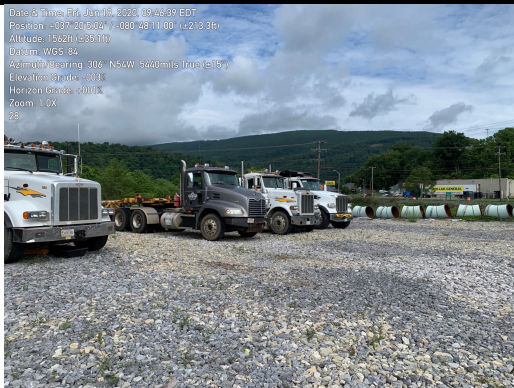
<b>GPS Location</b>	See picture above for GPS coordinates		<b>GPS Location</b>	See picture above for GPS coordinates	
<b>Field Station#</b>	12005+00		<b>Field Station#</b>	12005+00	
<b>Pic 5 Desc.</b>	ECD's and row conditions LDY 28		<b>Pic 6 Desc.</b>	ECD's and row conditions @ LDY 28
