## Visual Site Inspection Report

<b>Project Name</b>	H-600 Pipeline Spread G	<b>AFE</b>	124300137	<b>Spread</b>	H-600 Pipeline Spread G
<b>Contractor</b>	Precision			<b>Report #</b>	12061
<b>Inspector</b>	Chris Burns			<b>Date/Time</b>	6/22/2020 1:52 PM
<b>Permit #</b>	TBD	<b>Inspection Type</b>	VA SWPP	<b>Station Begin</b>	11023+80
<b>State</b>	VA	<b>Inspection Area</b>	Partial	<b>Station End</b>	11064+53
<b>County</b>	Giles	<b>Ground</b>	Wet	<b>Temperature (°F)</b>	80.00
<b>Municipality</b>	N/A	<b>Weather</b>	Cloudy	<b>Rain Gauge (in)</b>	0.45
				<b>Rain Accumulation Time (days)</b>	1.00

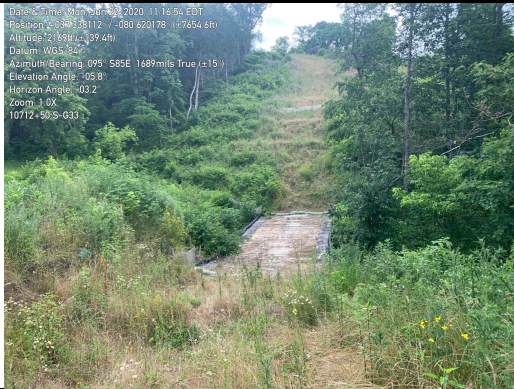
<p>Date &amp; Time: Mon Jun 22, 2020 11:00:58 EDT Position: +037.372542° / -080.678162° (+173.4ft) Altitude: 1757ft (+171.6ft) Datum: WGS-84 Azimuth/Bearing: 050° NSOE 089mils True (+15.1°) Elevation Angle: -04.2° Horizon Angle: -02.8° Zoom: 1.0X AR 234</p>		<p>Date &amp; Time: Mon Jun 22, 2020 11:12:50 EDT Position: +037.3953112° / -080.620178° (+17454.4ft) Altitude: 2159ft (+199.4ft) Datum: WGS-84 Azimuth/Bearing: 095° S85E 1689mils True (+15.1°) Elevation Angle: -05.8° Horizon Angle: -03.2° Zoom: 1.0X 10712+50 S-G33</p>			
<b>GPS Location</b>		See photo for GPS location.			
<b>Field Station#</b>		12005+00			
<b>Pic 1 Desc.</b>		Rain gauge at AR 234 reads 0.2 inches.

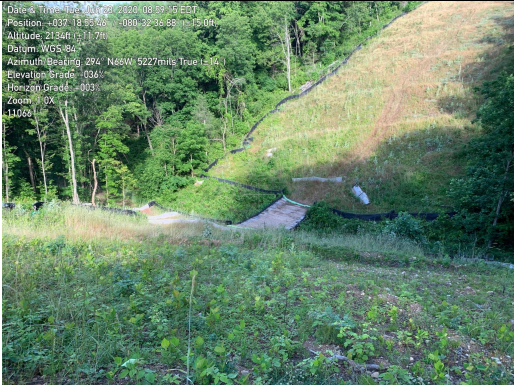
<b>GPS Location</b>	See picture above for GPS coordinates		<b>GPS Location</b>	See picture above for GPS coordinates	
<b>Field Station#</b>	11066+00		<b>Field Station#</b>	11078+00	
<b>Pic 1 Desc.</b>	ECD's and row conditions		<b>Pic 2 Desc.</b>	ECD's and row conditions

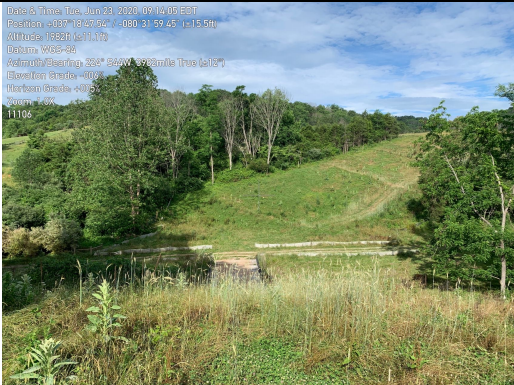
<b>GPS Location</b>	See picture above for GPS coordinates		<b>GPS Location</b>	See picture above for GPS coordinates	
<b>Field Station#</b>	11106+00		<b>Field Station#</b>	11120+00	
<b>Pic 3 Desc.</b>	ECD's and row conditions		<b>Pic 4 Desc.</b>	ECD's and row conditions

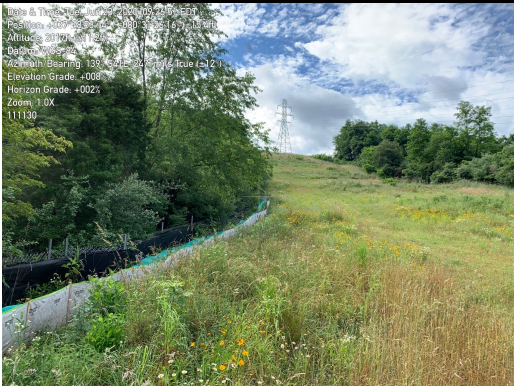
<b>GPS Location</b>	See picture above for GPS coordinates		<b>GPS Location</b>	See picture above for GPS coordinates	
<b>Field Station#</b>	11130+00		<b>Field Station#</b>	11140+00	
<b>Pic 5 Desc.</b>	ECD's and row conditions		<b>Pic 6 Desc.</b>	ECD's and row conditions

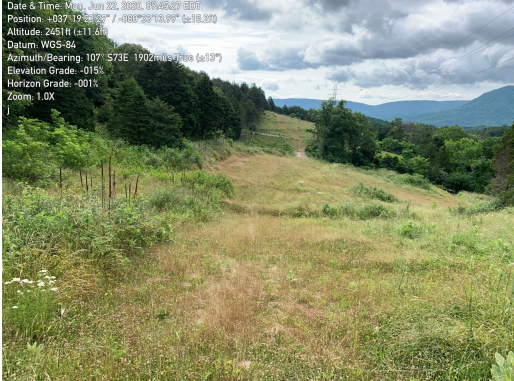
<b>GPS Location</b>	See picture above for GPS coordinates		<b>GPS Location</b>	See picture above for GPS coordinates	
<b>Field Station#</b>	10978+00		<b>Field Station#</b>	10987+00	
<b>Pic 1 Desc.</b>	ECD's and row conditions		<b>Pic 2 Desc.</b>	ECD's and row conditions	
<p>Date &amp; Time: Mon Jun 22, 2020, 11:22:38 EDT  Position: +037°19'38.98" / -080°32'17.85" (+15.4m)  Altitude: 2259ft (+11.3ft)  Datum: WGS-84  Azimuth/Bearing: 216°N49W 5529mils True (+13°)  Elevation Grade: -017%  Horizon Grade: -011%  Zoom: 1.0x</p>

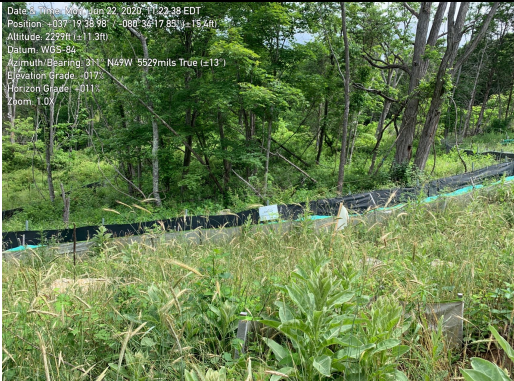
<b>GPS Location</b>	See picture above for GPS coordinates		<b>GPS Location</b>	See picture above for GPS coordinates	
<b>Field Station#</b>	10960+00		<b>Field Station#</b>	10950+00	
<b>Pic 3 Desc.</b>	ECD's and row conditions		<b>Pic 4 Desc.</b>	ECD's and row conditions	
<p>Date &amp; Time: Mon Jun 22, 2020, 11:55:34 EDT  Position: +037°20'4.75" / -080°35'42.61" (+197.1ft)  Altitude: 2155ft (+17.1ft)  Datum: WGS-84  Azimuth/Bearing: 276°N54W 4907mils True (+13°)  Elevation Grade: -05%  Horizon Grade: +003%  Zoom: 1.0x</p>

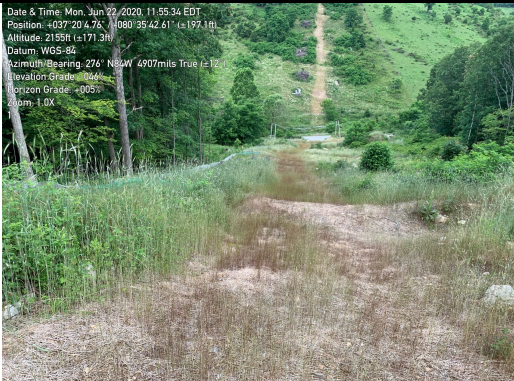
<b>Field Station#</b>	10900+00		<b>Field Station#</b>	10920+00	
<b>Pic 5 Desc.</b>	ECD's and row conditions		<b>Pic 6 Desc.</b>	ECD's and row conditions

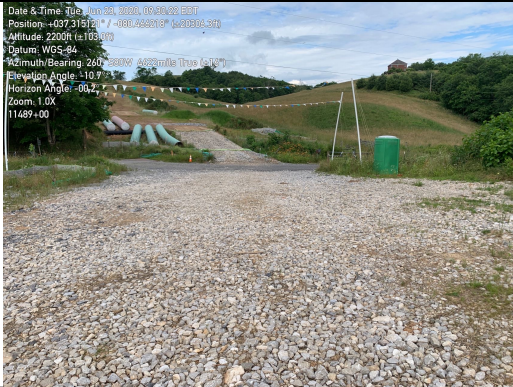
GPS Location	See photo for GPS location.		GPS Location	See photo for GPS location.	
Field Station#	11489+00		Field Station#	11478+00	
Pic 3 Desc.	RCE in place at Stevers Gap Road.		Pic 4 Desc.	Sump pit wall sloughed off resulting in priority one silt fence flap being exposed.

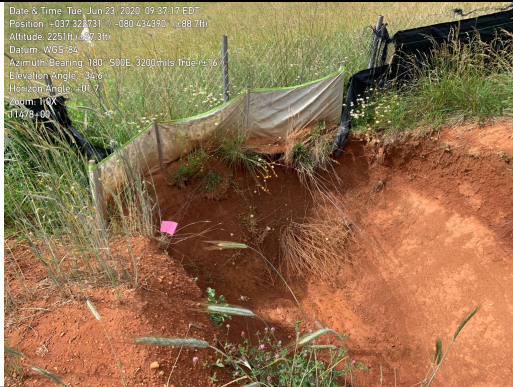
<b>A/E</b>	124300137	<b>Date/Time</b>	6/23/2020 3:15 PM	<b>Report #</b>	12089
<b>6. PCSM BMPs</b> (List BMPs and note if installed and maintained as per the plan. If corrective action is needed, a picture is required.)					
<b>PCSM BMPs</b>	<b>Compliance Level</b>	<b>Corrective Action</b>	<b>Corrective Time Frame</b>	<b>Date Repaired</b>	
<b>7. Identify all remedial measures that have been taken since the previous inspection was conducted.</b>					
<b>Comments</b> (Reference above questions as appropriate.)					
Conducted VA SWPPP inspection from MP 215 to MP 218.3. Since last inspection Precision Pipeline has conducted ECD maintenance and ECD upgrades where needed. No forward progress has been completed due to FERC shut down. Right of way has been stabilized using seed, mulch, and natural vegetation. Deficiencies located at; Downed priority one silt fence at station number 11413+00 and at 11478+00 sump pit wall sloughed off exposing priority on flap.

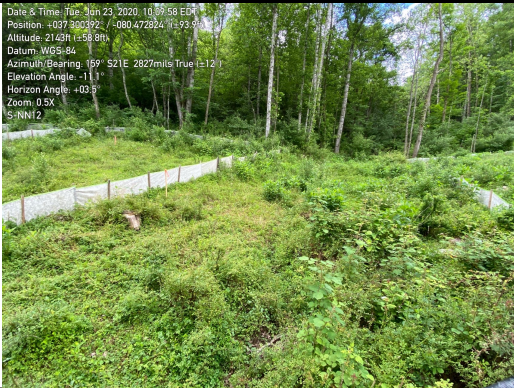
<b>GPS Location</b>	5	<b>GPS Location</b>	6		
<b>Field Station#</b>	11327+85	<b>Field Station#</b>	11352+97		
<b>Pic 5 Desc.</b>	S-NN12 and controls.	<b>Pic 6 Desc.</b>	S-NN11 and controls.

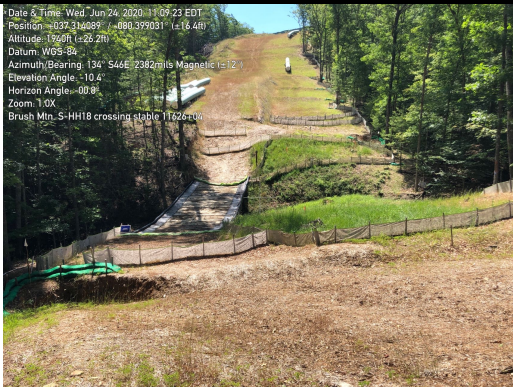
GPS Location	On photo		GPS Location	On photo	
Field Station#	11626+04		Field Station#	11614+20	
Pic 3 Desc.	S-HH18 crossing is stable		Pic 4 Desc.	S-RR14 crossing is stable

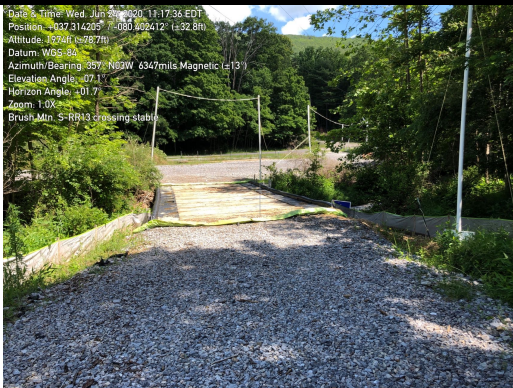
GPS Location	On photo		GPS Location	On photo	
Field Station#	11613+69		Field Station#	11607+81	
Pic 5 Desc.	S-RR13 crossing is stable		Pic 6 Desc.	S-006 crossing is stable

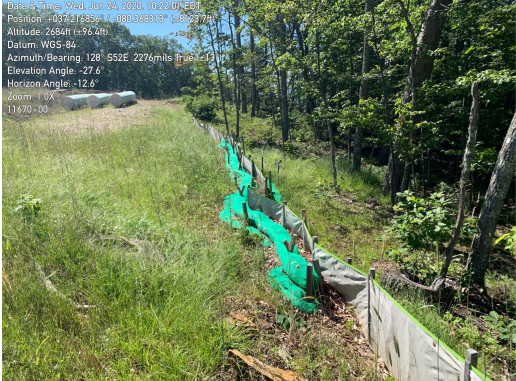
<b>Field Station#</b>	11670+00		<b>Field Station#</b>	11671+00	
<b>Pic 1 Desc.</b>	Triple stack compost filter sock and priority one silt fence in place along LOD.		<b>Pic 2 Desc.</b>	Waterbar, sump pit, and waterbar end treatment in place.

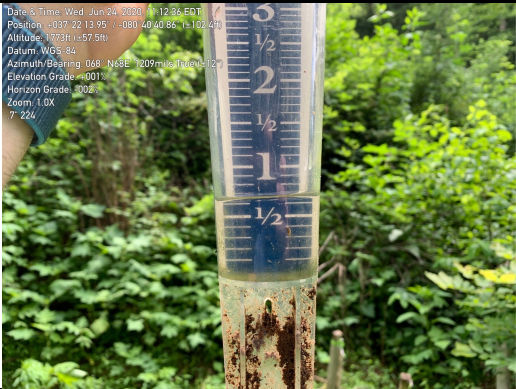
<p>Date &amp; Time: Wed Jun 24, 2020, 11:28:25 EDT Position: +037 22 13 37 / -080 35 48 39 / +139 45 Altitude: 2024ft (+617m) Datum: WGS 84 Azimuth/Bearing: 280° N80W 4978mils True (+22°) Elevation Grade: -005% Horizon Grade: -006% Zoom: 1.0x 7' kow</p>			
<b>GPS Location</b>	See picture above for GPS coordinates		<b>GPS Location</b>	See picture above for GPS coordinates	
<b>Field Station#</b>	+1		<b>Field Station#</b>	+2	
<b>Pic 1 Desc.</b>	.7" of rain recorded @ 234		<b>Pic 2 Desc.</b>	.7" of rain recorded @ Kow Camp

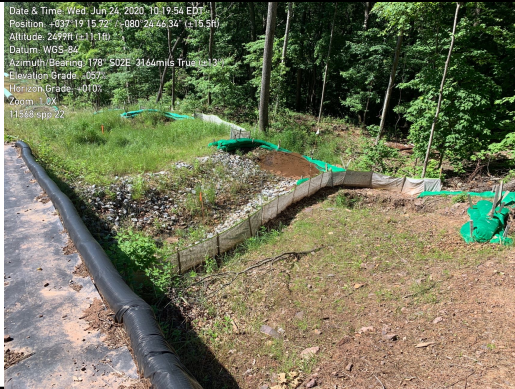
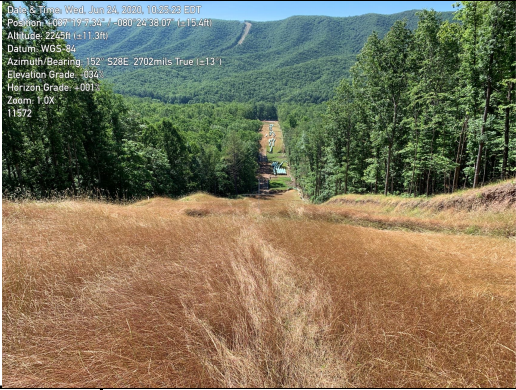
<b>GPS Location</b>	See picture above for GPS coordinates		<b>GPS Location</b>	See picture above for GPS coordinates	
<b>Field Station#</b>	11548+00		<b>Field Station#</b>	11568+00	
<b>Pic 3 Desc.</b>	ECD's and row conditions		<b>Pic 4 Desc.</b>	ECD's and row conditions Spp22

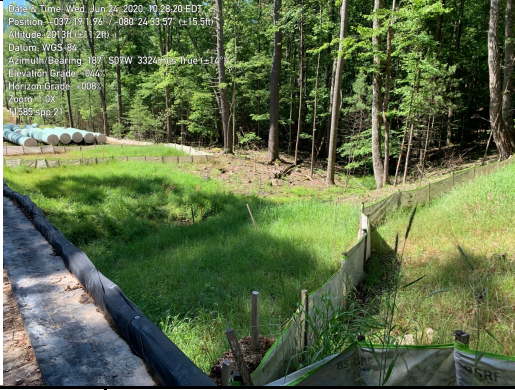
<b>Field Station#</b>	11572+00		<b>Field Station#</b>	11585+00	
<b>Pic 5 Desc.</b>	ECD's and row conditions		<b>Pic 6 Desc.</b>	ECD's and row conditions

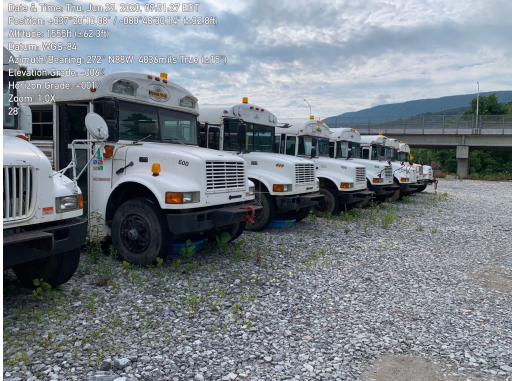
<p>Date &amp; Time: Thu, Jun 25, 2020, 10:49:27 EDT Position: +48°57'31.88" / -88°45'34.12" (43.0m) Altitude: 1533 ft (468.9m) Datum: WGS-84 Azimuth Bearing: 150° S24E 2773mils True (415°) Elevation Grade: +00% Horizon Grade: +00% Zoom: 1.0X 28</p>			
GPS Location	See picture above for GPS coordinates		GPS Location	See picture above for GPS coordinates	
Field Station#	12005+00		Field Station#	12005+00	
Pic 1 Desc.	ECD's and row conditions		Pic 2 Desc.	Secondary containment

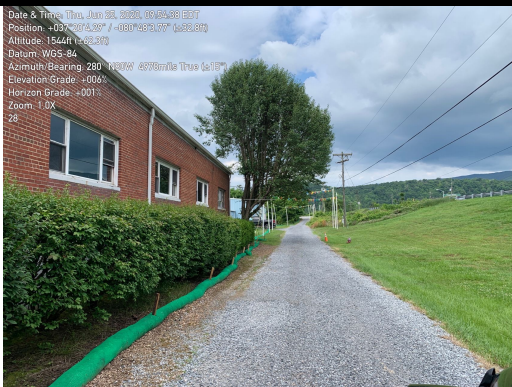
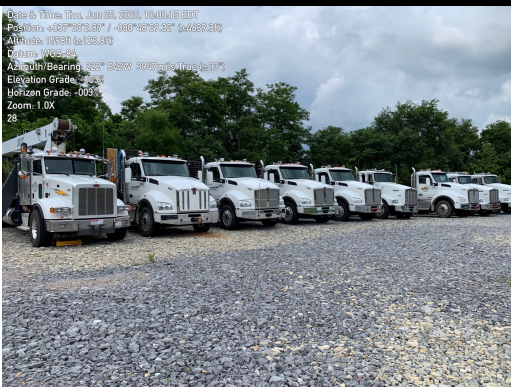
GPS Location	See picture above for GPS coordinates		GPS Location	See picture above for GPS coordinates	
Field Station#	12005+00		Field Station#	12005+00	
Pic 3 Desc.	ECD's and row conditions		Pic 4 Desc.	ECD's and row conditions

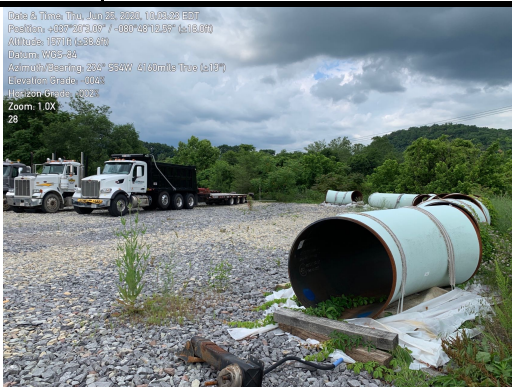
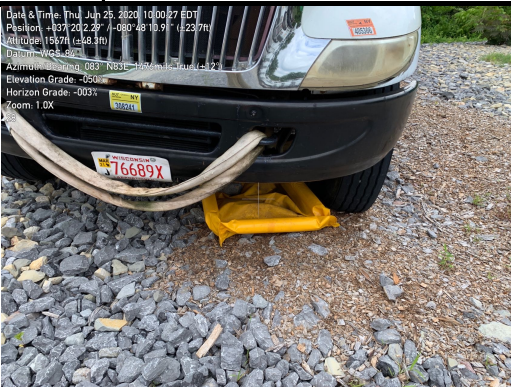
<p>Date &amp; Time: Thu, Jun 25, 2020, 10:49:27 EDT Position: +48°57'31.88" / -88°45'34.12" (43.0m) Altitude: 1571 ft (488.3m) Datum: WGS-84 Azimuth Bearing: 083° N83E 1920mils True (415°) Elevation Grade: +00% Horizon Grade: +00% Zoom: 1.0X</p>			
GPS Location	See picture above for GPS coordinates		GPS Location	See picture above for GPS coordinates	
Field Station#	12005+00		Field Station#	12005+00	
Pic 5 Desc.	ECD's and row conditions		Pic 6 Desc.	ECD's and row conditions

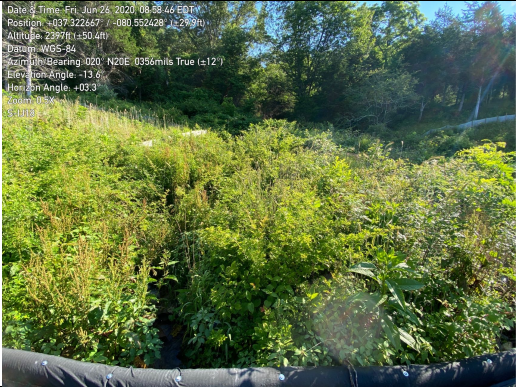
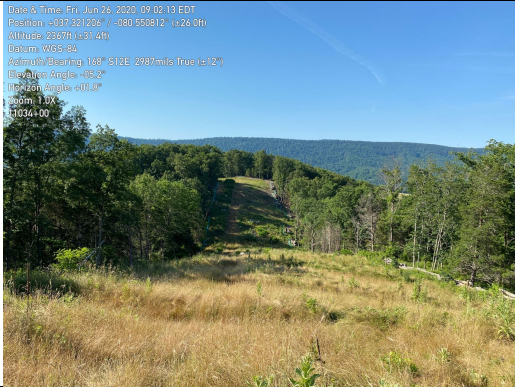
<p>Date &amp; Time: Fri Jun 26, 2020 09:02:13 EDT Position: +037.231024° -080.555812° (+26.6ft) Altitude: 2307ft (+51.0ft) Datum: WGS-84 Azimuth/Bearing: 168° S16E 2947mils True (+12°) Elevation Angle: -03.2° Horizon Angle: +01.8° Zoom: 1.0x S-IJ1034+00</p>			
<b>GPS Location</b>	1	<b>GPS Location</b>	2		
<b>Field Station#</b>	11025+50	<b>Field Station#</b>	11034+00		
<b>Pic 1 Desc.</b>	S-IJ18 and controls.	<b>Pic 2 Desc.</b>	Section of restored RoW showing conditions and controls.

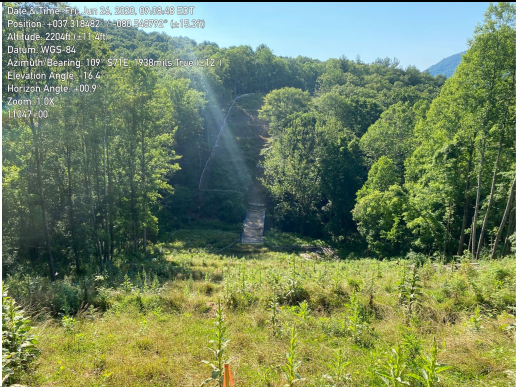
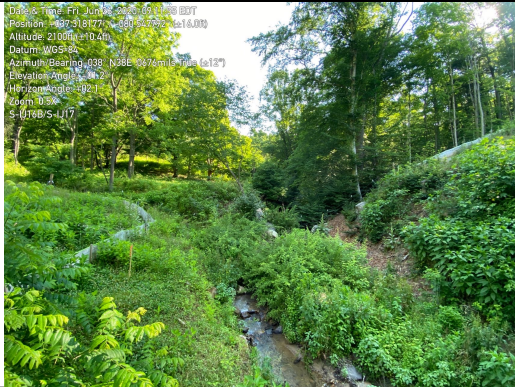
<b>GPS Location</b>	3	<b>GPS Location</b>	4		
<b>Field Station#</b>	11047+00	<b>Field Station#</b>	11050+10		
<b>Pic 3 Desc.</b>	Section of restored RoW showing conditions and controls. (Overview S-IJ16B/S-IJ17).	<b>Pic 4 Desc.</b>	S-IJ16B/S-IJ17 and controls.

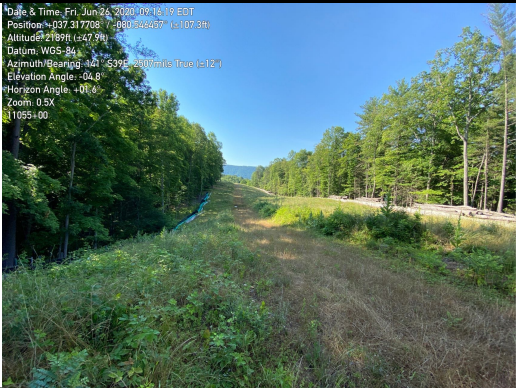
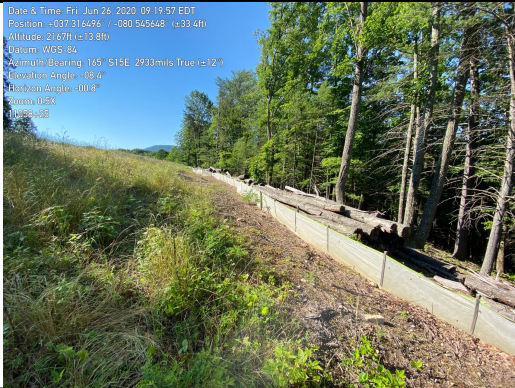
<p>Date &amp; Time: Fri Jun 26, 2020 09:19:57 EDT Position: +037.314494° -080.542648° (+33.4ft) Altitude: 2167ft (+3.8ft) Datum: WGS-84 Azimuth/Bearing: 165° S15E 2933mils True (+12°) Elevation Angle: -08.6° Horizon Angle: -00.6° Zoom: 1.0x S-IJ11058+25</p>			
<b>GPS Location</b>	5	<b>GPS Location</b>	6		
<b>Field Station#</b>	11055+00	<b>Field Station#</b>	11058+25		
<b>Pic 5 Desc.</b>	Section of RoW showing conditions and controls.	<b>Pic 6 Desc.</b>	Perimeter controls functional.

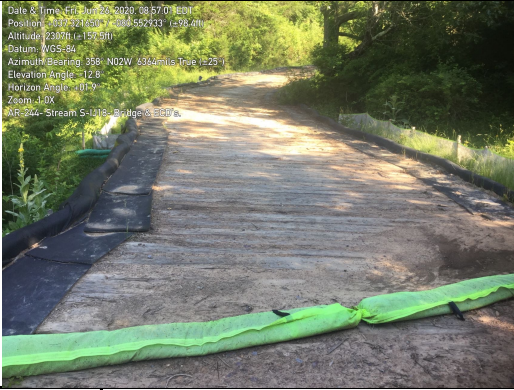
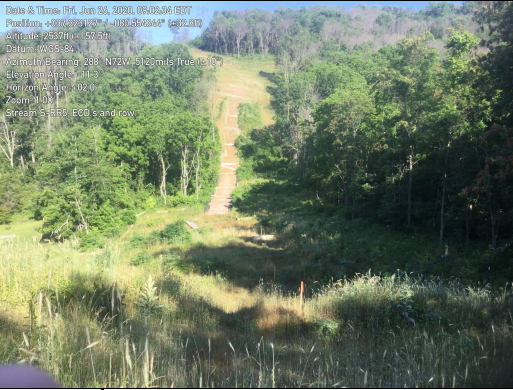
<p><small>Date &amp; Time: Fri, Jun 26, 2020 09:05:04 EDT Position: +037 331310 / +080 582827 (E-16-41) Altitude: 2632ft (+157.0ft) Datum: WGS-84 Azimuth/Bearing: 288° N22W 3320/mile True (+22.1) Elevation Angle: -11.3 Horizon Angle: -10.0 Zoom: 1.0X Stream S- RR5, ECD's and row</small></p>					
<b>GPS Location</b>	See photo GPS	<b>GPS Location</b>	See photo GPS				
<b>Field Station#</b>	11024+00	<b>Field Station#</b>	11017+00				
<b>Pic 1 Desc.</b>	Stream equipment bridge, buffers ECD's	<b>Pic 2 Desc.</b>	Stream S- RR5, row and controls

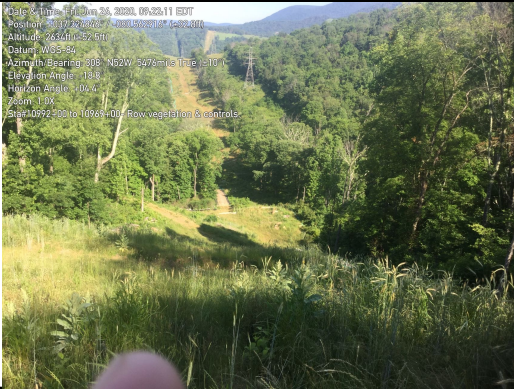
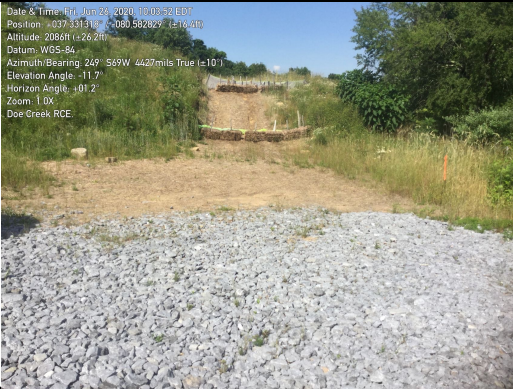
<p><small>Date &amp; Time: Fri, Jun 26, 2020 09:05:04 EDT Position: +037 331310 / +080 582827 (E-16-41) Altitude: 2086ft (+126.2ft) Datum: WGS-84 Azimuth/Bearing: 249° S69W 4427/mile True (+10.1) Elevation Angle: -11.7 Horizon Angle: -10.2 Zoom: 1.0X Doe Creek RCE</small></p>					
<b>GPS Location</b>	See photo GPS	<b>GPS Location</b>	See photo GPS				
<b>Field Station#</b>	10992+00	<b>Field Station#</b>	10930+00				
<b>Pic 3 Desc.</b>	Steep slope vegetation	<b>Pic 4 Desc.</b>	Doe Creek RCE

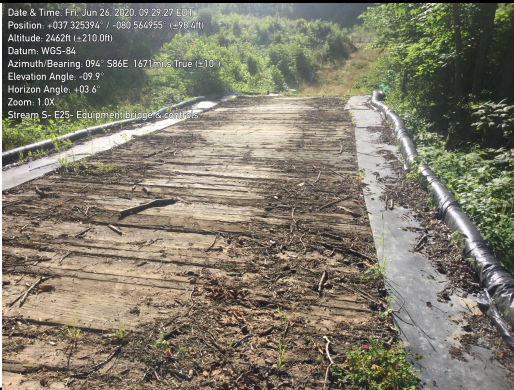
<b>GPS Location</b>	See photo GPS			<b>GPS Location</b>			
<b>Field Station#</b>	10986+00			<b>Field Station#</b>			
<b>Pic 5 Desc.</b>	Stream S- E25, equipment bridge	<b>Pic 6 Desc.</b>

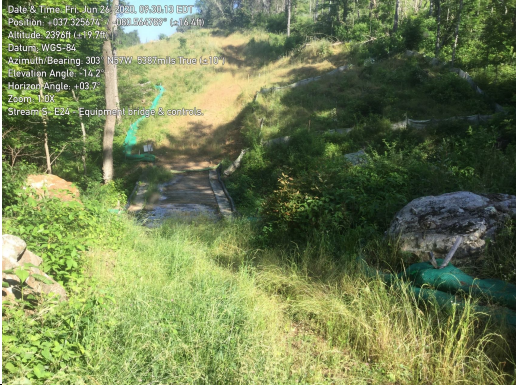
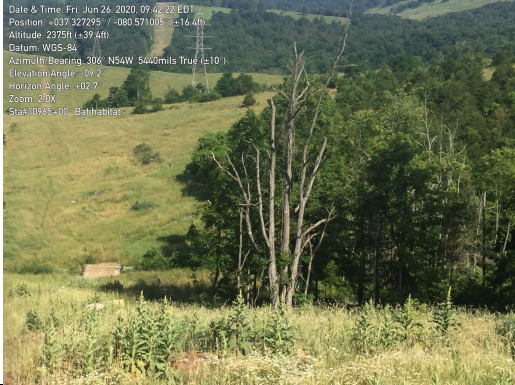
<p><small>Date &amp; Time: Fri Jun 26 2020 09:42:22 EDT Position: +037.327295, -080.571005 (+16.4ft) Altitude: 2375ft (+59.6ft) Datum: WGS-84 Azimuth: Bearing: 308 NSW 540mils True (+10°) Elevation Angle: +02.2 Horizon Angle: +02.7 Zoom: 2.0X Bat habitat</small></p>			
<b>GPS Location</b>	See photo GPS	<b>GPS Location</b>	See photo GPS		
<b>Field Station#</b>	10985+00	<b>Field Station#</b>	10965+00		
<b>Pic 7 Desc.</b>	Stream S- E24- Equipment bridge and ECD's.	<b>Pic 8 Desc.</b>	Bat habitat		
Insert image here		Insert image here

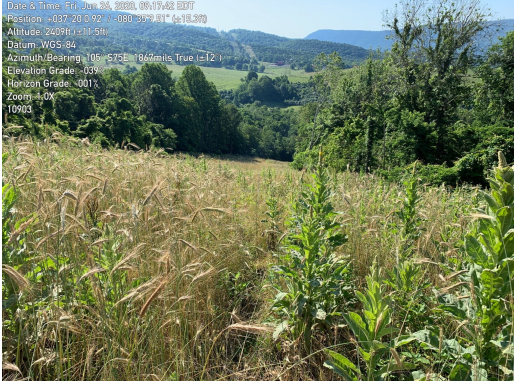
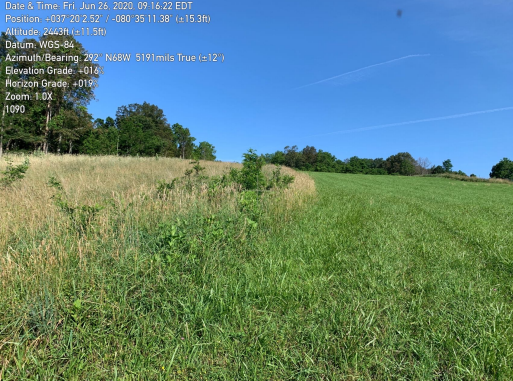
<b>GPS Location</b>	See picture above for GPS coordinates		<b>GPS Location</b>	See picture above for GPS coordinates	
<b>Field Station#</b>	10903+00		<b>Field Station#</b>	110901+00	
<b>Pic 1 Desc.</b>	ECD's and row conditions		<b>Pic 2 Desc.</b>	ECD's and row conditions

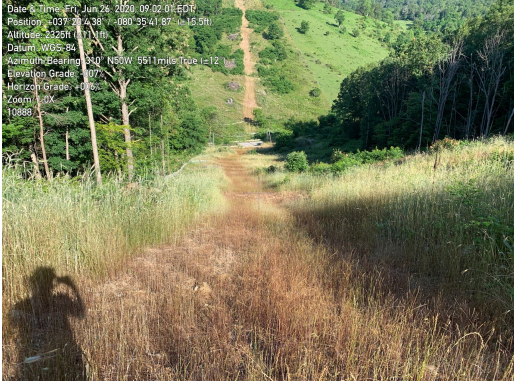
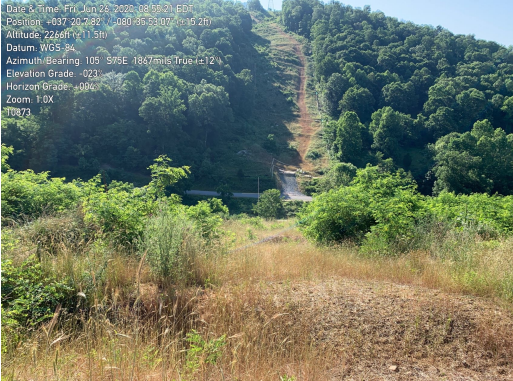
<b>GPS Location</b>	See picture above for GPS coordinates		<b>GPS Location</b>	See picture above for GPS coordinates	
<b>Field Station#</b>	10888+00		<b>Field Station#</b>	10873+00	
<b>Pic 3 Desc.</b>	ECD's and row conditions		<b>Pic 4 Desc.</b>	ECD's and row conditions

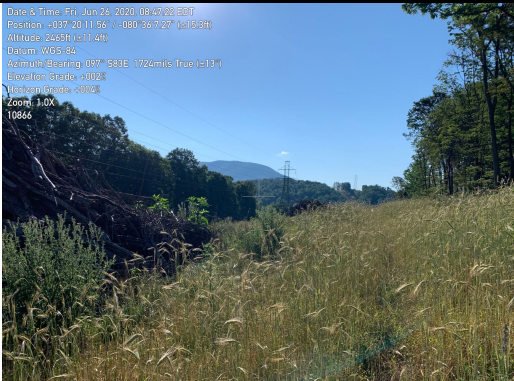
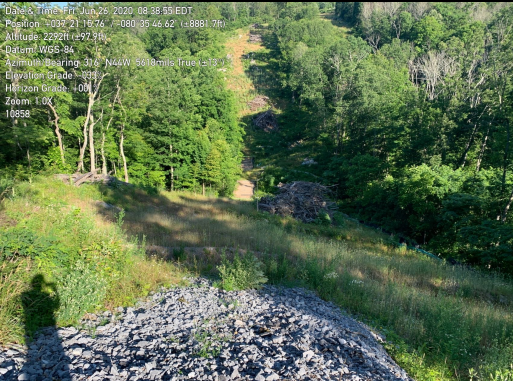
<b>GPS Location</b>	See picture above for GPS coordinates		<b>GPS Location</b>	See picture above for GPS coordinates	
<b>Field Station#</b>	10866+00		<b>Field Station#</b>	10858+00	
<b>Pic 5 Desc.</b>	ECD's and row conditions		<b>Pic 6 Desc.</b>	ECD's and row conditions
