Visual Site Inspection Report

Project Name	H-600 Pipeline Spread G	AFE	124300137	Spread	H-600 Pipeline Spread G
Contractor	Precision			Report #	11653
Inspector	Rob Robertson			Date/Time	6/8/2020 12:46 PM
Permit #	TBD	Inspection Type	VA SWPP	Station Begin	11600+01
State	VA	Inspection Area	Full	Station End	11670+00
County	Montgomery	Ground	Dry	Temperature (°F)	74.00
Municipality	N/A	Weather	Sunny	Rain Gauge (in)	0.00
				Rain Accumulation Time (days)	1.00

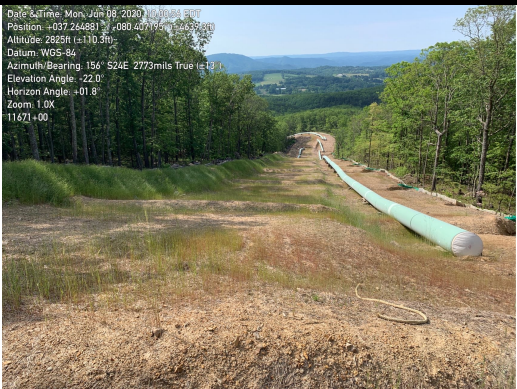
GPS Location	See photo for GPS location.		GPS Location	See photo for GPS location.	
Field Station#	11671+00		Field Station#	11687+40	
Pic 1 Desc.	Waterbars in place and ROW stabilized with seed, mulch, and minor vegetation growth.		Pic 2 Desc.	Sensitive resource buffer in place at stream S-MN21.	
<p>Date & Time: Mon, Jun 08, 2020, 11:20:15 EDT Position: +037.224881° / +080.427119° (+1623.00) Altitude: 2059ft (+125.7m) Datum: WGS-84 Azimuth/Bearing: 100° S80E 1278mils True (+13°) Elevation Angle: -07.3° Horizon Angle: +00.3° Zoom: 1.0X 11767+00</p>

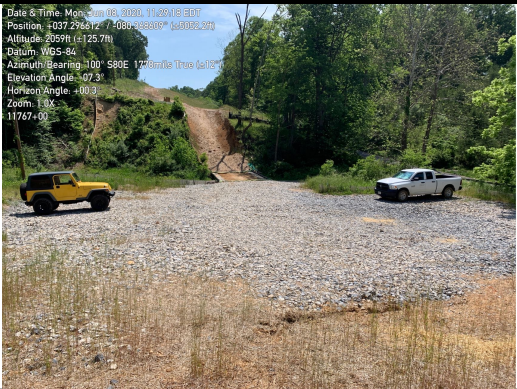
GPS Location	See photo for GPS location.		GPS Location	See photo for GPS location.	
Field Station#	11767+00		Field Station#	11767+00	
Pic 3 Desc.	RCE in place at main line valve 26.		Pic 4 Desc.	Rain gauge at Mount Tabor Road reads 0.15 inches.	
<p>Date & Time: Mon, Jun 08, 2020, 11:35:33 EDT Position: +037.224716° / +080.350446° (+31494.3ft) Altitude: 2613ft (+144.9m) Datum: WGS-84 Azimuth/Bearing: 095° N55E 0978mils True (+13°) Elevation Angle: +03.7° Horizon Angle: +03.2° Zoom: 1.0X 11772+00</p>

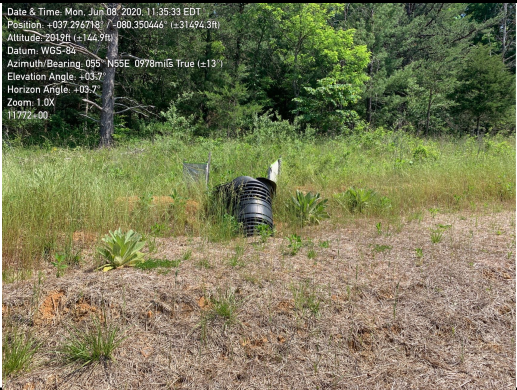
GPS Location	See photo for GPS location.		GPS Location	See photo for GPS location.	
Field Station#	11772+00		Field Station#	11775+00	
Pic 5 Desc.	Clean water diversion pipe and clean water diversion berm in place.		Pic 6 Desc.	Clean water diversion pipe and plunge pool in place.

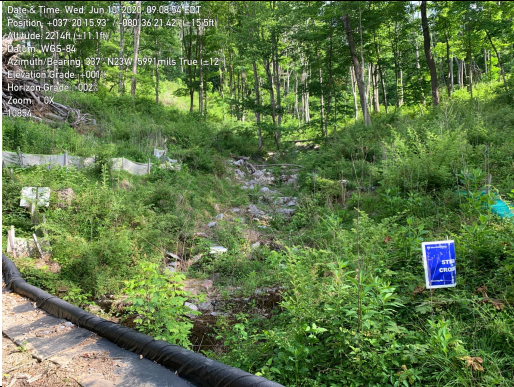
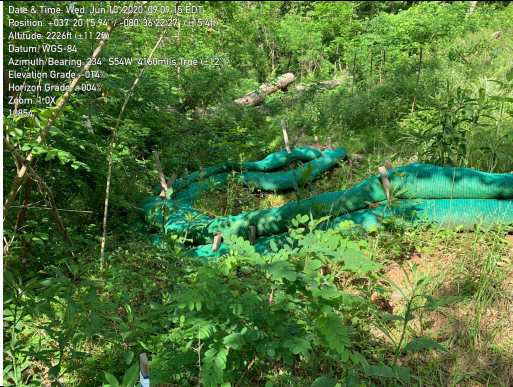
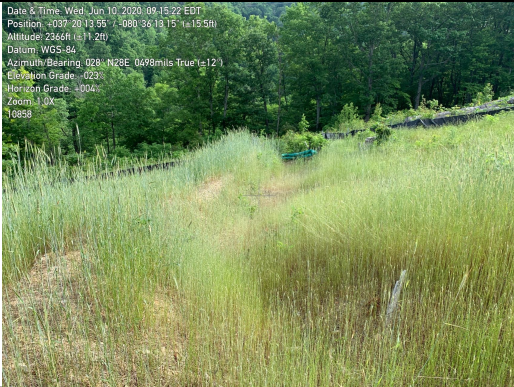
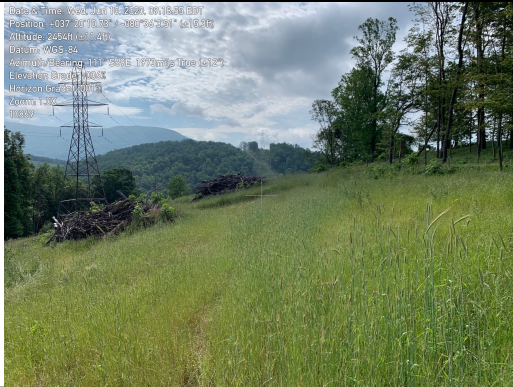
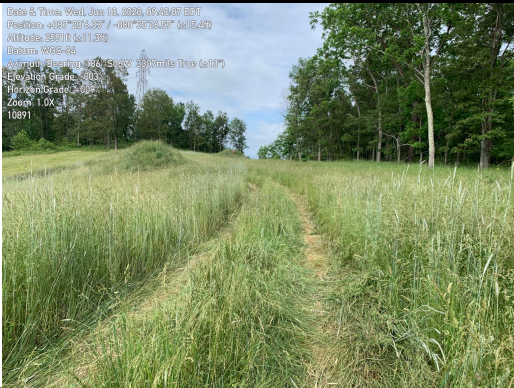
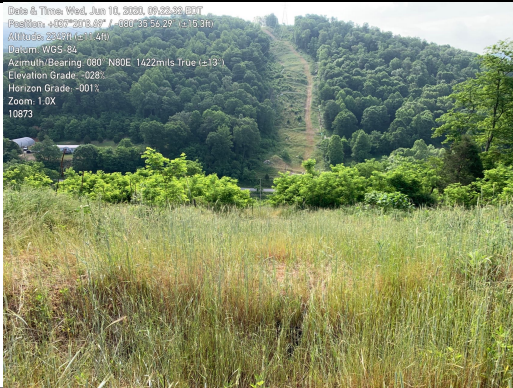
GPS Location	See picture above for GPS coordinates		GPS Location	See picture above for GPS coordinates	
Field Station#	10854+00		Field Station#	10854+00	
Pic 1 Desc.	ECD's and row conditions		Pic 2 Desc.	ECD's and row conditions

GPS Location	See picture above for GPS coordinates		GPS Location	See picture above for GPS coordinates	
Field Station#	10858+00		Field Station#	10869+00	
Pic 3 Desc.	ECD's and row conditions		Pic 4 Desc.	ECD's and row conditions

GPS Location	See picture above for GPS coordinates		GPS Location	See picture above for GPS coordinates	
Field Station#	10891+00		Field Station#	10873+00	
Pic 5 Desc.	ECD's and row conditions		Pic 6 Desc.	ECD's and row conditions

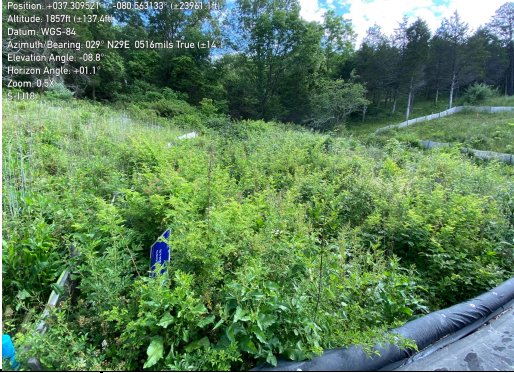
GPS Location	1	GPS Location	2		
Field Station#	11025+50	Field Station#	11034+00		
Pic 1 Desc.	S-IJ18 and controls.	Pic 2 Desc.	Section of RoW showing conditions and controls.		
<p>Date & Time Wed, Jun 10, 2020, 09:39:34 EDT Position: +037.216306° / +080.55752° (+2710' 04") Altitude: 2040ft (+41.5133) Datum: WGS-84 Azimuth/Bearing: 302° W08W 500mils True (+1.2) Elevation Angle: +00.4 Horizon Angle: +00.5 Zoom: 0.5X 11049+00</p>

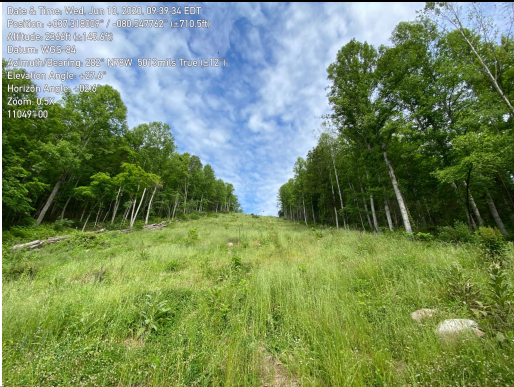
GPS Location	3	GPS Location	4		
Field Station#	11049+00	Field Station#	11050+10		
Pic 3 Desc.	Section of RoW showing conditions and controls.	Pic 4 Desc.	S-IJ16B/S-IJ7 and controls.		
<p>Date & Time Wed, Jun 10, 2020, 09:41:58 EDT Position: +037.217447° / +080.54677° (+2681' 57") Altitude: 2170ft (+43.57) Datum: WGS-84 Azimuth/Bearing: 149° S11E 300mils True (+1.2) Elevation Angle: -02.9 Horizon Angle: +00.9 Zoom: 0.5X 11054+50</p>

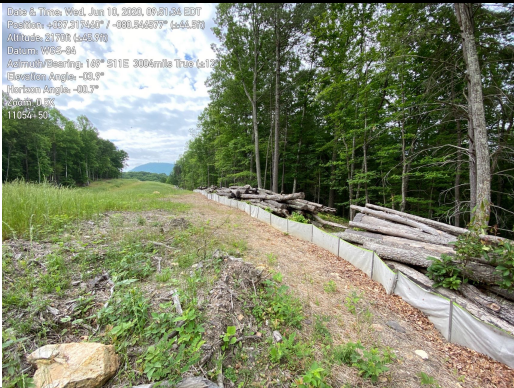
GPS Location	5	GPS Location	6		
Field Station#	11054+50	Field Station#	11064+50		
Pic 5 Desc.	Perimeter controls functional.	Pic 6 Desc.	Section of RoW showing conditions and controls.

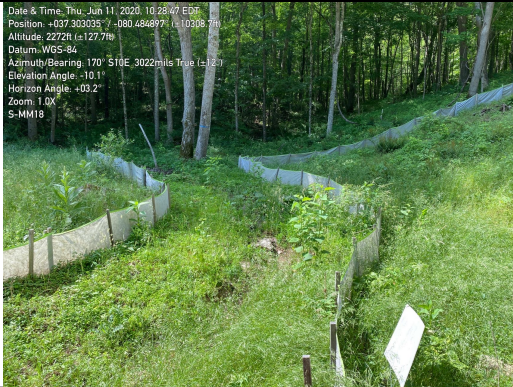
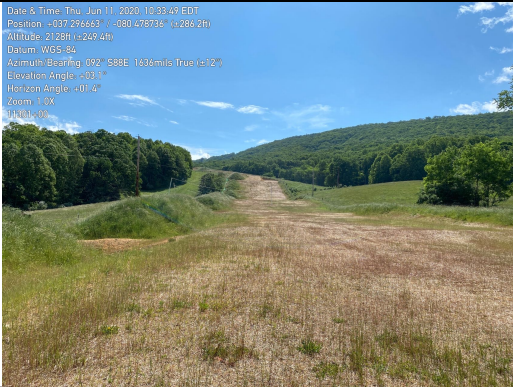
GPS Location	3		GPS Location	4	
Field Station#	11292+80		Field Station#	11301+00	
Pic 3 Desc.	S-MM18 and controls.		Pic 4 Desc.	Section of RoW showing conditions and controls.

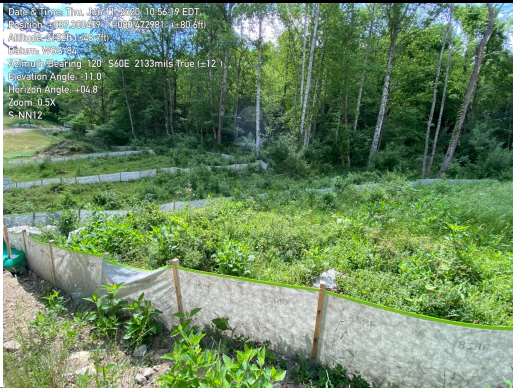
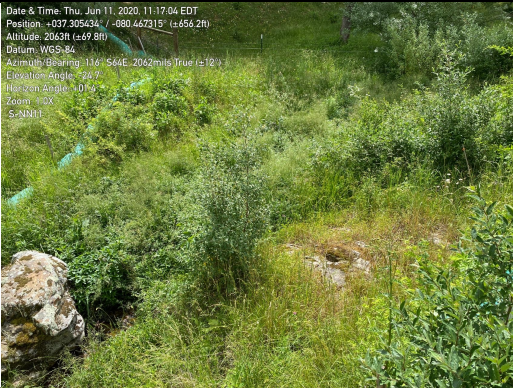
GPS Location	5		GPS Location	6	
Field Station#	11327+85		Field Station#	11352+97	
Pic 5 Desc.	S-NN12 overview.		Pic 6 Desc.	W-NN11 and controls.

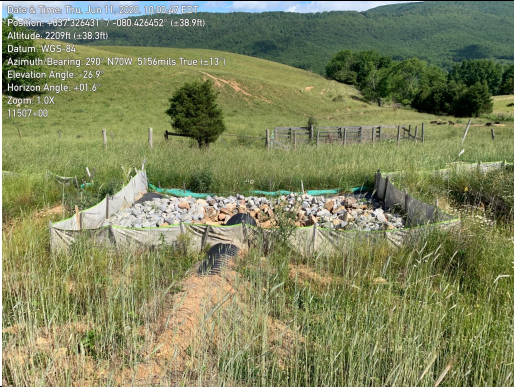
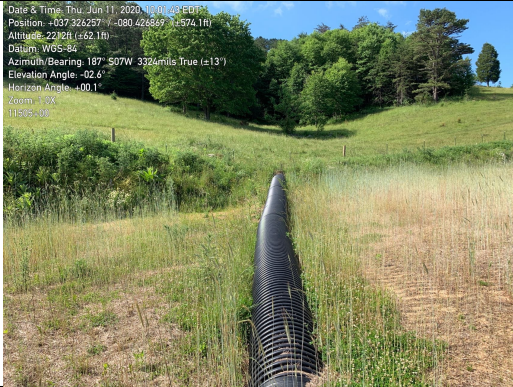
GPS Location	See photo for GPS location.		GPS Location	See photo for GPS location.	
Field Station#	11507+00		Field Station#	11505+00	
Pic 1 Desc.	Clean water diversion pipe and plunge pool in place.		Pic 2 Desc.	Clean water diversion pipe and clean water diversion berm in place.

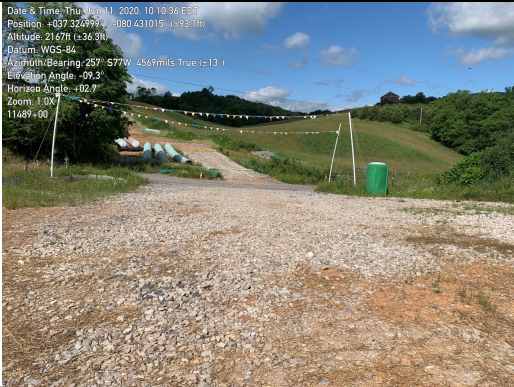
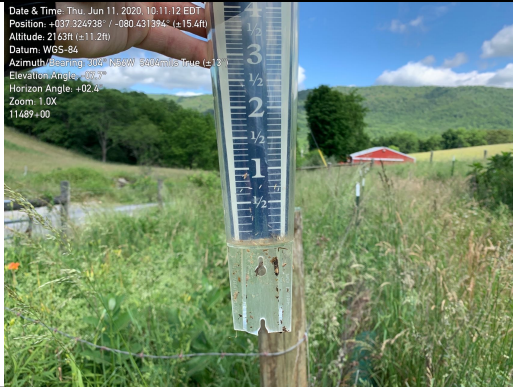
GPS Location	See photo for GPS location.		GPS Location	See photo for GPS location.	
Field Station#	11489+00		Field Station#	11489+00	
Pic 3 Desc.	RCE in place at Stevers Gap Road.		Pic 4 Desc.	Rain gauge at Stevers Gap Road reads 0.0.

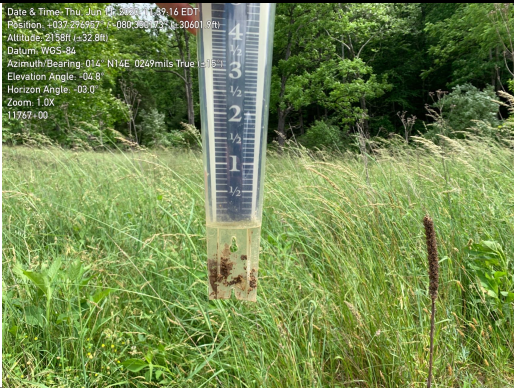
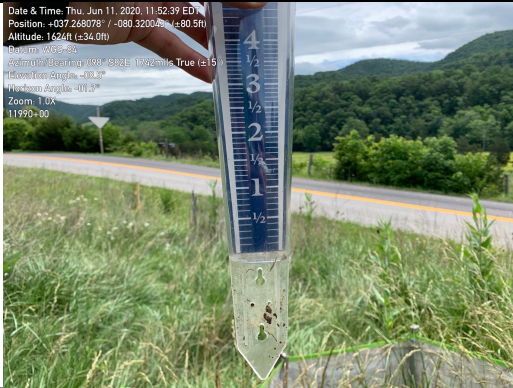
GPS Location	See photo for GPS location.		GPS Location	See photo for GPS location.	
Field Station#	11767+00		Field Station#	11990+00	
Pic 5 Desc.	Rain gauge at Mount Tabor Road reads 0.0 inches.		Pic 6 Desc.	Rain gauge at Catawba Road reads 0.0 inches.

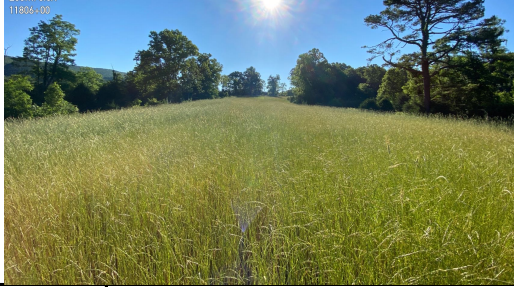
GPS Location	1	GPS Location	2		
Field Station#	11789+00	Field Station#	11806+00		
Pic 1 Desc.	Section of restored RoW showing conditions and controls.		Pic 2 Desc.	Section of restored RoW showing conditions and controls.	
<p>Date & Time: Fri Jun 12, 2020 08:39:34 EDT Position: +037 294768 / -080 351824 (+10796.4ft) Altitude: 2221ft (+104.7ft) Datum: WGS-84 Azimuth/Bearing: 172° S04E 3093mils True (+12.1) Elevation Angle: +03.3° Horizon Angle: +01° Zoom: 0.5x 11826+00</p>

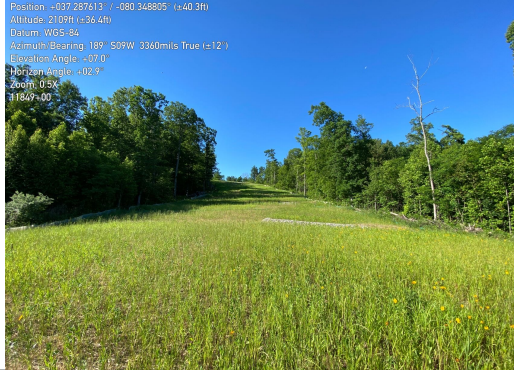
GPS Location	3	GPS Location	4		
Field Station#	11826+00	Field Station#	11849+00		
Pic 3 Desc.	Section of restored RoW showing conditions and controls.		Pic 4 Desc.	Section of restored RoW showing conditions and controls.	
<p>Date & Time: Fri Jun 12, 2020 08:55:29 EDT Position: +037 237051 / -080 346398 (+550.1ft) Altitude: 2185ft (+33.8ft) Datum: WGS-84 Azimuth/Bearing: 082° N38E 0676mils True (+12.1) Elevation Angle: +04.1° Horizon Angle: +03.8° Zoom: 1.5x P-KL2</p>

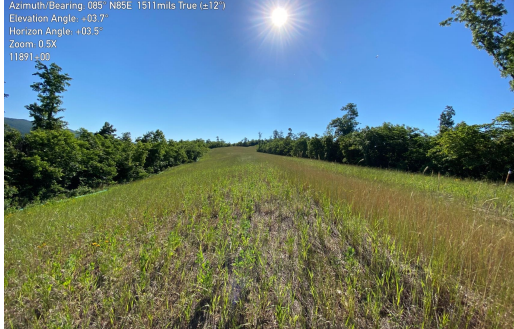
GPS Location	5	GPS Location	6		
Field Station#	11863+65	Field Station#	11891+00		
Pic 5 Desc.	Section of restored RoW showing conditions and controls.		Pic 6 Desc.	Section of restored RoW showing conditions and controls.

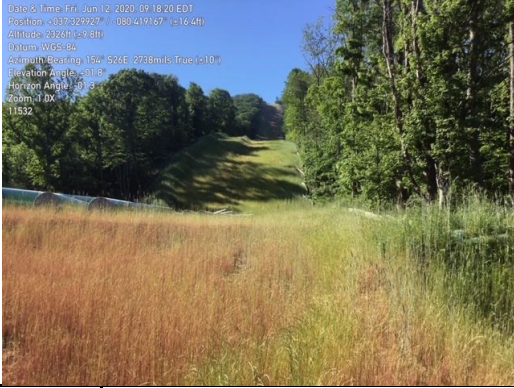
<p>Date & Time: Fri, Jun 12, 2020, 09:58:19 EDT Position: +037.310227° / -080.411935° (±3269.2ft) Altitude: 2605ft (±58.5ft) Datum: WGS-84 Azimuth/Bearing: 154° 52'4E 2773mils True (±10°) Elevation Angle: -34.8° Horizon Angle: +03.4° Zoom: 1.0X 11552</p>			
GPS Location	See picture above for GPS coordinates		GPS Location	See picture above for GPS coordinates	
Field Station#	11532+00		Field Station#	11552+00	
Pic 1 Desc.	ECD's and row conditions		Pic 2 Desc.	ECD's and row conditions

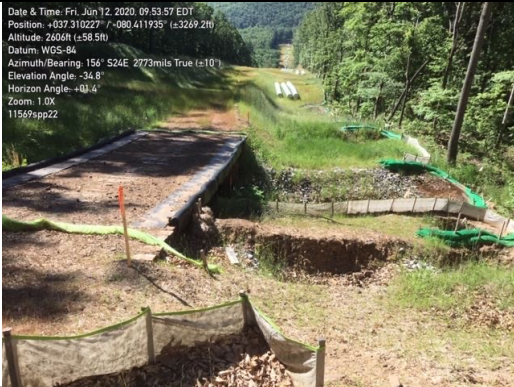
GPS Location	See picture above for GPS coordinates		GPS Location	See picture above for GPS coordinates	
Field Station#	11569+00		Field Station#	11569+00	
Pic 3 Desc.	ECD's and row conditions		Pic 4 Desc.	ECD's and row conditions

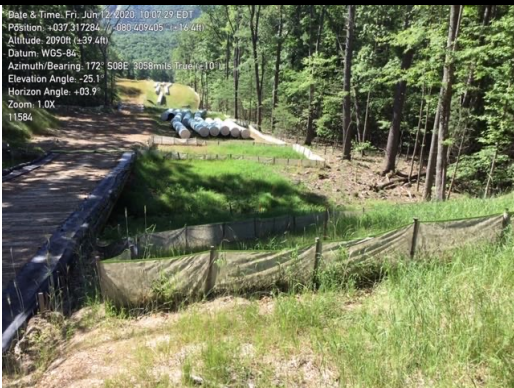
Pic 5 Desc.	ECD's and row conditions		Pic 6 Desc.	ECD's and row conditions

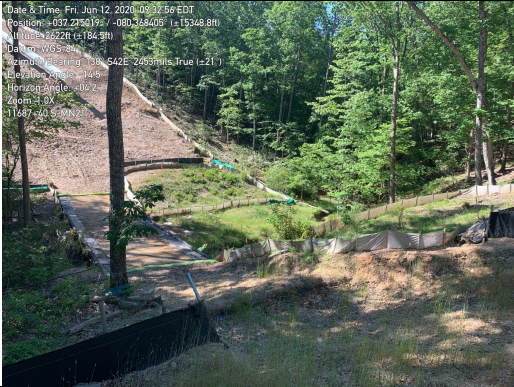
GPS Location	See photo for GPS location.		GPS Location	See photo for GPS location.	
Field Station#	11687+40		Field Station#	11704+00	
Pic 1 Desc.	Sensitive resource buffer in place at stream S-MN21.		Pic 2 Desc.	Sensitive resource buffer in place at stream S-MN22.

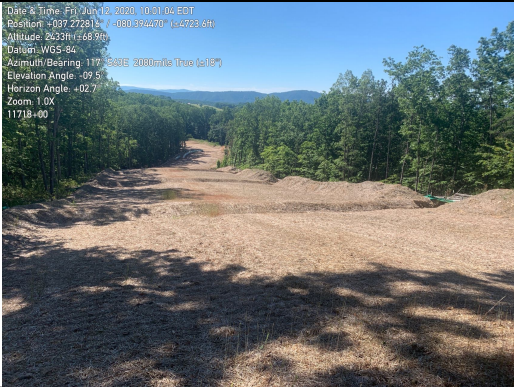
GPS Location	See photo for GPS location.		GPS Location	See photo for GPS location.	
Field Station#	11718+00		Field Station#	11767+00	
Pic 3 Desc.	ROW stabilized with mulch. Waterbars in place.		Pic 4 Desc.	RCE in place at Main Line Valve 26.

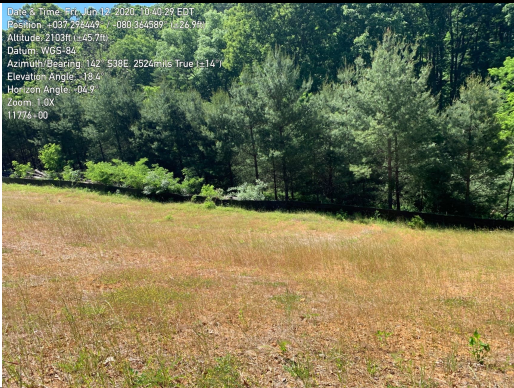
GPS Location	See photo for GPS location.		GPS Location	See photo for GPS location.	
Field Station#	11776+00		Field Station#	11778+00	
Pic 5 Desc.	Reinforced super silt fence in place along LOD.		Pic 6 Desc.	Clean water diversion pipe and plunge pool in place.
