# Visual Site Inspection Report

<b>Project Name</b>	H-600 Pipeline Spread G	<b>AFE</b>	124300137	<b>Spread</b>	H-600 Pipeline Spread G
<b>Contractor</b>	Precision			<b>Report #</b>	12821
<b>Inspector</b>	Chris Burns			<b>Date/Time</b>	7/20/2020 8:14 AM
<b>Permit #</b>	TBD	<b>Inspection Type</b>	VA SWPP	<b>Station Begin</b>	11023+80
<b>State</b>	VA	<b>Inspection Area</b>	Partial	<b>Station End</b>	11064+53
<b>County</b>	Giles	<b>Ground</b>	Dry	<b>Temperature (°F)</b>	92.00
<b>Municipality</b>	N/A	<b>Weather</b>	Sunny	<b>Rain Gauge (in)</b>	0.00
				<b>Rain Accumulation Time (days)</b>	1.00

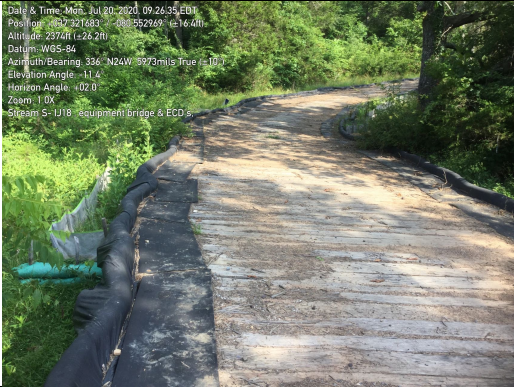
<p>Date &amp; Time: Mon, Jul 20, 2020, 09:26:35 EDT Position: +037.324041 / -089.554660 (-16.4ft) Altitude: 2697ft (+26.2ft) Datum: WGS-84 Azimuth/Bearing: 336° N24W 373mils True (+10°) Elevation Angle: -11.4° Horizon Angle: +02.0° Zoom: 1.0X Stream S- IJ18- Equipment bridge, buffers &amp; ECD's</p>

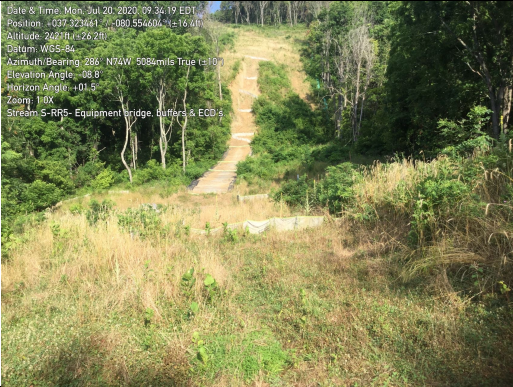
<p>Date &amp; Time: Mon, Jul 20, 2020, 09:34:19 EDT Position: +037.324041 / -089.554660 (-16.4ft) Altitude: 2697ft (+26.2ft) Datum: WGS-84 Azimuth/Bearing: 286° N24W 508mils True (+10°) Elevation Angle: -08.8° Horizon Angle: +01.5° Zoom: 1.0X Stream S- RR5- Equipment bridge, buffers &amp; ECD's</p>			
<b>GPS Location</b>	See photo GPS	<b>GPS Location</b>	See photo GPS		
<b>Field Station#</b>	11024+00	<b>Field Station#</b>	11018+00		
<b>Pic 1 Desc.</b>	Stream S- IJ18- Equipment bridge, buffers & ECD's.	<b>Pic 2 Desc.</b>	Row, stream S- RR5, ECD's.

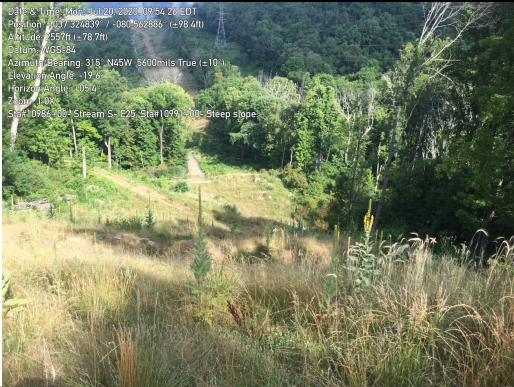
<p>Date &amp; Time: Mon, Jul 20, 2020, 10:54:20 EDT Position: +037.324839 / -089.562884 (-98.4ft) Altitude: 2557ft (+78.7ft) Datum: WGS-84 Azimuth/Bearing: 315° N45W 540mils True (+10°) Elevation Angle: -13° Horizon Angle: +05.2° Zoom: 1.0X Stream S- E25- Steep slope</p>

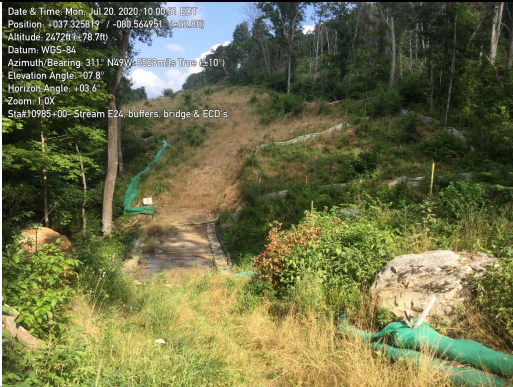
<p>Date &amp; Time: Mon, Jul 20, 2020, 10:06:01 EDT Position: +037.325819 / -089.564951 (-60.2ft) Altitude: 2472ft (+78.7ft) Datum: WGS-84 Azimuth/Bearing: 311° N49W 588mils True (+10°) Elevation Angle: -07.8° Horizon Angle: +03.6° Zoom: 1.0X Stream S- E24- bridge, ECD's, buffers</p>			
<b>GPS Location</b>	See photo GPS	<b>GPS Location</b>	See photo GPS		
<b>Field Station#</b>	10986+00	<b>Field Station#</b>	10985+00		
<b>Pic 3 Desc.</b>	Steep slope, stream S- E25	<b>Pic 4 Desc.</b>	Stream S- E24, bridge, ECD's, buffers.

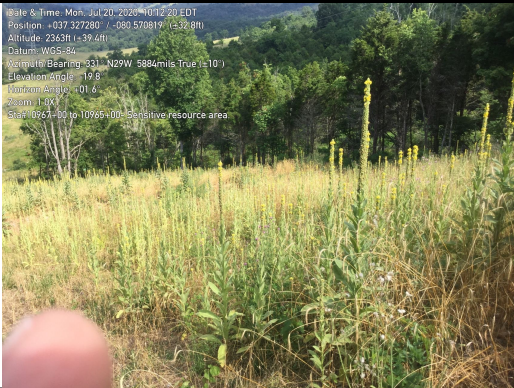
<p>Date &amp; Time: Mon, Jul 20, 2020, 10:12:20 EDT Position: +037.327290 / -089.570819 (-32.8ft) Altitude: 2363ft (+39.4ft) Datum: WGS-84 Azimuth/Bearing: 331° N29W 584mils True (+10°) Elevation Angle: -19.8° Horizon Angle: +01.6° Zoom: 1.0X Stream S- E24- Sensitive resource area</p>

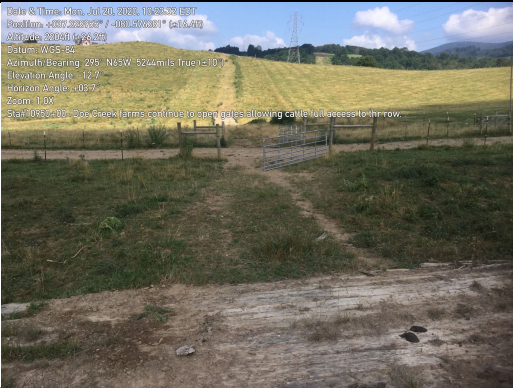
<p>Date &amp; Time: Mon, Jul 20, 2020, 10:26:39 EDT Position: +037.327290 / -089.570819 (-32.8ft) Altitude: 2363ft (+39.4ft) Datum: WGS-84 Azimuth/Bearing: 295° N45W 524mils True (+10°) Elevation Angle: -12.7° Horizon Angle: +05.7° Zoom: 1.0X Stream S- E24- Doe Creek Farms continue to steep slope following cattle farm access to the row</p>

<b>GPS Location</b>	See photo GPS	<b>GPS Location</b>	See photo GPS		
<b>Field Station#</b>	10967+00	<b>Field Station#</b>	10950+00		
<b>Pic 5 Desc.</b>	Sensitive resource area	<b>Pic 6 Desc.</b>	Open cattle gates on Doe Creek Farms row.

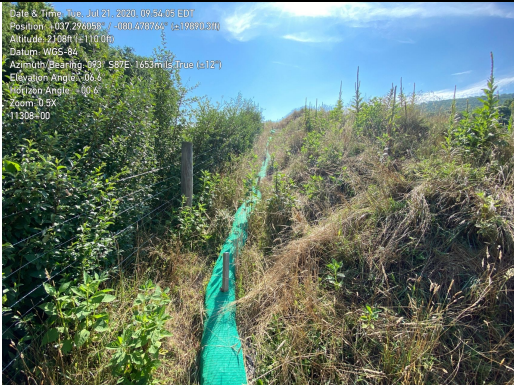
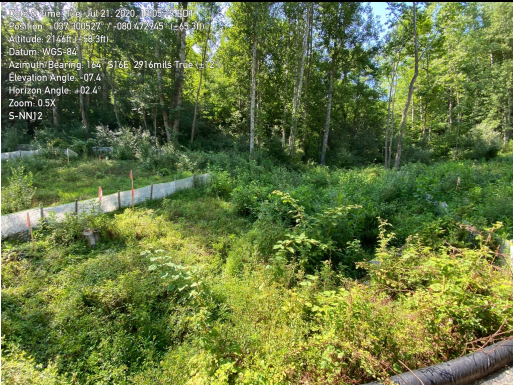
<b>GPS Location</b>	3	<b>GPS Location</b>	4		
<b>Field Station#</b>	11308+00	<b>Field Station#</b>	11327+85		
<b>Pic 3 Desc.</b>	Perimeter controls functional.	<b>Pic 4 Desc.</b>	S-NN12 and controls.

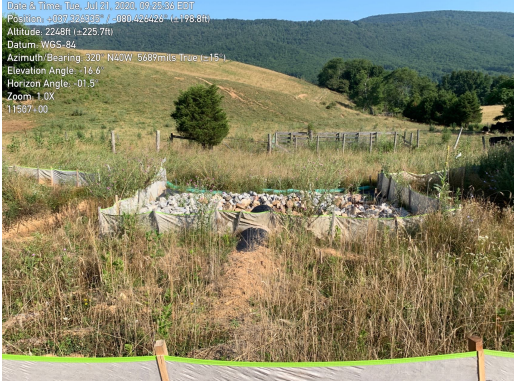
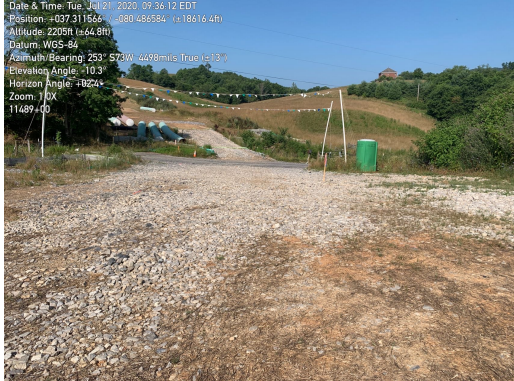
<p>Date &amp; Time: Tue, Jul 21, 2020, 09:36:12 EDT Position: +037 311534 / -080 426524 (+181.6 ft) Altitude: 2205ft (+44.8ft) Datum: WGS-84 Azimuth/Bearing: 253° S24W 449mits True (+13°) Elevation Angle: -10.3° Horizon Angle: -02.4° Zoom: 1.0X 11489+00</p>			
<b>GPS Location</b>	See photo for GPS location.		<b>GPS Location</b>	See photo for GPS location.	
<b>Field Station#</b>	11507+00		<b>Field Station#</b>	11489+00	
<b>Pic 1 Desc.</b>	Plunge pool and clean water diversion pipe in place.		<b>Pic 2 Desc.</b>	RCE in place at Stevers Gap Road.

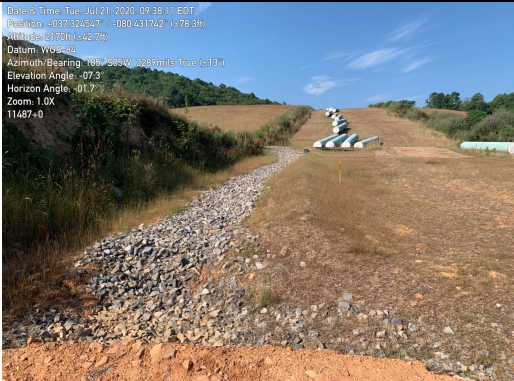
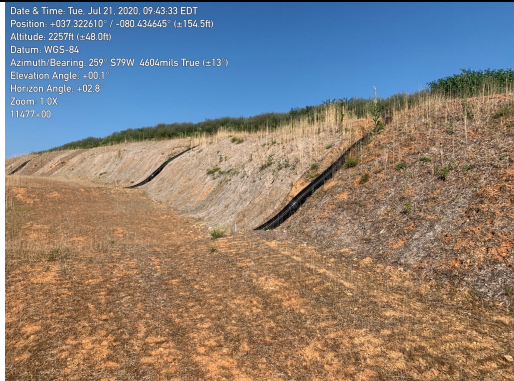
<p>Date &amp; Time: Tue, Jul 21, 2020, 09:43:33 EDT Position: +037 322610 / -080 434645 (+154.5ft) Altitude: 2257ft (+48.0ft) Datum: WGS-84 Azimuth/Bearing: 259° S79W 460mits True (+13°) Elevation Angle: -00.1° Horizon Angle: -02.8° Zoom: 1.0X 11477+00</p>			
<b>GPS Location</b>	See photo for GPS location.		<b>GPS Location</b>	See photo for GPS location.	
<b>Field Station#</b>	11487+00		<b>Field Station#</b>	11477+00	
<b>Pic 3 Desc.</b>	Rock lined over spill channel in place.		<b>Pic 4 Desc.</b>	Two tone stabilized with ECB and slope drain pipes in place.

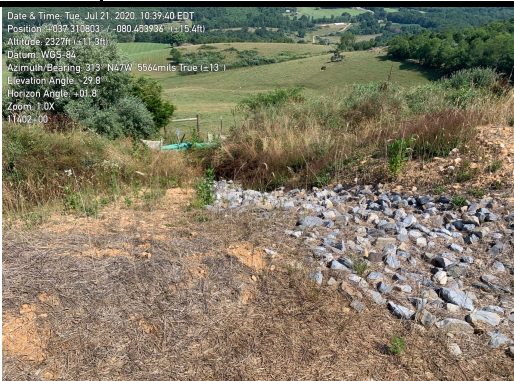
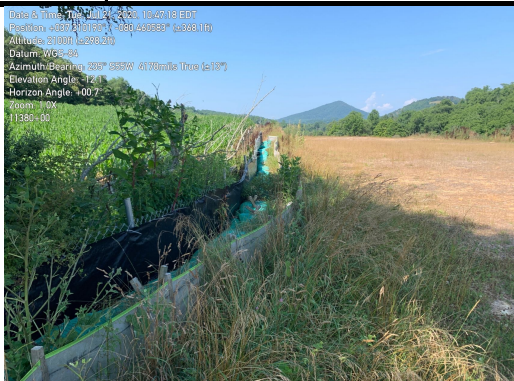
<b>GPS Location</b>	See photo for GPS location.		<b>GPS Location</b>	See photo for GPS location.	
<b>Field Station#</b>	11402+00		<b>Field Station#</b>	11380+00	
<b>Pic 5 Desc.</b>	Rock lined channel in place over fill slope.		<b>Pic 6 Desc.</b>	Triple barrier ECDs in place at off ROW karst feature.

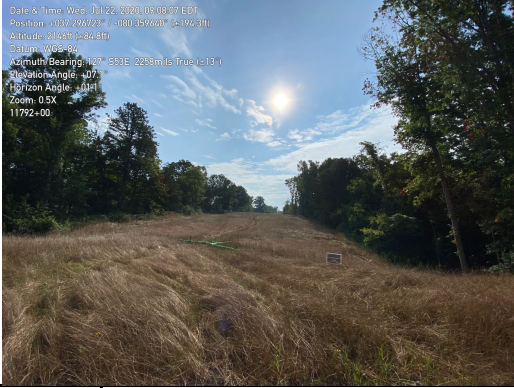
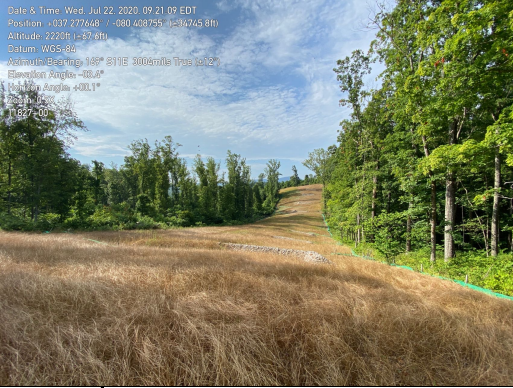
<b>GPS Location</b>	1	<b>GPS Location</b>	2		
<b>Field Station#</b>	11792+00	<b>Field Station#</b>	11827+00		
<b>Pic 1 Desc.</b>	Section of restored RoW showing conditions and controls.		<b>Pic 2 Desc.</b>	Section of restored RoW showing conditions and controls.

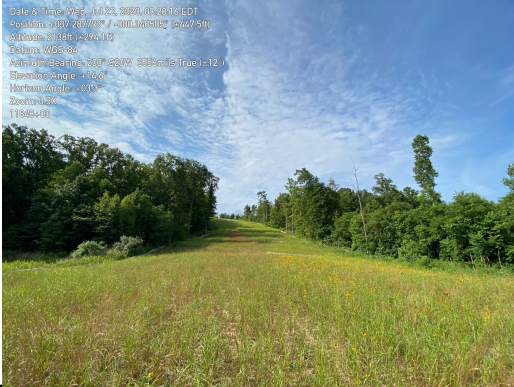
<b>GPS Location</b>	3	<b>GPS Location</b>	4		
<b>Field Station#</b>	11848+00	<b>Field Station#</b>	11863+65		
<b>Pic 3 Desc.</b>	Section of restored RoW showing conditions and controls.		<b>Pic 4 Desc.</b>	P-KL2 and controls.

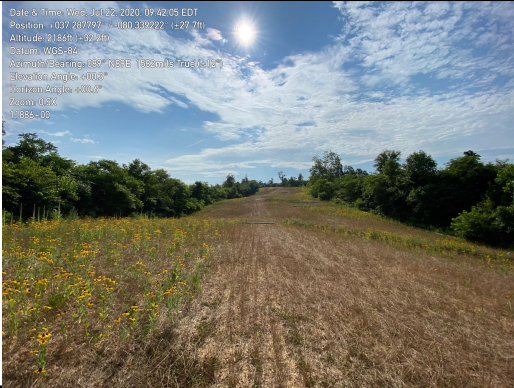
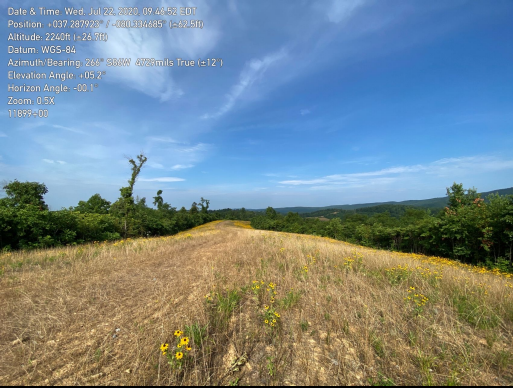
<b>GPS Location</b>	5	<b>GPS Location</b>	6		
<b>Field Station#</b>	11886+00	<b>Field Station#</b>	11899+00		
<b>Pic 5 Desc.</b>	Section of restored RoW showing conditions and controls.		<b>Pic 6 Desc.</b>	Section of restored RoW showing conditions and controls.

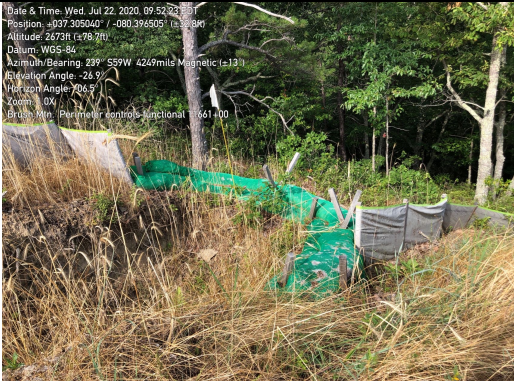
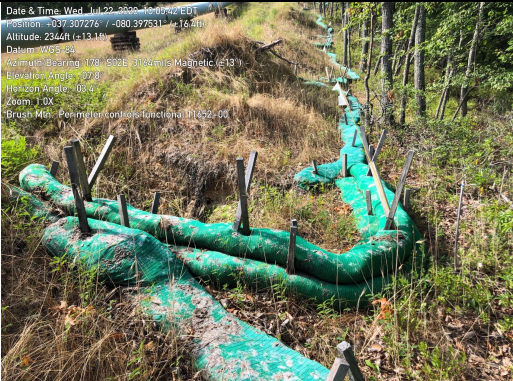
<b>GPS Location</b>	On photo	<b>GPS Location</b>	On photo		
<b>Field Station#</b>	11661+00	<b>Field Station#</b>	11652+00		
<b>Pic 3 Desc.</b>	End treatments are working as designed	<b>Pic 4 Desc.</b>	Perimeter controls are in place and functional

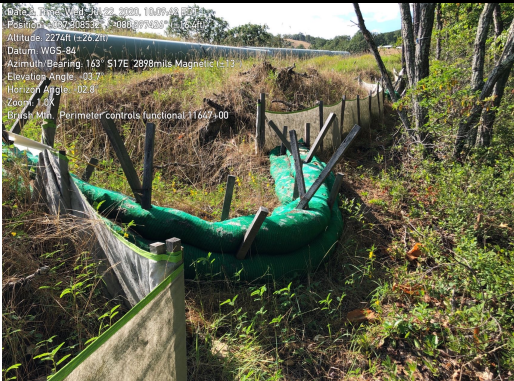
<b>GPS Location</b>	On photo	<b>GPS Location</b>	On photo		
<b>Field Station#</b>	11647+00	<b>Field Station#</b>	11628+00		
<b>Pic 5 Desc.</b>	Perimeter controls are functional	<b>Pic 6 Desc.</b>	Perimeter controls are functional. ROW stable.

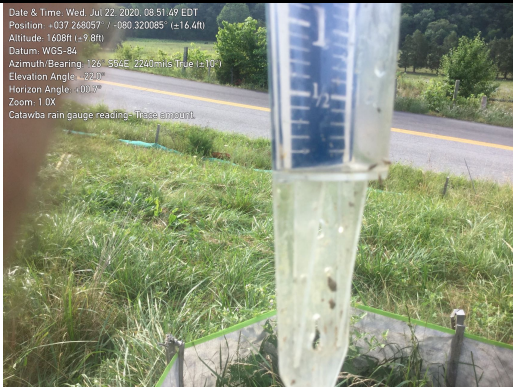
AFE	124300137	Date/Time	7/22/2020 1:32 PM	Report #	
Pictures					
<p>Date &amp; Time: Wed, Jul 22, 2020, 08:51:49 EDT Position: +037.248957 / -080.320089 (+16.4ft) Altitude: +608ft (+19.8m) Datum: WGS-84 Azimuth/Bearing: 126.5545° (2260mils True ±10°) Elevation Angle: +20.7° Horizon Angle: +00.3° Zoom: 1.0X Catawba rain gauge reading - Trace amounts</p>

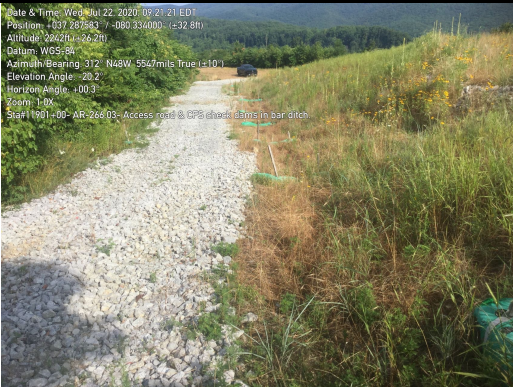
<p>Date &amp; Time: Wed, Jul 22, 2020, 09:21:21 EDT Position: +037.261931 / -080.336000 (+32.8ft) Altitude: +262ft (+80.2m) Datum: WGS-84 Azimuth/Bearing: 312.5547mils True ±10° Elevation Angle: -20.2° Horizon Angle: +00.3° Zoom: 1.0X Sta#11901+00- AR-266.03- Access road &amp; GPS chart. Same in bar ditch</p>

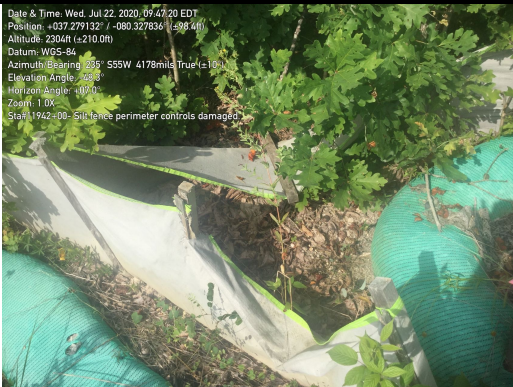
<p>Date &amp; Time: Wed, Jul 22, 2020, 09:47:20 EDT Position: +037.279132 / -080.327836 (+98.4ft) Altitude: +2304ft (+701.0m) Datum: WGS-84 Azimuth/Bearing: 139° 55SW 4178mils True ±10° Elevation Angle: -68° Horizon Angle: +07.0° Zoom: 1.0X Sta#11942+00- Silt fence perimeter controls damaged</p>

GPS Location	See photo GPS	GPS Location	See photo GPS		
Field Station#	11936+00	Field Station#	11941+00		
Pic 3 Desc.	Row vegetation is very good.	Pic 4 Desc.	Silt fence perimeter controls damaged.		
<p>Date &amp; Time: Wed, Jul 22, 2020, 09:58:26 EDT Position: +037.226012 / -080.326190 (+32.8ft) Altitude: +1957ft (+59.4m) Datum: WGS-84 Azimuth/Bearing: 215.555W 3822mils True ±10° Elevation Angle: -22.1° Horizon Angle: +07.0° Zoom: 1.0X Sta#11955+00- Level spreader vegetation</p>

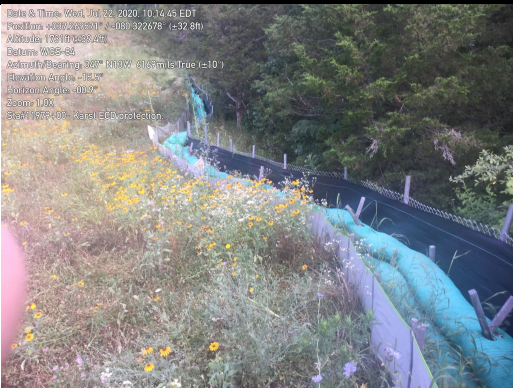
<p>Date &amp; Time: Wed, Jul 22, 2020, 10:14:45 EDT Position: +037.226012 / -080.322678 (+32.8ft) Altitude: +1951ft (+59.2m) Datum: WGS-84 Azimuth/Bearing: 307° N83W 3133mils True ±10° Elevation Angle: -16.5° Horizon Angle: +00.4° Zoom: 1.0X Sta#11979+00- Karst ECD's protection</p>

GPS Location	See photo GPS	GPS Location	See photo GPS		
Field Station#	11955+00	Field Station#	11979+00		
Pic 5 Desc.	Level spreader and row vegetation.	Pic 6 Desc.	Karst ECD's protection.

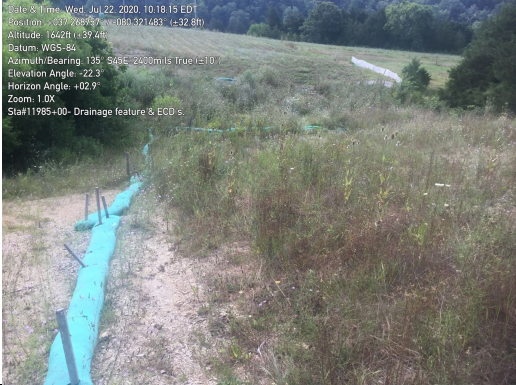
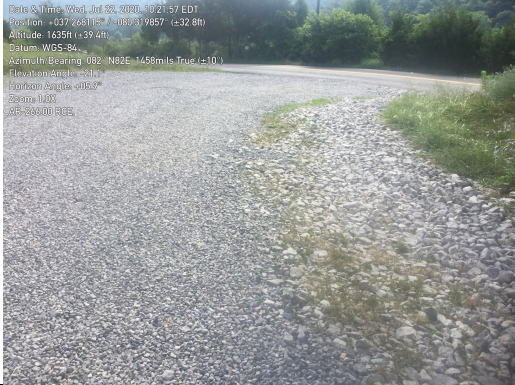
<b>GPS Location</b>	See photo GPS		<b>GPS Location</b>	See photo GPS	
<b>Field Station#</b>	11985+00		<b>Field Station#</b>	11989+00	
<b>Pic 7 Desc.</b>	Drainage feature & ECD's.		<b>Pic 8 Desc.</b>	AR-266.00 RCE off Catawba road.	
Insert image here			Insert image here		
<b>GPS Location</b>			<b>GPS Location</b>		
<b>Field Station#</b>			<b>Field Station#</b>		
<b>Pic 9 Desc.</b>			<b>Pic 10 Desc.</b>		
Insert image here			Insert image here		
<b>GPS Location</b>			<b>GPS Location</b>		
<b>Field Station#</b>			<b>Field Station#</b>		
<b>Pic 11 Desc.</b>			<b>Pic 12 Desc.</b>

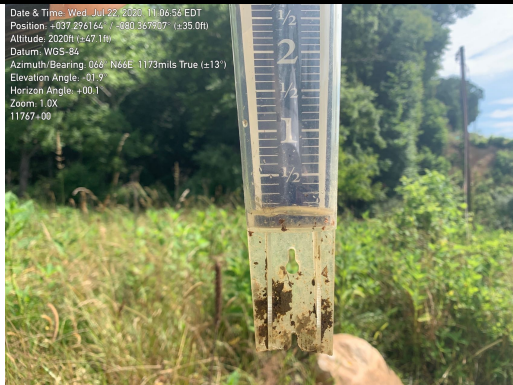
<b>GPS Location</b>		See photo for GPS location.		<b>GPS Location</b>	
<b>Field Station#</b>		11719+00		<b>Field Station#</b>	
<b>Pic 3 Desc.</b>		Top soil pile stabilized with seed and mulch after 3 party damages occurred.		<b>Pic 4 Desc.</b>	
				Rain gauge at Mount Tabor Road reads 0.1 inches.

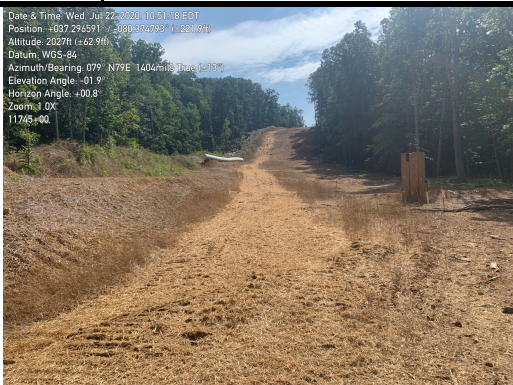
<b>Pic 5 Desc.</b>		Travel lane stabilized with mulch and seed after equipment completed repairs.		<b>Pic 6 Desc.</b>	
				Clean water diversion pipe and plunge pool in place.

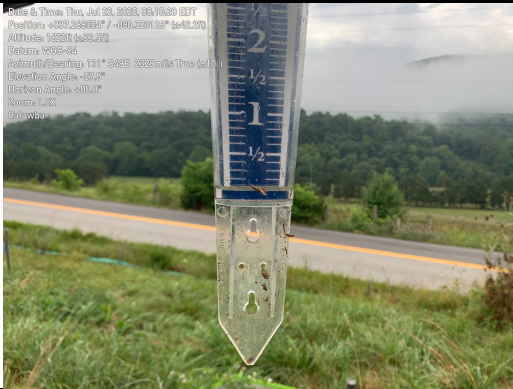
GPS Location		See photo for GPS location.		GPS Location	
Field Station#		11990+00		Field Station#	
Pic 1 Desc.		Rain gauge at Catawba Road reads 0.1 inches.		Pic 2 Desc.

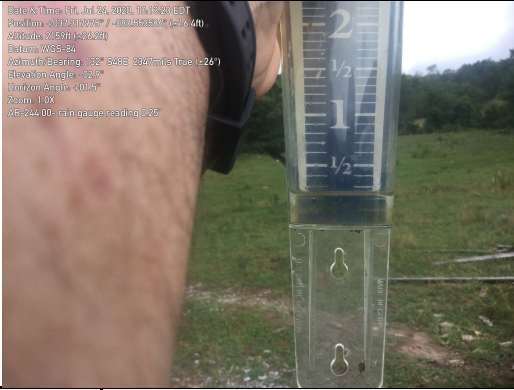
<p>Date &amp; Time: Fri, Jul 24, 2020, 10:15:20 EDT Position: +037.322505° / -080.554915° (+32.40ft) Altitude: 2324ft (+39.4ft) Datum: WGS-84 Azimuth/Bearing: 137° 54SE 3076mils True (+10°) Elevation Angle: -23.2° Horizon Angle: -00.2° Zoom: 1.0X AR-244.00- rain gauge reading 0.25"</p>		  <p>Date &amp; Time: Fri, Jul 24, 2020, 10:21:19 EDT Position: +037.322505° / -080.553270° (+32.40ft) Altitude: 2324ft (+39.4ft) Datum: WGS-84 Azimuth/Bearing: 173° 507E 3076mils True (+10°) Elevation Angle: -23.2° Horizon Angle: -00.2° Zoom: 1.0X Stream S-IJ18- AR-244.00- Bridge, buffers, ECD's signage</p>			
<b>GPS Location</b>	See photo GPS	<b>GPS Location</b>	See photo GPS		
<b>Field Station#</b>	11024+00	<b>Field Station#</b>	11024+00		
<b>Pic 1 Desc.</b>	AR-244.00 rain gauge reading - 0.25"	<b>Pic 2 Desc.</b>	Stream S- IJ18- Equipment bridge, ECD's, buffers.

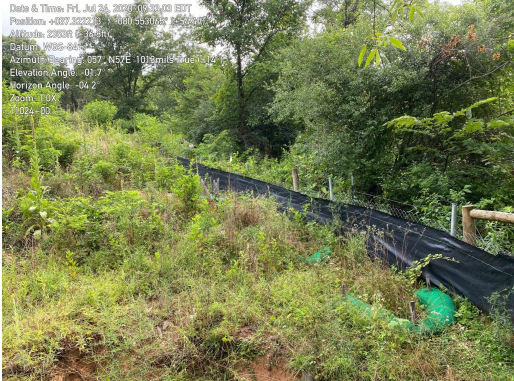
<b>GPS Location</b>	1	<b>GPS Location</b>	2		
<b>Field Station#</b>	11024+00	<b>Field Station#</b>	11025+50		
<b>Pic 1 Desc.</b>	Perimeter controls functional.		<b>Pic 2 Desc.</b>	S-IJ18 and controls.

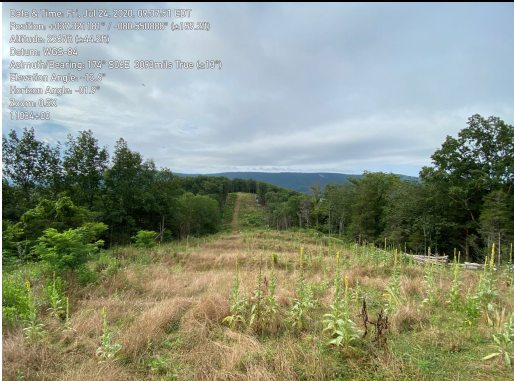
<b>GPS Location</b>	3	<b>GPS Location</b>	4		
<b>Field Station#</b>	11034+00	<b>Field Station#</b>	11050+10		
<b>Pic 3 Desc.</b>	Section of RoW showing conditions and controls.		<b>Pic 4 Desc.</b>	S-IJ16B/S-IJ17 and controls.

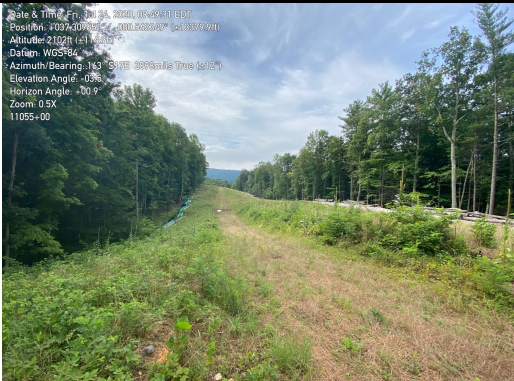
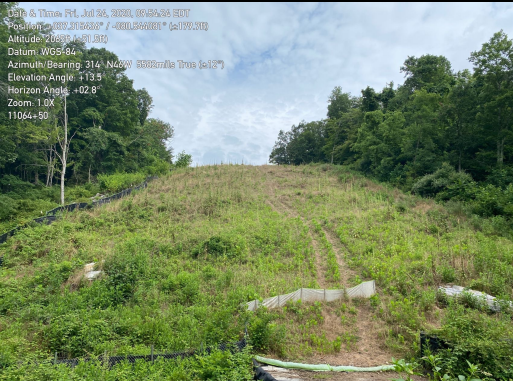
<b>GPS Location</b>	5	<b>GPS Location</b>	6		
<b>Field Station#</b>	11055+00	<b>Field Station#</b>	11064+50		
<b>Pic 5 Desc.</b>	Section of RoW showing conditions and controls.		<b>Pic 6 Desc.</b>	Section of RoW showing conditions and controls.
