Visual Site Inspection Report

Project Name	H-600 Pipeline Spread G	AFE	124300137	Spread	H-600 Pipeline Spread G
Contractor	Precision			Report #	12458
Inspector	Len Kruizenga			Date/Time	7/6/2020 8:29 AM
Permit #	TBD	Inspection Type	VA SWPP	Station Begin	11788+52
State	VA	Inspection Area	Full	Station End	12005+00
County	Giles	Ground	Dry	Temperature (°F)	85.00
Municipality	N/A	Weather	Sunny	Rain Gauge (in)	0.00
				Rain Accumulation Time (days)	1.00

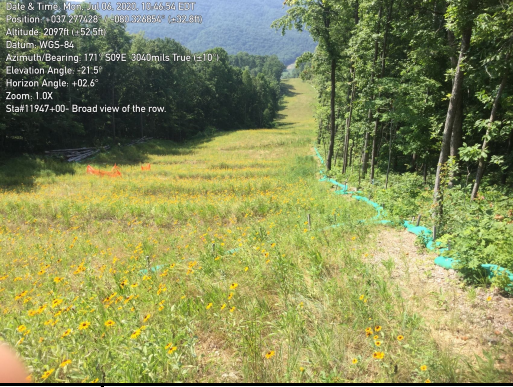
GPS Location	See photo GPS		GPS Location	See	
Field Station#	12942+00		Field Station#	11947+00	
Pic 5 Desc.	Karst ECD's		Pic 6 Desc.	Broad view of the row.

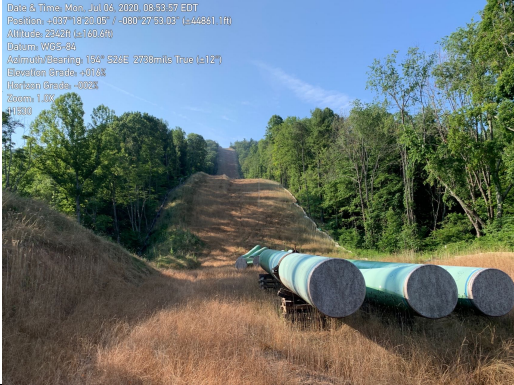
GPS Location	See picture above for GPS coordinates		GPS Location	See picture above for GPS coordinates	
Field Station#	11530+00		Field Station#	11543+00	
Pic 1 Desc.	ECD's and row conditions		Pic 2 Desc.	Damaged P1

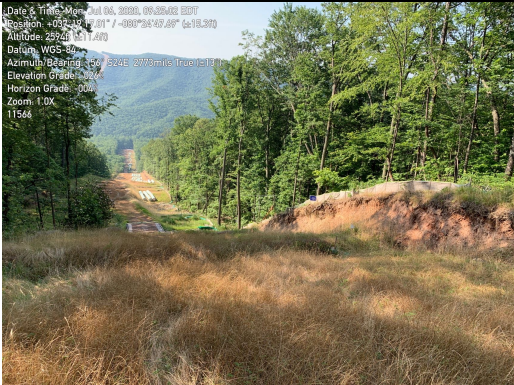
GPS Location	See picture above for GPS coordinates		GPS Location	See picture above for GPS coordinates	
Field Station#	11566+00		Field Station#	11569+00	
Pic 3 Desc.	ECD's and row conditions		Pic 4 Desc.	ECD's and row conditions

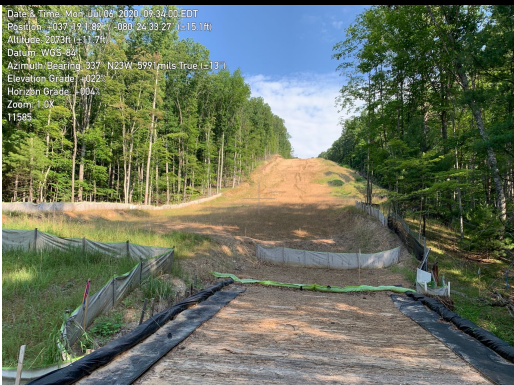
GPS Location	See picture above for GPS coordinates		GPS Location	See picture above for GPS coordinates	
Field Station#	11585+00		Field Station#	11593+00	
Pic 5 Desc.	ECD's and row conditions		Pic 6 Desc.	ECD's and row conditions

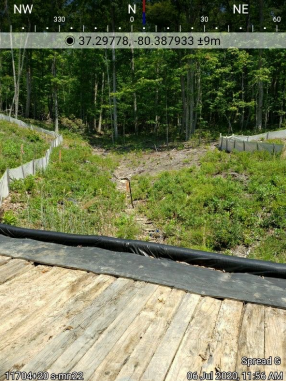
GPS Location	See photo for GPS location.		GPS Location	See photo for GPS location.	
Field Station#	11704+20		Field Station#	11705+00	
Pic 3 Desc.	Sensitive resource buffer in place at stream S-MN22.		Pic 4 Desc.	ROW stabilized with mulch.

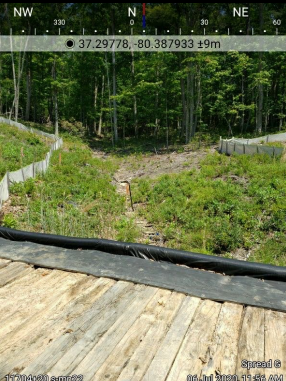
GPS Location	See photo for GPS location.		GPS Location	See photo for GPS location.	
Field Station#	11704+20		Field Station#	11713+25	
Pic 5 Desc.	Steam bed S-MN22.		Pic 6 Desc.	ROW stabilized with mulch. Waterbar, sump pit and waterbar end treatment in place.

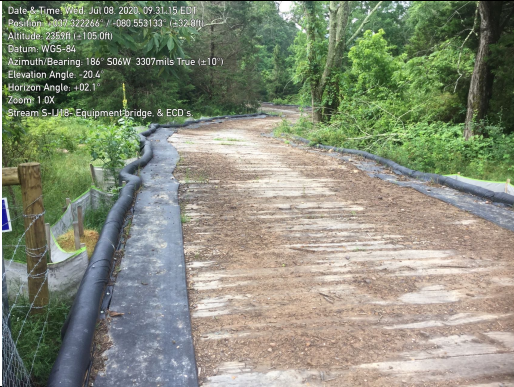
<p>Date & Time: Wed, Jul 08, 2020, 09:31:15 EDT Position: +037 322441, -080 553133 (±12m) Altitude: 2350ft (±105.0ft) Datum: WGS-84 Azimuth/Bearing: 186° S06W 3307mils True (±10°) Elevation Angle: -20.4° Horizon Angle: -102.1° Zoom: 1.0x Stn#10945+00 - Stream S-IJ18 - Equipment bridge & ECD's</p>

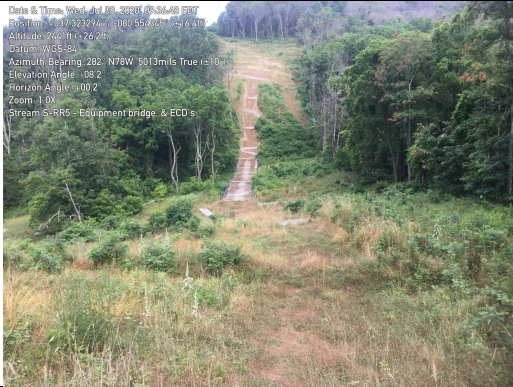
<p>Date & Time: Wed, Jul 08, 2020, 08:56:40 EDT Position: +037 322441, -080 552635 (±12m) Altitude: 2350ft (±105.0ft) Datum: WGS-84 Azimuth/Bearing: 282° N78W 5013mils True (±10°) Elevation Angle: -08.2° Horizon Angle: -100.2° Zoom: 1.0x Stn#10945+00 - Stream S-RR5 - Equipment bridge & ECD's</p>	
GPS Location	See photo GPS	GPS Location	See photo GPS
Field Station#	11024+00	Field Station#	11017+00
Pic 1 Desc.	Stream S-IJ18 - Equipment bridge & ECD's	Pic 2 Desc.	Stream S- RR5 and broad view of the row.

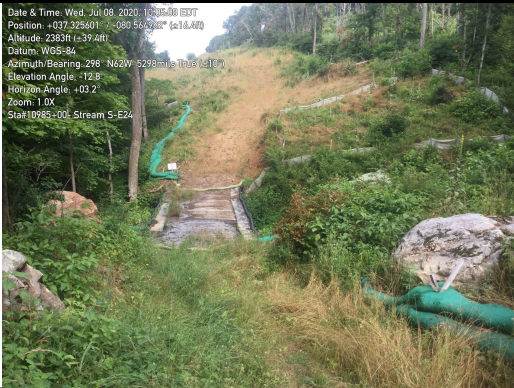
<p>Date & Time: Wed, Jul 08, 2020, 10:05:00 EDT Position: +037 322501, -080 552527 (±10.7m) Altitude: 2383ft (±116.4ft) Datum: WGS-84 Azimuth/Bearing: 298° N62W 5298mils True (±10°) Elevation Angle: -12.9° Horizon Angle: -103.2° Zoom: 1.0x Stn#10985+00 - Stream S-E24</p>

Pic 5 Desc.	Stream S- E24 equipment bridge and ECD's.	Pic 6 Desc.	Bat habitat and ECD's

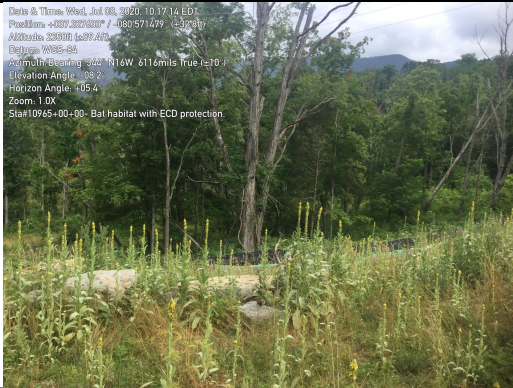
<p>Date & Time: Wed, Jul 08, 2020, 10:17:14 EDT Position: +037 322501, -080 571479 (±12m) Altitude: 2388ft (±116.4ft) Datum: WGS-84 Azimuth/Bearing: 322° N14W 6116mils True (±10°) Elevation Angle: -08.2° Horizon Angle: -105.4° Zoom: 1.0x Stn#10965+00+00 - Bat habitat with ECD protection</p>	
GPS Location	See photo GPS	GPS Location	See photo GPS
Field Station#	10985+00	Field Station#	10965+00

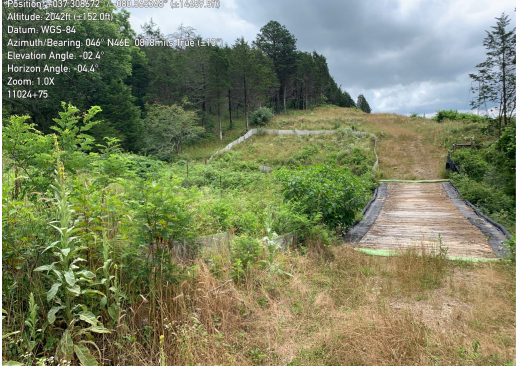
GPS Location	See photo for GPS location.		GPS Location	See photo for GPS location.	
Field Station#	11024+75		Field Station#	11026+00	
Pic 1 Desc.	Sensitive resource buffer in place at stream S-IJ18.		Pic 2 Desc.	ROW stabilized with natural vegetation growth.

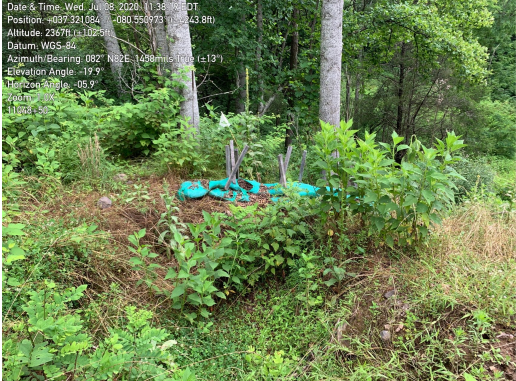
GPS Location	See photo for GPS location.		GPS Location	See photo for GPS location.	
Field Station#	11048+50		Field Station#	11058+00	
Pic 3 Desc.	Waterbar end treatment triple stack CFS needs repaired.		Pic 4 Desc.	Priority one silt fence LOD control in place.

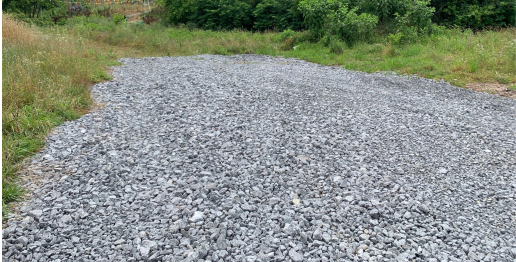
GPS Location	See photo for GPS location.		GPS Location	See photo for GPS location.	
Field Station#	10696+00		Field Station#	110670+00	
Pic 5 Desc.	RCE at Buffalo Anklets Road in place.		Pic 6 Desc.	Reinforced super silt fence in place along LOD.

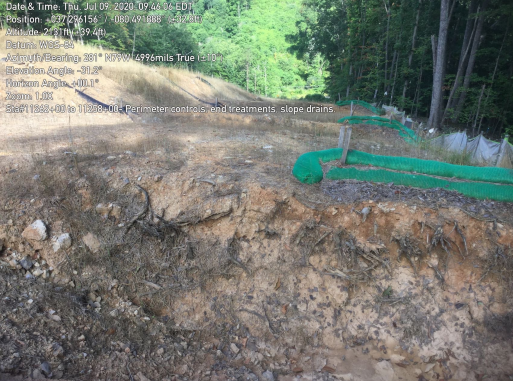
GPS Location	See photo GPS	GPS Location	See photo GPS		
Field Station#	11258+00	Field Station#	11262+00		
Pic 1 Desc.	Sta#11258+00 to 11237+00- Trees felled but not cleared or processed.	Pic 2 Desc.	Sta#11262+00 to 11258+00- Slope drains, water bars, end treatments, perimeter controls.

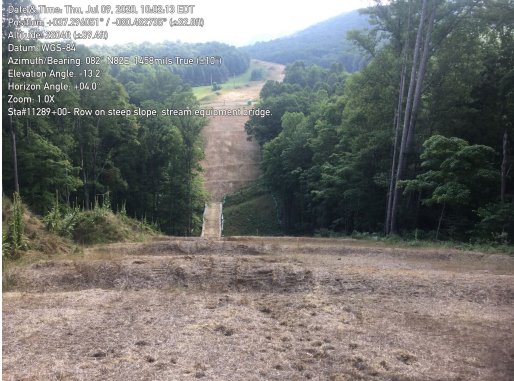
GPS Location	See photo GPS	GPS Location	See photo GPS		
Field Station#	11289+00	Field Station#	11326+00		
Pic 3 Desc.	Row on steep slope, stream, equipment bridge & ECD's	Pic 4 Desc.	Stream, equipment bridge and stream controls.

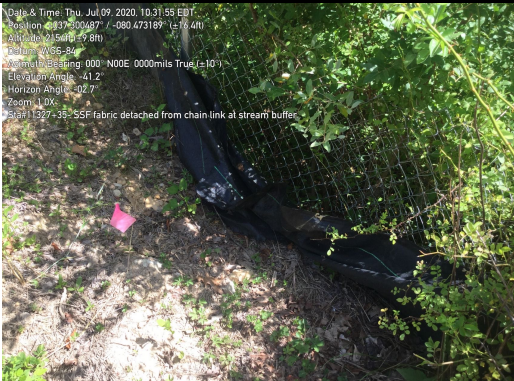
GPS Location	See photo GPS	GPS Location	See photo GPS		
Field Station#	11327+35	Field Station#	11332+00		
Pic 5 Desc.	SSF fabric detached from chain link at stream buffer.	Pic 6 Desc.	Rock channel and P1 perimeter controls.

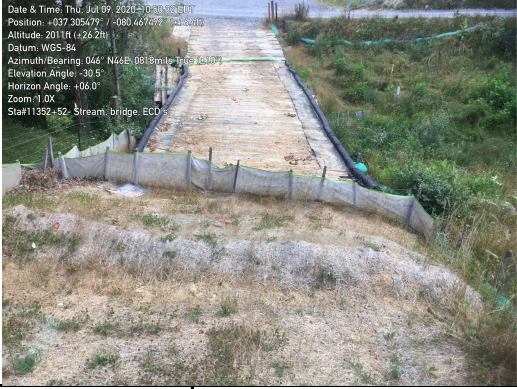
<p>Insert image here</p>			
GPS Location	See photo GPS	GPS Location			
Field Station#	11352+52	Field Station#			
Pic 7 Desc.	Stream, equipment bridge, stream controls.	Pic 8 Desc.			
<p>Insert image here</p>		<p>Insert image here</p>			
GPS Location		GPS Location			
Field Station#		Field Station#			
Pic 9 Desc.		Pic 10 Desc.			
<p>Insert image here</p>		<p>Insert image here</p>			
GPS Location		GPS Location			
Field Station#		Field Station#			
Pic 11 Desc.		Pic 12 Desc.

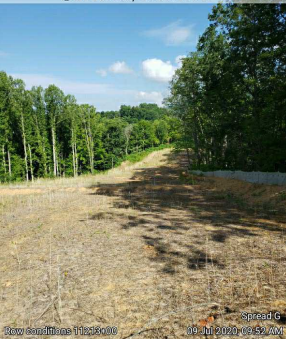
Row conditions 11213+00 Spread G 09 Jul 2020, 09:59 AM			North East Elevation ● 37.301607, -80.50415 ±8m

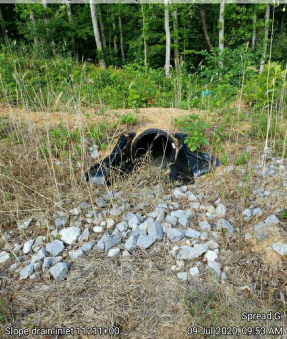
Slope drain inlet 11211+00 Spread G 09 Jul 2020, 09:59 AM	
GPS Location	see photo		GPS Location	see photo	
Field Station#	11213+00		Field Station#	11211+00	
Pic 1 Desc.	Stabilized row conditions		Pic 2 Desc.	slope drain inlet	
	West Elevation ● 37.30403, -80.506697 ±6m

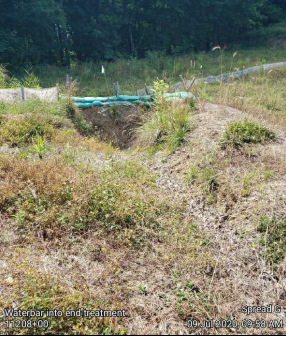
Waterbar into end treatment 11108+00 Spread G 09 Jul 2020, 10:08 AM			South Elevation ● 37.307376, -80.511913 ±9m

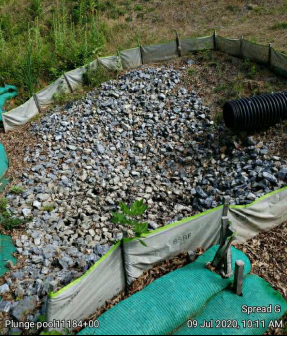
Plunge pool 11184+00 Spread G 09 Jul 2020, 10:11 AM	
GPS Location	see photo		GPS Location	see photo	
Field Station#	11108+00		Field Station#	11184+00	
Pic 3 Desc.	waterbar into end treatment		Pic 4 Desc.	installed plunge pool	
	South East Elevation ● 37.30739, -80.511969 ±15m

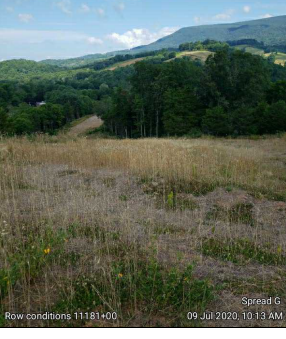
Row conditions 11181+00 Spread G 09 Jul 2020, 10:13 AM			South West Elevation ● 37.310377, -80.51419 ±4m

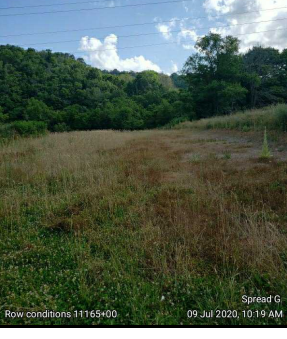
Row conditions 11165+00 Spread G 09 Jul 2020, 10:19 AM

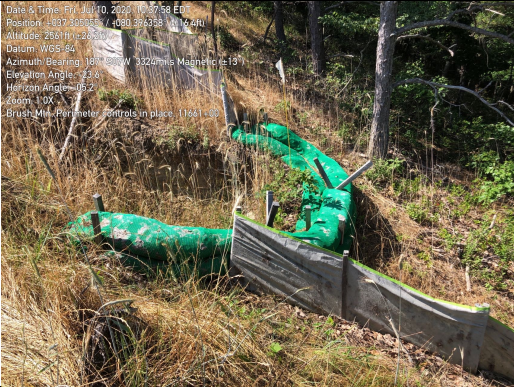
GPS Location	On photo	GPS Location	On photo		
Field Station#	11665+50	Field Station#	11661+00		
Pic 1 Desc.	ROW stable. Slope breakers functional.	Pic 2 Desc.	Perimeter controls in place and functioning.		
<p>Date & Time: Fri, Jul 10, 2020 10:40:28 EDT Position: +437.005264° / +680.555133° / +16.4m Altitude: 18.3ft (+19.7m) Datum: WGS-84 Azimuth/Bearing: 322° N83W 592mils Magnetic (+12°) Elevation Angle: -26.6° Horizon Angle: +03.2° Zoom: 1.0X Brush Min. Perimeter controls in place. 11660+00</p>

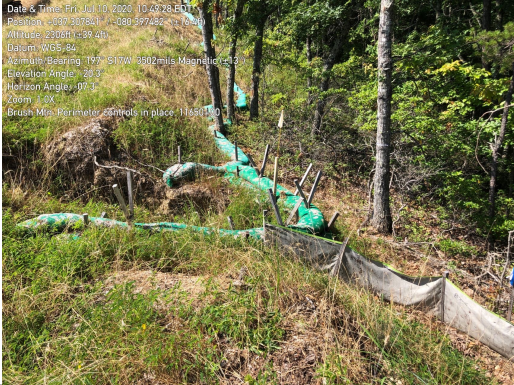
<p>Date & Time: Fri, Jul 10, 2020 10:40:28 EDT Position: +437.005264° / +680.555133° / +16.4m Altitude: 18.3ft (+19.7m) Datum: WGS-84 Azimuth/Bearing: 322° N83W 592mils Magnetic (+12°) Elevation Angle: -26.6° Horizon Angle: +03.2° Zoom: 1.0X Brush Min. Perimeter controls in place. 11660+00</p>

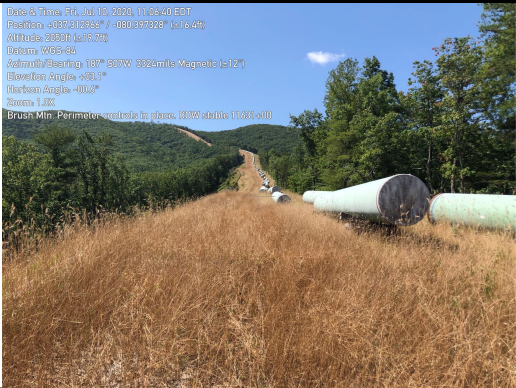
GPS Location	On photo	GPS Location	On photo		
Field Station#	11660+00	Field Station#	11650+00		
Pic 3 Desc.	Perimeter controls in place. ROW currently stable.	Pic 4 Desc.	ECDs in place and functional.		
<p>Date & Time: Fri, Jul 10, 2020 11:03:40 EDT Position: +407.213510° / +680.377597° / +32.8m Altitude: 231.4m (+39.4m) Datum: WGS-84 Azimuth/Bearing: 033° N33E 0587mils Magnetic (+12°) Elevation Angle: -23.1° Horizon Angle: +00.0° Zoom: 1.0X Brush Min. Perimeter controls in place. ROW stable 11628+50</p>

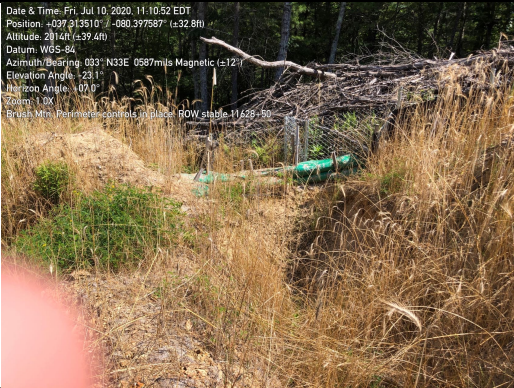
Pic 5 Desc.	ROW stable. Slope breakers are functional.	Pic 6 Desc.	Perimeter controls in place and functioning.

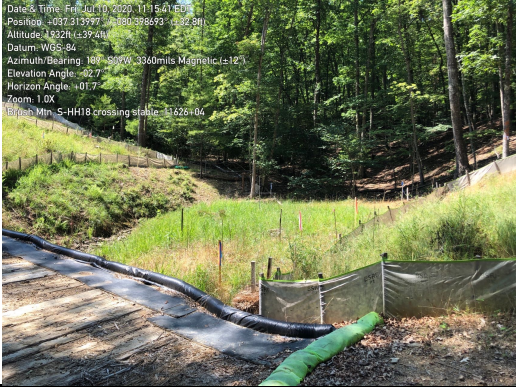
GPS Location	On photo	GPS Location	On photo		
Field Station#	11626+04	Field Station#	11614+20		
Pic 7 Desc.	Resource crossing at S-HH18 is stable with ECDs in place.	Pic 8 Desc.	Resource crossing at S-RR14 is stable with ECDs in place.

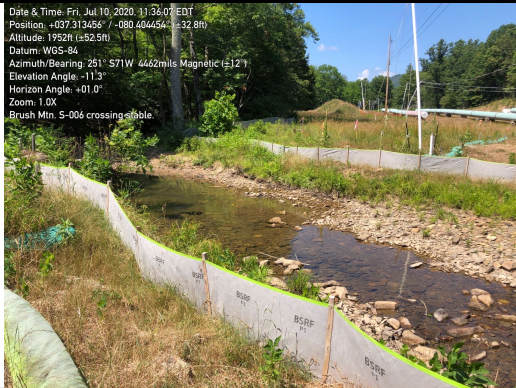
<small> Date & Time: Fri Jul 10 2020 11:36:01 EDT Position: +037.313456 / -080.404454 (+32.8ft) Altitude: 1922ft (+32.5ft) Datum: WGS-84 Azimuth/Bearing: 251° S71W 4462mils Magnetic (+12°) Elevation Angle: -11.3° Horizon Angle: +01.0° Zoom: 1.0X Brush Mtn. S-006 crossing stable </small>

<div style="text-align: center;">Insert image here</div>			
GPS Location	On photo	GPS Location			
Field Station#	11608+17	Field Station#			
Pic 9 Desc.	Resource crossing at S-is stable with ECDs in place.	Pic 10 Desc.			
<div style="text-align: center;">Insert image here</div>		<div style="text-align: center;">Insert image here</div>			
GPS Location		GPS Location			
Field Station#		Field Station#			
Pic 11 Desc.		Pic 12 Desc.

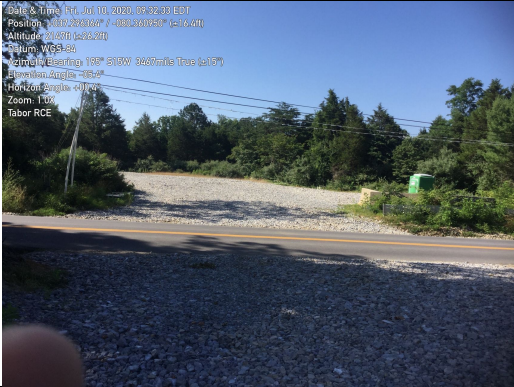
GPS Location	See photo GPS		GPS Location	See photo GPS	
Field Station#	11788+52		Field Station#	11832+00	
Pic 1 Desc.	Tabor RCE		Pic 2 Desc.	Level spreaders, CFS controls & row vegetation.

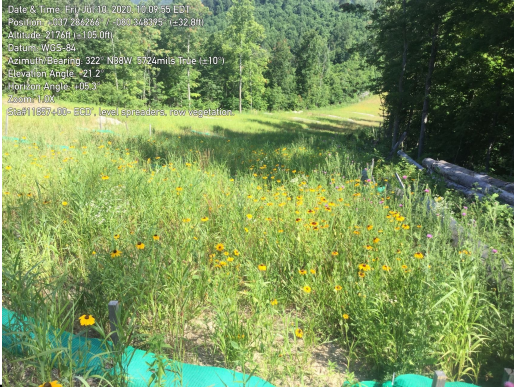
GPS Location	See photo GPS		GPS Location	See photo GPS	
Field Station#	11857+00		Field Station#	11867+00	
Pic 3 Desc.	Level spreaders,ECD's, row vegetation on slope.		Pic 4 Desc.	Silt fence perimeter control stakes broken off, contractor has been informed, issue added to the punch list.

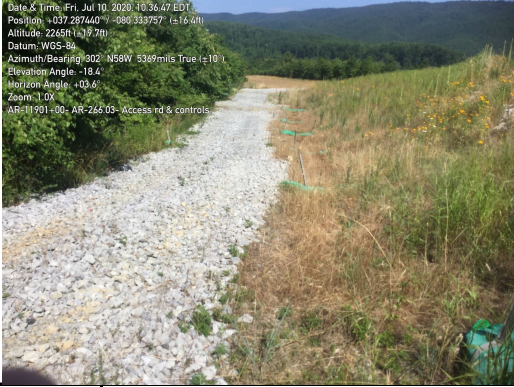
GPS Location	See photo GPS		GPS Location	See photo GPS	
Field Station#	11901+00		Field Station#	11942+00	
Pic 5 Desc.	AR-266.00- Access road and CFS check dams in bar ditch.		Pic 6 Desc.	Karst ECD's

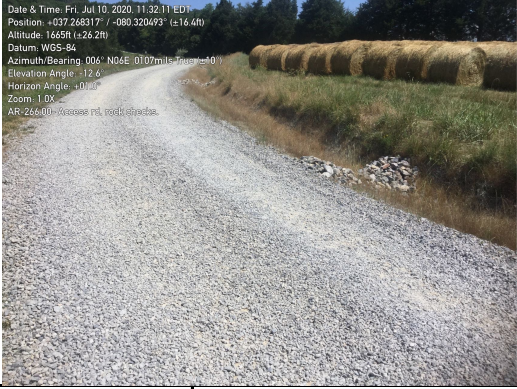
<p> <small> Date & Time: Fri Jul 10, 2020 11:32:11 EDT Position: +037 266317° / -080 320493° (+16.4ft) Altitude: 1665ft (+26.2ft) Datum: WGS-84 Azimuth/Bearing: 006° N04E 0107mils (+10°) Elevation Angle: +12.6° Horizon Angle: +08.0° Zoom: 1.0X AR-266.00- Access rd, rock check dams </small> </p>					
GPS Location	See photo GPS	GPS Location			
Field Station#	11988+00	Field Station#			
Pic 7 Desc.	AR-266.00- Access road with rock check dams in bar ditch.	Pic 8 Desc.			
Insert image here		Insert image here			
GPS Location		GPS Location			
Field Station#		Field Station#			
Pic 9 Desc.		Pic 10 Desc.			
Insert image here		Insert image here			
GPS Location		GPS Location			
Field Station#		Field Station#			
Pic 11 Desc.		Pic 12 Desc.

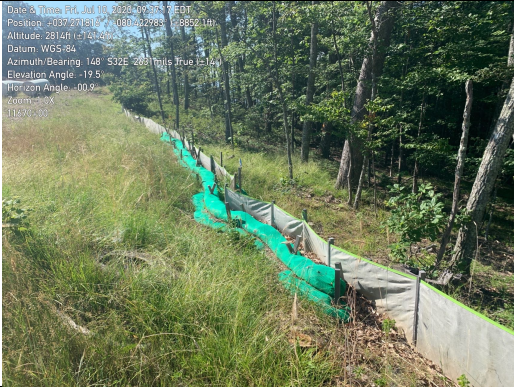
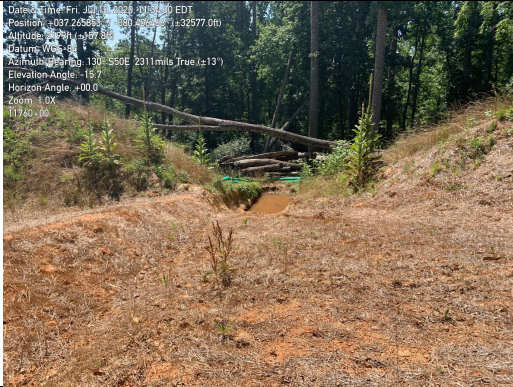
<p>Date & Time: Fri, Jul 10, 2020, 11:40:59 EDT Position: +037 294567° / +080 369278° (+101.3ft) Altitude: 2022ft (+1203) Datum: WGS-84 Azimuth/Bearing: 148° S32E 2631mils True (+13°) Elevation Angle: -19.5° Horizon Angle: +00.0° Zoom: 1.0x 11767+00</p>			
GPS Location	See photo for GPS location.		GPS Location	See photo for GPS location.	
Field Station#	11670+00		Field Station#	11760+00	
Pic 1 Desc.	Triple stack compost filter sock and priority one silt fence in place as LOD controls.		Pic 2 Desc.	Waterbar, sump pit, and waterbar end treatment in place.

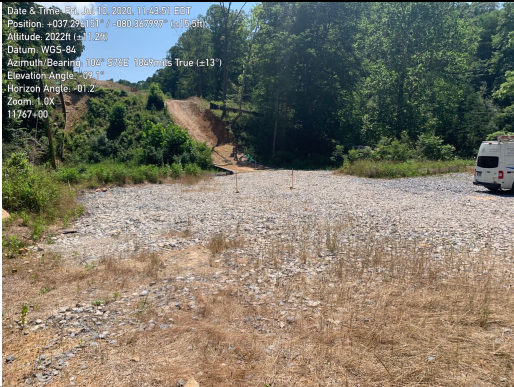
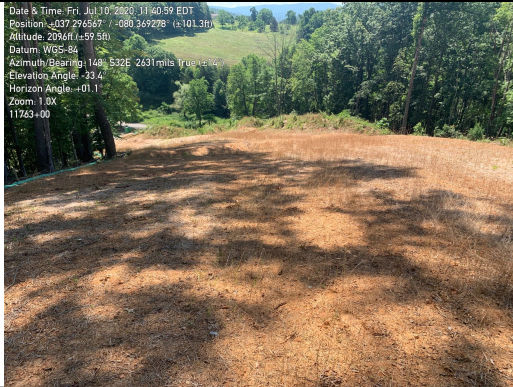
GPS Location	See photo for GPS location.		GPS Location	See photo for GPS location.	
Field Station#	11767+00		Field Station#	11763+00	
Pic 3 Desc.	RCE in place at Main Line Valve 26.		Pic 4 Desc.	ROW stabilized with mulch and vegetation growth.

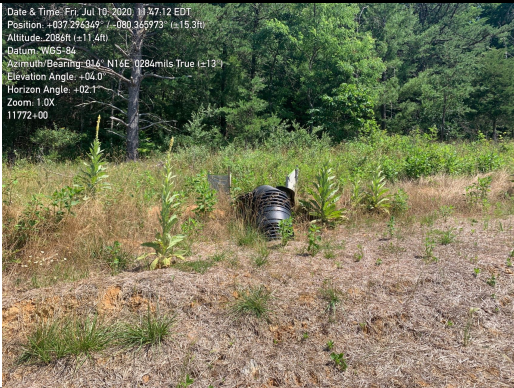
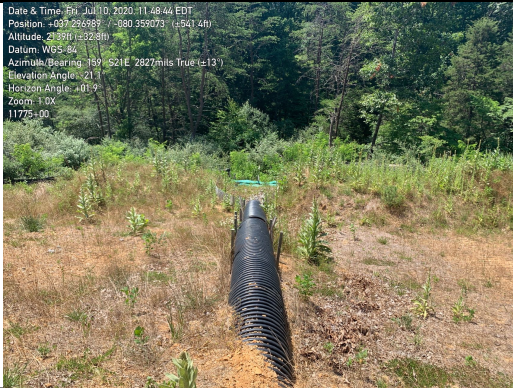
<p>Date & Time: Fri, Jul 10, 2020, 11:48:44 EDT Position: +037 294567° / +080 369278° (+101.3ft) Altitude: 2022ft (+1203) Datum: WGS-84 Azimuth/Bearing: 148° S32E 2631mils True (+13°) Elevation Angle: -19.5° Horizon Angle: +00.0° Zoom: 1.0x 11775+00</p>			
GPS Location	See photo for GPS location.		GPS Location	See photo for GPS location.	
Field Station#	11772+00		Field Station#	11775+00	
Pic 5 Desc.	Clean water diversion pipe inlet and clean water diversion berm in place.		Pic 6 Desc.	Clean water diversion pipe and plunge pool in place.

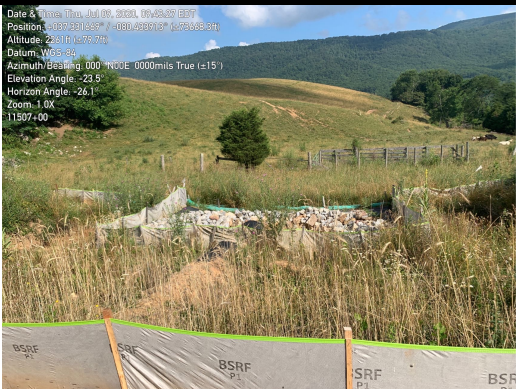
GPS Location	See photo for GPS location.
				GPS Location	See photo for GPS location.
	Field Station#	11507+00		Field Station#	11489+00
Pic 1 Desc.	Clean water diversion pipe and plunge pool in place.		Pic 2 Desc.	RCE in place At Stevers Gap Road.	
<p>Date & Time: Thu, Jul 09, 2020, 10:11W EDT Position: +037.307429° / -080.490331° (+38161.8m) Altitude: 2156ft (+104.8m) Datum: WGS-84 Azimuth/Bearing: 281° N79W 4996mils True (±15°) Elevation Angle: -17.5° Horizon Angle: -01.6° Zoom: 1.0X 11438+50</p>

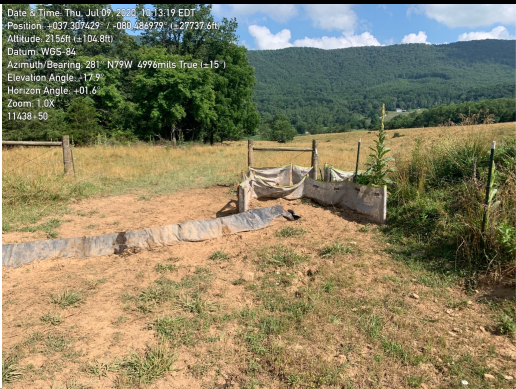
GPS Location	See photo for GPS location.
	Field Station#	11438+50		Field Station#	11412+00
Pic 3 Desc.	Holes in priority one silt fence from land owner cattle.		Pic 4 Desc.	Priority one silt fence end treatment with a broken stake.	
<p>Date & Time: Thu, Jul 09, 2020, 11:15W EDT Position: +037.295586° / -080.490331° (+38161.8m) Altitude: 2020ft (+146.0m) Datum: WGS-84 Azimuth/Bearing: 359° N01W 6382mils True (±15°) Elevation Angle: -07.6° Horizon Angle: -03.3° Zoom: 1.0X 11395+00</p>

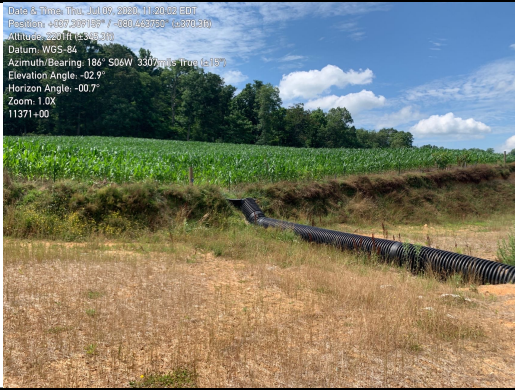
GPS Location	See photo for GPS location.
				GPS Location	See photo for GPS location.
	Field Station#	11395+00		Field Station#	11371+00
Pic 5 Desc.	Hole in priority one silt fence end treatment.		Pic 6 Desc.	Clean water diversion pipe and clean water diversion berm in place.

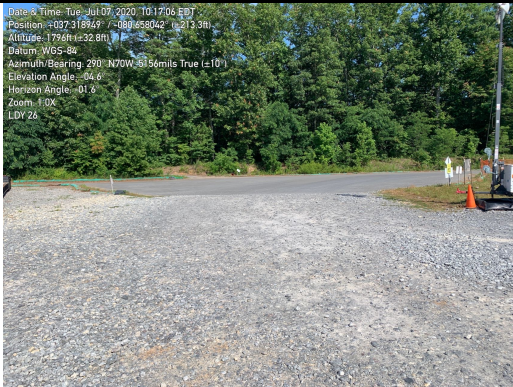
GPS Location		See photo for GPS location.						GPS Location		See photo for GPS location.	
Field Station#		12005+00						Field Station#		12005+00	
Pic 1 Desc.		RCE in place at LDY 26 entrance.						Pic 2 Desc.		18 inch compost filter sock in place along LOD.	
<p>Date & Time: Tue Jul 07, 2020 10:17:20 EDT Position: +037 318752 / -080 658498 (+13.2m) Altitude: 1788ft (+37.2m) Datum: WGS-84 Azimuth/Bearing: 111° S89E 308mils True (+10°) Elevation Angle: -02.1° Horizon Angle: -00.3° Zoom: 1.0X LDY 26</p>

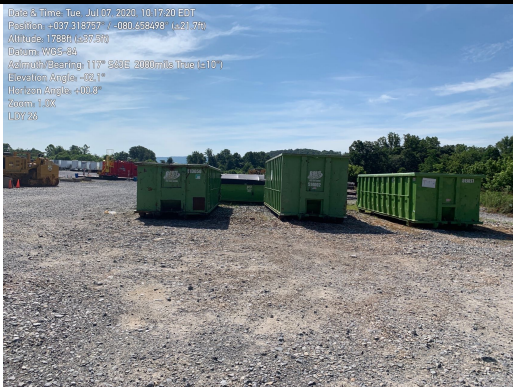
GPS Location		See photo for GPS location.						GPS Location		See photo for GPS location.	
Field Station#		12005+00						Field Station#		12005+00	
Pic 3 Desc.		Dumpsters being utilized for trash management.						Pic 4 Desc.		Triple stack 18 compost filter sock in place around drainage.	
<p>Date & Time: Tue Jul 07, 2020 10:19:26 EDT Position: +037 318353 / -080 657762 (+13.4m) Altitude: 1790ft (+11.3m) Datum: WGS-84 Azimuth/Bearing: 322 N38W 572mils True (+15°) Elevation Angle: -02.0° Horizon Angle: -01.5° Zoom: 1.0X LDY 26</p>

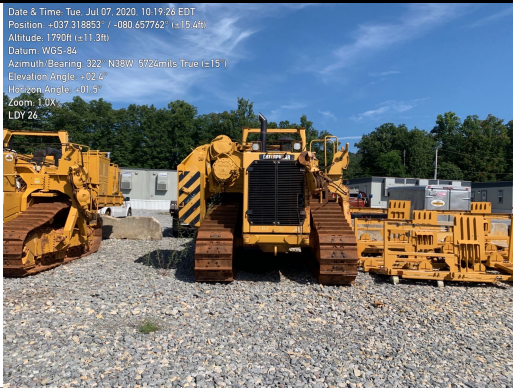
Pic 5 Desc.		Checked staged equipment for leaks.						Pic 6 Desc.		Secondary containment in place under fuel cell.
