Visual Site Inspection Report

Project Name	H-600 Pipeline Spread G	AFE	124300137	Spread	H-600 Pipeline Spread G
Contractor	Precision			Report #	13199
Inspector	Jared Saunders			Date/Time	8/2/2020 1:54 PM
Permit #	TBD	Inspection Type	VA SWPP	Station Begin	11353+00
State	VA	Inspection Area	Partial	Station End	11471+00
County	Giles	Ground	Wet	Temperature (°F)	85.00
Municipality	N/A	Weather	Sunny	Rain Gauge (in)	0.30
				Rain Accumulation Time (days)	1.00

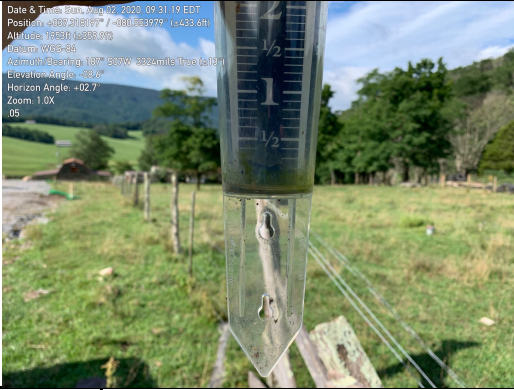
GPS Location	See photo for GPS location.		GPS Location	See photo for GPS location.	
Field Station#	11024+00		Field Station#	11489+00	
Pic 1 Desc.	Rain gauge at AR 244 reads 0.05 inches.		Pic 2 Desc.	Rain gauge at Stevers Gap Road reads 0.2 inches.

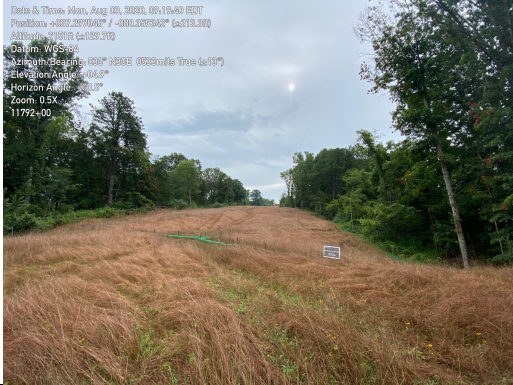
GPS Location				1				GPS Location				2			
Field Station#				11792+00				Field Station#				11818+00			
Pic 1 Desc.				Section of restored RoW showing conditions and controls.				Pic 2 Desc.				Section of restored RoW showing conditions and controls.			
				<p>Date & Time: Mon, Aug 03, 2020, 06:04:19 EDT Position: +482.258297° / -404.361730° (±11.10) Altitude: 21770 (±11.10) Datum: WGS-84 Azimuth/Heading: 135° 330W 330mils True (±15°) Elevation Angle: +05.0° Horizon Angle: +01.4° Zoom: 0.5X 11792+00</p>

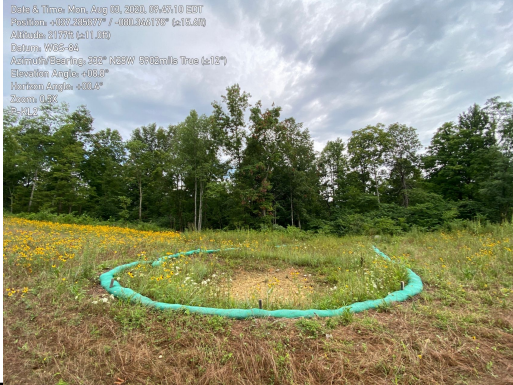
GPS Location				3				GPS Location				4			
Field Station#				11863+65				Field Station#				11906+00			
Pic 3 Desc.				P-KL2 and controls.				Pic 4 Desc.				Section of semi-restored RoW showing conditions and controls.			
				<p>Date & Time: Mon, Aug 03, 2020, 10:36:51 EDT Position: +482.257646° / -404.358297° (±11.10) Altitude: 21922 (±11.10) Datum: WGS-84 Azimuth/Heading: 135° 330W 330mils True (±15°) Elevation Angle: +02.4° Horizon Angle: +01.2° Zoom: 0.5X 11952+00</p>

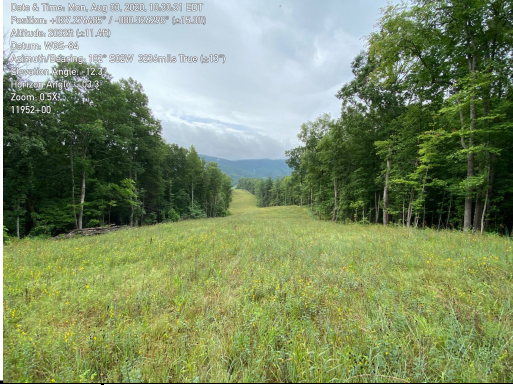
GPS Location				5				GPS Location				6			
Field Station#				11952+00				Field Station#				11991+00			
Pic 5 Desc.				Section of semi-restored RoW showing conditions and controls.				Pic 6 Desc.				Section of restored RoW showing conditions and controls.

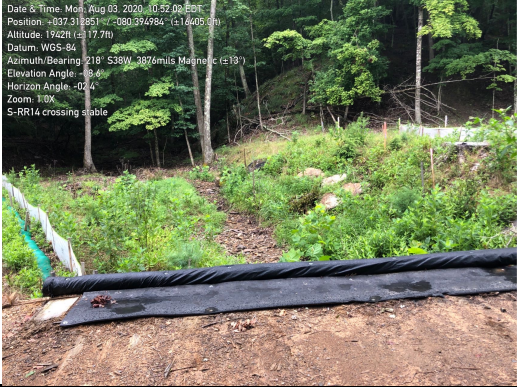
<p><small>Date & Time: Mon, Aug 03, 2020, 10:52:00 EDT Position: +037.311851° / -080.394984° (+14405.0ft) Altitude: 1942ft (+17.7ft) Datum: WGS-84 Azimuth/Bearing: 218° S38W 1876mils Magnetic (+13°) Elevation Angle: -8.4° Horizon Angle: -02.4° Zoom: 1.0X S-RR14 crossing stable</small></p>

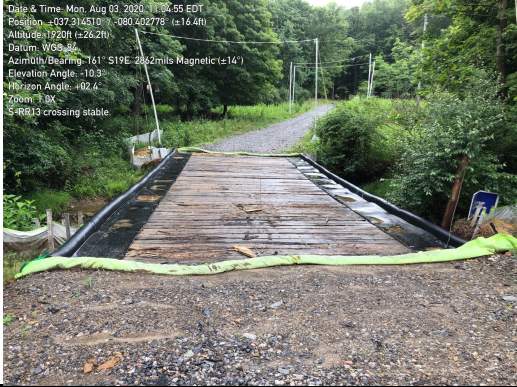
<p><small>Date & Time: Mon, Aug 03, 2020, 11:04:55 EDT Position: +037.314510° / -080.402278° (+16.4ft) Altitude: 1920ft (+26.2ft) Datum: WGS-84 Azimuth/Bearing: 161° S19E 2032mils Magnetic (+14°) Elevation Angle: -10.3° Horizon Angle: -02.4° Zoom: 1.0X S-RR13 crossing stable</small></p>			
GPS Location	On photo	GPS Location	On photo		
Field Station#	11614+20	Field Station#	11613+69		
Pic 7 Desc.	S-RR14 crossing stable	Pic 8 Desc.	S-RR13 crossing stable access road MN-258.04

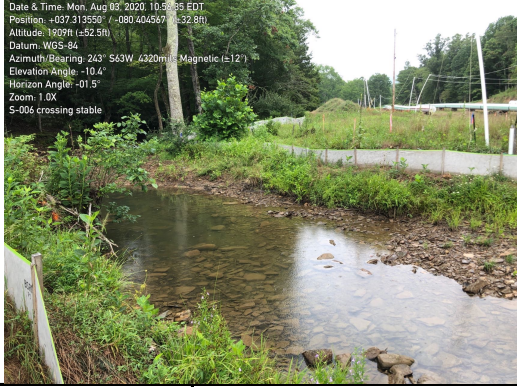
<p><small>Date & Time: Mon, Aug 03, 2020, 10:50:35 EDT Position: +037.313550° / -080.404567° (+32.8ft) Altitude: 1909ft (+52.5ft) Datum: WGS-84 Azimuth/Bearing: 243° S43W 4320mils Magnetic (+12°) Elevation Angle: -10.4° Horizon Angle: -01.5° Zoom: 1.0X S-006 crossing stable</small></p>		<p style="text-align: center;">Insert image here</p>

GPS Location	On photo	GPS Location			
Field Station#	11608+17	Field Station#			
Pic 9 Desc.	S-006 crossing stable	Pic 10 Desc.			
<p style="text-align: center;">Insert image here</p>		<p style="text-align: center;">Insert image here</p>			
GPS Location		GPS Location			
Field Station#		Field Station#			
Pic 11 Desc.		Pic 12 Desc.

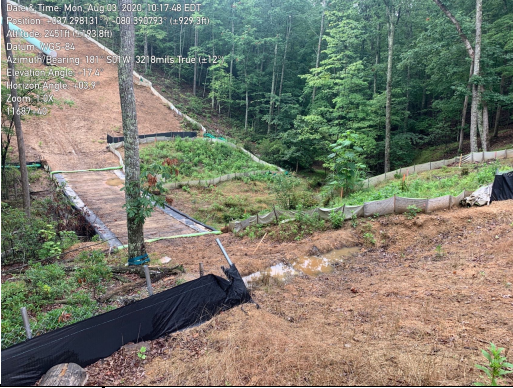
GPS Location		See photo for GPS location.		GPS Location	
Field Station#		11670+00		Field Station#	
Pic 1 Desc.		Triple stack CFS and priority one silt fence in place along LOD.		Pic 2 Desc.

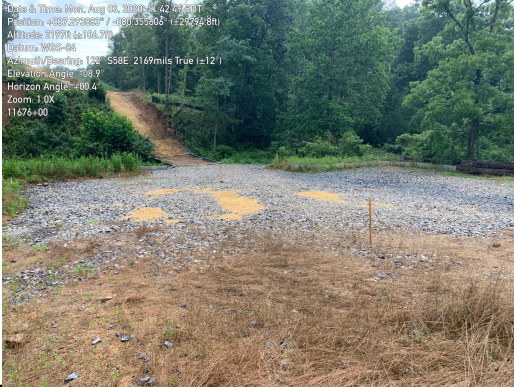
GPS Location		See photo for GPS location.		GPS Location	
Field Station#		11767+00		Field Station#	
Pic 3 Desc.		RCE in place at Main Line Valve 26.		Pic 4 Desc.

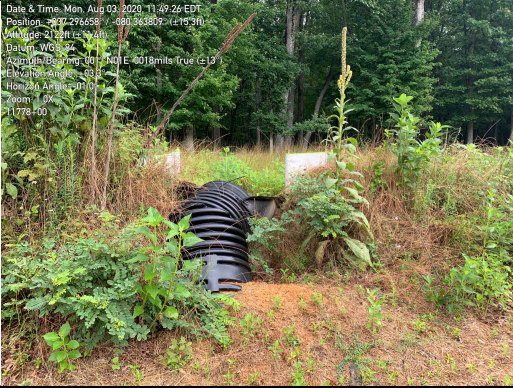
GPS Location		See photo for GPS location.		GPS Location	
Field Station#		11775+00		Field Station#	
Pic 5 Desc.		Clean water diversion pipe disconnected. Item added to punchlist.		Pic 6 Desc.

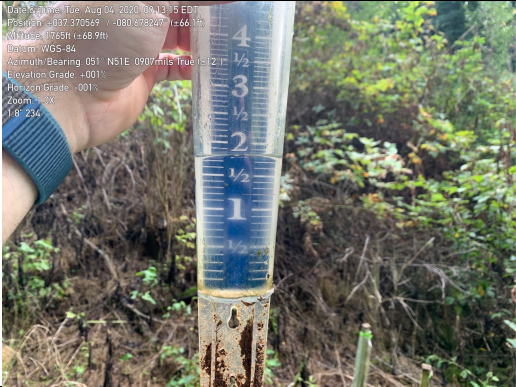
GPS Location	See picture above for GPS coordinates		GPS Location	See picture above for GPS coordinates	
Field Station#	+1		Field Station#	+1	
Pic 1 Desc.	1.8" of rain recorded @ AR 234		Pic 2 Desc.	.2" of rain recorded @ Buffalo Anklets

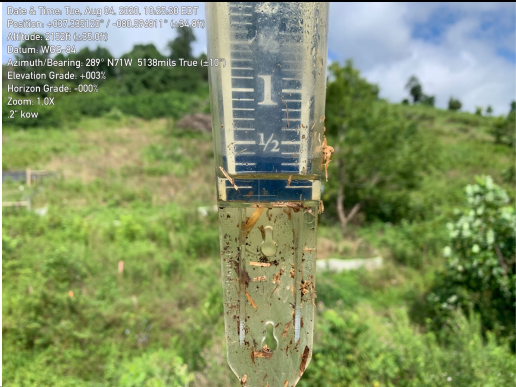
GPS Location	See picture above for GPS coordinates		GPS Location	See picture above for GPS coordinates	
Field Station#	+1		Field Station#	12005+00	
Pic 3 Desc.	.2" of rain recorded @ Kow Camp		Pic 4 Desc.	ECD's and row conditions @ LDY 28

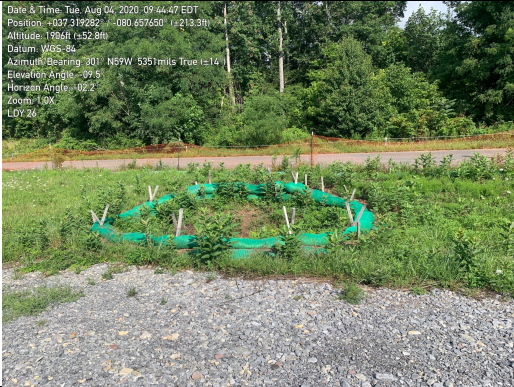
GPS Location	See photo for GPS location.		GPS Location	See photo for GPS location.	
Field Station#	12005+00		Field Station#	12005+00	
Pic 1 Desc.	Triple stack CFS in place around drainage feature.		Pic 2 Desc.	RCE in place at LDY 26 entrance.

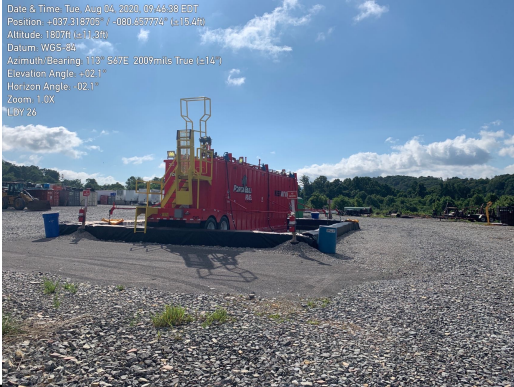
GPS Location	See photo for GPS location.		GPS Location	See photo for GPS location.	
Field Station#	12005+00		Field Station#	12005+00	
Pic 3 Desc.	Secondary containment in place under fuel cell.		Pic 4 Desc.	Dumpsters being utilized for trash management.

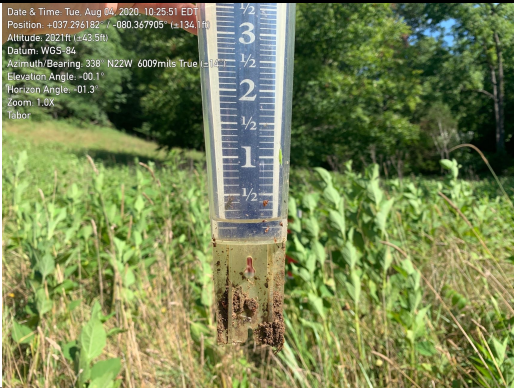
GPS Location	See photo for GPS location.		GPS Location	See photo for GPS location.	
Field Station#	11767+00		Field Station#	11990+00	
Pic 5 Desc.	Rain gauge at Mount Tabor Road reads 0.2 inches.		Pic 6 Desc.	Rain gauge at Catawba Road reads 0.4 inches.

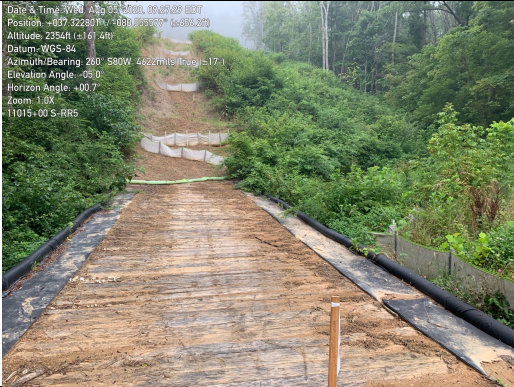
<p>Date & Time: Wed Aug 05 2020 3:07:00 EDT Position: +39.32261N -88.55577W (+88.55577) (+88.55577) Altitude: 2354ft (+161.4m) Datum: WGS-84 Azimuth/Bearing: 260 S80W 442mils True (+17.1) Elevation Angle: -05.0 Horizon Angle: +00.7 Zoom: 1.0X 11015+00 S-RR5</p>

<p>Date & Time: Wed Aug 05 2020 3:07:00 EDT Position: +39.32261N -88.55577W (+88.55577) (+88.55577) Altitude: 2354ft (+161.4m) Datum: WGS-84 Azimuth/Bearing: 260 S80W 442mils True (+17.1) Elevation Angle: -05.0 Horizon Angle: +00.7 Zoom: 1.0X 11012+00</p>			
GPS Location	See photo for GPS location.		GPS Location	See photo for GPS location.	
Field Station#	11015+00		Field Station#	11012+00	
Pic 1 Desc.	Sensitive resource buffer in place at stream S-RR5		Pic 2 Desc.	Waterbar and end treatment in place.

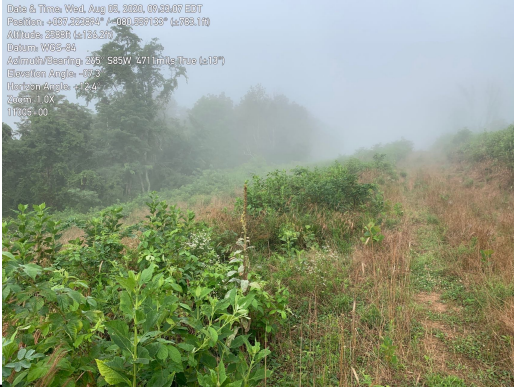
<p>Date & Time: Wed Aug 05 2020 3:07:00 EDT Position: +39.32261N -88.55577W (+88.55577) (+88.55577) Altitude: 2354ft (+161.4m) Datum: WGS-84 Azimuth/Bearing: 260 S80W 442mils True (+17.1) Elevation Angle: -05.0 Horizon Angle: +00.7 Zoom: 1.0X 11005+00</p>

GPS Location	See photo for GPS location.		GPS Location	See photo for GPS location.	
Field Station#	11005+00		Field Station#	10966+00	
Pic 3 Desc.	ROW stabilized with natural vegetation growth.		Pic 4 Desc.	Triple barrier ECDs in place at off ROW karst feature.

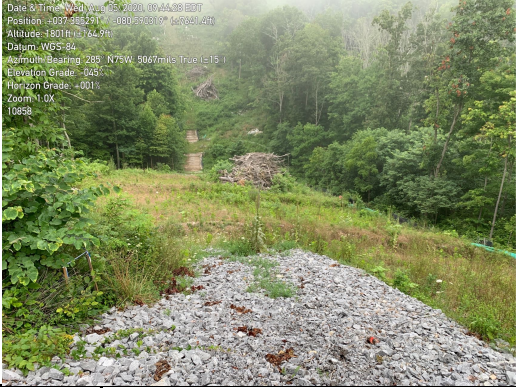
GPS Location		See picture above for GPS coordinates		GPS Location	
Field Station#		10858+00		Field Station#	
Pic 1 Desc.		ECD's and row conditions		Pic 2 Desc.

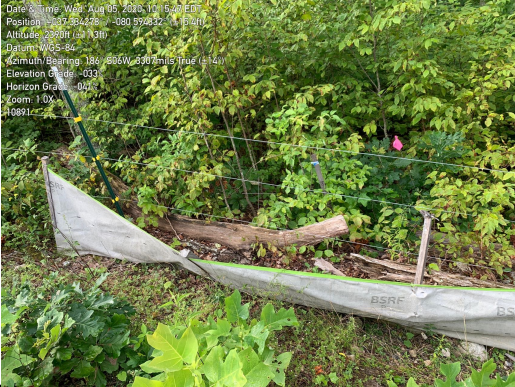
GPS Location		See picture above for GPS coordinates		GPS Location	
Field Station#		10885+00		Field Station#	
Pic 3 Desc.		Damaged P1		Pic 4 Desc.

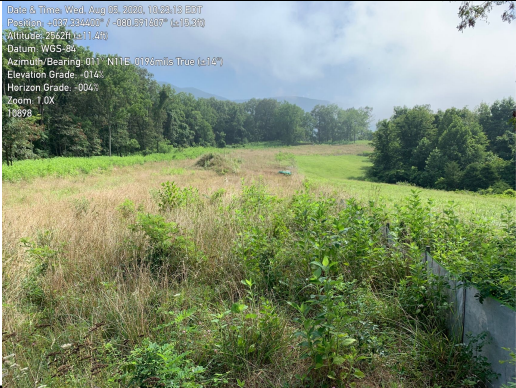
GPS Location		See picture above for GPS coordinates		GPS Location	
Field Station#		10898+00		Field Station#	
Pic 5 Desc.		ECD's and row conditions		Pic 6 Desc.

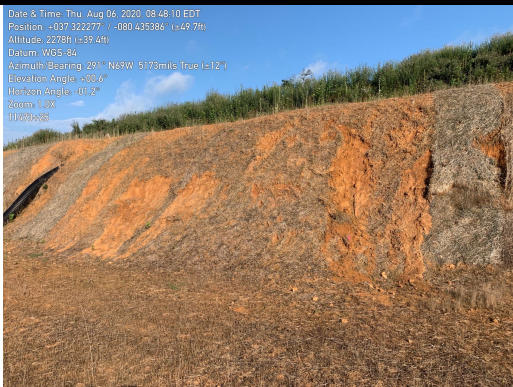
<p>Date & Time: Thu, Aug 06, 2020, 08:48:10 EDT Position: +037.322277° / -080.439386° (+49.7m) Altitude: 2279ft (+40.6m) Datum: WGS-84 Azimuth/Bearing: 29° N59W 5173mils True (+12°) Elevation Angle: +02.6° Horizon Angle: -01.2° Zoom: 1.0X 11473+00</p>		<p>Date & Time: Thu, Aug 06, 2020, 08:57:17 EDT Position: +037.319159° / -080.440573° (+802.1m) Altitude: 2279ft (+40.6m) Datum: WGS-84 Azimuth/Bearing: 239° S59W 4249mils True (+12°) Elevation Angle: -10.0° Horizon Angle: -01.1° Zoom: 1.0X 11451+00 S-0012 & S-0013</p>			
GPS Location	See photo for GPS location.		GPS Location	See photo for GPS location.	
Field Station#	11473+25		Field Station#	11451+00	
Pic 1 Desc.	ECB on two tone needs replace.		Pic 2 Desc.	Sensitive resource buffer in place at stream S-0012 and S-0013.

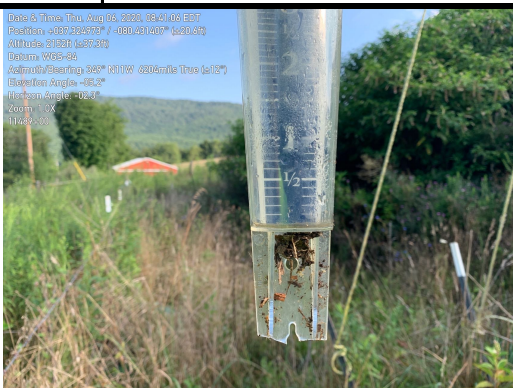
GPS Location	See photo for GPS location.		GPS Location	See photo for GPS location.	
Field Station#	11489+00		Field Station#	11489+00	
Pic 3 Desc.	Rain gauge at Stevers Gap Road reads 0.0 inches.		Pic 4 Desc.	RCE in place at Stevers Gap Road.

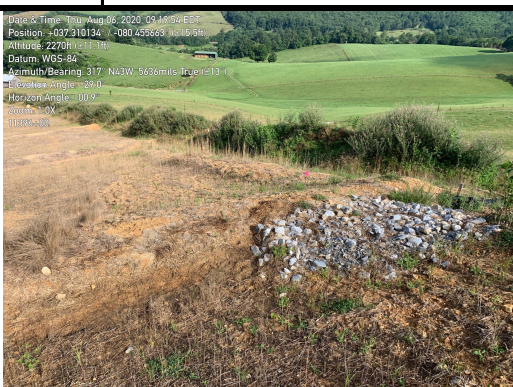
<p>Date & Time: Thu, Aug 06, 2020, 09:48:55 EDT Position: +037.310134° / -080.435663° (+49.6m) Altitude: 2270ft (+40.6m) Datum: WGS-84 Azimuth/Bearing: 317° N43W 5636mils True (+13°) Elevation Angle: -02.0° Horizon Angle: -00.9° Zoom: 1.0X 11396+00</p>		<p>Date & Time: Thu, Aug 06, 2020, 10:05:47 EDT Position: +037.294102° / -080.367868° (+43.6m) Altitude: 2016ft (+46.4m) Datum: WGS-84 Azimuth/Bearing: 015° N15E 0267mils True (+13°) Elevation Angle: -02.5° Horizon Angle: -01.5° Zoom: 1.0X 11767+00</p>			
GPS Location	See photo for GPS location.		GPS Location	See photo for GPS location.	
Field Station#	11396+00		Field Station#	11767+00	
Pic 5 Desc.	Rock inlet needs cleaned out and waterbar needs built up to ensure water discharge off ROW.		Pic 6 Desc.	Rain gauge at Mount Tabor Road reads 0.1 inches.

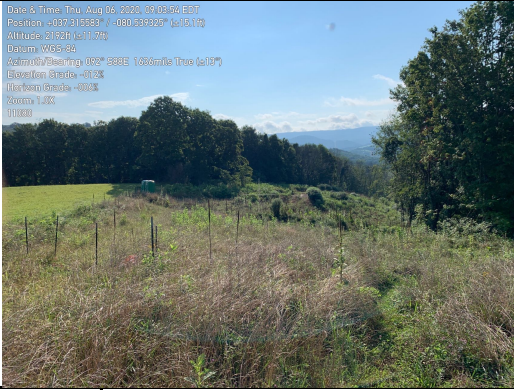
GPS Location	See picture above for GPS coordinates		GPS Location	See picture above for GPS coordinates	
Field Station#	11080+00		Field Station#	11101+00	
Pic 1 Desc.	ECD's and row conditions		Pic 2 Desc.	ECD's and row conditions

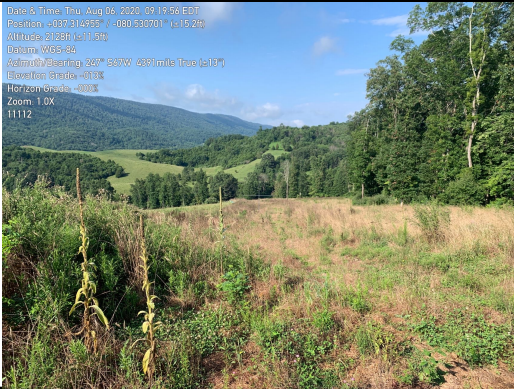
GPS Location	See picture above for GPS coordinates		GPS Location	See picture above for GPS coordinates	
Field Station#	11112+00		Field Station#	11217+00	
Pic 3 Desc.	ECD's and row conditions		Pic 4 Desc.	ECD's and row conditions

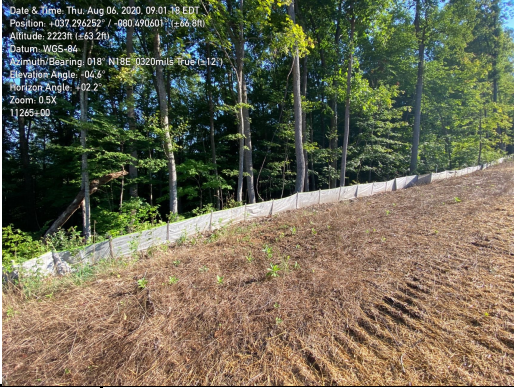
GPS Location	1	GPS Location	2		
Field Station#	11265+00	Field Station#	11309+00		
Pic 1 Desc.	Perimeter controls functional.	Pic 2 Desc.	Crews redressing RoW.

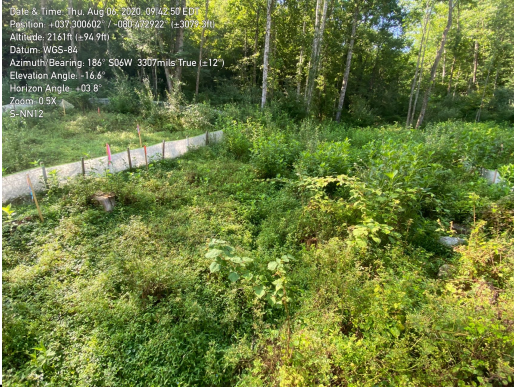
GPS Location	3	GPS Location	4		
Field Station#	11327+85	Field Station#	11334+00		
Pic 3 Desc.	S-NN12 and controls.	Pic 4 Desc.	Section of RoW showing conditions and controls.

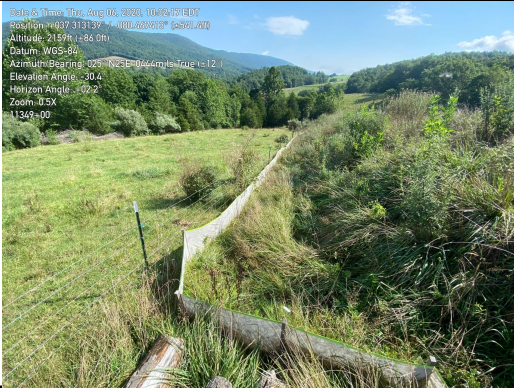
GPS Location	5	GPS Location	6		
Field Station#	11349+00	Field Station#	11352+97		
Pic 5 Desc.	Perimeter controls functional.	Pic 6 Desc.	S-NN11 and controls.

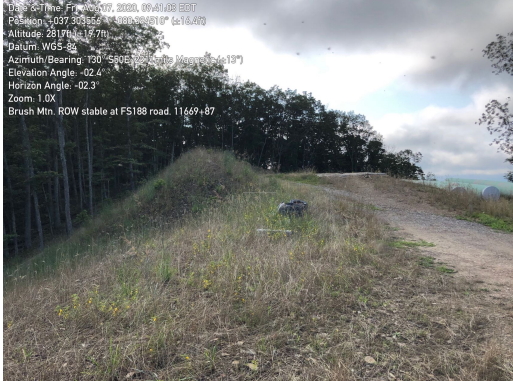
Date & Time: Fri Aug 07, 2020, 09:41:00 EDT Position: +037.313798° / +080.377568° (+16.4ft) Altitude: 2231ft (+19.7ft) Datum: WGS-84 Azimuth/Bearing: 120° S05E 3182mils Magnetic (+19°) Elevation Angle: -02.4° Horizon Angle: -02.3° Zoom: 1.0X Brush Mtn. ROW stable at FS188 road. 11669+87			Date & Time: Fri Aug 07, 2020, 09:58:00 EDT Position: +037.313798° / +080.376360° (+132.8ft) Altitude: 2588ft (+29.4ft) Datum: WGS-84 Azimuth/Bearing: 341° N19W 4062mils Magnetic (+12°) Elevation Angle: -21.6° Horizon Angle: -00.9° Zoom: 1.0X Brush Mtn. Slope breakers functioning properly. 11662+00								
GPS Location			On photo			GPS Location			On photo		
Field Station#			11669+87			Field Station#			11662+00		
Pic 1 Desc.			Stable conditions at top of Brush Mountain. No trespass or vandalism identified.			Pic 2 Desc.			Slope breakers and perimeter controls effective

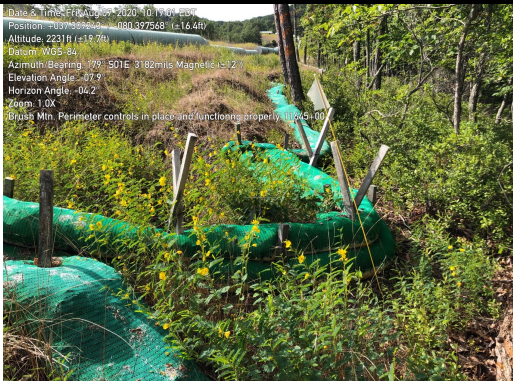
Date & Time: Fri Aug 07, 2020, 10:14:00 EDT Position: +037.313798° / +080.422233° (+16.4ft) Altitude: 2231ft (+19.7ft) Datum: WGS-84 Azimuth/Bearing: 120° S01E 3182mils Magnetic (+12°) Elevation Angle: -07.3° Horizon Angle: -04.2° Zoom: 1.0X Brush Mtn. Perimeter controls in place and functioning properly. 11645+00			Date & Time: Fri Aug 07, 2020, 10:50:01 EDT Position: +037.313798° / +080.402233° (+16.4ft) Altitude: 1912ft (+19.7ft) Datum: WGS-84 Azimuth/Bearing: 085° N05E 1511mils Magnetic (+13°) Elevation Angle: -14.0° Horizon Angle: -01.2° Zoom: 1.0X ROW stable. ECDs in place. 11614+75								
GPS Location			On photo			GPS Location			On photo		
Field Station#			11645+00			Field Station#			11614+75		
Pic 3 Desc.			End treatments are working as designed			Pic 4 Desc.			End treatments are working properly

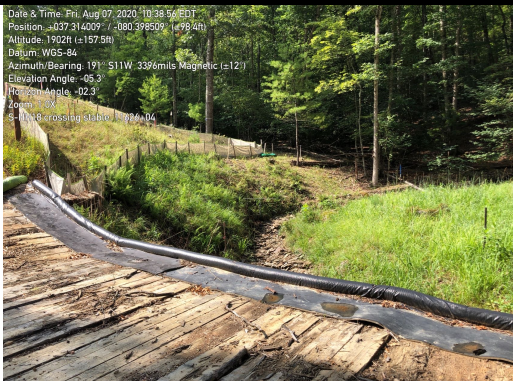
Date & Time: Fri Aug 07, 2020, 10:38:56 EDT Position: +037.314099° / +080.396509° (+19.4ft) Altitude: 1902ft (+157.5ft) Datum: WGS-84 Azimuth/Bearing: 191° S11W 3396mils Magnetic (+12°) Elevation Angle: -05.3° Horizon Angle: -02.3° Zoom: 1.0X S-006 crossing stable. 11626+04			Date & Time: Fri Aug 07, 2020, 10:42:08 EDT Position: +037.313554° / +080.406712° (+16.4ft) Altitude: 1918ft (+26.2ft) Datum: WGS-84 Azimuth/Bearing: 143° S37E 2542mils Magnetic (+14°) Elevation Angle: -07.2° Horizon Angle: -01.4° Zoom: 1.0X S-006 crossing stable. ECDs in place.

GPS Location			On photo			GPS Location			On photo		
Field Station#			11626+04			Field Station#			11608+17		
Pic 5 Desc.			Resource crossings stable. ECDs in place at buffers and equipment bridges.			Pic 6 Desc.			S-006 crossing stable with no impact.

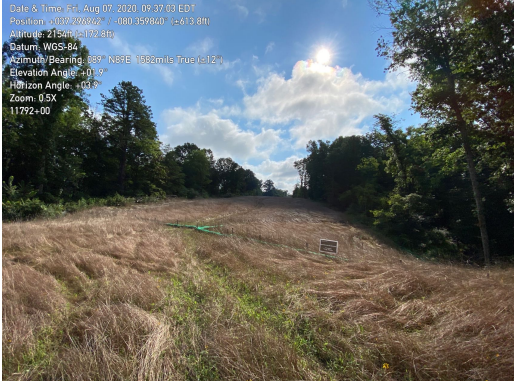
GPS Location	1	GPS Location	2		
Field Station#	11792+00	Field Station#	11825+00		
Pic 1 Desc.	Section of restored RoW showing conditions and controls.		Pic 2 Desc.	Section of restored RoW showing conditions and controls.

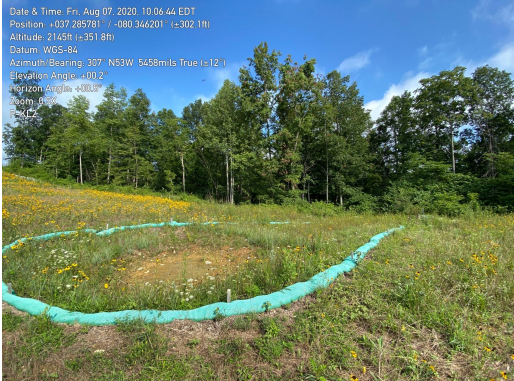
GPS Location	3	GPS Location	4		
Field Station#	11863+65	Field Station#	11906+00		
Pic 3 Desc.	P-KL2 and controls.		Pic 4 Desc.	Section of semi restored RoW showing conditions and controls.

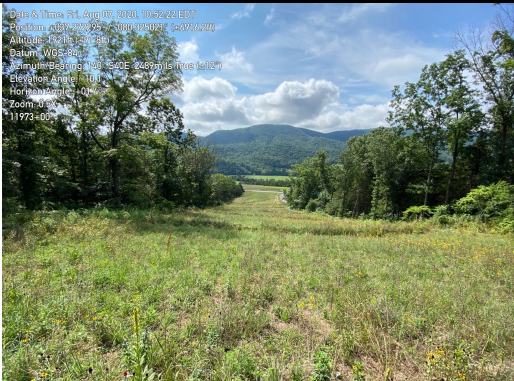
GPS Location	5	GPS Location	6		
Field Station#	11973+00	Field Station#	11991+00		
Pic 5 Desc.	Section of semi restored RoW showing conditions and controls.		Pic 6 Desc.	Section of restored RoW showing conditions and controls.

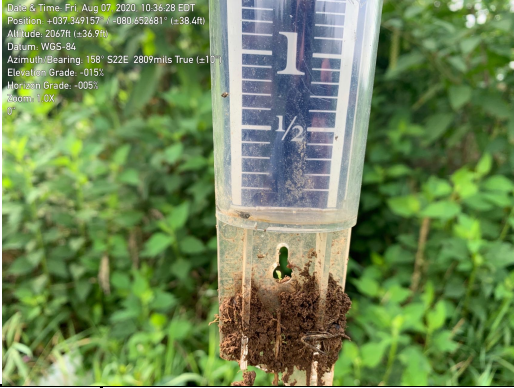
<p>Date & Time: Fri, Aug 07, 2020, 08:45:46 EDT Position: +037.239157° / -089.519197° (+18.2ft) Altitude: 2163ft (+41.2ft) Datum: WGS-84 Azimuth/Bearing: 130° S55E 2801mils True (+16°) Elevation Grade: +124° Horizon Grade: -003° Zoom: 10X 11530</p>			
GPS Location	See picture above for GPS coordinates	GPS Location	See picture above for GPS coordinates		
Field Station#	+1	Field Station#	11530+00		
Pic 1 Desc.	No rain recorded	Pic 2 Desc.	ECD's and row conditions

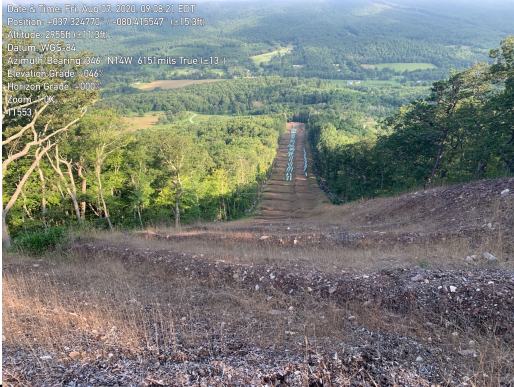
GPS Location	See picture above for GPS coordinates	GPS Location	See picture above for GPS coordinates		
Field Station#	11553+00	Field Station#	11563+00		
Pic 3 Desc.	ECD's and row conditions	Pic 4 Desc.	ECD's and row conditions

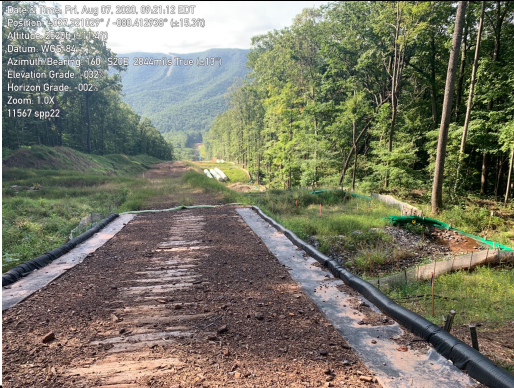
<p>Date & Time: Fri, Aug 07, 2020, 09:43:00 EDT Position: +037.217912° / -089.512998° (+15.3ft) Altitude: 2048ft (+37.0ft) Datum: WGS-84 Azimuth/Bearing: 167° S13E 2869mils True (+13°) Elevation Grade: +034° Horizon Grade: -003° Zoom: 10X 11584</p>			
GPS Location	See picture above for GPS coordinates	GPS Location	See picture above for GPS coordinates		
Field Station#	11567+00	Field Station#	11584+00		
Pic 5 Desc.	ECD's and row conditions	Pic 6 Desc.	ECD's and row conditions
