Visual Site Inspection Report

Project Name	H-600 Pipeline Spread H	AFE	124300138	Spread	H-600 Pipeline Spread H
Contractor	Precision			Report #	11460
Inspector	Dustin Lyons			Date/Time	6/1/2020 4:08 PM
Permit #	TBD	Inspection Type	VA SWPP	Station Begin	12005+00
State	VA	Inspection Area	Partial	Station End	12119+17
County	Montgomery	Ground	Damp	Temperature (°F)	74.00
Municipality	N/A	Weather	Sunny	Rain Gauge (in)	0.00
				Rain Accumulation Time (days)	3.00

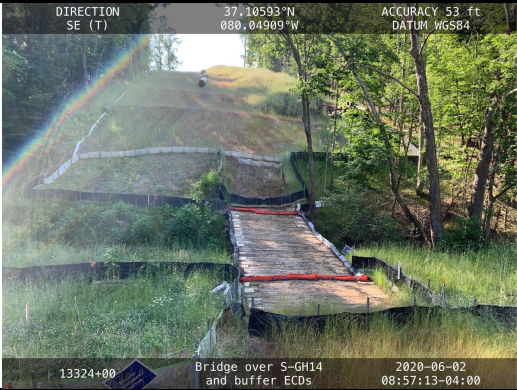
<p>DIRECTION SE (T) 37.10593°N 080.04909°W ACCURACY 53 ft DATUM WGS84</p> <p>13324+00 Bridge over S-GH14 and buffer ECDs 2020-06-02 08:57:13-04:00</p>

GPS Location	See photo for gps location data.		GPS Location	See photo for gps location data.	
Field Station#	13325+20		Field Station#	13324+00	
Pic 9 Desc.	Photo shows the bridge over stream S-GH14.		Pic 10 Desc.	Photo shows the bridge over stream S-GH14 and buffer ECDs.

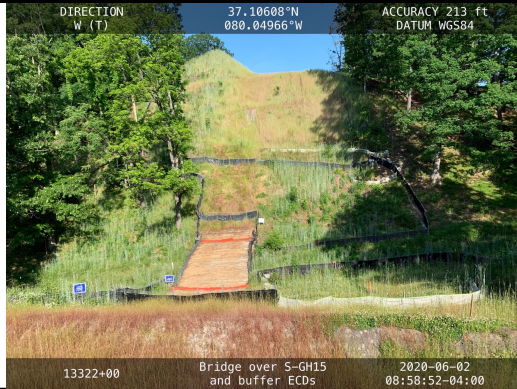
<p>DIRECTION W (T) 37.10608°N 080.04966°W ACCURACY 213 ft DATUM WGS84</p> <p>13322+00 Bridge over S-GH15 and buffer ECDs 2020-06-02 08:58:52-04:00</p>

<p>DIRECTION SE (T) 37.10366°N 080.04273°W ACCURACY 15 ft DATUM WGS84</p> <p>13346+00 Clean water outlet structure 2020-06-02 09:31:39-04:00</p>			
GPS Location	See photo for gps location data.		GPS Location	See photo for gps location data.	
Field Station#	13322+00		Field Station#	13346+00	
Pic 11 Desc.	Photo shows the bridge over stream S-GH15 and buffer ECDs.		Pic 12 Desc.	Photo shows the clean water outlet structure.

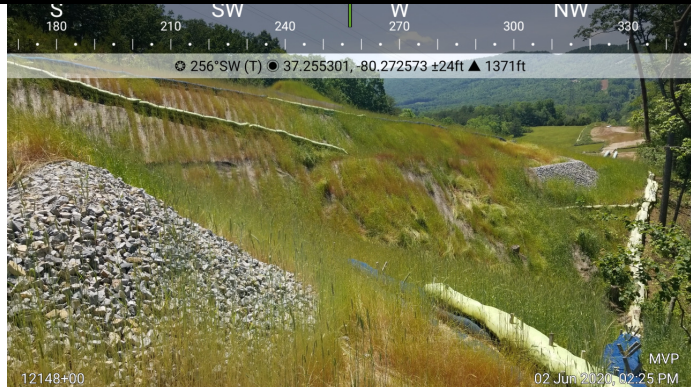
GPS Location	See Above	GPS Location	See Above		
Field Station#	12148+00	Field Station#	12157+50		
Pic 3 Desc.	Temporary and permanent vegetation remain stable and ECDs are functional. Looking West.	Pic 4 Desc.	Head-water area Stream S-C23, Looking West. ECDs are functional.

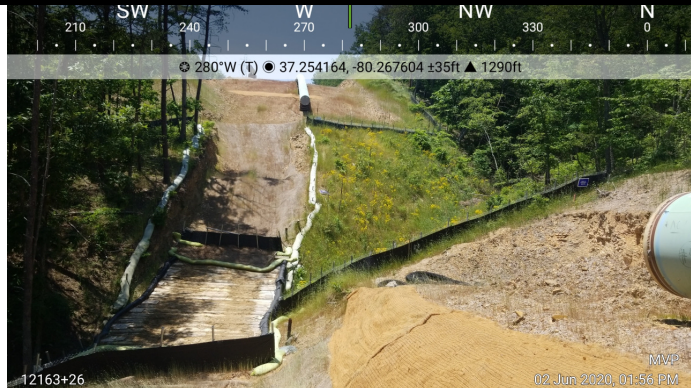
GPS Location	See Above	GPS Location	See Above		
Field Station#	12163+26	Field Station#	12166+50		
Pic 5 Desc.	Stream S-C25, Looking West. ECDs are functional.	Pic 6 Desc.	Stream S-C24, Looking West. ECDs are functional.

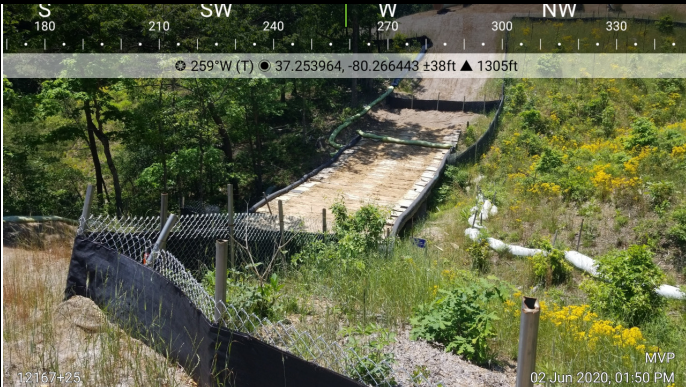
GPS Location	See Above		GPS Location	See Above	
Field Station#	12167+25		Field Station#	12189+00	
Pic 7 Desc.	Stream S-C24, Looking West. ECDs are functional.		Pic 8 Desc.	Temporary vegetation remains stable and ECDs are functional. Looking NorthEast.

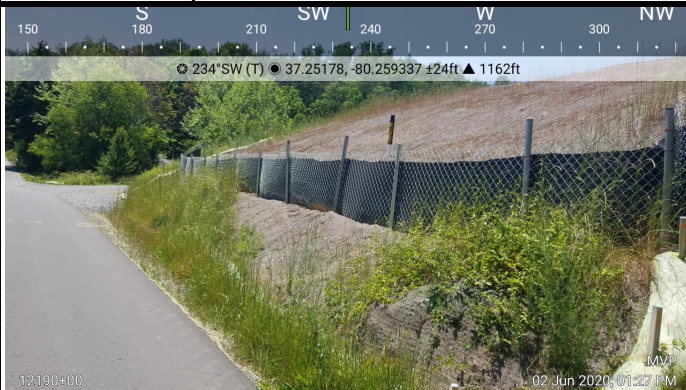
GPS Location	See Above		GPS Location	See Above	
Field Station#	12190+00		Field Station#	12193+00	
Pic 9 Desc.	Temporary vegetation remains stable and ECDs are functional. Looking SouthWest.		Pic 10 Desc.	Stream S-C21, Looking West. ECDs are functional.

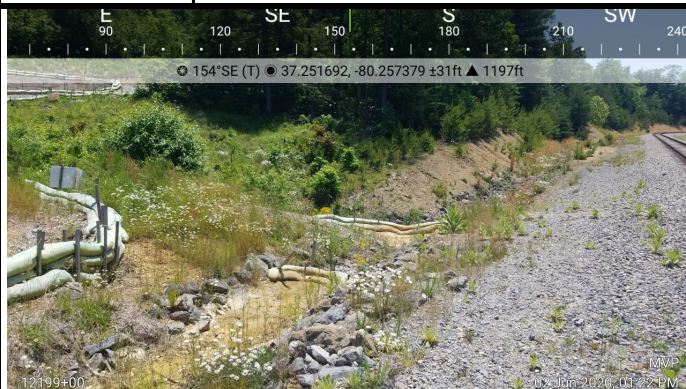
GPS Location	See Above		GPS Location	See Above	
Field Station#	12199+00		Field Station#	12204+00	
Pic 11 Desc.	Near Stream S-0011, Looking SouthEast. Temporary vegetation remains stable and ECDs are functional.		Pic 12 Desc.	Temporary vegetation remains stable and ECDs are functional. Looking West.

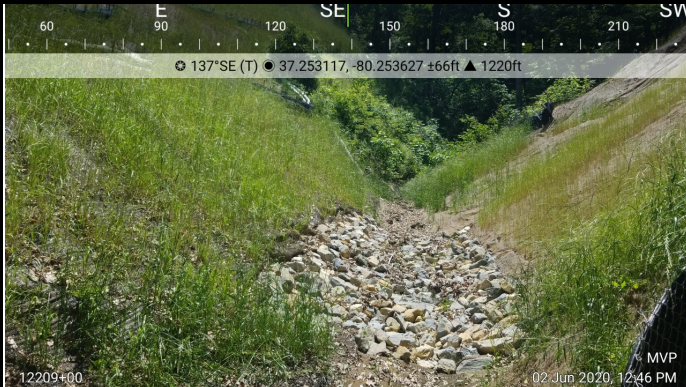
GPS Location	See Above		GPS Location	See Above	
Field Station#	12209+00		Field Station#	12210+00	
Pic 13 Desc.	Temporary and permanent vegetation remain stable and ECDs are functional. Looking SouthEast.		Pic 14 Desc.	Temporary and permanent vegetation remain stable and ECDs are functional. Looking SouthEast.

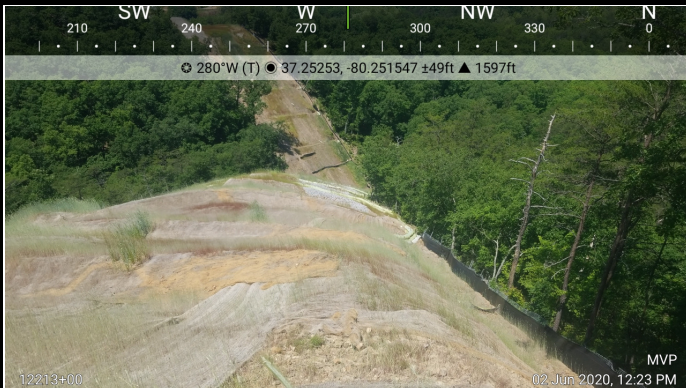
GPS Location	See Above		GPS Location	See Above	
Field Station#	12213+00		Field Station#	12219+00	
Pic 15 Desc.	Temporary and permanent vegetation remain stable and ECDs are functional. Looking West.		Pic 16 Desc.	Temporary vegetation remains stable and ECDs are functional. Looking SouthWest.

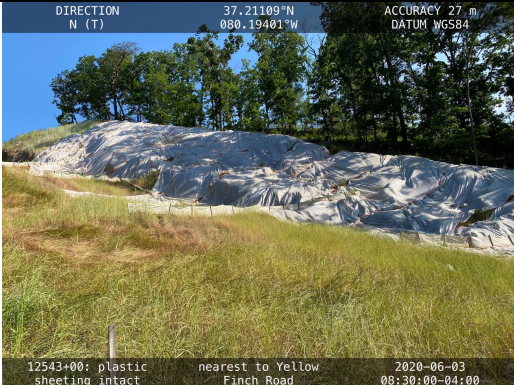
GPS Location	See photo		GPS Location	See photo	
Field Station#	12543+00		Field Station#	12530+00	
Pic 3 Desc.	Plastic sheeting nearest to Yellow Finch Road intact and functional.		Pic 4 Desc.	Plastic sheeting approximately 1400 feet from Yellow Finch Road, intact and effective I

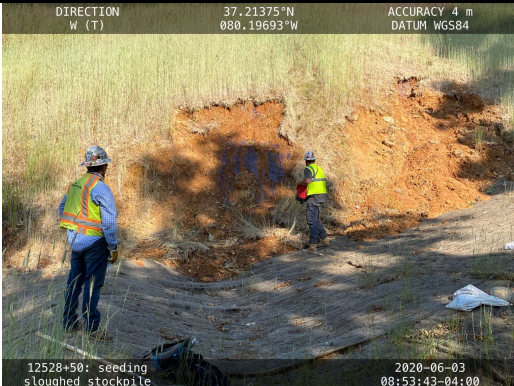
GPS Location	See photo		GPS Location	See photo	
Field Station#	12528+50		Field Station#	12528+00	
Pic 5 Desc.	A laborer seeded the stockpile where it sloughed before installation of erosion control blanket.		Pic 6 Desc.	Laborers installed erosion control blanket over the stockpile where it sloughed.

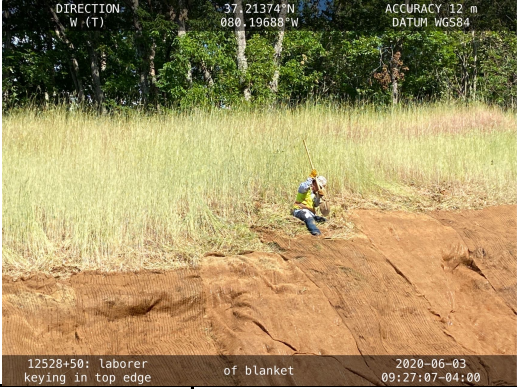
<p>DIRECTION: W (T) 37.21374°N 080.19688°W ACCURACY 12 m DATUM WGS84</p> <p>12528+50: laborer keying in top edge of blanket 2020-06-03 09:27:07-04:00</p>

<p>DIRECTION S (T) 37.21649°N 080.19757°W ACCURACY 47 m DATUM WGS84</p> <p>12522+00: slope remains stable 2020-06-03 10:56:29-04:00</p>			
GPS Location	See photo		GPS Location	See photo	
Field Station#	12528+50		Field Station#	12522+00	
Pic 7 Desc.	A laborer keyed in the top edge of erosion control blanket.		Pic 8 Desc.	The steep slope on the going away side of stream S-EF19 remains stable.

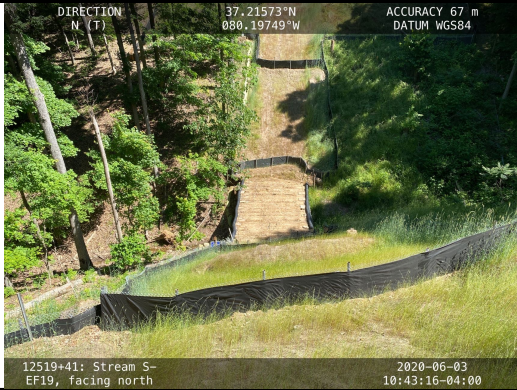
<p>DIRECTION N (T) 37.21573°N 080.19749°W ACCURACY 67 m DATUM WGS84</p> <p>12519+41: Stream S-EF19, facing north 2020-06-03 10:43:16-04:00</p>

GPS Location	See photo		GPS Location	See photo	
Field Station#	12519+41		Field Station#	12519+41	
Pic 9 Desc.	Stream S-EF19 and its buffer zone, facing north		Pic 10 Desc.	Stream S-EF19, facing east, upstream

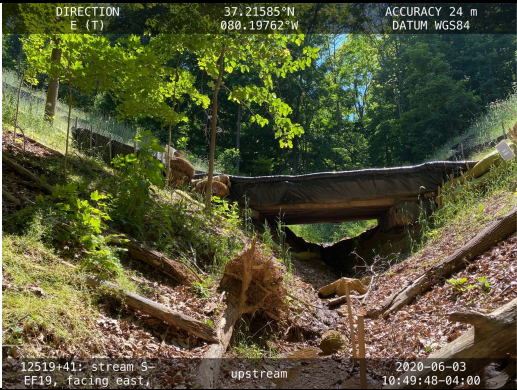
<p>DIRECTION E (T) 37.21585°N 080.19762°W ACCURACY 24 m DATUM WGS84</p> <p>12519+41: stream S-EF19, facing east, upstream 2020-06-03 10:49:48-04:00</p>

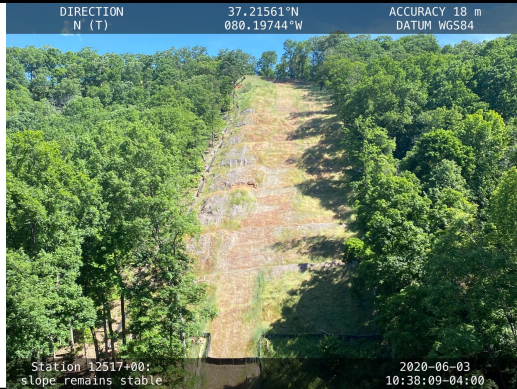
<p>DIRECTION N (T) 37.21561°N 080.19744°W ACCURACY 18 m DATUM WGS84</p> <p>Station 12517+00: slope remains stable 2020-06-03 10:38:09-04:00</p>

<p>DIRECTION NW (T) 37.21798°N 080.19983°W ACCURACY 44 m DATUM WGS84</p> <p>12503+00: minimal vegetation Blanket still effective 2020-06-03 11:30:32-04:00</p>			
GPS Location	See photo		GPS Location	See photo	
Field Station#	12517+00		Field Station#	12503+00	
Pic 11 Desc.	The steep slope on the coming in side of stream S-EF19 remains stable.		Pic 12 Desc.	Minimal vegetative cover, blanket still intact maintaining stability.

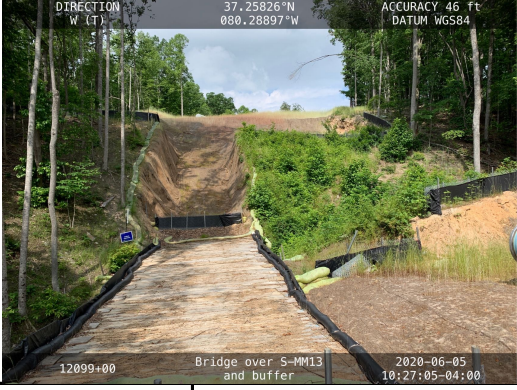
GPS Location	See photo for gps location data.		GPS Location	See photo for gps location data.	
Field Station#	12099+00		Field Station#	12108+50	
Pic 17 Desc.	Photo shows the bridge over stream S-MM13 and buffer ECDs.		Pic 18 Desc.	Photo shows the bridge over stream S-F15 and buffer.

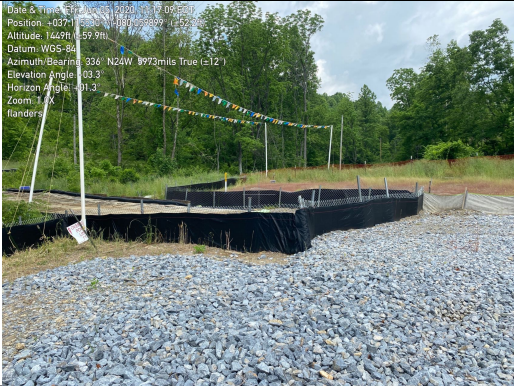
GPS Location	See photo for coordinates.		GPS Location	See photo for coordinates.	
Field Station#	13261+00		Field Station#	13260+80	
Pic 5 Desc.	ATWS-1055, ECDs functioning acceptably.		Pic 6 Desc.	S-II4, GAS, ECDs functioning acceptably.

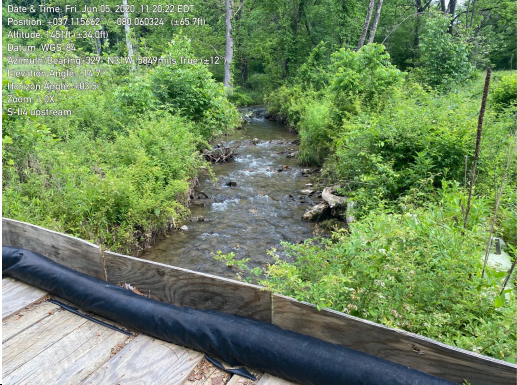
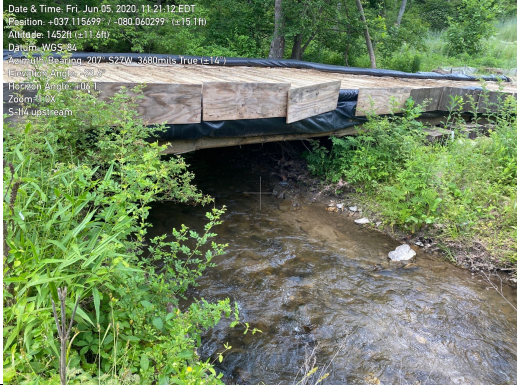
<p>Date & Time: Fri, Jun 05, 2020, 11:20:22 EDT Position: +037.115632 / -080.060324 (±95.7ft) Altitude: 1452ft (±11.6ft) Datum: WGS-84 Magnetic Declination: 207.433W 1849mils True (±12.7) Horizontal Angle: -10.1 Horizon: -009 Zoom: 1.0X S-II4 upstream</p>

<p>Date & Time: Fri, Jun 05, 2020, 11:21:12 EDT Position: +037.115639 / -080.060299 (±15.1ft) Altitude: 1452ft (±11.6ft) Datum: WGS-84 Magnetic Declination: 207.433W 1849mils True (±12.7) Horizontal Angle: -10.1 Horizon: -009 Zoom: 1.0X S-II4 upstream</p>			
GPS Location		See photo for coordinates.		GPS Location	
Field Station#		13260+60		Field Station#	
Pic 7 Desc.		S-II4, upstream, no environmental issues noted.		Pic 8 Desc.

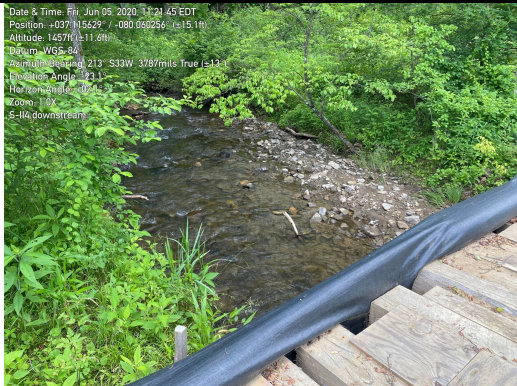
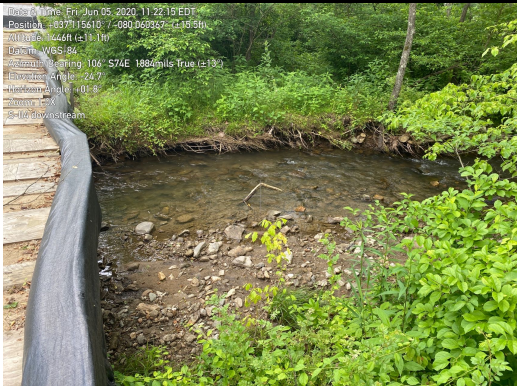
<p>Date & Time: Fri, Jun 05, 2020, 11:21:45 EDT Position: +037.115629 / -080.060236 (±15.1ft) Altitude: 1427ft (±11.6ft) Datum: WGS-84 Magnetic Declination: 213.533W 1787mils True (±12.7) Horizontal Angle: -12.1 Horizon: -009 Zoom: 1.0X S-II4 downstream</p>

GPS Location		See photo for coordinates.		GPS Location	
Field Station#		13260+60		Field Station#	
Pic 9 Desc.		S-II4, downstream, no environmental issues noted.		Pic 10 Desc.

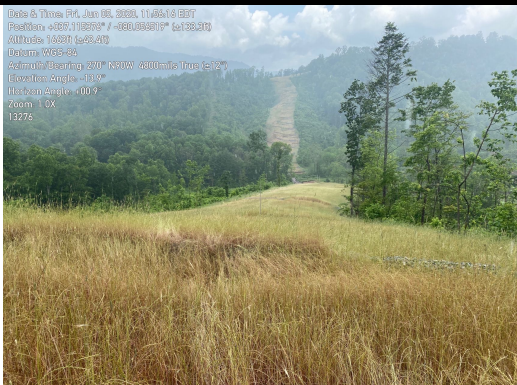
<p>Date & Time: Fri, Jun 05, 2020, 11:26:15 EDT Position: +037.115634 / -080.060457 (±15.1ft) Altitude: 1428ft (±11.6ft) Datum: WGS-84 Magnetic Declination: 207.433W 1849mils True (±12.7) Horizontal Angle: -10.1 Horizon: -009 Zoom: 1.0X 13276</p>			
GPS Location		See photo for coordinates.		GPS Location	
Field Station#		13259+75		Field Station#	
Pic 11 Desc.		S-II4, CIS, ECDs functioning acceptably, ROW stable with good vegetative cover.		Pic 12 Desc.
