Visual Site Inspection Report

Project Name	H-600 Pipeline Spread H	AFE	124300138	Spread	H-600 Pipeline Spread H
Contractor	Precision			Report #	11635
Inspector	Pat Davis			Date/Time	6/8/2020 4:00 PM
Permit #	TBD	Inspection Type	VA SWPP	Station Begin	+0
State	VA	Inspection Area	Partial	Station End	+0
County	Montgomery	Ground	Damp	Temperature (°F)	84.00
Municipality	N/A	Weather	Sunny	Rain Gauge (in)	0.20
				Rain Accumulation Time (days)	0.00

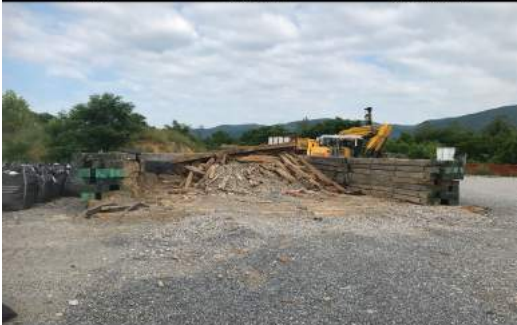
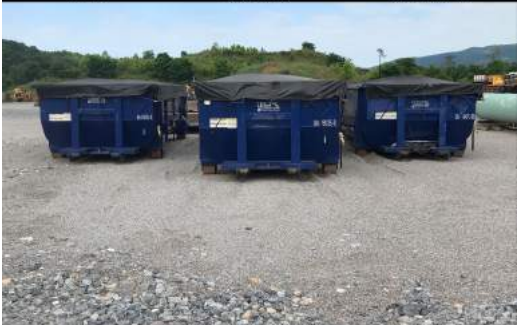
MVP-LY-049_060820 Condition of temporary trash ... 2020-06-08 08:53:53-04:00		MVP-LY-049_060820 No debris around hazardous waste ... 2020-06-08 08:54:50-04:00			
GPS Location	MVP-LY-049 See photo for gps data		GPS Location	MVP-LY-049 See photo for gps data	
Field Station#	+0		Field Station#	+0	
Pic 7 Desc.	Condition of temporary trash transfer pit. Looking W.		Pic 8 Desc.	No debris around hazardous waste dumpsters. Looking N.	
DIRECTION SE (M) +37.27032° -080.12113° ACCURACY 16 ft DATUM WGS84		DIRECTION W (M) +37.27119° -080.12077° ACCURACY 16 ft DATUM WGS84

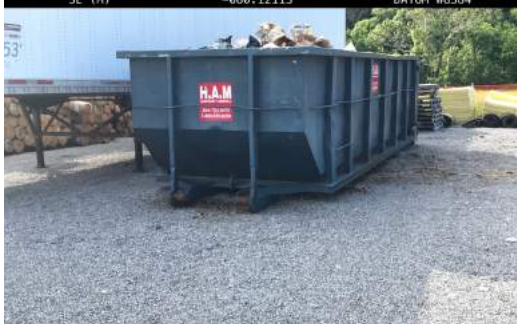
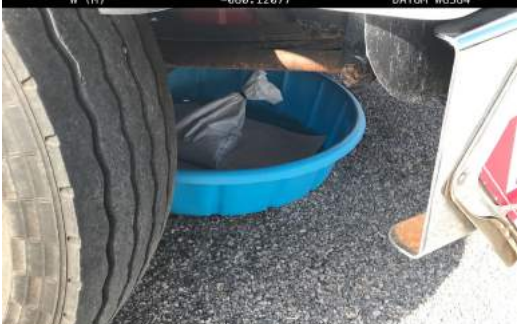
MVP-LY-049_060820 No loose trash around south dumpster 2020-06-08 09:15:47-04:00		MVP-LY-049_060820 Containment under stored vehicle 2020-06-08 09:18:46-04:00

GPS Location	MVP-LY-049 See photo for gps data		GPS Location	MVP-LY-049 See photo for gps data	
Field Station#	+0		Field Station#	+0	
Pic 9 Desc.	No loose trash around south dumpster. Looking SE.		Pic 10 Desc.	Condition of containment under stored vehicle. Looking W.	
DIRECTION W (M) +37.27114° -080.12031° ACCURACY 16 ft DATUM WGS84		DIRECTION SW (M) +37.27111° -080.12084° ACCURACY 16 ft DATUM WGS84

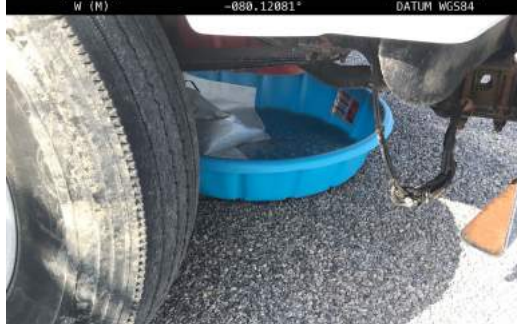
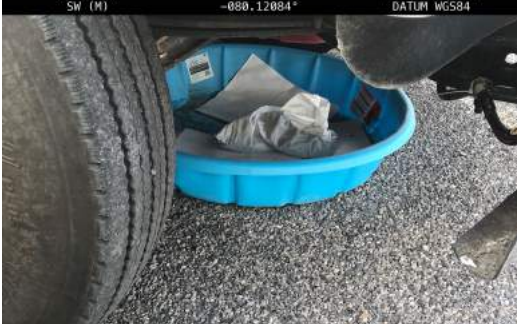
MVP-LY-049_060820 Containment under stored vehicle 2020-06-08 09:18:54-04:00		MVP-LY-049_060820 Containment under stored vehicle 2020-06-08 09:19:02-04:00			
GPS Location	MVP-LY-049 See photo for gps data		GPS Location	MVP-LY-049 See photo for gps data	
Field Station#	+0		Field Station#	+0	
Pic 11 Desc.	Condition of containment under stored vehicle. Looking W.		Pic 12 Desc.	Condition of containment under stored vehicle. Looking SW.

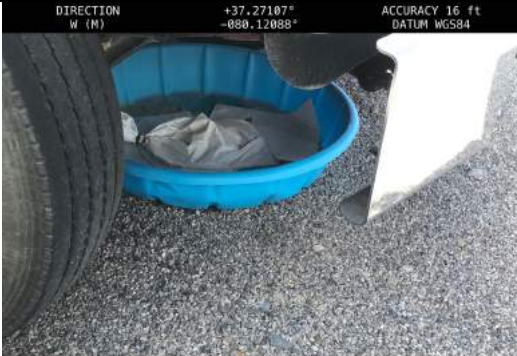
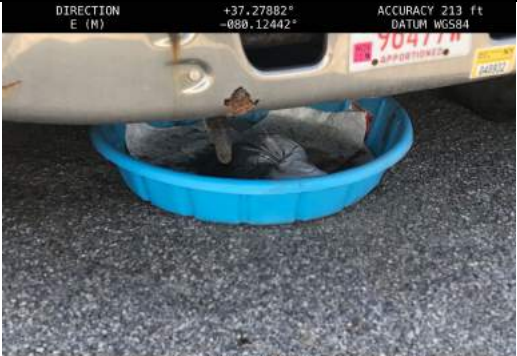
GPS Location	MVP-LY-049 See photo for gps data	GPS Location	MVP-LY-049 See photo for gps data		
Field Station#	+0	Field Station#	+0		
Pic 13 Desc.	Condition of containment under stored vehicle. Looking W.	Pic 14 Desc.	Condition of containment under stored vehicle. Looking E.

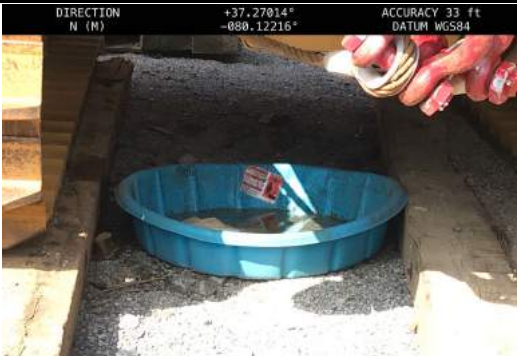
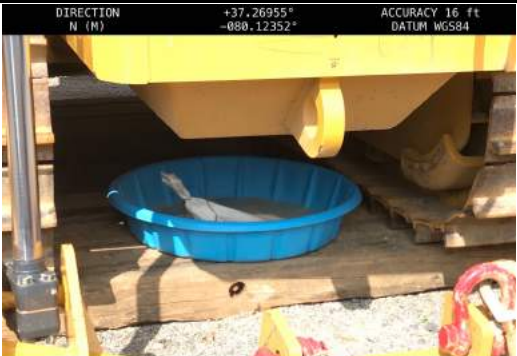
GPS Location	MVP-LY-049 See photo for gps data	GPS Location	MVP-LY-049 See photo for gps data		
Field Station#	+0	Field Station#	+0		
Pic 15 Desc.	Condition of containment under stored equipment. Looking SW.	Pic 16 Desc.	Condition of containment under stored equipment. Looking SW.

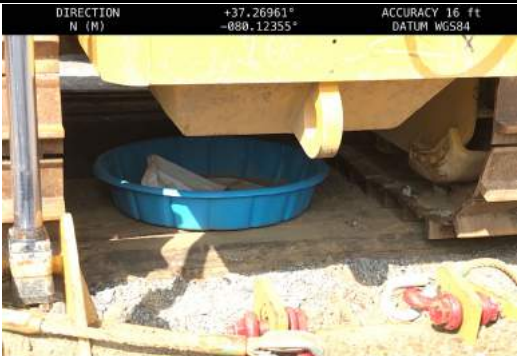
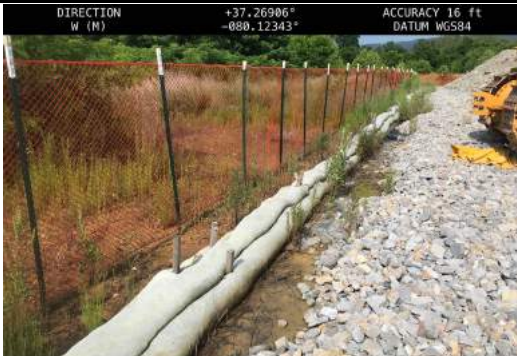
GPS Location	MVP-LY-049 See photo for gps data	GPS Location	MVP-LY-049 See photo for gps data		
Field Station#	+0	Field Station#	+0		
Pic 17 Desc.	Condition of containment under stored equipment. Looking NW.	Pic 18 Desc.	Condition of compost filter sock and safety fence along the south LOD. Looking W.

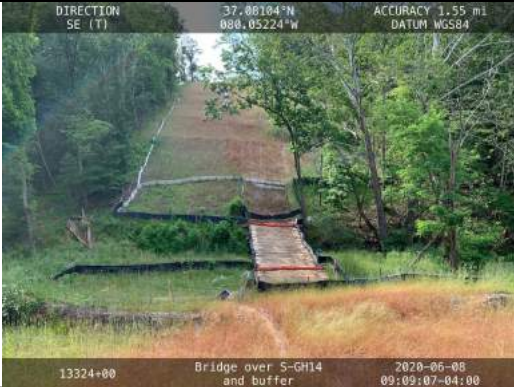
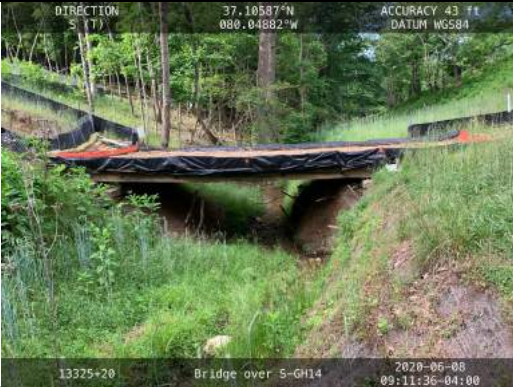
GPS Location	See photo for gps location data.		GPS Location	See photo for gps location data.	
Field Station#	13324+00		Field Station#	13325+20	
Pic 3 Desc.	Photo shows the bridge over stream S-GH14 and buffer ECDs.		Pic 4 Desc.	Photo shows the bridge over stream S-GH14.

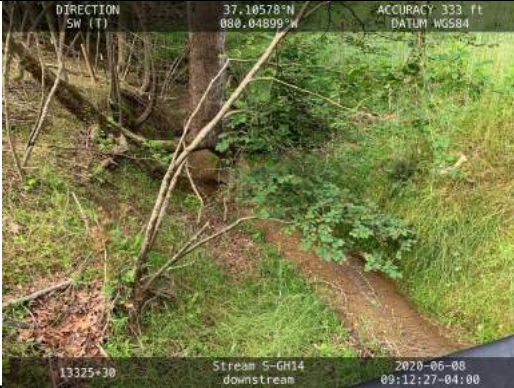
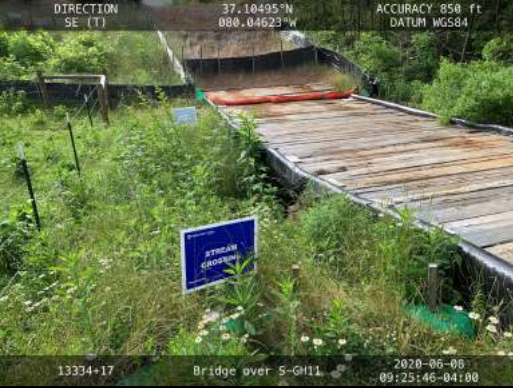
GPS Location	See photo for gps location data.		GPS Location	See photo for gps location data.	
Field Station#	13326+30		Field Station#	13334+17	
Pic 5 Desc.	Photo shows stream S-GH14 downstream from the ROW crossing.		Pic 6 Desc.	Photo shows the bridge over stream S-GH11.

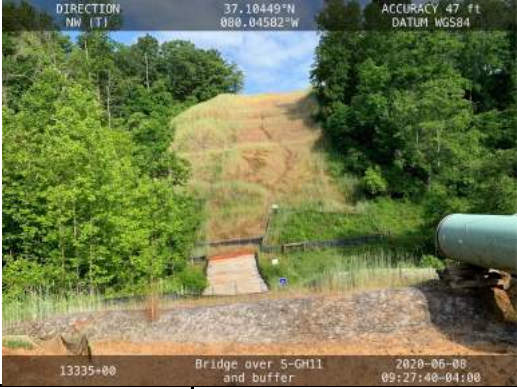
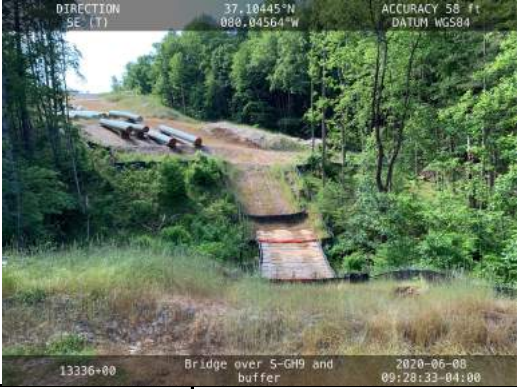
GPS Location	See photo for gps location data.		GPS Location	See photo for gps location data.	
Field Station#	13335+00		Field Station#	13336+00	
Pic 7 Desc.	Photo shows the bridge over stream S-GH11 and buffer ECDs.		Pic 8 Desc.	Photo shows the bridge over stream S-GH9 and buffer ECDs.

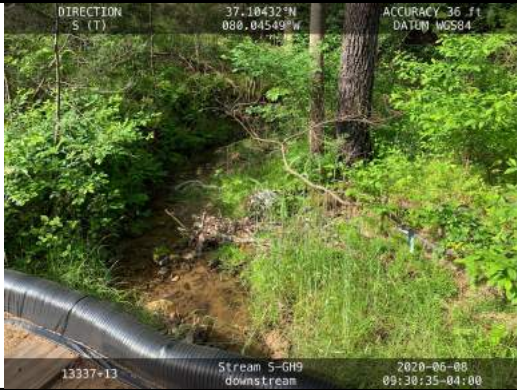
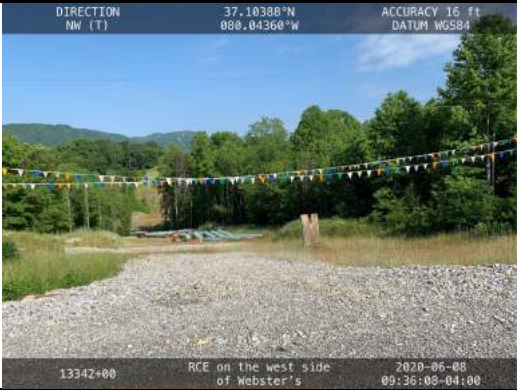
GPS Location	See photo for gps location data.		GPS Location	See photo for gps location data.	
Field Station#	13337+13		Field Station#	13342+00	
Pic 9 Desc.	Photo shows stream S-GH9 downstream from the ROW crossing.		Pic 10 Desc.	Photo shows the RCE on the west side of Webster's Corner Road.

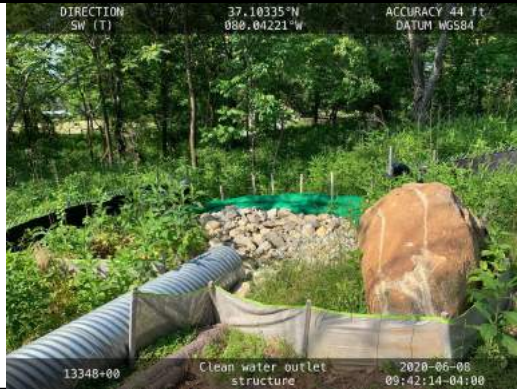
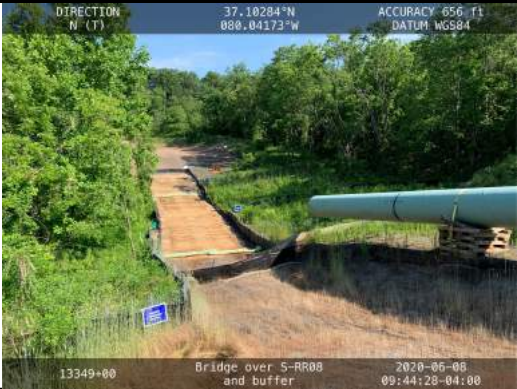
GPS Location	See photo for gps location data.		GPS Location	See photo for gps location data.	
Field Station#	13348+00		Field Station#	13349+00	
Pic 11 Desc.	Photo shows clean water outlet structure.		Pic 12 Desc.	Photo shows the bridge over stream S-RR8 and buffer ECDs.

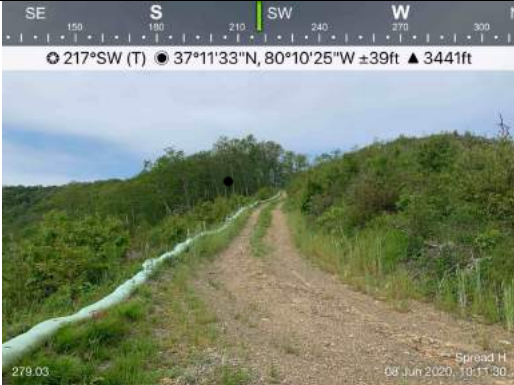
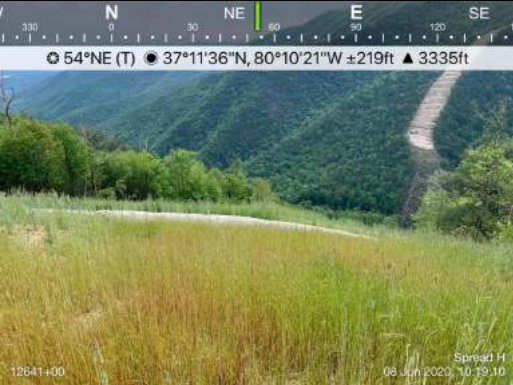
GPS Location	see photo		GPS Location	see photo	
Field Station#	279+01		Field Station#	12641+00	
Pic 1 Desc.	AR-279.01 in good condition, control measures in place.		Pic 2 Desc.	ROW vegetation is established and mature.

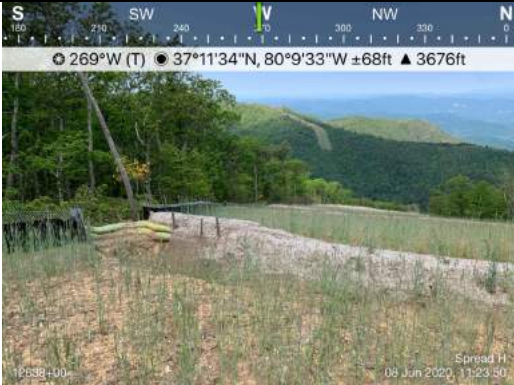
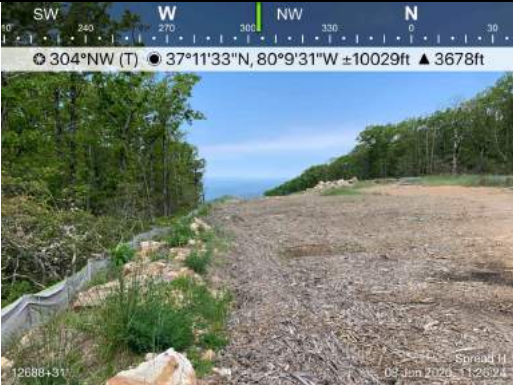
GPS Location	See photo		GPS Location	see photo	
Field Station#	12638+00		Field Station#	12688+31	
Pic 3 Desc.	Waterbar, end treatment, and sumps are in acceptable condition.		Pic 4 Desc.	SSF is in acceptable condition.

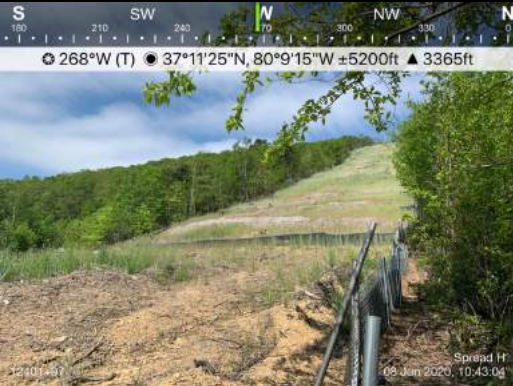
GPS Location	see photo		GPS Location	see photo	
Field Station#	12690+29		Field Station#	12701+37	
Pic 5 Desc.	Construction entrances are in acceptable condition.		Pic 6 Desc.	SSF is in place and functional.

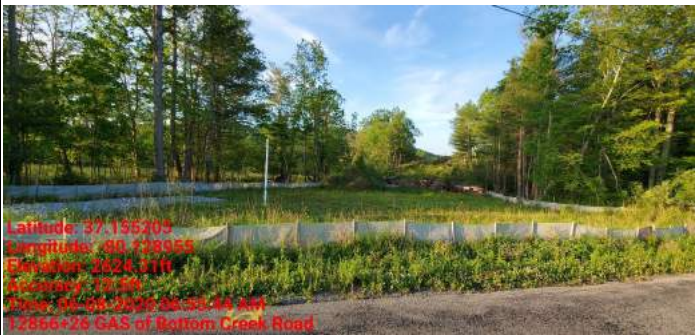
<p>Latitude: 37.155209 Longitude: -80.128955 Elevation: 2624.71ft Accuracy: 12.5ft Time: 06-08-2020 06:57:33 AM 12866+26 GAS of Bottom Creek Road</p>			  <p>Latitude: 37.155213 Longitude: -80.128927 Elevation: 2619.25ft Accuracy: 32.5ft Time: 06-08-2020 06:57:33 AM 12866+26 CIS of Bottom Creek Road</p>		
GPS Location	See pic for GPS location		GPS Location	See pic for GPS location	
Field Station#	12866+26		Field Station#	12866+26	
Pic 1 Desc.	GAS of the Bottom Creek Road crossing		Pic 2 Desc.	CIS of the Bottom Creek Road crossing.

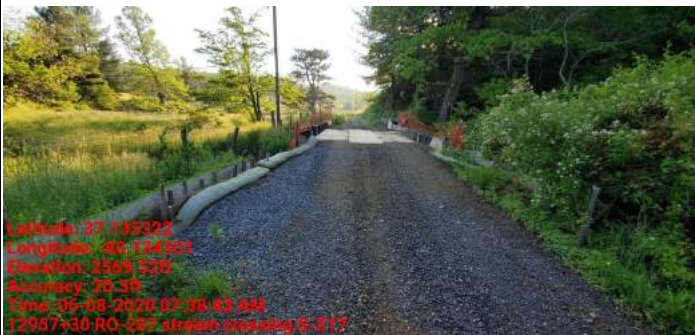
<p>Latitude: 37.129322 Longitude: -80.128301 Elevation: 2569.52ft Accuracy: 20.3ft Time: 06-08-2020 07:38:43 AM 12957+30 RO-287 stream crossing S-Z17</p>			  <p>Latitude: 37.129541 Longitude: -80.128444 Elevation: 2566.35ft Accuracy: 12.5ft Time: 06-08-2020 07:39:35 AM 12957+30 RO-287 stream crossing S-Z17</p>

GPS Location	See pic for GPS location		GPS Location	See pic for GPS location	
Field Station#	12957+30		Field Station#	12957+30	
Pic 3 Desc.	Stream S-Z17 crossing at RO-287		Pic 4 Desc.	Access road RO-287 stream crossing S-Z17.

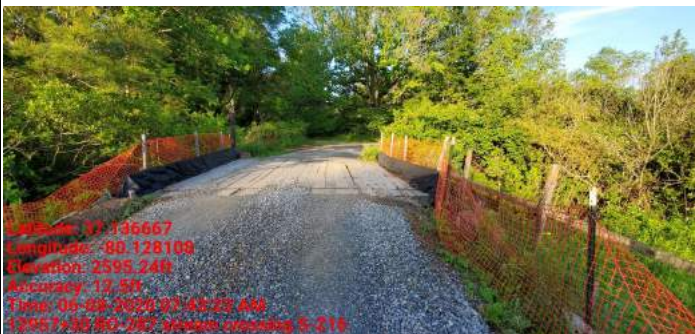
<p>Latitude: 37.136667 Longitude: -80.128109 Elevation: 2595.24ft Accuracy: 12.5ft Time: 06-08-2020 07:44:23 AM 12957+30 RO-287 stream crossing S-Z16</p>

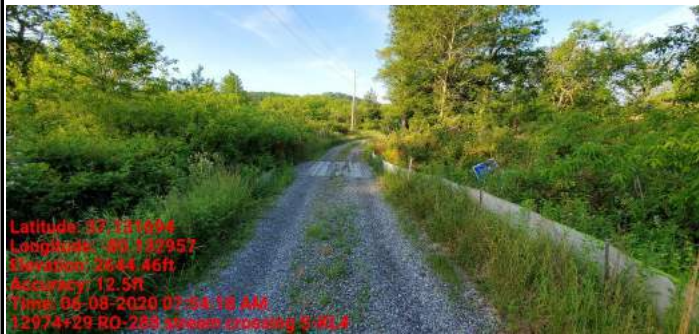
<p>Latitude: 37.121544 Longitude: -80.127957 Elevation: 2644.46ft Accuracy: 12.5ft Time: 06-08-2020 07:54:18 AM 12974+29 RO-288 stream crossing S-KL4</p>		
GPS Location	See pic for GPS location		GPS Location	See pic for GPS location	
Field Station#	12957+30		Field Station#	12974+29	
Pic 5 Desc.	Access road RO-287 stream crossing S-Z16.		Pic 6 Desc.	Access road RO-288 stream crossing S-KL4.

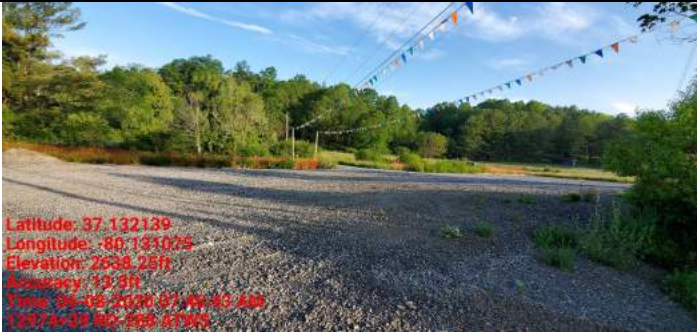
<p>Latitude: 37.132139 Longitude: -80.131075 Elevation: 2538.25ft Accuracy: 12.5ft Time: 06-08-2020 07:49:40 AM 12974+29 RO-288 ATWS</p>		
GPS Location	See pic for GPS location		GPS Location	See pic for GPS location	
Field Station#	12974+29		Field Station#	12974+29	
Pic 7 Desc.	Access road RO-288 stream crossing S-Q20.		Pic 8 Desc.	Access road RO-288 ATWS.	
  <p>Latitude: 37.128531 Longitude: -80.130577 Elevation: 2634.4ft Accuracy: 16.7ft Time: 06-08-2020 08:04:34 AM 12994+02 CIS of US-221</p>			  <p>Latitude: 37.127729 Longitude: -80.132424 Elevation: 2544.19ft Accuracy: 12.5ft Time: 06-08-2020 08:04:49 AM 12994+02 GAS of US-221</p>		
GPS Location	See pic for GPS location		GPS Location	See pic for GPS location

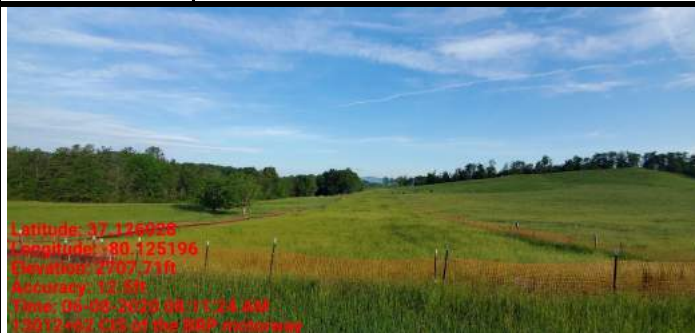
<p>Latitude: 37.126898 Longitude: -80.125196 Elevation: 2707.71ft Accuracy: 12.5ft Time: 06-08-2020 08:17:24 AM 13012+62 CIS of the BRP motorway</p>			  <p>Latitude: 37.126898 Longitude: -80.125196 Elevation: 2711.45ft Accuracy: 12.5ft Time: 06-08-2020 08:17:27 AM 13012+62 GAS of the BRP motorway</p>		
GPS Location	See pic for GPS location		GPS Location	See pic for GPS location	
Field Station#	13012+62		Field Station#	13012+62	
Pic 11 Desc.	CIS of the BRP motorway.		Pic 12 Desc.	GAS of the BRP motorway

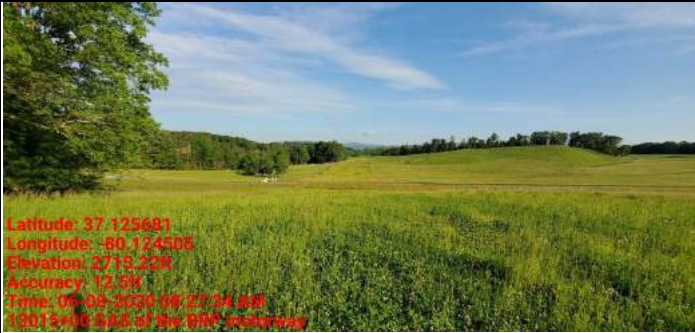
<p>Latitude: 37.125681 Longitude: -80.124505 Elevation: 2715.22ft Accuracy: 12.5ft Time: 06-08-2020 09:27:34 AM 13015+00 GAS of the BRP motorway</p>

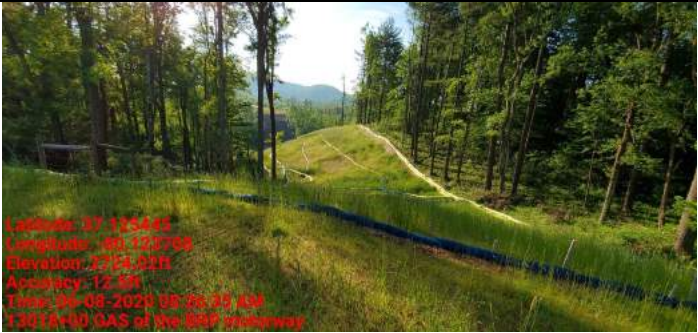
<p>Latitude: 37.125445 Longitude: -80.123769 Elevation: 2713.21ft Accuracy: 12.5ft Time: 06-08-2020 09:28:29 AM 13018+00 GAS of the BRP motorway</p>		
GPS Location			See pic for GPS location		
Field Station#			13015+00		
Pic 13 Desc.			BRP motorway from the GAS.

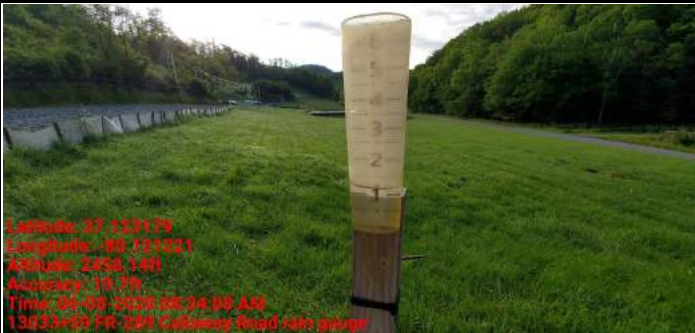
<p>Latitude: 37.123179 Longitude: -80.121821 Elevation: 2254.14ft Accuracy: 10.1ft Time: 06-08-2020 08:34:08 AM 13033+00 FR-289 Callaway Road rain gauge</p>

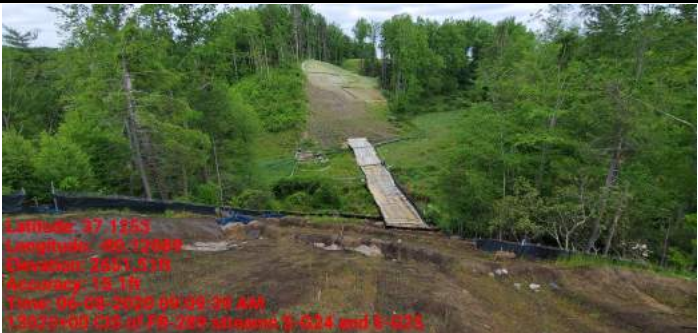
<p>Latitude: 37.1155 Longitude: -80.10889 Elevation: 2661.57ft Accuracy: 15.1ft Time: 06-08-2020 09:04:38 AM 13025+00 CIS of FR-289 streams S-G24 and S-G25</p>		
GPS Location			See pic for GPS location		
Field Station#			13033+59		
Pic 15 Desc.			Callaway Road rain gauge at FR-289. 1.3" total precipitation.

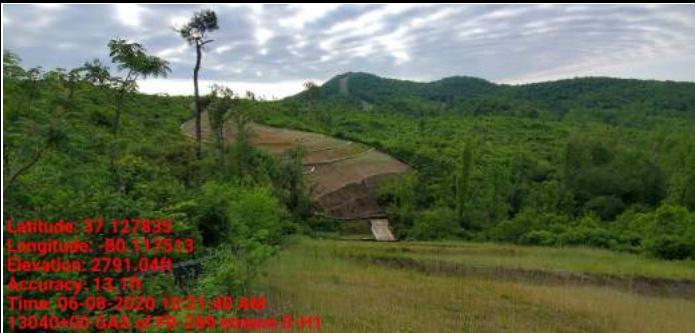
<p>Latitude: 37.127835 Longitude: -80.117513 Elevation: 2791.04ft Accuracy: 13.1ft Time: 06-08-2020 10:21:40 AM 13040+00 GAS of FR-289 stream S-H1</p>

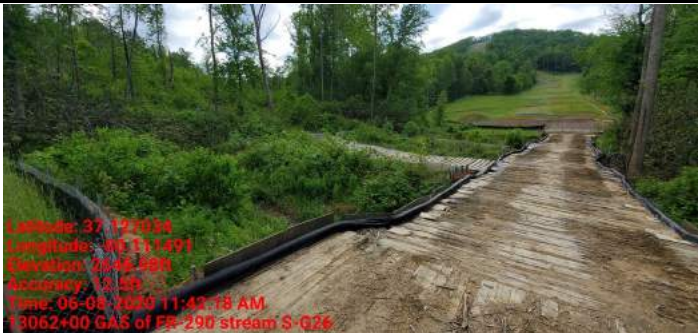
<p>Latitude: 37.127014 Longitude: -80.11497 Elevation: 2646.88ft Accuracy: 13.5ft Time: 06-08-2020 11:42:18 AM 13062+00 GAS of FR-290 stream S-G26</p>		
GPS Location			See pic for GPS location		
Field Station#			13040+00		
Pic 17 Desc.			Stream S-H1 on the GAS of access road FR-289.		
GPS Location			See pic for GPS location		
Field Station#			13062+00		
Pic 18 Desc.			Streams S-G26 and S-G27 on the GAS of access road FR-290.

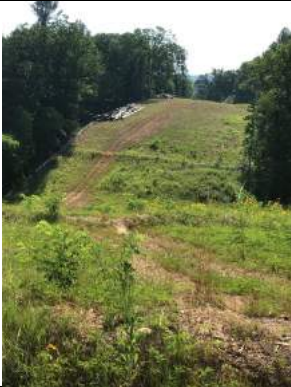
GPS Location	00000	GPS Location	00000		
Field Station#	13601+80	Field Station#	13588+80		
Pic 1 Desc.	Checked ECDs and vegetation throughout my travels	Pic 2 Desc.	Photo showing permanent vegetation growth

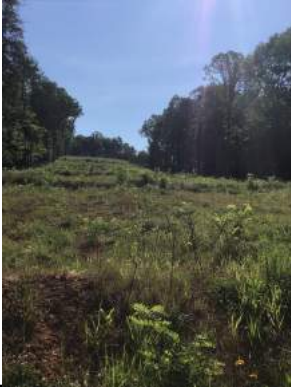
GPS Location	00000	GPS Location	0000		
Field Station#	13580+50	Field Station#	13579+70		
Pic 3 Desc.	Vegetation photo	Pic 4 Desc.	Vegetation photo		
Insert image here			Insert image here		
GPS Location		GPS Location			
Field Station#		Field Station#			
Pic 5 Desc.		Pic 6 Desc.

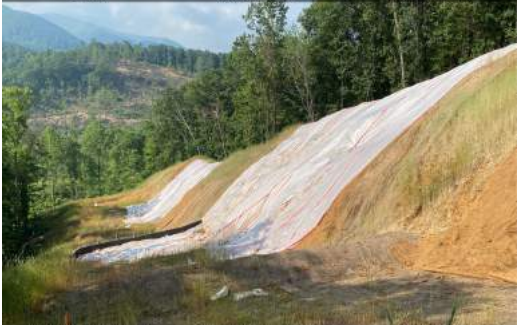
12531+00: facing back toward Yellow Finch Road 2020-06-09 09:37:11-04:00		12529+00: plastic sheeting app. 1500 ft from Yellow Finch Road remains intact and effective 2020-06-09 09:46:21-04:00			
GPS Location	See photo		GPS Location	See photo	
Field Station#	12531+00		Field Station#	12529+00	
Pic 7 Desc.	Facing in the direction of Yellow Finch Road, a ROW stable.		Pic 8 Desc.	Plastic sheeting on the stockpiles approximately 1500 feet from Yellow Finch Road remains intact and effective.	
DIRECTION S (T) 37.21636°N 088.19758°W ACCURACY 14 m DATUM WGS84

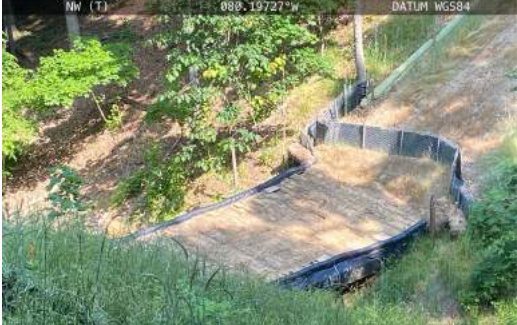
12522+00: slope on GAS of S-EF19 well vegetated and stable 2020-06-09 10:19:01-04:00		12519+41: stream S-EF19, facing NW 2020-06-09 10:09:16-04:00

GPS Location	See photo		GPS Location	See photo	
Field Station#	12522+00		Field Station#	12519+41	
Pic 9 Desc.	Slope on GAS of stream S-EF19 is well vegetated and stable.		Pic 10 Desc.	Stream S-EF19, facing northwest	
DIRECTION N (T) 37.21558°N 088.19717°W ACCURACY 22 m DATUM WGS84

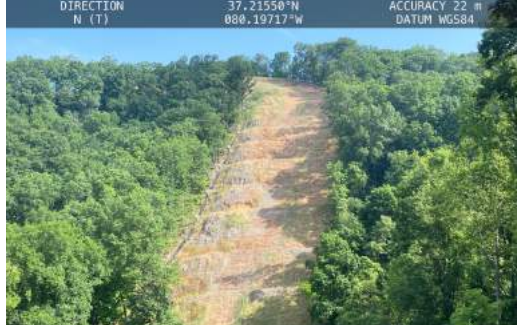
12517+00: slope on CIS of S-EF19 well vegetated and stable 2020-06-09 10:04:12-04:00		12503+00: slopes remain stable, clean water diversion pipe functional 2020-06-09 10:48:32-04:00			
GPS Location	See photo		GPS Location	See photo	
Field Station#	12517+00		Field Station#	12503+00	
Pic 11 Desc.	Slope on CIS of stream S-EF19 is well vegetated and stable.		Pic 12 Desc.	Slopes remain stable, clean water diversion pipe functional.

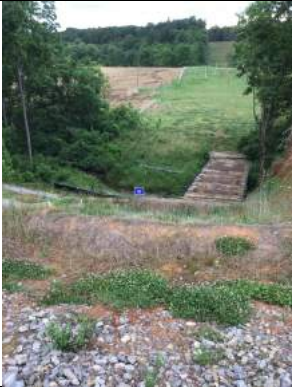
GPS Location	00000	GPS Location	0000		
Field Station#	13530+78	Field Station#	13541+67		
Pic 1 Desc.	Row photo showing vegetation	Pic 2 Desc.	Monitored ECDs on hill side above stream crossing while checking rain gauges .

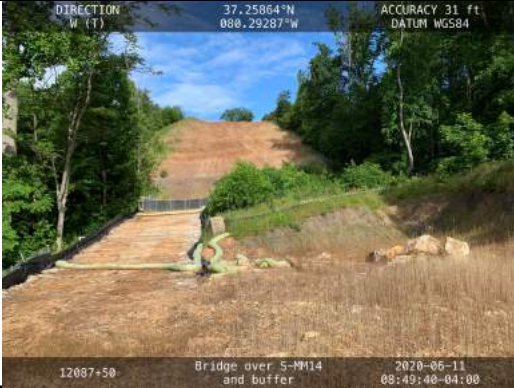
GPS Location	See photo for gps location data.		GPS Location	See photo for gps location data.	
Field Station#	12087+50		Field Station#	12094+60	
Pic 5 Desc.	Photo shows the bridge over stream S-MM14 and buffer ECDs.		Pic 6 Desc.	Photo shows the clean water outlet structure.

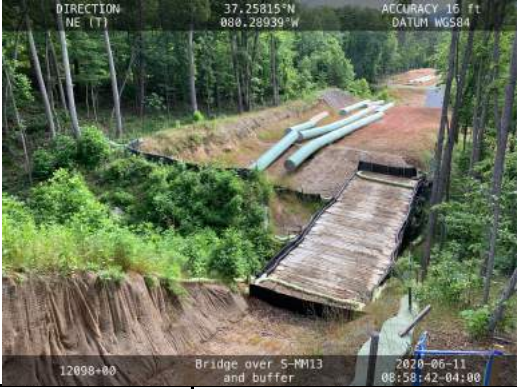
GPS Location	See photo for gps location data.		GPS Location	See photo for gps location data.	
Field Station#	12098+00		Field Station#	12098+55	
Pic 7 Desc.	Photo shows the bridge over stream S-MM13 and buffer.		Pic 8 Desc.	Photo shows stream S-MM13 downstream from the ROW crossing.

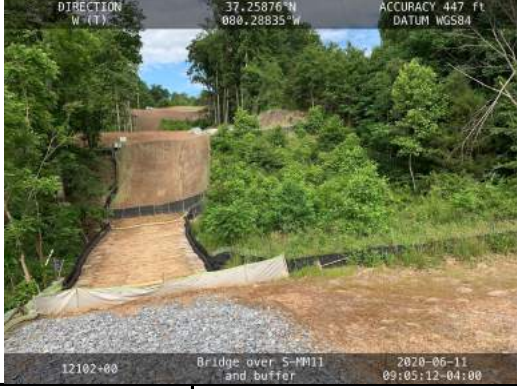
GPS Location	See photo for gps location data.		GPS Location	See photo for gps location data.	
Field Station#	12102+00		Field Station#	12111+00	
Pic 9 Desc.	Photo shows the bridge over stream S-MM11 and buffer.		Pic 10 Desc.	Photo shows the RCE on MN-271, bridge over S-EF16 a/b and buffer ECDs.

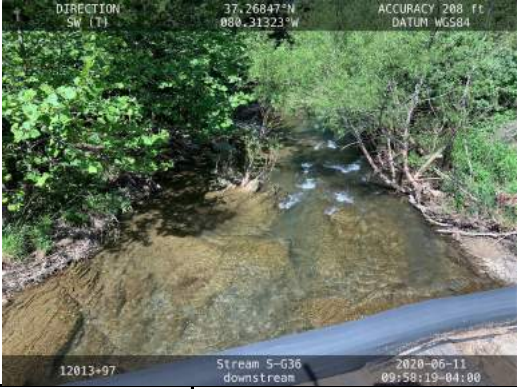
<p>DIRECTION SW (T) 37.26847°N 88.31323°W ACCURACY 208 ft DATUM WGS84</p> <p>12013+97 Stream S-G36 downstream 2020-06-11 09:50:19-04:00</p>

<p>DIRECTION SE (T) 37.26490°N 88.30862°W ACCURACY 47 ft DATUM WGS84</p> <p>12031+50 Bridge over S-G39 2020-06-11 10:11:00-04:00</p>			
GPS Location	See photo for gps location data.		GPS Location	See photo for gps location data.	
Field Station#	12013+97		Field Station#	12031+50	
Pic 13 Desc.	Photo shows stream S-G36.		Pic 14 Desc.	Photo shows the bridge over stream S-G39.

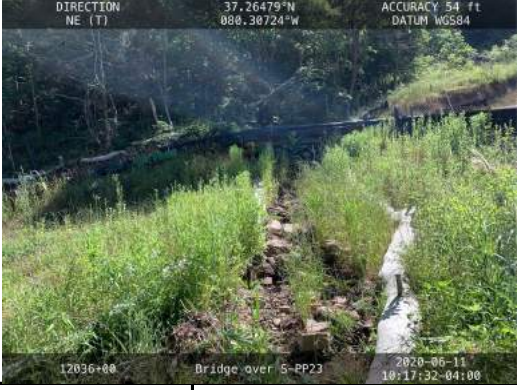
<p>DIRECTION NE (T) 37.26479°N 88.30724°W ACCURACY 54 ft DATUM WGS84</p> <p>12036+00 Bridge over S-PP23 2020-06-11 10:17:32-04:00</p>

<p>DIRECTION SE (T) 37.26484°N 88.30707°W ACCURACY 17 ft DATUM WGS84</p> <p>12037+00 ROW conditions 2020-06-11 10:18:09-04:00</p>			
GPS Location	See photo for gps location data.		GPS Location	See photo for gps location data.	
Field Station#	12036+00		Field Station#	12037+00	
Pic 17 Desc.	photo shows the bridge over stream S-PP23.		Pic 18 Desc.	Photo shows the ROW condition from about 12037+00 to 12052+00.

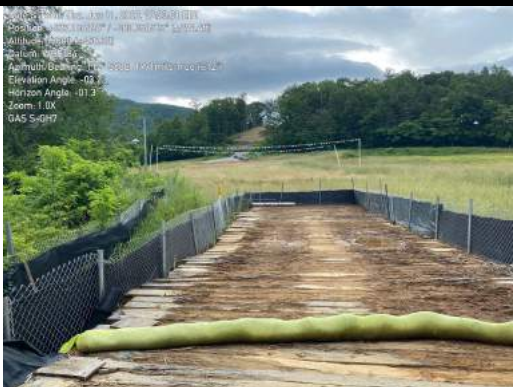
GPS Location		See photo for coordinates.		GPS Location	
Field Station#		13309+09		Field Station#	
Pic 3 Desc.		GAS S-GH7, perimeter ECDs functioning acceptably, good vegetative cover.		Pic 4 Desc.

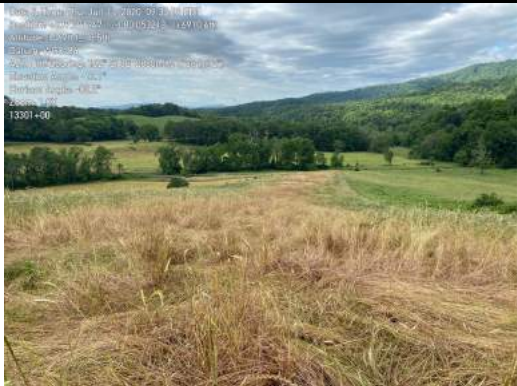
GPS Location	See photo for coordinates.		GPS Location	See photo for coordinates.	
Field Station#	13301+00		Field Station#	13300+00	
Pic 9 Desc.	Good vegetative cover across LOD in restored area, some vegetation matted down, ECDs functioning acceptably.		Pic 10 Desc.	Good vegetative cover across LOD in restored area, some vegetation matted down.

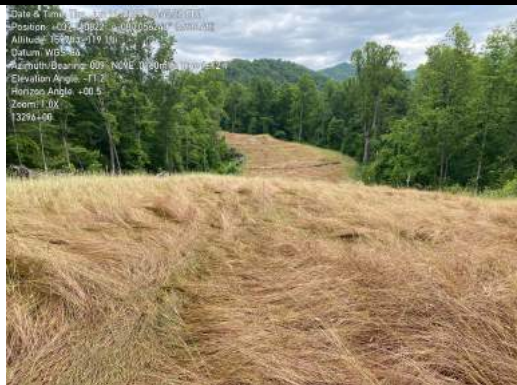
GPS Location	See photo for coordinates.		GPS Location	See photo for coordinates.	
Field Station#	13296+00		Field Station#	13276+00	
Pic 11 Desc.	Good vegetative cover across LOD in restored area, some vegetation matted down, permanent waterbars stable.		Pic 12 Desc.	Good vegetative cover across LOD in restored area, some vegetation matted down, permanent waterbars stable.

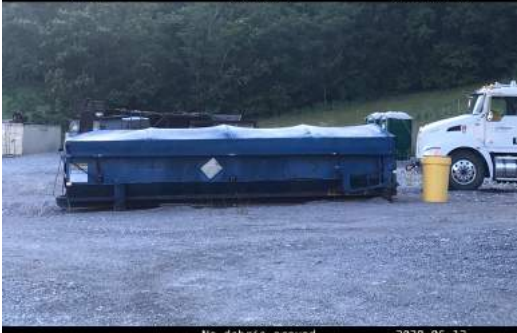
DIRECTION SW (M) +37.23563° -080.22668° ACCURACY 33 ft DATUM WGS84	
MVP-PY-006_061220 No debris around hazardous waste ... 2020-06-12 07:23:17-04:00				MVP-PY-006_061220 No loose trash around dumpsters 2020-06-12 07:25:30-04:00	
GPS Location	MVP-PY-006 See photo for gps data		GPS Location	MVP-PY-006 See photo for gps data	
Field Station#	+0		Field Station#	+0	
Pic 7 Desc.	No debris around hazardous waste dumpsters. Looking SE.		Pic 8 Desc.	No loose trash around dumpsters. Looking SW.	
DIRECTION NW (M) +37.23548° -080.22651° ACCURACY 33 ft DATUM WGS84

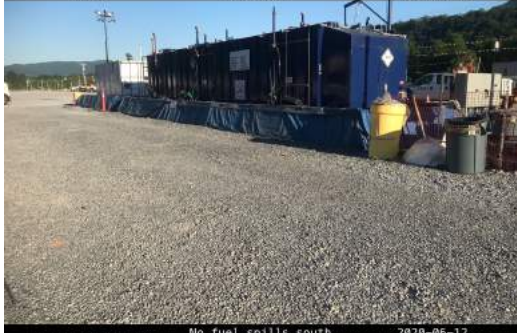
DIRECTION SW (M) +37.23560° -080.22685° ACCURACY 33 ft DATUM WGS84	
MVP-PY-006_061220 No fuel spills south of tanks 2020-06-12 07:27:58-04:00				MVP-PY-006_061220 No leaky internal fittings 2020-06-12 07:28:36-04:00

GPS Location	MVP-PY-006 See photo for gps data		GPS Location	MVP-PY-006 See photo for gps data	
Field Station#	+0		Field Station#	+0	
Pic 9 Desc.	No fuel spills south of bulk fuel tanks. Looking NW.		Pic 10 Desc.	Blue bulk fuel tanks no leaky internal fittings. Looking SW.	
DIRECTION S (M) +37.23568° -080.22674° ACCURACY 16 ft DATUM WGS84

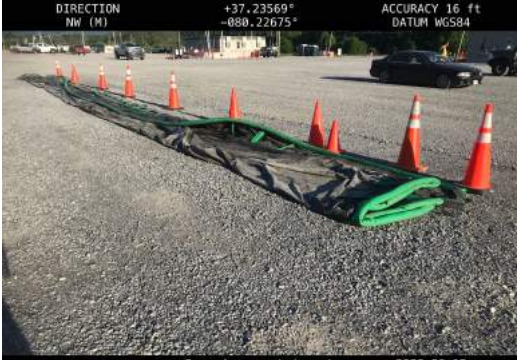
<p>DIRECTION NW (M) +37.23569° -080.22675° ACCURACY 16 ft DATUM WGS84</p> <p>MVP-PY-006_061220 Secondary containment on site for tankers 2020-06-12 07:30:31-04:00</p>

<p>DIRECTION S (M) +37.23562° -080.22683° ACCURACY 16 ft DATUM WGS84</p> <p>MVP-PY-006_061220 No leaky fittings or nozzles 2020-06-12 07:31:11-04:00</p>			
GPS Location	MVP-PY-006 See photo for gps data		GPS Location	MVP-PY-006 See photo for gps data	
Field Station#	+0		Field Station#	+0	
Pic 13 Desc.	Secondary containment on site for tankers offloading fuel into blue bulk tanks. Looking NW.		Pic 14 Desc.	Blue Bulk Fuel tanks no leaky fittings or nozzles. Looking S.

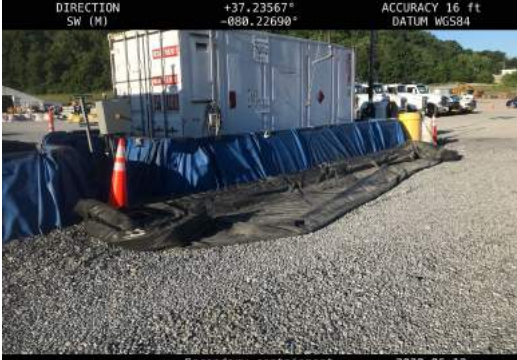
<p>DIRECTION SW (M) +37.23567° -080.22690° ACCURACY 16 ft DATUM WGS84</p> <p>MVP-PY-006_061220 Secondary containment on site for tankers 2020-06-12 07:31:19-04:00</p>

GPS Location	MVP-PY-006 See photo for gps data		GPS Location	MVP-PY-006 See photo for gps data	
Field Station#	+0		Field Station#	+0	
Pic 15 Desc.	Secondary containment on site for tankers offloading fuel into off road fuel unit. Looking SW.		Pic 16 Desc.	Off Road Fuel unit no leaky internal fittings. Looking NE.

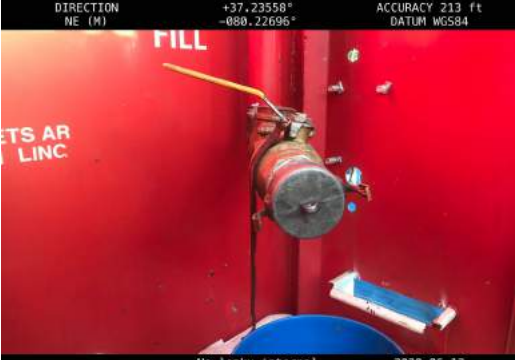
<p>DIRECTION NE (M) +37.23558° -080.22696° ACCURACY 213 ft DATUM WGS84</p> <p>MVP-PY-006_061220 No leaky internal fittings 2020-06-12 07:32:05-04:00</p>

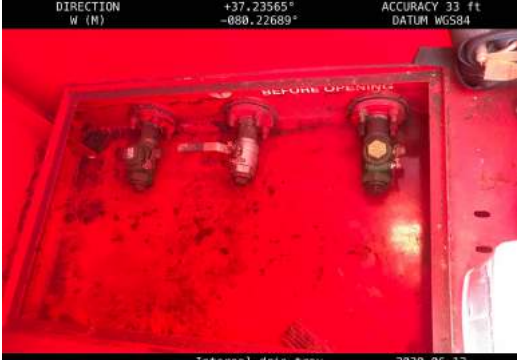
<p>DIRECTION W (M) +37.23565° -080.22689° ACCURACY 33 ft DATUM WGS84</p> <p>MVP-PY-006_061220 Internal drip tray empty 2020-06-12 07:32:13-04:00</p>

<p>DIRECTION N (M) +37.23541° -080.22611° ACCURACY 16 ft DATUM WGS84</p> <p>MVP-PY-006_061220 Condition of CFS along East LOD 2020-06-12 07:42:23-04:00</p>			
GPS Location	MVP-PY-006 See photo for gps data		GPS Location	MVP-PY-006 See photo for gps data	
Field Station#	+0		Field Station#	+0	
Pic 17 Desc.	Off Road Fuel unit internal drip pan empty. Looking W.		Pic 18 Desc.	Condition of compost filter sock along the East LOD. Grass and weeds over growing sock. Looking N.

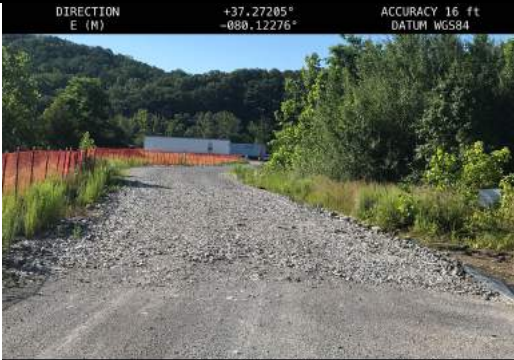
GPS Location	MVP-LY-049 See photo for gps data	GPS Location	MVP-LY-049 See photo for gps data		
Field Station#	+0	Field Station#	+0		
Pic 1 Desc.	Condition of rock entrance on center drive. No sediment on the stone. Looking S.	Pic 2 Desc.	Condition of containment under stored equipment. Looking SW.

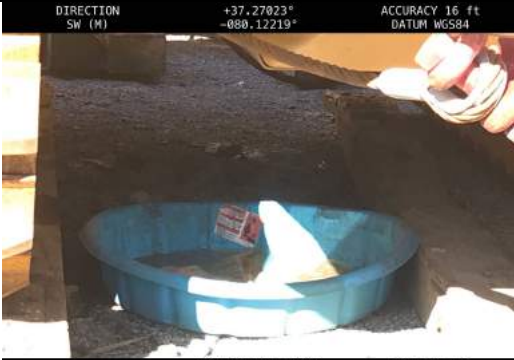
GPS Location	MVP-LY-049 See photo for gps data	GPS Location	MVP-LY-049 See photo for gps data		
Field Station#	+0	Field Station#	+0		
Pic 3 Desc.	Condition of containment under stored equipment. Looking SW.	Pic 4 Desc.	Condition of containment under stored equipment. Looking SW.

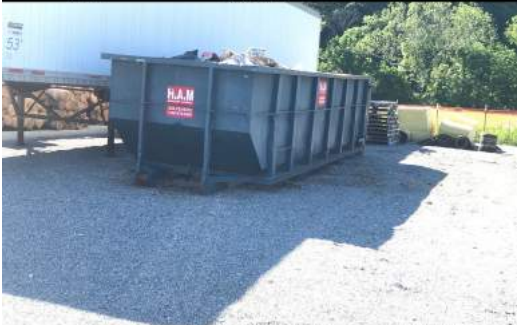
<div> MVP-LY-049_061220 No loose trash around south dumpster 2020-06-12 09:20:53-04:00 </div> </div>		<div> <div> DIRECTION W (M) +37.27110° -080.12158° ACCURACY 16 ft DATUM WGS84 </div>

<div> MVP-LY-049_061220 Condition of trays and containment 2020-06-12 09:21:43-04:00 </div> </div>			
GPS Location	MVP-LY-049 See photo for gps data		GPS Location	MVP-LY-049 See photo for gps data	
Field Station#	+0		Field Station#	+0	
Pic 13 Desc.	No loose trash around south dumpster. Looking SE.		Pic 14 Desc.	Condition of trays and containment under toilets. Looking W.	
<div> <div> DIRECTION SE (M) +37.27122° -080.12034° ACCURACY 98 ft DATUM WGS84 </div>

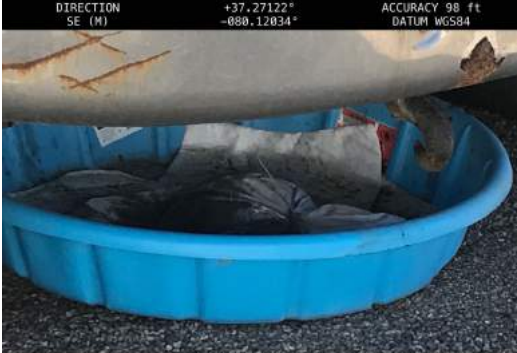
<div> MVP-LY-049_061220 Containment under stored vehicle 2020-06-12 09:23:12-04:00 </div> </div>		<div> <div> DIRECTION E (M) +37.27107° -080.12091° ACCURACY 16 ft DATUM WGS84 </div>

GPS Location	MVP-LY-049 See photo for gps data		GPS Location	MVP-LY-049 See photo for gps data	
Field Station#	+0		Field Station#	+0	
Pic 15 Desc.	Condition of containment under stored vehicle. Looking SE.		Pic 16 Desc.	Condition of containment under stored vehicle. Looking E.	
<div> <div> DIRECTION SE (M) +37.27089° -080.12127° ACCURACY 16 ft DATUM WGS84 </div>

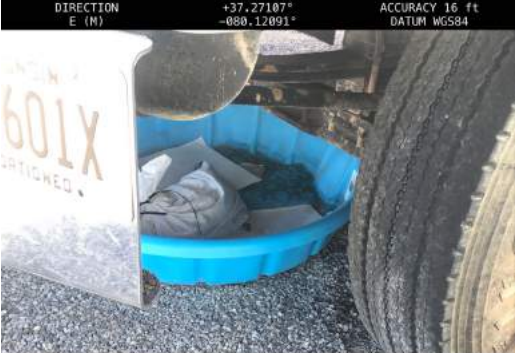
<div> MVP-LY-049_061220 Containment under stored vehicle 2020-06-12 09:26:11-04:00 </div> </div>

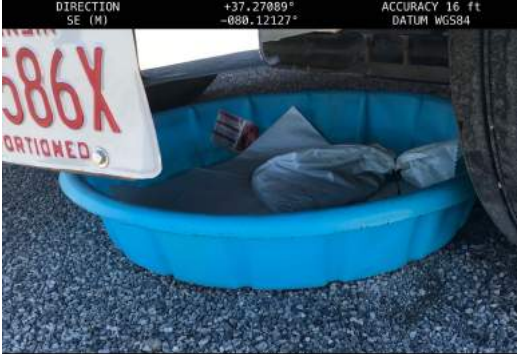
<div> MVP-LY-049_061220 Containment under stored vehicle 2020-06-12 09:27:20-04:00 </div> </div>		<div> <div> DIRECTION S (M) +37.27347° -080.11702° ACCURACY 0.80 mi DATUM WGS84 </div>

<div> MVP-LY-049_061220 Restoration supplies covered and protected 2020-06-12 09:29:13-04:00 </div> </div>			
GPS Location	MVP-LY-049 See photo for gps data		GPS Location	MVP-LY-049 See photo for gps data	
Field Station#	+0		Field Station#	+0	
Pic 17 Desc.	Condition of containment under stored vehicle. Looking SE.		Pic 18 Desc.	Restoration supplies covered and protected from the elements. Looking S.

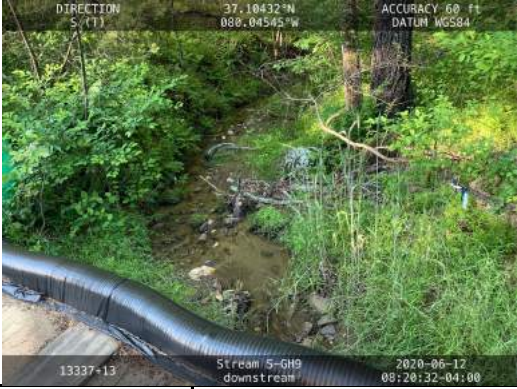
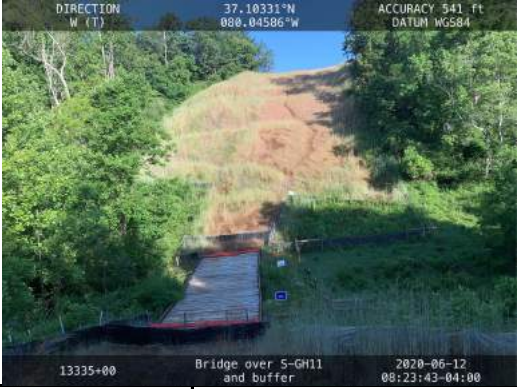
GPS Location	See photo for gps location data.		GPS Location	See photo for gps location data.	
Field Station#	13337+13		Field Station#	13335+00	
Pic 7 Desc.	Photo shows stream S-GH9 downstream from the ROW crossing.		Pic 8 Desc.	Photo shows the bridge over stream S-RR11 and buffer ECDs.

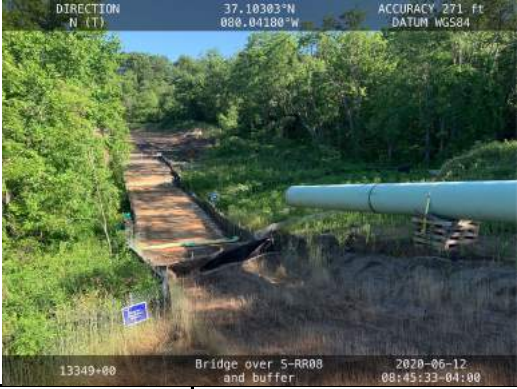
<p>DIRECTION N (T) 37.10303°N 080.04180°W ACCURACY 271 ft DATUM WGS84</p> <p>13349+00 Bridge over S-RR08 and buffer 2020-06-12 08:43:33-04:00</p>

<p>DIRECTION SW (T) 37.10338°N 080.04212°W ACCURACY 738 ft DATUM WGS84</p> <p>13348+00 Clean water outlet structure 2020-06-12 08:48:21-04:00</p>			
GPS Location	See photo for gps location data.		GPS Location	See photo for gps location data.	
Field Station#	13349+00		Field Station#	13348+00	
Pic 13 Desc.	Photo shows the bridge over stream S-RR08 and buffer ECDs.		Pic 14 Desc.	Photo shows the clean water outlet structure.

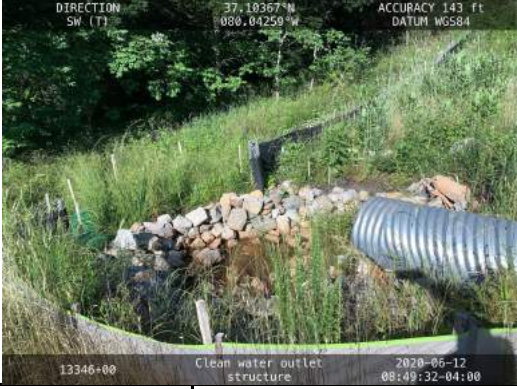
<p>DIRECTION SW (T) 37.10367°N 080.04250°W ACCURACY 143 ft DATUM WGS84</p> <p>13346+00 Clean water outlet structure 2020-06-12 08:49:32-04:00</p>

GPS Location	See photo for gps location data.		GPS Location	See photo for gps location data.	
Field Station#	13346+00		Field Station#	13319+00	
Pic 15 Desc.	Photo shows the clean water outlet structure.		Pic 16 Desc.	Photo shows the bridge over stream S-GH15 and buffer ECDs.

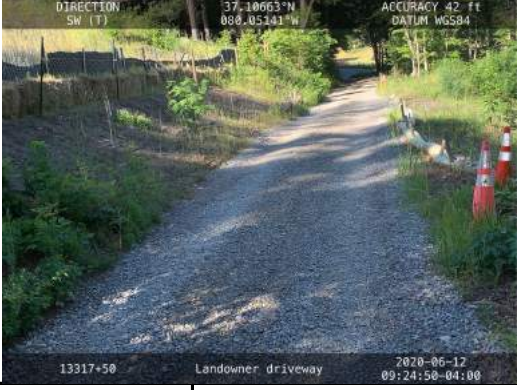
<p>DIRECTION SW (T) 37.10663°N 080.05341°W ACCURACY 42 ft DATUM WGS84</p> <p>13317+50 Landowner driveway 2020-06-12 09:24:50-04:00</p>

<p>DIRECTION SE (T) 37.10656°N 080.05191°W ACCURACY 45 ft DATUM WGS84</p> <p>13316+00 RCE on east side of Wades Gap 2020-06-12 09:26:36-04:00</p>			
GPS Location	See photo for gps location data.		GPS Location	See photo for gps location data.	
Field Station#	13317+50		Field Station#	13316+00	
Pic 17 Desc.	Photo shows the landowner driveway near Wades Gap Road.		Pic 18 Desc.	Photo shows the RCE on the east side of Wades Gap Road.

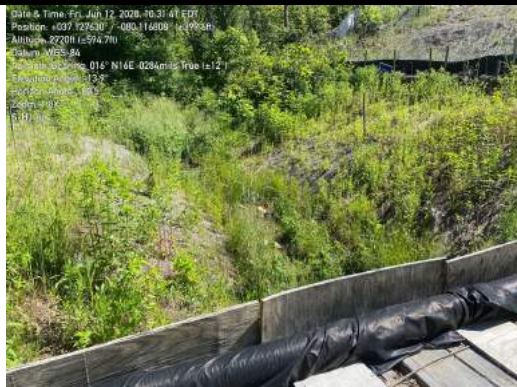
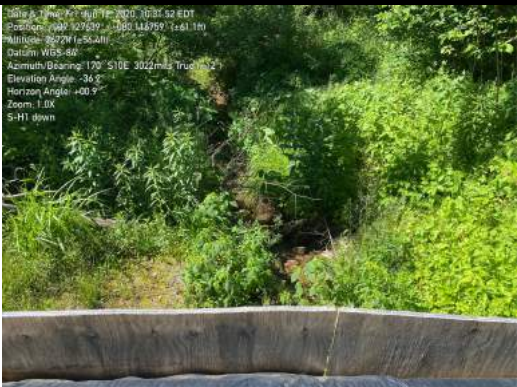
Pic 11 Desc.	S-H1, upstream, bridge in acceptable condition, stream banks stable.		Pic 12 Desc.	S-H1, downstream, no environmental issues noted at stream.

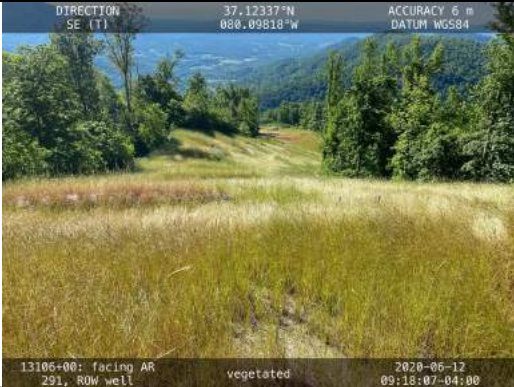
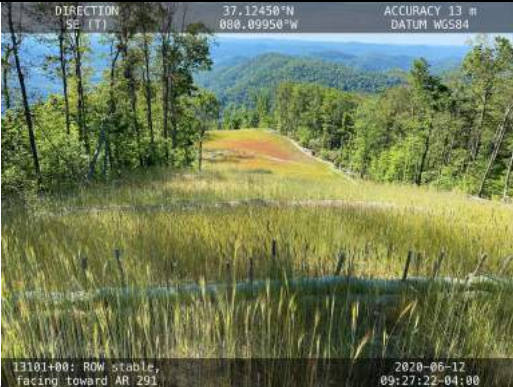
GPS Location	See photo		GPS Location	See photo	
Field Station#	13106+00		Field Station#	13101+00	
Pic 3 Desc.	Slope leading down to AR 291 very well vegetated and stable.		Pic 4 Desc.	ROW completely covered by vegetation, facing AR 291.

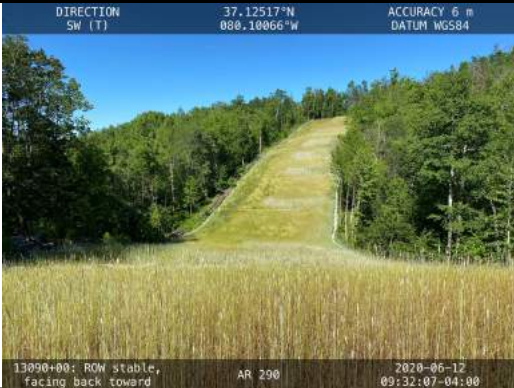
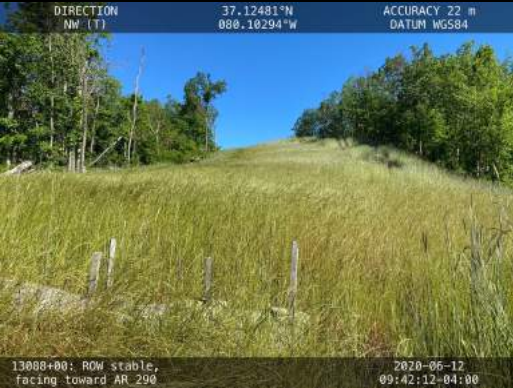
GPS Location	See photo		GPS Location	See photo	
Field Station#	13090+00		Field Station#	13080+00	
Pic 5 Desc.	Row 100% vegetated, no erosion issues.		Pic 6 Desc.	Permanent restoration completely stabilized.

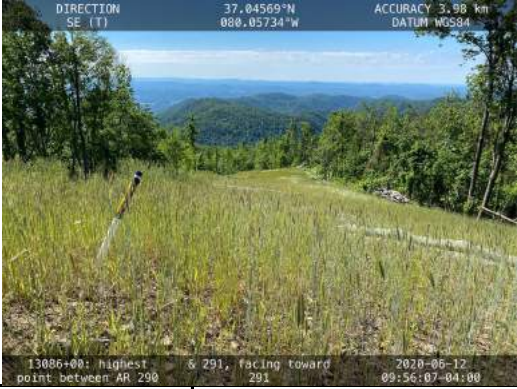
<p>DIRECTION SE (T) 37.04569°N 088.05734°W ACCURACY 3.98 m DATUM WGS84</p> <p>13086+00: highest point between AR 290 & 291, facing toward 291 2020-06-12 09:56:07-04:00</p>

<p>DIRECTION W (T) 37.12606°N 088.10415°W ACCURACY 5 m DATUM WGS84</p> <p>13085+00: ROW well vegetated and stable facing AR 290 2020-06-12 10:02:27-04:00</p>			
GPS Location	See photo		GPS Location	See photo	
Field Station#	13086+00		Field Station#	13085+00	
Pic 7 Desc.	Standing at the highest point between AR 290 and 291, facing toward 291. ROW stable.		Pic 8 Desc.	Facing towards AR 290, ROW stable.

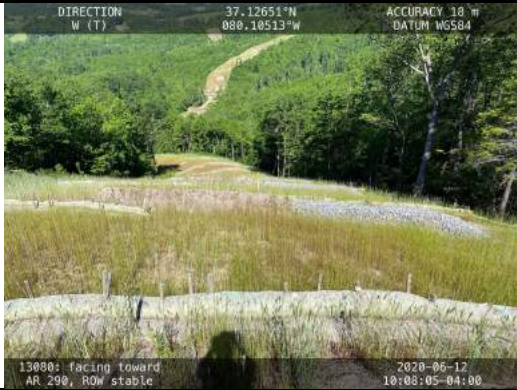
<p>DIRECTION W (T) 37.12651°N 088.10513°W ACCURACY 18 m DATUM WGS84</p> <p>13080: facing toward AR 290, ROW stable 2020-06-12 10:08:05-04:00</p>

GPS Location	See photo		GPS Location	See photo	
Field Station#	13080+00		Field Station#	13078+32	
Pic 9 Desc.	Facing AR 290, ROW stable.		Pic 10 Desc.	Facing AR 290, ROW stable.

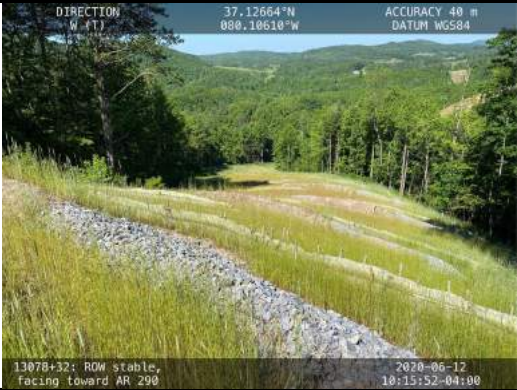
<p>DIRECTION W (T) 37.12664°N 088.10610°W ACCURACY 40 m DATUM WGS84</p> <p>13078+32: ROW stable, facing toward AR 290 2020-06-12 10:15:52-04:00</p>

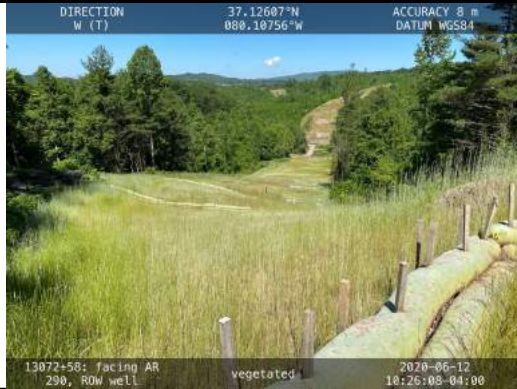
<p>DIRECTION W (T) 37.12607°N 088.10756°W ACCURACY 8 m DATUM WGS84</p> <p>13072+58: facing AR 290, ROW well vegetated 2020-06-12 10:26:08-04:00</p>
