Visual Site Inspection Report

Project Name	H-600 Pipeline Spread I	AFE	124300139	Spread	H-600 Pipeline Spread I
Contractor	Precision			Report #	12082
Inspector	Logan Box			Date/Time	6/24/2020 5:23 PM
Permit #	TBD	Inspection Type	VA SWPP	Station Begin	13670+00
State	VA	Inspection Area	Partial	Station End	13784+35
County	Franklin	Ground	Wet	Temperature (°F)	85.00
Municipality	N/A	Weather	Sunny	Rain Gauge (in)	4.20
				Rain Accumulation Time (days)	6.00

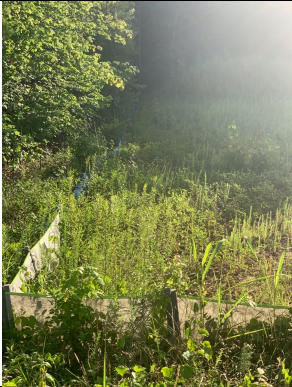
GPS Location	O		GPS Location	O	
Field Station#	15+00		Field Station#	14+50	
Pic 1 Desc.	Observing temporary vegetation and sensitive resource signage.		Pic 2 Desc.	Observing temporary vegetation and ECD's performing as they should.

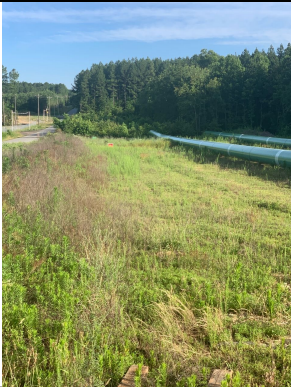
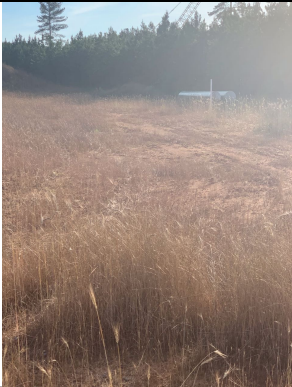
GPS Location	O		GPS Location	O	
Field Station#	21+00		Field Station#	4+00	
Pic 3 Desc.	Observing temporary vegetation.		Pic 4 Desc.	Observing temporary vegetation.	
Insert image here			Insert image here		
GPS Location			GPS Location		
Field Station#			Field Station#		
Pic 5 Desc.			Pic 6 Desc.

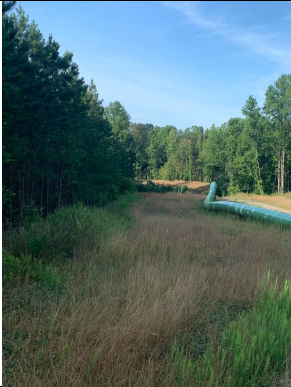
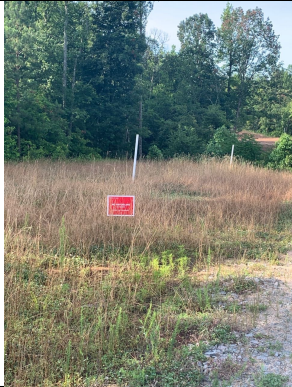
GPS Location	O	GPS Location	O		
Field Station#	7+00	Field Station#	11+50		
Pic 1 Desc.	Observing temporary vegetation.	Pic 2 Desc.	Observing sensitive resource signage.

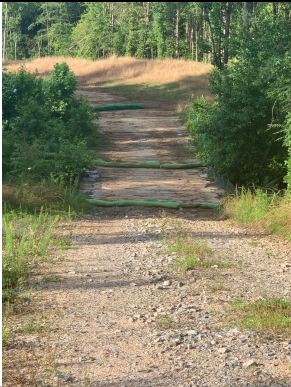
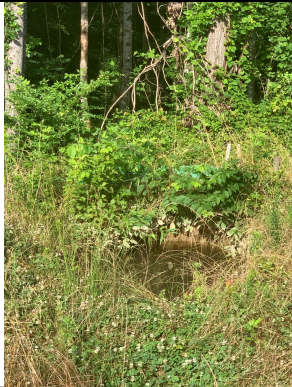
GPS Location	O	GPS Location	O		
Field Station#	12+65	Field Station#	12+00		
Pic 3 Desc.	Observing equipment crossing and ECD's performing as they should.	Pic 4 Desc.	Observing sump and end treatment.		
Insert image here			Insert image here		
GPS Location		GPS Location			
Field Station#		Field Station#			
Pic 5 Desc.		Pic 6 Desc.

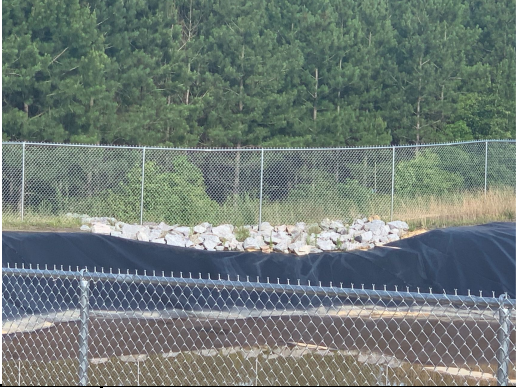
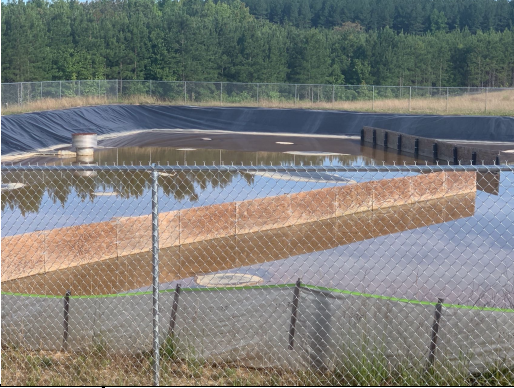
GPS Location	O	GPS Location	O		
Field Station#	00+00	Field Station#	00+00		
Pic 1 Desc.	Observing emergency overflow at the Transco storm water pond.	Pic 2 Desc.	Observing storm water pond at Transco.

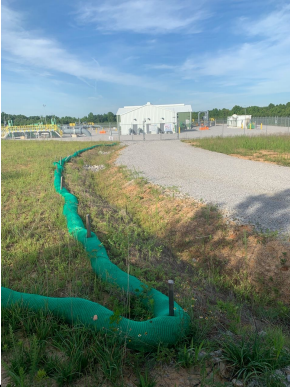
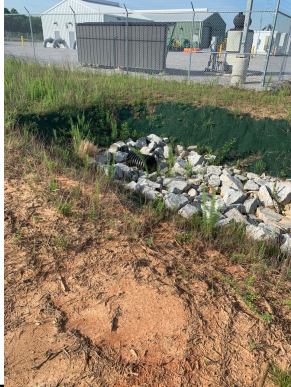
GPS Location	O	GPS Location	O		
Field Station#	00+00	Field Station#	00+00		
Pic 3 Desc.	Observing ECD's performing as they should.	Pic 4 Desc.	Observing outlet and outlet protection.		
Insert image here			Insert image here		
GPS Location		GPS Location			
Field Station#		Field Station#			
Pic 5 Desc.		Pic 6 Desc.

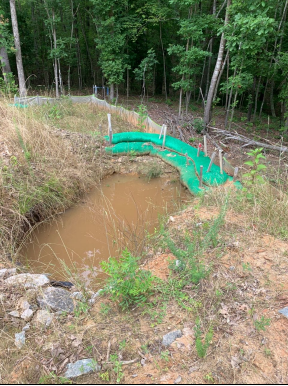
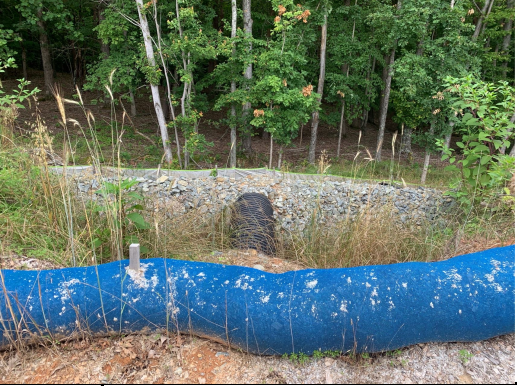
GPS Location	O	GPS Location	O		
Field Station#	15793+00	Field Station#	15790+00		
Pic 1 Desc.	Observing sump and end treatment performing as they should.	Pic 2 Desc.	Observing CWD outlet performing as it should.

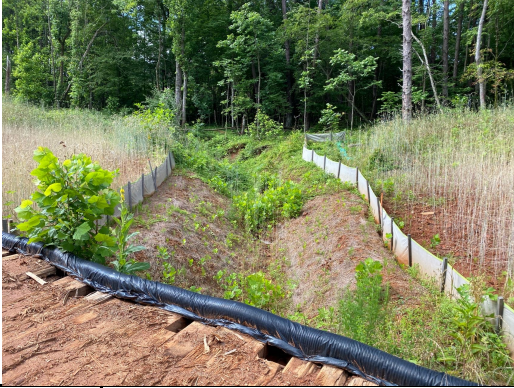
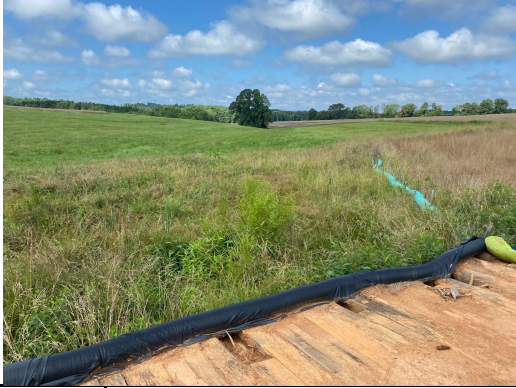
GPS Location	0	GPS Location	0		
Field Station#	15393+63	Field Station#	15476+00		
Pic 1 Desc.	Natural drainage feature.	Pic 2 Desc.	Natural drainage feature.
