Visual Site Inspection Report

Project Name	H-600 Pipeline Spread I	AFE	124300139	Spread	H-600 Pipeline Spread I
Contractor	Precision			Report #	12288
Inspector	Justin Burch			Date/Time	6/30/2020 7:53 AM
Permit #	TBD	Inspection Type	VA SWPP	Station Begin	14171+36
State	VA	Inspection Area	Full	Station End	14546+75
County	Franklin	Ground	Damp	Temperature (°F)	84.00
Municipality	N/A	Weather	Sunny	Rain Gauge (in)	0.00
				Rain Accumulation Time (days)	6.00

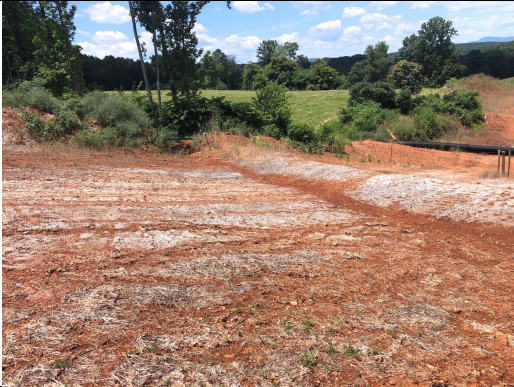
GPS Location	0	GPS Location	0		
Field Station#	14522+00	Field Station#	14248+66		
Pic 1 Desc.	Waterbar in acceptable condition	Pic 2 Desc.	Super silt fence in acceptable condition
