Visual Site Inspection Report

Project Name	H-600 Pipeline Spread I	AFE	124300139	Spread	H-600 Pipeline Spread I
Contractor	Precision			Report #	13213
Inspector	Glenn Mike Renfro			Date/Time	8/3/2020 9:24 AM
Permit #	TBD	Inspection Type	VA SWPP	Station Begin	0000+00
State	VA	Inspection Area	Full	Station End	0000+00
County	Franklin	Ground	Wet	Temperature (°F)	73.00
Municipality	N/A	Weather	Light Rain	Rain Gauge (in)	0.80
				Rain Accumulation Time (days)	0.80

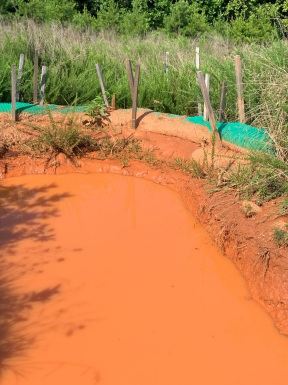
GPS Location	O	GPS Location	O		
Field Station#	15725+00	Field Station#	15734+45		
Pic 3 Desc.	Observing end treatment that requires maintenance.	Pic 4 Desc.	Observing safety fence that requires maintenance.

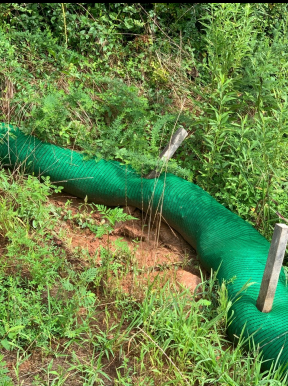
<p style="text-align: center;">Insert image here</p>			
GPS Location	O	GPS Location			
Field Station#	15944+00	Field Station#			
Pic 5 Desc.	Observing CFS that requires maintenance.	Pic 6 Desc.

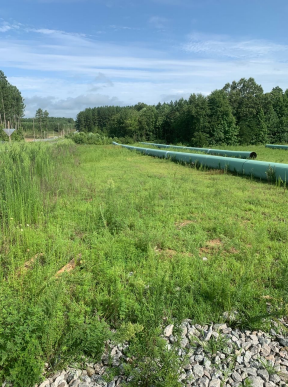
GPS Location	O	GPS Location	O		
Field Station#	21+00	Field Station#	13+00		
Pic 3 Desc.	Observing temporary vegetation.	Pic 4 Desc.	Observing ECD's performing as they should.		
Insert image here			Insert image here		
GPS Location		GPS Location			
Field Station#		Field Station#			
Pic 5 Desc.		Pic 6 Desc.

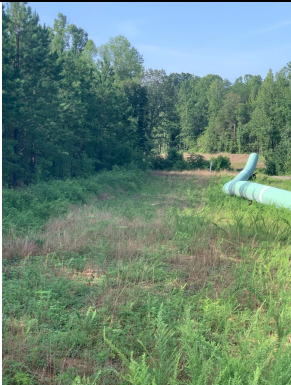
GPS Location	O	GPS Location	O		
Field Station#	10+00	Field Station#	7+00		
Pic 3 Desc.	Observing temporary vegetation.	Pic 4 Desc.	Observing temporary vegetation.		
Insert image here			Insert image here		
GPS Location		GPS Location			
Field Station#		Field Station#			
Pic 5 Desc.		Pic 6 Desc.

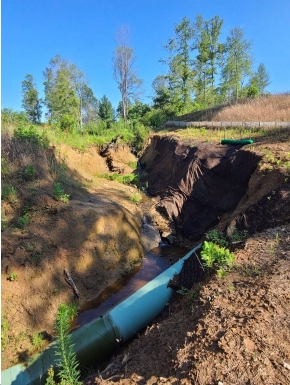
GPS Location	0	GPS Location	0		
Field Station#	14000+00	Field Station#	14072+75		
Pic 3 Desc.	Approximately 14000+00. Overview of adjacent pond overflow entering the ROW.		Pic 4 Desc.	Approximately 14072+75. Overview of stream crossing, equipment bridge and ECDs at stream S-KL61.

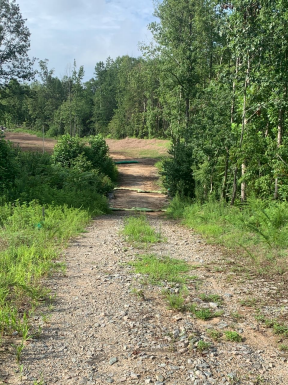
GPS Location	O		GPS Location	O	
Field Station#	12+65		Field Station#	9+00	
Pic 3 Desc.	Observing equipment crossing and ECD's performing as they should.		Pic 4 Desc.	Observing temporary vegetation.	
Insert image here			Insert image here		
GPS Location			GPS Location		
Field Station#			Field Station#		
Pic 5 Desc.			Pic 6 Desc.

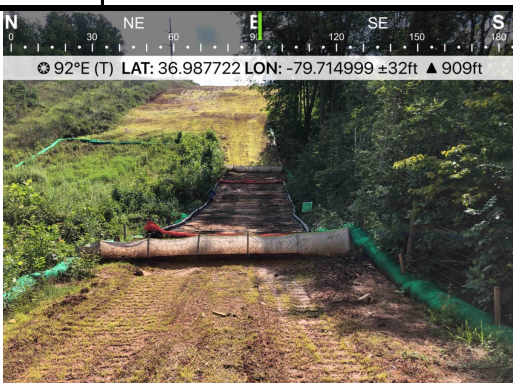
<p>181°S (T) LAT: 36.987821 LON: -79.717036 ±98ft ▲ 970ft</p>			
GPS Location	0	GPS Location	0		
Field Station#	14673+10	Field Station#	14675+00		
Pic 3 Desc.	Equipment bridge clean at stream S-H37		Pic 4 Desc.	Sump pit functioning as intended after rain events

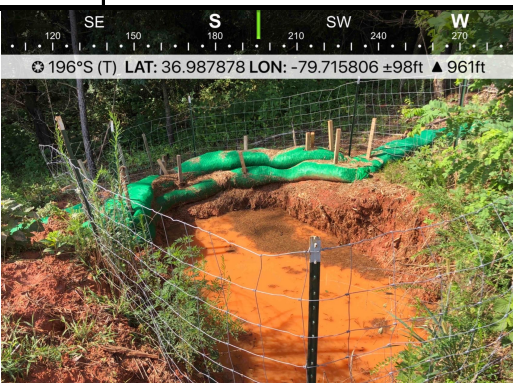
Pic 5 Desc.	Equipment bridge clean at stream S-H36		Pic 6 Desc.	Sump pit functioning as intended after rain events

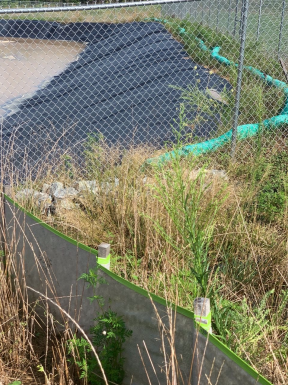
GPS Location	O	GPS Location	O		
Field Station#	00+00	Field Station#	00+00		
Pic 3 Desc.	Observing ECD's performing as they should.	Pic 4 Desc.	Observing storm water pond.		
Insert image here			Insert image here		
GPS Location		GPS Location			
Field Station#		Field Station#			
Pic 5 Desc.		Pic 6 Desc.

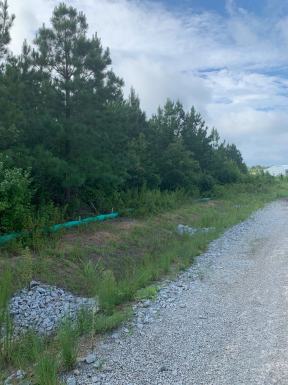
GPS Location	O		GPS Location	O	
Field Station#	00+00		Field Station#	00+00	
Pic 3 Desc.	Observing rock check dams.		Pic 4 Desc.	Observing storm water pond and ECD's performing as they should.	
Insert image here			Insert image here		
GPS Location			GPS Location		
Field Station#			Field Station#		
Pic 5 Desc.			Pic 6 Desc.
