# Visual Site Inspection Report

<b>Project Name</b>	H-600 Pipeline Spread G	<b>AFE</b>	124300137	<b>Spread</b>	H-600 Pipeline Spread G
<b>Contractor</b>	Precision			<b>Report #</b>	15492
<b>Inspector</b>	Len Kruizenga			<b>Date/Time</b>	10/12/2020 1:20 PM
<b>Permit #</b>	TBD	<b>Inspection Type</b>	VA SWPP	<b>Station Begin</b>	12005+00
<b>State</b>	VA	<b>Inspection Area</b>	Full	<b>Station End</b>	12005+00
<b>County</b>	Giles	<b>Ground</b>	Wet	<b>Temperature (°F)</b>	60.00
<b>Municipality</b>	N/A	<b>Weather</b>	Cloudy	<b>Rain Gauge (in)</b>	1.40
				<b>Rain Accumulation Time (days)</b>	2.00

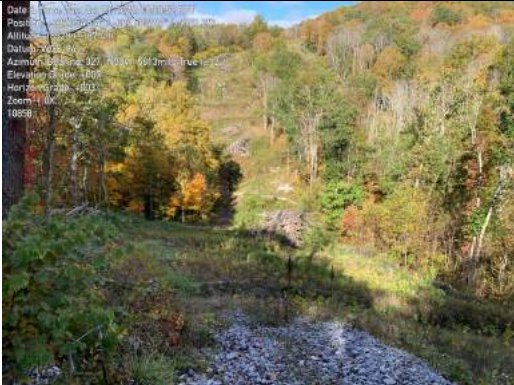
<b>GPS Location</b>	See picture above for GPS coordinates		<b>GPS Location</b>	See picture above for GPS coordinates	
<b>Field Station#</b>	10858+00		<b>Field Station#</b>	10864+00	
<b>Pic 1 Desc.</b>	ECD's and row conditions		<b>Pic 2 Desc.</b>	ECD's and row conditions

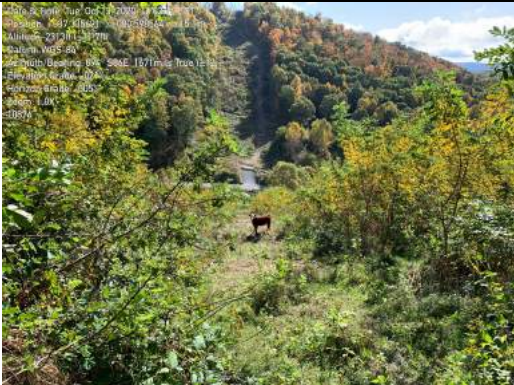
<b>GPS Location</b>	See picture above for GPS coordinates		<b>GPS Location</b>	See picture above for GPS coordinates	
<b>Field Station#</b>	10876+00		<b>Field Station#</b>	10888+00	
<b>Pic 3 Desc.</b>	ECD's and row conditions		<b>Pic 4 Desc.</b>	ECD's and row conditions

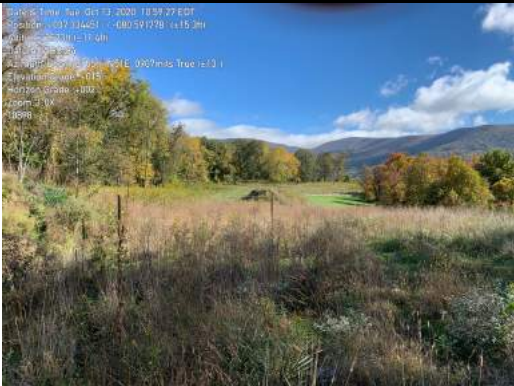
<b>GPS Location</b>	See picture above for GPS coordinates		<b>GPS Location</b>	See picture above for GPS coordinates	
<b>Field Station#</b>	10898+00		<b>Field Station#</b>	10922+00	
<b>Pic 5 Desc.</b>	ECD's and row conditions		<b>Pic 6 Desc.</b>	ECD's and row conditions

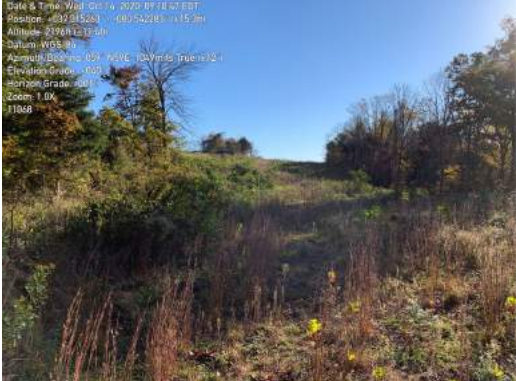
<b>GPS Location</b>	See picture above for GPS coordinates		<b>GPS Location</b>	See picture above for GPS coordinates	
<b>Field Station#</b>	11068+00		<b>Field Station#</b>	11072+00	
<b>Pic 1 Desc.</b>	ECD's and row conditions		<b>Pic 2 Desc.</b>	ECD's and row conditions

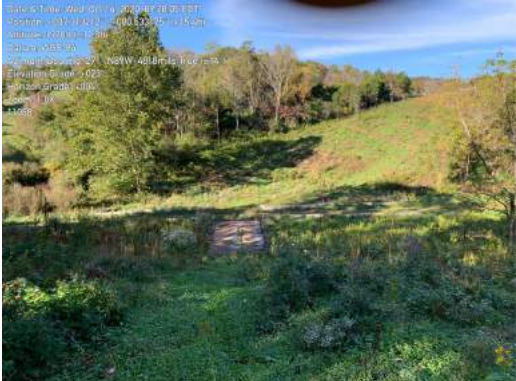
<b>GPS Location</b>	See picture above for GPS coordinates		<b>GPS Location</b>	See picture above for GPS coordinates	
<b>Field Station#</b>	11088+00		<b>Field Station#</b>	11110+00	
<b>Pic 3 Desc.</b>	ECD's and row conditions		<b>Pic 4 Desc.</b>	ECD's and row conditions

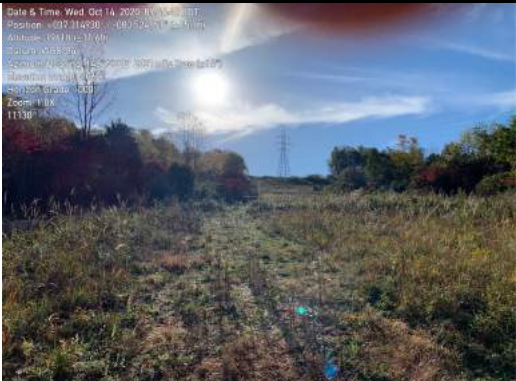
<b>GPS Location</b>	See picture above for GPS coordinates		<b>GPS Location</b>	See picture above for GPS coordinates	
<b>Field Station#</b>	11130+00		<b>Field Station#</b>	11140+00	
<b>Pic 5 Desc.</b>	ECD's and row conditions		<b>Pic 6 Desc.</b>	ECD's and row conditions

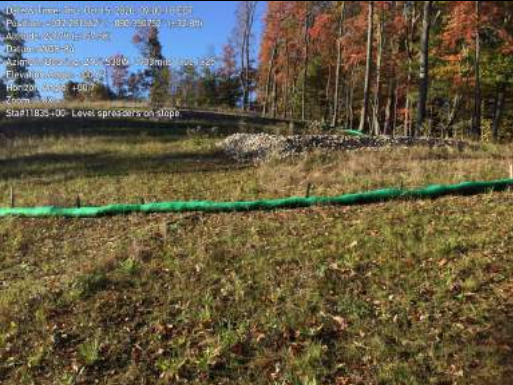
<b>GPS Location</b>	See photo GPS	<b>GPS Location</b>	See photo GPS		
<b>Field Station#</b>	11817+00	<b>Field Station#</b>	11835+00		
<b>Pic 1 Desc.</b>	P1 silt fence damaged, contractor notified, item added to the punch list.	<b>Pic 2 Desc.</b>	Level spreaders on slope.

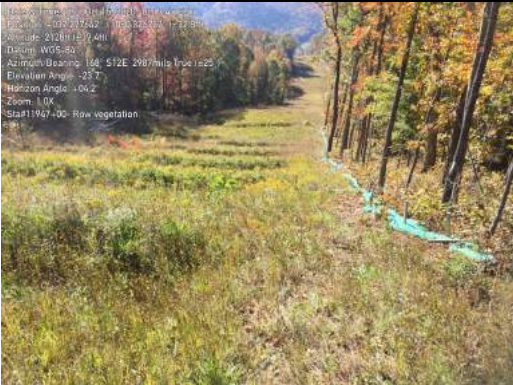
<b>GPS Location</b>	See photo GPS	<b>GPS Location</b>	See photo GPS		
<b>Field Station#</b>	11905+50	<b>Field Station#</b>	11947+00		
<b>Pic 3 Desc.</b>	P1 silt fence damaged by bear. Contractor notified and item added to the punch list.	<b>Pic 4 Desc.</b>	Row vegetation & perimeter controls.

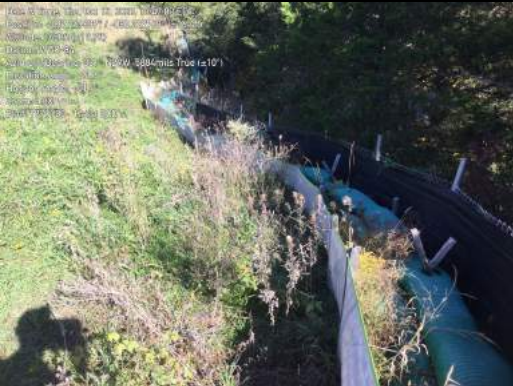
<b>GPS Location</b>	See photo GPS	<b>GPS Location</b>	See photo GPS		
<b>Field Station#</b>	11967+00	<b>Field Station#</b>	11979+00		
<b>Pic 5 Desc.</b>	P1 perimeter controls damaged by bear. Contractor notified and item added to the punch list.	<b>Pic 6 Desc.</b>	Karst ECD's.

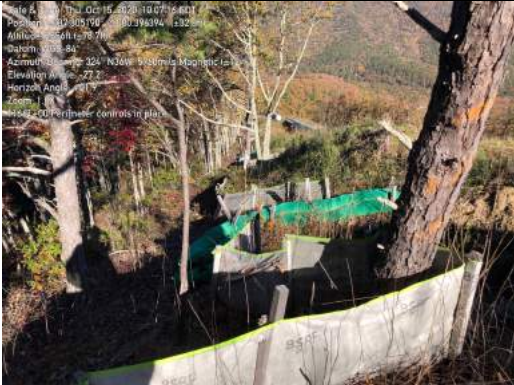
<b>GPS Location</b>		On photo		<b>GPS Location</b>	
<b>Field Station#</b>		11661+00		<b>Field Station#</b>	
<b>Pic 1 Desc.</b>		Perimeter controls are in place		<b>Pic 2 Desc.</b>

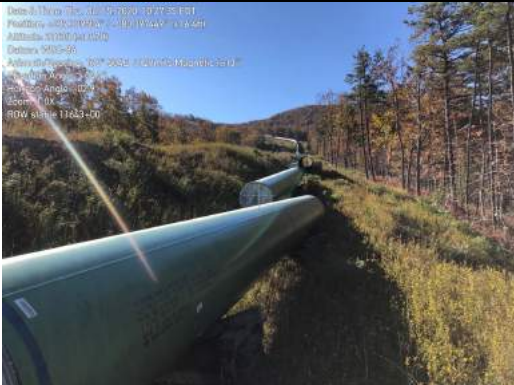
<b>GPS Location</b>		On photo		<b>GPS Location</b>	
<b>Field Station#</b>		11643+00		<b>Field Station#</b>	
<b>Pic 3 Desc.</b>		ROW stable with perimeter controls in place		<b>Pic 4 Desc.</b>

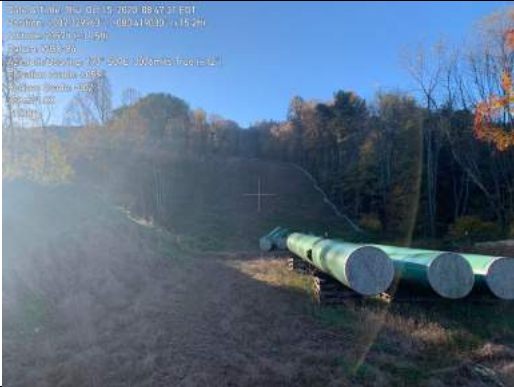
<b>GPS Location</b>	See picture above for GPS coordinates		<b>GPS Location</b>	See picture above for GPS coordinates	
<b>Field Station#</b>	11530+00		<b>Field Station#</b>	11550+00	
<b>Pic 1 Desc.</b>	ECD's and row conditions		<b>Pic 2 Desc.</b>	Damaged P1

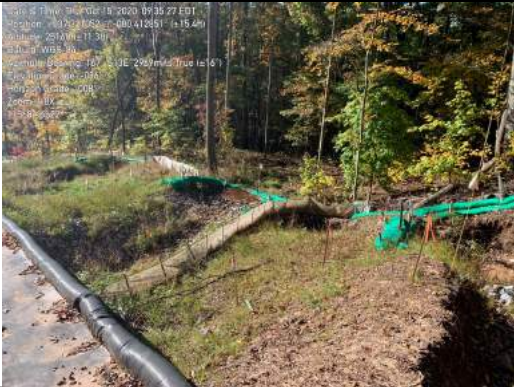
<b>GPS Location</b>	See picture above for GPS coordinates		<b>GPS Location</b>	See picture above for GPS coordinates	
<b>Field Station#</b>	11568+00		<b>Field Station#</b>	11578+00	
<b>Pic 3 Desc.</b>	ECD's and row conditions		<b>Pic 4 Desc.</b>	ECD's and row conditions

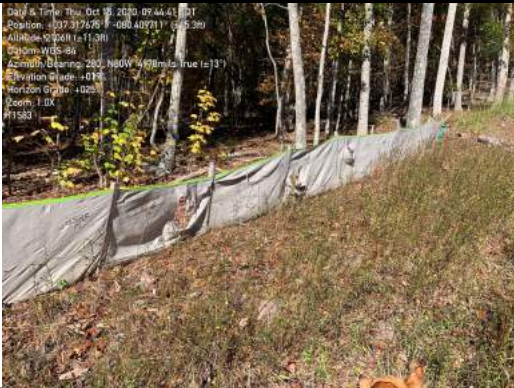
<b>GPS Location</b>	See picture above for GPS coordinates		<b>GPS Location</b>	See picture above for GPS coordinates	
<b>Field Station#</b>	11583+00		<b>Field Station#</b>	11587+00	
<b>Pic 5 Desc.</b>	ECD's and row conditions		<b>Pic 6 Desc.</b>	ECD's and row conditions

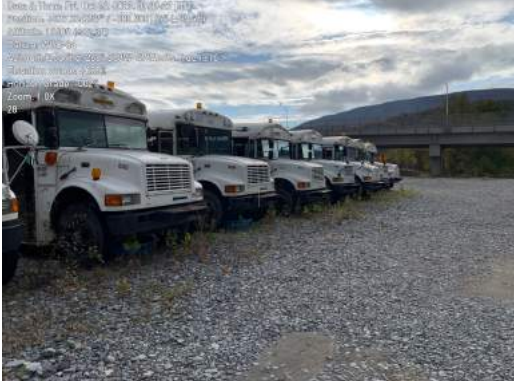
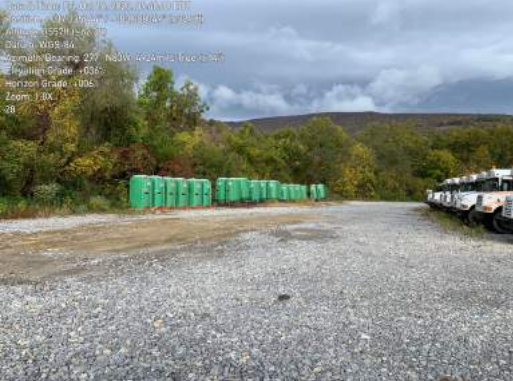
<b>GPS Location</b>	See picture above for GPS coordinates		<b>GPS Location</b>	See picture above for GPS coordinates	
<b>Field Station#</b>	12005+00		<b>Field Station#</b>	12005+00	
<b>Pic 1 Desc.</b>	ECD's and row conditions		<b>Pic 2 Desc.</b>	ECD's and row conditions

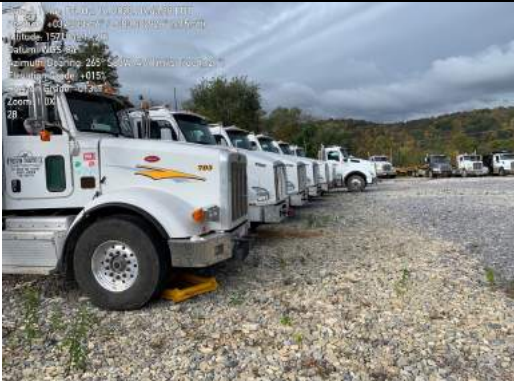
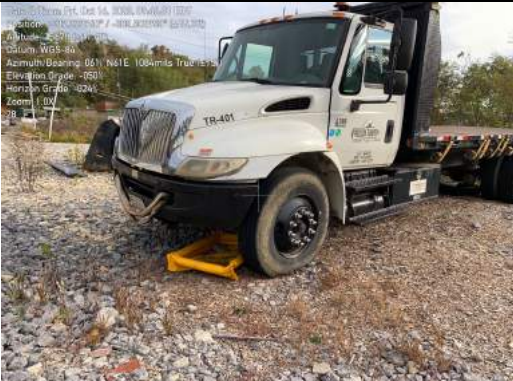
<b>GPS Location</b>	See picture above for GPS coordinates		<b>GPS Location</b>	See picture above for GPS coordinates	
<b>Field Station#</b>	12005+00		<b>Field Station#</b>	12005+00	
<b>Pic 3 Desc.</b>	ECD's and row conditions		<b>Pic 4 Desc.</b>	ECD's and row conditions

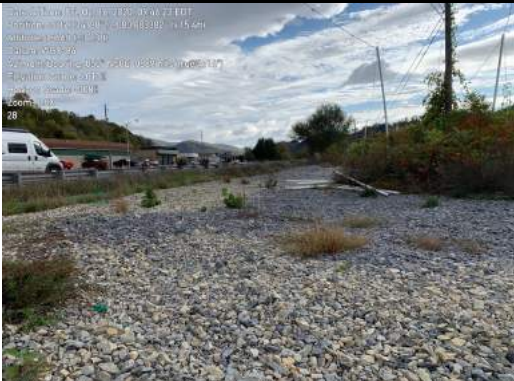
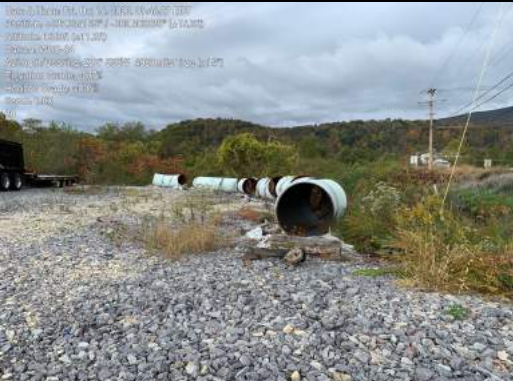
<b>GPS Location</b>	See picture above for GPS coordinates		<b>GPS Location</b>	See picture above for GPS coordinates	
<b>Field Station#</b>	12005+00		<b>Field Station#</b>	12005+00	
<b>Pic 5 Desc.</b>	ECD's and row conditions		<b>Pic 6 Desc.</b>	ECD's and row conditions
