# Visual Site Inspection Report

<b>Project Name</b>	H-600 Pipeline Spread G	<b>AFE</b>	124300137	<b>Spread</b>	H-600 Pipeline Spread G
<b>Contractor</b>	Precision			<b>Report #</b>	16918
<b>Inspector</b>	Len Kruizenga			<b>Date/Time</b>	11/16/2020 8:29 AM
<b>Permit #</b>	TBD	<b>Inspection Type</b>	VA SWPP	<b>Station Begin</b>	10930+00
<b>State</b>	VA	<b>Inspection Area</b>	Full	<b>Station End</b>	11064+53
<b>County</b>	Giles	<b>Ground</b>	Damp	<b>Temperature (°F)</b>	39.00
<b>Municipality</b>	N/A	<b>Weather</b>	Sunny	<b>Rain Gauge (in)</b>	0.00
				<b>Rain Accumulation Time (days)</b>	1.00

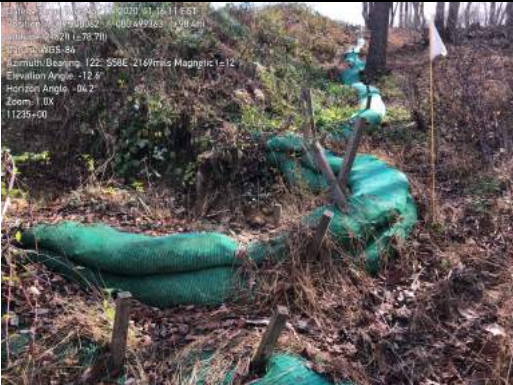
<b>GPS Location</b>	On photo	<b>GPS Location</b>	On photo		
<b>Field Station#</b>	11233+00	<b>Field Station#</b>	11235+00		
<b>Pic 3 Desc.</b>	End treatments and perimeter controls are in place and in acceptable condition.	<b>Pic 4 Desc.</b>	End treatments and perimeter controls are in place and in acceptable condition.

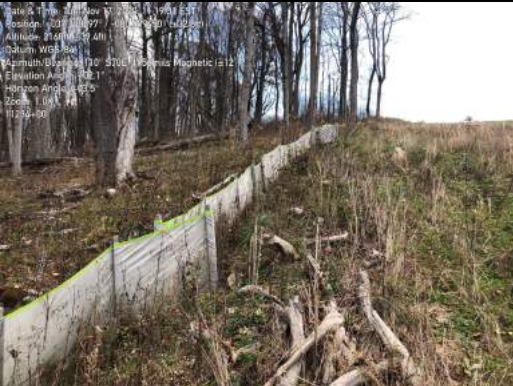
<b>GPS Location</b>	On photo	<b>GPS Location</b>	On photo		
<b>Field Station#</b>	11236+00	<b>Field Station#</b>	11234+00		
<b>Pic 5 Desc.</b>	Perimeter controls are in place and in acceptable condition.	<b>Pic 6 Desc.</b>	Perimeter controls are in place and functional.

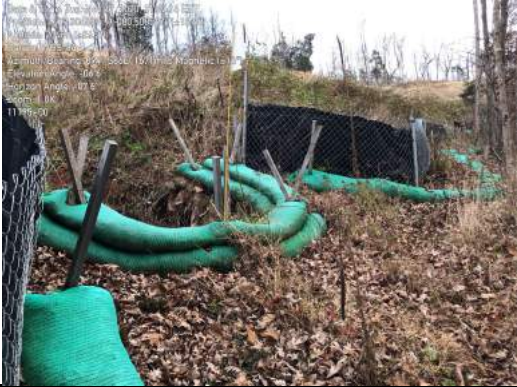
<b>GPS Location</b>	On photo	<b>GPS Location</b>	On photo		
<b>Field Station#</b>	11195+00	<b>Field Station#</b>	11191+00		
<b>Pic 7 Desc.</b>	Perimeter controls are in place and in acceptable condition.	<b>Pic 8 Desc.</b>	Perimeter controls are in place and in acceptable condition.

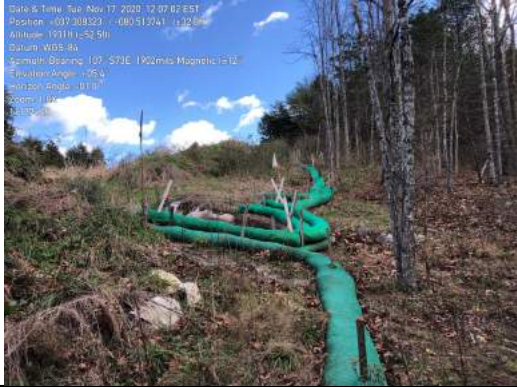
<p style="text-align: center;">Insert image here</p>			
<b>GPS Location</b>	On photo	<b>GPS Location</b>			
<b>Field Station#</b>	11177+25	<b>Field Station#</b>			
<b>Pic 9 Desc.</b>	Perimeter controls and end treatments are effective.	<b>Pic 10 Desc.</b>			
<p style="text-align: center;">Insert image here</p>		<p style="text-align: center;">Insert image here</p>			
<b>GPS Location</b>		<b>GPS Location</b>			
<b>Field Station#</b>		<b>Field Station#</b>			
<b>Pic 11 Desc.</b>		<b>Pic 12 Desc.</b>

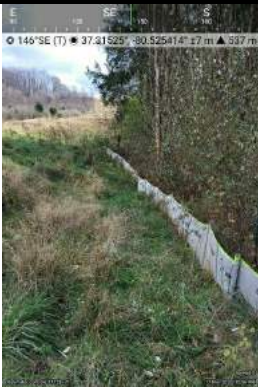
<b>GPS Location</b>	See Photo		<b>GPS Location</b>	See photo	
<b>Field Station#</b>	11128+00		<b>Field Station#</b>	11149+50	
<b>Pic 3 Desc.</b>	Installed Perimeter controls		<b>Pic 4 Desc.</b>	ssf in need of repair

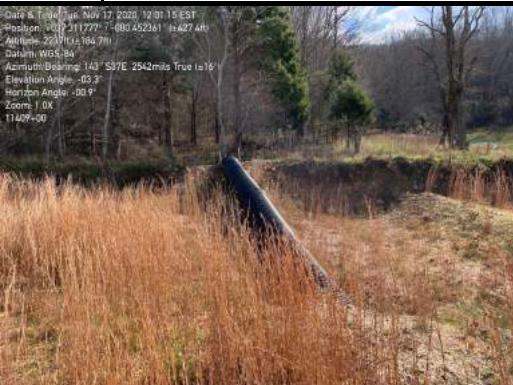
<b>GPS Location</b>	See photo for GPS location.	<b>GPS Location</b>	See photo for GPS location.
<b>Field Station#</b>	11427+00	<b>Field Station#</b>	11409+00
<b>Pic 5 Desc.</b>	ROW stabilized with seed and mulch. Minor vegetation growth present.	<b>Pic 6 Desc.</b>	Clean water diversion pipe and clean water diversion berm in place.

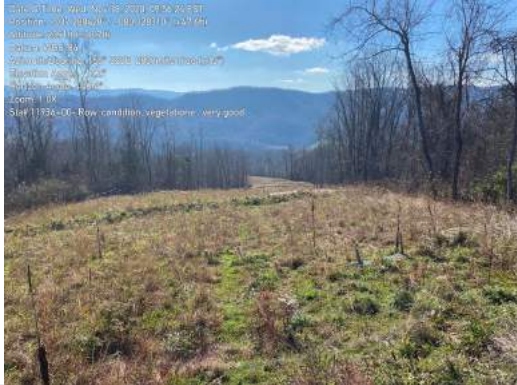
<b>GPS Location</b>	See photo GPS	<b>GPS Location</b>	See photo GPS		
<b>Field Station#</b>	11936+00	<b>Field Station#</b>	11986+00		
<b>Pic 9 Desc.</b>	Row condition, row vegetation is very good.	<b>Pic 10 Desc.</b>	Slope ECD's and drainage feature.		
Insert image here		Insert image here			
<b>GPS Location</b>		<b>GPS Location</b>			
<b>Field Station#</b>		<b>Field Station#</b>			
<b>Pic 11 Desc.</b>		<b>Pic 12 Desc.</b>

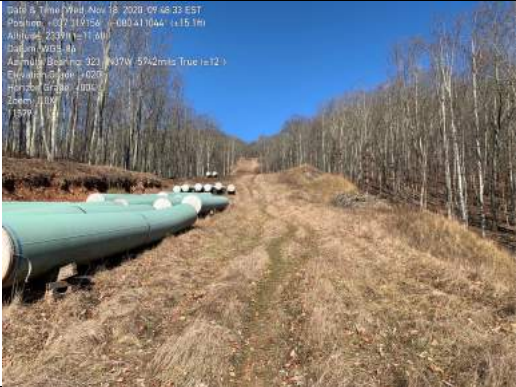
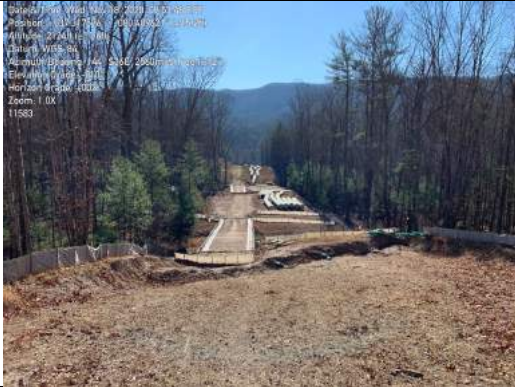
<b>GPS Location</b>	See picture above for GPS coordinates		<b>GPS Location</b>	See picture above for GPS coordinates	
<b>Field Station#</b>	11579+00		<b>Field Station#</b>	11583+00	
<b>Pic 1 Desc.</b>	ECD's and row conditions		<b>Pic 2 Desc.</b>	ECD's and row conditions

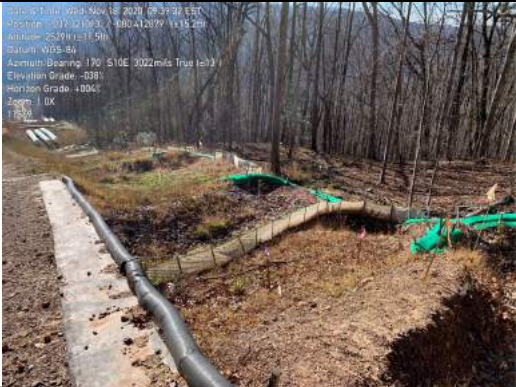
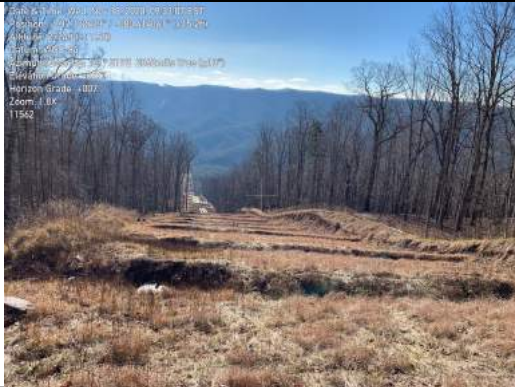
<b>GPS Location</b>	See picture above for GPS coordinates		<b>GPS Location</b>	See picture above for GPS coordinates	
<b>Field Station#</b>	11569+00		<b>Field Station#</b>	11562+00	
<b>Pic 3 Desc.</b>	ECD's and row conditions		<b>Pic 4 Desc.</b>	ECD's and row conditions

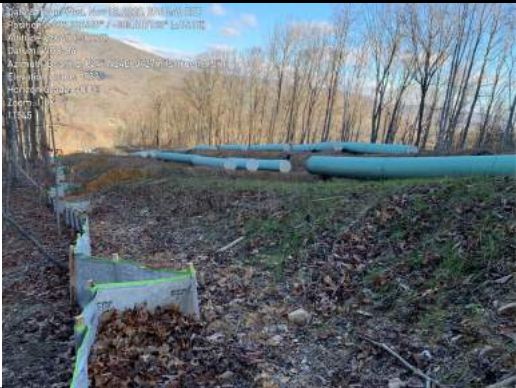
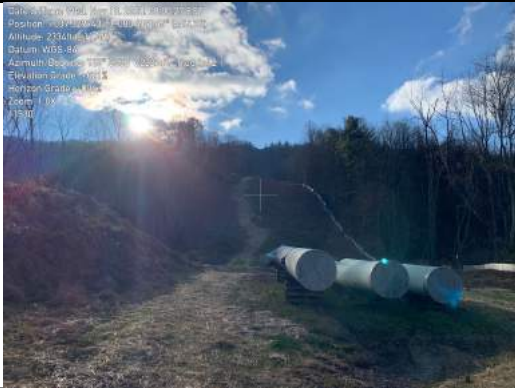
<b>GPS Location</b>	See picture above for GPS coordinates		<b>GPS Location</b>	See picture above for GPS coordinates	
<b>Field Station#</b>	11545+00		<b>Field Station#</b>	11530+00	
<b>Pic 5 Desc.</b>	ECD's and row conditions		<b>Pic 6 Desc.</b>	ECD's and row conditions

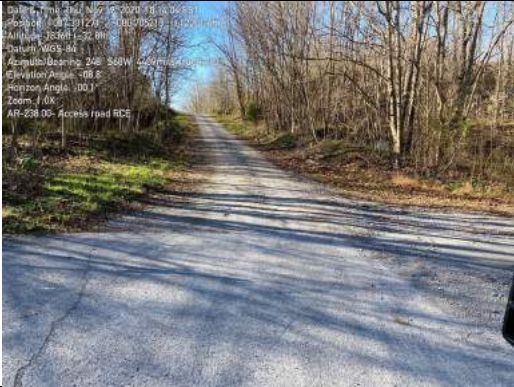
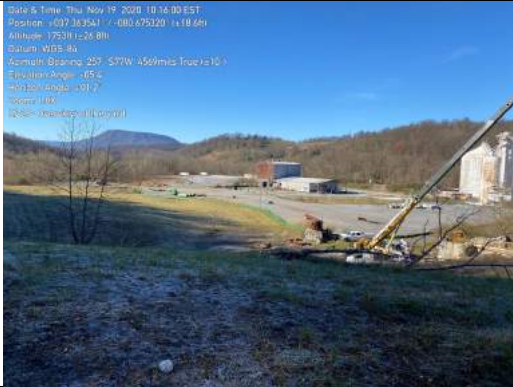
<b>GPS Location</b>	See photo GPS		<b>GPS Location</b>	See photo GPS	
<b>Field Station#</b>	12005+00		<b>Field Station#</b>	12005+00	
<b>Pic 1 Desc.</b>	AR-238.00 Access road serving LY-29		<b>Pic 2 Desc.</b>	LY-29- Overview of the yard

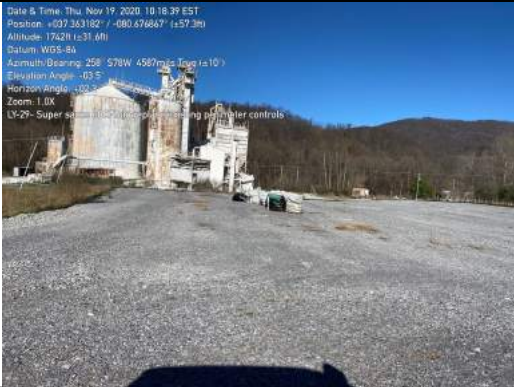
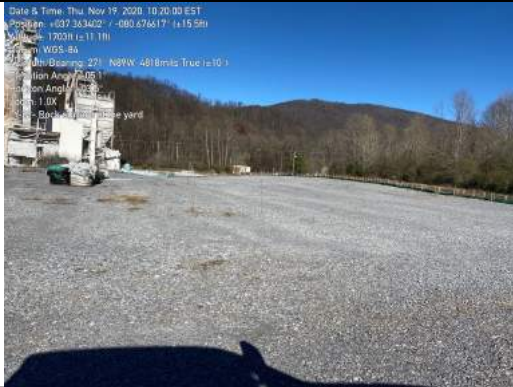
<b>GPS Location</b>	See photo GPS		<b>GPS Location</b>	See photo GPS	
<b>Field Station#</b>	12005+00		<b>Field Station#</b>	12005+00	
<b>Pic 3 Desc.</b>	LY-29- Super sacks of CFS to replace existing perimeter controls.		<b>Pic 4 Desc.</b>	LY-29- Rock surface of the yard

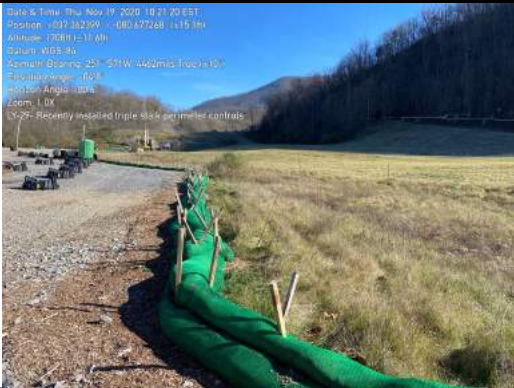
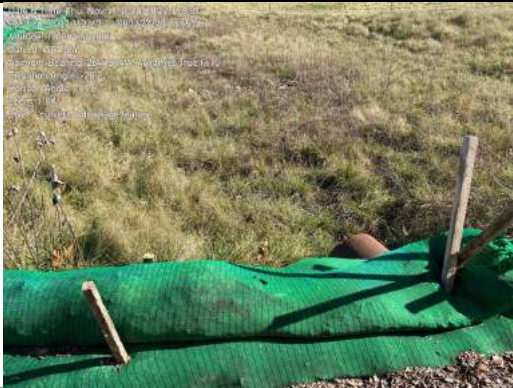
<b>GPS Location</b>	See photo GPS		<b>GPS Location</b>	See photo GPS	
<b>Field Station#</b>	12005+00		<b>Field Station#</b>	12005+00	
<b>Pic 5 Desc.</b>	LY-29- Recently installed perimeter controls		<b>Pic 6 Desc.</b>	LY-29- Culvert and drainage feature.

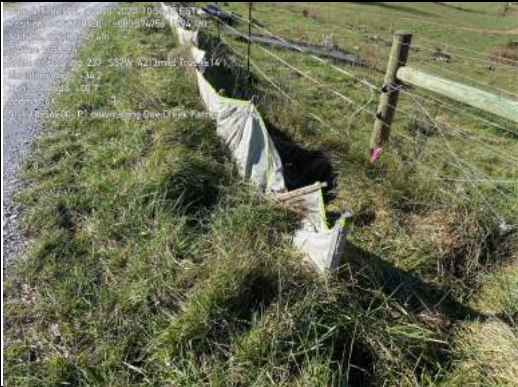
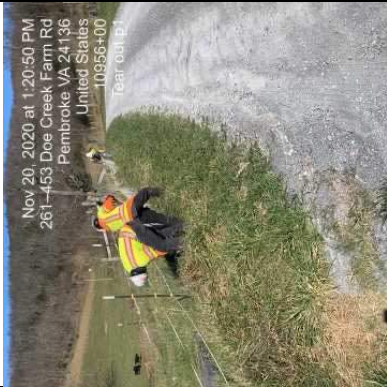
<b>GPS Location</b>	See photo GPS	<b>GPS Location</b>	See photo GPS		
<b>Field Station#</b>	10956+00	<b>Field Station#</b>	10956+00		
<b>Pic 7 Desc.</b>	P1 along Doe Creek Farms driveway damaged	<b>Pic 8 Desc.</b>	Mike Perry stated that the contractor received permission to remove controls.

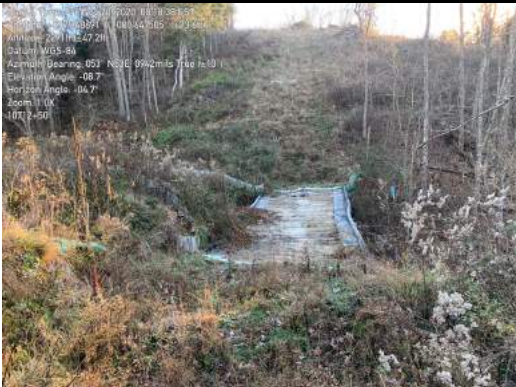
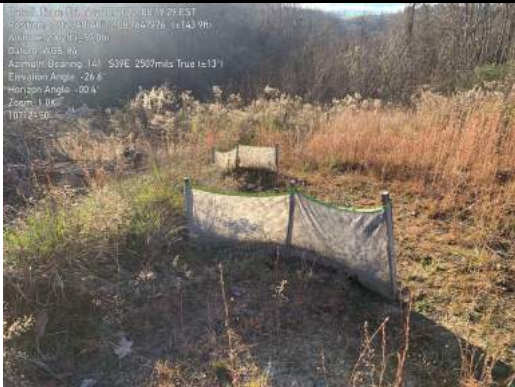
<b>GPS Location</b>	See photo for GPS location.		<b>GPS Location</b>	See photo for GPS location.	
<b>Field Station#</b>	10712+59		<b>Field Station#</b>	10711+00	
<b>Pic 1 Desc.</b>	Sensitive resource buffer in place at stream S-G33.		<b>Pic 2 Desc.</b>	Priority one silt fence checks in place.

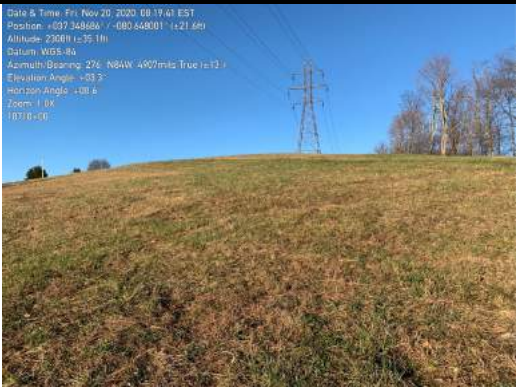
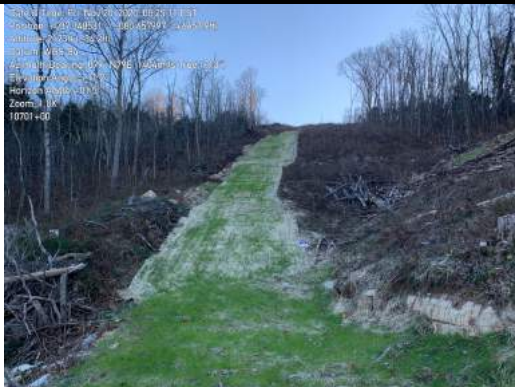
<b>GPS Location</b>	See photo for GPS location.		<b>GPS Location</b>	See photo for GPS location.	
<b>Field Station#</b>	10710+00		<b>Field Station#</b>	10701+00	
<b>Pic 3 Desc.</b>	ROW stabilized with natural vegetation growth.		<b>Pic 4 Desc.</b>	Steep slope stabilized with ECB. Minor vegetation growth present.

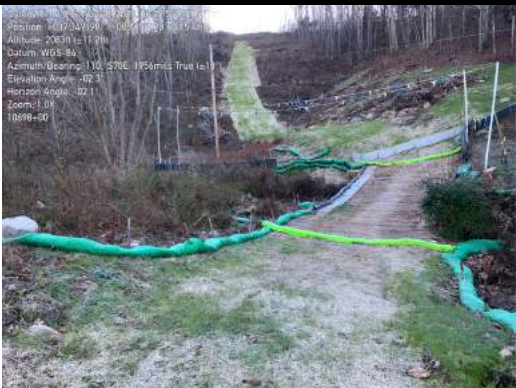
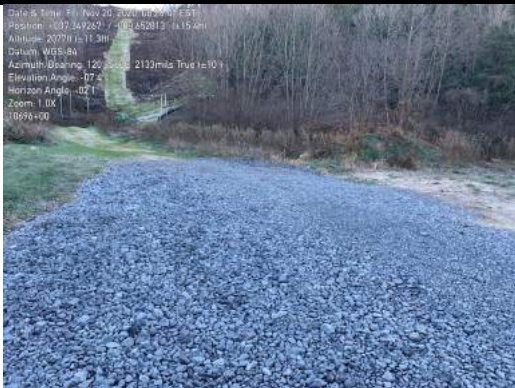
<b>GPS Location</b>	See photo for GPS location.		<b>GPS Location</b>	See photo for GPS location.	
<b>Field Station#</b>	10698+00		<b>Field Station#</b>	10696+00	
<b>Pic 5 Desc.</b>	Sensitive resource buffer in place at stream S-G32.		<b>Pic 6 Desc.</b>	RCE in place at Buffalo Anklets Road.

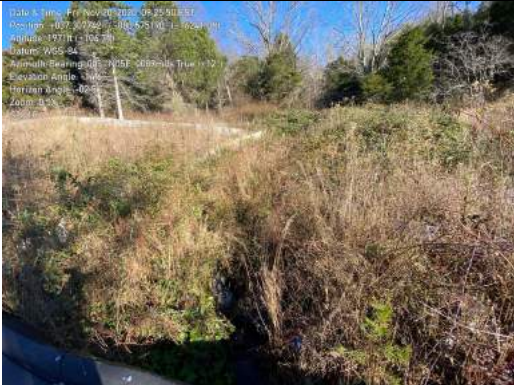
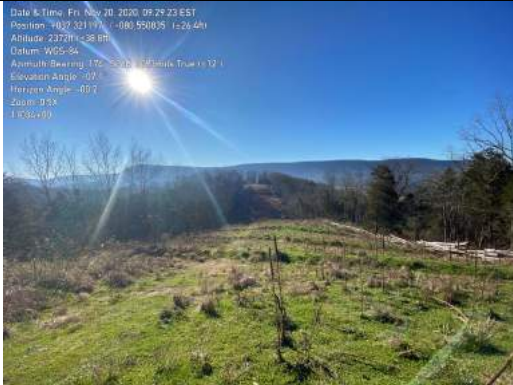
<b>GPS Location</b>	1	<b>GPS Location</b>	2		
<b>Field Station#</b>	11025+50	<b>Field Station#</b>	11034+00		
<b>Pic 1 Desc.</b>	S-IJ18 and controls.	<b>Pic 2 Desc.</b>	Section of RoW showing conditions and controls.

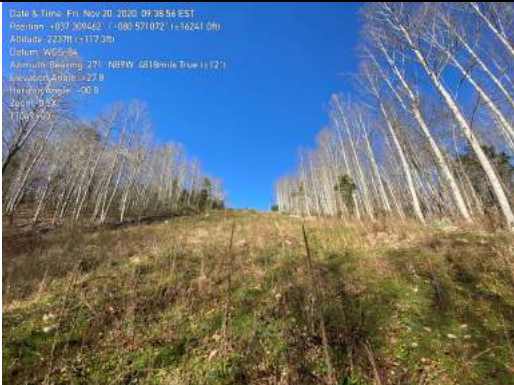
<b>GPS Location</b>	3	<b>GPS Location</b>	4		
<b>Field Station#</b>	11049+00	<b>Field Station#</b>	11050+10		
<b>Pic 3 Desc.</b>	Section of RoW showing conditions and controls.	<b>Pic 4 Desc.</b>	S-IJ16B/S-IJ17 and controls.

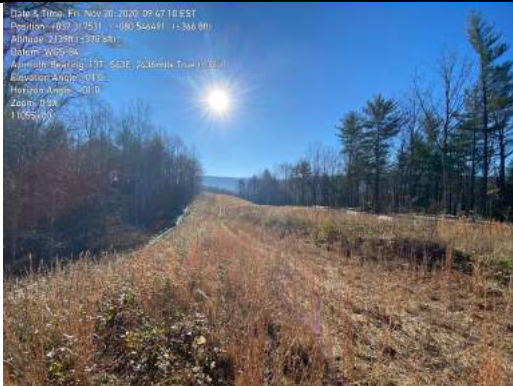
<b>GPS Location</b>	5	<b>GPS Location</b>	6		
<b>Field Station#</b>	11050+50	<b>Field Station#</b>	11055+00		
<b>Pic 5 Desc.</b>	Downed P-1. Item punch listed.	<b>Pic 6 Desc.</b>	Section of RoW showing conditions and controls.
