Visual Site Inspection Report

| Project Name | H-600 Pipeline Spread G | AFE | 124300137 | Spread | H-600 Pipeline Spread G |

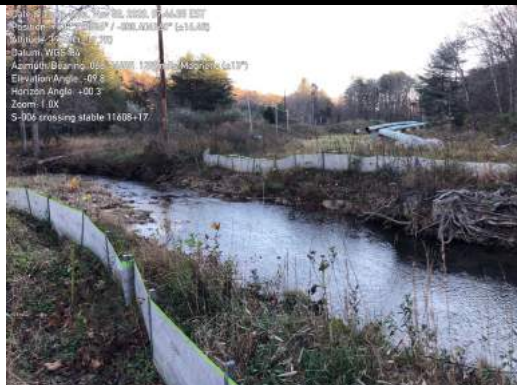
| Field Station# | 11608+17 | Field Station# | | | |

| <p> <small> Date & Time: 11/2/2020 12:27 PM Position: 43° 51' 56.0" N, 120° 39' 27.0" W Altitude: 1980 ft Datum: WGS-84 Azimuth/Bearing: 135° S/45° Magnetic (+12°) Elevation Angle: +00.4° Horizon Angle: +01.2° Zoom: 1.0X Field Station: 11608+17 S-006 crossing stable </small> </p> | | <div style="text-align: center;">Insert image here</div> | | | |

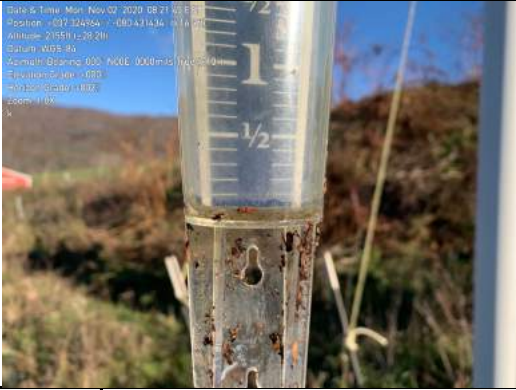
| Field Station# | +1 | | Field Station# | 11530+00 | |

| Pic 1 Desc. | ECD's and row conditions | | Pic 2 Desc. | ECD's and row conditions | |

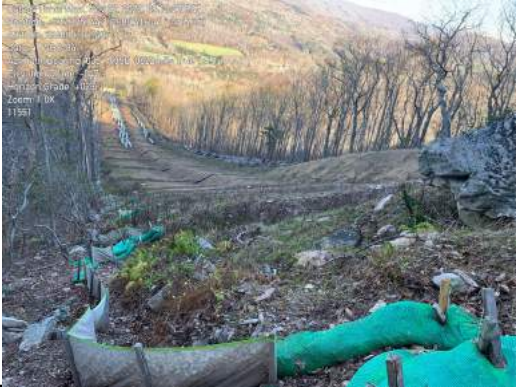
| Field Station# | 11551+00 | | Field Station# | 11569+00 | |

| Pic 3 Desc. | ECD's and row conditions | | Pic 4 Desc. | ECD's and row conditions | |

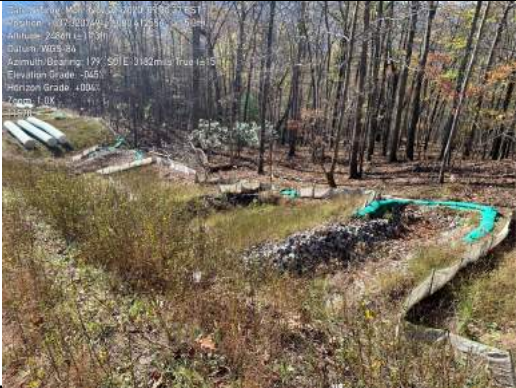
| Field Station# | 11570+00 | | Field Station# | 11584+00 | |

| Pic 5 Desc. | ECD's and row conditions | | Pic 6 Desc. | ECD's and row conditions | |

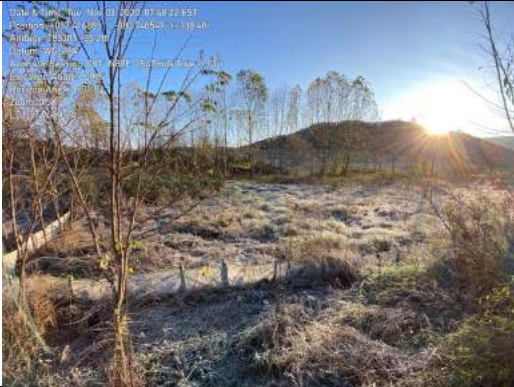
| Field Station# | 12005+00 | Field Station# | 12005+00 | | |

| Pic 1 Desc. | W-KL24 and controls. | Pic 2 Desc. | Overview of the lower section of LDY 37. | | |

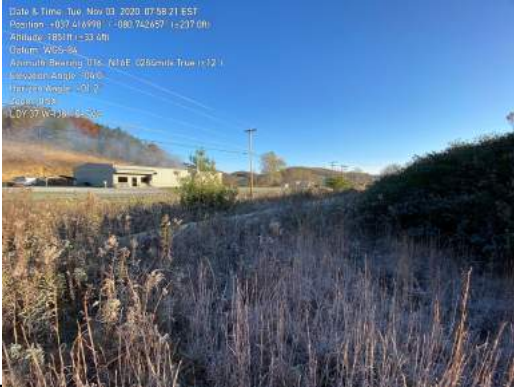
| Field Station# | 12005+00 | Field Station# | 12005+00 | | |

| Pic 3 Desc. | W-IJ81/S-SV2 and controls. | Pic 4 Desc. | W-IJ82 and controls. | | |

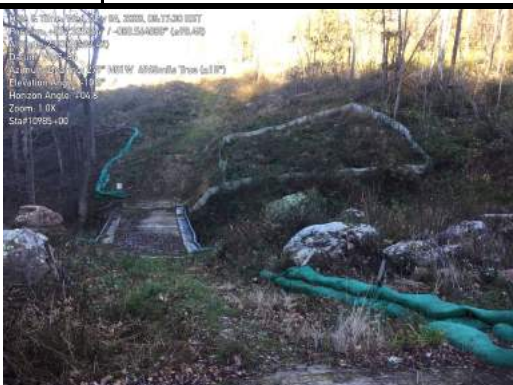
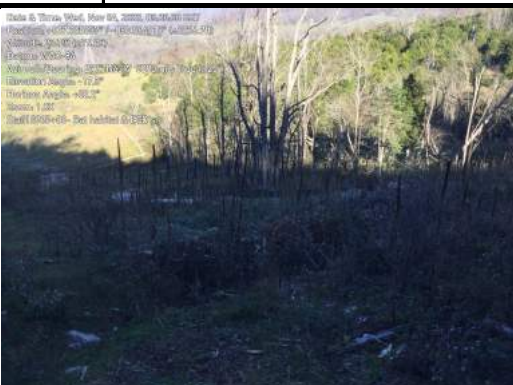
| Field Station# | 10985+00 | Field Station# | 10965+00 | | |

| <p>Photo 6 Time: 11/4/2020 1:10 PM, Nov 04, 2020, 01:10:20 EST Position: 43.07303447, -108.5588877 (43.07303447, -108.5588877) Altitude: 2547ft (777m) Datum: WGS-84 Azimuth/Bearing: 303° N57W 5387mils True (428°) Elevation Angle: -20.1° Horizon Angle: 104.1° Zoom: 1.0X AR-20% Stream S-RR5- Contractors replaced P1 stream buffer</p> | | <p>Photo 6 Time: 11/4/2020 1:10 PM, Nov 04, 2020, 01:10:20 EST Position: 43.07303447, -108.5588877 (43.07303447, -108.5588877) Altitude: 2547ft (777m) Datum: WGS-84 Azimuth/Bearing: 303° N57W 5387mils True (428°) Elevation Angle: -20.1° Horizon Angle: 104.1° Zoom: 1.0X AR-20% Stream S-RR5- Contractors replaced P1 stream buffer</p> | | | |

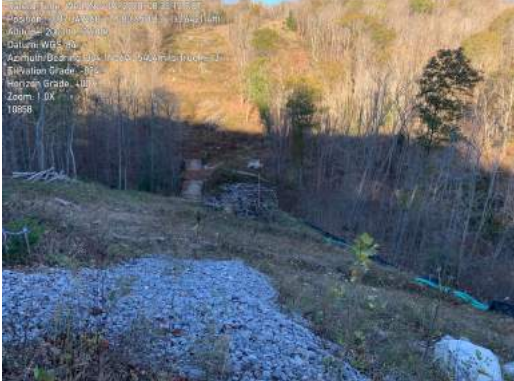
| Field Station# | 10858+00 | | Field Station# | 10873+00 | |

| Pic 1 Desc. | ECD's and row conditions | | Pic 2 Desc. | ECD's and row conditions | |

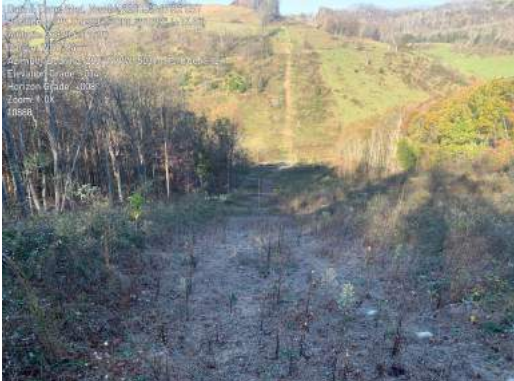
| Field Station# | 10888+00 | | Field Station# | 10898+00 | |

| Pic 3 Desc. | ECD's and row conditions | | Pic 4 Desc. | ECD's and row conditions | |

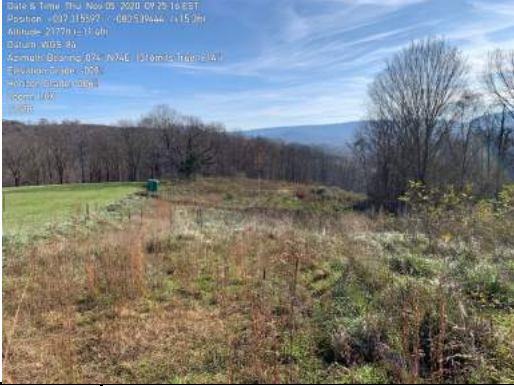
| Field Station# | 11078+00 | | Field Station# | 11070+00 | |

| Pic 1 Desc. | ECD's and row conditions | | Pic 2 Desc. | ECD's and row conditions | |

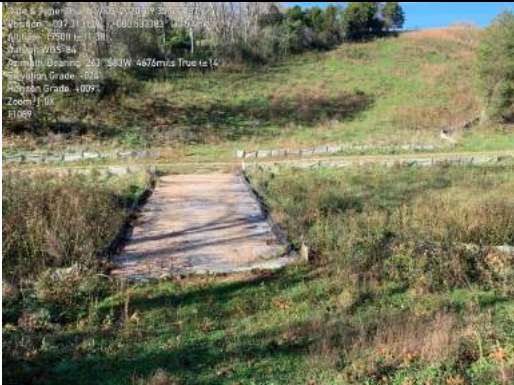
| Field Station# | 11089+00 | | Field Station# | 11110+00 | |

| Pic 3 Desc. | ECD's and row conditions | | Pic 4 Desc. | ECD's and row conditions | |
