Visual Site Inspection Report

Project Name	H-600 Pipeline Spread G	AFE	124300137	Spread	H-600 Pipeline Spread G
Contractor	Precision			Report #	17199
Inspector	Chris Burns			Date/Time	11/23/2020 7:58 AM
Permit #	TBD	Inspection Type	VA SWPP	Station Begin	11254+99
State	VA	Inspection Area	Partial	Station End	11353+67
County	Giles	Ground	Damp	Temperature (°F)	45.00
Municipality	N/A	Weather	Sunny	Rain Gauge (in)	0.00
				Rain Accumulation Time (days)	1.00

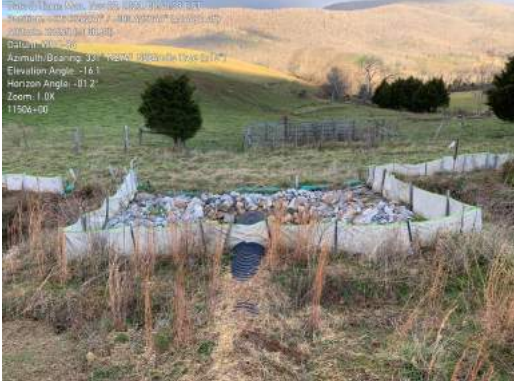
GPS Location	See photo for GPS location.		GPS Location	See photo for GPS location.	
Field Station#	11506+00		Field Station#	11505+00	
Pic 1 Desc.	Clean water diversion pipe and plunge pool in place.		Pic 2 Desc.	Clean water diversion pipe and clean water diversion berm in place.

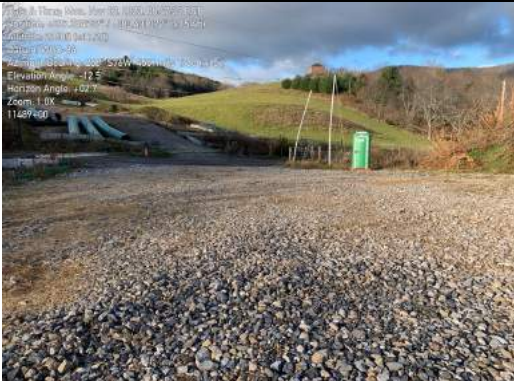
GPS Location	See photo for GPS location.		GPS Location	See photo for GPS location.	
Field Station#	11489+00		Field Station#	11482+00	
Pic 3 Desc.	RCE in place at Stevers Gap Road.		Pic 4 Desc.	Priority one silt fence damaged by animals.

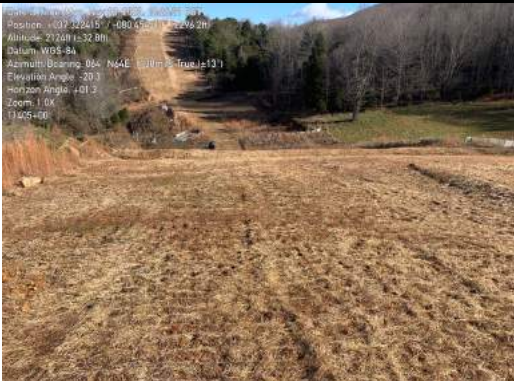
GPS Location	See photo for GPS location.		GPS Location	See photo for GPS location.	
Field Station#	11405+00		Field Station#	11476+00	
Pic 5 Desc.	ROW stabilized with seed and mulch. ECDs in place.		Pic 6 Desc.	Two-tone stabilized with ECB and slope drains in place.

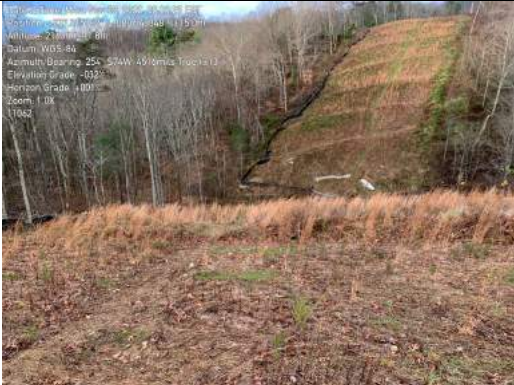
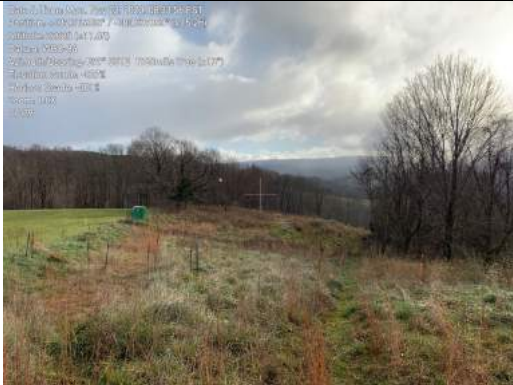
GPS Location	See picture above for GPS coordinates		GPS Location	See picture above for GPS coordinates	
Field Station#	11062+00		Field Station#	11079+00	
Pic 1 Desc.	ECD's and row conditions		Pic 2 Desc.	ECD's and row conditions

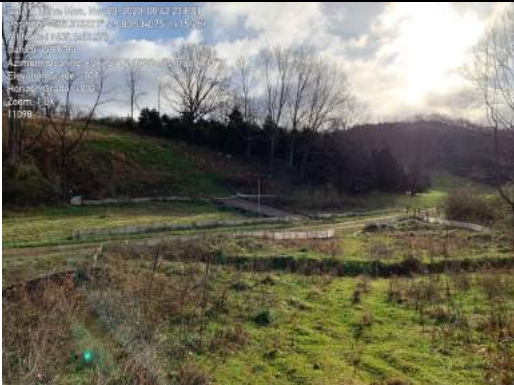
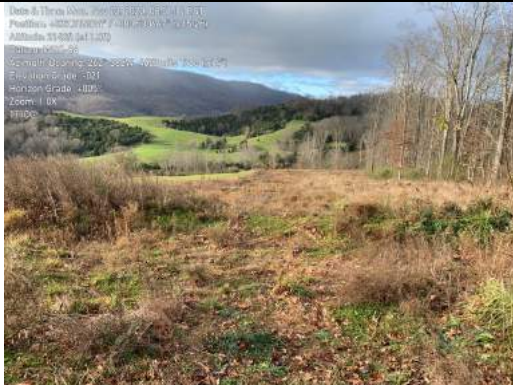
GPS Location	See picture above for GPS coordinates		GPS Location	See picture above for GPS coordinates	
Field Station#	11098+00		Field Station#	11103+00	
Pic 3 Desc.	ECD's and row conditions		Pic 4 Desc.	ECD's and row conditions

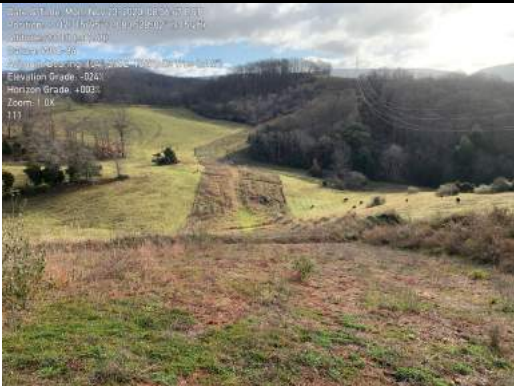
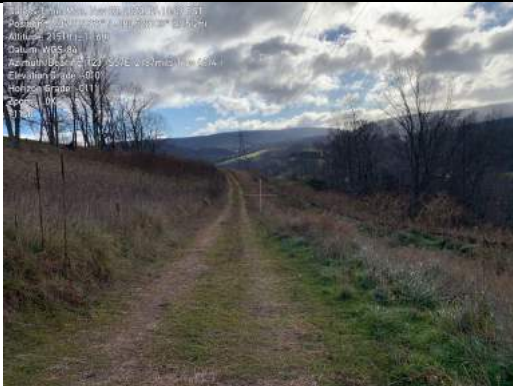
GPS Location	See picture above for GPS coordinates		GPS Location	See picture above for GPS coordinates	
Field Station#	11120+00		Field Station#	11140+00	
Pic 5 Desc.	ECD's and row conditions		Pic 6 Desc.	ECD's and row conditions

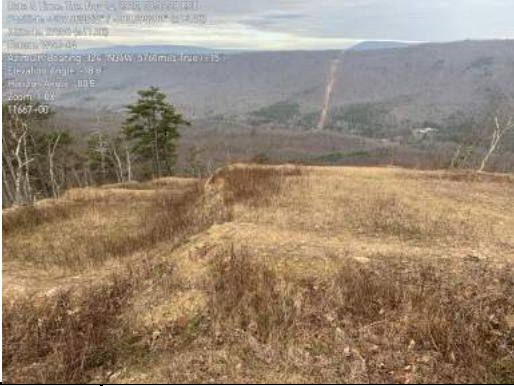
GPS Location	On photo	GPS Location	On photo		
Field Station#	11667+00	Field Station#	11665+00		
Pic 1 Desc.	Perimeter controls in place. Slope breakers functional. ROW surface stable.	Pic 2 Desc.	Perimeter controls in place. Slope breakers functional. ROW surface stable.

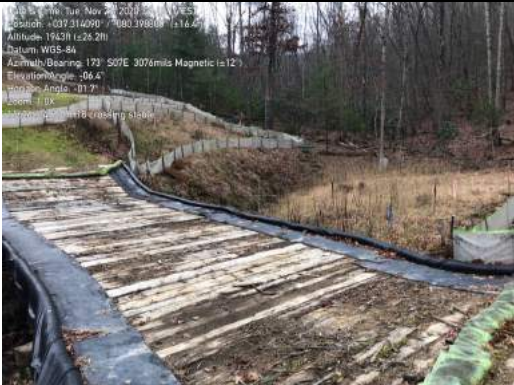
GPS Location	On photo	GPS Location	On photo		
Field Station#	11626+04	Field Station#	11614+20		
Pic 3 Desc.	S-HH18 crossing currently stable with ECDs in place.	Pic 4 Desc.	S-RR14 crossing stable. ECDs are in place.

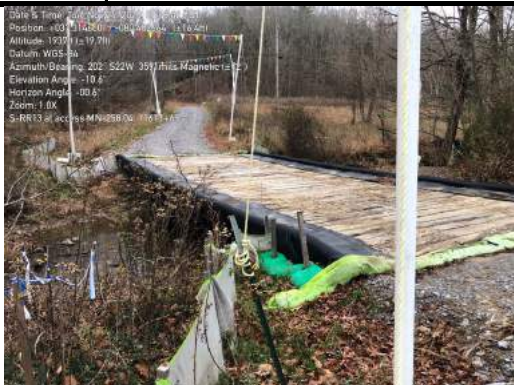
GPS Location	On photo	GPS Location	On photo		
Field Station#	11608+17	Field Station#	11613+69		
Pic 5 Desc.	S-006 crossing is stable. ECDs are in place.	Pic 6 Desc.	SRR13 crossing at access road MN-258.04 is stable with ECDs in place.

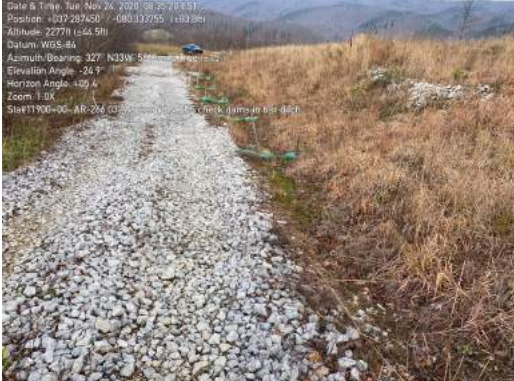
<p>Date & Time: Tue, Nov 24, 2020, 12:35:21 EST Position: 4327.289450° N, -68.132735° W (-68.132735) Altitude: 2270.1665 ft Datum: WGS-84 Azimuth/Bearing: 327° N33W 54.0m True (+13.1) Elevation Angle: -24.1° Horizon Angle: -10.4° Zoom: 1.0x Star#11900+00- AR-266.03- Access road and CFS check dams in the dist.</p>

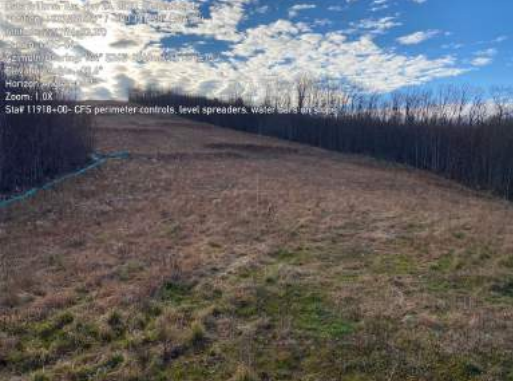
<p>Date & Time: Tue, Nov 24, 2020, 12:35:41 EST Position: 4327.289450° N, -68.132735° W (-68.132735) Altitude: 2270.1665 ft Datum: WGS-84 Azimuth/Bearing: 327° N33W 54.0m True (+13.1) Elevation Angle: -24.1° Horizon Angle: -10.4° Zoom: 1.0x Star#11918+00- CFS perimeter controls, level spreaders, water bars in dist.</p>			
GPS Location	See photo GPS	GPS Location	See photo GPS		
Field Station#	11900+00	Field Station#	11918+00		
Pic 1 Desc.	AR- 266.03- Access road and CFS check dams.	Pic 2 Desc.	CFS perimeter controls, water bars and level spreaders, row vegetation.

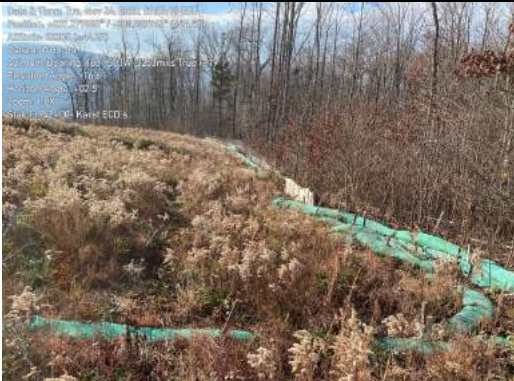
<p>Date & Time: Tue, Nov 24, 2020, 12:35:41 EST Position: 4327.289450° N, -68.132735° W (-68.132735) Altitude: 2270.1665 ft Datum: WGS-84 Azimuth/Bearing: 327° N33W 54.0m True (+13.1) Elevation Angle: -24.1° Horizon Angle: -10.4° Zoom: 1.0x Star#11942+00- Karst ECD's</p>

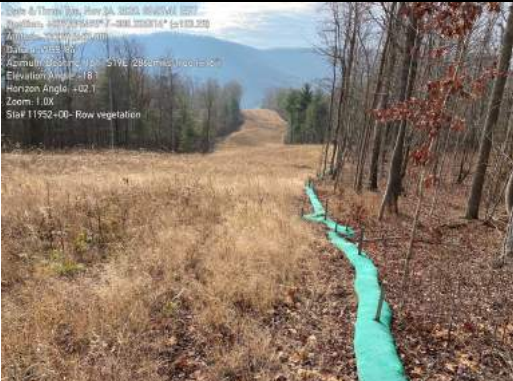
<p>Date & Time: Tue, Nov 24, 2020, 12:35:41 EST Position: 4327.289450° N, -68.132735° W (-68.132735) Altitude: 2270.1665 ft Datum: WGS-84 Azimuth/Bearing: 327° N33W 54.0m True (+13.1) Elevation Angle: -24.1° Horizon Angle: -10.4° Zoom: 1.0x Star#11952+00- Row vegetation</p>			
GPS Location	See photo GPS	GPS Location	See photo GPS		
Field Station#	11942+00	Field Station#	11952+00		
Pic 3 Desc.	Karst ECD's	Pic 4 Desc.	Row condition, row vegetation

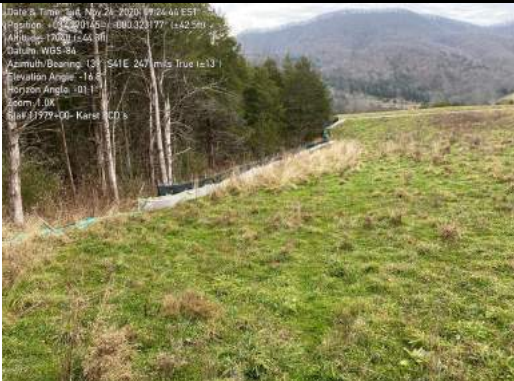
<p>Date & Time: Tue, Nov 24, 2020, 12:35:41 EST Position: 4327.289450° N, -68.132735° W (-68.132735) Altitude: 2270.1665 ft Datum: WGS-84 Azimuth/Bearing: 327° N33W 54.0m True (+13.1) Elevation Angle: -24.1° Horizon Angle: -10.4° Zoom: 1.0x Star#11979+00- Karst ECD's</p>

GPS Location	See photo GPS	GPS Location	See photo GPS		
Field Station#	11979+00	Field Station#	11988+00		
Pic 5 Desc.	Karst ECD's	Pic 6 Desc.	AR-266.00- Access road and rock check dams are maintained.

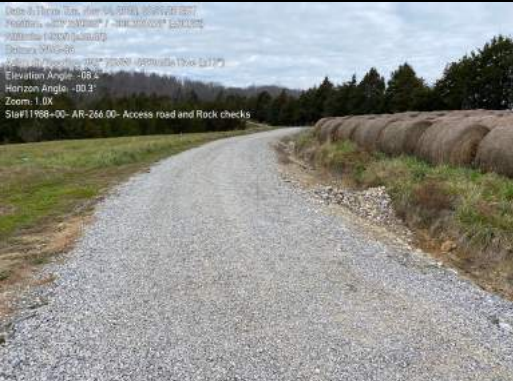
<p>Date & Time: Tue, Nov 24, 2020, 12:35:41 EST Position: 4327.289450° N, -68.132735° W (-68.132735) Altitude: 2270.1665 ft Datum: WGS-84 Azimuth/Bearing: 327° N33W 54.0m True (+13.1) Elevation Angle: -24.1° Horizon Angle: -10.4° Zoom: 1.0x Star#11988+00- AR-266.00- Access road and Rock checks</p>

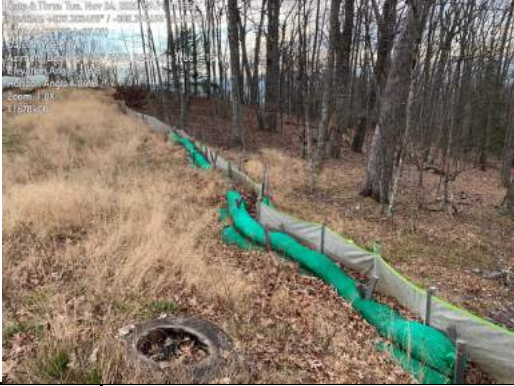
GPS Location	See photo for GPS location.		GPS Location	See photo for GPS location.	
Field Station#	11670+00		Field Station#	11672+00	
Pic 1 Desc.	Triple stack cfs in place along LOD.		Pic 2 Desc.	ROW stabilized with seed and mulch. ECDs in place.

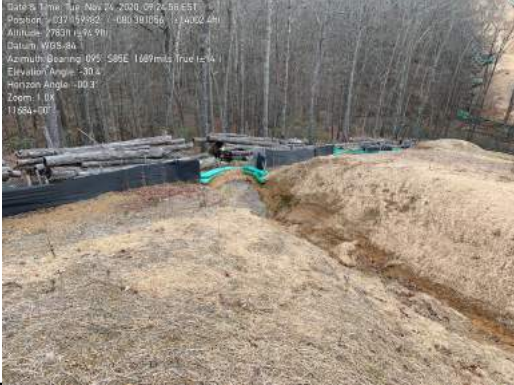
GPS Location	See photo for GPS location.		GPS Location	See photo for GPS location.	
Field Station#	11684+00		Field Station#	11687+40	
Pic 3 Desc.	Waterbar in place with sump pit and end treatment.		Pic 4 Desc.	Sensitive resource buffer in place at stream S-MN21

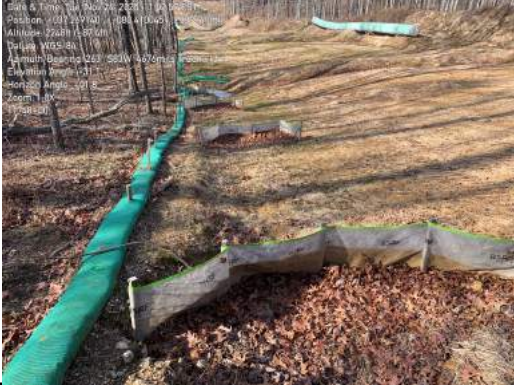
GPS Location	See photo for GPS location.		GPS Location	See photo for GPS location.	
Field Station#	11748+00		Field Station#	11767+00	
Pic 5 Desc.	Priority one silt fence checks in place.		Pic 6 Desc.	RCE in place at Main Line Valve 26.

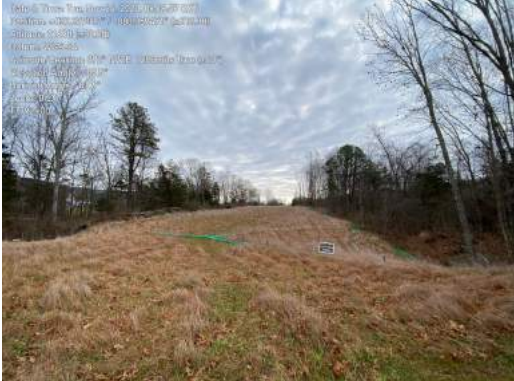
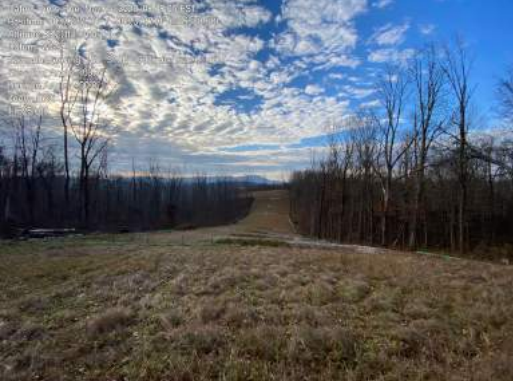
GPS Location	1	GPS Location	2		
Field Station#	11792+00	Field Station#	11825+00		
Pic 1 Desc.	Section of restored RoW showing conditions and controls.		Pic 2 Desc.	Section of restored RoW showing conditions and controls.

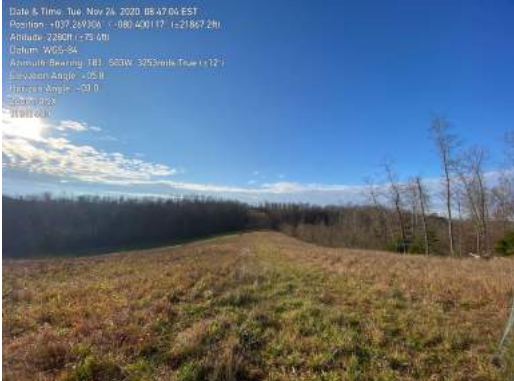
GPS Location	3	GPS Location	4		
Field Station#	11841+00	Field Station#	11843+00		
Pic 3 Desc.	Section of restored RoW showing conditions and controls.		Pic 4 Desc.	Wildlife damage to CFS.

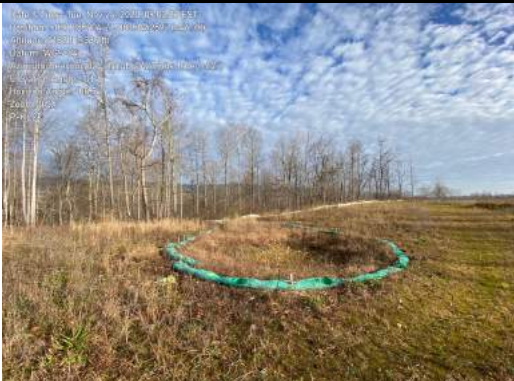
GPS Location	5	GPS Location	6		
Field Station#	11863+65	Field Station#	11881+15		
Pic 5 Desc.	P-KL2 and controls.		Pic 6 Desc.	Wildlife damage to P-1 silt fence.

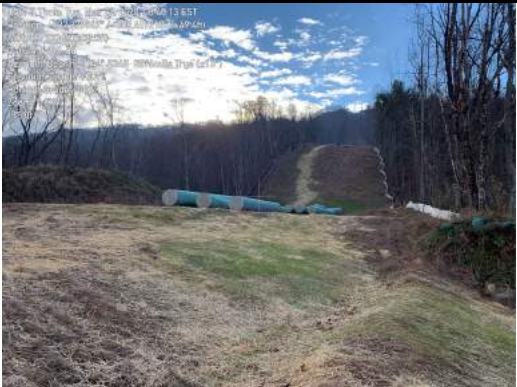
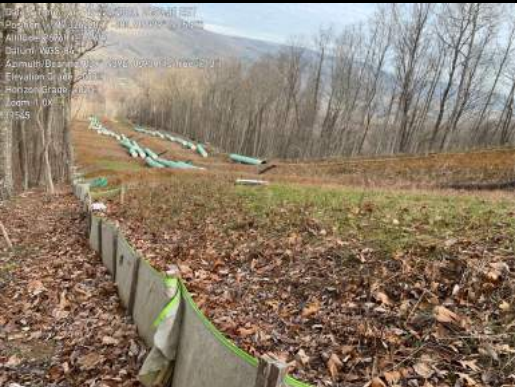
GPS Location	See picture above for GPS coordinates		GPS Location	See picture above for GPS coordinates	
Field Station#	11530+00		Field Station#	11545+00	
Pic 1 Desc.	ECD's and row conditions		Pic 2 Desc.	ECD's and row conditions

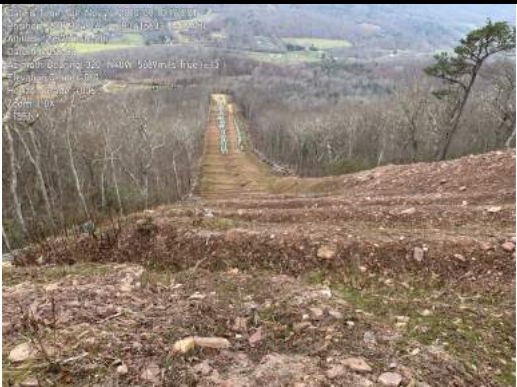
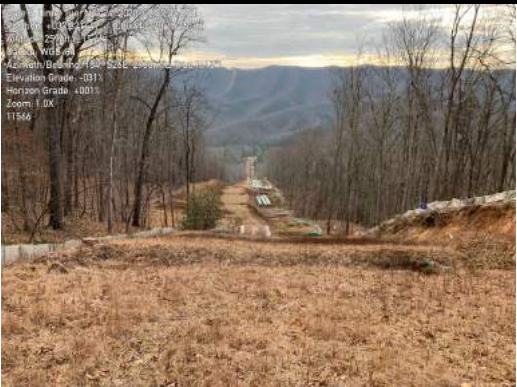
GPS Location	See picture above for GPS coordinates		GPS Location	See picture above for GPS coordinates	
Field Station#	11551+00		Field Station#	11566+00	
Pic 3 Desc.	ECD's and row conditions		Pic 4 Desc.	ECD's and row conditions

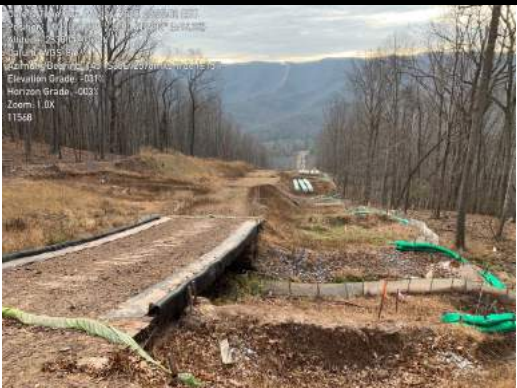
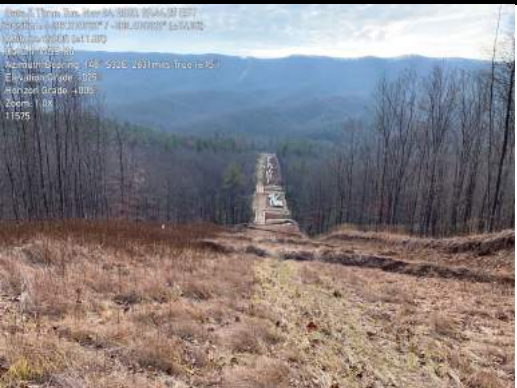
GPS Location	See picture above for GPS coordinates		GPS Location	See picture above for GPS coordinates	
Field Station#	11568+00		Field Station#	11575+00	
Pic 5 Desc.	ECD's and row conditions		Pic 6 Desc.	ECD's and row conditions

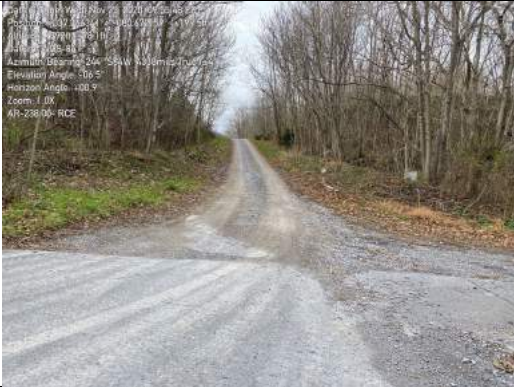
GPS Location	See photo GPS		GPS Location	See photo GPS	
Field Station#	12005+00		Field Station#	12005+00	
Pic 1 Desc.	AR-238.00 RCE		Pic 2 Desc.	LY-29- Overview of the yard.

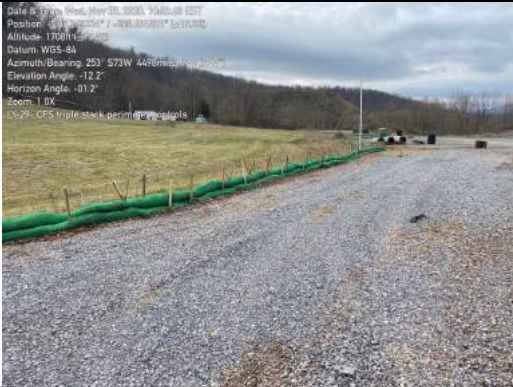
GPS Location	See photo GPS		GPS Location	See photo GPS	
Field Station#	12005+00		Field Station#	12005+00	
Pic 3 Desc.	Super sacks of CFS staged to replace worn perimeter controls.		Pic 4 Desc.	CFS triple stack perimeter controls.

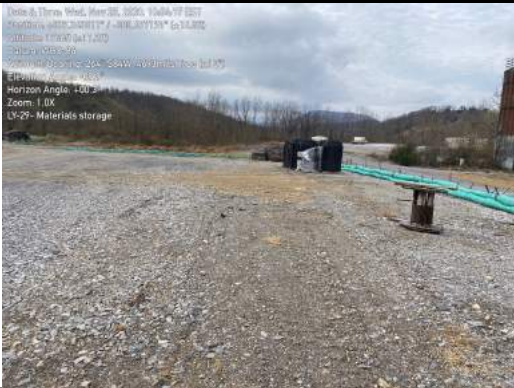
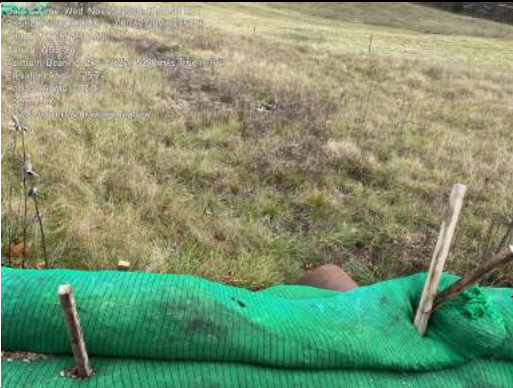
GPS Location	See photo GPS		GPS Location	See photo GPS	
Field Station#	12005+00		Field Station#	12005+00	
Pic 5 Desc.	LY-29- Materials storage.		Pic 6 Desc.	LY-29- Culvert and drainage feature.

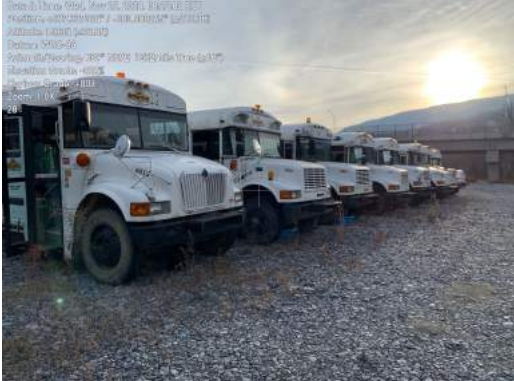
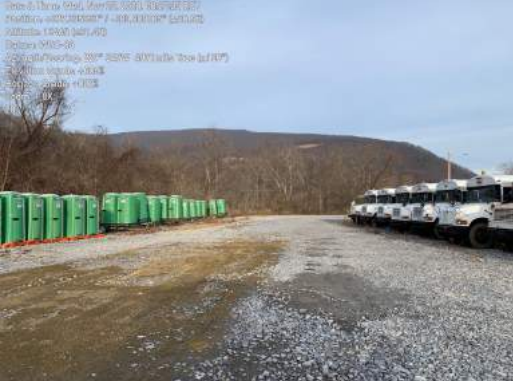
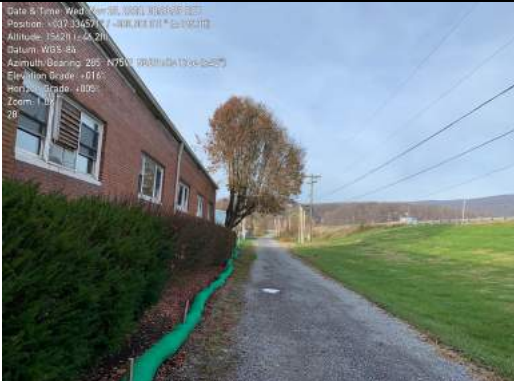
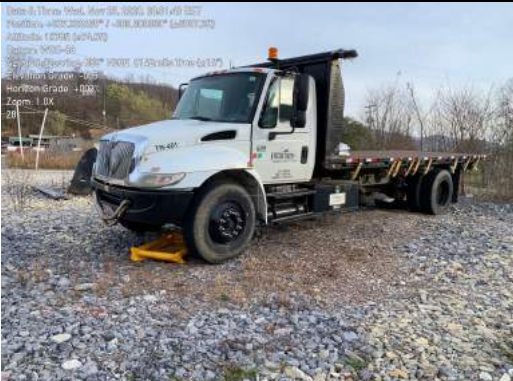
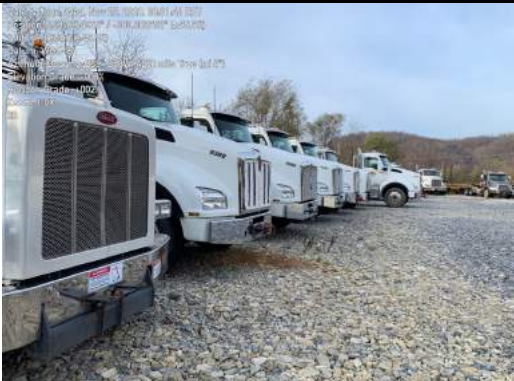
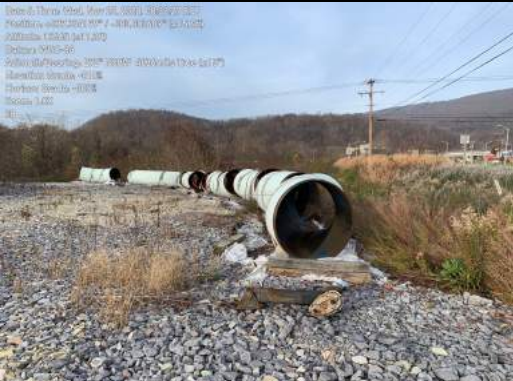
GPS Location	See picture above for GPS coordinates		GPS Location	See picture above for GPS coordinates	
Field Station#	12005+00		Field Station#	12005+00	
Pic 1 Desc.	ECD's and row conditions		Pic 2 Desc.	ECD's and row conditions

GPS Location	See picture above for GPS coordinates		GPS Location	See picture above for GPS coordinates	
Field Station#	12005+00		Field Station#	12005+00	
Pic 3 Desc.	ECD's and row conditions		Pic 4 Desc.	ECD's and row conditions

GPS Location	See picture above for GPS coordinates		GPS Location	See picture above for GPS coordinates	
Field Station#	12005+00		Field Station#	12005+00	
Pic 5 Desc.	ECD's and row conditions		Pic 6 Desc.	ECD's and row conditions

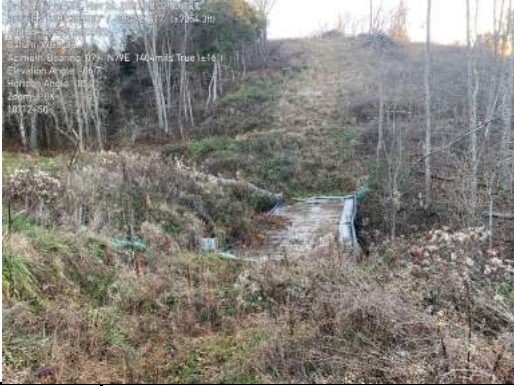
GPS Location	See photo for GPS location.		GPS Location	See photo for GPS location.	
Field Station#	10712+50		Field Station#	10710+00	
Pic 1 Desc.	Sensitive resource buffer in place at stream S-G33.		Pic 2 Desc.	ROW stabilized with natural vegetation growth.

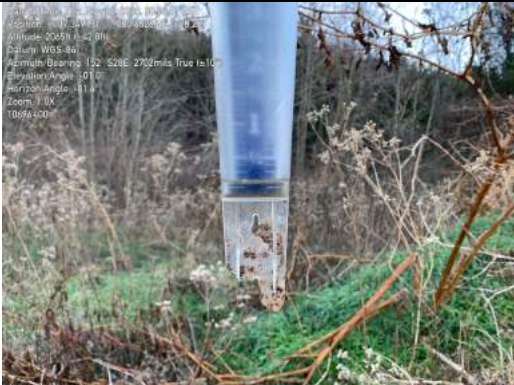
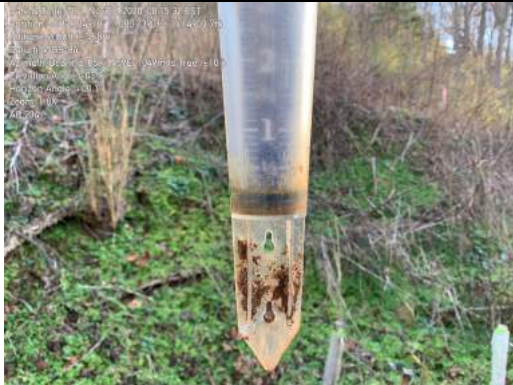
GPS Location	See photo for GPS location.		GPS Location	See photo for GPS location.	
Field Station#	10696+00		Field Station#	12005+00	
Pic 3 Desc.	Rain gauge at Buffalo Anklets Road reads 0.2 inches.		Pic 4 Desc.	Rain gauge at AR 234 reads 0.2 inches.

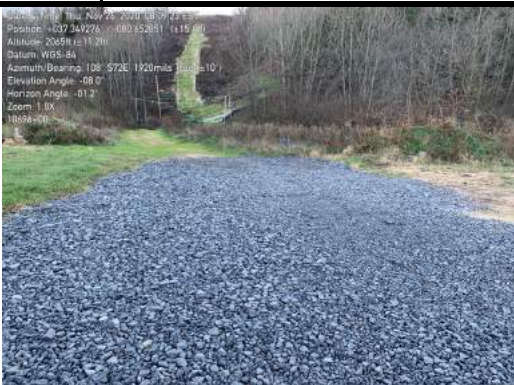
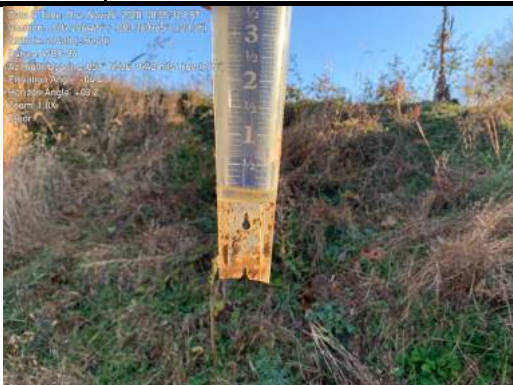
GPS Location	See photo for GPS location.		GPS Location	See photo for GPS location.	
Field Station#	10696+00		Field Station#	11788+00	
Pic 5 Desc.	RCE in place at Buffalo Anklets Road.		Pic 6 Desc.	Rain gauge at Mount Tabor Road reads 0.1 inches.

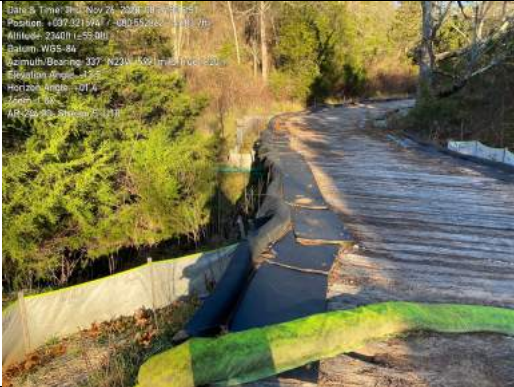
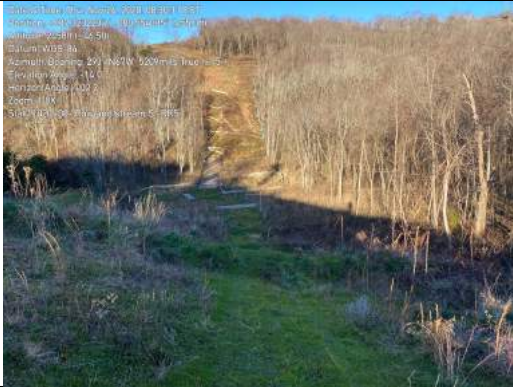
GPS Location	See photo GPS		GPS Location	See photo GPS	
Field Station#	11023+88		Field Station#	11020+00	
Pic 1 Desc.	AR-244- Stream S-IJ18		Pic 2 Desc.	Row and stream S-RR5

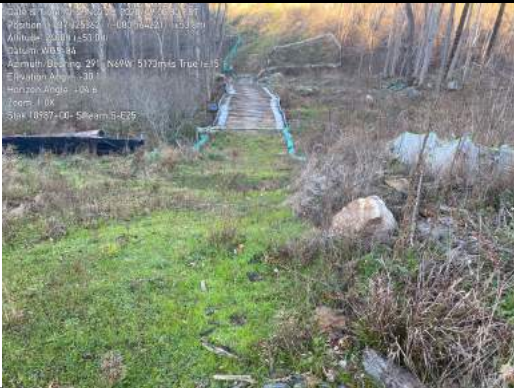
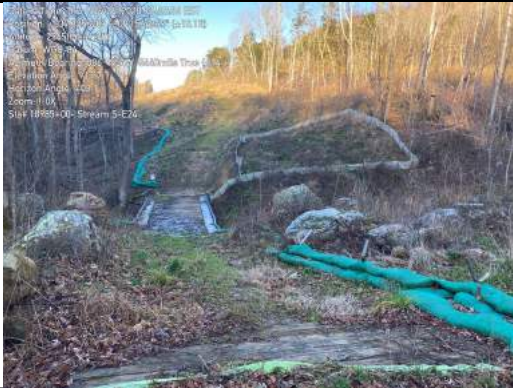
GPS Location	See photo GPS		GPS Location	See photo GPS	
Field Station#	10987+00		Field Station#	10985+00	
Pic 5 Desc.	Stream S-E25		Pic 6 Desc.	Stream S- E24

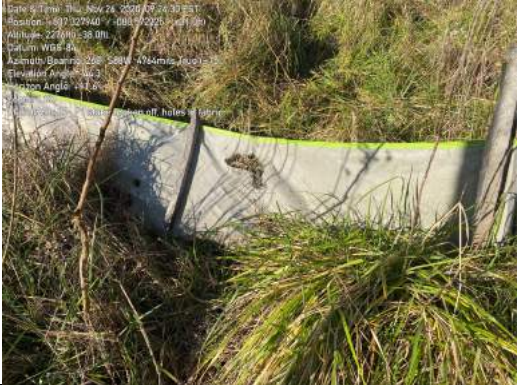
GPS Location	See photo GPS	GPS Location	See photo GPS		
Field Station#	10965+00	Field Station#	10963+65		
Pic 7 Desc.	SSF fabric detached from chain link at sensitive resource area. (Bat habitat).	Pic 8 Desc.	P1 stake broken off and holes in fabric at drainage feature.		
Insert image here		Insert image here			
GPS Location		GPS Location			
Field Station#		Field Station#			
Pic 9 Desc.		Pic 10 Desc.			
Insert image here		Insert image here			
GPS Location		GPS Location			
Field Station#		Field Station#			
Pic 11 Desc.		Pic 12 Desc.

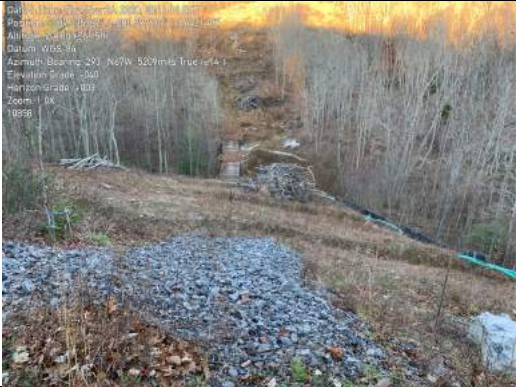
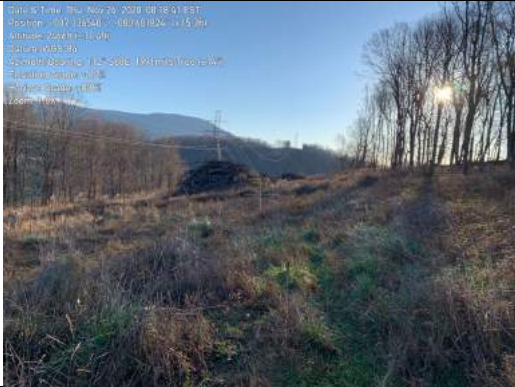
GPS Location	See picture above for GPS coordinates		GPS Location	See picture above for GPS coordinates	
Field Station#	10858+00		Field Station#	10862+00	
Pic 1 Desc.	ECD's and row conditions		Pic 2 Desc.	ECD's and row conditions

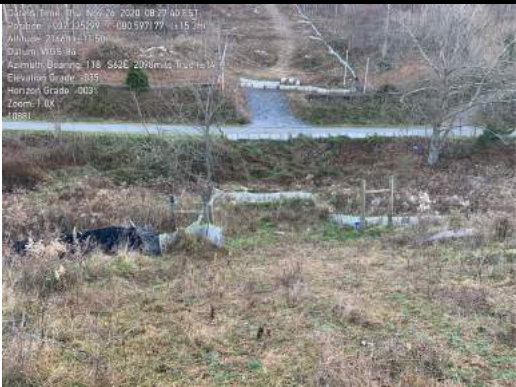
GPS Location	See picture above for GPS coordinates		GPS Location	See picture above for GPS coordinates	
Field Station#	10881+00		Field Station#	10883+00	
Pic 3 Desc.	ECD's and row conditions		Pic 4 Desc.	Damaged curlex and cowboy gap

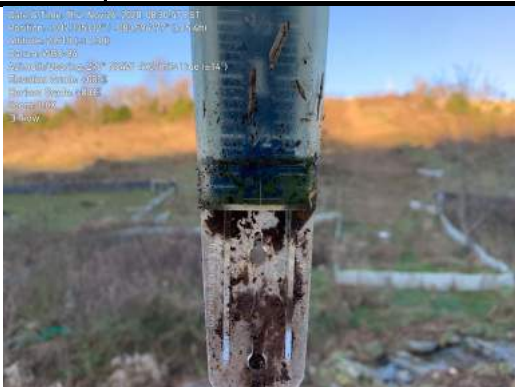
GPS Location	See picture above for GPS coordinates		GPS Location	See picture above for GPS coordinates	
Field Station#	10910+00		Field Station#	+1	
Pic 5 Desc.	Damaged SSF		Pic 6 Desc.	.3" of rain recorded

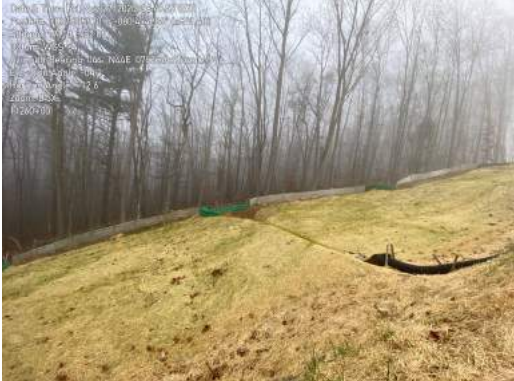
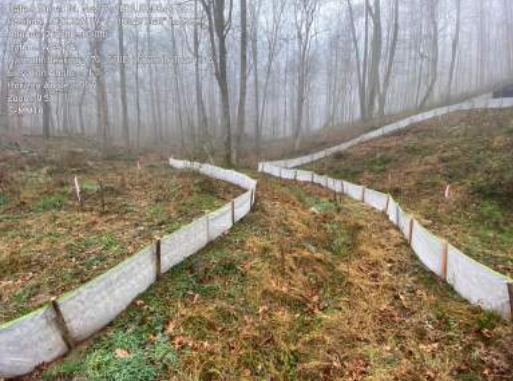
GPS Location	1	GPS Location	2		
Field Station#	11260+00	Field Station#	11292+80		
Pic 1 Desc.	Perimeter controls functional.	Pic 2 Desc.	S-MM18 and controls.

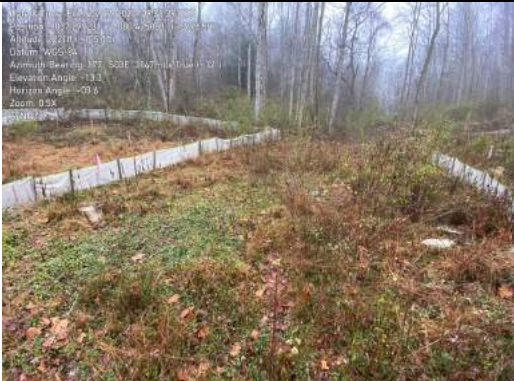
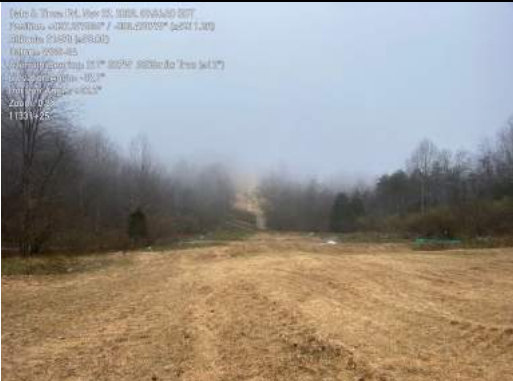
GPS Location	3	GPS Location	4		
Field Station#	11327+85	Field Station#	11331+25		
Pic 3 Desc.	S-NN12 and controls.	Pic 4 Desc.	Section of RoW showing conditions and controls.

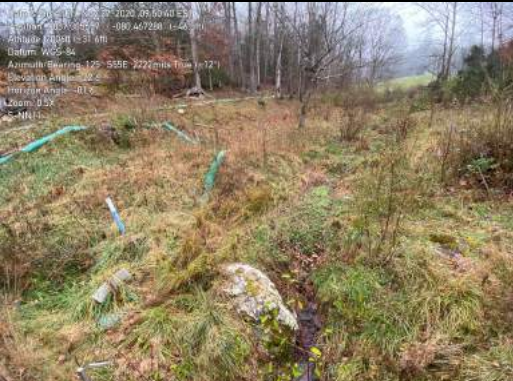
GPS Location	5	GPS Location	6		
Field Station#	11345+85	Field Station#	11352+97		
Pic 5 Desc.	Damaged P-1 perimeter controls.	Pic 6 Desc.	S-NN11 and controls.

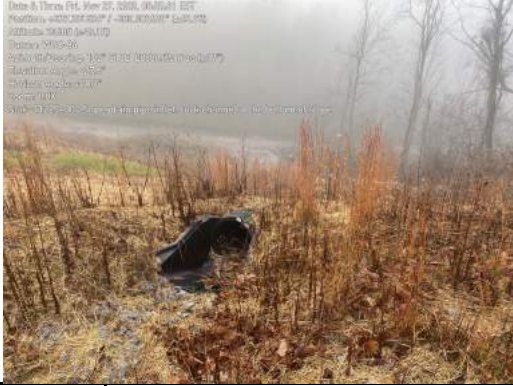
GPS Location	See photo GPS	GPS Location	See photo GPS		
Field Station#	11227+00	Field Station#	11225+00		
Pic 1 Desc.	Foggy conditions, row controls.	Pic 2 Desc.	Slope drain inlet, rock channel at the bottom of the slope.
