# Visual Site Inspection Report

<b>Project Name</b>	H-600 Pipeline Spread G	<b>AFE</b>	124300137	<b>Spread</b>	H-600 Pipeline Spread G
<b>Contractor</b>	Precision			<b>Report #</b>	17455
<b>Inspector</b>	Chris Burns			<b>Date/Time</b>	11/30/2020 8:01 AM
<b>Permit #</b>	TBD	<b>Inspection Type</b>	VA SWPP	<b>Station Begin</b>	11788+52
<b>State</b>	VA	<b>Inspection Area</b>	Partial	<b>Station End</b>	11899+99
<b>County</b>	Montgomery	<b>Ground</b>	Wet	<b>Temperature (°F)</b>	46.00
<b>Municipality</b>	N/A	<b>Weather</b>	Light Rain	<b>Rain Gauge (in)</b>	1.00
				<b>Rain Accumulation Time (days)</b>	0.00

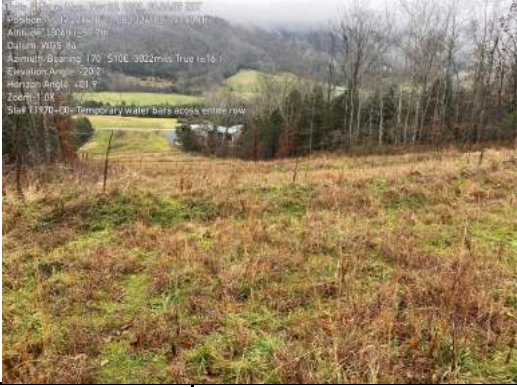
<p>Insert image here</p>			
<b>GPS Location</b>	See photo GPS	<b>GPS Location</b>			
<b>Field Station#</b>	11970+00	<b>Field Station#</b>			
<b>Pic 7 Desc.</b>	Temporary water bars extending across entire row.	<b>Pic 8 Desc.</b>			
<p>Insert image here</p>		<p>Insert image here</p>			
<b>GPS Location</b>		<b>GPS Location</b>			
<b>Field Station#</b>		<b>Field Station#</b>			
<b>Pic 9 Desc.</b>		<b>Pic 10 Desc.</b>			
<p>Insert image here</p>		<p>Insert image here</p>			
<b>GPS Location</b>		<b>GPS Location</b>			
<b>Field Station#</b>		<b>Field Station#</b>			
<b>Pic 11 Desc.</b>		<b>Pic 12 Desc.</b>

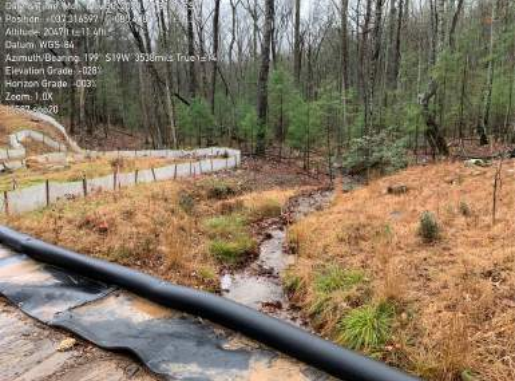
<b>GPS Location</b>	See picture above for GPS coordinates		<b>GPS Location</b>	See picture above for GPS coordinates	
<b>Field Station#</b>	11573+00		<b>Field Station#</b>	11587+00	
<b>Pic 1 Desc.</b>	ECD's and row conditions		<b>Pic 2 Desc.</b>	ECD's and row conditions

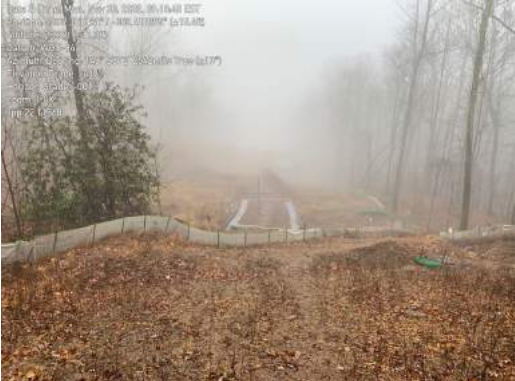
<b>GPS Location</b>	See picture above for GPS coordinates		<b>GPS Location</b>	See picture above for GPS coordinates	
<b>Field Station#</b>	11547+00		<b>Field Station#</b>	11568+00	
<b>Pic 3 Desc.</b>	ECD's and row conditions		<b>Pic 4 Desc.</b>	ECD's and row conditions

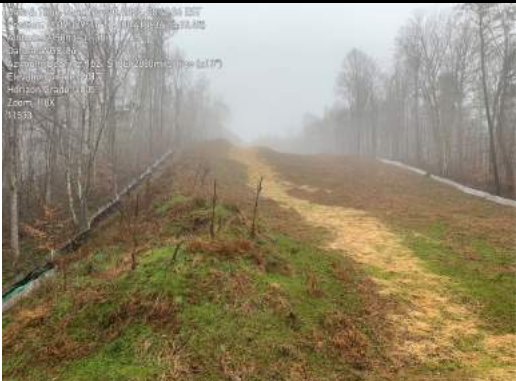
<b>GPS Location</b>	See picture above for GPS coordinates		<b>GPS Location</b>	See picture above for GPS coordinates	
<b>Field Station#</b>	11533+00		<b>Field Station#</b>	11530+00	
<b>Pic 5 Desc.</b>	ECD's and row conditions		<b>Pic 6 Desc.</b>	ECD's and row conditions

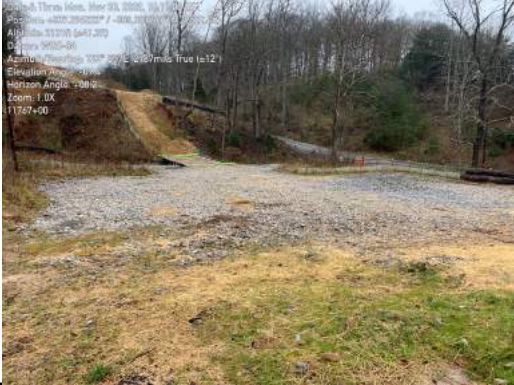
<b>Pic 5 Desc.</b>	RCE in place at Main Line Valve 26.		<b>Pic 6 Desc.</b>	Clean water diversion pipe inlet and clean water diversion berm in place.

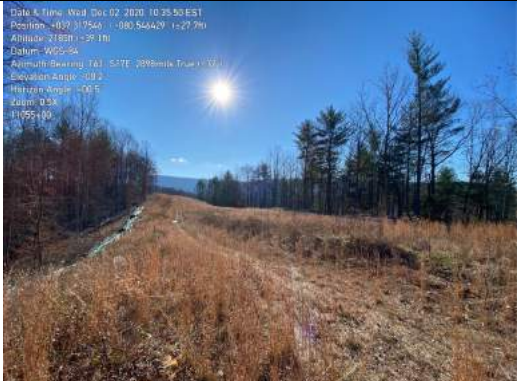
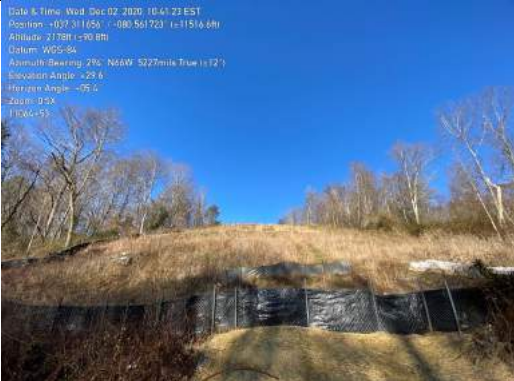
GPS Location	5	GPS Location	6		
Field Station#	11055+00	Field Station#	11064+53		
Pic 5 Desc.	Section of RoW showing conditions and controls.	Pic 6 Desc.	Section of RoW showing conditions and controls.

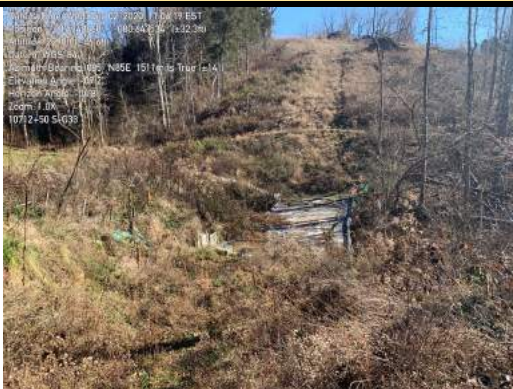
<p>Date &amp; Time: Wed Dec 02 2020 11:07:01 EST Position: 4017346680, -700847974, 1154m Altitude: 2301ft (11:30) Course: W05-84 Azimuth Bearing: 201 N29W 499m True is 10 Elevation Angle: +03.4 Horizontal Angle: 001.7 Zoom: 1.0x 10712+50 S-G33</p>

<p>Date &amp; Time: Wed Dec 02 2020 11:07:01 EST Position: 4017346680, -700847974, 1154m Altitude: 2301ft (11:30) Course: W05-84 Azimuth Bearing: 201 N29W 499m True is 10 Elevation Angle: +03.4 Horizontal Angle: 001.7 Zoom: 1.0x 10710+00</p>			
GPS Location	See photo for GPS location.		GPS Location	See photo for GPS location.	
Field Station#	10712+50		Field Station#	10710+00	
Pic 1 Desc.	Sensitive resource buffer in place at stream S-G33.		Pic 2 Desc.	ROW stabilized with natural vegetation growth.

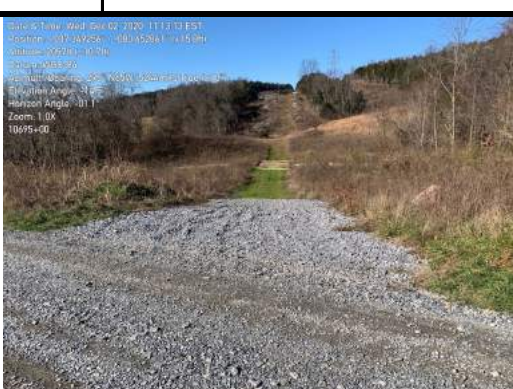
<p>Date &amp; Time: Wed Dec 02 2020 11:17:13 EST Position: 4017346680, -700847974, 1154m Altitude: 2301ft (11:30) Course: W05-84 Azimuth Bearing: 201 N29W 499m True is 10 Elevation Angle: +03.4 Horizontal Angle: 001.7 Zoom: 1.0x 10695+00</p>

<p>Date &amp; Time: Wed Dec 02 2020 11:17:13 EST Position: 4017346680, -700847974, 1154m Altitude: 2301ft (11:30) Course: W05-84 Azimuth Bearing: 201 N29W 499m True is 10 Elevation Angle: +03.4 Horizontal Angle: 001.7 Zoom: 1.0x 10670+00</p>			
GPS Location	See photo for GPS location.		GPS Location	See photo for GPS location.	
Field Station#	10695+00		Field Station#	10670+00	
Pic 5 Desc.	RCE in place at Buffalo Anklets Road.		Pic 6 Desc.	Reinforced super silt fence in place along LOD.

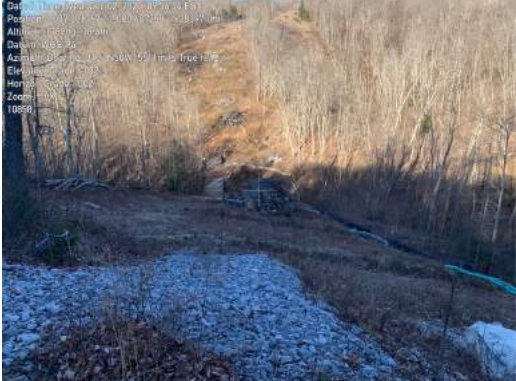
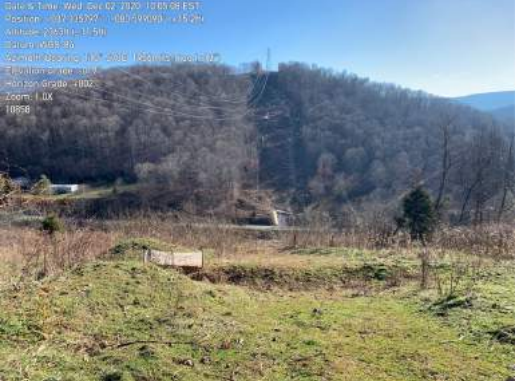
<b>GPS Location</b>	See picture above for GPS coordinates		<b>GPS Location</b>	See picture above for GPS coordinates	
<b>Field Station#</b>	10858+00		<b>Field Station#</b>	10872+00	
<b>Pic 1 Desc.</b>	ECD's and row conditions		<b>Pic 2 Desc.</b>	ECD's and row conditions

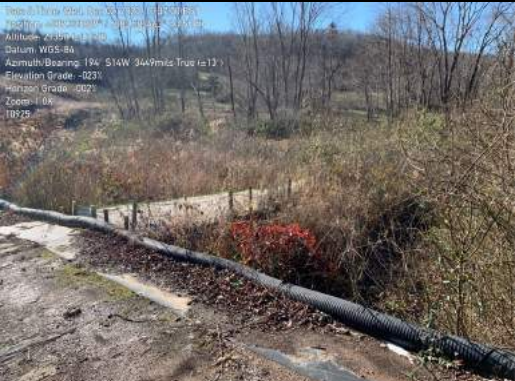
<b>GPS Location</b>	See picture above for GPS coordinates		<b>GPS Location</b>	See picture above for GPS coordinates	
<b>Field Station#</b>	10923+00		<b>Field Station#</b>	10925+00	
<b>Pic 5 Desc.</b>	ECD's and row conditions		<b>Pic 6 Desc.</b>	ECD's and row conditions

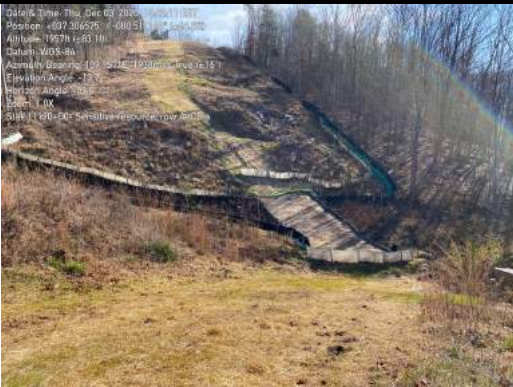
<b>GPS Location</b>	See photo GPS		<b>GPS Location</b>	See photo GPS	
<b>Field Station#</b>	11214+00		<b>Field Station#</b>	11190+00	
<b>Pic 3 Desc.</b>	Slope drain inlet, sump pit and end treatment.		<b>Pic 4 Desc.</b>	Sensitive resource area, ECD's & row.

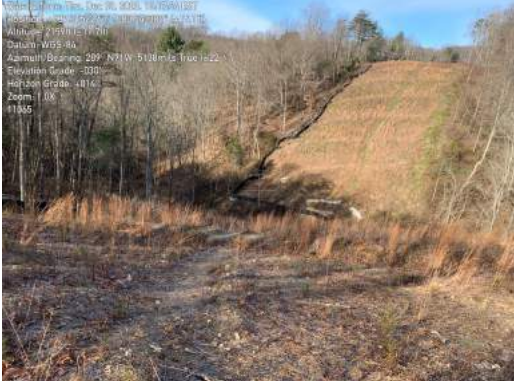
<b>Field Station#</b>	11065+00		<b>Field Station#</b>	11076+00	
<b>Pic 1 Desc.</b>	ECD's and row conditions		<b>Pic 2 Desc.</b>	ECD's and row conditions

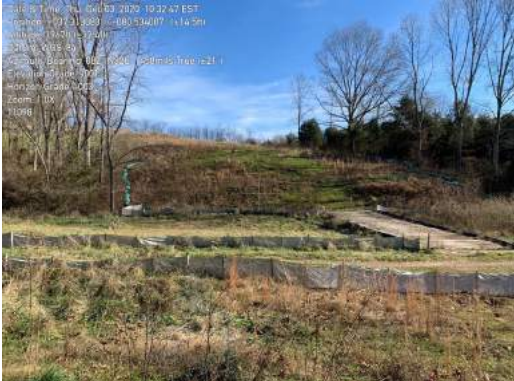
<b>GPS Location</b>	See picture above for GPS coordinates		<b>GPS Location</b>	See picture above for GPS coordinates	
<b>Field Station#</b>	11098+00		<b>Field Station#</b>	11128+00	
<b>Pic 3 Desc.</b>	ECD's and row conditions		<b>Pic 4 Desc.</b>	ECD's and row conditions

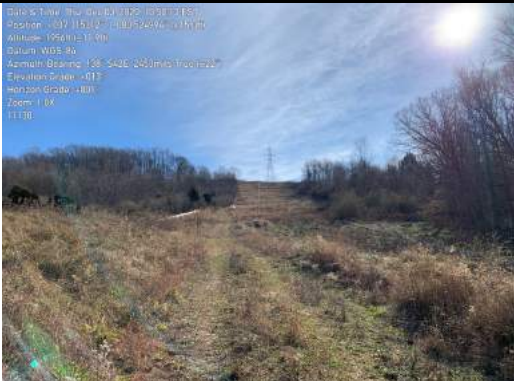
<b>GPS Location</b>	See picture above for GPS coordinates		<b>GPS Location</b>	See picture above for GPS coordinates	
<b>Field Station#</b>	11130+00		<b>Field Station#</b>	11140+00	
<b>Pic 5 Desc.</b>	ECD's and row conditions		<b>Pic 6 Desc.</b>	ECD's and row conditions

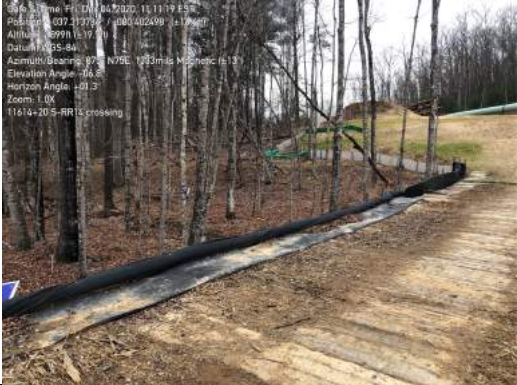
<p> <small> Date &amp; Time: Fri, Dec 04, 2020, 07:45:18 EST  Position: +037.314449° / -550.482614° (+12.8m)  Altitude: 1902ft (+19.7m)  Datum: WGS-84  Azimuth/Bearing: 015° N/SE 0267mils Magnetic (+12°)  Elevation Angle: -13.7°  Horizon Angle: -02.1°  Zoom: 1.0X  S-RR13 crossing 11613+69 </small> </p>			
<b>GPS Location</b>	On photo	<b>GPS Location</b>	On photo		
<b>Field Station#</b>	11614+20	<b>Field Station#</b>	11613+69		
<b>Pic 7 Desc.</b>	The S-RR14 crossing is stable with ECDs in place.	<b>Pic 8 Desc.</b>	The S-RR13 crossing on access road MN-258.04 is in compliance.

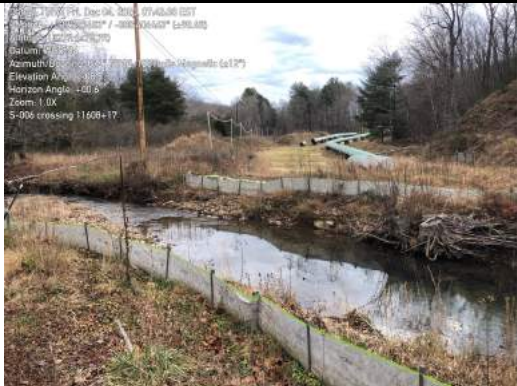
<p> <small> Date &amp; Time: Fri, Dec 04, 2020, 07:43:58 EST  Position: +037.314449° / -550.482614° (+12.8m)  Altitude: 1902ft (+19.7m)  Datum: WGS-84  Azimuth/Bearing: 015° N/SE 0267mils Magnetic (+12°)  Elevation Angle: -13.7°  Horizon Angle: -02.1°  Zoom: 1.0X  S-006 crossing 11608+17 </small> </p>		<div style="text-align: center; height: 100px;">Insert image here</div>			
<b>GPS Location</b>	On photo	<b>GPS Location</b>			
<b>Field Station#</b>	11608+17	<b>Field Station#</b>			
<b>Pic 9 Desc.</b>	The S-006 crossing is stable with adequate ECDs installed.	<b>Pic 10 Desc.</b>			
<div style="text-align: center;">Insert image here</div>		<div style="text-align: center;">Insert image here</div>			
<b>GPS Location</b>		<b>GPS Location</b>			
<b>Field Station#</b>		<b>Field Station#</b>			
<b>Pic 11 Desc.</b>		<b>Pic 12 Desc.</b>

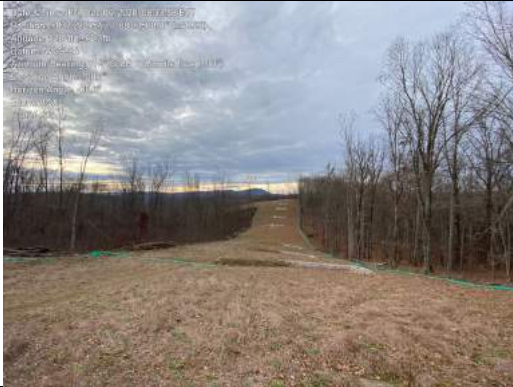
<b>GPS Location</b>	1	<b>GPS Location</b>	2		
<b>Field Station#</b>	11792+00	<b>Field Station#</b>	11826+00		
<b>Pic 1 Desc.</b>	Section of restored RoW showing conditions and controls.	<b>Pic 2 Desc.</b>	Section of restored RoW showing conditions and controls.
