Visual Site Inspection Report

Project Name	H-600 Pipeline Spread G	AFE	124300137	Spread	H-600 Pipeline Spread G
Contractor	Precision			Report #	16591
Inspector	Len Kruizenga			Date/Time	11/9/2020 9:01 AM
Permit #	TBD	Inspection Type	VA SWPP	Station Begin	12005+00
State	VA	Inspection Area	Full	Station End	12005+00
County	Giles	Ground	Dry	Temperature (°F)	67.00
Municipality	N/A	Weather	Sunny	Rain Gauge (in)	0.00
				Rain Accumulation Time (days)	1.00

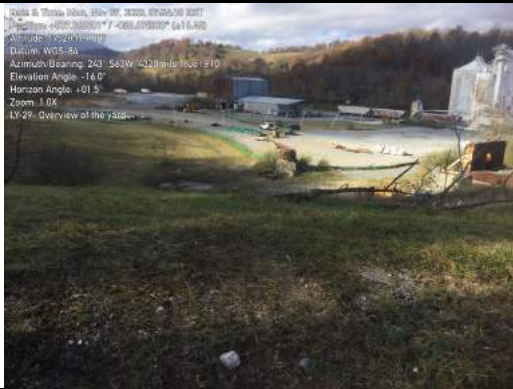
<p>Date & Time: Mon, Nov 9, 2020, 09:05:00 AM Position: 4227.345404°N 77°40'00.0000°W Elevation: 1041 ft (317.27 m) Datum: WGS-84 Azimuth Bearing: 242° 54'00" (428.0000° True) Elevation Angle: -16.0° Horizon Angle: -01.5° Zoom: 1.0x LY-29: Overview of the yard.</p>			
GPS Location	See photo GPS	GPS Location	See photo GPS		
Field Station#	12005+00	Field Station#	12005+00		
Pic 1 Desc.	AR-238.00	Pic 2 Desc.	Overview of LY29

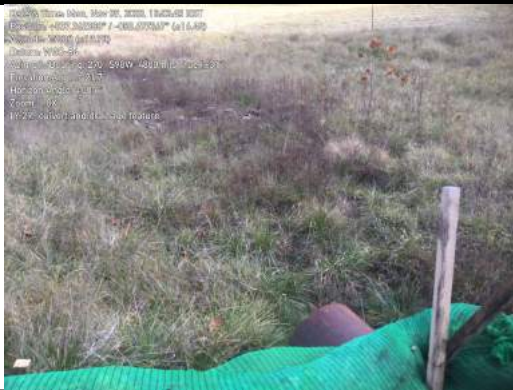
<p>Date & Time: Mon, Nov 9, 2020, 09:07:00 AM Position: 4227.345404°N 77°40'00.0000°W Elevation: 1041 ft (317.27 m) Datum: WGS-84 Azimuth Bearing: 229° 54'00" (450.0000° True) Elevation Angle: -16.0° Horizon Angle: -01.7° Zoom: 1.0x LY-29: Culvert and drainage feature.</p>			
GPS Location	See photo GPS	GPS Location	See photo GPS		
Field Station#	12005+00	Field Station#	12005+00

Pic 5 Desc.	Contractor is replacing old CFS perimeter controls.	Pic 6 Desc.	Culvert and drainage feature.

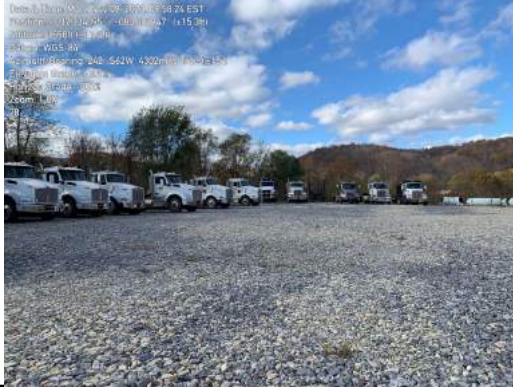
GPS Location	See picture above for GPS coordinates		GPS Location	See picture above for GPS coordinates	
Field Station#	12005+00		Field Station#	12005+00	
Pic 3 Desc.	ECD's and row conditions		Pic 4 Desc.	ECD's and row conditions

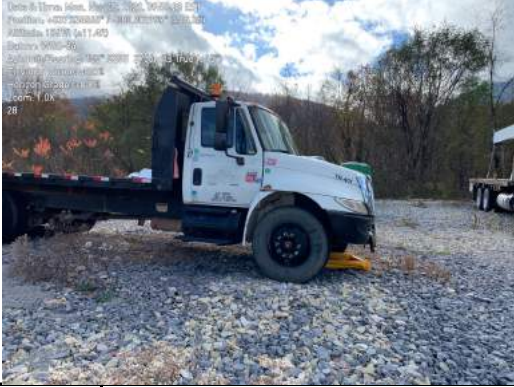
GPS Location	See picture above for GPS coordinates		GPS Location	See picture above for GPS coordinates	
Field Station#	12005+00		Field Station#	12005+00	
Pic 5 Desc.	ECD's and row conditions		Pic 6 Desc.	ECD's and row conditions

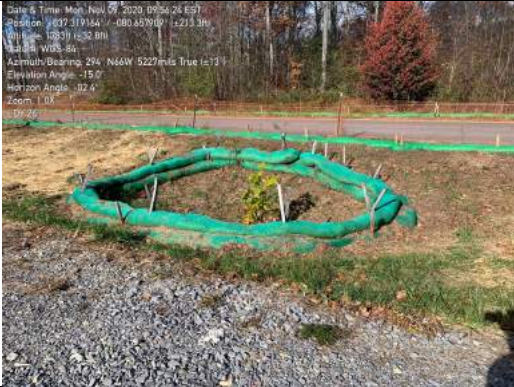
GPS Location	See photo for GPS location.		GPS Location	See photo for GPS location.	
Field Station#	12005+00		Field Station#	12005+00	
Pic 1 Desc.	Triple stack compost filter sock in place around drainage.		Pic 2 Desc.	RCE in place at MLV 26 entrance.

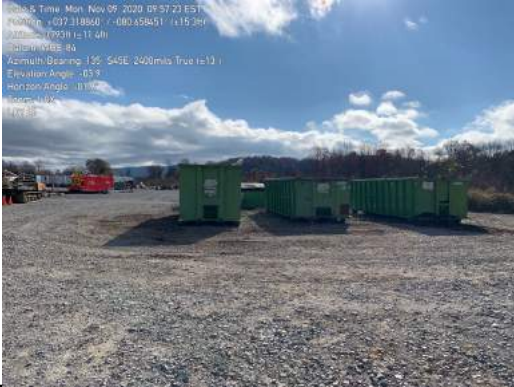
GPS Location	See photo for GPS location.		GPS Location	See photo for GPS location.	
Field Station#	12005+00		Field Station#	12005+00	
Pic 3 Desc.	Dumpsters being utilized for trash management.		Pic 4 Desc.	18 inch compost filter sock in place along LOD.

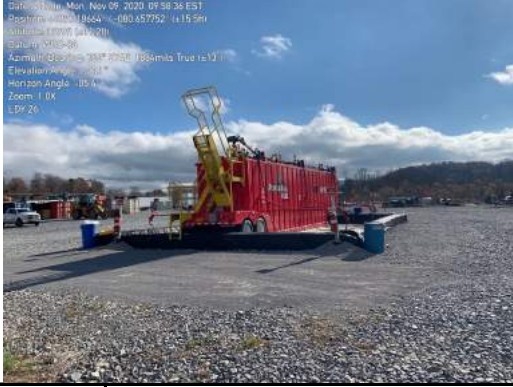
GPS Location	See photo for GPS location.		GPS Location	See photo for GPS location.	
Field Station#	12005+00		Field Station#	12005+00	
Pic 5 Desc.	Checked staged equipment for leaks.		Pic 6 Desc.	Secondary containment in place under fuel.

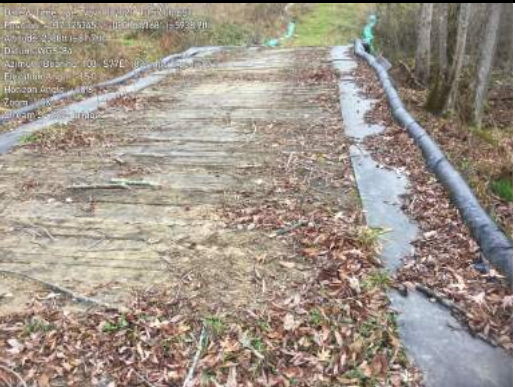
GPS Location	See photo GPS		GPS Location	See photo GPS	
Field Station#	11023+88		Field Station#	10986+00	
Pic 1 Desc.	P1 damaged, added to the punch list.		Pic 2 Desc.	Stream S- E25

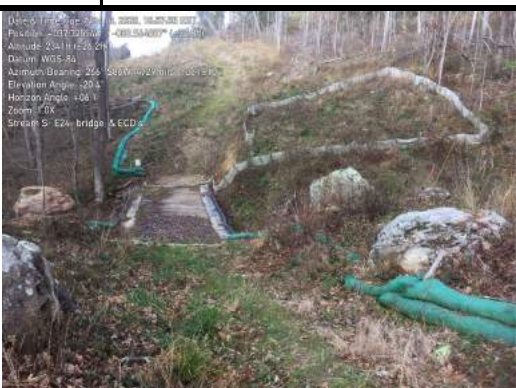
GPS Location	See photo GPS		GPS Location	See photo GPS	
Field Station#	10985+00		Field Station#	10965+00	
Pic 3 Desc.	Stream S- E24		Pic 4 Desc.	Sensitive resource ECD's.

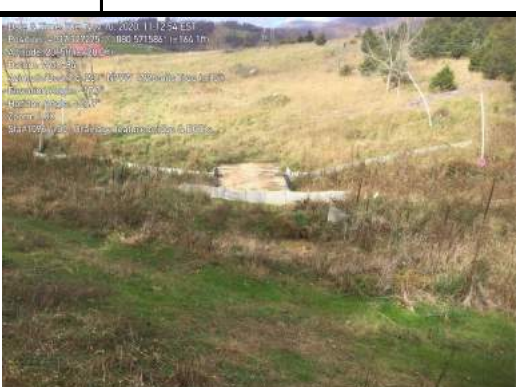
GPS Location	See photo GPS		GPS Location	See photo GPS	
Field Station#	10964+00		Field Station#	10930+00	
Pic 5 Desc.	Drainage feature bridge and ECD's.		Pic 6 Desc.	Doe Creek RCE ECD's.

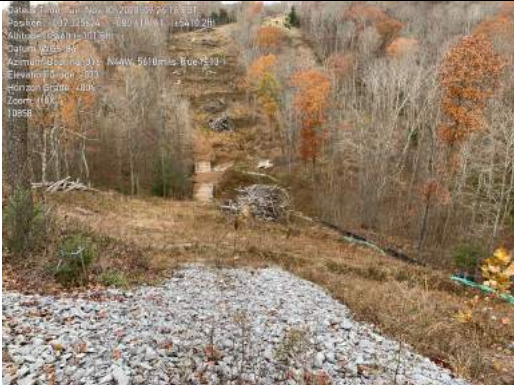
GPS Location	See picture above for GPS coordinates		GPS Location	See picture above for GPS coordinates	
Field Station#	10858+00		Field Station#	10863+00	
Pic 1 Desc.	ECD's and row conditions		Pic 2 Desc.	ECD's and row conditions

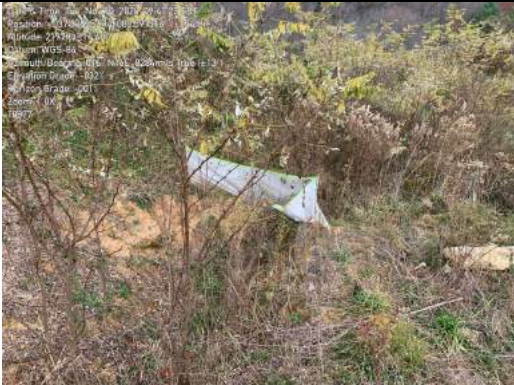
GPS Location	See picture above for GPS coordinates		GPS Location	See picture above for GPS coordinates	
Field Station#	10877+00		Field Station#	10888+00	
Pic 3 Desc.	ECD's and row conditions		Pic 4 Desc.	ECD's and row conditions

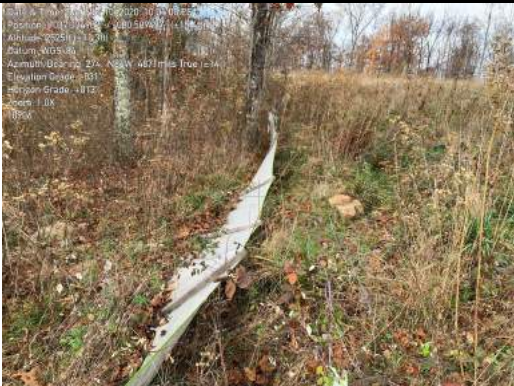
GPS Location	See picture above for GPS coordinates		GPS Location	See picture above for GPS coordinates	
Field Station#	10906+00		Field Station#	10909+00	
Pic 5 Desc.	ECD's and row conditions		Pic 6 Desc.	Damaged P1

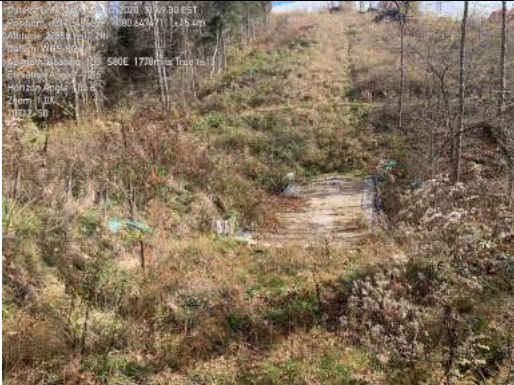
GPS Location	See photo for GPS location.		GPS Location	See photo for GPS location.	
Field Station#	10712+50		Field Station#	10711+00	
Pic 1 Desc.	Sensitive resource buffer in place at stream S-G33.		Pic 2 Desc.	Priority one silt fence checks in place.

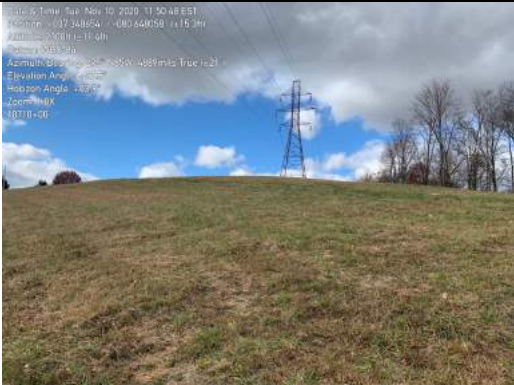
GPS Location	See photo for GPS location.		GPS Location	See photo for GPS location.	
Field Station#	10710+00		Field Station#	10702+00	
Pic 3 Desc.	ROW stabilized with natural vegetation growth.		Pic 4 Desc.	Travel lane stabilized with ECB and seed. Minor vegetation growth present.

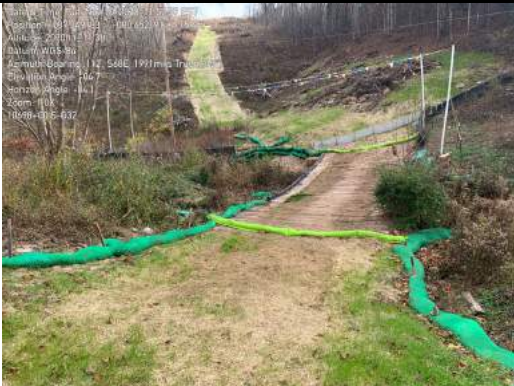
GPS Location	See photo for GPS location.		GPS Location	See photo for GPS location.	
Field Station#	10698+00		Field Station#	10696+00	
Pic 5 Desc.	Sensitive resource buffer in place at stream S-G32.		Pic 6 Desc.	RCE in place at Buffalo Anklets Road.

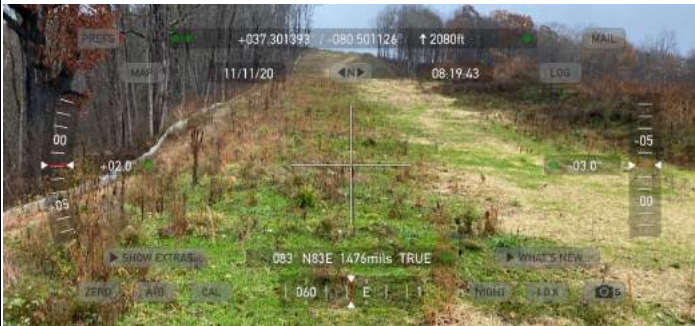
GPS Location	See photo GPS		GPS Location	See photo GPS	
Field Station#	11227+00		Field Station#	11217+00	
Pic 1 Desc.	Row stabilization		Pic 2 Desc.	P1 perimeter controls

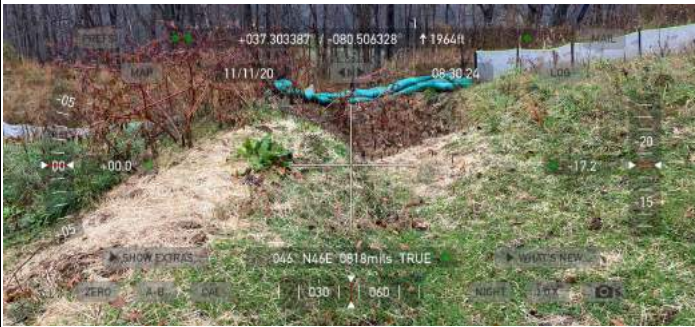
GPS Location	See photo GPS		GPS Location	See photo GPS	
Field Station#	11206+00		Field Station#	11191+00	
Pic 3 Desc.	Water bar and end treatment.		Pic 4 Desc.	Sensitive resource area/drainage feature and ECD's.

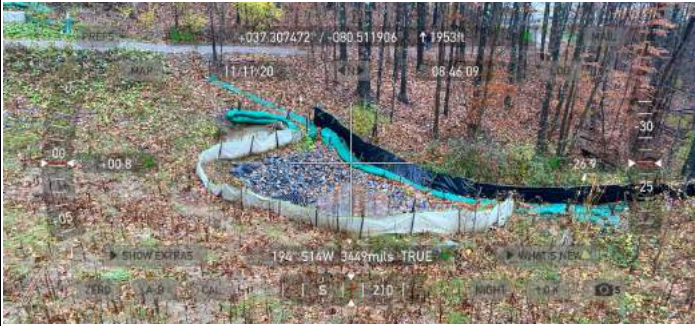
GPS Location	See photo GPS		GPS Location	See photo GPS	
Field Station#	11184+00		Field Station#	11172+70	
Pic 5 Desc.	CWD pipe and plunge pool		Pic 6 Desc.	Slope drain pipe, CSF check dams, sump pits, end treatment.

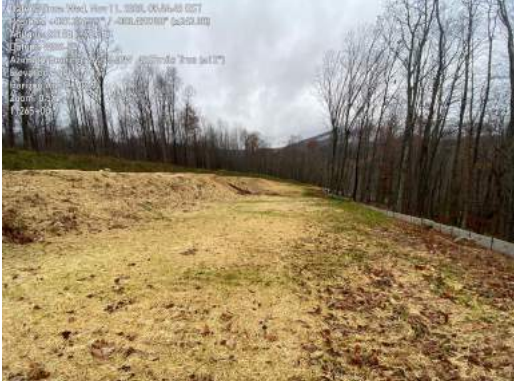
GPS Location	1	GPS Location	2		
Field Station#	11265+00	Field Station#	11292+80		
Pic 1 Desc.	Section of RoW showing conditions and controls.	Pic 2 Desc.	S-MM18 and controls.

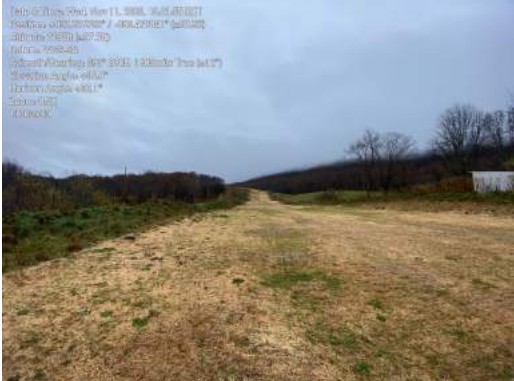
GPS Location	3	GPS Location	4		
Field Station#	11300+00	Field Station#	11327+85		
Pic 3 Desc.	Section of RoW showing conditions and controls.	Pic 4 Desc.	S-NN12 and controls.

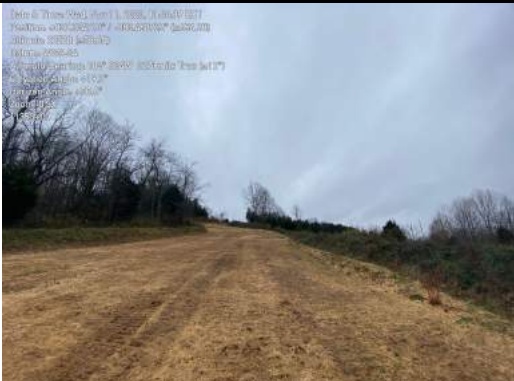
GPS Location	5	GPS Location	6		
Field Station#	11350+00	Field Station#	11352+97		
Pic 5 Desc.	Section of RoW showing conditions and controls.	Pic 6 Desc.	S-NN11 and controls.

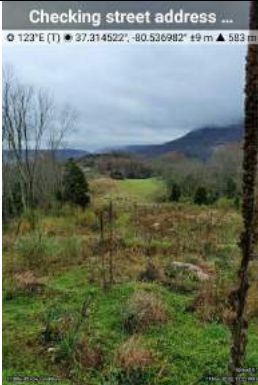
GPS Location	see photo		GPS Location	see photo	
Field Station#	11086+00		Field Station#	11136+00	
Pic 1 Desc.	stabilized row conditions		Pic 2 Desc.	downed p1, cause unknown

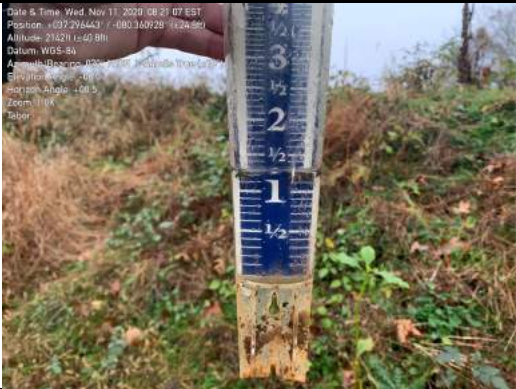
GPS Location	See photo for GPS location.		GPS Location	See photo for GPS location.	
Field Station#	11788+50		Field Station#	11990+00	
Pic 1 Desc.	Rain gauge at Mount Tabor Road reads 1.3 inches.		Pic 2 Desc.	Rain gauge at Catawba Road reads 1.5 inches.

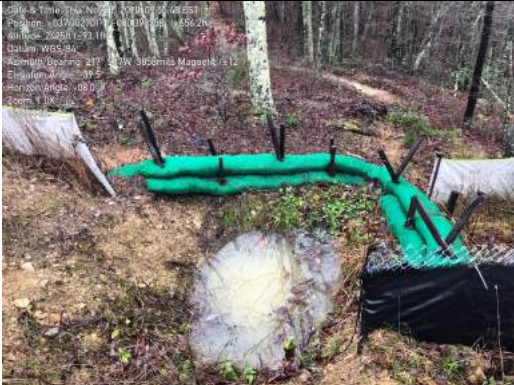
GPS Location	On photo	GPS Location	On photo		
Field Station#	11668+00	Field Station#	11663+00		
Pic 1 Desc.	Perimeter controls are functional.	Pic 2 Desc.	Perimeter controls are in place and functional.

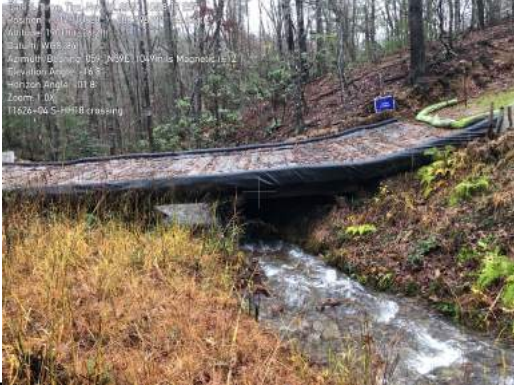
GPS Location	On photo	GPS Location	On photo		
Field Station#	11626+04	Field Station#	11614+20		
Pic 5 Desc.	S-HH18 has not been impacted. The buffer is stable with ECDs in place.	Pic 6 Desc.	S-RR14 has not been impacted. The buffer is stable with ECDs in place.

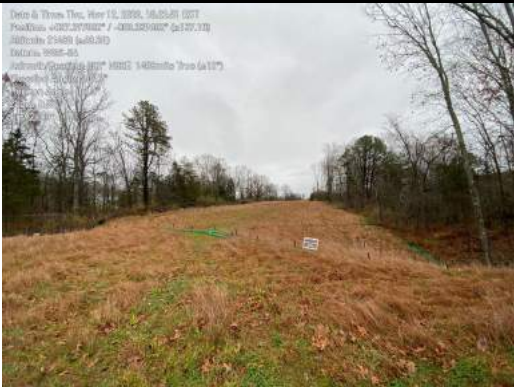
GPS Location	1	GPS Location	2		
Field Station#	11792+00	Field Station#	11818+00		
Pic 1 Desc.	Section of restored RoW showing conditions and controls.	Pic 2 Desc.	Section of restored RoW showing conditions and controls.

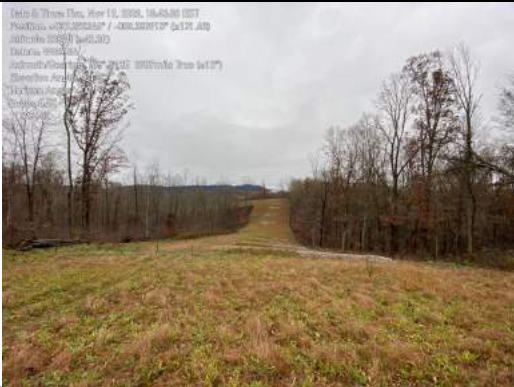
GPS Location	3	GPS Location	4		
Field Station#	11825+00	Field Station#	11863+65		
Pic 3 Desc.	Section of restored RoW showing conditions and controls.	Pic 4 Desc.	P-KL2 and controls.

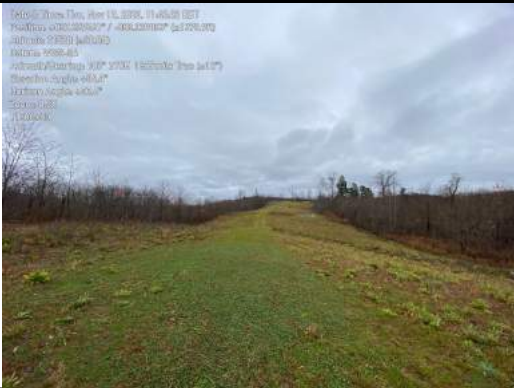
GPS Location	5	GPS Location	6		
Field Station#	11886+00	Field Station#	11899+75		
Pic 5 Desc.	Section of restored RoW showing conditions and controls.	Pic 6 Desc.	Section of restored RoW showing conditions and controls.

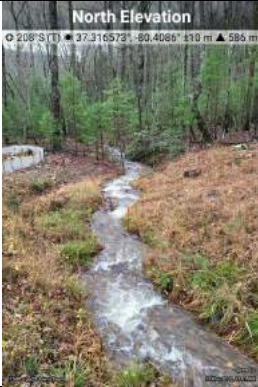
GPS Location	see photo		GPS Location	see photo	
Field Station#	11576+00		Field Station#	11588+00	
Pic 1 Desc.	ssf in need of repair		Pic 2 Desc.	s-pp20 crossing through the row

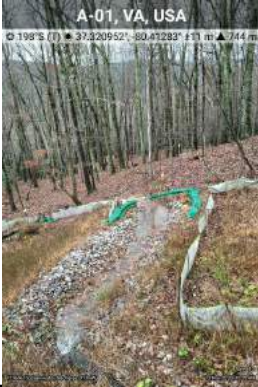
GPS Location	see photo		GPS Location	see photo	
Field Station#	11569+15		Field Station#	11558+00	
Pic 3 Desc.	clean water discharge off row		Pic 4 Desc.	silt fence down

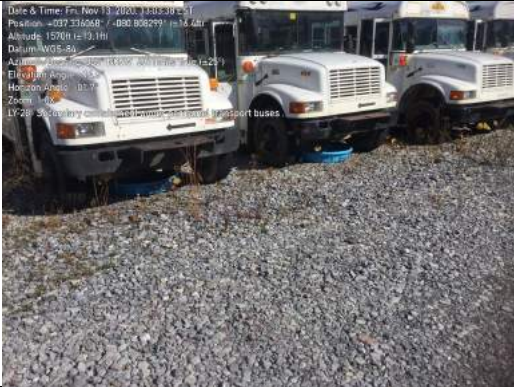
<p>Date & Time: Fri, Nov 13, 2020 3:53:38 EST Position: -077.2136427, 4382.8662797, 16.16 m Altitude: 1570ft (479.1m) Datum: WGS-84 Azimuth/Bearing: 244° 56'W 4373mils true (±31°) Elevation Angle: -07.5° Horizon Angle: -02.5° Zoom: 1.0K LY-28- Secondary controls, 2010 PPL personnel transport buses</p>

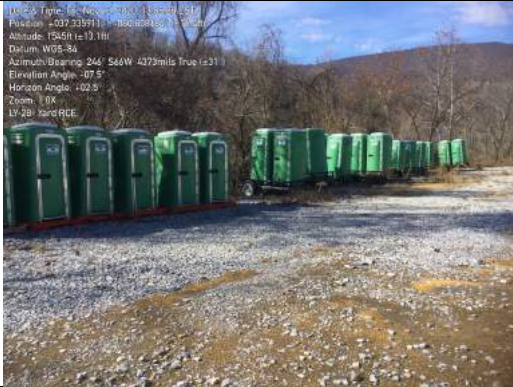
<p>Date & Time: Fri, Nov 13, 2020 3:53:38 EST Position: -077.2136427, 4382.8662797, 16.16 m Altitude: 1565ft (476.1m) Datum: WGS-84 Azimuth/Bearing: 244° 56'W 4373mils true (±31°) Elevation Angle: -07.5° Horizon Angle: -02.5° Zoom: 1.0K LY-28- Porta Johns stored.</p>			
GPS Location	See photo GPS	GPS Location	See photo GPS		
Field Station#	12005+00	Field Station#	12005+00		
Pic 1 Desc.	PPL personnel carriers, secondary containment under some units.	Pic 2 Desc.	LY-28- Porta Johns stored.

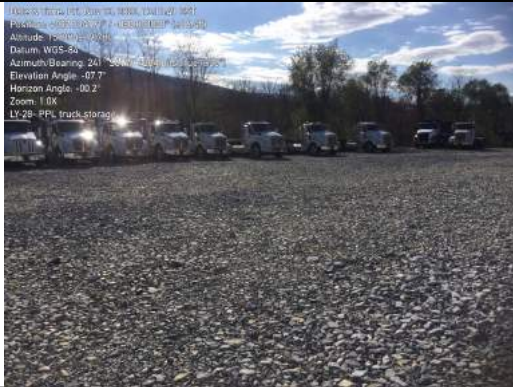
<p>Date & Time: Fri, Nov 13, 2020 3:54:00 EST Position: -077.2136427, 4382.8662797, 16.16 m Altitude: 1562ft (476.0m) Datum: WGS-84 Azimuth/Bearing: 244° 56'W 4373mils true (±31°) Elevation Angle: -07.5° Horizon Angle: -02.5° Zoom: 1.0K LY-28- PPL truck storage.</p>

GPS Location	See photo GPS	GPS Location	See photo GPS		
Field Station#	12005+00	Field Station#	12005+00		
Pic 3 Desc.	LY-28- CFS controls.	Pic 4 Desc.	LY-28- PPL truck storage.

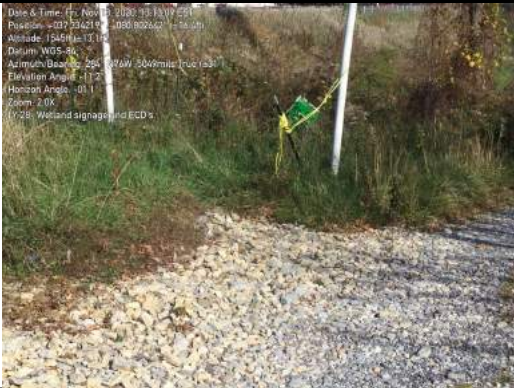
<p>Date & Time: Fri, Nov 13, 2020 3:54:00 EST Position: -077.2136427, 4382.8662797, 16.16 m Altitude: 1545ft (470.6m) Datum: WGS-84 Azimuth/Bearing: 244° 56'W 4373mils true (±31°) Elevation Angle: -07.5° Horizon Angle: -02.5° Zoom: 1.0K LY-28- Wetland signage and ECD's</p>		Insert image here			
GPS Location	See photo GPS	GPS Location			
Field Station#	12005+00	Field Station#			
Pic 5 Desc.	LY- 28- Sensitive resource signage.	Pic 6 Desc.

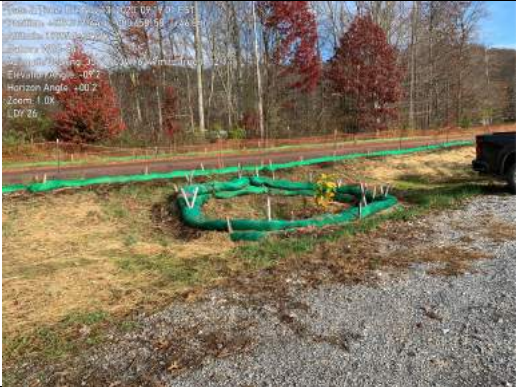
GPS Location	See photo for GPS location.		GPS Location	See photo for GPS location.	
Field Station#	12005+00		Field Station#	12005+00	
Pic 1 Desc.	Triple stack cfs in place around drainage.		Pic 2 Desc.	RCE in place at LDY 26 entrance.

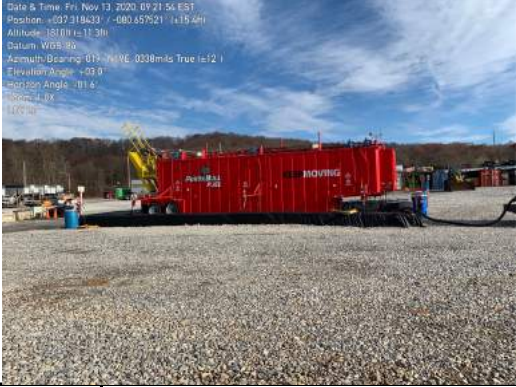
GPS Location	See photo for GPS location.		GPS Location	See photo for GPS location.	
Field Station#	12005+00		Field Station#	12005+00	
Pic 5 Desc.	Secondary containment in place under fuel cell.		Pic 6 Desc.	Checked staged equipment for leaks.
