Visual Site Inspection Report

Project Name	H-600 Pipeline Spread G	AFE	124300137	Spread	H-600 Pipeline Spread G
Contractor	Precision			Report #	14558
Inspector	Len Kruizenga			Date/Time	9/14/2020 12:54 PM
Permit #	TBD	Inspection Type	VA SWPP	Station Begin	12005+00
State	VA	Inspection Area	Full	Station End	12005+00
County	Giles	Ground	Dry	Temperature (°F)	70.00
Municipality	N/A	Weather	Cloudy	Rain Gauge (in)	0.00
				Rain Accumulation Time (days)	1.00

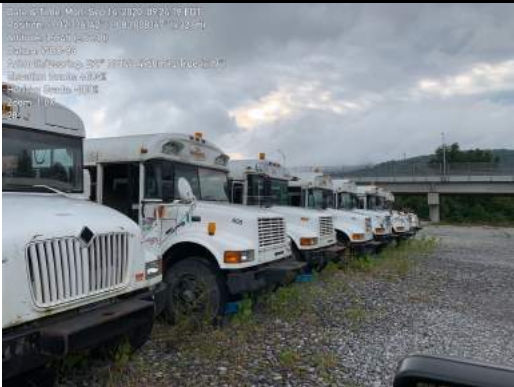
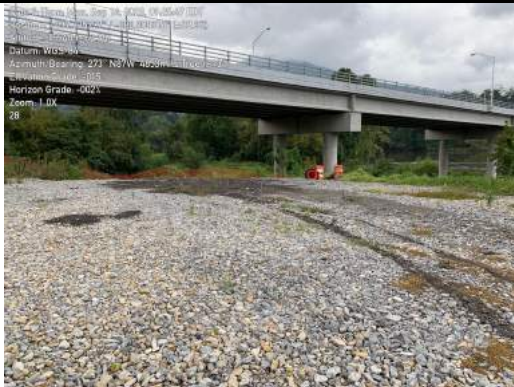
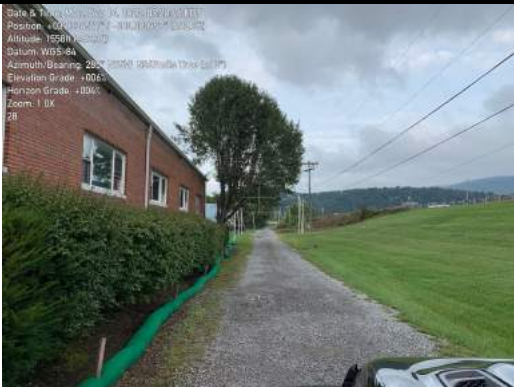
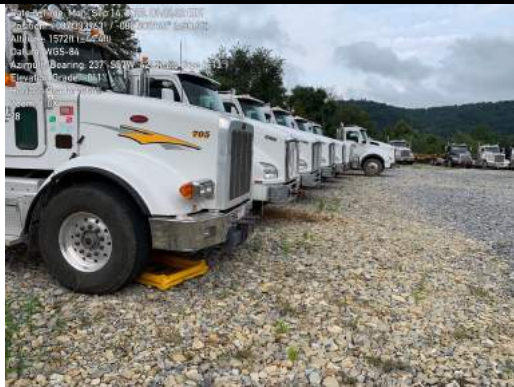
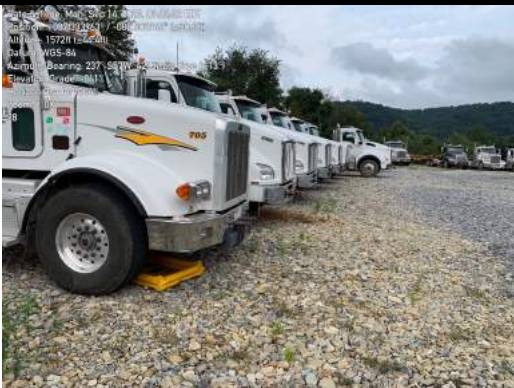
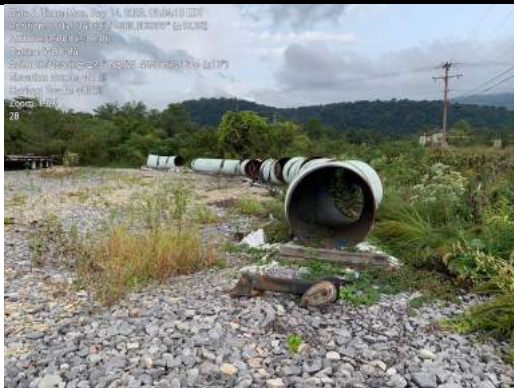
GPS Location	See picture above for GPS coordinates		GPS Location	See picture above for GPS coordinates	
Field Station#	12005+00		Field Station#	12005+00	
Pic 1 Desc.	ECD's and row conditions		Pic 2 Desc.	ECD's and row conditions

GPS Location	See picture above for GPS coordinates		GPS Location	See picture above for GPS coordinates	
Field Station#	12005+00		Field Station#	12005+00	
Pic 3 Desc.	ECD's and row conditions		Pic 4 Desc.	ECD's and row conditions

GPS Location	See picture above for GPS coordinates		GPS Location	See picture above for GPS coordinates	
Field Station#	12005+00		Field Station#	12005+00	
Pic 5 Desc.	ECD's and row conditions		Pic 6 Desc.	ECD's and row conditions

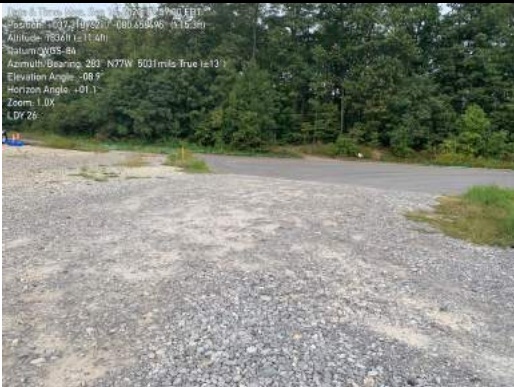
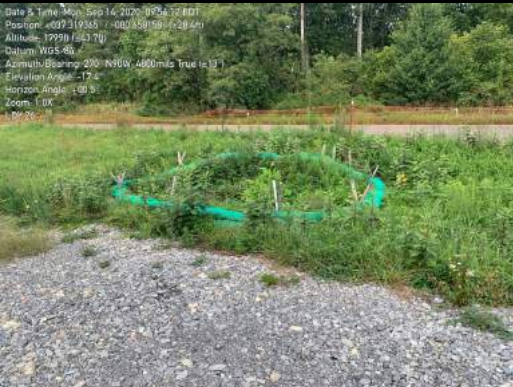
GPS Location	See photo for GPS location.		GPS Location	See photo for GPS location.	
Field Station#	12005+00		Field Station#	12005+00	
Pic 1 Desc.	RCE in place at Lay Down Yard 26.		Pic 2 Desc.	Triple stack compost filter sock in place around drainage.

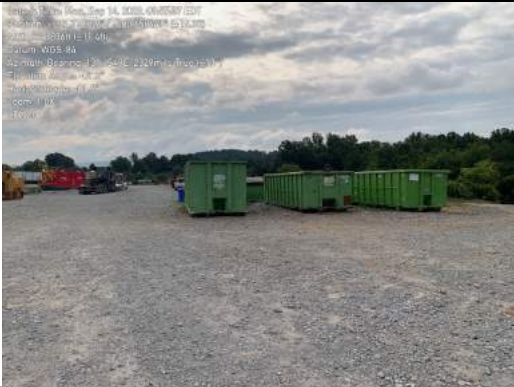
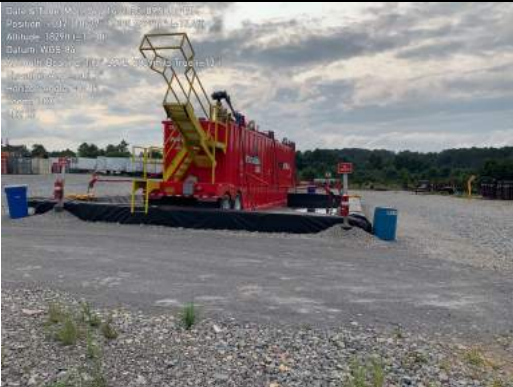
GPS Location	See photo for GPS location.		GPS Location	See photo for GPS location.	
Field Station#	12005+00		Field Station#	12005+00	
Pic 3 Desc.	Dumpsters being utilized for trash management.		Pic 4 Desc.	Secondary containment in place under fuel cell.

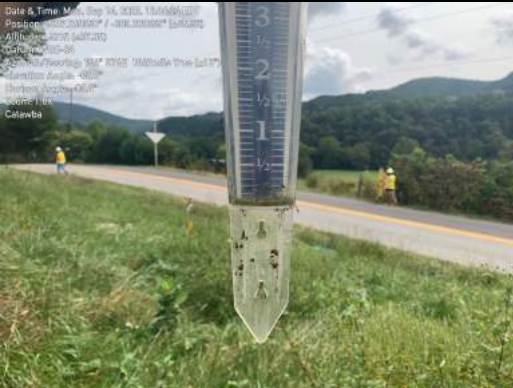
GPS Location	See photo for GPS location.		GPS Location	See photo for GPS location.	
Field Station#	11788+00		Field Station#	11990+00	
Pic 5 Desc.	Rain gauge at Mount Tabor reads 0.0 inches.		Pic 6 Desc.	Rain gauge at Catawba Road reads 0.05 inches.

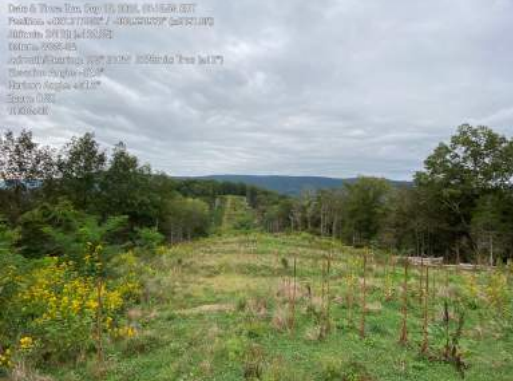
GPS Location	1	GPS Location	2		
Field Station#	11025+50	Field Station#	11034+00		
Pic 1 Desc.	S-IJ18 and controls.	Pic 2 Desc.	Section of RoW showing conditions and controls.

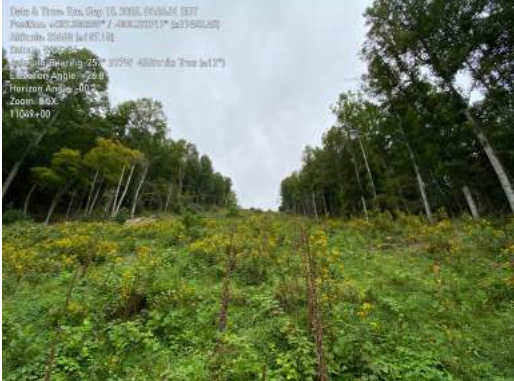
GPS Location	3	GPS Location	4		
Field Station#	11049+00	Field Station#	11050+10		
Pic 3 Desc.	Section of RoW showing conditions and controls.	Pic 4 Desc.	S-IJ16B/S-IJ17 and controls.

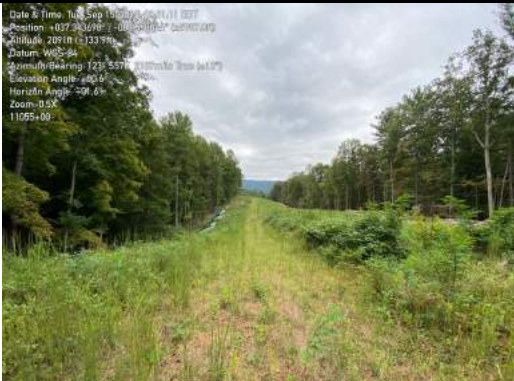
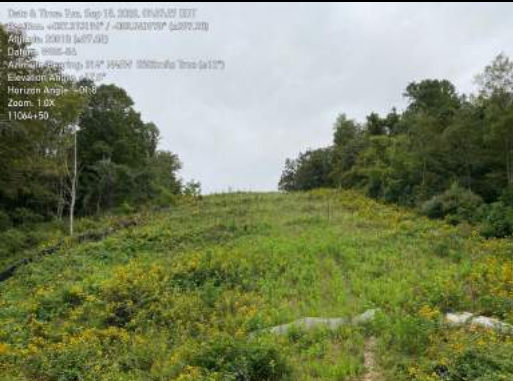
GPS Location	5	GPS Location	6		
Field Station#	11055+00	Field Station#	11064+50		
Pic 5 Desc.	Section of RoW showing conditions and controls.	Pic 6 Desc.	Section of RoW showing conditions and controls.

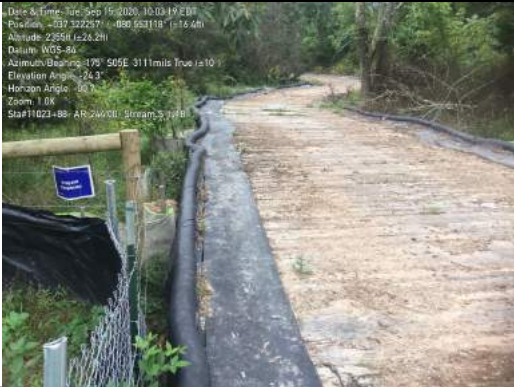
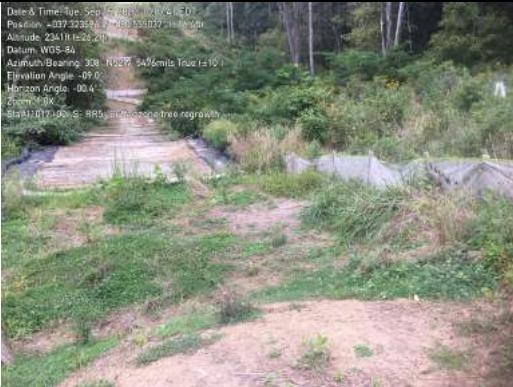
GPS Location	See photo GPS		GPS Location	See photo GPS	
Field Station#	11023+88		Field Station#	11017+00	
Pic 3 Desc.	Stream S-IJ18		Pic 4 Desc.	Stream S- RR5- Buffer tree regrowth.

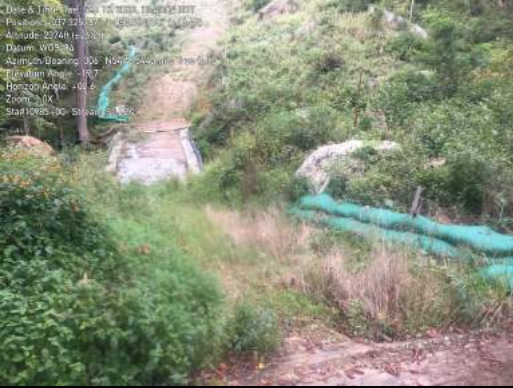
GPS Location	See photo GPS		GPS Location	See photo GPS	
Field Station#	10986+00		Field Station#	10985+00	
Pic 5 Desc.	Stream S- E25		Pic 6 Desc.	Stream S- E24

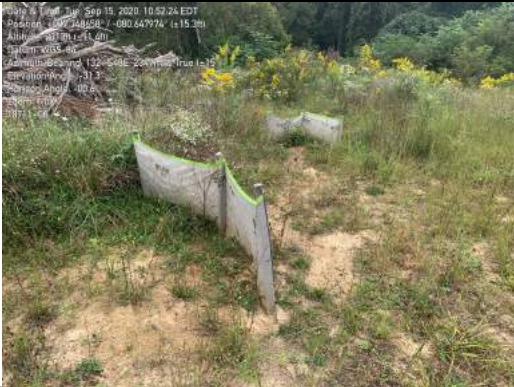
GPS Location	See photo for GPS location.		GPS Location	See photo for GPS location.	
Field Station#	10711+00		Field Station#	10710+00	
Pic 3 Desc.	Priority one silt fence checks in place.		Pic 4 Desc.	ROW stabilized with natural vegetation growth.

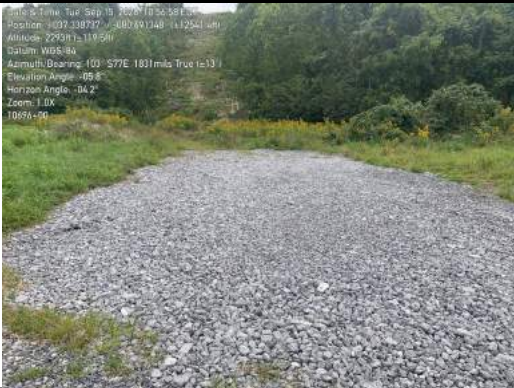
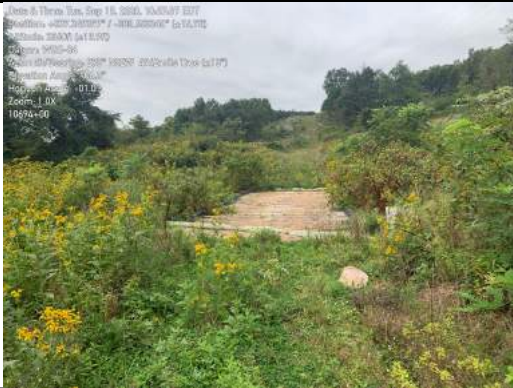
GPS Location	See photo for GPS location.		GPS Location	See photo for GPS location.	
Field Station#	10696+00		Field Station#	10694+00	
Pic 5 Desc.	RCE in place at Buffalo Anklets Road.		Pic 6 Desc.	Clean water drainage feature air bridge and ECDs in place.

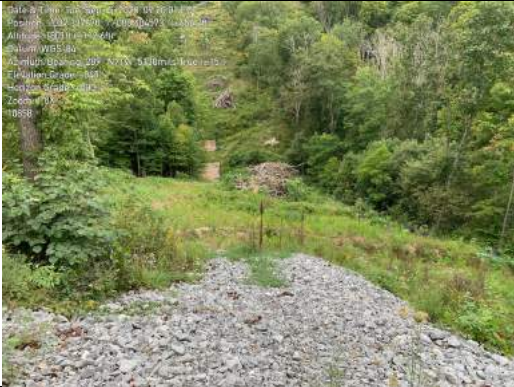
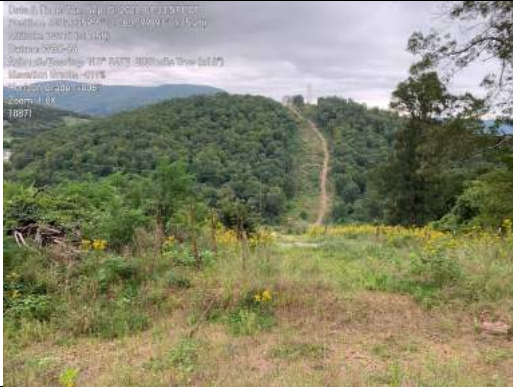
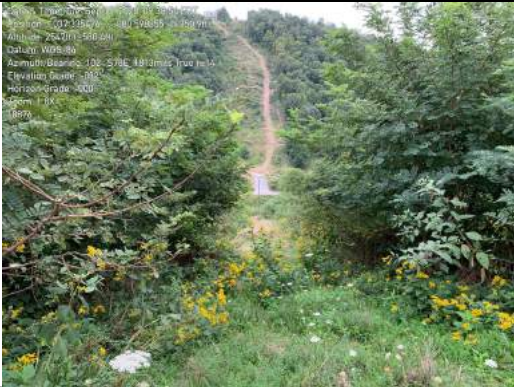
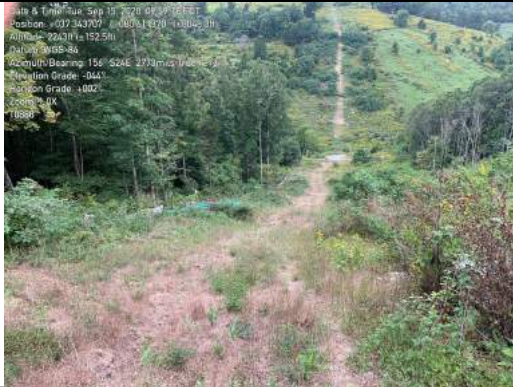
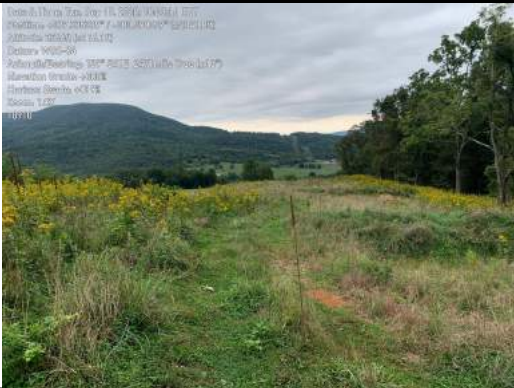
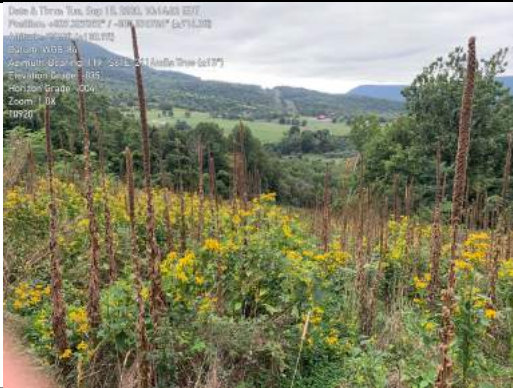
GPS Location	See picture above for GPS coordinates		GPS Location	See picture above for GPS coordinates	
Field Station#	10858+00		Field Station#	10871+00	
Pic 1 Desc.	ECD's and row conditions		Pic 2 Desc.	ECD's and row conditions

GPS Location	See picture above for GPS coordinates		GPS Location	See picture above for GPS coordinates	
Field Station#	10876+00		Field Station#	10888+00	
Pic 3 Desc.	ECD's and row conditions		Pic 4 Desc.	ECD's and row conditions

GPS Location	See picture above for GPS coordinates		GPS Location	See picture above for GPS coordinates	
Field Station#	10910+00		Field Station#	10920+00	
Pic 5 Desc.	ECD's and row conditions		Pic 6 Desc.	ECD's and row conditions

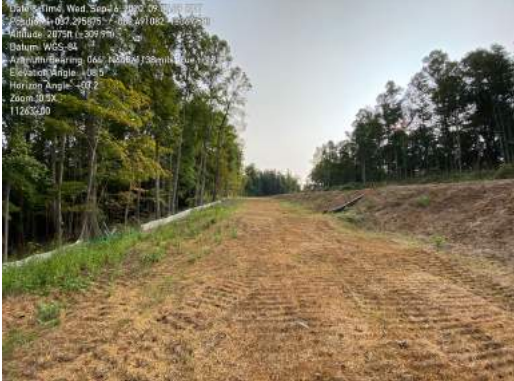
GPS Location	1	GPS Location	2		
Field Station#	11263+00	Field Station#	11292+80		
Pic 1 Desc.	Section of RoW showing conditions and controls.	Pic 2 Desc.	S-MM18 and controls.

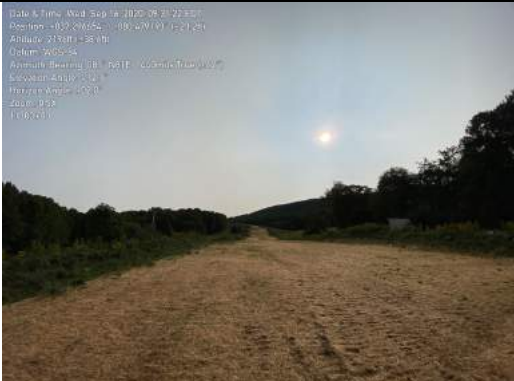
GPS Location	3	GPS Location	4		
Field Station#	11300+00	Field Station#	11327+85		
Pic 3 Desc.	Section of RoW showing conditions and controls.	Pic 4 Desc.	S-NN12 and controls.

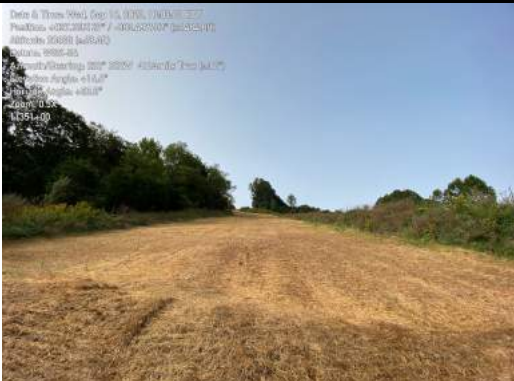
GPS Location	5	GPS Location	6		
Field Station#	11351+00	Field Station#	11352+97		
Pic 5 Desc.	Section of RoW showing conditions and controls.	Pic 6 Desc.	S-NN11 and controls.

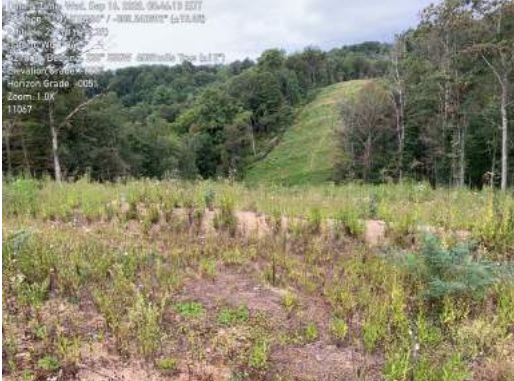
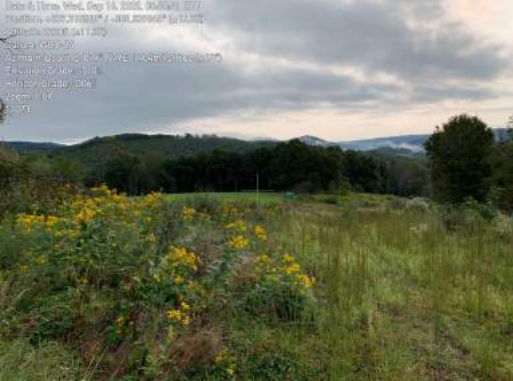
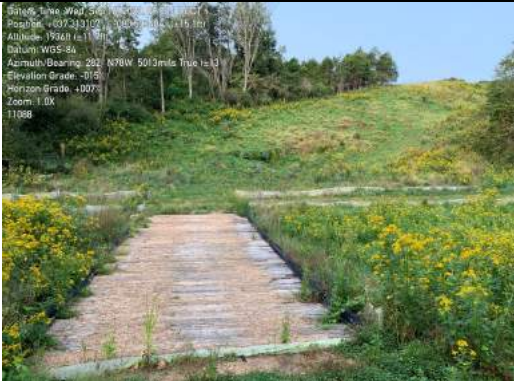
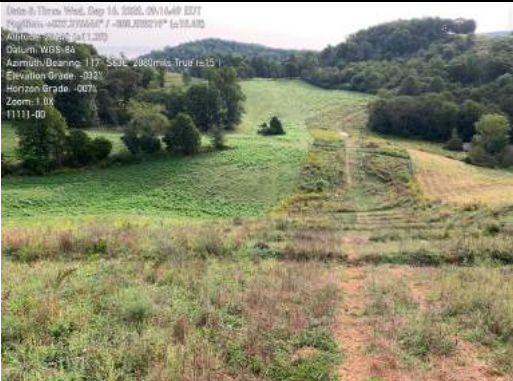
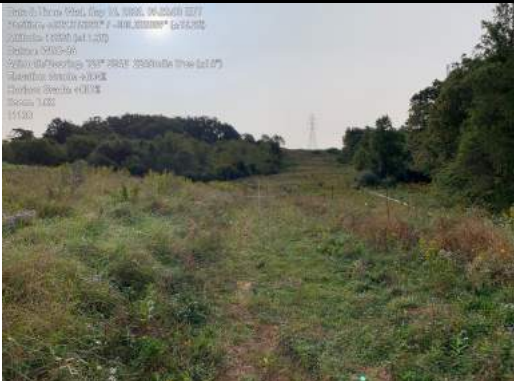
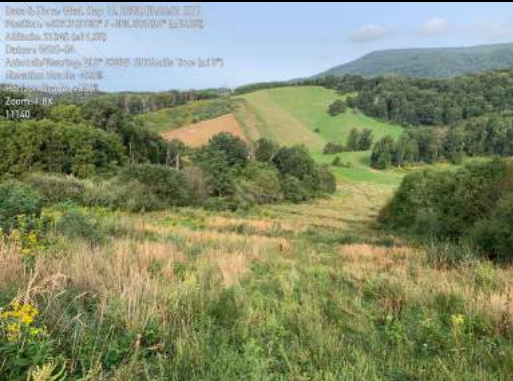
GPS Location	See picture above for GPS coordinates		GPS Location	See picture above for GPS coordinates	
Field Station#	11067+00		Field Station#	11073+00	
Pic 1 Desc.	ECD's and row conditions		Pic 2 Desc.	ECD's and row conditions

GPS Location	See picture above for GPS coordinates		GPS Location	See picture above for GPS coordinates	
Field Station#	11088+00		Field Station#	11111+00	
Pic 3 Desc.	ECD's and row conditions		Pic 4 Desc.	ECD's and row conditions

GPS Location	See picture above for GPS coordinates		GPS Location	See picture above for GPS coordinates	
Field Station#	11130+00		Field Station#	11140+00	
Pic 5 Desc.	ECD's and row conditions		Pic 6 Desc.	ECD's and row conditions

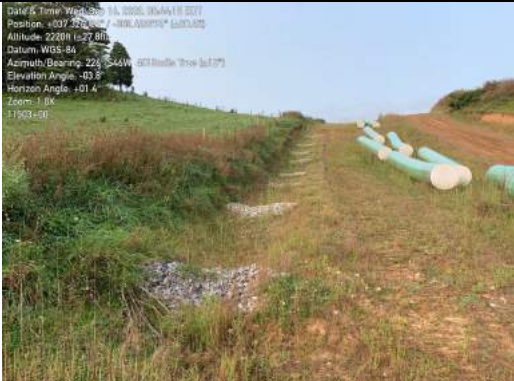
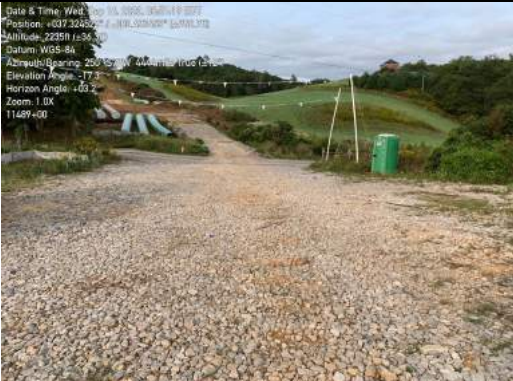
GPS Location	See photo for GPS location.		GPS Location	See photo for GPS location.	
Field Station#	11503+00		Field Station#	11489+00	
Pic 3 Desc.	ECB lined conveyance channel in place with rock checks.		Pic 4 Desc.	RCE in place at Stevers Gap Road.

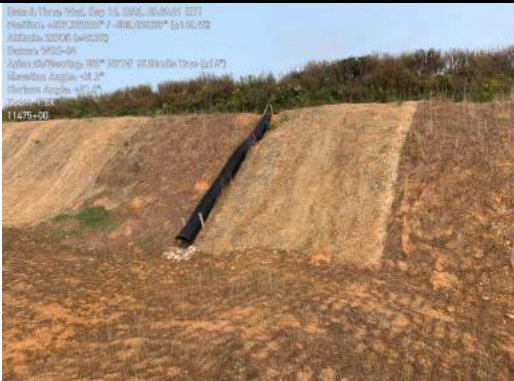
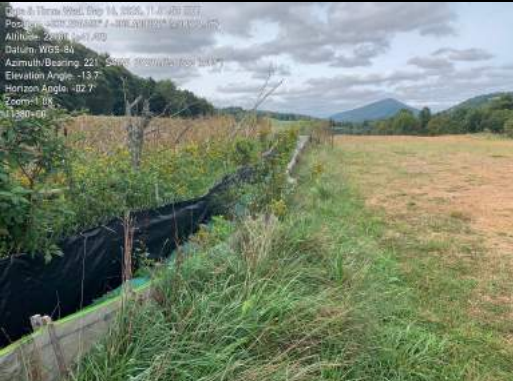
GPS Location	See photo for GPS location.		GPS Location	See photo for GPS location.	
Field Station#	11475+00		Field Station#	11380+00	
Pic 5 Desc.	Two-tone stabilized with ECB and slope drains in place.		Pic 6 Desc.	Triple barrier ECDs in place at off ROW karst feature.

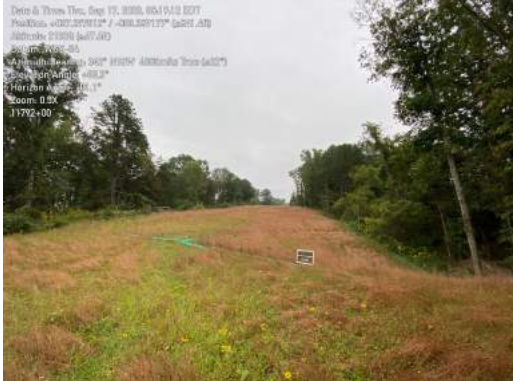
GPS Location	1	GPS Location	2		
Field Station#	11792+00	Field Station#	11826+00		
Pic 1 Desc.	Section of restored RoW showing conditions and controls.		Pic 2 Desc.	Section of restored RoW showing conditions and controls.

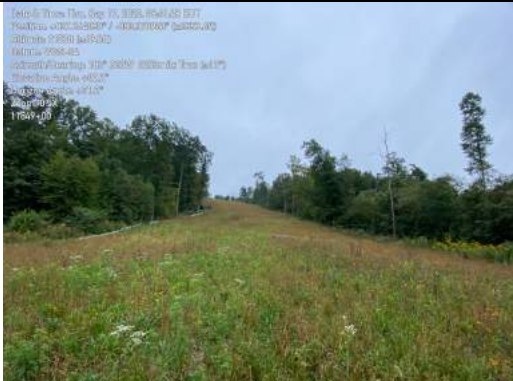
GPS Location	3	GPS Location	4		
Field Station#	11849+00	Field Station#	11863+65		
Pic 3 Desc.	Section of restored RoW showing conditions and controls.		Pic 4 Desc.	P-KL2 and controls.

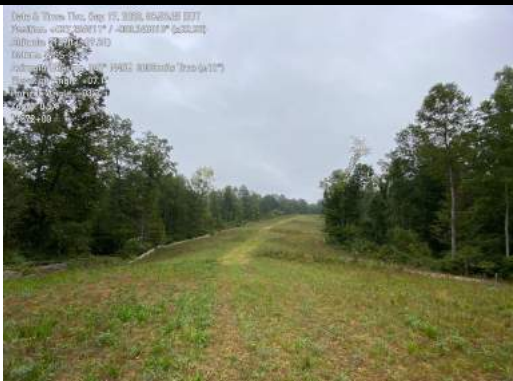
GPS Location	5	GPS Location	6		
Field Station#	11872+00	Field Station#	11899+75		
Pic 5 Desc.	Section of restored RoW showing conditions and controls.		Pic 6 Desc.	Section of restored RoW showing conditions and controls.

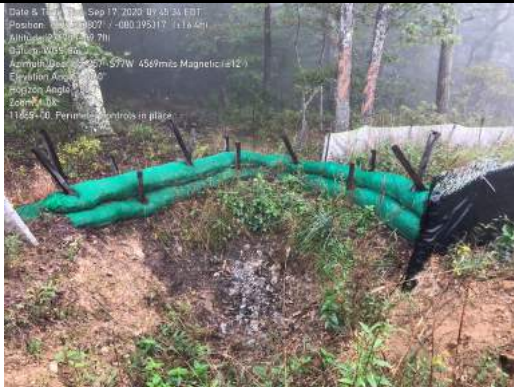
GPS Location	On photo	GPS Location	On photo		
Field Station#	11669+00	Field Station#	11665+00		
Pic 1 Desc.	ECDs in place, ROW stable at top of Brush Mountain.	Pic 2 Desc.	End treatments working as designed.		
<p>Date & Time: Thu, Sep 17, 2020, 10:20:43 EDT Position: 43°32'31.369"N / -88°39'53.17"W (43.54199) Altitude: 27318 (ft/8381m) Datum: WGS 84 Azimuth/Heading: 240.5 (az/58W 462m) (m/az/58W 462m) Elevation Angle: -31.5 Horizon Angle: -32.5 Zoom: 1.0x 11663+00: Perimeter controls in place.</p>

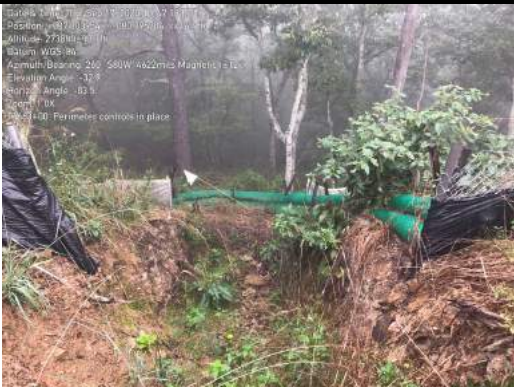
<p>Date & Time: Thu, Sep 17, 2020, 10:20:43 EDT Position: 43°32'31.369"N / -88°39'53.17"W (43.54199) Altitude: 27318 (ft/8381m) Datum: WGS 84 Azimuth/Heading: 106.574E 1884m (m/az/58W 462m) Elevation Angle: -13.5 Horizon Angle: -10.1 Zoom: 1.0x S-HH18 crossing stable.</p>

GPS Location	On photo	GPS Location	On photo		
Field Station#	11663+00	Field Station#	11626+04		
Pic 3 Desc.	Perimeter ECDs are in place and functional.	Pic 4 Desc.	S-HH18 crossing is stable.		
<p>Date & Time: Thu, Sep 17, 2020, 10:27:06 EDT Position: 43°31'38.99"N / -88°40'21.79"W (43.52747) Altitude: 19320 (ft/5898m) Datum: WGS 84 Azimuth/Heading: 337° N23W 5991m (m/az/353.1) Elevation Angle: -47.7 Horizon Angle: -48.1 Zoom: 1.0x Perimeter controls in place.</p>

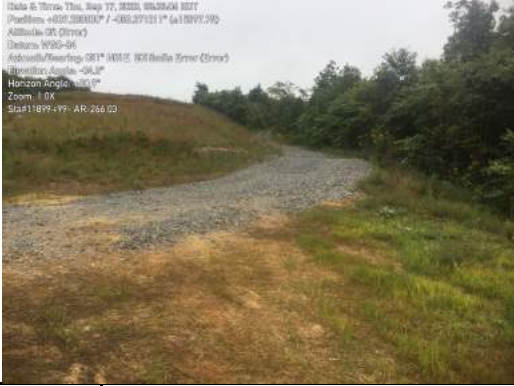
<p>Date & Time: Thu, Sep 17, 2020, 06:50:04 EDT Position: +48.338600° N / -90.338600° W (41899.99) Altitude: 266.03 (m) Datum: WGS-84 Azimuth/Bearing: 017° 00' 00" (017.000000 True is 10) Elevation Angle: -04.2° Horizon Angle: -01.2° Zoom: 1.0x Sta#11899+99- AR-266.03</p>		  <p>Date & Time: Thu, Sep 17, 2020, 06:50:04 EDT Position: +48.338600° N / -90.338600° W (41899.99) Altitude: 266.03 (m) Datum: WGS-84 Azimuth/Bearing: 147° 53'E 2613mils True is 10 Elevation Angle: -12.2° Horizon Angle: -01.2° Zoom: 1.0x Sta#11912+00 to 11927+00- Row / level spreaders & ECD's</p>			
GPS Location	See photo GPS		GPS Location	See photo GPS	
Field Station#	11899+99		Field Station#	11912+00	
Pic 1 Desc.	AR-266.03		Pic 2 Desc.	Row, level spreaders & ECD's

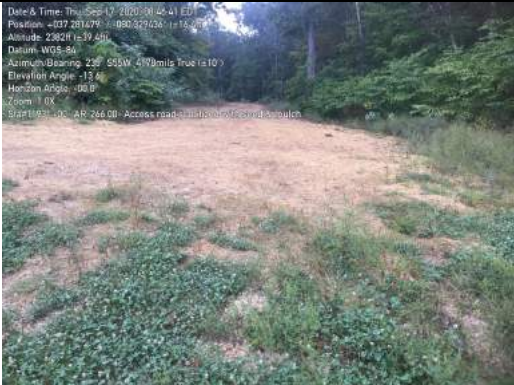
<p>Date & Time: Thu, Sep 17, 2020, 09:45:41 EDT Position: +48.338600° N / -90.338600° W (41931.00) Altitude: 266.00 (m) Datum: WGS-84 Azimuth/Bearing: 226° 55' 10" 41931.00mils True is 10 Elevation Angle: -13.6° Horizon Angle: -00.8° Zoom: 1.0x Sta#11931+00- AR-266.00- Access road stabilized with seed & mulch</p>		  <p>Date & Time: Thu, Sep 17, 2020, 09:45:41 EDT Position: +48.338600° N / -90.338600° W (41933.00) Altitude: 266.00 (m) Datum: WGS-84 Azimuth/Bearing: 163° 51'E 2660mils True is 10 Elevation Angle: -21.4° Horizon Angle: -04.5° Zoom: 1.0x Sta#11933+00 to 11938+00- Row vegetation is very good</p>

GPS Location	See photo GPS		GPS Location	See photo GPS	
Field Station#	11931+00		Field Station#	11933+00	
Pic 3 Desc.	AR-266.00- Access rd stabilized with seed & mulch.		Pic 4 Desc.	Row vegetation is very good.	
  <p>Date & Time: Thu, Sep 17, 2020, 09:45:41 EDT Position: +48.338600° N / -90.338600° W (41972.00) Altitude: 266.00 (m) Datum: WGS-84 Azimuth/Bearing: 158° 52'E 2620mils True is 10 Elevation Angle: -17.9° Horizon Angle: -00.5° Zoom: 1.0x Sta#11972+00- Row vegetation is very good</p>		  <p>Date & Time: Thu, Sep 17, 2020, 09:45:41 EDT Position: +48.338600° N / -90.338600° W (41979.00) Altitude: 266.00 (m) Datum: WGS-84 Azimuth/Bearing: 158° 52'E 2620mils True is 10 Elevation Angle: -17.9° Horizon Angle: -00.5° Zoom: 1.0x Sta#11979+00- Row vegetation is very good</p>			
GPS Location	See photo GPS		GPS Location	See photo GPS	
Field Station#	11972+00		Field Station#	11979+00	
Pic 5 Desc.	Row vegetation and water bars.		Pic 6 Desc.	Karst ECD's

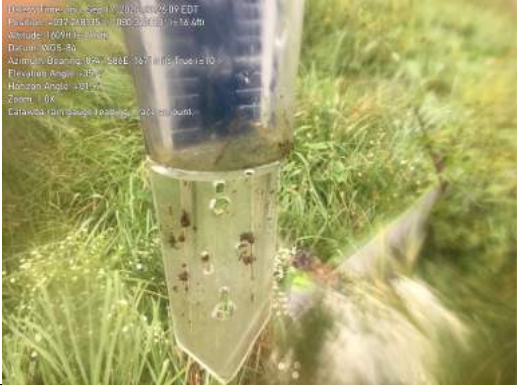
<p>Insert image here</p>			
GPS Location	See photo GPS	GPS Location			
Field Station#	11989+00	Field Station#			
Pic 7 Desc.	Catawba rain gauge reading- Trace amount.	Pic 8 Desc.			
<p>Insert image here</p>		<p>Insert image here</p>			
GPS Location		GPS Location			
Field Station#		Field Station#			
Pic 9 Desc.		Pic 10 Desc.			
<p>Insert image here</p>		<p>Insert image here</p>			
GPS Location		GPS Location			
Field Station#		Field Station#			
Pic 11 Desc.		Pic 12 Desc.

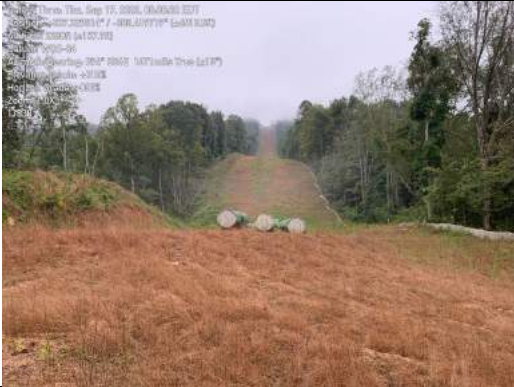
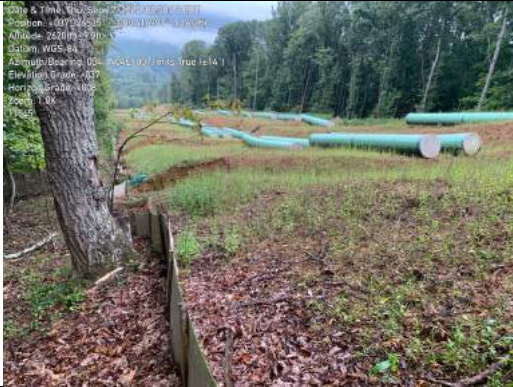
GPS Location	See picture above for GPS coordinates		GPS Location	See picture above for GPS coordinates	
Field Station#	11530+00		Field Station#	11545+00	
Pic 1 Desc.	ECD's and row conditions		Pic 2 Desc.	ECD's and row conditions

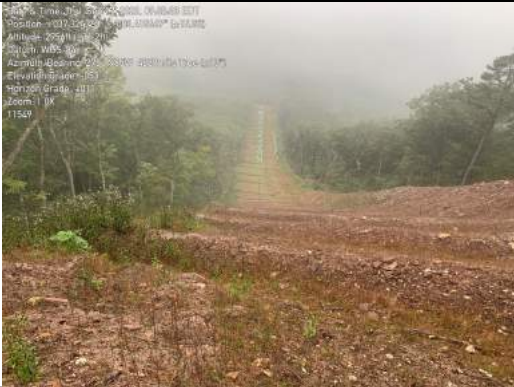
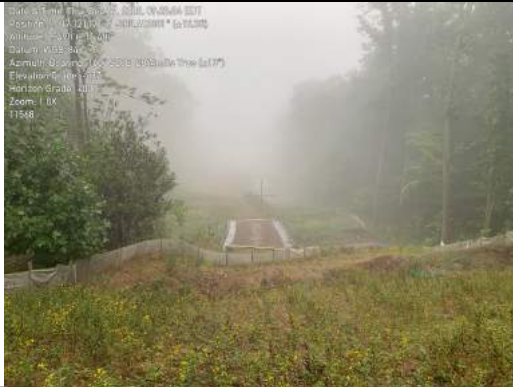
GPS Location	See picture above for GPS coordinates		GPS Location	See picture above for GPS coordinates	
Field Station#	11549+00		Field Station#	11568+00	
Pic 3 Desc.	ECD's and row conditions		Pic 4 Desc.	ECD's and row conditions

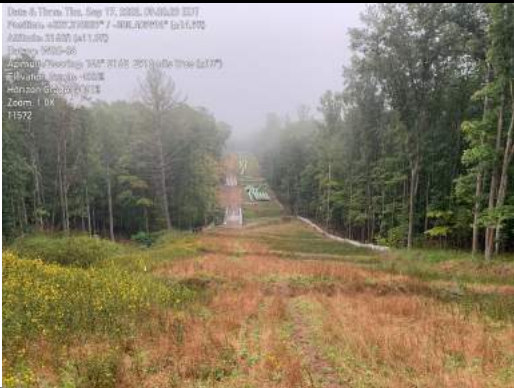
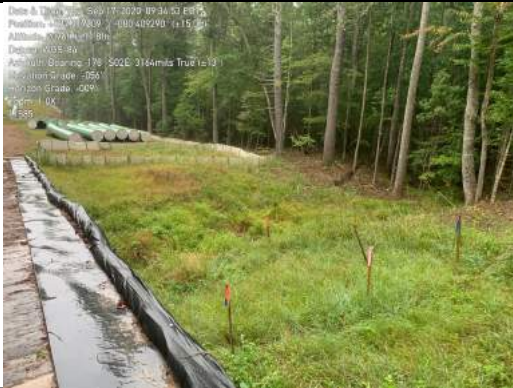
GPS Location	See picture above for GPS coordinates		GPS Location	See picture above for GPS coordinates	
Field Station#	11572+00		Field Station#	11585+00	
Pic 5 Desc.	ECD's and row conditions		Pic 6 Desc.	ECD's and row conditions

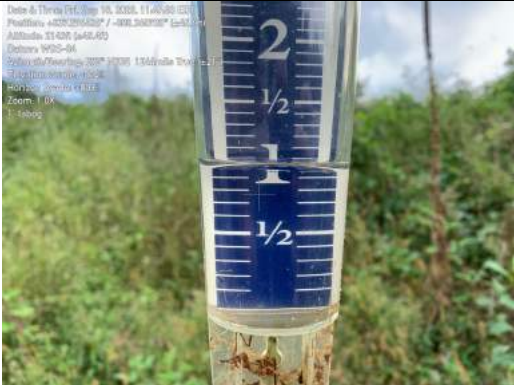
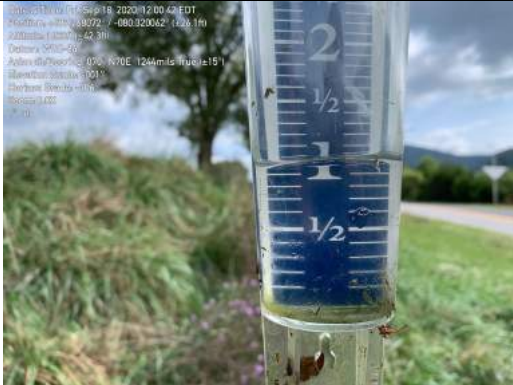
GPS Location	See picture above for GPS coordinates		GPS Location	See picture above for GPS coordinates	
Field Station#	+1		Field Station#	+1	
Pic 1 Desc.	1" of rain recorded		Pic 2 Desc.	1" of rain recorded

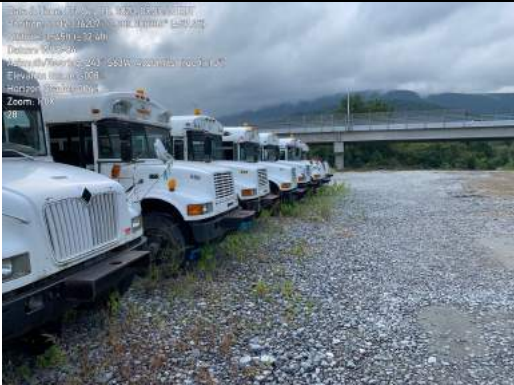
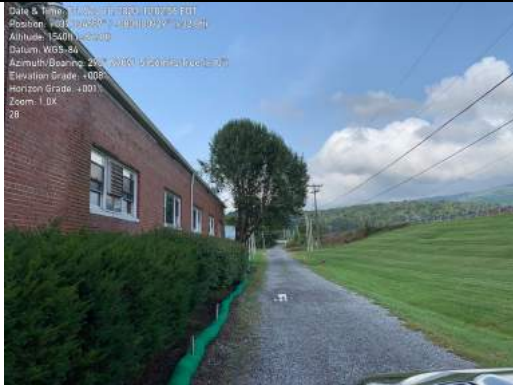
GPS Location	See picture above for GPS coordinates		GPS Location	See picture above for GPS coordinates	
Field Station#	12005+00		Field Station#	12005+00	
Pic 3 Desc.	ECD's and row conditions		Pic 4 Desc.	ECD's and row conditions

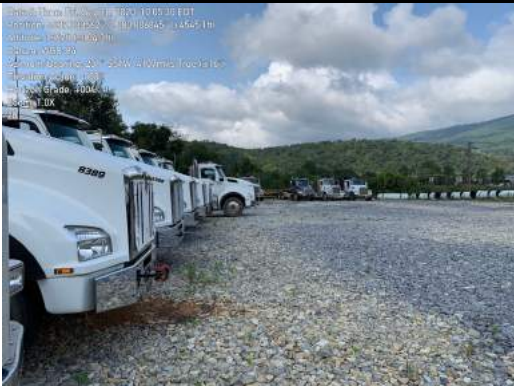
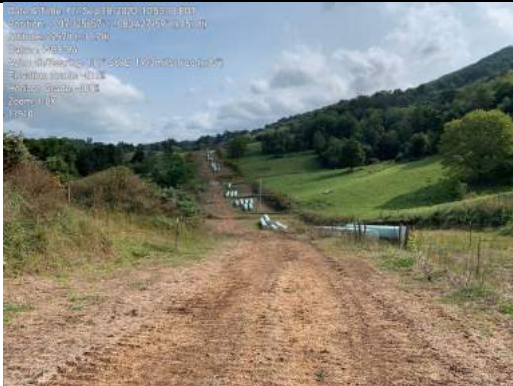
GPS Location	See picture above for GPS coordinates		GPS Location	See picture above for GPS coordinates	
Field Station#	12005+00		Field Station#	11510+00	
Pic 5 Desc.	ECD's and row conditions		Pic 6 Desc.	ECD's and row conditions
