Visual Site Inspection Report

Project Name	H-600 Pipeline Spread G	AFE	124300137	Spread	H-600 Pipeline Spread G
Contractor	Precision			Report #	14769
Inspector	Len Kruizenga			Date/Time	9/21/2020 8:43 AM
Permit #	TBD	Inspection Type	VA SWPP	Station Begin	1102388+00
State	VA	Inspection Area	Full	Station End	10930+00
County	Giles	Ground	Dry	Temperature (°F)	64.00
Municipality	N/A	Weather	Sunny	Rain Gauge (in)	0.00
				Rain Accumulation Time (days)	1.00

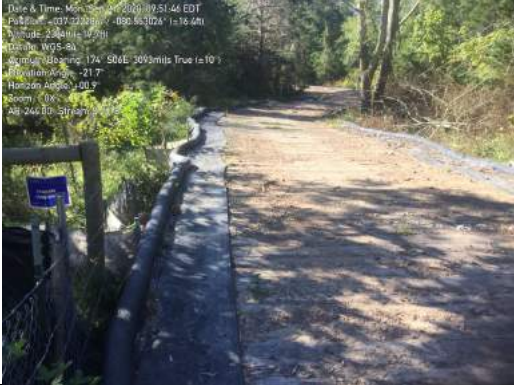
<p>Date & Time: Mon, Sep 21, 2020, 10:51:46 EDT Position: -017.232811, -090.561028 (s18.4ft) Altitude: 2366ft (s18.4ft) Datum: WGS-84 Azimuth/Bearing: 174.504E 3093mils True (s10°) Elevation Angle: -21.7° Horizon Angle: +01.9° Zoom: 1.0X Station: 11019+00</p>			
GPS Location	See photo GPS	GPS Location	See photo GPS		
Field Station#	11023+88	Field Station#	11019+00		
Pic 1 Desc.	AR-244- Stream S- IJ18	Pic 2 Desc.	Row vegetation and stream S- RR5

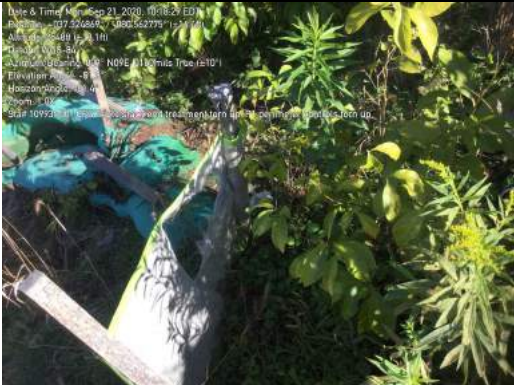
GPS Location	See photo GPS	GPS Location	See photo GPS		
Field Station#	10993+00	Field Station#	10986+00		
Pic 3 Desc.	P1 and CFS triple stack end treatment and perimeter controls, damaged by bear, contractor notified.	Pic 4 Desc.	Stream S- E25

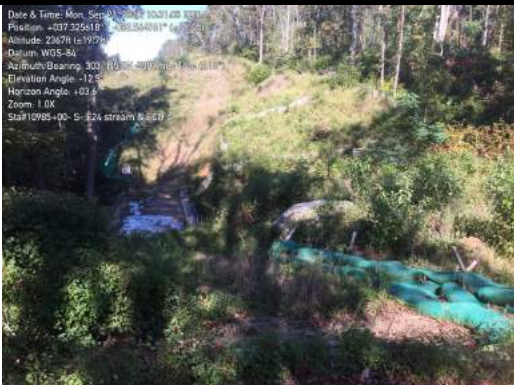
<p>Date & Time: Mon, Sep 21, 2020, 10:53:40 EDT Position: -017.232811, -090.564917 (s18.4ft) Altitude: 2367ft (s18.4ft) Datum: WGS-84 Azimuth/Bearing: 303.803W 4924mils True (s10°) Elevation Angle: -12.5° Horizon Angle: +01.8° Zoom: 1.0X Station: 10964+00</p>			
GPS Location	See photo GPS	GPS Location	See photo GPS		
Field Station#	10985+00	Field Station#	10964+00		
Pic 5 Desc.	Stream S- E24	Pic 6 Desc.	Drainage feature and ECD's.

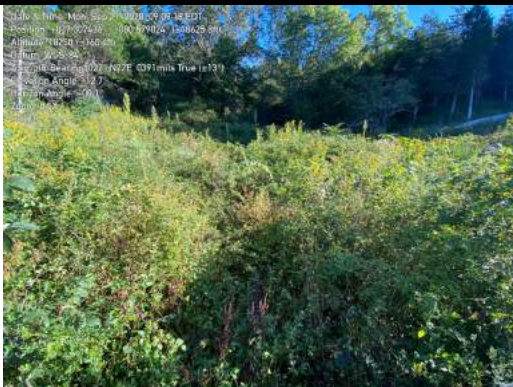
<p>Date & Time: Mon, Sep 21, 2020, 09:13:58 EDT Position: -117.02448, -10.17014, 150625.00 Altitude: 11230 (+456m) Datum: WGS-84 Azimuth Bearing: 105.7059, 50.7mils True (+13.1) Elevation Angle: 12.7 Horizontal Angle: 0.0 Zoom: 8.5X Size: (1056x768)</p>			
GPS Location	1	GPS Location	2		
Field Station#	11025+50	Field Station#	11034+00		
Pic 1 Desc.	S-IJ18 and controls.	Pic 2 Desc.	Section of RoW showing conditions and controls.

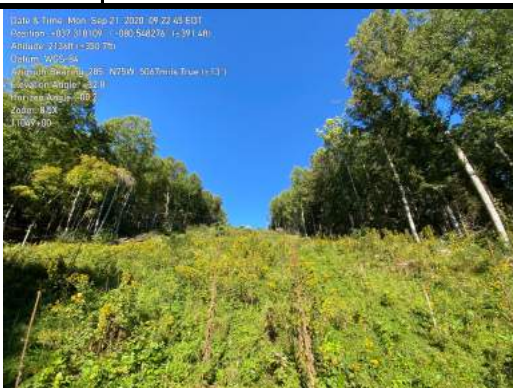
GPS Location	3	GPS Location	4		
Field Station#	11049+00	Field Station#	11050+10		
Pic 3 Desc.	Section of RoW showing conditions and controls.	Pic 4 Desc.	S-IJ16B/S-IJ17 and controls.

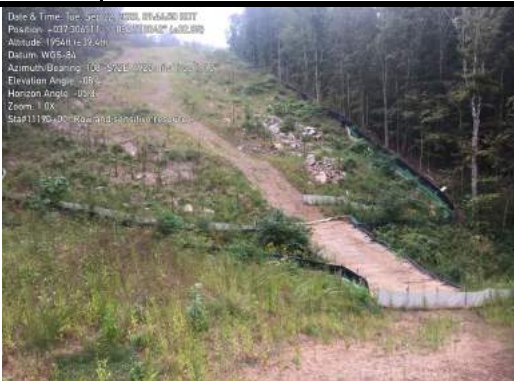
<p>Date & Time: Tue, Sep 22, 2020, 09:51:15 AM Position: 4232.202111, -71.053111, 19468.14 Altitude: 19468.14 Datum: WGS-84 Azimuth/Bearing: 128.542E, 327.0mils true (+10°) Elevation Angle: -09.5° Horizon Angle: +00.7° Zoom: 1.0x Stn#11190+00- Row, ECD's, drainage feature.</p>

Field Station#	11190+00		Field Station#	11191+00	
Pic 5 Desc.	Drainage feature, row, ECD's.		Pic 6 Desc.	CWD pipe and plunge pool.

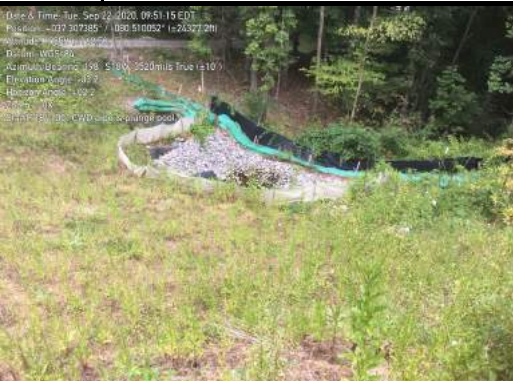
<p>Date & Time: Tue, Sep 22, 2020, 09:51:15 AM Position: 4232.202111, -71.053111, 19468.14 Altitude: 19468.14 Datum: WGS-84 Azimuth/Bearing: 128.542E, 327.0mils true (+10°) Elevation Angle: -09.5° Horizon Angle: +00.7° Zoom: 1.0x Stn#11191+00- CWD pipe and plunge pool.</p>			
GPS Location	See photo GPS		GPS Location	See photo GPS

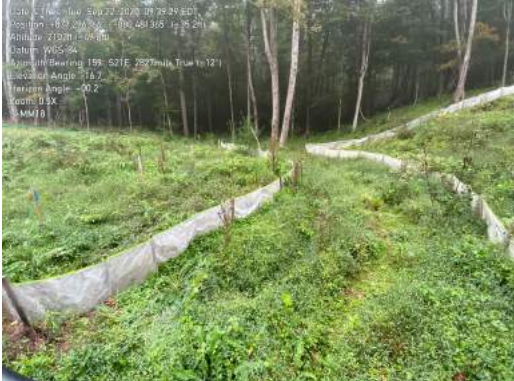
GPS Location	3	GPS Location	4		
Field Station#	11292+80	Field Station#	11305+00		
Pic 3 Desc.	S-MM18 and controls.	Pic 4 Desc.	Section of RoW showing conditions and controls.

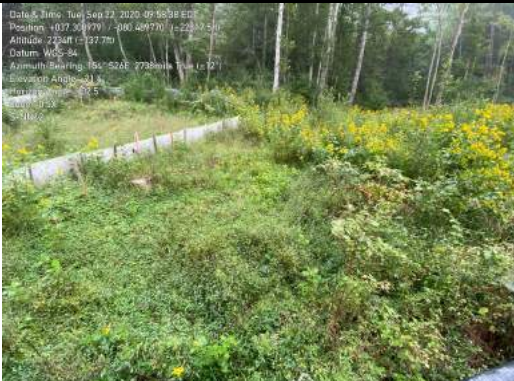
GPS Location	5	GPS Location	6		
Field Station#	11327+85	Field Station#	11352+97		
Pic 5 Desc.	S-NN12 and controls.	Pic 6 Desc.	S-NN11 and controls.

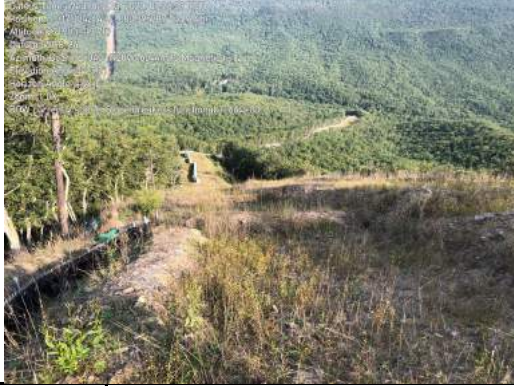
<p> Date & Time Wed, Sep 23, 2020, 09:26:58 EDT Position: +422.302772° / -808.391892° (+15.82) Altitude: 321.9 ft (+215.08) Azimuth/Heading: 147° 30206 361 Binsla Magnetar (+13°) Elevation Angle: +01.0° Horizontal Angle: +00.0° Zoom: 1.0x ROW currently stable at 11668+00 </p>			
GPS Location	On photo	GPS Location	On photo		
Field Station#	11668+00	Field Station#	11664+00		
Pic 1 Desc.	ROW stable at top of Brush Mountain. No evidence of vandalism in this area today.	Pic 2 Desc.	ROW stable with perimeter controls in place. Slope breakers functional.

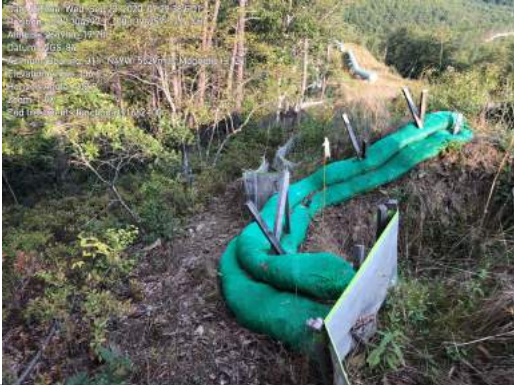
<p> Date & Time Wed, Sep 23, 2020, 09:26:58 EDT Position: +422.302772° / -808.391892° (+15.82) Altitude: 321.9 ft (+215.08) Azimuth/Heading: 147° 30206 361 Binsla Magnetar (+13°) Elevation Angle: +01.0° Horizontal Angle: +00.0° Zoom: 1.0x End treatments are functional. </p>

<p> Date & Time Wed, Sep 23, 2020, 09:26:58 EDT Position: +422.302772° / -808.391892° (+15.82) Altitude: 321.9 ft (+215.08) Azimuth/Heading: 147° 30206 361 Binsla Magnetar (+13°) Elevation Angle: +01.0° Horizontal Angle: +00.0° Zoom: 1.0x 11657+50: Slope breakers functional. Perimeter controls in place. </p>			
GPS Location	On photo	GPS Location	On photo		
Field Station#	11662+00	Field Station#	11657+50		
Pic 3 Desc.	End treatments are working properly.	Pic 4 Desc.	ECDs in place. Slope breakers functional.

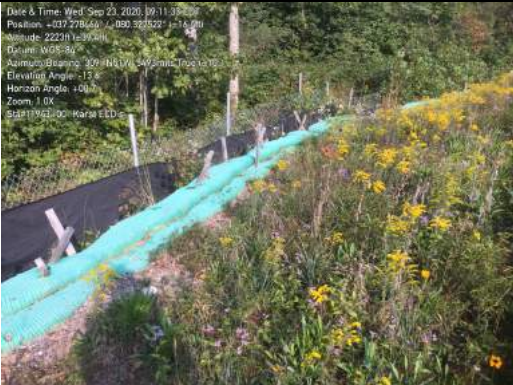
GPS Location	See photo GPS		GPS Location	See photo GPS	
Field Station#	11933+00		Field Station#	11942+00	
Pic 3 Desc.	Row vegetation and controls		Pic 4 Desc.	Karst ECD's

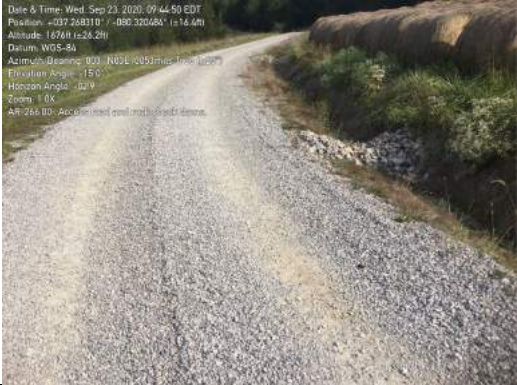
Insert image here	
GPS Location	See photo GPS	GPS Location			
Field Station#	11989+00	Field Station#			
Pic 7 Desc.	AR-266.00- Access road and rock check dams.	Pic 8 Desc.			
Insert image here		Insert image here			
GPS Location		GPS Location			
Field Station#		Field Station#			
Pic 9 Desc.		Pic 10 Desc.			
Insert image here		Insert image here			
GPS Location		GPS Location			
Field Station#		Field Station#			
Pic 11 Desc.		Pic 12 Desc.

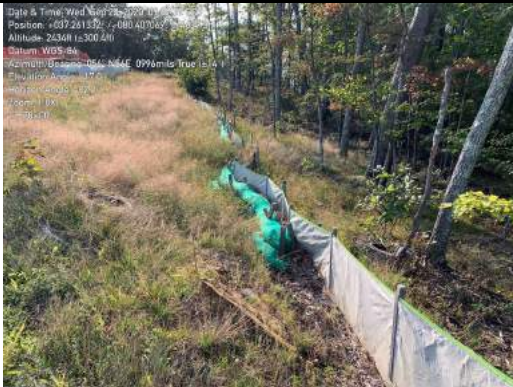
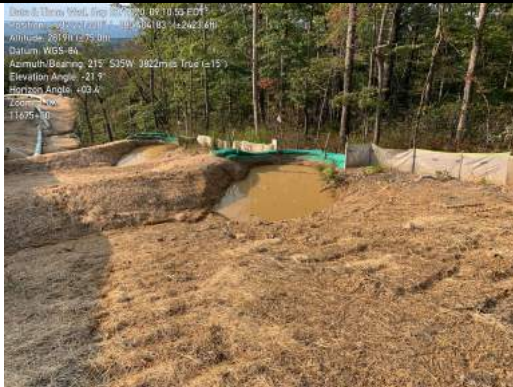
GPS Location		See photo for GPS location.				GPS Location		See photo for GPS location.			
Field Station#		11670+00				Field Station#		11675+00			
Pic 1 Desc.		Triple stack compost filter sock and priority one silt fence in place along LOD.				Pic 2 Desc.		Waterbar, sump pit, and waterbar end treatment in place.

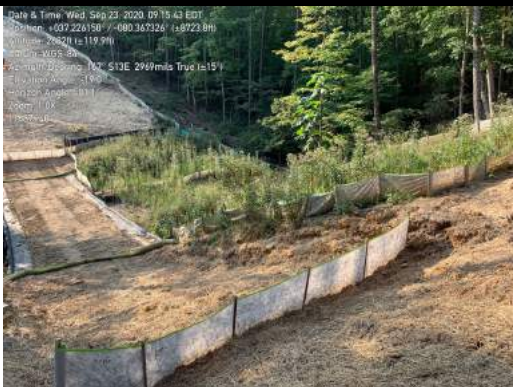
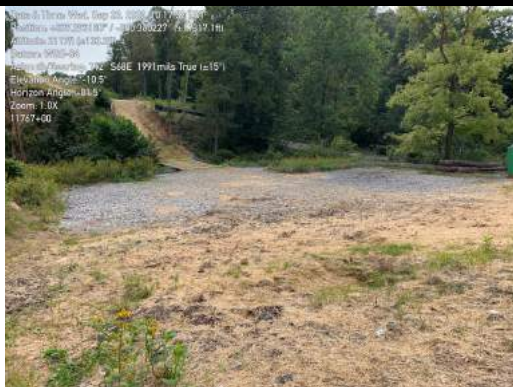
GPS Location		See photo for GPS location.				GPS Location		See photo for GPS location.			
Field Station#		11687+40				Field Station#		11767+00			
Pic 3 Desc.		Sensitive resource buffer in place at stream S-MN21.				Pic 4 Desc.		RCE in place at Main Line Valve 26.

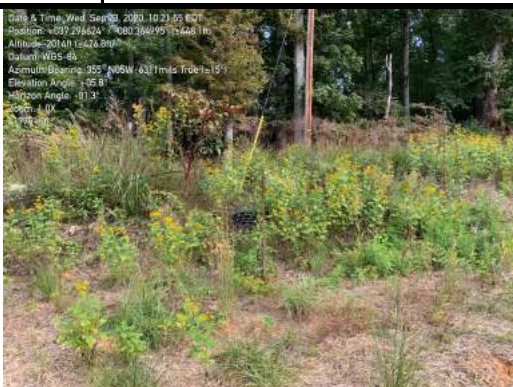
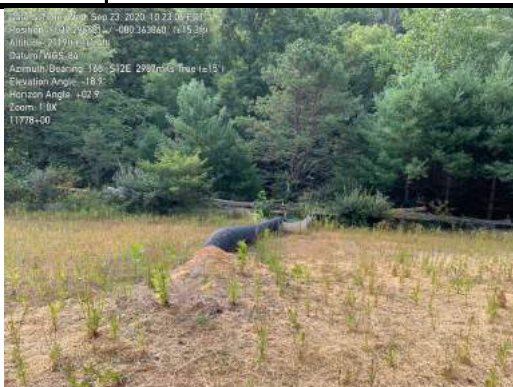
GPS Location		See photo for GPS location.				GPS Location		See photo for GPS location.			
Field Station#		11775+00				Field Station#		11778+00			
Pic 5 Desc.		Clean water diversion berm and clean water diversion pipe inlet in place.				Pic 6 Desc.		Clean water diversion pipe and plunge pool in place.

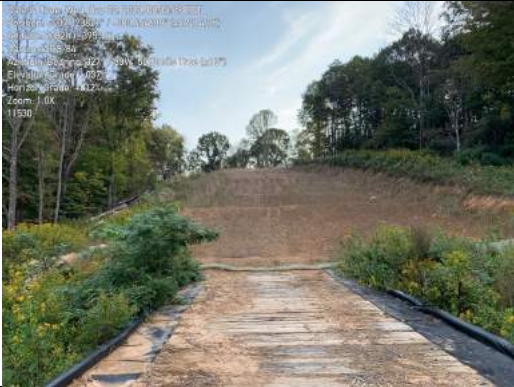
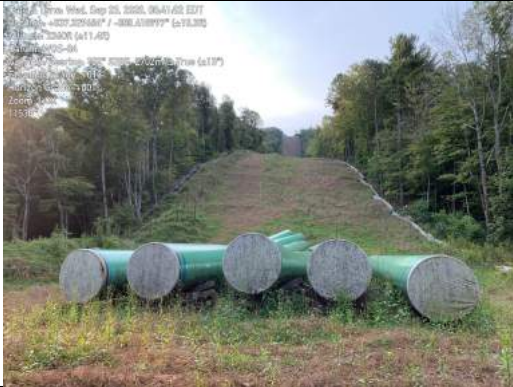
GPS Location See picture above for GPS coordinates	
Field Station# 11530+00		Field Station# 11532+00		Pic 1 Desc. ECD's and row conditions

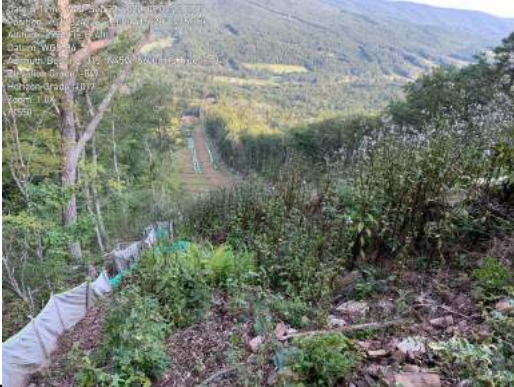
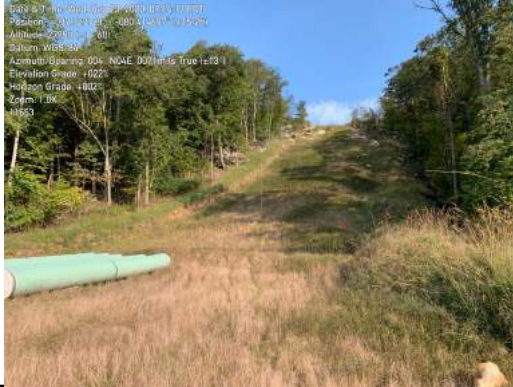
GPS Location See picture above for GPS coordinates	
Field Station# 11550+00		Field Station# 11553+00		Pic 3 Desc. ECD's and row conditions

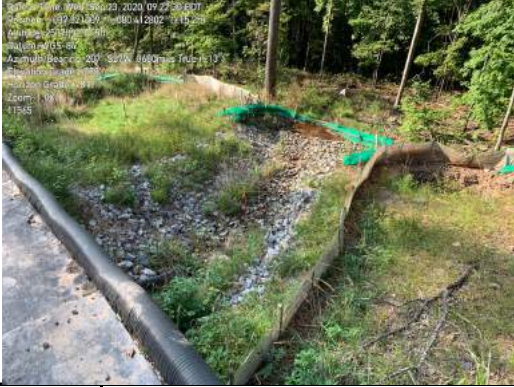
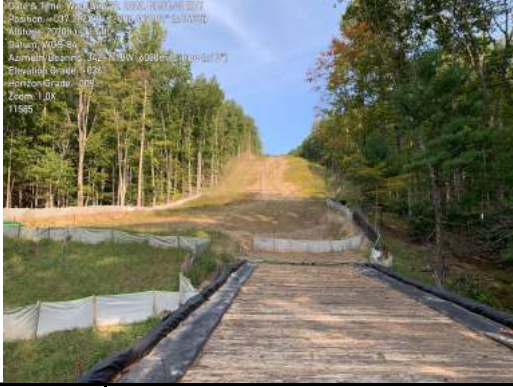
GPS Location See picture above for GPS coordinates	
Field Station# 11565+00		Field Station# 11585+00		Pic 5 Desc. ECD's and row conditions

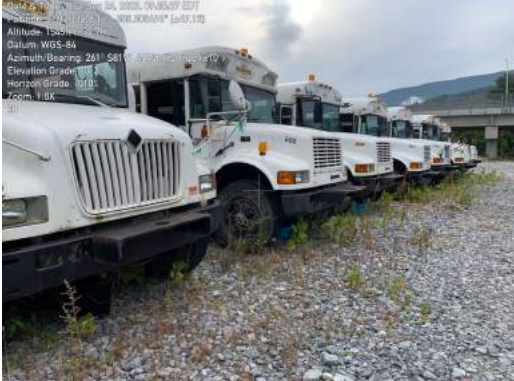
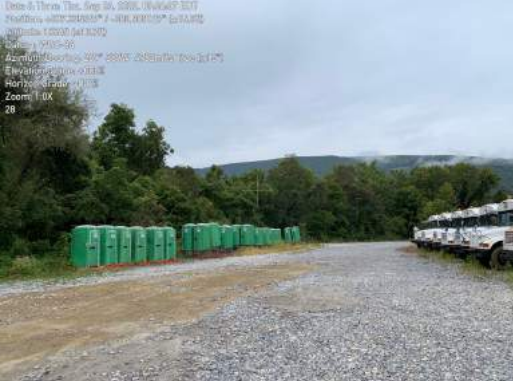
GPS Location	See picture above for GPS coordinates		GPS Location	See picture above for GPS coordinates	
Field Station#	12005+00		Field Station#	12005+00	
Pic 1 Desc.	ECD's and row		Pic 2 Desc.	ECD's and row conditions

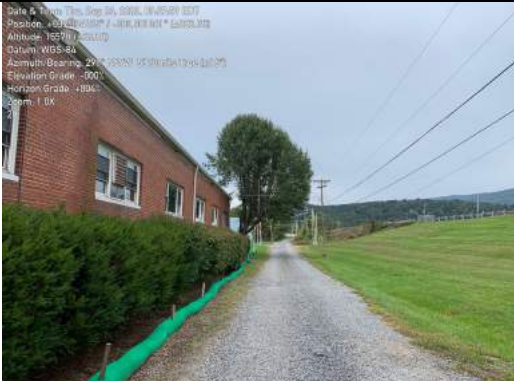
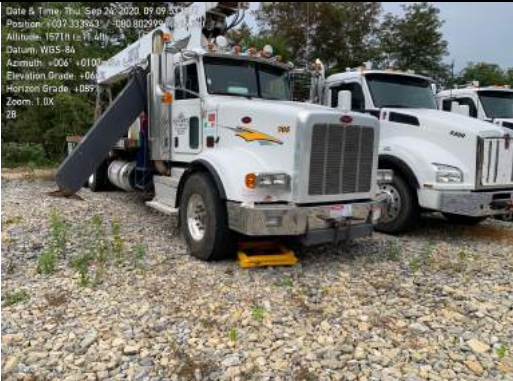
GPS Location	See picture above for GPS coordinates		GPS Location	See picture above for GPS coordinates	
Field Station#	12005+00		Field Station#	12005+00	
Pic 3 Desc.	ECD's and row conditions		Pic 4 Desc.	ECD's and row conditions

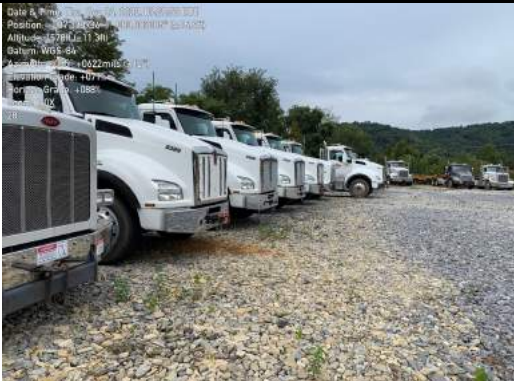
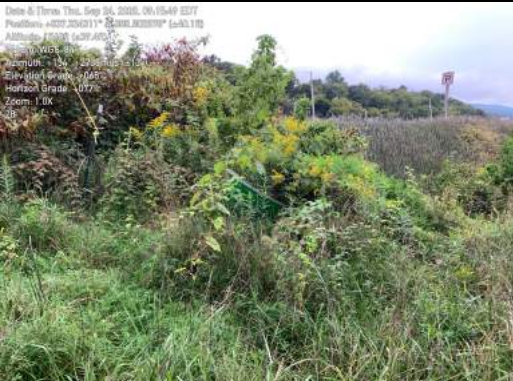
GPS Location	See picture above for GPS coordinates		GPS Location	See picture above for GPS coordinates	
Field Station#	12005+00		Field Station#	12005+00	
Pic 5 Desc.	ECD's and row conditions		Pic 6 Desc.	ECD's and row conditions

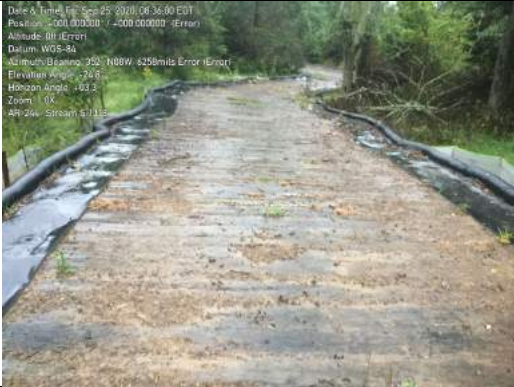
<p>Date & Time: Fri, Sep 25, 2020, 08:36:00 EDT Position: 401.00330, -74.0000000 (Error) Altitude: 401 (Error) Datum: WGS-84 Azimuth Bearing: 252. N00W 425mils Error (Error) Elevation Angle: -24.6 Horizon Angle: -103.3 Zoom: 1.0x AP-204 Stream Station</p>		  <p>Date & Time: Fri, Sep 25, 2020, 08:25:00 EDT Position: 401.00330, -74.0000000 (Error) Altitude: 401 (Error) Datum: WGS-84 Azimuth Bearing: 250. N70W 415mils True (10) Elevation Angle: -12.4 Horizon Angle: -103.1 Zoom: 1.0x Sta#11020+00 Stream S-RR5 row & vegetation</p>			
GPS Location	See photo GPS		GPS Location	See photo GPS	
Field Station#	11023+88		Field Station#	11020+00	
Pic 1 Desc.	Stream S- IJ18		Pic 2 Desc.	Row vegetation and stream S-RR5

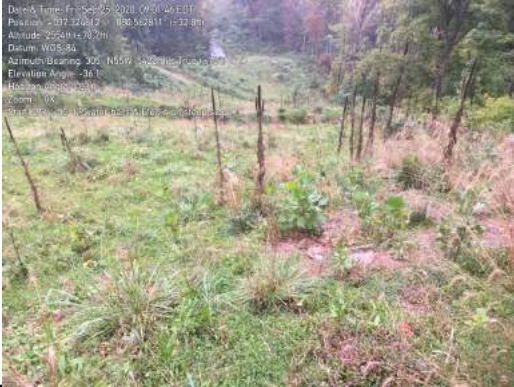
GPS Location	See photo GPS		GPS Location	See photo GPS	
Field Station#	10994+00		Field Station#	10986+00	
Pic 3 Desc.	Water bars and ECD's on steep slope.		Pic 4 Desc.	Stream S- E25	
  <p>Date & Time: Fri, Sep 25, 2020, 09:10:00 EDT Position: 401.22412, -74.0042814 (Error) Altitude: 255.4 (10.7m) Datum: WGS-84 Azimuth Bearing: 302. N55E 400mils True (10) Elevation Angle: -36.1 Horizon Angle: -103.3 Zoom: 1.0x Sta#10985+00 Stream S-E24</p>		  <p>Date & Time: Fri, Sep 25, 2020, 09:10:00 EDT Position: 401.22412, -74.0042814 (Error) Altitude: 255.4 (10.7m) Datum: WGS-84 Azimuth Bearing: 302. N55E 400mils True (10) Elevation Angle: -36.1 Horizon Angle: -103.3 Zoom: 1.0x Sta#10986+00 Stream S-E25</p>			
GPS Location	See photo GPS		GPS Location	See photo GPS	
Field Station#	10985+00		Field Station#	10966+00	
Pic 5 Desc.	Stream S- E24		Pic 6 Desc.	Sensitive resource area.

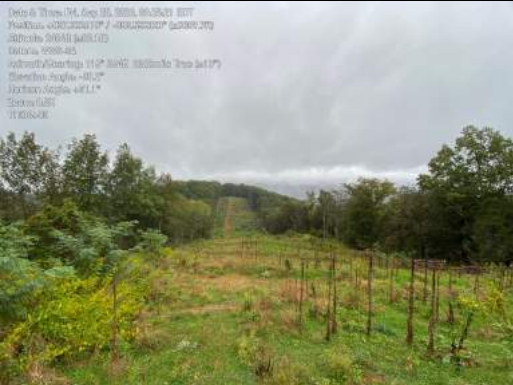
GPS Location	1	GPS Location	2		
Field Station#	11025+50	Field Station#	11034+00		
Pic 1 Desc.	S-IJ18 and controls.	Pic 2 Desc.	Section of RoW showing conditions and controls.

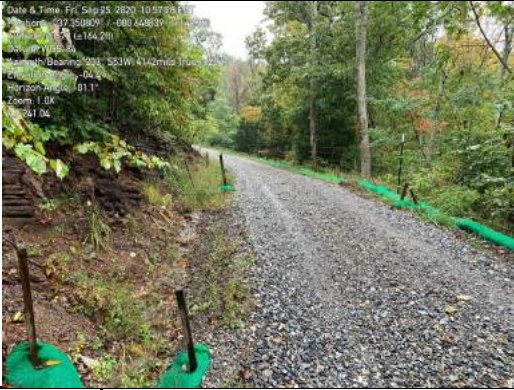
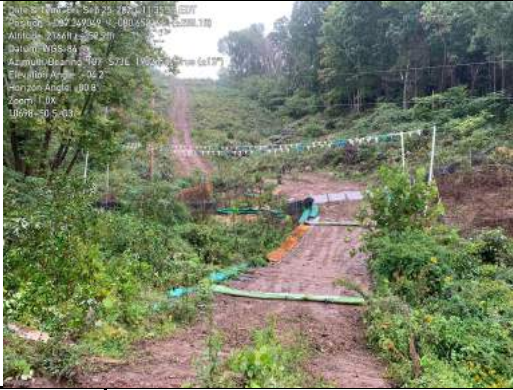
<p>Date & Time: Fri, Sep 25, 2020 11:11:55 AM Position: 42° 35' 00.0" N, -80° 44' 50.0" W Altitude: 1154.2m Datum: WGS-84 Geotagging: 113° 55' 31.0" W, 41° 42' 00.0" N Elevation Angle: 10.1° Zoom: 1.0x 10698+50</p>		GPS Location	See photo for GPS location.
Field Station#	10711+00	Field Station#	10698+50	GPS Location	See photo for GPS location.
Pic 1 Desc.	CFS in place along LOD.	Pic 2 Desc.	Sensitive resource buffer in place at stream S-G32.	GPS Location	See photo for GPS location.

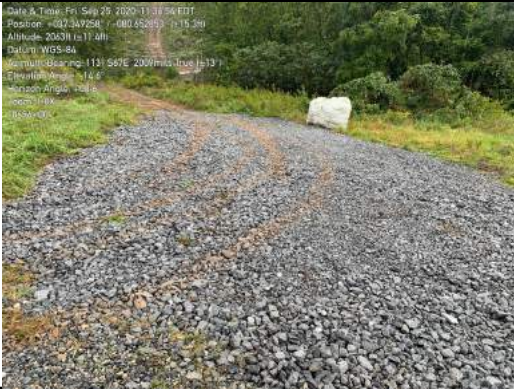
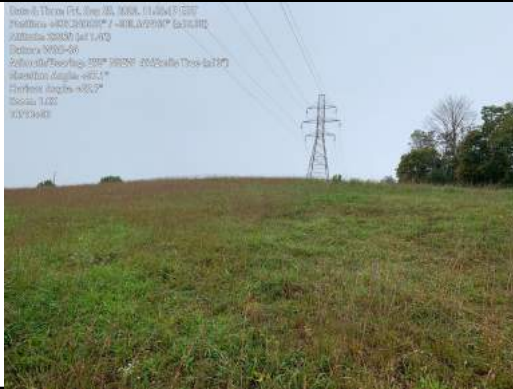
Field Station#	10696+00	Field Station#	10710+00	GPS Location	See photo for GPS location.
Pic 3 Desc.	RCE in place at Buffalo Anklets Road.	Pic 4 Desc.	ROW stabilized with natural vegetation.	GPS Location	See photo for GPS location.

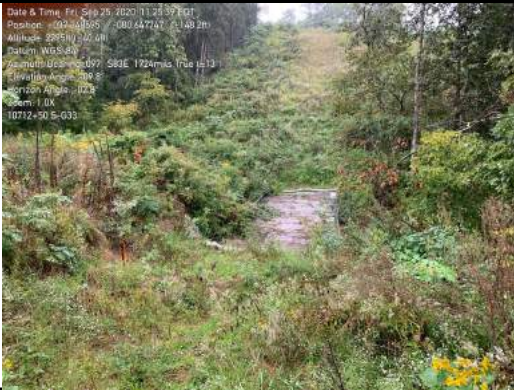
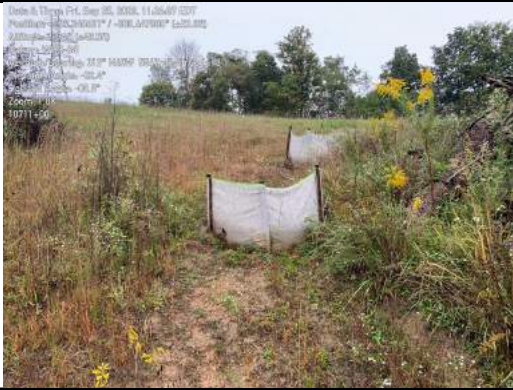
<p>Date & Time: Fri, Sep 25, 2020 11:40:47 AM Position: 42° 34' 50.0" N, -80° 45' 00.0" W Altitude: 2063.0m Datum: WGS-84 Geotagging: 113° 56' 10.0" W, 41° 42' 00.0" N Elevation Angle: 10.1° Zoom: 1.0x 10711+00</p>		GPS Location	See photo for GPS location.
Field Station#	10712+50	Field Station#	10711+00	GPS Location	See photo for GPS location.
Pic 5 Desc.	Sensitive resource buffer in place at stream S-G32.	Pic 6 Desc.	Priority one silt fence checks in place.	GPS Location	See photo for GPS location.

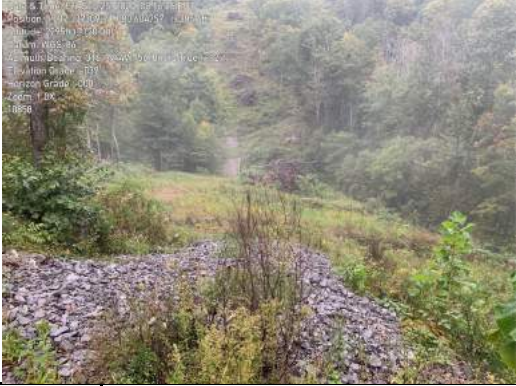
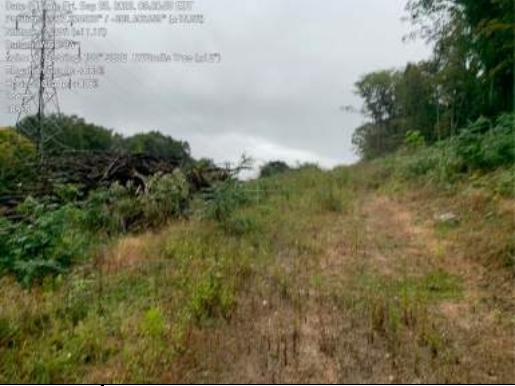
GPS Location	See picture above for GPS coordinates		GPS Location	See picture above for GPS coordinates	
Field Station#	10858+00		Field Station#	10865+00	
Pic 1 Desc.	ECD's and row conditions		Pic 2 Desc.	ECD's and row conditions

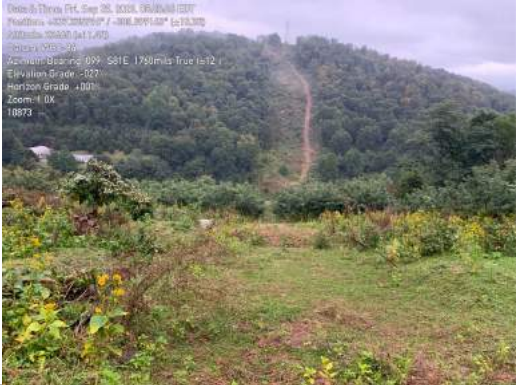
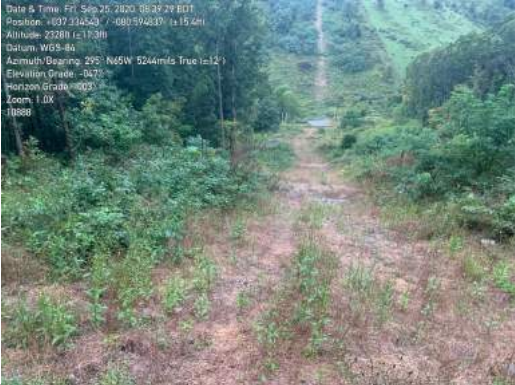
GPS Location	See picture above for GPS coordinates		GPS Location	See picture above for GPS coordinates	
Field Station#	10873+00		Field Station#	10888+00	
Pic 3 Desc.	ECD's and row conditions		Pic 4 Desc.	ECD's and row conditions

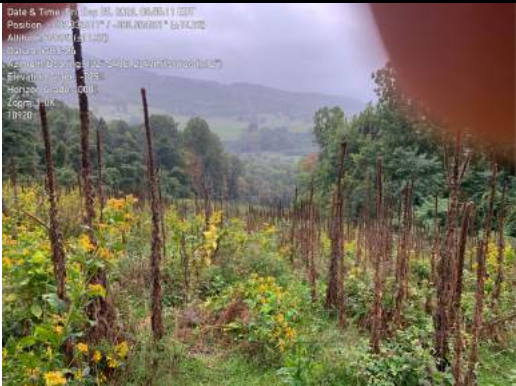
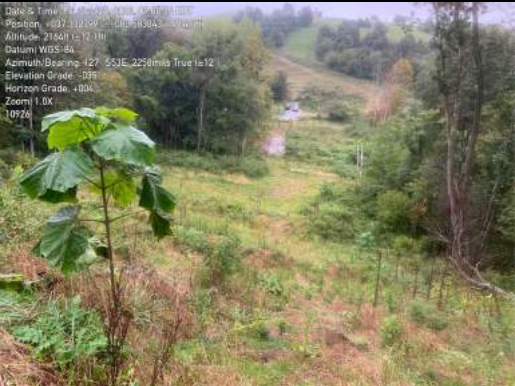
GPS Location	See picture above for GPS coordinates		GPS Location	See picture above for GPS coordinates	
Field Station#	10920+00		Field Station#	10926+00	
Pic 5 Desc.	ECD's and row conditions		Pic 6 Desc.	ECD's and row conditions
