# Visual Site Inspection Report

<b>Project Name</b>	H-600 Pipeline Spread G	<b>AFE</b>	124300137	<b>Spread</b>	H-600 Pipeline Spread G
<b>Contractor</b>	Precision			<b>Report #</b>	14982
<b>Inspector</b>	Chris Burns			<b>Date/Time</b>	9/28/2020 7:51 AM
<b>Permit #</b>	TBD	<b>Inspection Type</b>	VA SWPP	<b>Station Begin</b>	11254+99
<b>State</b>	VA	<b>Inspection Area</b>	Partial	<b>Station End</b>	11353+67
<b>County</b>	Giles	<b>Ground</b>	Wet	<b>Temperature (°F)</b>	72.00
<b>Municipality</b>	N/A	<b>Weather</b>	Cloudy	<b>Rain Gauge (in)</b>	0.00
				<b>Rain Accumulation Time (days)</b>	1.00

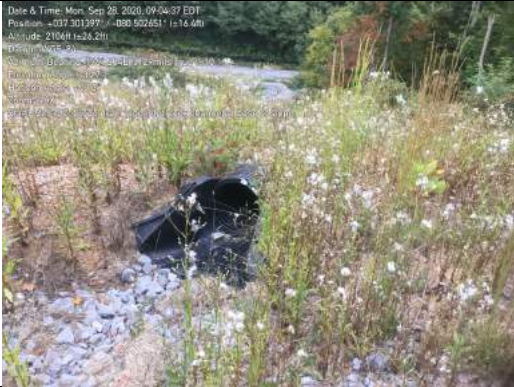
<p>Date &amp; Time: Mon, Sep 28, 2020, 09:34:37 EDT Position: -037.303197° / -080.502251° (±16.4m) Altitude: 2104ft (±6.2m) Datum: WGS-84 Azimuth Bearing: 291° N30W 5280mils True (±10°) Elevation Angle: 21.0° Horizon Angle: 21.0° Zoom: 14.0x Start 11225+00, End 11225+00, CWD pipe and plunge pool</p>

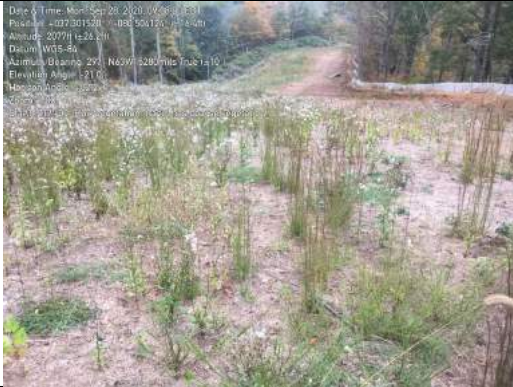
<p>Date &amp; Time: Mon, Sep 28, 2020, 09:34:38 EDT Position: -037.303197° / -080.502251° (±16.4m) Altitude: 2079ft (±6.2m) Datum: WGS-84 Azimuth Bearing: 291° N30W 5280mils True (±10°) Elevation Angle: 21.0° Horizon Angle: 21.0° Zoom: 14.0x Start 11217+00, End 11217+00, CWD pipe and plunge pool</p>			
<b>GPS Location</b>	See photo GPS	<b>GPS Location</b>	See photo GPS		
<b>Field Station#</b>	11225+00	<b>Field Station#</b>	11217+00		
<b>Pic 1 Desc.</b>	Slope drain inlet, rock channel at the bottom of the slope.	<b>Pic 2 Desc.</b>	Row vegetation, travel lane is sparsely vegetated.

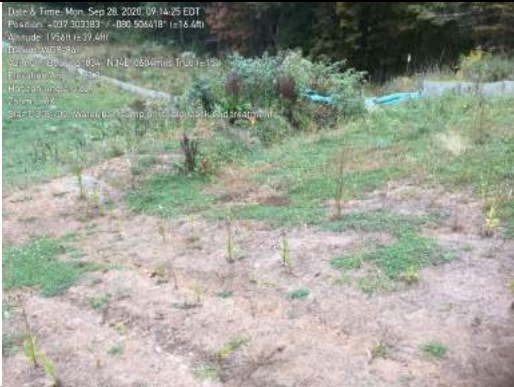
<p>Date &amp; Time: Mon, Sep 28, 2020, 09:14:25 EDT Position: -037.303197° / -080.506418° (±16.4m) Altitude: 1954ft (±6.2m) Datum: WGS-84 Azimuth Bearing: 291° N30W 5280mils True (±10°) Elevation Angle: 21.0° Horizon Angle: 21.0° Zoom: 14.0x Start 11206+00, End 11206+00, CWD pipe and plunge pool</p>

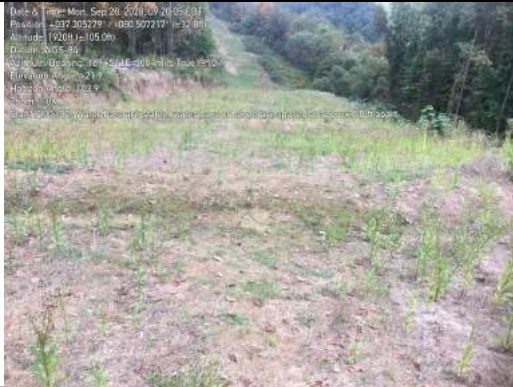
<p>Date &amp; Time: Mon, Sep 28, 2020, 09:24:05 EDT Position: -037.305279° / -080.507217° (±16.4m) Altitude: 1920ft (±6.2m) Datum: WGS-84 Azimuth Bearing: 291° N30W 5280mils True (±10°) Elevation Angle: 21.0° Horizon Angle: 21.0° Zoom: 14.0x Start 11200+00, End 11200+00, CWD pipe and plunge pool</p>			
<b>GPS Location</b>	See photo GPS	<b>GPS Location</b>	See photo GPS		
<b>Field Station#</b>	11206+00	<b>Field Station#</b>	11200+00		
<b>Pic 3 Desc.</b>	Water bar, sump pit and triple stack end treatment.	<b>Pic 4 Desc.</b>	Water bars are stable and spaced at approximately, 5 ft intervals on the slope.

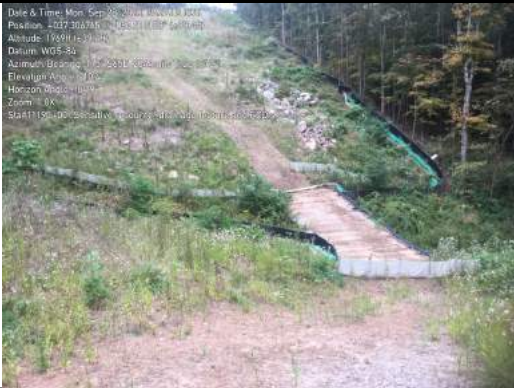
<p>Date &amp; Time: Mon, Sep 28, 2020, 09:34:07 EDT Position: -037.303684° / -080.511935° (±16.4m) Altitude: 1950ft (±6.2m) Datum: WGS-84 Azimuth Bearing: 291° N30W 5280mils True (±10°) Elevation Angle: 21.0° Horizon Angle: 21.0° Zoom: 14.0x Start 11190+00, End 11190+00, CWD pipe and plunge pool</p>

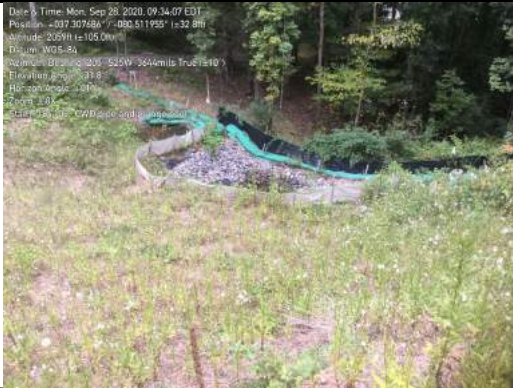
<p>Date &amp; Time: Mon, Sep 28, 2020, 09:34:07 EDT Position: -037.303684° / -080.511935° (±16.4m) Altitude: 2059ft (±6.2m) Datum: WGS-84 Azimuth Bearing: 291° N30W 5280mils True (±10°) Elevation Angle: 21.0° Horizon Angle: 21.0° Zoom: 14.0x Start 11184+00, End 11184+00, CWD pipe and plunge pool</p>			
<b>GPS Location</b>	See photo GPS	<b>GPS Location</b>	See photo GPS		
<b>Field Station#</b>	11190+00	<b>Field Station#</b>	11184+00		
<b>Pic 5 Desc.</b>	Sensitive resource area/ drainage feature and ECD's.	<b>Pic 6 Desc.</b>	CWD pipe and plunge pool.

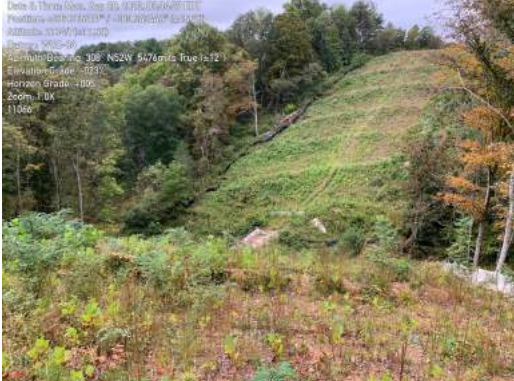
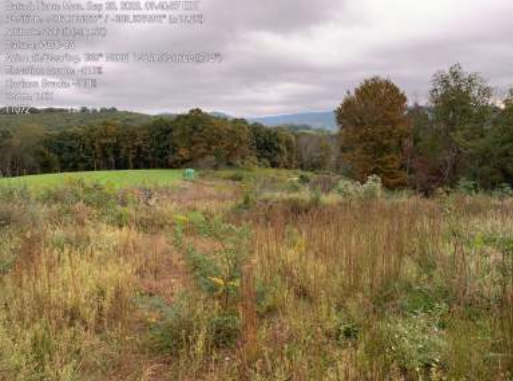
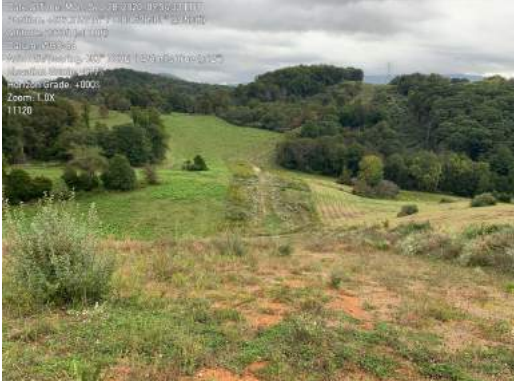
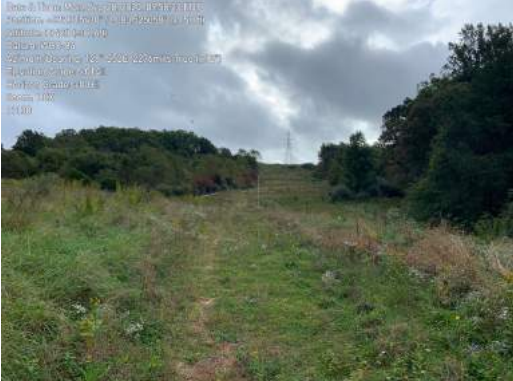
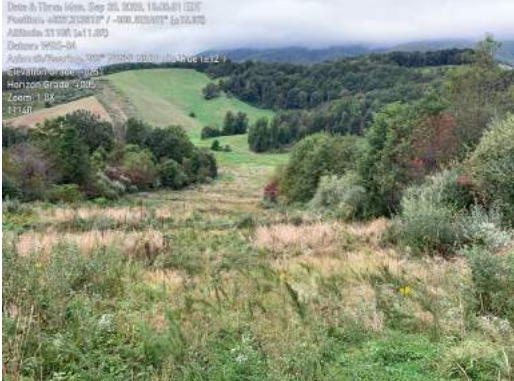
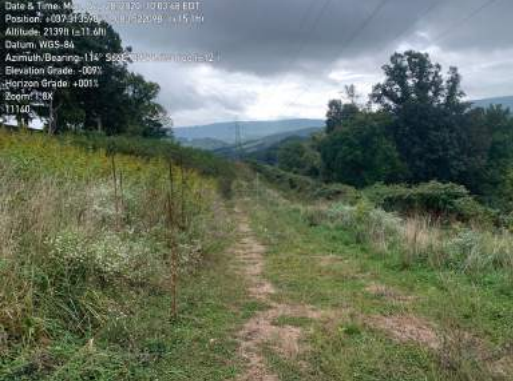
<b>GPS Location</b>	See picture above for GPS coordinates		<b>GPS Location</b>	See picture above for GPS coordinates	
<b>Field Station#</b>	11066+00		<b>Field Station#</b>	11072+00	
<b>Pic 1 Desc.</b>	ECD's and row conditions		<b>Pic 2 Desc.</b>	ECD's and row conditions

<b>GPS Location</b>	See picture above for GPS coordinates		<b>GPS Location</b>	See picture above for GPS coordinates	
<b>Field Station#</b>	11120+00		<b>Field Station#</b>	11130+00	
<b>Pic 3 Desc.</b>	ECD's and row conditions		<b>Pic 4 Desc.</b>	ECD's and row conditions

<b>GPS Location</b>	See picture above for GPS coordinates		<b>GPS Location</b>	See picture above for GPS coordinates	
<b>Field Station#</b>	11140+00		<b>Field Station#</b>	11140+00	
<b>Pic 5 Desc.</b>	ECD's and row conditions		<b>Pic 6 Desc.</b>	ECD's and row conditions

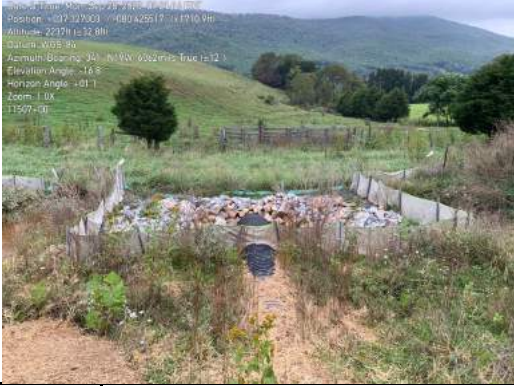
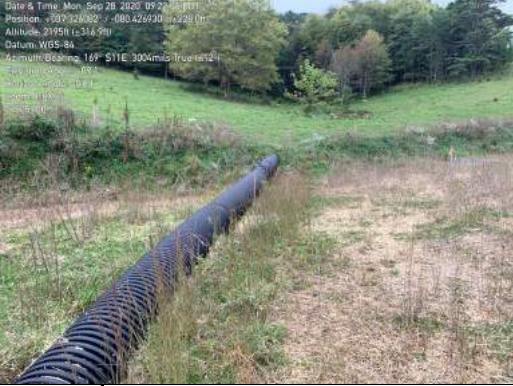
<b>GPS Location</b>	See photo for GPS location.		<b>GPS Location</b>	See photo for GPS location.	
<b>Field Station#</b>	11507+00		<b>Field Station#</b>	11505+00	
<b>Pic 1 Desc.</b>	Plunge pool in place.		<b>Pic 2 Desc.</b>	Clean water diversion pipe and clean water diversion berm in place.

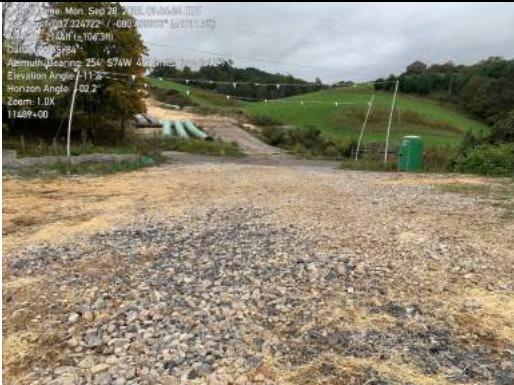
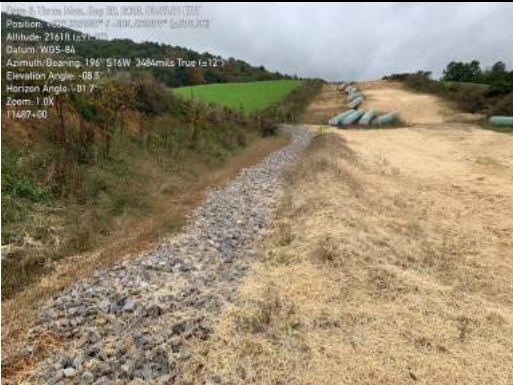
<b>GPS Location</b>	See photo for GPS location.		<b>GPS Location</b>	See photo for GPS location.	
<b>Field Station#</b>	11489+00		<b>Field Station#</b>	11487+00	
<b>Pic 3 Desc.</b>	RCE in place at Stevers Gap Road.		<b>Pic 4 Desc.</b>	Rock lined channel in place.

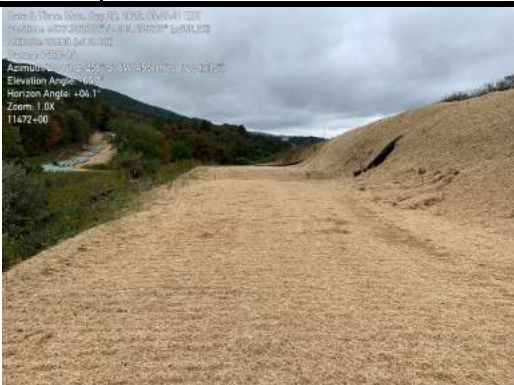
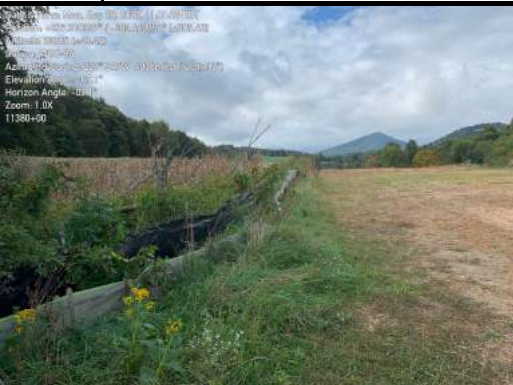
<b>GPS Location</b>	See photo for GPS location.		<b>GPS Location</b>	See photo for GPS location.	
<b>Field Station#</b>	11472+00		<b>Field Station#</b>	11380+00	
<b>Pic 5 Desc.</b>	ROW stabilized with seed and mulch.		<b>Pic 6 Desc.</b>	Triple barrier ECDs in place at off ROW karst feature.

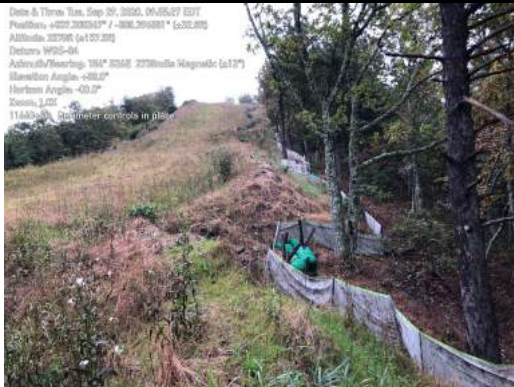
<b>GPS Location</b>	On photo	<b>GPS Location</b>	On photo		
<b>Field Station#</b>	11669+50	<b>Field Station#</b>	11660+00		
<b>Pic 1 Desc.</b>	ROW stable at JNF property line at FS188 crossing	<b>Pic 2 Desc.</b>	Perimeter controls in place. Slope breakers functional.

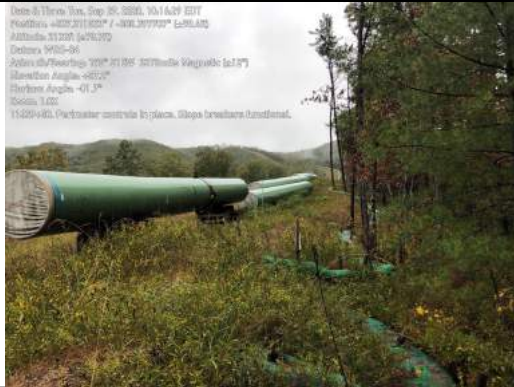
<b>GPS Location</b>	On photo	<b>GPS Location</b>	On photo		
<b>Field Station#</b>	11657+00	<b>Field Station#</b>	11639+00		
<b>Pic 3 Desc.</b>	Perimeter controls in place and slope breakers functioning properly.	<b>Pic 4 Desc.</b>	Perimeter controls in place and functional.

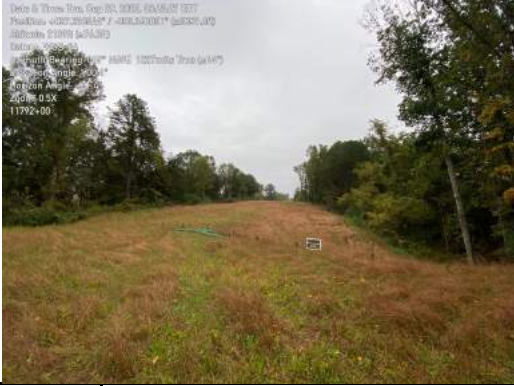
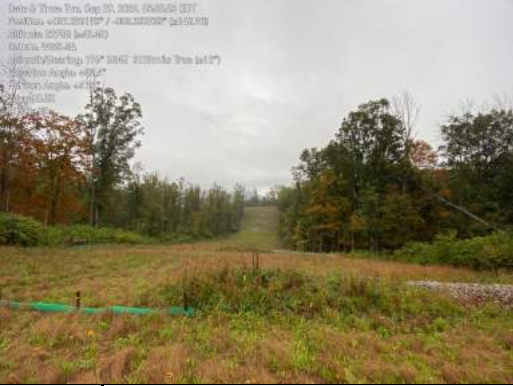
<b>GPS Location</b>	1	<b>GPS Location</b>	2		
<b>Field Station#</b>	11792+00	<b>Field Station#</b>	11825+00		
<b>Pic 1 Desc.</b>	Section of restored RoW showing conditions and controls.	<b>Pic 2 Desc.</b>	Section of restored RoW showing conditions and controls.

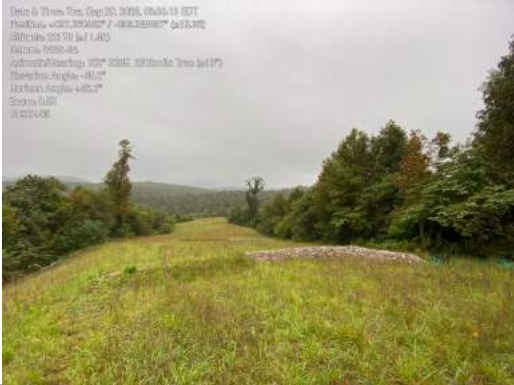
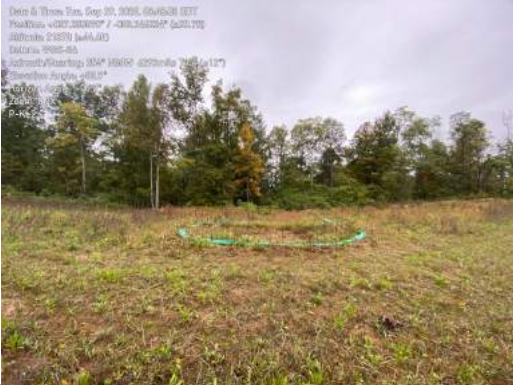
<b>GPS Location</b>	3	<b>GPS Location</b>	4		
<b>Field Station#</b>	11837+00	<b>Field Station#</b>	11863+65		
<b>Pic 3 Desc.</b>	Section of restored RoW showing conditions and controls.	<b>Pic 4 Desc.</b>	P-KL2 and controls.

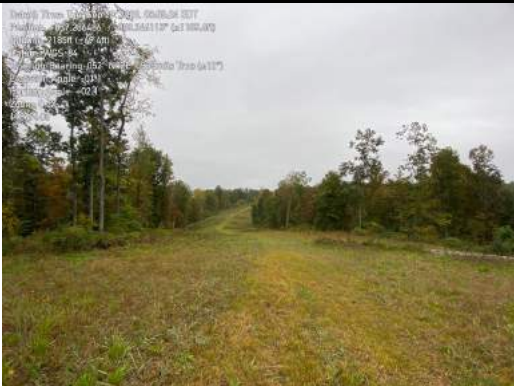
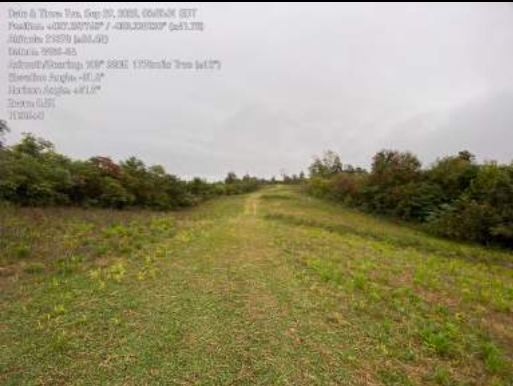
<b>GPS Location</b>	5	<b>GPS Location</b>	6		
<b>Field Station#</b>	11869+00	<b>Field Station#</b>	11886+00		
<b>Pic 5 Desc.</b>	Section of restored RoW showing conditions and controls.	<b>Pic 6 Desc.</b>	Section of restored RoW showing conditions and controls.

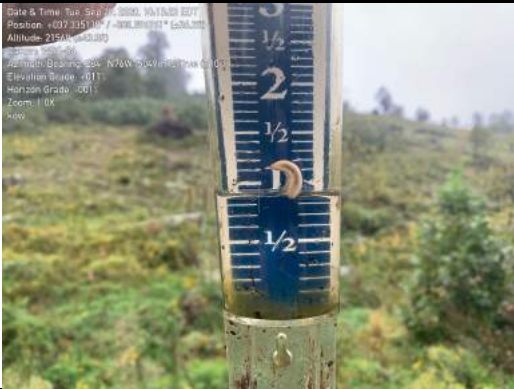
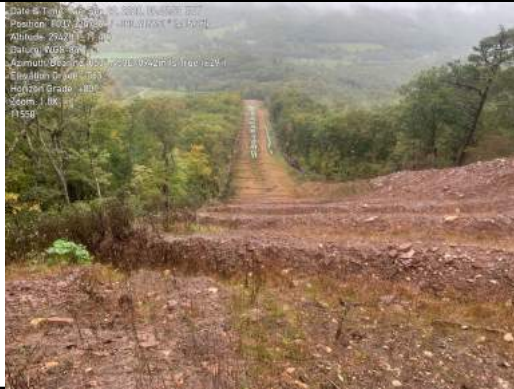
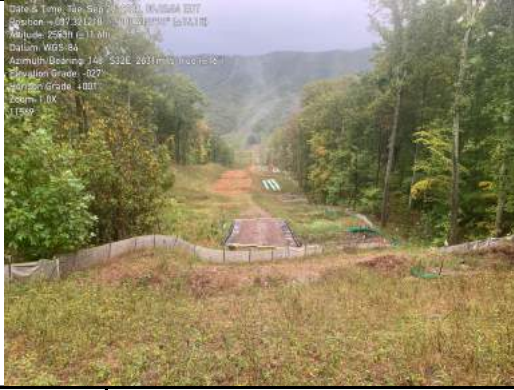
<b>GPS Location</b>	See picture above for GPS coordinates		<b>GPS Location</b>	See picture above for GPS coordinates	
<b>Field Station#</b>	11530+00		<b>Field Station#</b>	11550+00	
<b>Pic 3 Desc.</b>	ECD's and row conditions		<b>Pic 4 Desc.</b>	ECD's and row conditions	
  <p>Date &amp; Time: Tue, Sep 29, 2020, 10:04:07 EDT Position: +037.315042, -080.553596 (s64.98) Altitude: 25619 (s11.6M) Datum: WGS-84 Azimuth Bearing: 148.531E 269.1mils True (s147) Elevation Grade: +000 Horizon Grade: +000 Zoom: 1.0X 11.5m</p>

<b>Pic 5 Desc.</b>	ECD's and row conditions		<b>Pic 6 Desc.</b>	ECD's and row conditions

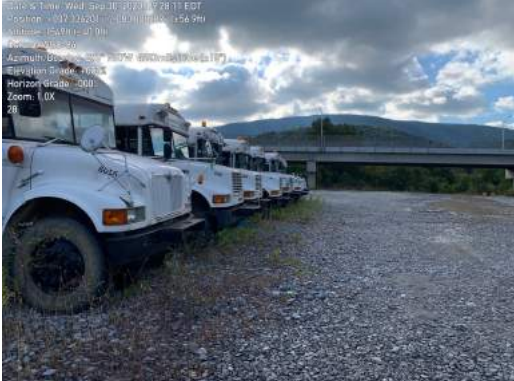
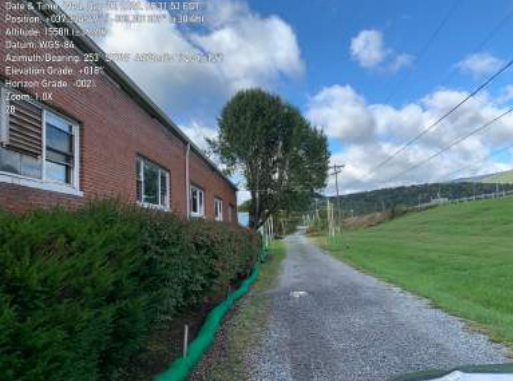
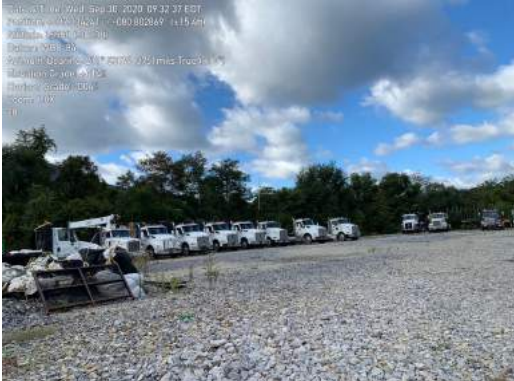
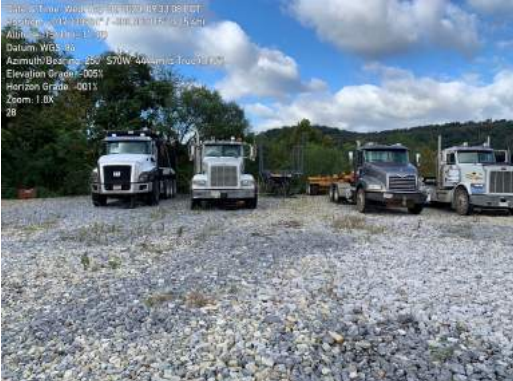
<b>GPS Location</b>	See picture above for GPS coordinates		<b>GPS Location</b>	See picture above for GPS coordinates	
<b>Field Station#</b>	12005+00		<b>Field Station#</b>	12005+00	
<b>Pic 1 Desc.</b>	ECD's and row conditions		<b>Pic 2 Desc.</b>	ECD's and row conditions

<b>GPS Location</b>	See picture above for GPS coordinates		<b>GPS Location</b>	See picture above for GPS coordinates	
<b>Field Station#</b>	12005+00		<b>Field Station#</b>	12005+00	
<b>Pic 3 Desc.</b>	ECD's and row conditions		<b>Pic 4 Desc.</b>	ECD's and row conditions

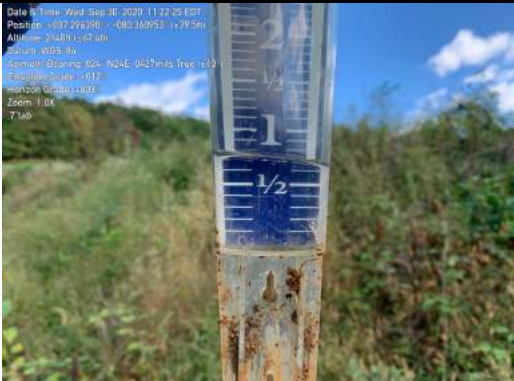
<b>GPS Location</b>	See picture above for GPS coordinates		<b>GPS Location</b>	See picture above for GPS coordinates	
<b>Field Station#</b>	+1		<b>Field Station#</b>	+1	
<b>Pic 5 Desc.</b>	.7" of rain recorded		<b>Pic 6 Desc.</b>	ECD's and row conditions

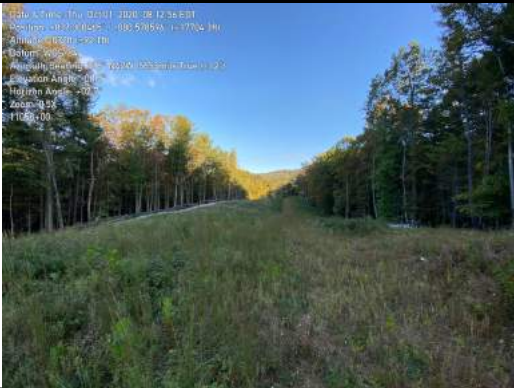
<b>GPS Location</b>	5	<b>GPS Location</b>	6		
<b>Field Station#</b>	11058+00	<b>Field Station#</b>	11064+50		
<b>Pic 5 Desc.</b>	Section of RoW showing conditions and controls.	<b>Pic 6 Desc.</b>	Section of RoW showing conditions and controls.

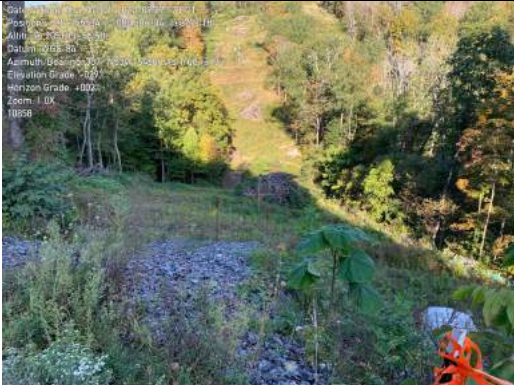
<b>GPS Location</b>	See picture above for GPS coordinates		<b>GPS Location</b>	See picture above for GPS coordinates	
<b>Field Station#</b>	10858+00		<b>Field Station#</b>	10862+00	
<b>Pic 1 Desc.</b>	ECD's and row conditions		<b>Pic 2 Desc.</b>	ECD's and row conditions

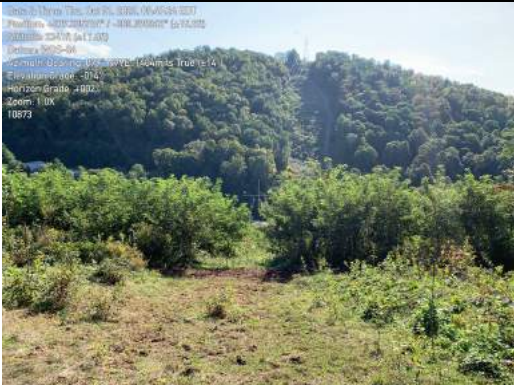
<b>GPS Location</b>	See picture above for GPS coordinates		<b>GPS Location</b>	See picture above for GPS coordinates	
<b>Field Station#</b>	10873+00		<b>Field Station#</b>	10888+00	
<b>Pic 3 Desc.</b>	ECD's and row conditions		<b>Pic 4 Desc.</b>	ECD's and row conditions

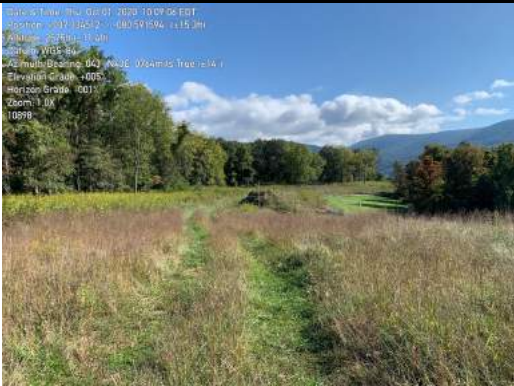
<b>GPS Location</b>	See picture above for GPS coordinates		<b>GPS Location</b>	See picture above for GPS coordinates	
<b>Field Station#</b>	10898+00		<b>Field Station#</b>	10920+00	
<b>Pic 5 Desc.</b>	ECD's and row conditions		<b>Pic 6 Desc.</b>	ECD's and row conditions

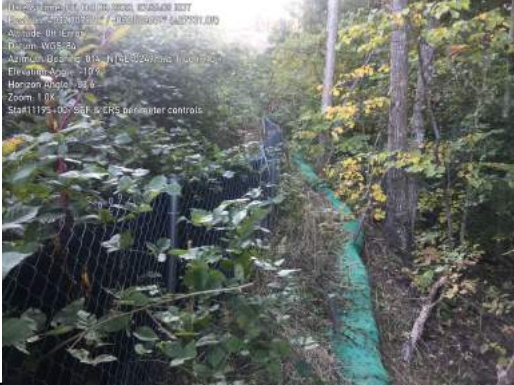
<b>GPS Location</b>	See photo GPS	<b>GPS Location</b>	See photo GPS		
<b>Field Station#</b>	11195+00	<b>Field Station#</b>	11191+00		
<b>Pic 3 Desc.</b>	SSF & CFS perimeter controls.	<b>Pic 4 Desc.</b>	Drainage feature & ECD's

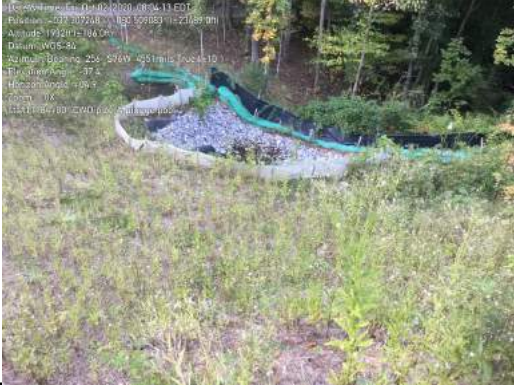
<b>GPS Location</b>	See photo GPS	<b>GPS Location</b>	See photo GPS		
<b>Field Station#</b>	11184+00	<b>Field Station#</b>	11172+70		
<b>Pic 5 Desc.</b>	CWD pipe and plunge pool.	<b>Pic 6 Desc.</b>	Slope drain inlet.
