Visual Site Inspection Report

Project Name	H-600 Pipeline Spread G	AFE	124300137	Spread	H-600 Pipeline Spread G
Contractor	Precision			Report #	14394
Inspector	Len Kruizenga			Date/Time	9/8/2020 8:28 AM
Permit #	TBD	Inspection Type	VA SWPP	Station Begin	12005+00
State	VA	Inspection Area	Full	Station End	12005+00
County	Giles	Ground	Dry	Temperature (°F)	76.00
Municipality	N/A	Weather	Cloudy	Rain Gauge (in)	0.00
				Rain Accumulation Time (days)	1.00

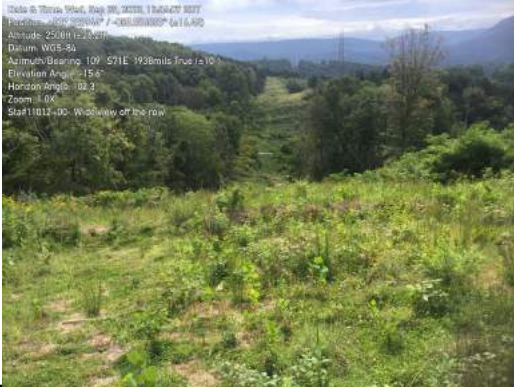
GPS Location	See photo GPS	GPS Location	See photo GPS		
Field Station#	11023+88	Field Station#	11017+00		
Pic 1 Desc.	AR-244- stream S-IJ18	Pic 2 Desc.	Stream S- RR5

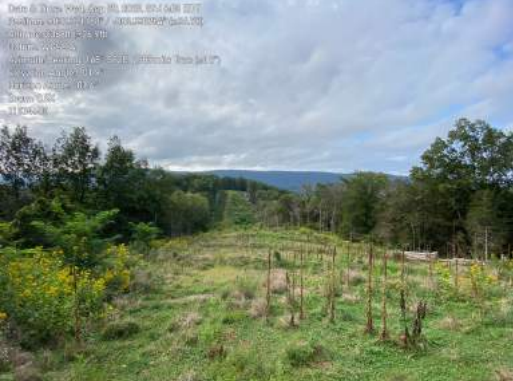
GPS Location	1	GPS Location	2		
Field Station#	11025+50	Field Station#	11034+00		
Pic 1 Desc.	S-IJ18.	Pic 2 Desc.	Section of RoW showing conditions and controls.

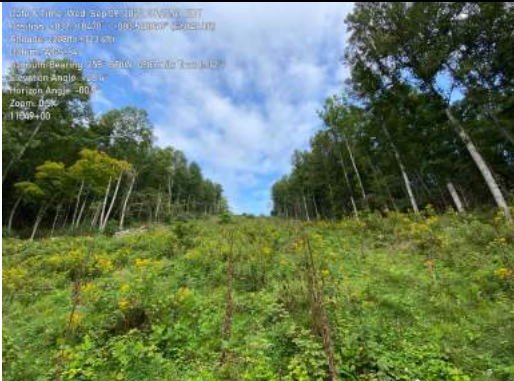
GPS Location	3	GPS Location	4		
Field Station#	11049+00	Field Station#	11050+10		
Pic 3 Desc.	Section of RoW showing conditions and controls.	Pic 4 Desc.	S-IJ16B/S-IJ17 and controls.

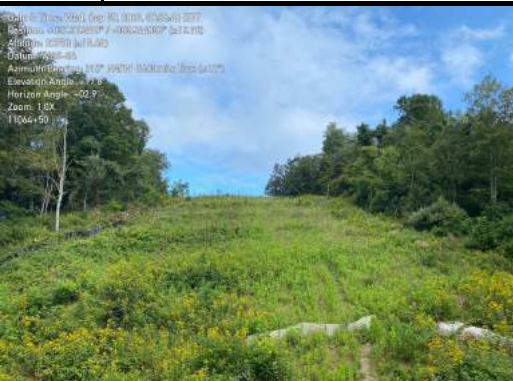
GPS Location	5	GPS Location	6		
Field Station#	11057+00	Field Station#	11064+50		
Pic 5 Desc.	Karst protection controls.	Pic 6 Desc.	Section of RoW showing conditions and controls.

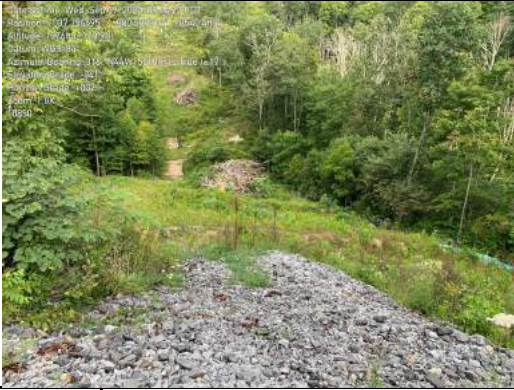
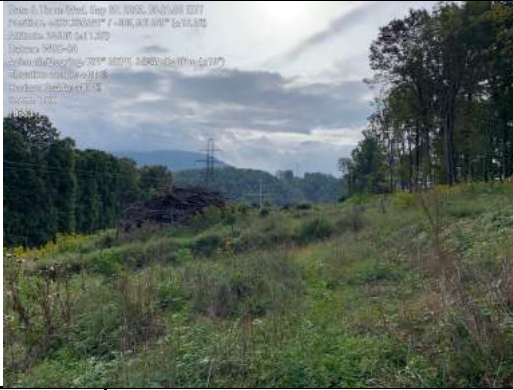
GPS Location	See picture above for GPS coordinates		GPS Location	See picture above for GPS coordinates	
Field Station#	10858+00		Field Station#	10862+00	
Pic 1 Desc.	ECD's and row conditions		Pic 2 Desc.	ECD's and row conditions

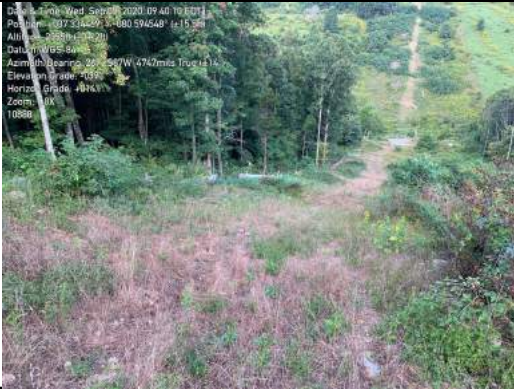
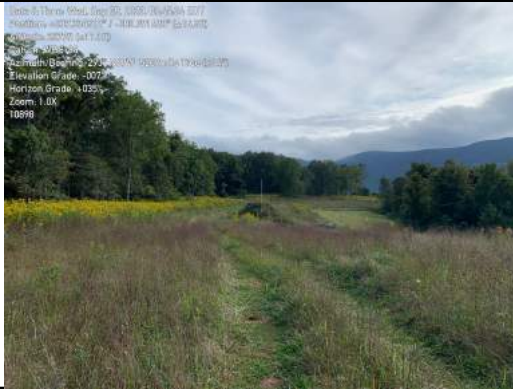
GPS Location	See picture above for GPS coordinates		GPS Location	See picture above for GPS coordinates	
Field Station#	10888+00		Field Station#	10898+00	
Pic 3 Desc.	ECD's and row conditions		Pic 4 Desc.	ECD's and row conditions

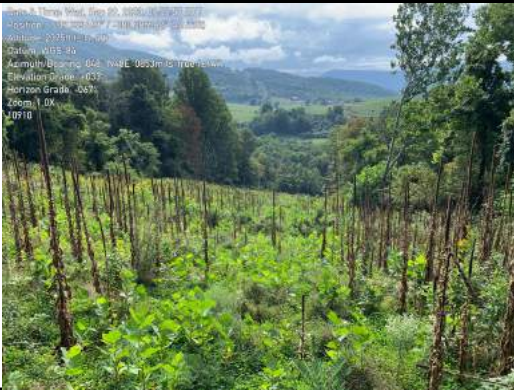
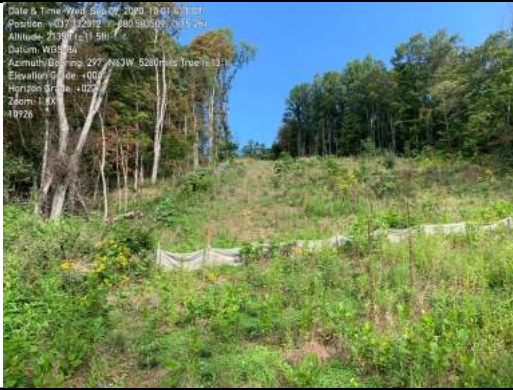
GPS Location	See picture above for GPS coordinates		GPS Location	See picture above for GPS coordinates	
Field Station#	10910+00		Field Station#	10926+00	
Pic 5 Desc.	ECD's and row conditions		Pic 6 Desc.	ECD's and row conditions

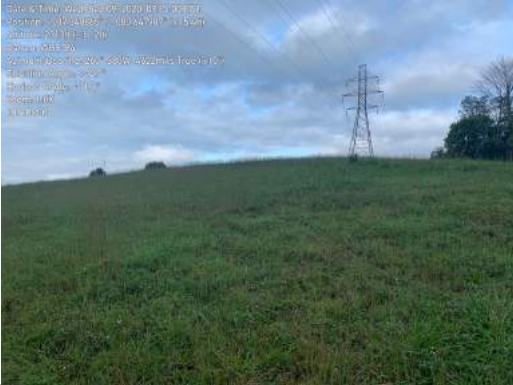
GPS Location	See photo for GPS location.		GPS Location	See photo for GPS location.	
Field Station#	10711+00		Field Station#	10710+00	
Pic 3 Desc.	Priority one silt fence checks in place.		Pic 4 Desc.	ROW is stabilized with natural vegetation growth.

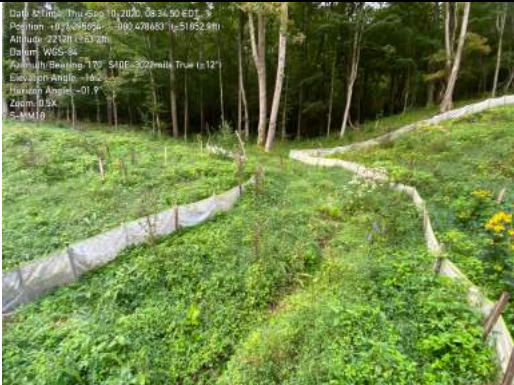
GPS Location	3	GPS Location	4		
Field Station#	11292+80	Field Station#	11327+85		
Pic 3 Desc.	S-MM18 and controls.		Pic 4 Desc.	S-MM12 and controls.

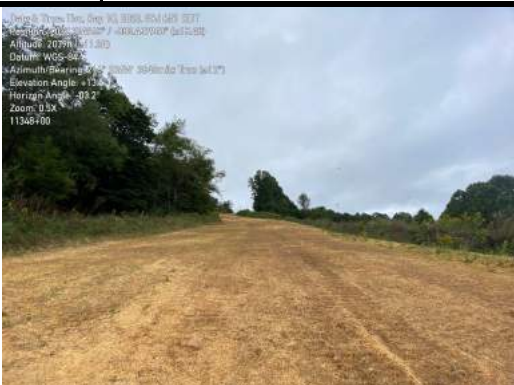
GPS Location	5	GPS Location	6		
Field Station#	11348+00	Field Station#	11352+97		
Pic 5 Desc.	Section of RoW showing conditions and controls.		Pic 6 Desc.	S-MM11 and controls.

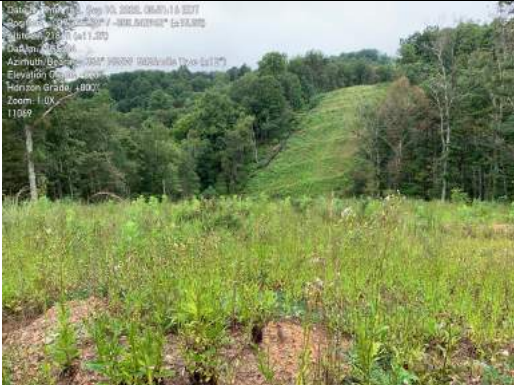
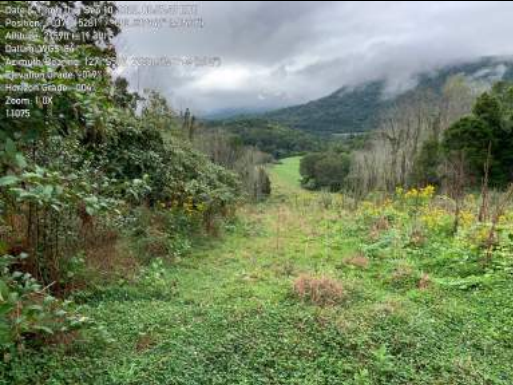
GPS Location	See picture above for GPS coordinates		GPS Location	See picture above for GPS coordinates	
Field Station#	11069+00		Field Station#	11075+00	
Pic 1 Desc.	ECD's and row conditions		Pic 2 Desc.	ECD's and row conditions

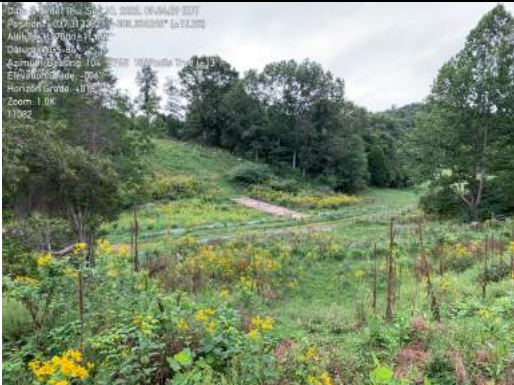
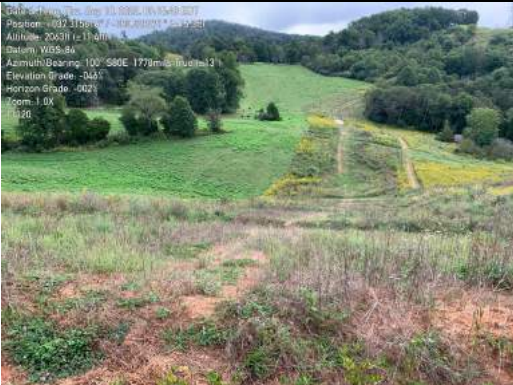
GPS Location	See picture above for GPS coordinates		GPS Location	See picture above for GPS coordinates	
Field Station#	11082+00		Field Station#	11120+00	
Pic 3 Desc.	ECD's and row conditions		Pic 4 Desc.	ECD's and row conditions

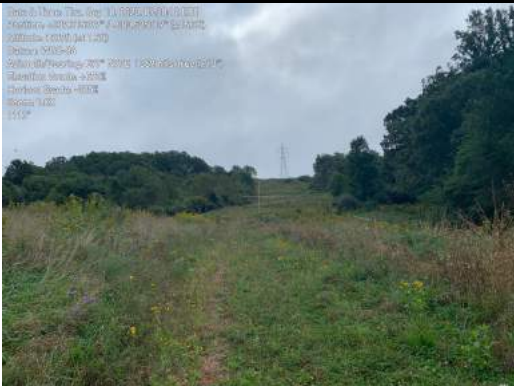
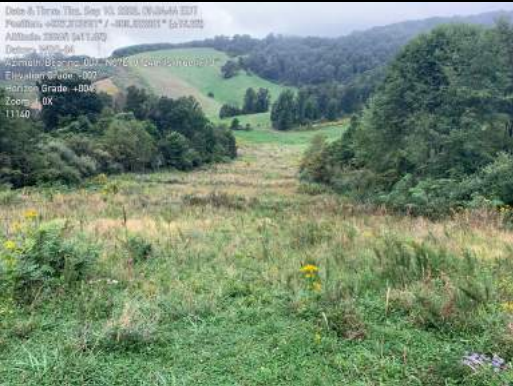
GPS Location	See picture above for GPS coordinates		GPS Location	See picture above for GPS coordinates	
Field Station#	11130+00		Field Station#	11140+00	
Pic 5 Desc.	ECD's and row conditions		Pic 6 Desc.	ECD's and row conditions

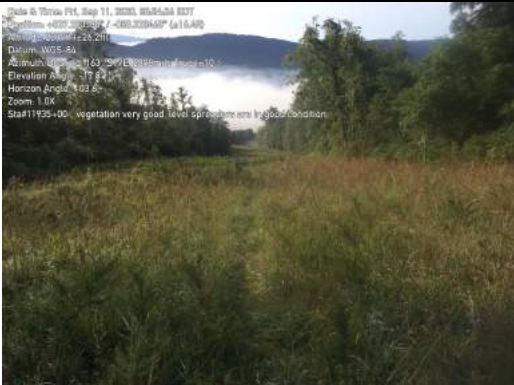
<p>Date & Time Fri, Sep 11, 2020, 09:54:00 EDT Position: +027.235847° / -080.332244° (a15.6N) Altitude: 2220ft (a25.2N) Datum: WGS-84 Azimuth/Bearing: 172° 50'E 305mils True (a10°) Elevation Angle: -17.8° Horizon Angle: -10.3° Zoom: 1.0X Sta#11935+00- vegetation very good, level spreaders are in good condition.</p>

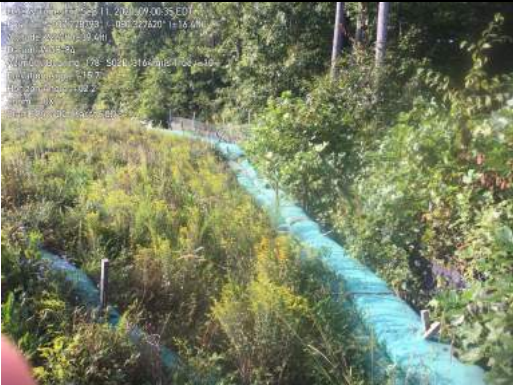
<p>Date & Time Fri, Sep 11, 2020, 09:59:00 EDT Position: +027.235847° / -080.332244° (a15.6N) Altitude: 2220ft (a25.2N) Datum: WGS-84 Azimuth/Bearing: 172° 50'E 305mils True (a10°) Elevation Angle: -16.2° Horizon Angle: -10.3° Zoom: 1.0X Sta#11942+00- Karst ECD's.</p>			
GPS Location	See photo GPS		GPS Location	See photo GPS	
Field Station#	11935+00		Field Station#	11942+00	
Pic 3 Desc.	Vegetation is very good		Pic 4 Desc.	Karst ECD's

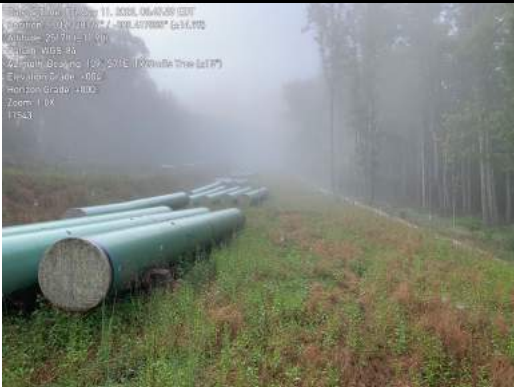
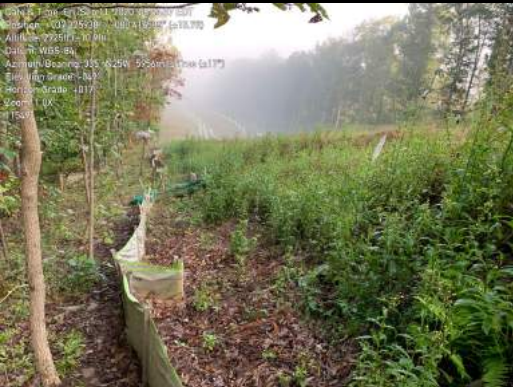
GPS Location	See picture above for GPS coordinates		GPS Location	See picture above for GPS coordinates	
Field Station#	11543+00		Field Station#	11549+00	
Pic 1 Desc.	ECD's and row conditions		Pic 2 Desc.	ECD's and row conditions

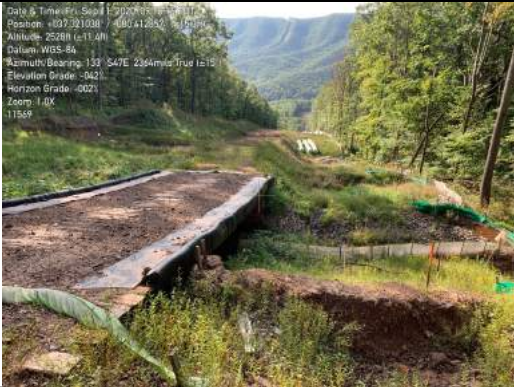
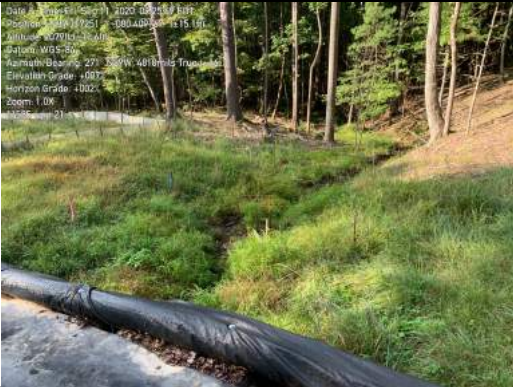
GPS Location	See picture above for GPS coordinates		GPS Location	See picture above for GPS coordinates	
Field Station#	11569+00		Field Station#	11585+00	
Pic 3 Desc.	ECD's and row conditions Spp22		Pic 4 Desc.	ECD's and row conditions SPP21

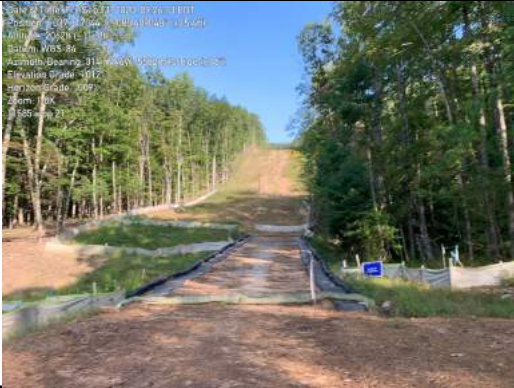
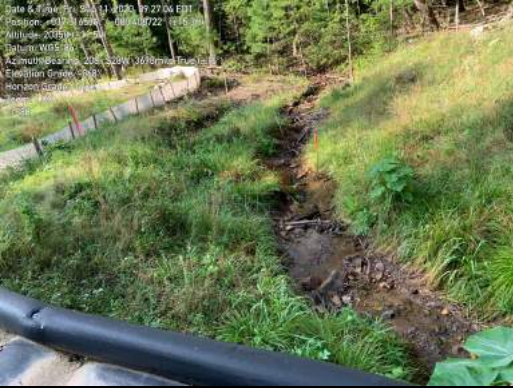
GPS Location	See picture above for GPS coordinates		GPS Location	See picture above for GPS coordinates	
Field Station#	11585+00		Field Station#	11588+00	
Pic 5 Desc.	ECD's and row conditions		Pic 6 Desc.	ECD's and row conditions SPP20
