Visual Site Inspection Report

Project Name	H-600 Pipeline Spread G	AFE	124300137	Spread	H-600 Pipeline Spread G
Contractor	Precision			Report #	15212
Inspector	Rob Robertson			Date/Time	10/5/2020 11:29 AM
Permit #	TBD	Inspection Type	VA SWPP	Station Begin	11600+01
State	VA	Inspection Area	Full	Station End	11670+00
County	Montgomery	Ground	Damp	Temperature (°F)	50.00
Municipality	N/A	Weather	Sunny	Rain Gauge (in)	0.00
				Rain Accumulation Time (days)	1.00

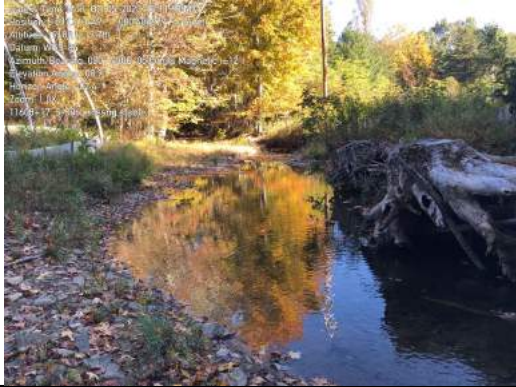
<p> Date & Time: Mon, Oct 5, 2020, 10:10:38 EDT Position: 43°07'31.9670"N 116°02'28.011"W (44°) Altitude: 928ft (±19.5ft) Datum: WGS-84 Azimuth/Heading: 250° 57'W 144mils Magnetic (±14°) Deviation Angle: 10°W Horizon Angle: 70°W Zoom: 1.0X 11614+20, S-RR14 crossing stable </p>			
GPS Location	On photo	GPS Location	On photo		
Field Station#	11614+20	Field Station#	11613+69		
Pic 7 Desc.	The S-RR14 crossing is stable with ECDs in place.	Pic 8 Desc.	The S-RR13 crossing at MN-258.04 is stable.

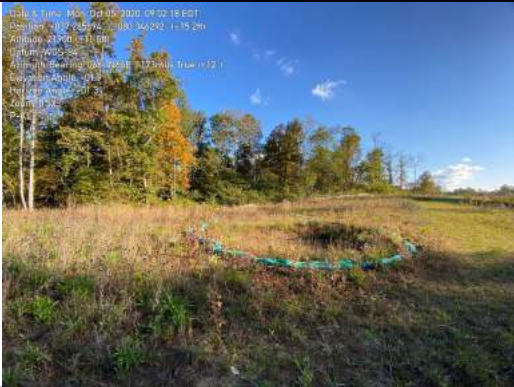
GPS Location	1	GPS Location	2		
Field Station#	11792+00	Field Station#	11825+00		
Pic 1 Desc.	Section of restored RoW showing conditions and controls.	Pic 2 Desc.	Section of restored RoW showing conditions and controls.

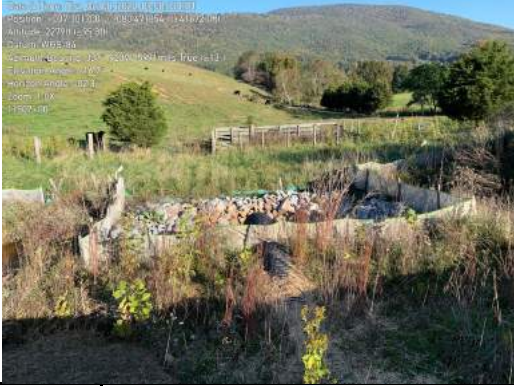
<p>Date & Time: Thu, Oct 8, 2020 11:50:00 Position: +017.31259 / -083.427194 (1341072.0m) Altitude: 2270ft (+55.2m) Datum: WGS-84 Azimuth/Bearing: 184° 50W 3271mils True (+13°) Elevation Angle: -03.7° Horizon Angle: -02.9° Zoom: 1.0X 11505+00</p>			
GPS Location		See photo for GPS location.		GPS Location	
Field Station#		11507+00		Field Station#	
Pic 1 Desc.		Clean water diversion pipe and plunge pool in place.		Pic 2 Desc.

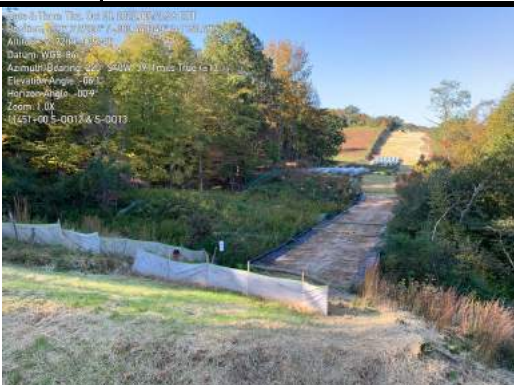
GPS Location		See photo for GPS location.		GPS Location	
Field Station#		11489+00		Field Station#	
Pic 3 Desc.		RCE in place at Stevers Gap Road.		Pic 4 Desc.
