Visual Site Inspection Report

Project Name	H-600 Pipeline Spread H	AFE	124300138	Spread	H-600 Pipeline Spread H
Contractor	Precision			Report #	17755
Inspector	John Brcic			Date/Time	12/7/2020 10:10 AM
Permit #	TBD	Inspection Type	VA SWPP	Station Begin	13262+50
State	VA	Inspection Area	Partial	Station End	13315+70
County	Franklin	Ground	Damp	Temperature (°F)	31.00
Municipality	N/A	Weather	Snow/Sleet	Rain Gauge (in)	0.10
				Rain Accumulation Time (days)	2.00

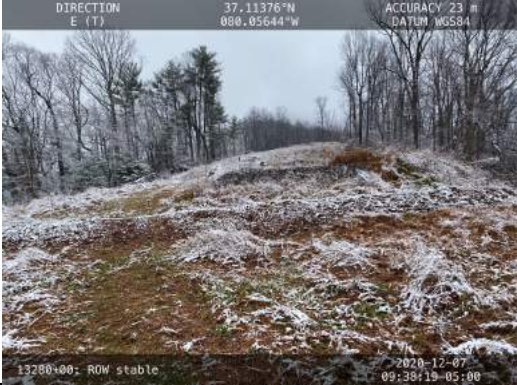
GPS Location	See photo		GPS Location	See photo	
Field Station#	13280+00		Field Station#	13275+00	
Pic 15 Desc.	ROW stable		Pic 16 Desc.	ROW stable

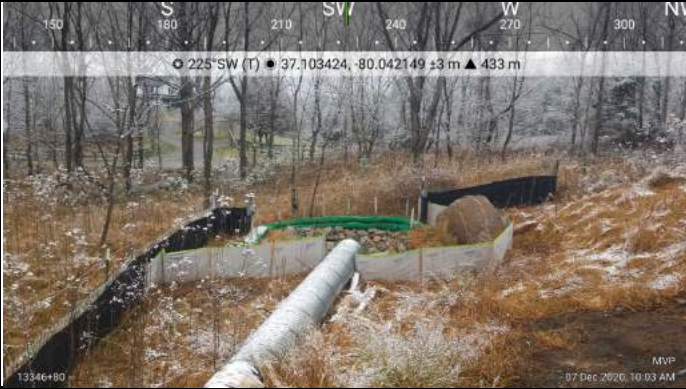
GPS Location	See Above		GPS Location	See Above	
Field Station#	13346+80		Field Station#	13348+46	
Pic 7 Desc.	Cleanwater diversion pipe outlet. ECDs are functional.		Pic 8 Desc.	Waterbody S-RR08. ECDs are functional.

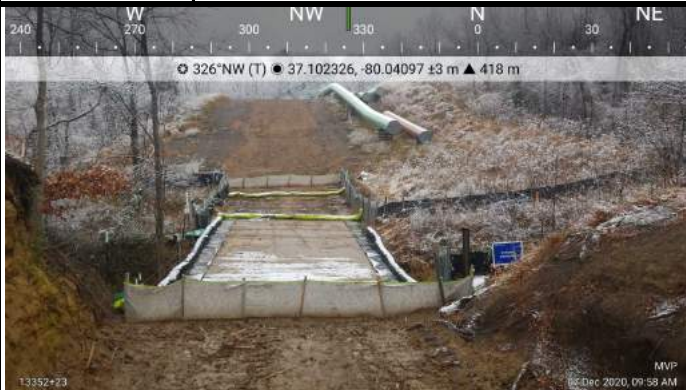
GPS Location	See Above		GPS Location	See Above	
Field Station#	13352+23		Field Station#	13354+50	
Pic 9 Desc.	Waterbody S-RR09. ECDs are functional.		Pic 10 Desc.	Overview of equipment bridge over grassy swale/drainage area. ECDs are functional.

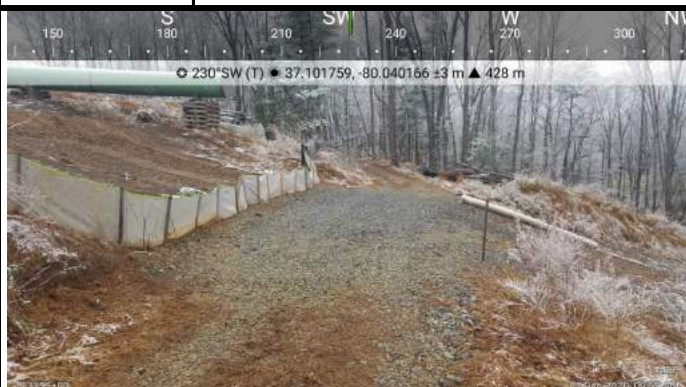
GPS Location	See Above		GPS Location	See Above	
Field Station#	13355+90		Field Station#	13358+64	
Pic 11 Desc.	Overview of private road crossing ROW. ECDs are functional.		Pic 12 Desc.	Waterbody S-RR11. ECDs are functional.

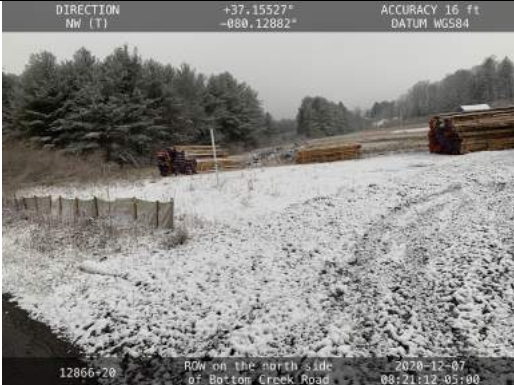
GPS Location	See photo for gps location data.		GPS Location	See photo for gps location data.	
Field Station#	12866+20		Field Station#	12957+38	
Pic 1 Desc.	Photo shows the ROW on the east side of Bottom Creek Road.		Pic 2 Desc.	Photo shows the bridge over stream S-Z16 on access road RO-287.

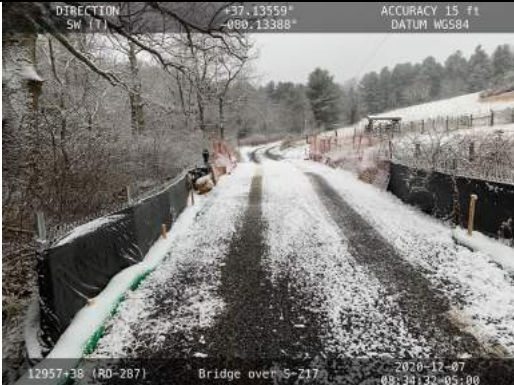
GPS Location	See photo for gps location data.		GPS Location	See photo for gps location data.	
Field Station#	12957+38		Field Station#	12957+38	
Pic 3 Desc.	Photo shows the bridge over stream S-Z17 on access road RO-287.		Pic 4 Desc.	Photo shows stream S-Z17 downstream from access road RO-287.

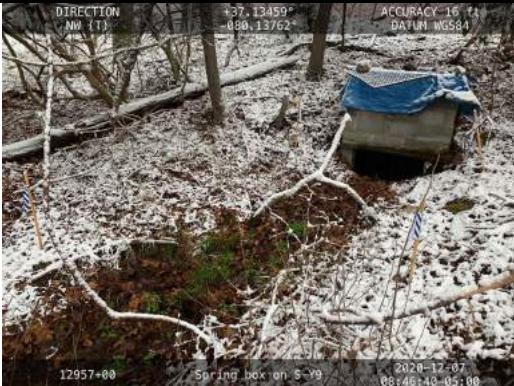
GPS Location	See photo for gps location data.		GPS Location	See photo for gps location data.	
Field Station#	12957+00		Field Station#	12956+50	
Pic 5 Desc.	Photo shows the spring box on stream S-Y9.		Pic 6 Desc.	Photo shows the sump pit plunge pool outlet structure.

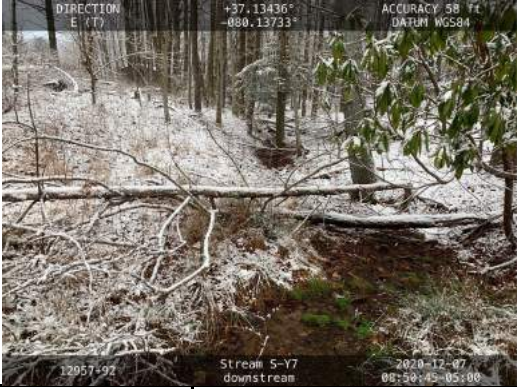
GPS Location	See photo for gps location data.		GPS Location	See photo for gps location data.	
Field Station#	12957+92		Field Station#	12958+78	
Pic 7 Desc.	Photo shows stream S-Y7 down stream from the ROW.		Pic 8 Desc.	Photo shows stream S-Y8 downstream from the ROW.

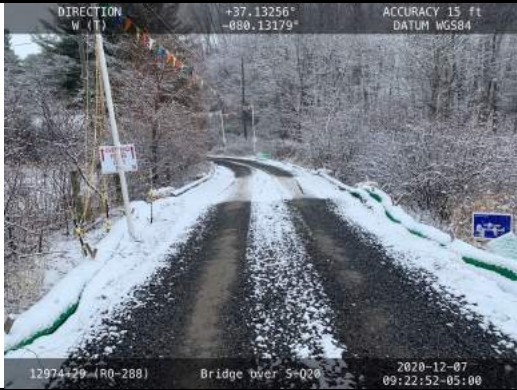
GPS Location	See photo for gps location data.		GPS Location	See photo for gps location data.	
Field Station#	12974+29		Field Station#	12974+29	
Pic 9 Desc.	Photo shows the bridge over stream S-Q20 on access road RO-288.		Pic 10 Desc.	Photo the ECDs along RO-288 near the bridge over S-Q20.

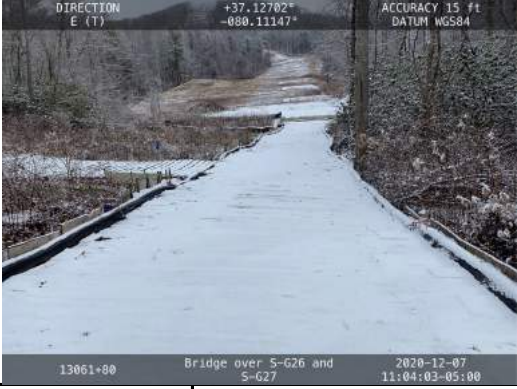
GPS Location	See photo for gps location data.		GPS Location	See photo for gps location data.	
Field Station#	13061+80		Field Station#	12061+89	
Pic 15 Desc.	Photo shows the bridge over streams S-G26 and S-G27.		Pic 16 Desc.	Photo shows stream S-G26 downstream from the bridge.

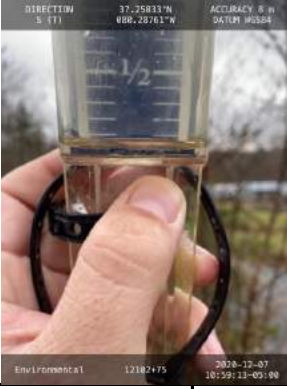
GPS Location	See photo for GPS coordinates		GPS Location	See photo for GPS coordinates	
Field Station#	12108+41		Field Station#	12102+75	
Pic 15 Desc.	Bridge and ECDs in working conditions and well vegetated buffer zone.		Pic 16 Desc.	Rain gauge totals following the snow from the previous night melting. (0.1"). Half Acre of Rock Rd

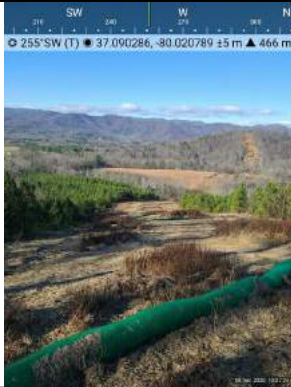
GPS Location	00000	GPS Location	0000		
Field Station#	13468+88	Field Station#	13426+16		
Pic 3 Desc.	Stabilization observation, ECDs checked and functioning during routine row inspection		Pic 4 Desc.	Stabilization observation, ECDs checked and functioning during routine row inspection

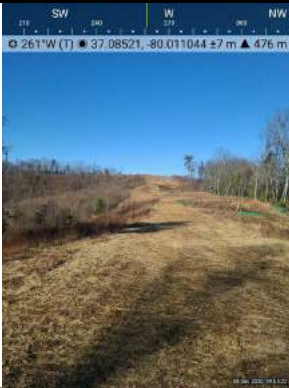
GPS Location	00000	GPS Location	00000		
Field Station#	13470+00	Field Station#	13497+70		
Pic 5 Desc.	Stabilization observation, ECDs checked and functioning during routine row inspection		Pic 6 Desc.	Vegetation observation by the EI showing good coverage over row, ECDs checked and in place and functioning at stream crossing

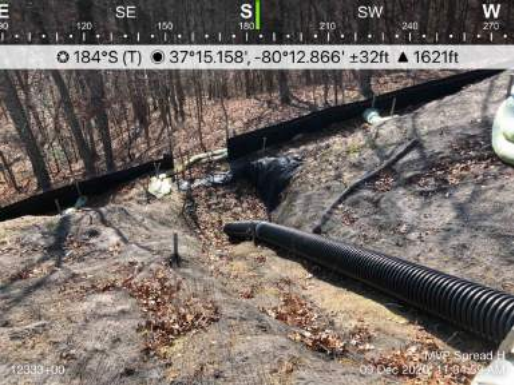
GPS Location	See Picture Watermark		GPS Location	See Picture Watermark	
Field Station#	12314+00		Field Station#	12333+00	
Pic 9 Desc.	Recently restabilized area continues to germinate and prevent accelerated erosion.		Pic 10 Desc.	Slope drains remain installed, functional, and no maintenance is needed.

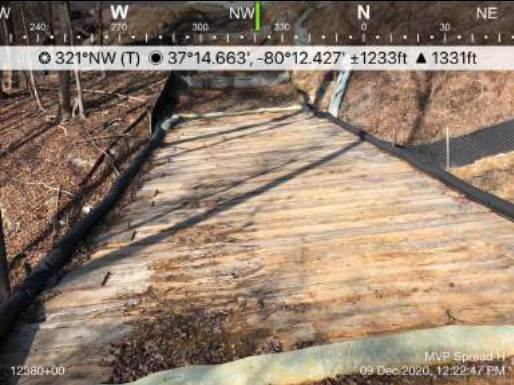
GPS Location	See Picture Watermark		GPS Location	See Picture Watermark	
Field Station#	12380+00		Field Station#	12380+00	
Pic 11 Desc.	S-NN19 is in good condition, and no maintenance is needed in the area.		Pic 12 Desc.	Equipment bridge at S-NN19 is in good condition.

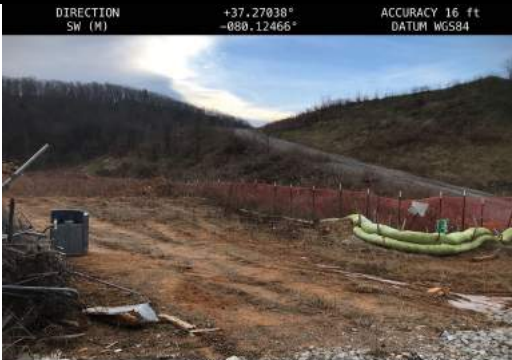
<p>DIRECTION SW (N) +37.27038° -080.12466° ACCURACY 16 ft DATUM WGS84</p> <p>MVP-LY-049_120920 Landowner disturbance along CFS & feature 2020-12-09 08:45:43-05:00</p>

GPS Location	MVP-LY-049 See photo for gps data	GPS Location	MVP-LY-049 See photo for gps data		
Field Station#	+0	Field Station#	+0		
Pic 3 Desc.	Landowner soil disturbance along compost filter sock and feature W-CV21B. Area not stabilized. Looking SW.	Pic 4 Desc.	Landowner soil disturbance within 66' and 120' of feature W-CV21B. Area not stabilized. No impacts. Looking W.

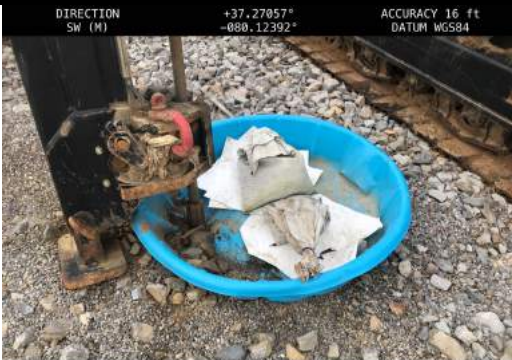
<p>DIRECTION SW (N) +37.27057° -080.12392° ACCURACY 16 ft DATUM WGS84</p> <p>MVP-LY-049_120920 Condition of containment 2020-12-09 08:47:31-05:00</p>

<p>DIRECTION SW (N) +37.27052° -080.12384° ACCURACY 16 ft DATUM WGS84</p> <p>MVP-LY-049_120920 Containment under stored equipment 2020-12-09 08:47:43-05:00</p>			
GPS Location	MVP-LY-049 See photo for gps data	GPS Location	MVP-LY-049 See photo for gps data		
Field Station#	+0	Field Station#	+0		
Pic 5 Desc.	Condition of containment under stored equipment. Looking SW.	Pic 6 Desc.	Condition of containment under stored equipment. Looking SW.

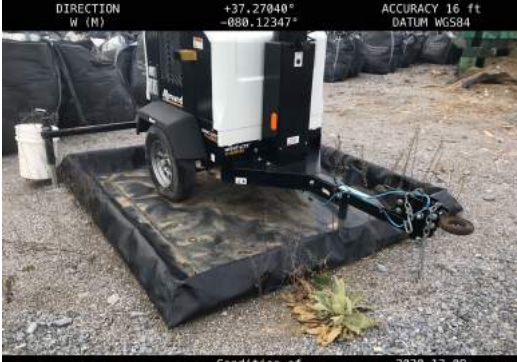
<p>DIRECTION W (M) +37.27040° -080.12347° ACCURACY 16 ft DATUM WGS84</p> <p>MVP-LY-049_120920 Condition of containment 2020-12-09 08:48:46-05:00</p>

<p>DIRECTION W (M) +37.27040° -080.12347° ACCURACY 16 ft DATUM WGS84</p> <p>MVP-LY-049_120920 Condition of temporary trash 2020-12-09 08:48:50-05:00</p>			
GPS Location	MVP-LY-049 See photo for gps data		GPS Location	MVP-LY-049 See photo for gps data	
Field Station#	+0		Field Station#	+0	
Pic 7 Desc.	Condition of containment under light plant. Looking W.		Pic 8 Desc.	Condition of debris in the Temporary trash transfer pit. Debris inside boundary of pit. Looking W.

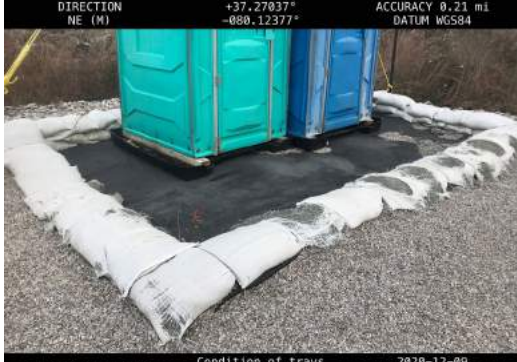
<p>DIRECTION NE (M) +37.27037° -080.12377° ACCURACY 0.21 mi DATUM WGS84</p> <p>MVP-LY-049_120920 Condition of trays and containment 2020-12-09 08:49:28-05:00</p>

GPS Location	MVP-LY-049 See photo for gps data		GPS Location	MVP-LY-049 See photo for gps data	
Field Station#	+0		Field Station#	+0	
Pic 9 Desc.	Condition of trays and containment under toilets. Looking NE.		Pic 10 Desc.	No loose trash around dumpster. Looking SW.

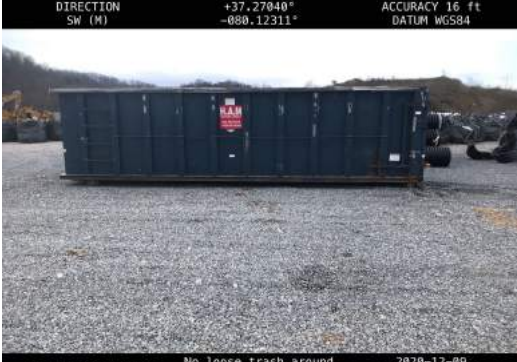
<p>DIRECTION SW (M) +37.27040° -080.12311° ACCURACY 16 ft DATUM WGS84</p> <p>MVP-LY-049_120920 No loose trash around dumpster 2020-12-09 08:53:00-05:00</p>

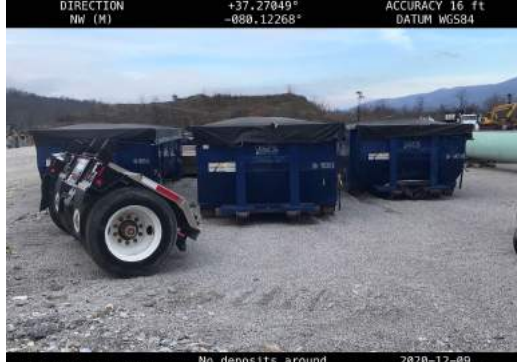
<p>DIRECTION NW (M) +37.27049° -080.12268° ACCURACY 16 ft DATUM WGS84</p> <p>MVP-LY-049_120920 No deposits around hazardous waste 2020-12-09 08:54:54-05:00</p>

<p>DIRECTION N (M) +37.27103° -080.12199° ACCURACY 16 ft DATUM WGS84</p> <p>MVP-LY-049_120920 Condition of CFS & safety fence 2020-12-09 08:56:30-05:00</p>			
GPS Location	MVP-LY-049 See photo for gps data		GPS Location	MVP-LY-049 See photo for gps data	
Field Station#	+0		Field Station#	+0	
Pic 11 Desc.	No fluids or deposits around hazardous waste dumpsters. Looking NW.		Pic 12 Desc.	Condition of compost filter sock along center drive. Looking N.

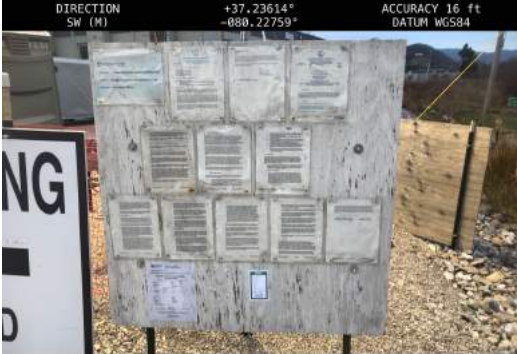
GPS Location	MVP-PY-006 See photo for gps data		GPS Location	MVP-PY-006 See photo for gps data	
Field Station#	+0		Field Station#	+0	
Pic 7 Desc.	Condition of posted documents at main entrance. Looking SW.		Pic 8 Desc.	No loose trash around dumpsters. Looking S.

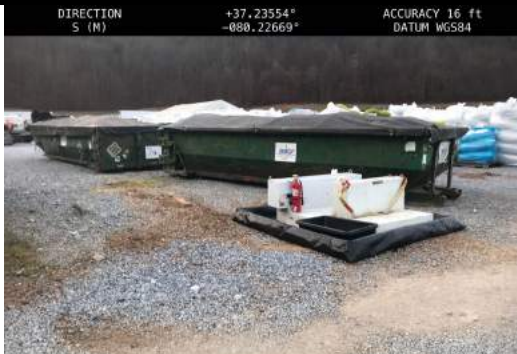
GPS Location	MVP-PY-006 See photo for gps data		GPS Location	MVP-PY-006 See photo for gps data	
Field Station#	+0		Field Station#	+0	
Pic 9 Desc.	No deposits or fluids around hazardous waste dumpsters. Looking S.		Pic 10 Desc.	Blue Bulk Fuel tanks no leaky internal fittings. Looking NW.

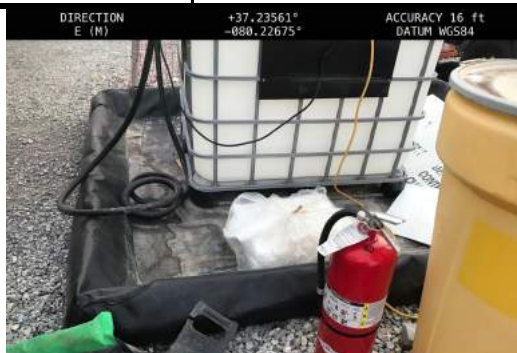
GPS Location	MVP-PY-006 See photo for gps data		GPS Location	MVP-PY-006 See photo for gps data	
Field Station#	+0		Field Station#	+0	
Pic 11 Desc.	Condition of containment under DEF tank. Free of stormwater. Looking E.		Pic 12 Desc.	Blue Bulk Fuel tanks no leaky fittings or nozzles. Looking S.

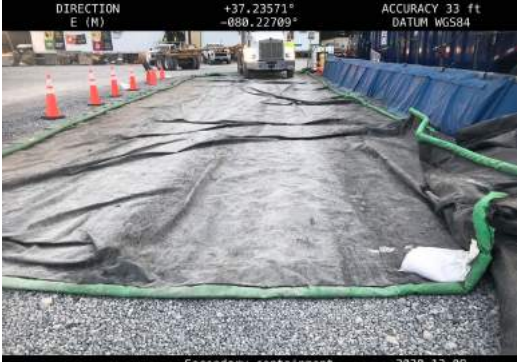
<p>DIRECTION E (M) +37.23571° -080.22709° ACCURACY 33 ft DATUM WGS84</p> <p>MVP-PY-006_120920 Secondary containment on site for tankers 2020-12-09 07:43:31-05:00</p>

<p>DIRECTION SW (M) +37.23558° -080.22698° ACCURACY 16 ft DATUM WGS84</p> <p>MVP-PY-006_120920 Condition of internal drip pan 2020-12-09 07:44:29-05:00</p>			
GPS Location	MVP-PY-006 See photo for gps data		GPS Location	MVP-PY-006 See photo for gps data	
Field Station#	+0		Field Station#	+0	
Pic 13 Desc.	Secondary containment on site for tankers offloading fuel into Blue Bulk fuel tanks. Looking E.		Pic 14 Desc.	Off Road Fuel unit condition of internal drip pan. Looking SW.

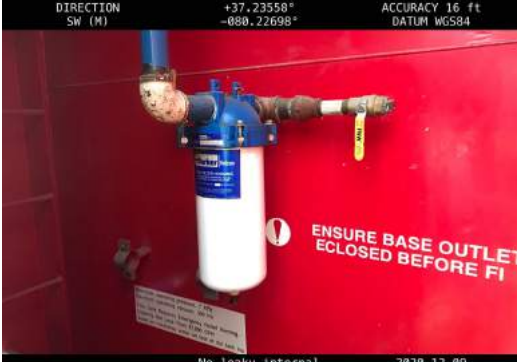
<p>DIRECTION SW (M) +37.23558° -080.22698° ACCURACY 16 ft DATUM WGS84</p> <p>MVP-PY-006_120920 No leaky internal fittings 2020-12-09 07:44:31-05:00</p>

GPS Location	MVP-PY-006 See photo for gps data		GPS Location	MVP-PY-006 See photo for gps data	
Field Station#	+0		Field Station#	+0	
Pic 15 Desc.	Off Road Fuel unit no leaky internal fittings. Looking SW.		Pic 16 Desc.	No fluids or deposits around hazardous waste dumpsters west of mechanics building. Looking S.

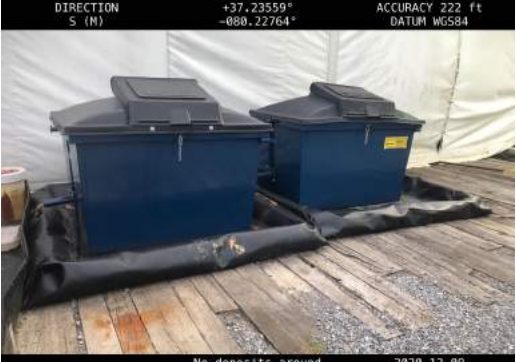
<p>DIRECTION S (M) +37.23559° -080.22764° ACCURACY 222 ft DATUM WGS84</p> <p>MVP-PY-006_120920 No deposits around hazardous waste 2020-12-09 07:56:05-05:00</p>

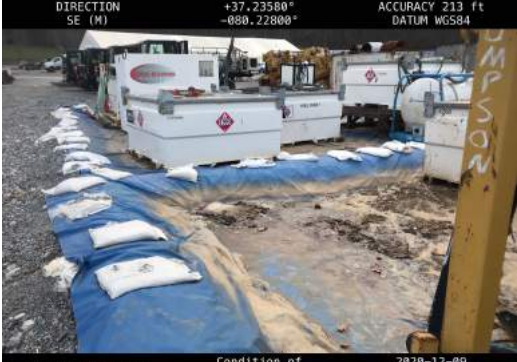
<p>DIRECTION SE (M) +37.23580° -080.22800° ACCURACY 213 ft DATUM WGS84</p> <p>MVP-PY-006_120920 Condition of containment 2020-12-09 08:03:10-05:00</p>

<p>DIRECTION NW (M) +37.23452° -080.22882° ACCURACY 16 ft DATUM WGS84</p> <p>MVP-PY-006_120920 Containment under stored equipment 2020-12-09 08:04:56-05:00</p>			
GPS Location	MVP-PY-006 See photo for gps data		GPS Location	MVP-PY-006 See photo for gps data	
Field Station#	+0		Field Station#	+0	
Pic 17 Desc.	Condition of containments. Free of stormwater. Looking SE.		Pic 18 Desc.	Condition of containment under stored equipment. Looking NW.

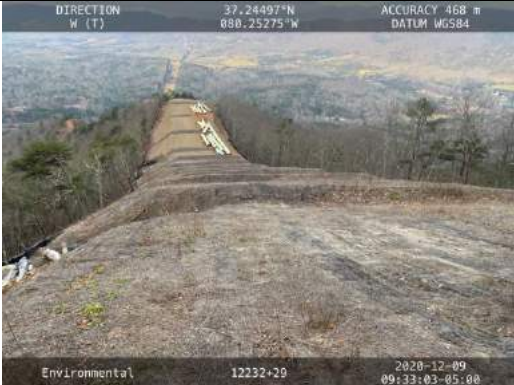
GPS Location	See photo for GPS coordinates		GPS Location	See photo for GPS coordinates	
Field Station#	12232+29		Field Station#	12230+00	
Pic 1 Desc.	Temporary stabilization in acceptable condition with vegetive cover across LOD		Pic 2 Desc.	Waterbar outlet in a temporary stabilized ROW.

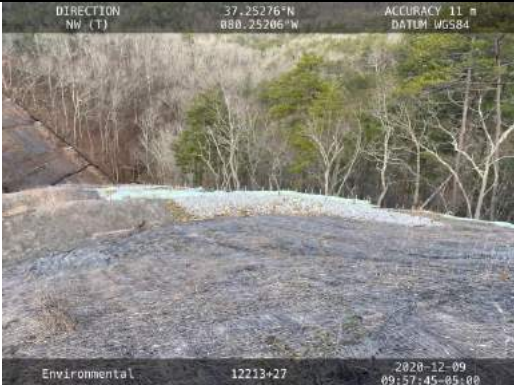
GPS Location	See photo for GPS coordinates		GPS Location	See photo for GPS coordinates	
Field Station#	12213+27		Field Station#	12210+00	
Pic 3 Desc.	Rock Weir I'm finally stabilized section is in acceptable working conditions.		Pic 4 Desc.	Stabilized steep slope in acceptable condition with vegetation across LOD

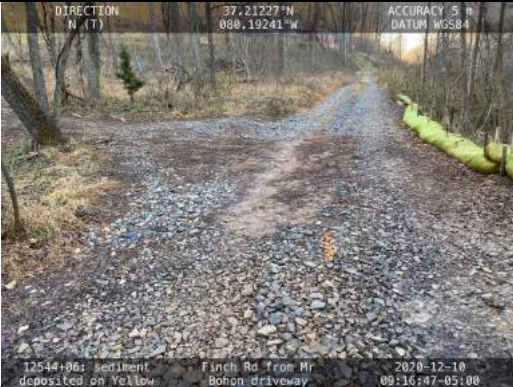
GPS Location	See photo		GPS Location	See photo	
Field Station#	12544+06		Field Station#	12544+06	
Pic 3 Desc.	Stream S-EF54, facing northwest, upstream from Yellow Finch Road		Pic 4 Desc.	Sediment deposits building up on Yellow Finch Road where it is being washed out of Mr Bohon's driveway.

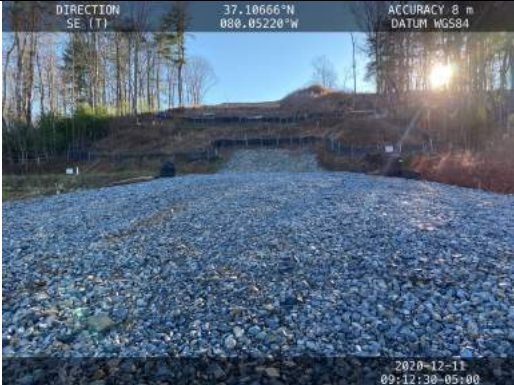
GPS Location	See photo		GPS Location	See photo	
Field Station#	13315+70		Field Station#	13313+00	
Pic 1 Desc.	The RCE on the coming in side of Wades Gap Road is in satisfactory condition.		Pic 2 Desc.	Temporary stabilization well vegetated between stream S-GH7 and Wades Gap Road.

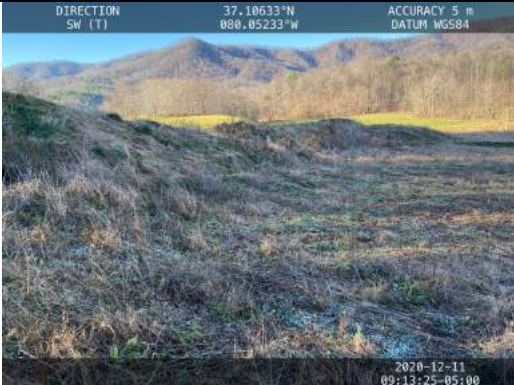
GPS Location	See photo		GPS Location	See photo	
Field Station#	13314+00		Field Station#	1309+75	
Pic 3 Desc.	Stockpiles stable on coming in side of Wades Gap Road.		Pic 4 Desc.	Buffer zone, ECDs and bridge in satisfactory condition at stream S-GH7.

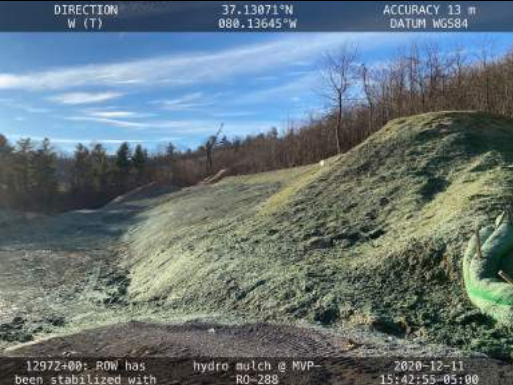
GPS Location	See photo		GPS Location	See photo	
Field Station#	12866+36		Field Station#	12972+00	
Pic 1 Desc.	Bottom Creek Road crossing		Pic 2 Desc.	ROW has been stabilized with hydro mulch at access road MVP-RO-288.

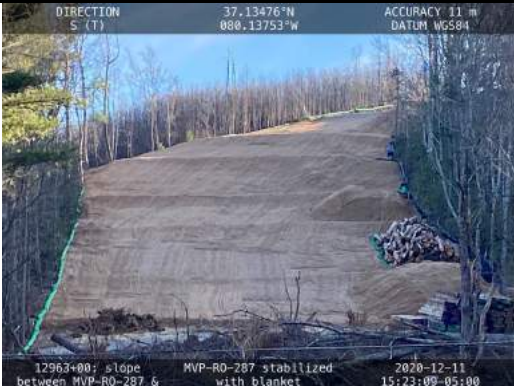
GPS Location	See photo		GPS Location	See photo	
Field Station#	12963+00		Field Station#	12958+72	
Pic 5 Desc.	Slope between access roads MVP-RO-287 and MVP-RO-288 was stabilized with blanket.		Pic 6 Desc.	Stream S-Y8, facing east, downstream

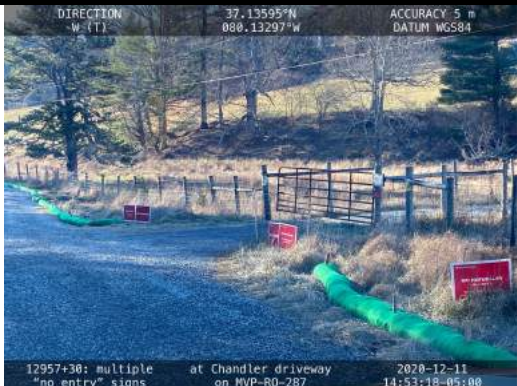
GPS Location	See photo		GPS Location	See photo	
Field Station#	12957+30		Field Station#	12957+30	
Pic 9 Desc.	Multiple "do not enter" signs installed at the Chandler driveway on MVP-RO-287.		Pic 10 Desc.	Stream S-Z16 on access road MVP-RO-287, facing southwest

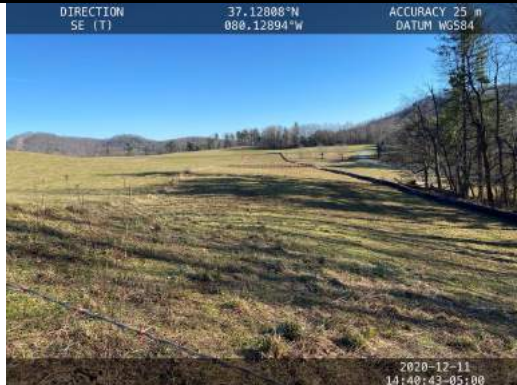
GPS Location	See photo		GPS Location	See photo	
Field Station#	13000+00		Field Station#	13042+60	
Pic 11 Desc.	ROW stable between Highway 221 and Blue Ridge Parkway.		Pic 12 Desc.	Stream S-H1, facing south, downstream

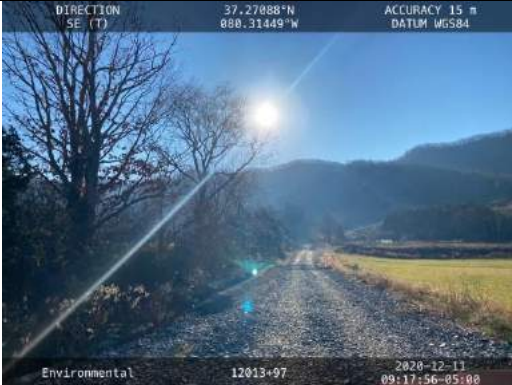
GPS Location	See photo for GPS coordinates		GPS Location	See photo for GPS coordinates	
Field Station#	12013+97		Field Station#	12013+97	
Pic 1 Desc.	Access Road MVP-MN-268 I'm acceptable condition.		Pic 2 Desc.	Equipment bridge crossing of S-G36 on MVP-MN-268 in acceptable condition.

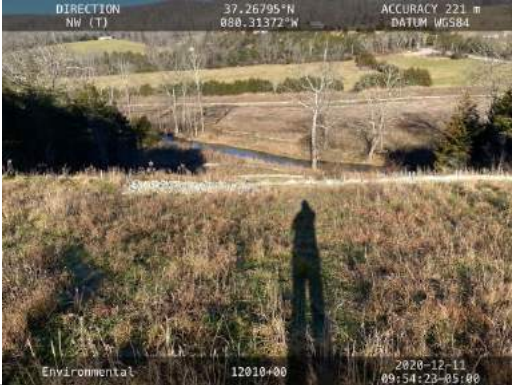
GPS Location	See photo for GPS coordinates		GPS Location	See photo for GPS coordinates	
Field Station#	12010+00		Field Station#	12015+84	
Pic 3 Desc.	Final Restored ROW with acceptable vegetative coverage across LOD		Pic 4 Desc.	Equipment bridge crossing S-G38 is in acceptable condition.

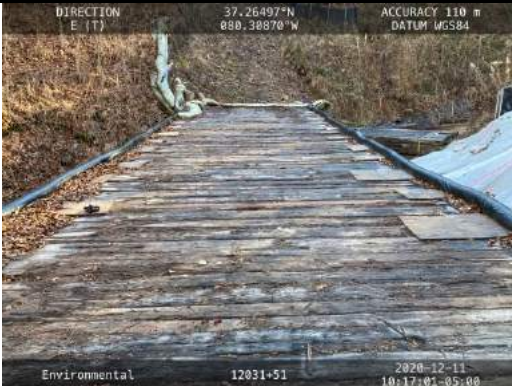
GPS Location	See photo for GPS coordinates		GPS Location	See photo for GPS coordinates	
Field Station#	12031+51		Field Station#	12030+00	
Pic 5 Desc.	Equipment bridge crossing S-G39 in acceptable condition.		Pic 6 Desc.	Temporary Restoration with acceptable vegetative coverage across LOD
