Visual Site Inspection Report

Project Name	H-600 Pipeline Spread H	AFE	124300138	Spread	H-600 Pipeline Spread H
Contractor	Precision			Report #	14139
Inspector	Kaitlyn Ball			Date/Time	8/31/2020 1:08 PM
Permit #	TBD	Inspection Type	VA SWPP	Station Begin	12233+50
State	VA	Inspection Area	Partial	Station End	12443+75
County	Montgomery	Ground	Damp	Temperature (°F)	67.00
Municipality	N/A	Weather	Light Rain	Rain Gauge (in)	0.20
				Rain Accumulation Time (days)	1.00

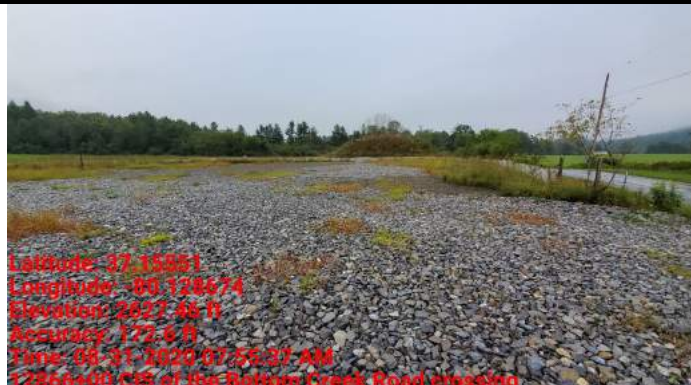
GPS Location	See pic for GPS location	GPS Location	See pic for GPS location		
Field Station#	12866+00	Field Station#	12866+26		
Pic 3 Desc.	CIS of the Bottom Creek Road crossing ATWS and topsoil pile.	Pic 4 Desc.	GAS of the Bottom Creek Road crossing.

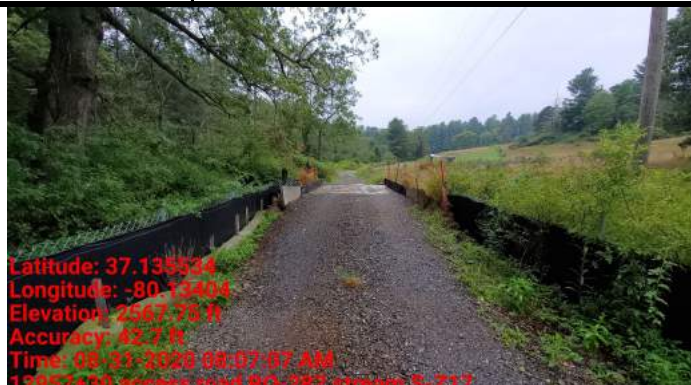
GPS Location	See pic for GPS location	GPS Location	See pic for GPS location		
Field Station#	12957+30	Field Station#	12957+30		
Pic 5 Desc.	Access road RO-287 at stream S-Z17.	Pic 6 Desc.	Access road RO-287 at stream S-Z17. Downstream side.

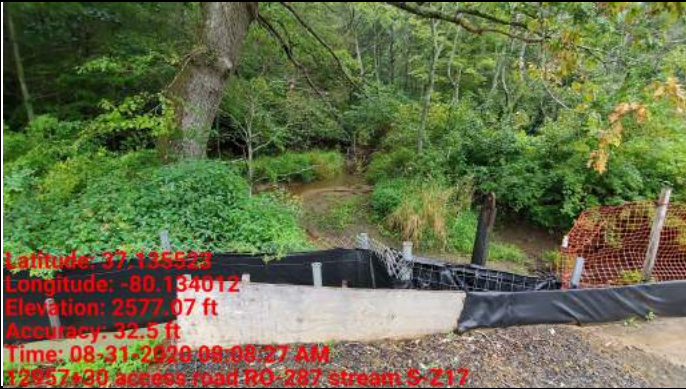
GPS Location	See pic for GPS location		GPS Location	See pic for GPS location	
Field Station#	12957+30		Field Station#	12957+30	
Pic 7 Desc.	Access road RO-287 at stream S-Z17. Upstream side.		Pic 8 Desc.	Access road RO-287 at stream S-Z16.

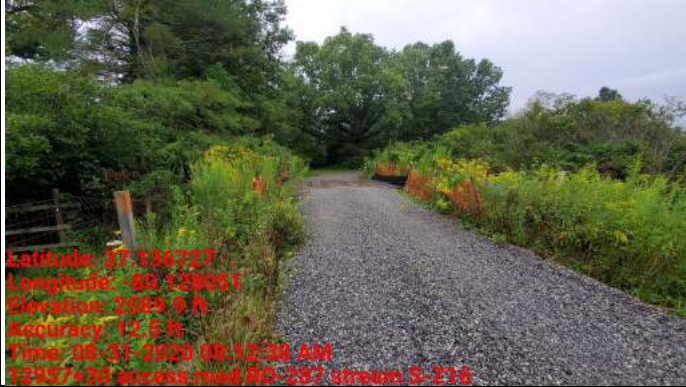
GPS Location	See pic for GPS location		GPS Location	See pic for GPS location	
Field Station#	12957+30		Field Station#	12974+29	
Pic 9 Desc.	Access road RO-287 at stream S-Z16.		Pic 10 Desc.	Access road RO-288 at stream S-Q20.

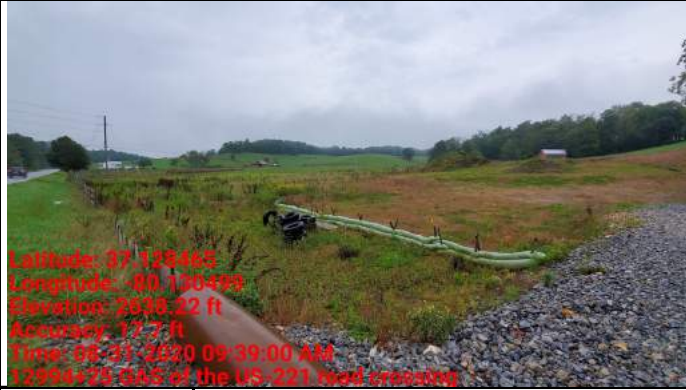
GPS Location	See pic for GPS location		GPS Location	See pic for GPS location	
Field Station#	12994+25		Field Station#	12994+02	
Pic 11 Desc.	GAS of the US-221 road crossing.		Pic 12 Desc.	CIS of the US-221 road crossing.

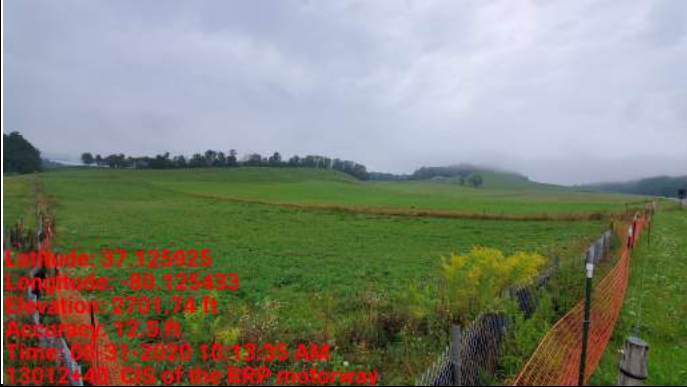
<p>Latitude: 37.125425 Longitude: -85.125422 Elevation: 2791.74 ft Accuracy: 12.5 ft Time: 08/31/2020 10:13:31 AM 13012+40 CIS of the BRP motorway</p>

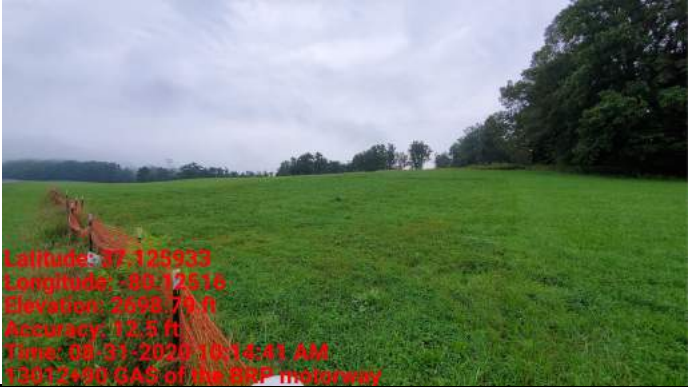
<p>Latitude: 37.125933 Longitude: -85.12516 Elevation: 2858.74 ft Accuracy: 12.5 ft Time: 08/31/2020 10:14:41 AM 13012+90 GAS of the BRP motorway</p>		
GPS Location	See pic for GPS location		GPS Location	See pic for GPS location	
Field Station#	13012+40		Field Station#	13012+90	
Pic 13 Desc.	CIS of the BRP motorway.		Pic 14 Desc.	GAS of the BRP motorway.

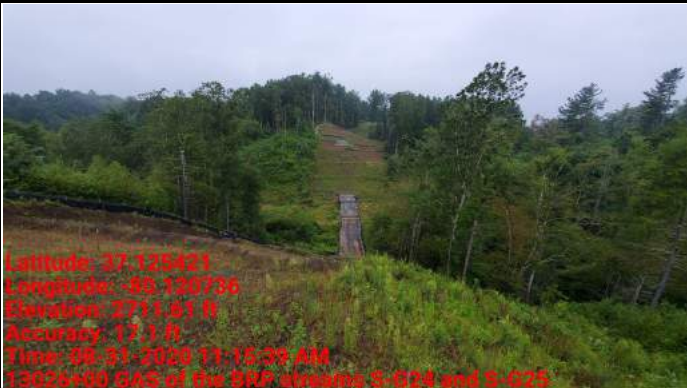
<p>Latitude: 37.125421 Longitude: -85.130736 Elevation: 2711.51 ft Accuracy: 17.1 ft Time: 08/31/2020 11:15:39 AM 13026+00 GAS of the BRP streams S-G24 and S-G25</p>

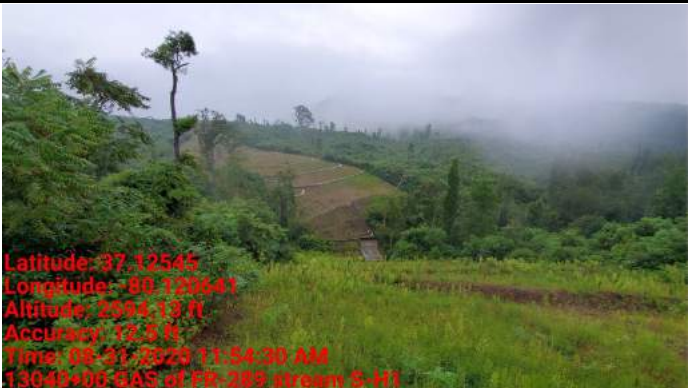
<p>Latitude: 37.12545 Longitude: -85.129641 Altitude: 2994.19 ft Accuracy: 12.3 ft Time: 08/31/2020 11:54:30 AM 13040+00 GAS of FR-289 stream S-H1</p>

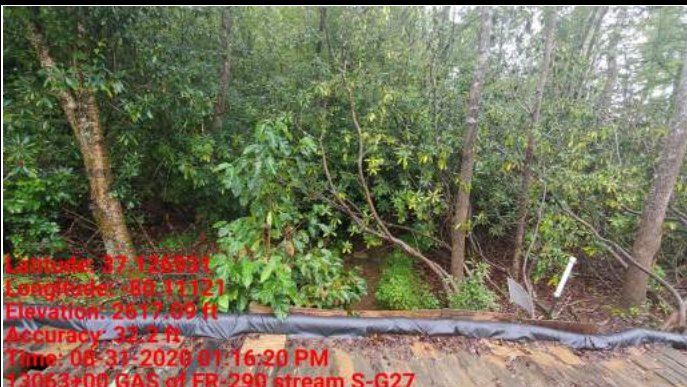
<p>Latitude: 37.126941 Longitude: -85.11121 Elevation: 2617.89 ft Accuracy: 22.2 ft Time: 08/31/2020 01:16:20 PM 13063+00 GAS of FR-290 stream S-G27</p>

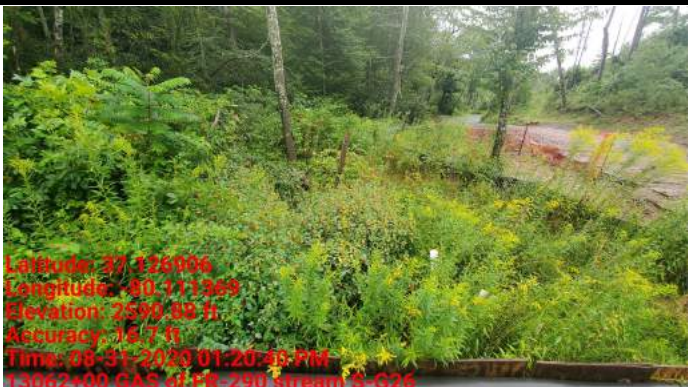
<p>Latitude: 37.126906 Longitude: -85.111869 Elevation: 2590.88 ft Accuracy: 14.7 ft Time: 08/31/2020 01:20:45 PM 13062+00 GAS of FR-290 stream S-G26</p>		
GPS Location	See pic for GPS location		GPS Location	See pic for GPS location	
Field Station#	13063+00		Field Station#	13062+00	
Pic 17 Desc.	Downstream side of Stream S-G27 GAS of FR-290.		Pic 18 Desc.	Downstream side of Stream S-G26 GAS of FR-290.

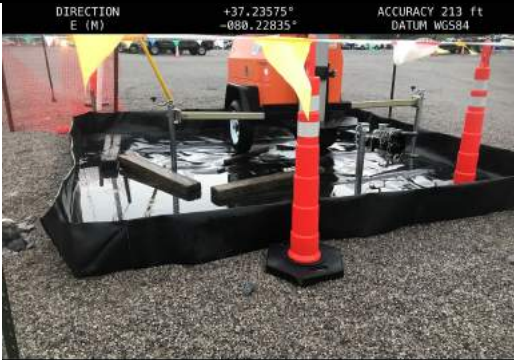
<p>DIRECTION E (N) +37.23575° -080.22835° ACCURACY 213 ft DATUM WGS84</p> <p>MVP-PY-006_083120 Condition of containment 2020-08-31 07:09:15-04:00</p>

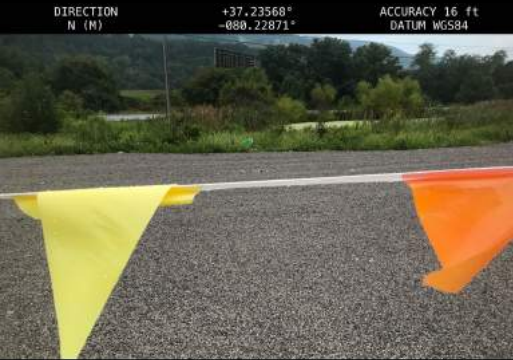
<p>DIRECTION N (N) +37.23568° -080.22871° ACCURACY 16 ft DATUM WGS84</p> <p>MVP-PY-006_083120 Signage and buffer flagging for feature 2020-08-31 07:09:31-04:00</p>			
GPS Location	MVP-PY-006 See photo for gps data		GPS Location	MVP-PY-006 See photo for gps data	
Field Station#	+0		Field Station#	+0	
Pic 1 Desc.	Condition of containment under light plant. Holding some stormwater. Looking E.		Pic 2 Desc.	Condition of signage and buffer flagging for feature W-008. Looking N.

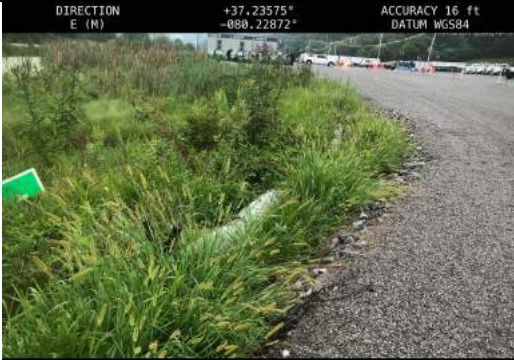
<p>DIRECTION E (N) +37.23575° -080.22872° ACCURACY 16 ft DATUM WGS84</p> <p>MVP-PY-006_083120 Condition of CFS along feature 2020-08-31 07:09:49-04:00</p>

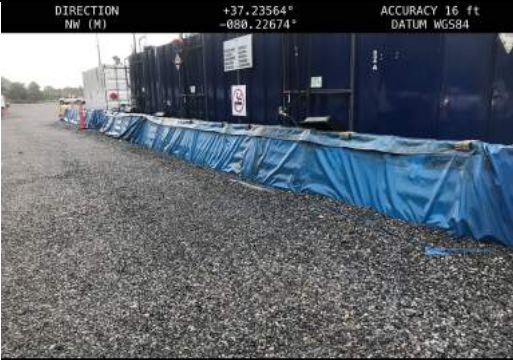
<p>DIRECTION NW (N) +37.23564° -080.22674° ACCURACY 16 ft DATUM WGS84</p> <p>MVP-PY-006_083120 No fuel spills south of tanks 2020-08-31 07:42:52-04:00</p>

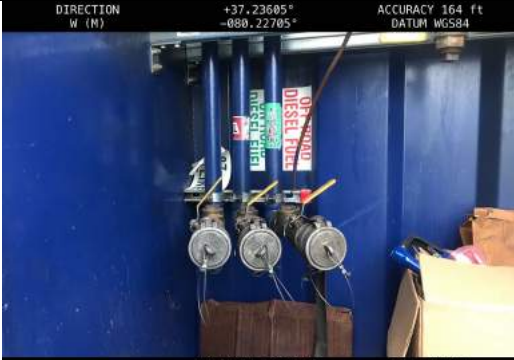
<p>DIRECTION W (N) +37.23605° -080.22705° ACCURACY 164 ft DATUM WGS84</p> <p>MVP-PY-006_083120 No leaky internal fittings 2020-08-31 07:43:18-04:00</p>

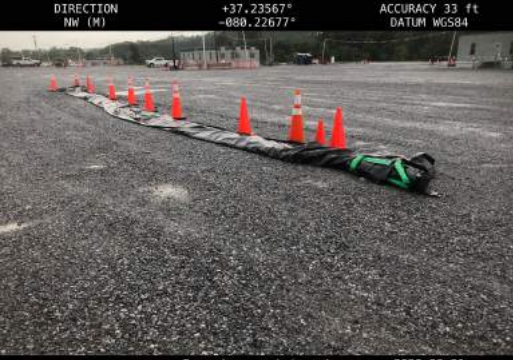
<p>DIRECTION NW (N) +37.23567° -080.22677° ACCURACY 33 ft DATUM WGS84</p> <p>MVP-PY-006_083120 Secondary containment on site for tankers 2020-08-31 07:43:57-04:00</p>			
GPS Location	MVP-PY-006 See photo for gps data		GPS Location	MVP-PY-006 See photo for gps data	
Field Station#	+0		Field Station#	+0	
Pic 5 Desc.	Blue Bulk Fuel tanks no leaky internal fittings. Looking W.		Pic 6 Desc.	Secondary containment on site for tankers offloading fuel into Blue Bulk fuel tanks. Looking NW.

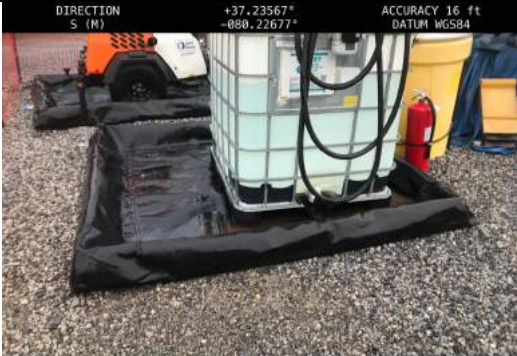
GPS Location	MVP-PY-006 See photo for gps data	GPS Location	MVP-PY-006 See photo for gps data		
Field Station#	+0	Field Station#	+0		
Pic 7 Desc.	Condition of containment under DEF tank. Looking S.	Pic 8 Desc.	Off Road Fuel unit no leaky internal fittings. Looking NW.

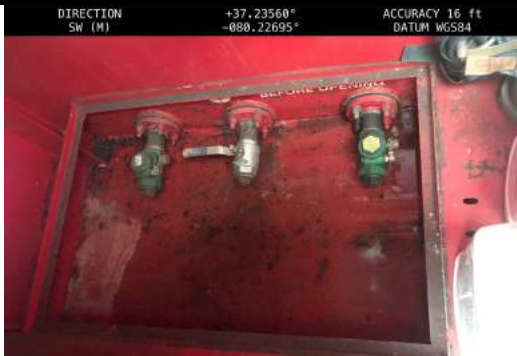
GPS Location	MVP-PY-006 See photo for gps data	GPS Location	MVP-PY-006 See photo for gps data		
Field Station#	+0	Field Station#	+0		
Pic 9 Desc.	Off Road Fuel unit condition of internal drip pan. Holding some stormwater. Looking SW.	Pic 10 Desc.	Off Road Fuel unit containment, lite sheen on stormwater. Looking N.

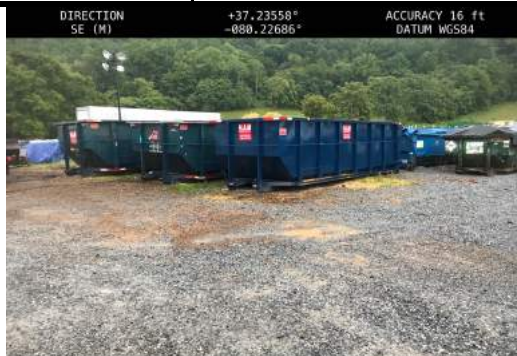
GPS Location	MVP-PY-006 See photo for gps data	GPS Location	MVP-PY-006 See photo for gps data		
Field Station#	+0	Field Station#	+0		
Pic 11 Desc.	No loose trash around dumpsters. Looking SE.	Pic 12 Desc.	No deposits around hazardous waste dumpster. Looking W.

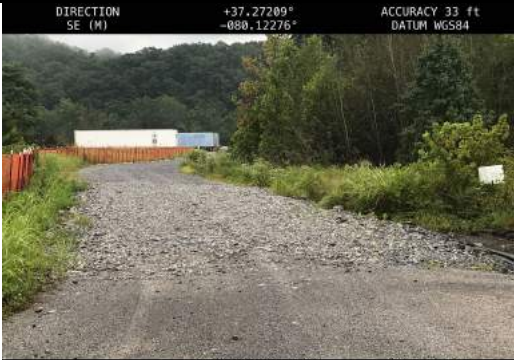
<p>DIRECTION SE (N) +37.27289° -080.12276° ACCURACY 33 ft DATUM WGS84</p> <p>MVP-LY-049_083120 Condition of rock entrance 2020-08-31 08:21:54-04:00</p>

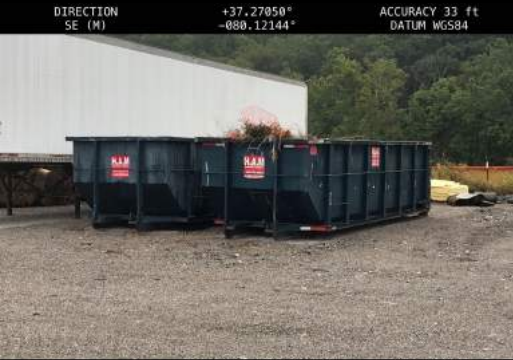
<p>DIRECTION SE (N) +37.27050° -080.12144° ACCURACY 33 ft DATUM WGS84</p> <p>MVP-LY-049_083120 No loose trash around south dumpsters 2020-08-31 08:25:08-04:00</p>			
GPS Location	MVP-LY-049 See photo for gps data		GPS Location	MVP-LY-049 See photo for gps data	
Field Station#	+0		Field Station#	+0	
Pic 1 Desc.	Condition of rock entrance. No sediment on stone surface. Looking SE.		Pic 2 Desc.	No loose trash around dumpsters. Looking SE.

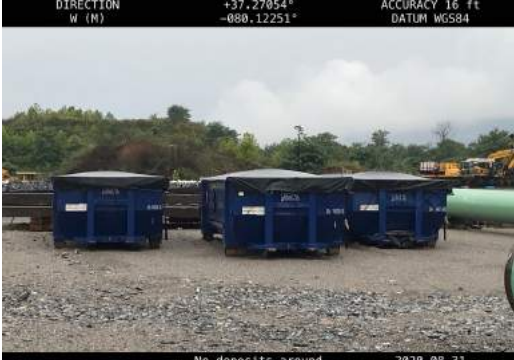
<p>DIRECTION W (N) +37.27054° -080.12251° ACCURACY 16 ft DATUM WGS84</p> <p>MVP-LY-049-083120 No deposits around hazardous waste 2020-08-31 08:25:44-04:00</p>

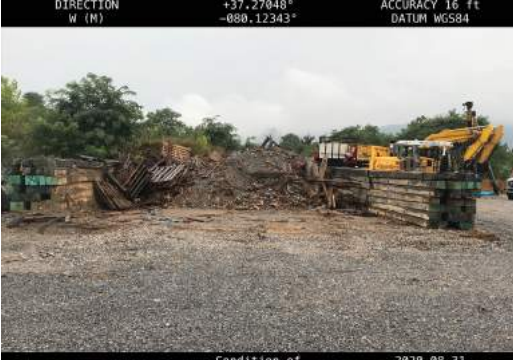
<p>DIRECTION W (N) +37.27048° -080.12343° ACCURACY 16 ft DATUM WGS84</p> <p>MVP-LY-049_083120 Condition of temporary trash 2020-08-31 08:26:17-04:00</p>

GPS Location	MVP-LY-049 See photo for gps data		GPS Location	MVP-LY-049 See photo for gps data	
Field Station#	+0		Field Station#	+0	
Pic 3 Desc.	No deposits around hazardous waste dumpsters. Looking W.		Pic 4 Desc.	Condition of temporary trash transfer pit. Debris inside boundary of pit. Looking W.

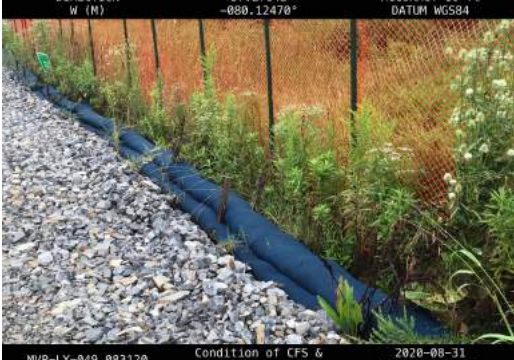
<p>DIRECTION W (N) +37.27042° -080.12470° ACCURACY 16 ft DATUM WGS84</p> <p>MVP-LY-049_083120 Condition of CFS & safety fence 2020-08-31 08:27:08-04:00</p>

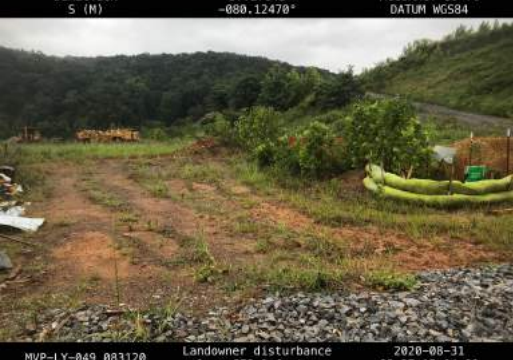
<p>DIRECTION S (N) +37.27042° -080.12470° ACCURACY 16 ft DATUM WGS84</p> <p>MVP-LY-049_083120 Landowner disturbance along CFS & feature 2020-08-31 08:27:15-04:00</p>			
GPS Location	MVP-LY-049 See photo for gps data		GPS Location	MVP-LY-049 See photo for gps data	
Field Station#	+0		Field Station#	+0	
Pic 5 Desc.	Condition of compost filter sock and safety fence along feature W-CV21A. Looking W.		Pic 6 Desc.	Landowner disturbance along compost filter sock and feature W-CV21B. No impacts. Looking S.

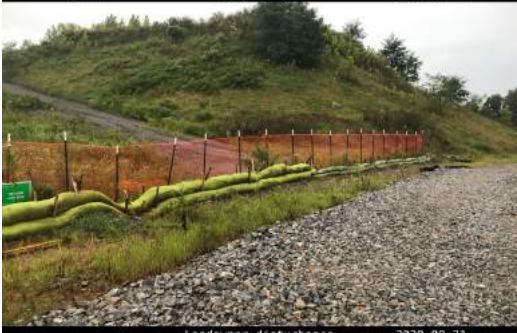
MVP-LY-049_083120 Landowner disturbance within 66' of feature 2020-08-31 08:27:33-04:00		MVP-LY-049_083120 Condition of trays and containment 2020-08-31 08:32:59-04:00			
GPS Location	MVP-LY-049 See photo for gps data		GPS Location	MVP-LY-049 See photo for gps data	
Field Station#	+0		Field Station#	+0	
Pic 7 Desc.	Landowner disturbance within 66' of feature W-CV21B. No impacts. Looking SW.		Pic 8 Desc.	Condition of trays and containment under toilets. Looking N.	
DIRECTION SW (M) +37.27046° -080.12347° ACCURACY 16 ft DATUM WGS84

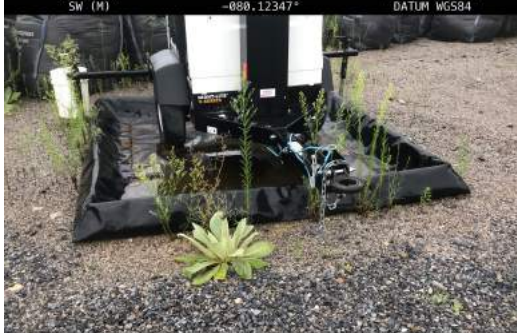
MVP-LY-049_083120 Condition of containment 2020-08-31 08:33:29-04:00		MVP-LY-049_083120 Condition of CFS around sand pile 2020-08-31 08:37:15-04:00

GPS Location	MVP-LY-049 See photo for gps data		GPS Location	MVP-LY-049 See photo for gps data	
Field Station#	+0		Field Station#	+0	
Pic 9 Desc.	Condition of containment under light plant. Holding some stormwater. Looking SW.		Pic 10 Desc.	Condition of compost filter sock around sand pile. Looking W.	
DIRECTION W (M) +37.26933° -080.12372° ACCURACY 33 ft DATUM WGS84

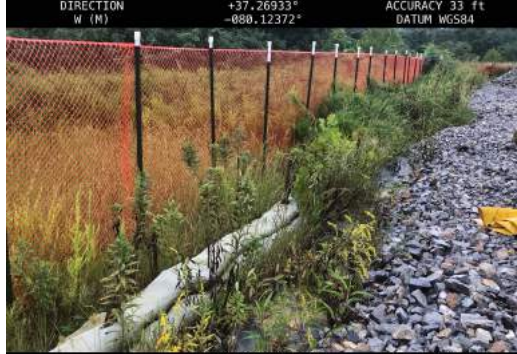
MVP-LY-049_083120 Condition of CFS & safety fence 2020-08-31 08:39:16-04:00		MVP-LY-049_083120 Condition of CFS & safety fence 2020-08-31 08:39:27-04:00			
GPS Location	MVP-LY-049 See photo for gps data		GPS Location	MVP-LY-049 See photo for gps data	
Field Station#	+0		Field Station#	+0	
Pic 11 Desc.	Condition of compost filter sock and safety fence along south LOD. Looking W.		Pic 12 Desc.	Condition of compost filter sock and safety fence along South LOD. Looking SE.

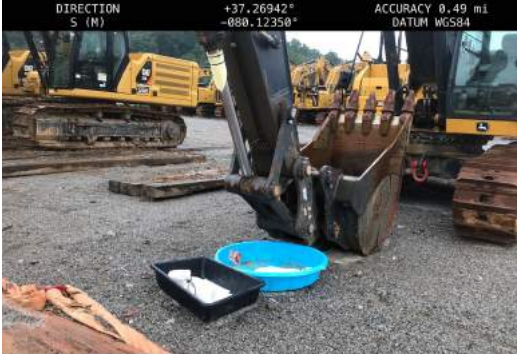
<p>MVP-LY-049_083120 Containments under stored equipment 2020-08-31 08:41:40-04:00</p>

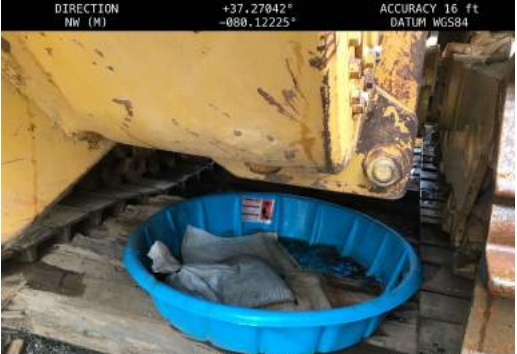
<p>MVP-LY-049_083120 Containment under stored equipment 2020-08-31 08:42:45-04:00</p>		GPS Location	MVP-LY-049 See photo for gps data
Field Station#	+0	Field Station#	+0	Field Station#	+0
Pic 13 Desc.	Condition of containments under stored equipment. Looking S.	Pic 14 Desc.	Condition of containment under stored equipment. Looking SW.	Pic 14 Desc.	Condition of containment under stored equipment. Looking SW.

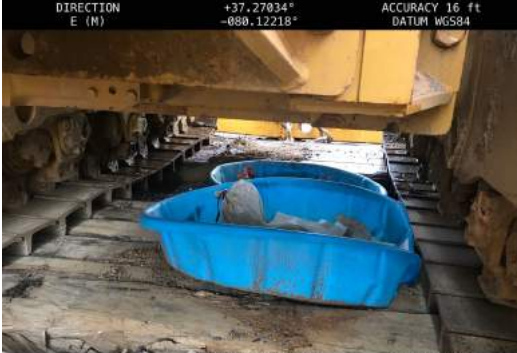
<p>MVP-LY-049_083120 Containments under stored equipment 2020-08-31 08:43:04-04:00</p>

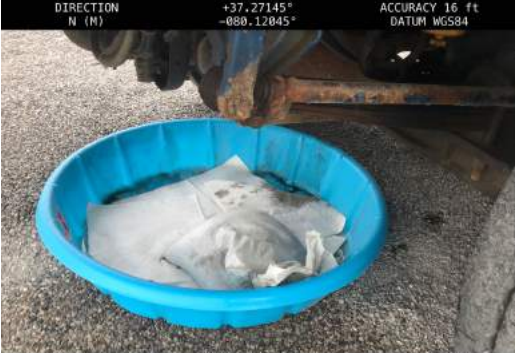
<p>MVP-LY-049_083120 Containment under stored vehicle 2020-08-31 08:46:58-04:00</p>		GPS Location	MVP-LY-049 See photo for gps data
Field Station#	+0	Field Station#	+0	Field Station#	+0
Pic 15 Desc.	Condition of containments under stored equipment. Looking E.	Pic 16 Desc.	Condition of containment under stored vehicle. Looking N.	Pic 16 Desc.	Condition of containment under stored vehicle. Looking N.

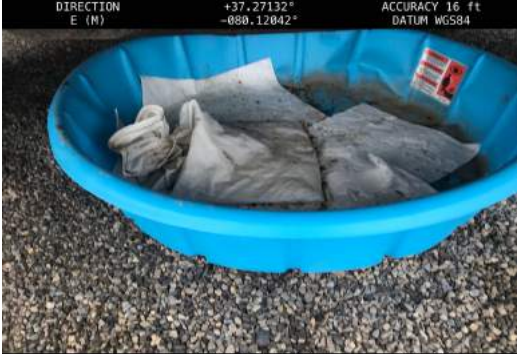
<p>MVP-LY-049_083120 Containment under stored vehicle 2020-08-31 08:47:15-04:00</p>

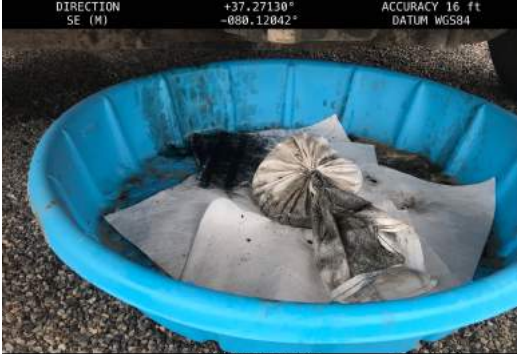
<p>MVP-LY-049_083120 Containment under stored vehicle 2020-08-31 08:47:22-04:00</p>		GPS Location	MVP-LY-049 See photo for gps data
Field Station#	+0	Field Station#	+0	Field Station#	+0
Pic 17 Desc.	Condition of containment under stored vehicle. Looking E.	Pic 18 Desc.	Condition of containment under stored equipment. Looking SE.	Pic 18 Desc.	Condition of containment under stored equipment. Looking SE.

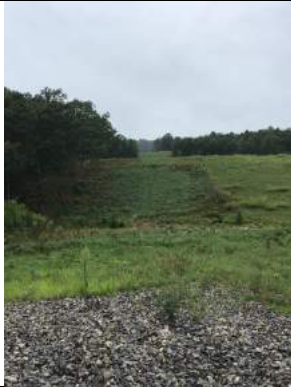
GPS Location	00000	GPS Location	00000		
Field Station#	13437+75	Field Station#	13541+53		
Pic 1 Desc.	CFS damaged and needs repaired , added to the punch list	Pic 2 Desc.	Row photo showing vegetation while checking row conditions during rain events

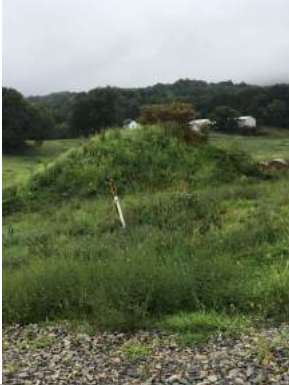
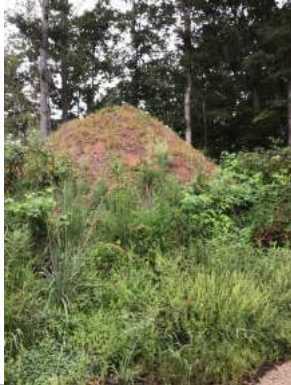
GPS Location	00000	GPS Location	00000		
Field Station#	13541+53	Field Station#	13541+73		
Pic 3 Desc.	Photo showing stabilized top soil pile during rain events today	Pic 4 Desc.	Photo showing stabilized top soil		
Insert image here			Insert image here		
GPS Location		GPS Location			
Field Station#		Field Station#			
Pic 5 Desc.		Pic 6 Desc.

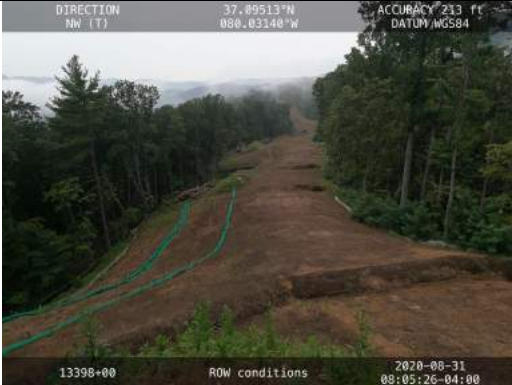
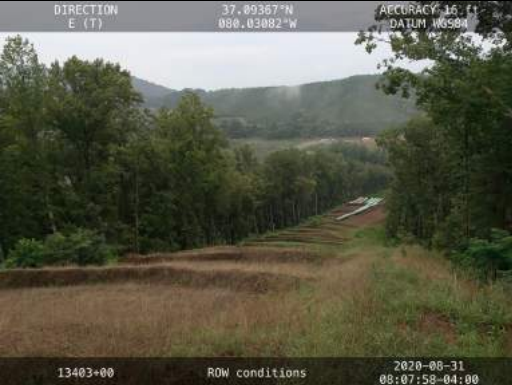
GPS Location	See photo for gps location data.		GPS Location	See photo for gps location data.	
Field Station#	13398+00		Field Station#	13403+00	
Pic 1 Desc.	Photo shows the ROW condition from about 13390+00 to 13398+00.		Pic 2 Desc.	Photo shows the ROW condition from about 13403+00 to 13410+00.

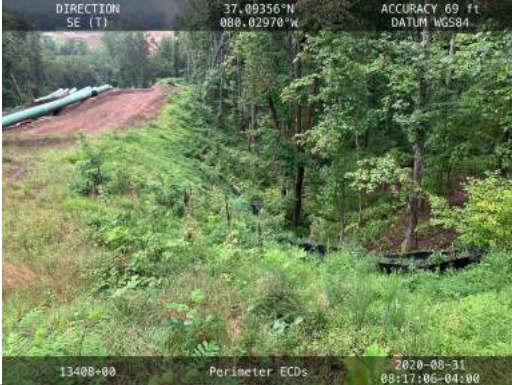
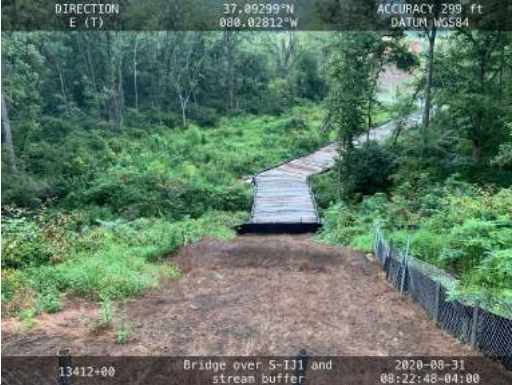
GPS Location	See photo for gps location data.		GPS Location	See photo for gps location data.	
Field Station#	13408+00		Field Station#	13412+00	
Pic 3 Desc.	Photo shows the perimeter ECDs from about 13408+00 to 13410+00.		Pic 4 Desc.	Photo shows the bridge over stream S-IJ1 and adjacent stream buffer.

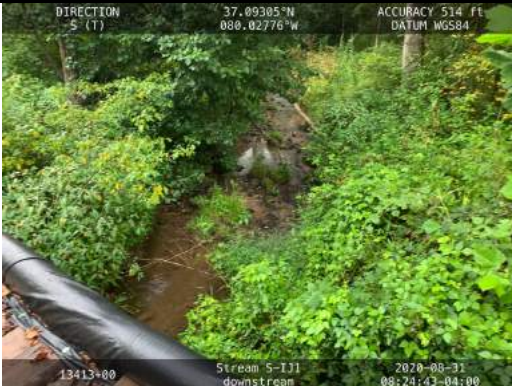
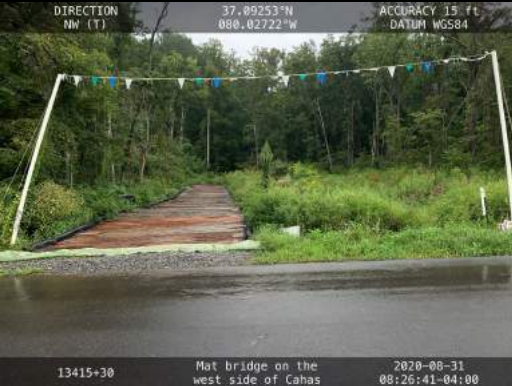
GPS Location	See photo for gps location data.		GPS Location	See photo for gps location data.	
Field Station#	13413+00		Field Station#	13415+30	
Pic 5 Desc.	Photo shows stream S-IJ1 downstream from the bridge.		Pic 6 Desc.	Photo shows the mat bridge on the west side of Cahas.

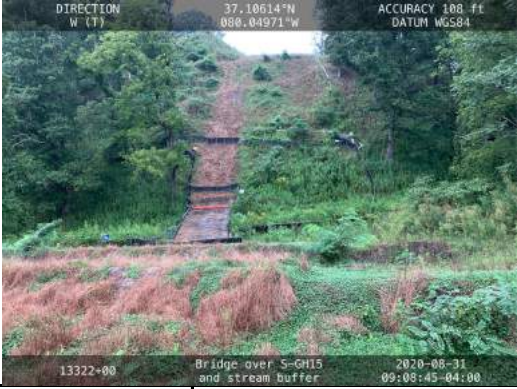
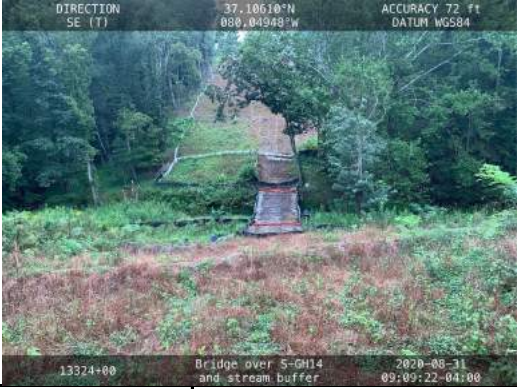
GPS Location	See photo for gps location data.		GPS Location	See photo for gps location data.	
Field Station#	13322+00		Field Station#	13324+00	
Pic 7 Desc.	Photo shows the bridge over stream S-GH15 and adjacent stream buffer.		Pic 8 Desc.	Photo shows the bridge over stream S-GH14 and adjacent stream buffer.

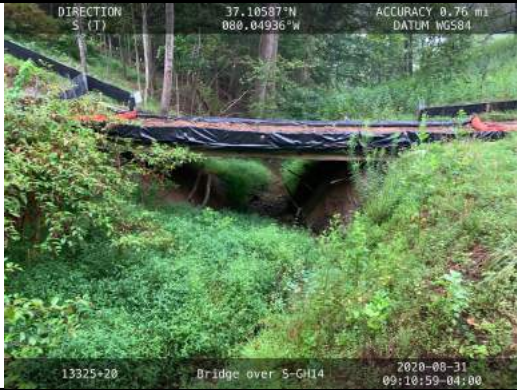
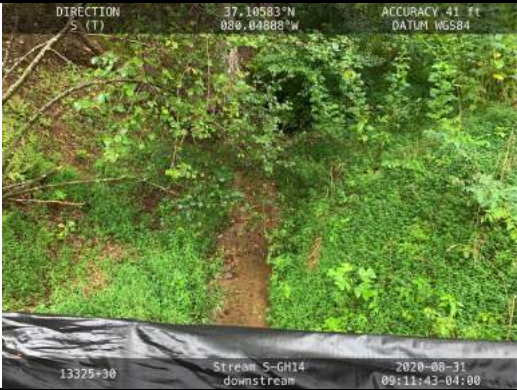
GPS Location	See photo for gps location data.		GPS Location	See photo for gps location data.	
Field Station#	13325+20		Field Station#	13325+30	
Pic 9 Desc.	Photo shows the bridge over stream S-GH14.		Pic 10 Desc.	Photo shows stream S-GH14 downstream from the bridge.

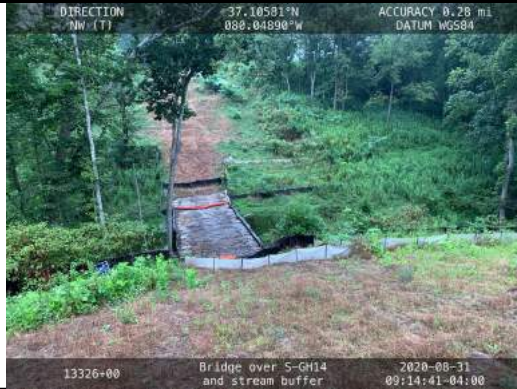
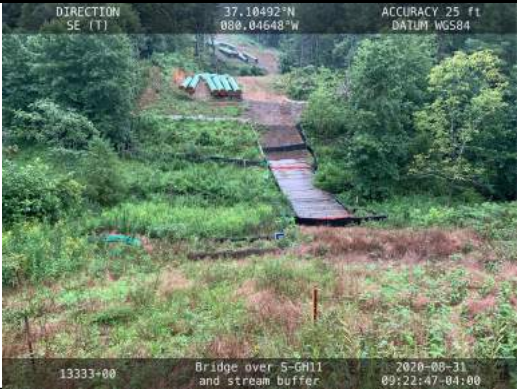
GPS Location	See photo for gps location data.		GPS Location	See photo for gps location data.	
Field Station#	13326+00		Field Station#	13333+00	
Pic 11 Desc.	Photo shows the bridge over stream S-GH14 and adjacent stream buffer.		Pic 12 Desc.	Photo shows the bridge over stream S-GH11 and adjacent stream buffer.

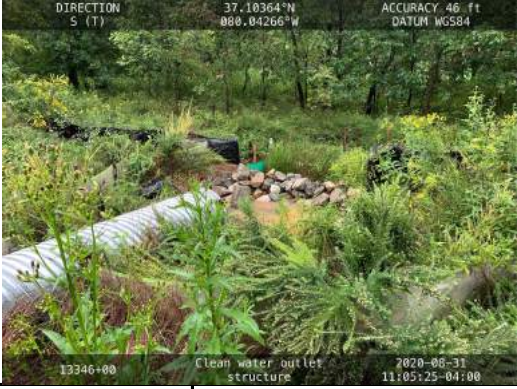
<p>DIRECTION 37.10364°N ACCURACY 46 ft S (T) 080.04266°W DATUM WGS84</p> <p>13346+00 Clean water outlet structure 2020-08-31 11:05:25-04:00</p>

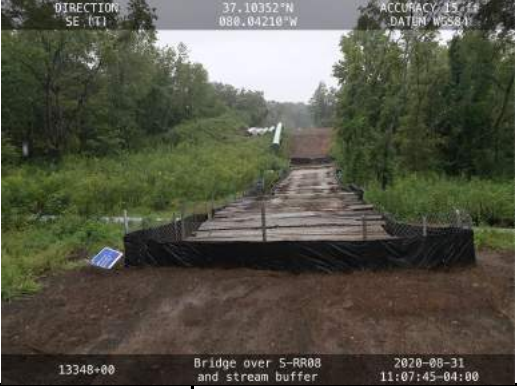
<p>DIRECTION 37.10352°N ACCURACY 15 ft SE (T) 080.04210°W DATUM WGS84</p> <p>13348+00 Bridge over S-RR08 and stream buffer 2020-08-31 11:07:45-04:00</p>		GPS Location	See photo for gps location data.

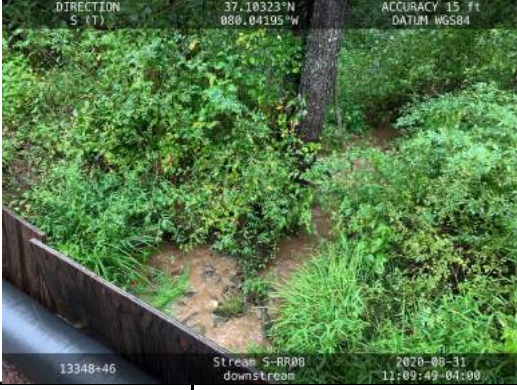
<p>DIRECTION 37.10323°N ACCURACY 15 ft S (T) 080.04195°W DATUM WGS84</p> <p>13348+46 Stream S-RR08 downstream 2020-08-31 11:09:49-04:00</p>

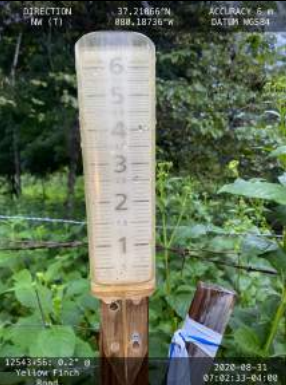
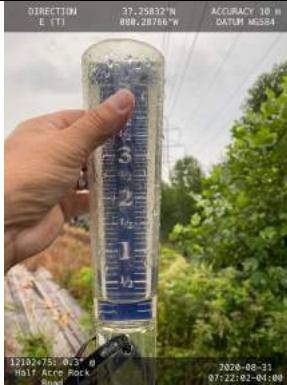
GPS Location	See photo		GPS Location	See photo	
Field Station#	12543+56		Field Station#	12102+75	
Pic 1 Desc.	0.2" of rain in the gauge at Yellow Finch Road this morning.		Pic 2 Desc.	0.3 inches of rain in the gauge at Half Acre Rock Road this morning.

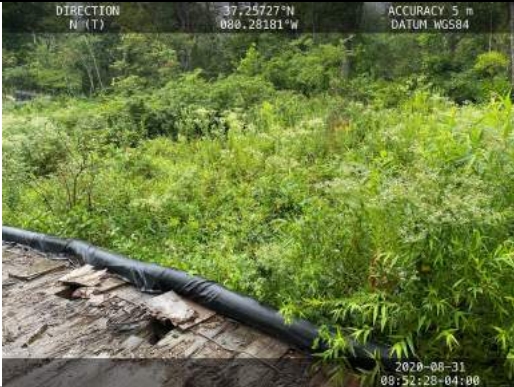
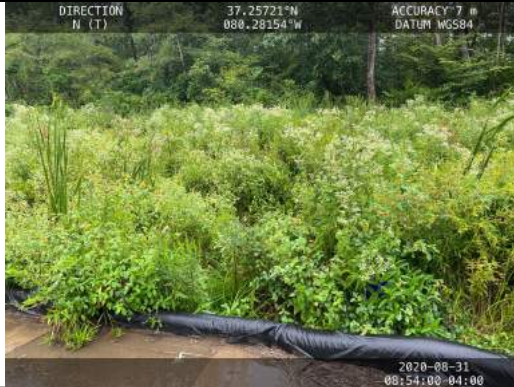
GPS Location	See photo		GPS Location	See photo	
Field Station#	12121+33		Field Station#	12121+83	
Pic 3 Desc.	Stream S-C33, facing north, upstream		Pic 4 Desc.	Stream S-C36, facing north, upstream

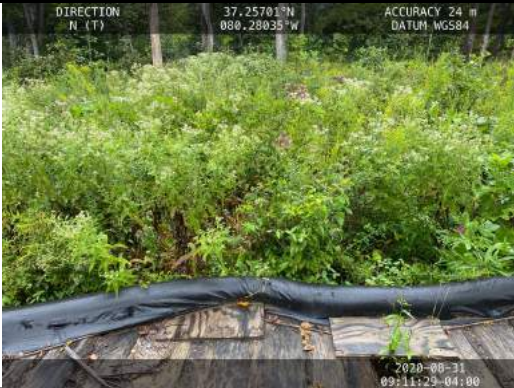
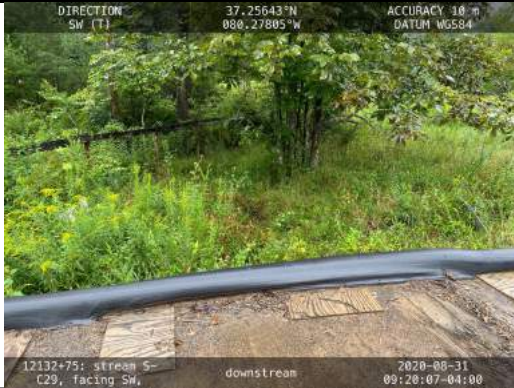
GPS Location	See photo		GPS Location	See photo	
Field Station#	12125+65		Field Station#	12132+73	
Pic 5 Desc.	Stream S-MM31, facing north, upstream		Pic 6 Desc.	Stream S-C29, facing southwest, upstream

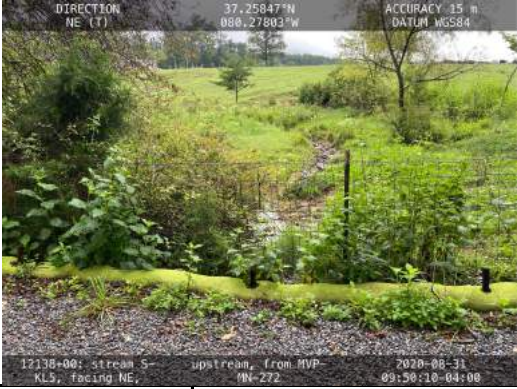
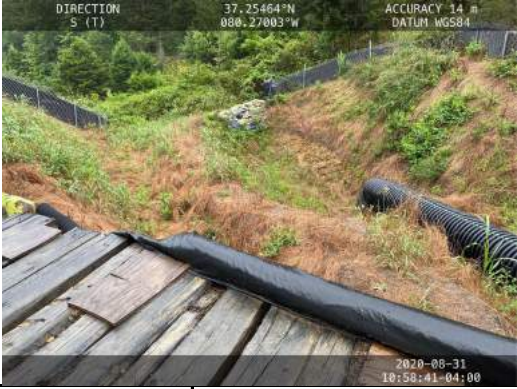
GPS Location	See photo	GPS Location	See photo		
Field Station#	12138+00	Field Station#	12157+00		
Pic 7 Desc.	Stream S-KL5, facing northeast, upstream, from access road MVP-MN-272.	Pic 8 Desc.	Clean water diversion channel and temporary sediment trap are both well stabilized and functioning per design.

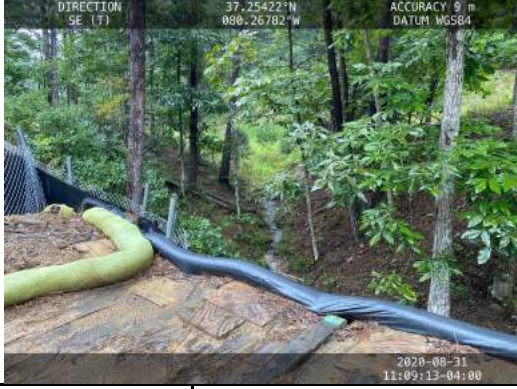
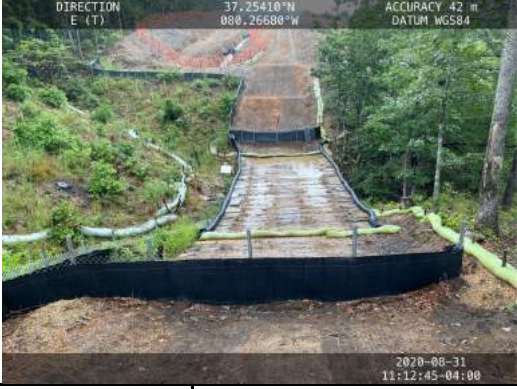
GPS Location	See photo	GPS Location	See photo		
Field Station#	12163+05	Field Station#	12166+47		
Pic 9 Desc.	Stream S-C25, facing southeast, downstream	Pic 10 Desc.	Stream S-C24, facing east

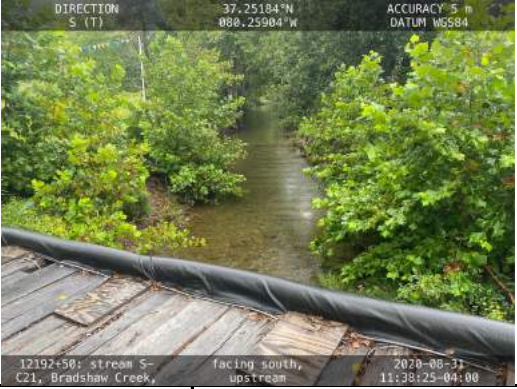
GPS Location	See photo		GPS Location	See photo	
Field Station#	12190+85		Field Station#	12192+50	
Pic 13 Desc.	Bradshaw Road crossing, facing southeast		Pic 14 Desc.	Stream S-C21, facing south, downstream

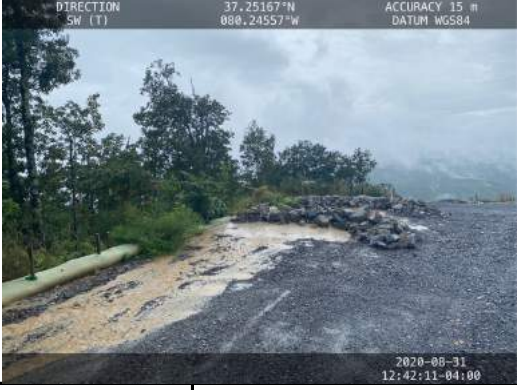
GPS Location	See photo		GPS Location	See photo	
Field Station#	12234+50		Field Station#	12233+00	
Pic 17 Desc.	Recently installed rock check dams on uphill side of switchback on Reese Mountain appears to be slowing runoff around the turn.		Pic 18 Desc.	The slope on the coming in side of the switchback on Reese Mountain remains stable.

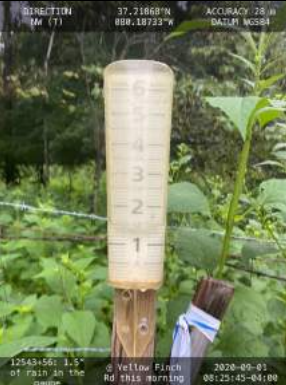
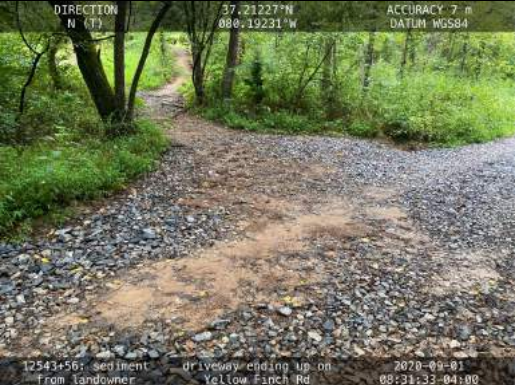
GPS Location	See photo		GPS Location	See photo	
Field Station#	12543+56		Field Station#	12543+56	
Pic 1 Desc.	1.5" of precipitation accumulated in the rain gauge at Yellow Finch Road over the past 24 hours.		Pic 2 Desc.	Sediment is being deposited on Yellow Finch Road from this landowner's driveway at the turnaround.

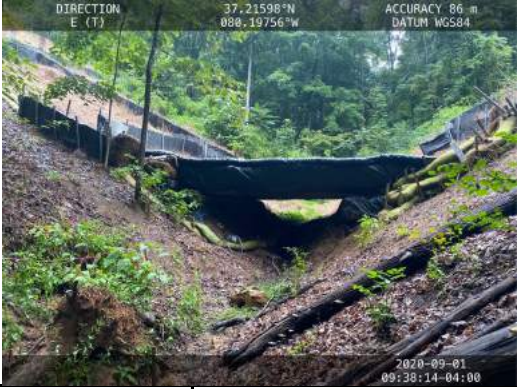
GPS Location	See photo		GPS Location	See photo	
Field Station#	12519+41		Field Station#	12519+41	
Pic 13 Desc.	Stream S-EF19, facing east, upstream		Pic 14 Desc.	Buffer zone of stream S-EF19 remains stable and surrounding ECDs are in satisfactory condition and effective.

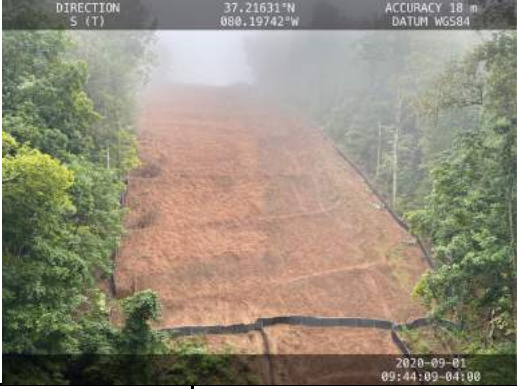
GPS Location	See photo		GPS Location	See photo	
Field Station#	12522+00		Field Station#	12503+70	
Pic 15 Desc.	ROW remains stable on the slope on the going away side stream S-EF19.		Pic 16 Desc.	Clean water diversion pipe outlet in satisfactory condition.

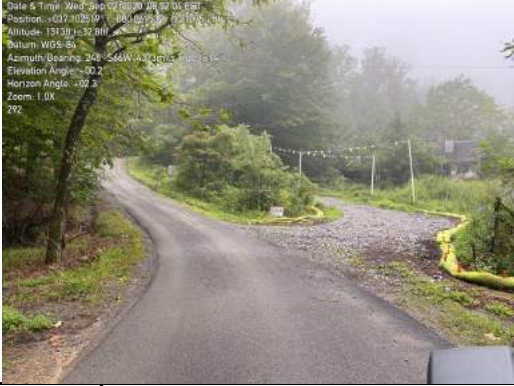
<p>Date & Time: Wed Sep 02 2020 09:53:05 EDT Position: +007.003301 / -080.06186 Altitude: 1511ft (+46.2m) Datum: WGS-84 Azimuth/Bearing: 337.823W/59.1mils True (+14.2) Elevation Angle: -06.1 Horizon Angle: +01.6 Zoom: 1.0X S-II4-299</p>			
GPS Location	See photo for coordinates.		GPS Location	See photo for coordinates.	
Field Station#	13148+00		Field Station#	13190+00	
Pic 1 Desc.	MVP-FR-292, Adney Gap, RCE in acceptable condition.		Pic 2 Desc.	MVP-AR-29, cattle noted in field.

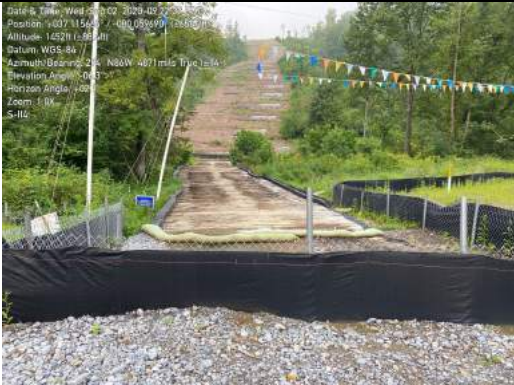
GPS Location	See photo for coordinates.		GPS Location	See photo for coordinates.	
Field Station#	13261+00		Field Station#	13260+60	
Pic 3 Desc.	GAS S-II4, perimeter controls in acceptable condition.		Pic 4 Desc.	S-II4, downstream, no changes noted to stream bed or banks.

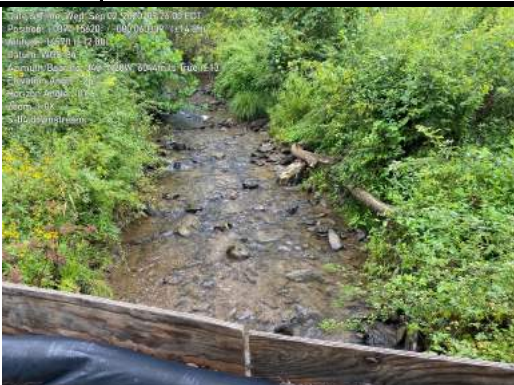
Pic 5 Desc.	S-II4, upstream, no changes noted to stream bed or banks.		Pic 6 Desc.	ROW stable with vegetative cover across LOD, primarily temporary vegetation.

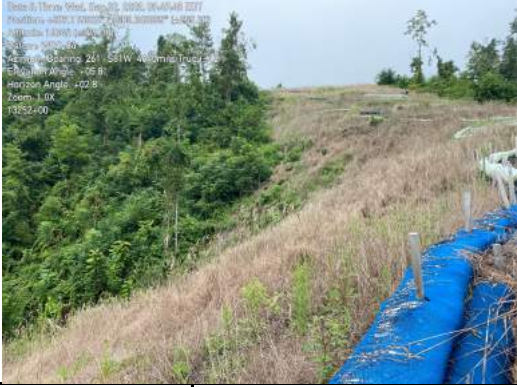
GPS Location	See photo for coordinates.		GPS Location	See photo for coordinates.	
Field Station#	13252+00		Field Station#	13250+00	
Pic 7 Desc.	Side slope stable.		Pic 8 Desc.	Restored ROW stable with good vegetative cover across LOD, temporary and permanent species noted.

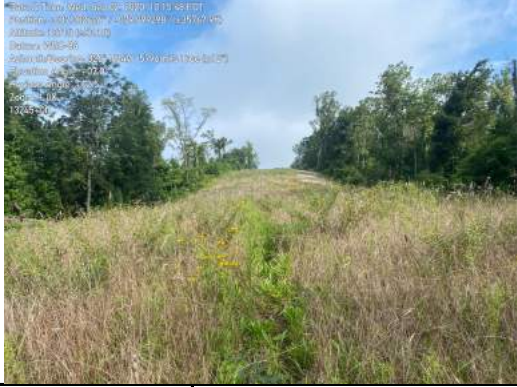
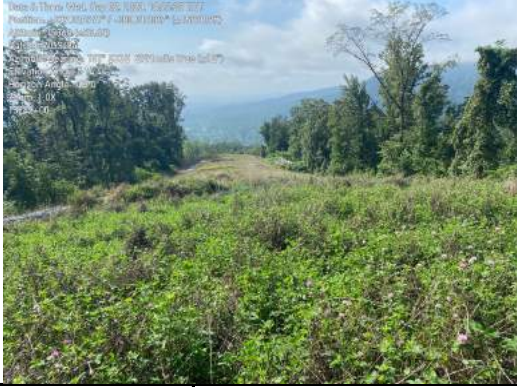
GPS Location	See photo for coordinates.		GPS Location	See photo for coordinates.	
Field Station#	13245+00		Field Station#	13242+00	
Pic 9 Desc.	Restored ROW stable with good vegetative cover across LOD, temporary and permanent species noted.		Pic 10 Desc.	Restored ROW stable with good vegetative cover across LOD, temporary and permanent species noted.

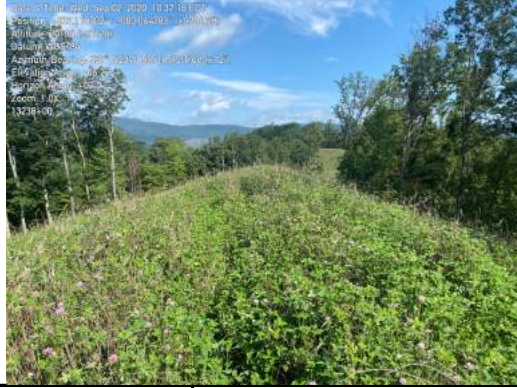
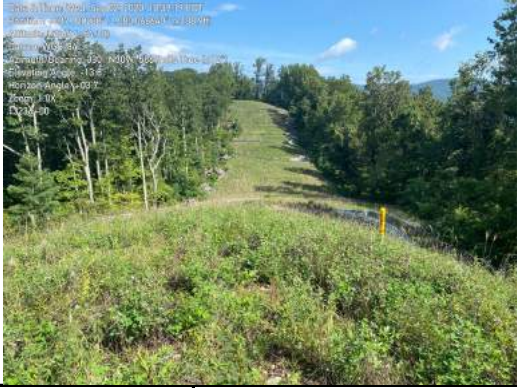
GPS Location	See photo for coordinates.		GPS Location	See photo for coordinates.	
Field Station#	13238+00		Field Station#	13236+00	
Pic 11 Desc.	Restored ROW stable with good vegetative cover across LOD, temporary and permanent species noted.		Pic 12 Desc.	Restored ROW stable with good vegetative cover across LOD, temporary and permanent species noted.

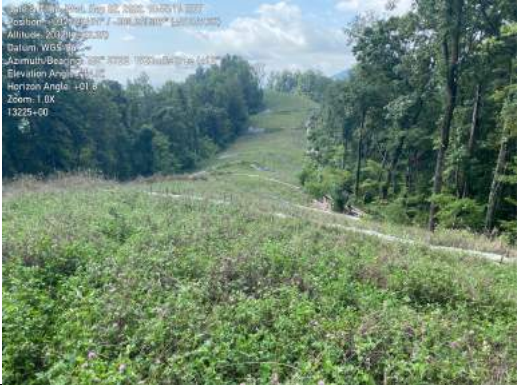
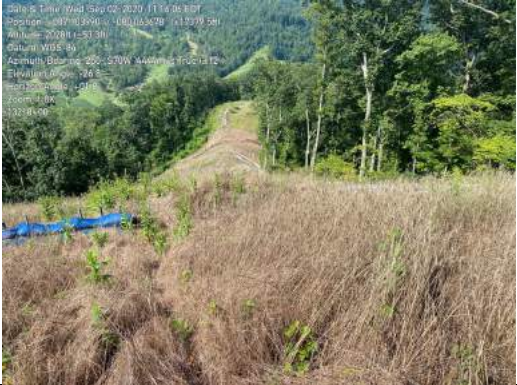
GPS Location	See photo for coordinates.		GPS Location	See photo for coordinates.	
Field Station#	13225+00		Field Station#	13218+00	
Pic 13 Desc.	Restored ROW stable with good vegetative cover across LOD, temporary and permanent species noted.		Pic 14 Desc.	Restored ROW stable with good vegetative cover across LOD, mostly temporary vegetation.

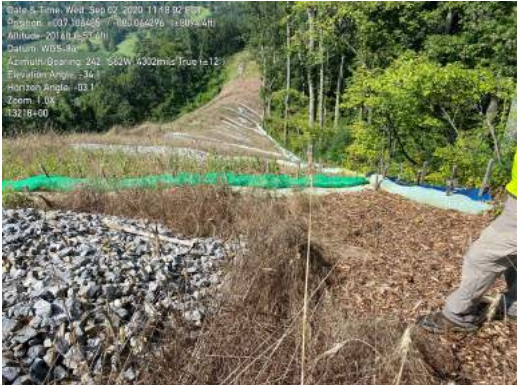
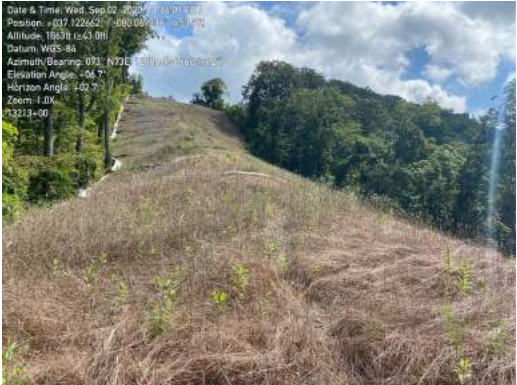
GPS Location	See photo for coordinates.		GPS Location	See photo for coordinates.	
Field Station#	13218+00		Field Station#	13213+00	
Pic 15 Desc.	Restored ROW stable with good vegetative cover across LOD, mostly temporary vegetation.		Pic 16 Desc.	Restored ROW stable with good vegetative cover across LOD, mostly temporary vegetation.

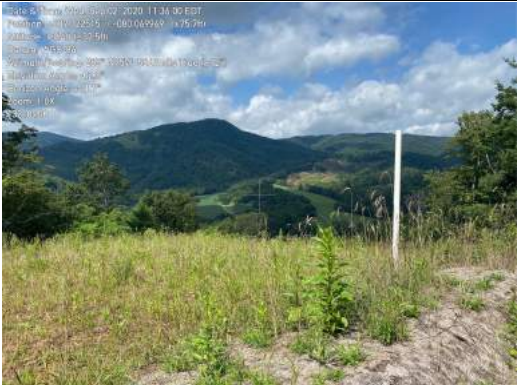
Pic 17 Desc.	Logging activity noted near ROW across Dillons Mill.		Pic 18 Desc.	ROW stabilized with acceptable vegetative cover.

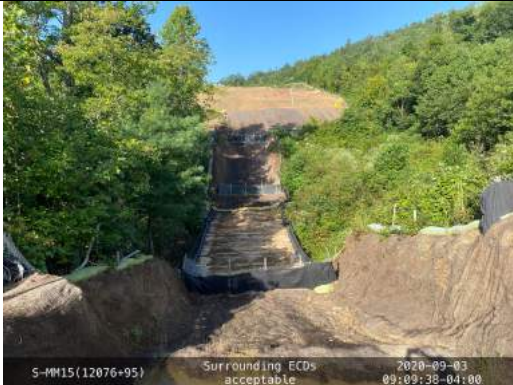
GPS Location	See photo GPS for location		GPS Location	See photo GPS for location	
Field Station#	12076+95		Field Station#	12076+95	
Pic 1 Desc.	ECDs surrounding stream are acceptable.		Pic 2 Desc.	ECDs surrounding stream are acceptable.

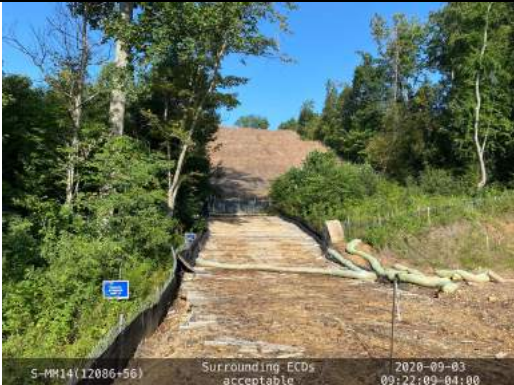
GPS Location	See photo GPS for location		GPS Location	See photo GPS for location	
Field Station#	12086+56		Field Station#	12093+00	
Pic 3 Desc.	ECDs surrounding stream are acceptable.		Pic 4 Desc.	Clean water crossing pipe and plunge pool outlet are in acceptable condition.

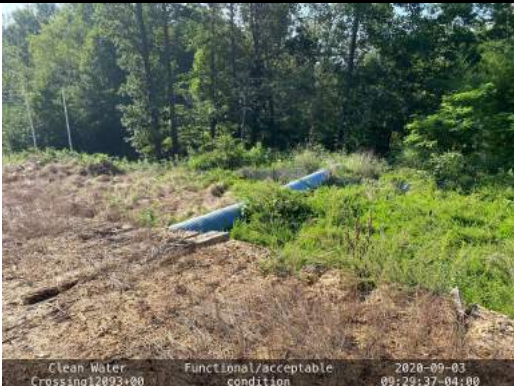
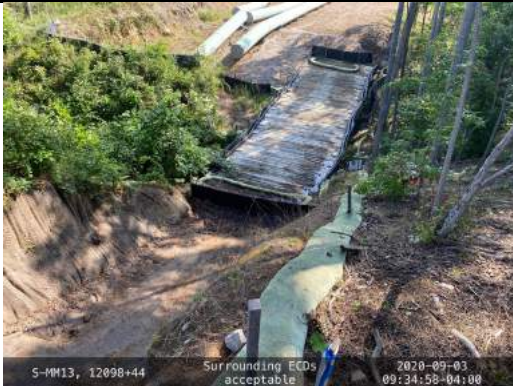
GPS Location	See photo GPS for location		GPS Location	See photo GPS for location	
Field Station#	12093+00		Field Station#	12098+45	
Pic 5 Desc.	Clean water crossing pipe and plunge pool outlet are in acceptable condition.		Pic 6 Desc.	ECDs surrounding stream are acceptable.

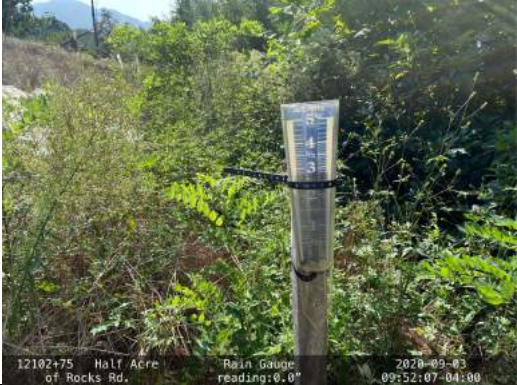
<p>12102+75 Half Acre of Rocks Rd. Rain Gauge reading:0.0" 2020-09-03 09:52:07-04:00</p>			
GPS Location	See photo GPS for location		GPS Location	See photo GPS for location	
Field Station#	12098+44		Field Station#	12103+75	
Pic 7 Desc.	I		Pic 8 Desc.	There was no recordable rainfall.
