Visual Site Inspection Report

Project Name	H-600 Pipeline Spread H	AFE	124300138	Spread	H-600 Pipeline Spread H
Contractor	Precision			Report #	14139
Inspector	Kaitlyn Ball			Date/Time	8/31/2020 1:08 PM
Permit #	TBD	Inspection Type	VA SWPP	Station Begin	12233+50
State	VA	Inspection Area	Partial	Station End	12443+75
County	Montgomery	Ground	Damp	Temperature (°F)	67.00
Municipality	N/A	Weather	Light Rain	Rain Gauge (in)	0.20
				Rain Accumulation Time (days)	1.00

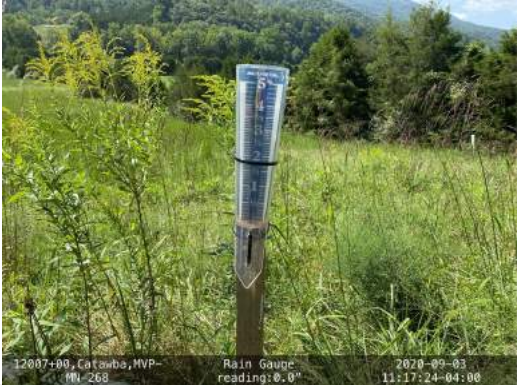
<p>12007+00, Catawba, MVP- MN-268 Rain Gauge reading:0.0" 2020-09-03 11:17:24-04:00</p>			
GPS Location	See photo GPS for location		GPS Location	See photo GPS for location	
Field Station#	12116+80		Field Station#	12007+00	
Pic 9 Desc.	Level spreaders and permanent seeding is acceptable at this time.		Pic 10 Desc.	There was no recordable rainfall.

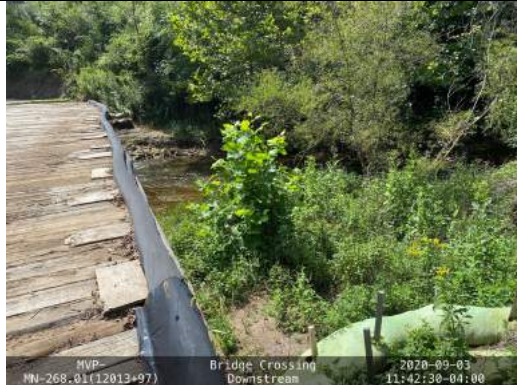
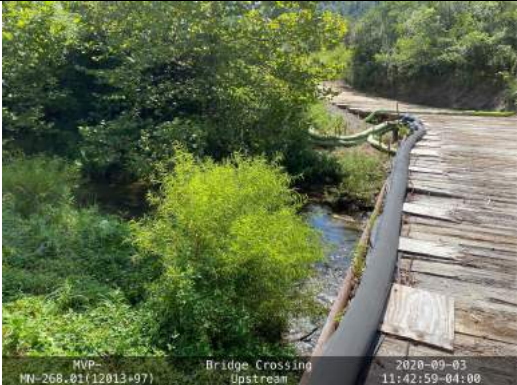
GPS Location	See photo GPS for location		GPS Location	See photo GPS for location	
Field Station#	12013+97		Field Station#	12013+97	
Pic 11 Desc.	ECDs surrounding stream are acceptable.		Pic 12 Desc.	ECDs surrounding stream are acceptable.

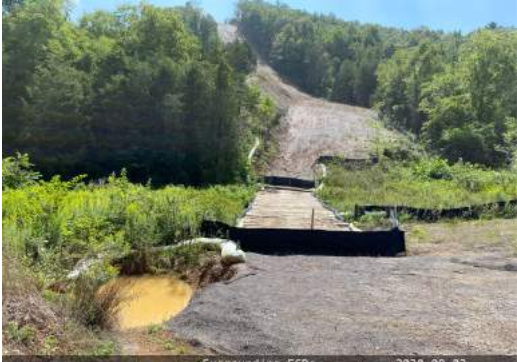
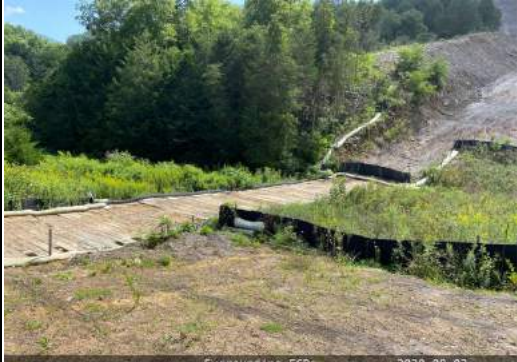
<small>S-638, 12015+84 Surrounding ECDs acceptable 2020-09-03 11:48:52-04:00</small>		<small>S-638, 12015+84 Surrounding ECDs acceptable 2020-09-03 11:49:48-04:00</small>			
GPS Location	See photo GPS for location		GPS Location	See photo GPS for location	
Field Station#	12015+84		Field Station#	12015+84	
Pic 13 Desc.	ECDs surrounding stream are acceptable.		Pic 14 Desc.	ECDs surrounding stream are acceptable.

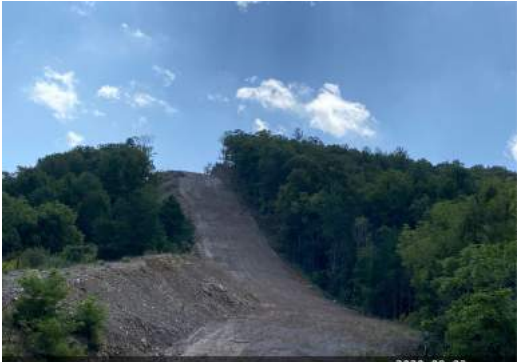
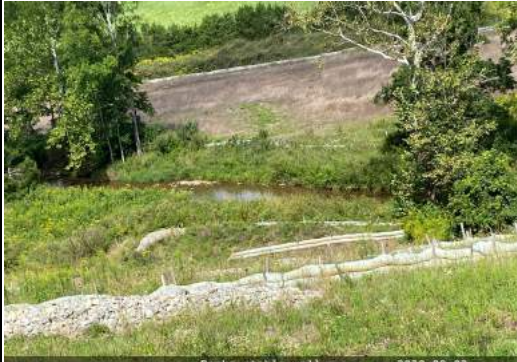
<small>12017+00 ECDs acceptable 2020-09-03 11:51:08-04:00</small>		<small>S-636, 12008+69 Banks stable, well vegetated 2020-09-03 11:55:08-04:00</small>			
GPS Location	See photo GPS for location		GPS Location	See photo GPS for location	
Field Station#	12017+00		Field Station#	12008+69	
Pic 15 Desc.	Area of ROW is stable.		Pic 16 Desc.	Banks are stable. Permanent restoration level spreaders, perimeter CFS, and vegetation are acceptable at this time.

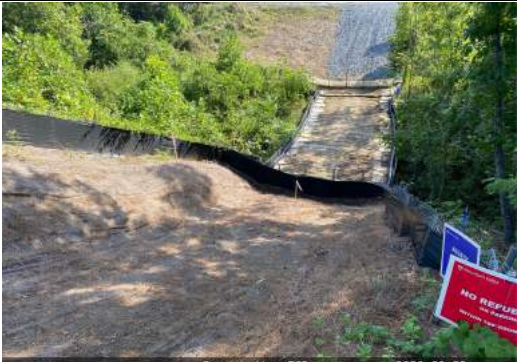
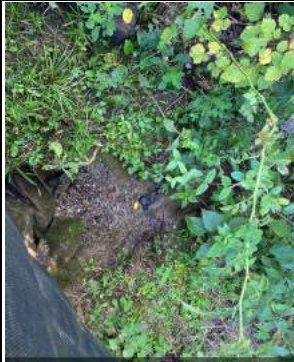
<small>S-MM11, 12101+57 Surrounding ECDs acceptable 2020-09-03 09:42:46-04:00</small>		<small>S-MM11, 12101+57 Banks stable 2020-09-03 09:47:05-04:00</small>			
GPS Location	See photo GPS for location		GPS Location	See photo GPS for location	
Field Station#	12101+57		Field Station#	12101+57	
Pic 17 Desc.	ECDs surrounding stream are acceptable.		Pic 18 Desc.	Stream is low and flowing slow.

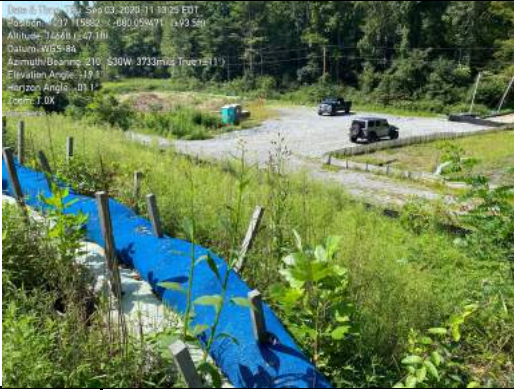
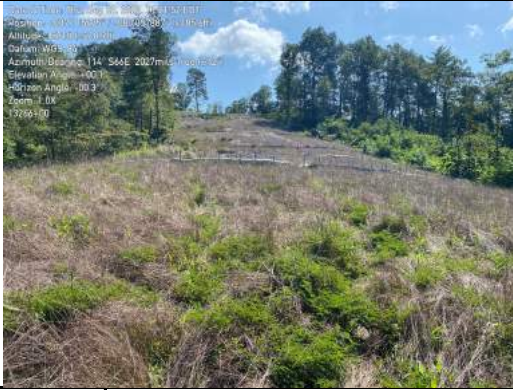
<p>Date & Time: Thu, Sep 3, 2020 11:39:25 EDT Position: +012 13266+00 Altitude: 1654ft (504.7m) Datum: WGS 84 Azimuth Bearing: 114.546E 2027mils True (105) Elevation Angle: -10.0 Horizon Angle: -00.3 Zoom: 1.0X 13266+00</p>			
GPS Location	See photo for coordinates.		GPS Location	See photo for coordinates.	
Field Station#	13263+00		Field Station#	13266+00	
Pic 1 Desc.	GAS Flanders Road (MVP-FR-293.01), acceptable vegetative cover, perimeter ECDs in acceptable condition.		Pic 2 Desc.	Restored ROW stable with acceptable vegetative cover across LOD.

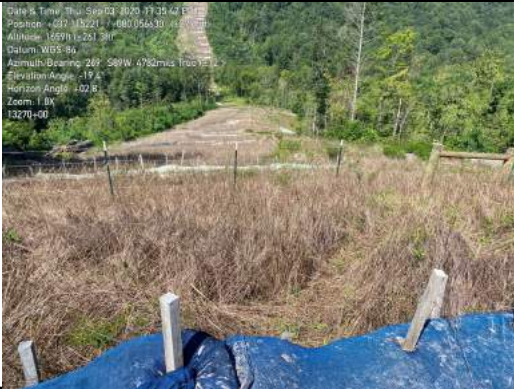
<p>Date & Time: Thu, Sep 3, 2020 11:39:25 EDT Position: +012 13270+00 Altitude: 1659ft (506.5m) Datum: WGS 84 Azimuth Bearing: 289.589W 4754mils True (12) Elevation Angle: -19.8 Horizon Angle: -02.5 Zoom: 1.0X 13270+00</p>

GPS Location	See photo for coordinates.		GPS Location	See photo for coordinates.	
Field Station#	13270+00		Field Station#	13274+00	
Pic 3 Desc.	Restored ROW stable with acceptable vegetative cover across LOD.		Pic 4 Desc.	Restored ROW stable with acceptable vegetative cover across LOD.

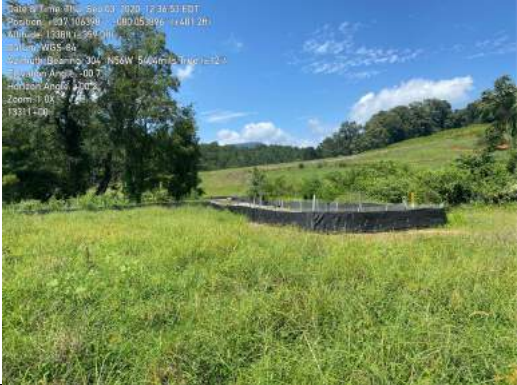
GPS Location	See photo for coordinates.		GPS Location	See photo for coordinates.	
Field Station#	13311+00		Field Station#	13312+00	
Pic 13 Desc.	GAS S-GH7, good vegetation noted across LOD.		Pic 14 Desc.	Permanent and temporary vegetation noted in restored agricultural area.

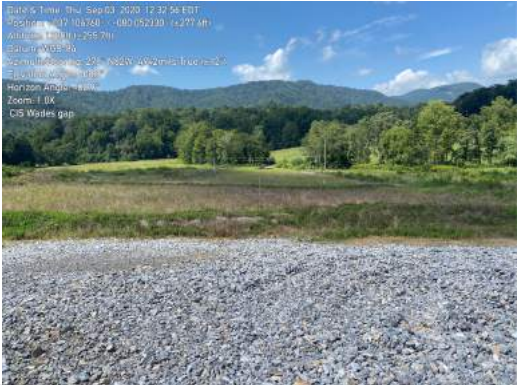
GPS Location	See photo for coordinates.		GPS Location	See photo for coordinates.	
Field Station#	13314+00		Field Station#	13315+00	
Pic 15 Desc.	CIS Wades Gap, ROW stable with acceptable vegetative cover.		Pic 16 Desc.	Wades Gap, RCE in acceptable condition.	
Insert image here			Insert image here		
GPS Location	See photo for coordinates.		GPS Location	See photo for coordinates.	
Field Station#			Field Station#		
Pic 17 Desc.			Pic 18 Desc.

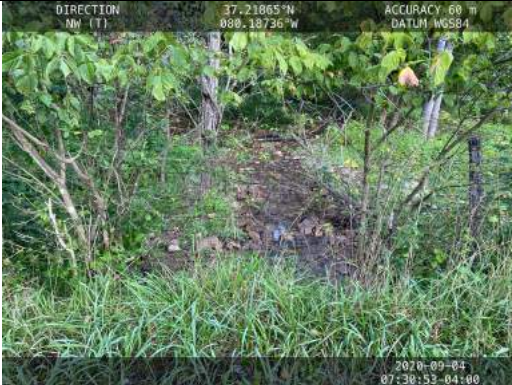
GPS Location	See photo		GPS Location	See photo	
Field Station#	12543+56		Field Station#	12543+56	
Pic 1 Desc.	Stream S-KL32, facing northwest, downstream, from Yellow Finch Road		Pic 2 Desc.	Stream S-EF20b, facing north, downstream, from Yellow Finch Road

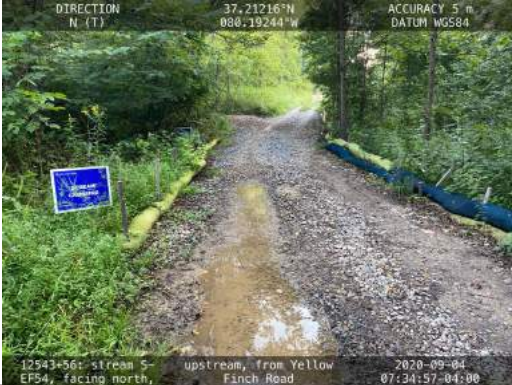
GPS Location	See photo		GPS Location	See photo	
Field Station#	12543+56		Field Station#	12543+56	
Pic 3 Desc.	Stream S-EF54, facing north		Pic 4 Desc.	MVP ROW crossing on access road MVP-MN-278.01, Yellow Finch Road.

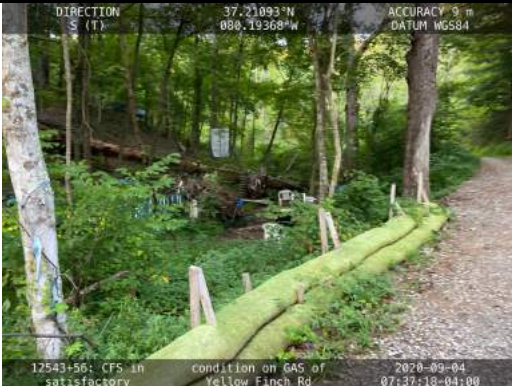
GPS Location	See photo		GPS Location	See photo	
Field Station#	12543+56		Field Station#	12543+00	
Pic 5 Desc.	CFS along the going away side of the ROW crossing on Yellow Finch Road is in good repair.		Pic 6 Desc.	Plastic sheeting on the stockpile nearest to Yellow Finch Road remains intact and secure.

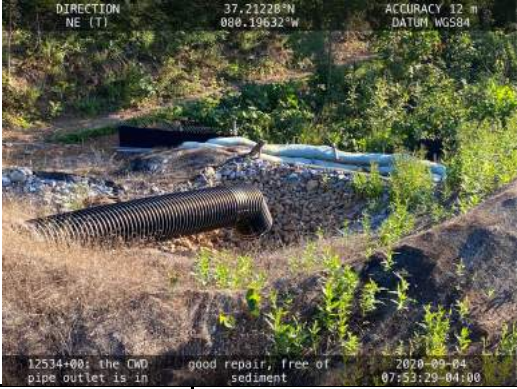
GPS Location	See photo	GPS Location	See photo		
Field Station#	12534+00	Field Station#	12529+00		
Pic 7 Desc.	The CWD pipe outlet plunge pool next to the landowner's crossing is in satisfactory condition and free of sediment.		Pic 8 Desc.	Plastic sheeting approximately 1500 feet from Yellow Finch Road is intact and secure.

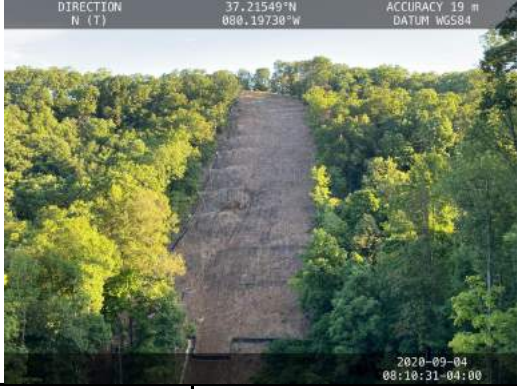
GPS Location	See photo	GPS Location	See photo		
Field Station#	12517+00	Field Station#	12519+41		
Pic 9 Desc.	The slope on the coming in side of stream S-EF19 remains stable.		Pic 10 Desc.	Stream S-EF19, facing east, upstream

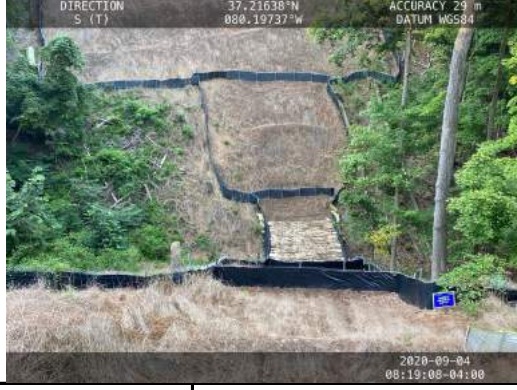
GPS Location	See photo	GPS Location	See photo		
Field Station#	12519+43	Field Station#	12507+87		
Pic 11 Desc.	Buffer zone of stream S-EF19 is stable, ECDs in satisfactory condition.		Pic 12 Desc.	Slope drain in good repair, functioning per design.

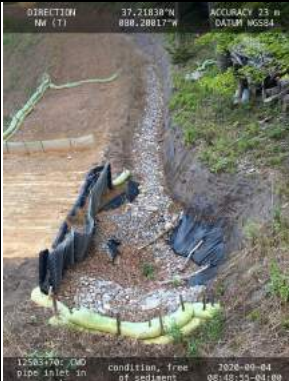
GPS Location	See photo		GPS Location	See photo	
Field Station#	12503+70		Field Station#	12482+00	
Pic 13 Desc.	This clean water diversion pipe inlet is in good repair and functioning properly.		Pic 14 Desc.	Plastic sheeting on the site of the "pig parts" excavation is intact and secure.

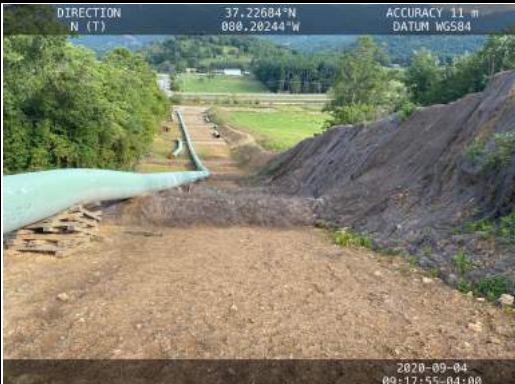
GPS Location	See photo		GPS Location	See photo	
Field Station#	12477+00		Field Station#	12460+75	
Pic 15 Desc.	ROW and stockpiles stable.		Pic 16 Desc.	Wetland W-KL58, facing west

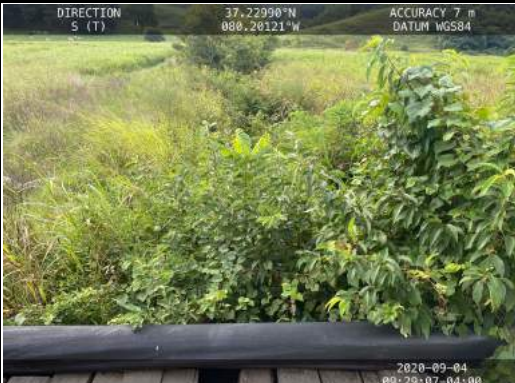
GPS Location	See photo		GPS Location	See photo	
Field Station#	12455+21		Field Station#	12444+94	
Pic 17 Desc.	Stream S-CD12, facing south, upstream		Pic 18 Desc.	Stream S-I1, facing southwest, upstream

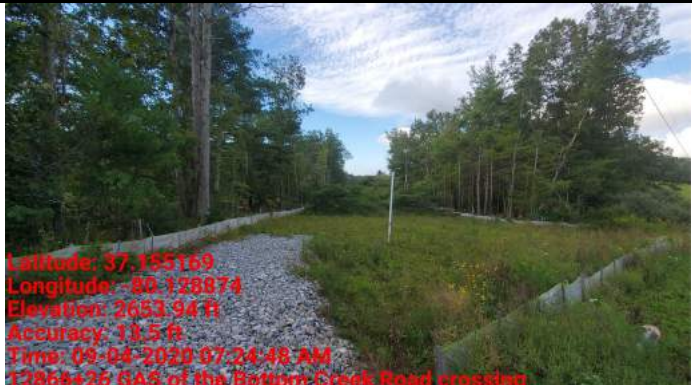
GPS Location	See pic for GPS location		GPS Location	See pic for GPS location	
Field Station#	12866+26		Field Station#	12866+26	
Pic 1 Desc.	GAS of the Bottom Creek Road crossing.		Pic 2 Desc.	CIS of the Bottom Creek Road crossing.

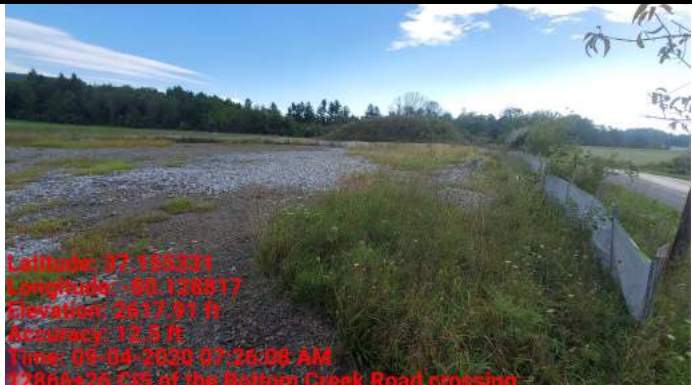
GPS Location	See pic for GPS location		GPS Location	See pic for GPS location	
Field Station#	12866+26		Field Station#	12957+30	
Pic 3 Desc.	CIS of the Bottom Creek Road crossing. ATWS and topsoil pile.		Pic 4 Desc.	Access road RO-287 at stream S-Z16.

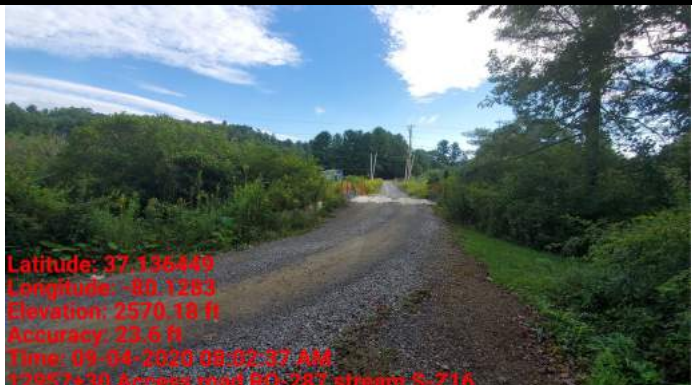
GPS Location	See pic for GPS location		GPS Location	See pic for GPS location	
Field Station#	12957+30		Field Station#	12957+30	
Pic 5 Desc.	Access road RO-287 at stream S-Z16.		Pic 6 Desc.	Access road RO-287 at stream S-Z17.

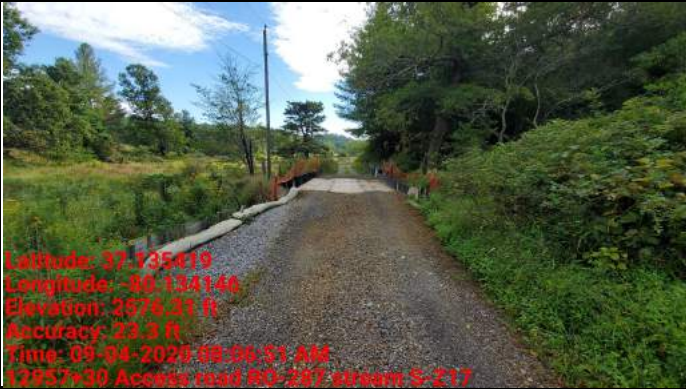
Latitude: 37.135419 Longitude: -80.134148 Elevation: 2576.31 ft Accuracy: 23.3 ft Time: 09-04-2020 09:36:31 AM 12957+30 Access road RO-287 stream S-Z17			Latitude: 37.132695 Longitude: -80.132894 Elevation: 2611.13 ft Accuracy: 19.7 ft Time: 09-04-2020 08:45:28 AM 12974+29 Access road RO-288 stream S-Q20		
GPS Location	See pic for GPS location		GPS Location	See pic for GPS location	
Field Station#	12957+30		Field Station#	12974+29	
Pic 7 Desc.	Access road RO-287 at stream S-Z17.		Pic 8 Desc.	Access road RO-288 at stream S-Q20

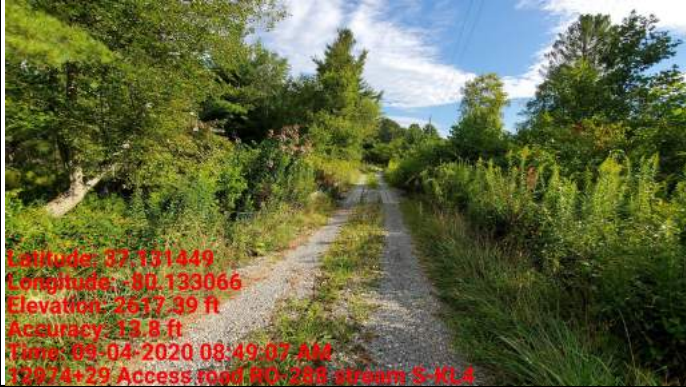
GPS Location	See pic for GPS location		GPS Location	See pic for GPS location	
Field Station#	12974+29		Field Station#	12974+29	
Pic 9 Desc.	Access road RO-288 at stream S-KL4		Pic 10 Desc.	ROW ATWS at Access road RO-288

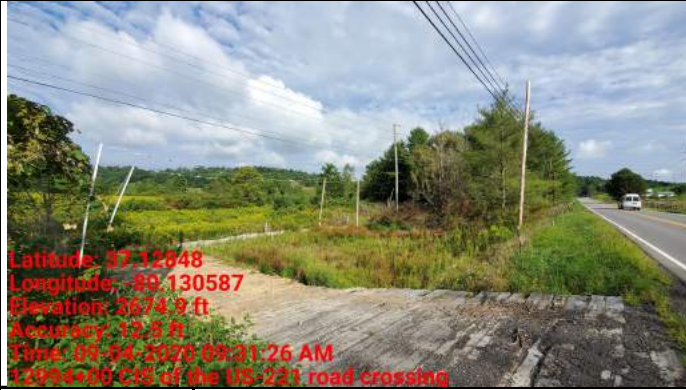
Latitude: 37.12848 Longitude: -80.130587 Elevation: 2674.9 ft Accuracy: 12.9 ft Time: 09-04-2020 09:31:26 AM 12994+00 CIS of the US-221 road crossing			Latitude: 37.128565 Longitude: -80.130604 Elevation: 2638.32 ft Accuracy: 12.5 ft Time: 09-04-2020 09:32:29 AM 12994+43 GAS of the US-221 road crossing		
GPS Location	See pic for GPS location		GPS Location	See pic for GPS location	
Field Station#	12994+00		Field Station#	12994+00	
Pic 11 Desc.	CIS of the US-221 road crossing.		Pic 12 Desc.	GAS of the US-221 road crossing.

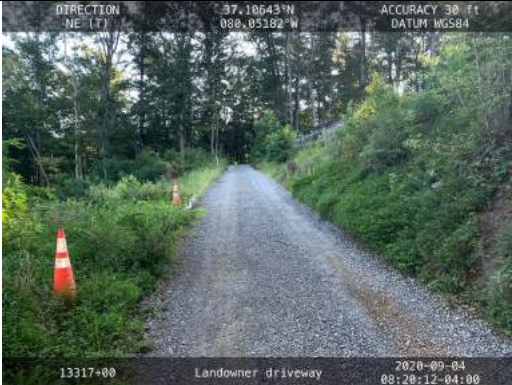
GPS Location	See photo for gps location data.		GPS Location	See photo for gps location data.	
Field Station#	13317+00		Field Station#	13321+47	
Pic 1 Desc.	Photo shows the landowner driveway.		Pic 2 Desc.	Photo shows stream S-GH15 downstream from the bridge.

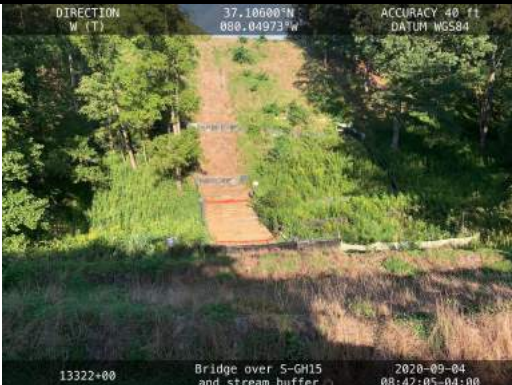
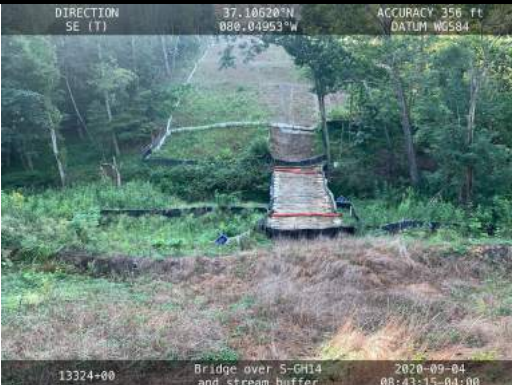
GPS Location	See photo for gps location data.		GPS Location	See photo for gps location data.	
Field Station#	13322+00		Field Station#	13324+00	
Pic 3 Desc.	Photo shows the bridge over stream S-GH15 and adjacent stream buffer.		Pic 4 Desc.	Photo shows the bridge over stream S-GH14 and adjacent stream buffer.

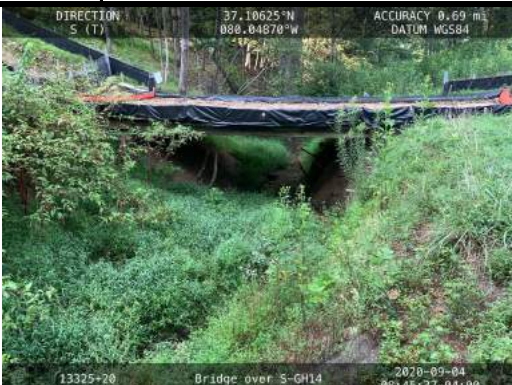
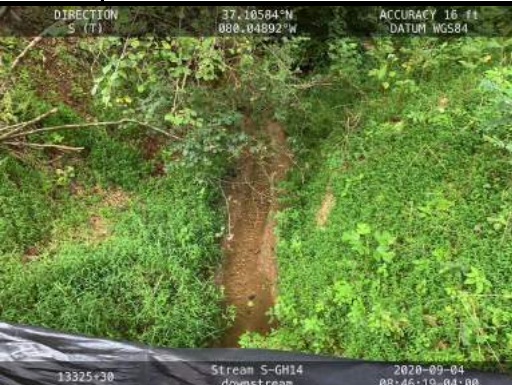
GPS Location	See photo for gps location data.		GPS Location	See photo for gps location data.	
Field Station#	13325+20		Field Station#	13325+30	
Pic 5 Desc.	Photo shows the bridge over stream S-GH14.		Pic 6 Desc.	Photo shows stream S-GH14 downstream from the bridge.

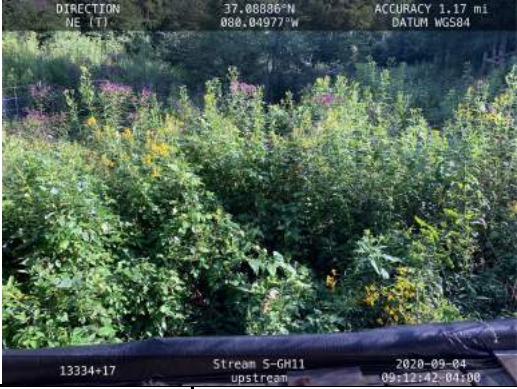
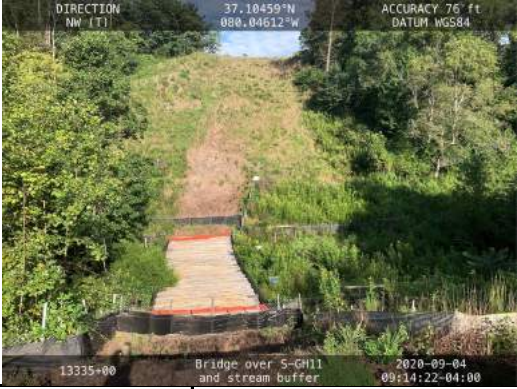
GPS Location	See photo for gps location data.		GPS Location	See photo for gps location data.	
Field Station#	13334+17		Field Station#	13335+00	
Pic 7 Desc.	Photo shows stream S-GH11 upstream from the bridge.		Pic 8 Desc.	Photo shows the bridge over stream S-GH11 and adjacent stream buffer.

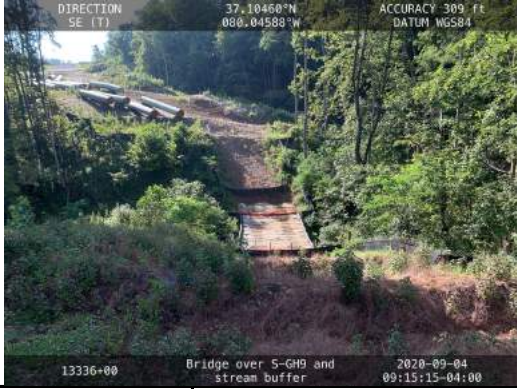
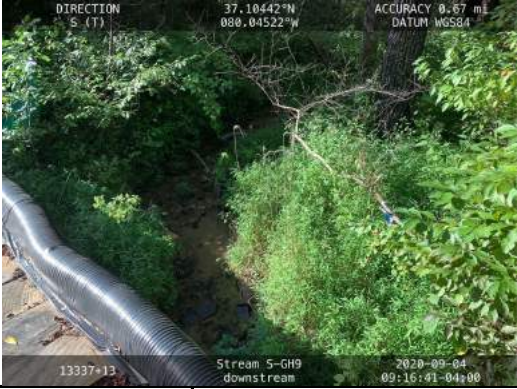
GPS Location	See photo for gps location data.		GPS Location	See photo for gps location data.	
Field Station#	13336+00		Field Station#	13337+13	
Pic 9 Desc.	Photo shows the bridge over stream S-GH9 and adjacent stream buffer.		Pic 10 Desc.	Photo shows stream S-GH9 downstream from the bridge.

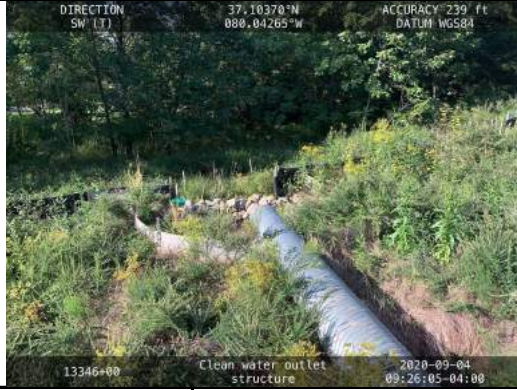
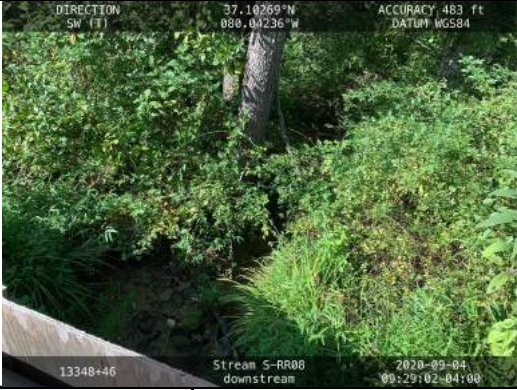
GPS Location	See photo for gps location data.		GPS Location	See photo for gps location data.	
Field Station#	13346+00		Field Station#	13348+46	
Pic 11 Desc.	Photo shows the clean water outlet structure.		Pic 12 Desc.	Photo shows stream S-RR08 downstream from the bridge.

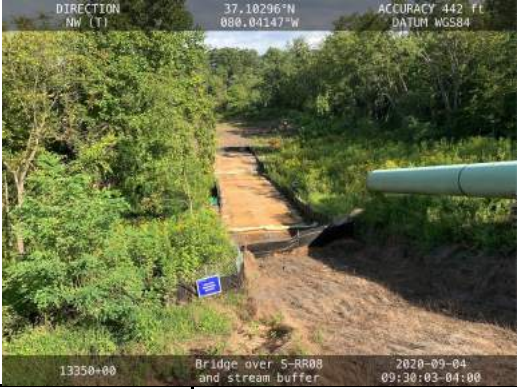
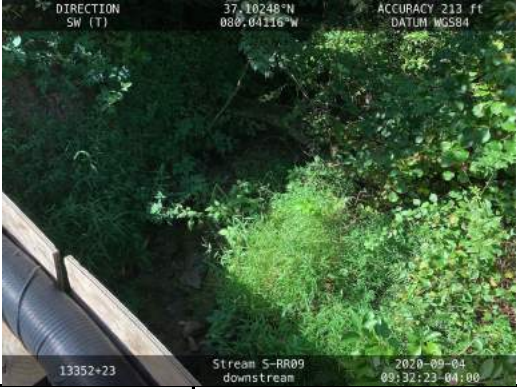
GPS Location	See photo for gps location data.		GPS Location	See photo for gps location data.	
Field Station#	13350+00		Field Station#	13352+23	
Pic 13 Desc.	Photo shows the bridge over stream S-GH08 and adjacent stream buffer.		Pic 14 Desc.	Photo shows stream S-RR09 downstream from the bridge.

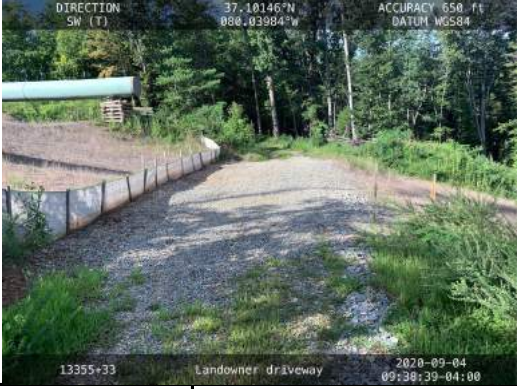
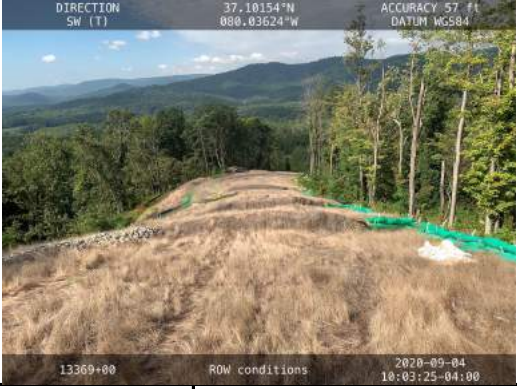
GPS Location	See photo for gps location data.		GPS Location	See photo for gps location data.	
Field Station#	13355+33		Field Station#	13369+00	
Pic 15 Desc.	Photo shows the landowner driveway.		Pic 16 Desc.	Photo shows the ROW condition from about 13365+00 to 13369+00.

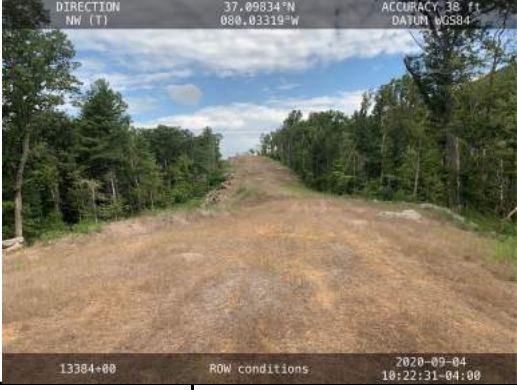
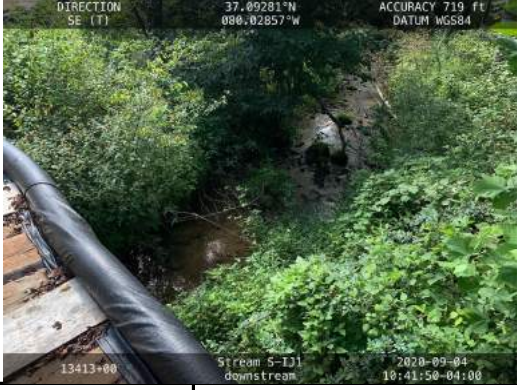
GPS Location	See photo for gps location data.		GPS Location	See photo for gps location data.	
Field Station#	13384+00		Field Station#	13413+00	
Pic 17 Desc.	Photo shows the ROW condition from about 13375+00 to 13384+00.		Pic 18 Desc.	Photo shows stream S-IJ1 downstream from the bridge.

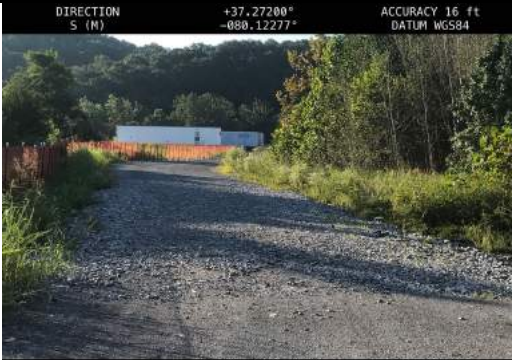
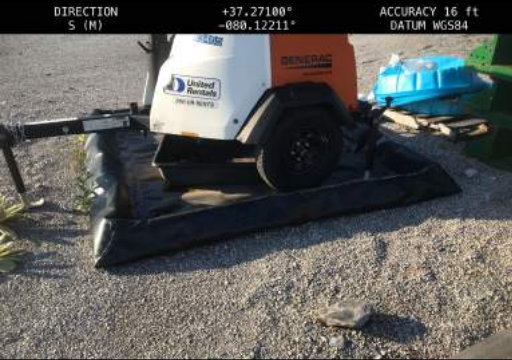
GPS Location	MVP-LY-049 See photo for gps data	GPS Location	MVP-LY-049 See photo for gps data		
Field Station#	+0	Field Station#	+0		
Pic 1 Desc.	Condition of rock entrance on center drive. No sediment on stone surface. Looking S.	Pic 2 Desc.	Condition of containment under light plant. Free of stormwater. Looking S.

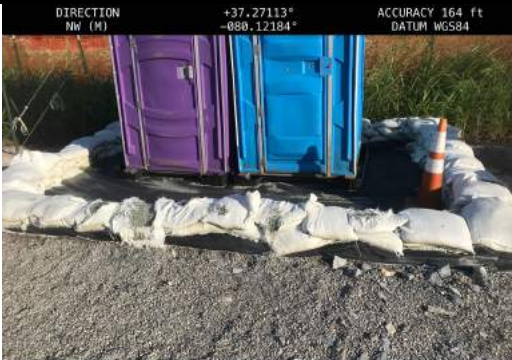
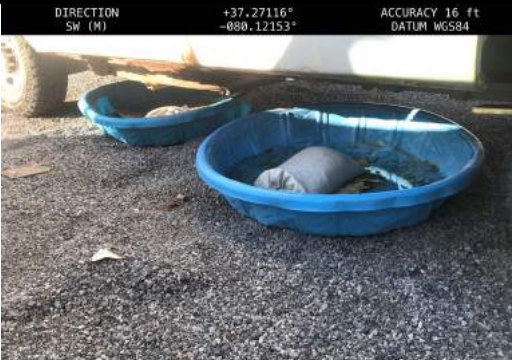
GPS Location	MVP-LY-049 See photo for gps data	GPS Location	MVP-LY-049 See photo for gps data		
Field Station#	+0	Field Station#	+0		
Pic 3 Desc.	Condition of trays and containment under toilets. Looking NW	Pic 4 Desc.	Condition of containments under stored vehicle. Looking SW.

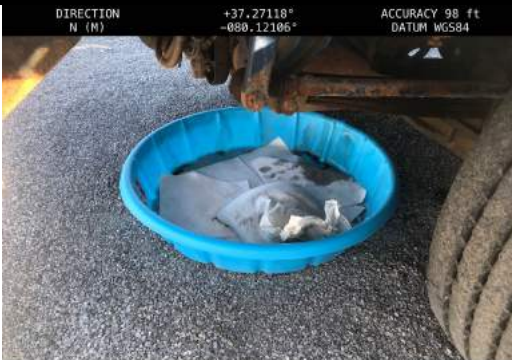
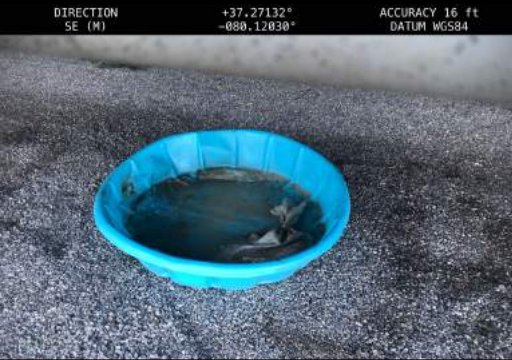
GPS Location	MVP-LY-049 See photo for gps data	GPS Location	MVP-LY-049 See photo for gps data		
Field Station#	+0	Field Station#	+0		
Pic 5 Desc.	Condition of containment under stored vehicle. Looking N.	Pic 6 Desc.	Condition of containment under stored vehicle. Looking SE.

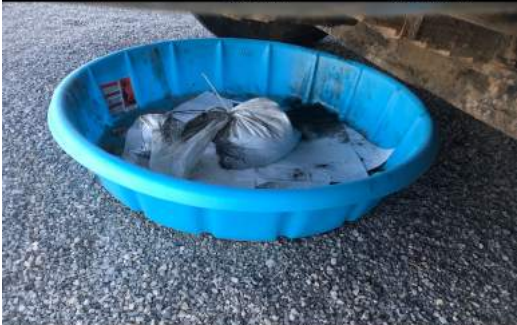
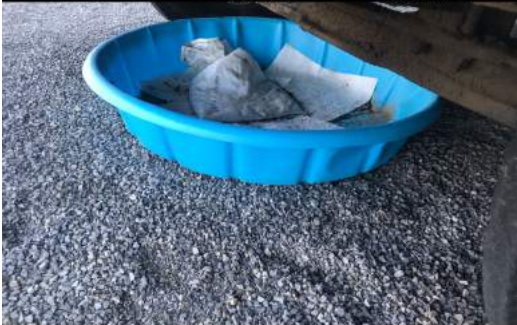
GPS Location	MVP-LY-049 See photo for gps data		GPS Location	MVP-LY-049 See photo for gps data	
Field Station#	+0		Field Station#	+0	
Pic 7 Desc.	Condition of containment under stored vehicle. Looking N.		Pic 8 Desc.	Condition of containment under stored vehicle. Looking N.	
DIRECTION S (M) +37.26998° -080.12314° ACCURACY 16 ft DATUM WGS84

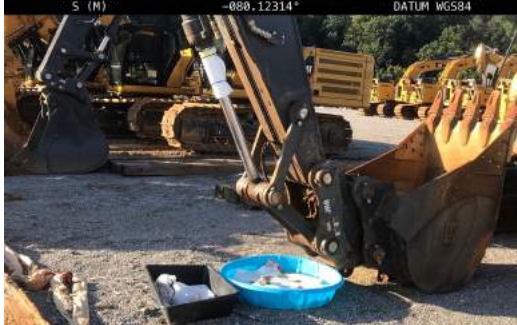
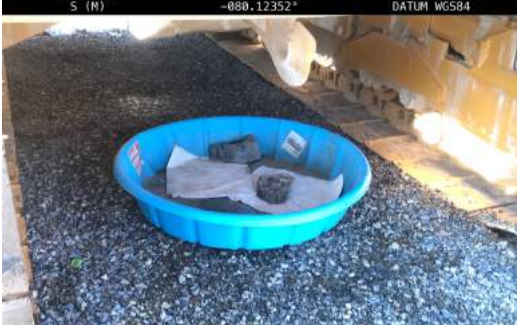
GPS Location	MVP-LY-049 See photo for gps data		GPS Location	MVP-LY-049 See photo for gps data	
Field Station#	+0		Field Station#	+0	
Pic 9 Desc.	Condition of containments under stored equipment. Looking S.		Pic 10 Desc.	Condition of containment under stored equipment. Looking S.

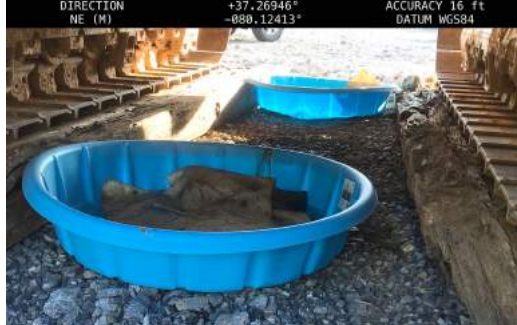
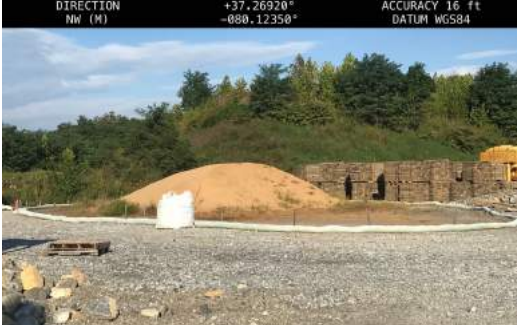
GPS Location	MVP-LY-049 See photo for gps data		GPS Location	MVP-LY-049 See photo for gps data	
Field Station#	+0		Field Station#	+0	
Pic 11 Desc.	Condition of containments under stored equipment. Looking NE.		Pic 12 Desc.	Condition of compost filter sock around sand pile. Looking NW.

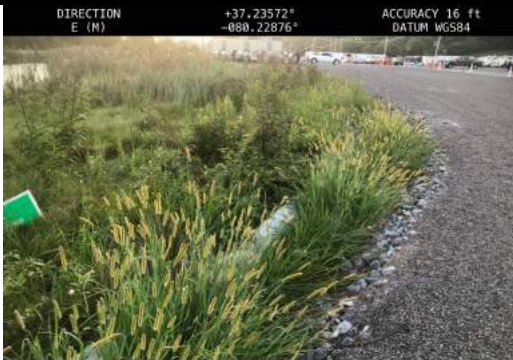
<p>DIRECTION E (N) +37.23572° -080.22876° ACCURACY 16 ft DATUM WGS84</p> <p>MVP-PY-006_090420 Condition of CFS along feature 2020-09-04 07:08:50-04:00</p>

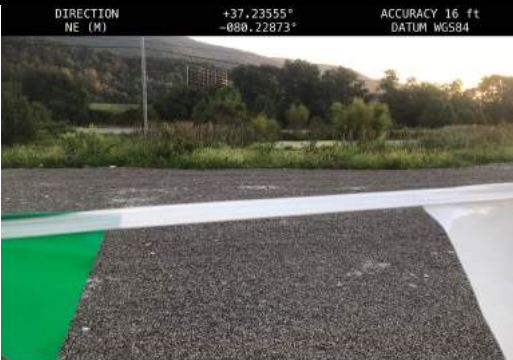
<p>DIRECTION NE (N) +37.23555° -080.22873° ACCURACY 16 ft DATUM WGS84</p> <p>MVP-PY-006_090420 Signage and buffer flagging for feature 2020-09-04 07:09:18-04:00</p>			
GPS Location	MVP-PY-006 See photo for gps data		GPS Location	MVP-PY-006 See photo for gps data	
Field Station#	+0		Field Station#	+0	
Pic 1 Desc.	Condition of compost filter sock along south edge of feature W-008. CFS over grown with vegetation. Looking E.		Pic 2 Desc.	Condition of signage and buffer flagging for feature W-008. Looking NE.

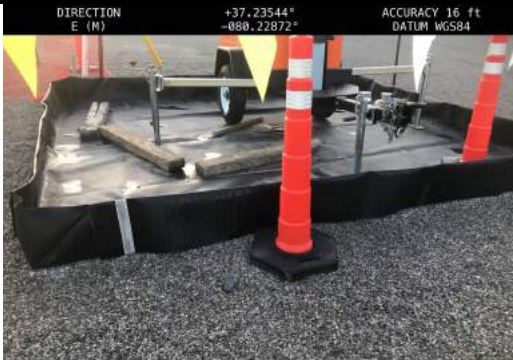
<p>DIRECTION E (N) +37.23544° -080.22872° ACCURACY 16 ft DATUM WGS84</p> <p>MVP-PY-006_090420 Condition of containment 2020-09-04 07:09:37-04:00</p>

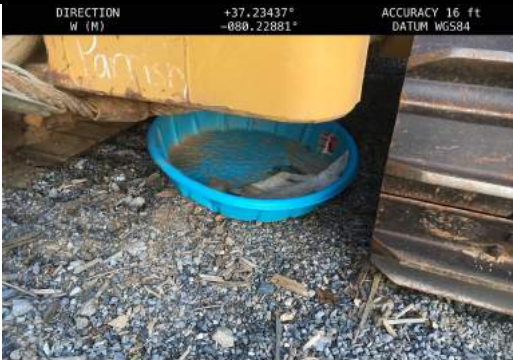
<p>DIRECTION W (N) +37.23437° -080.22881° ACCURACY 16 ft DATUM WGS84</p> <p>MVP-PY-006_090420 Containment under stored equipment 2020-09-04 07:12:28-04:00</p>

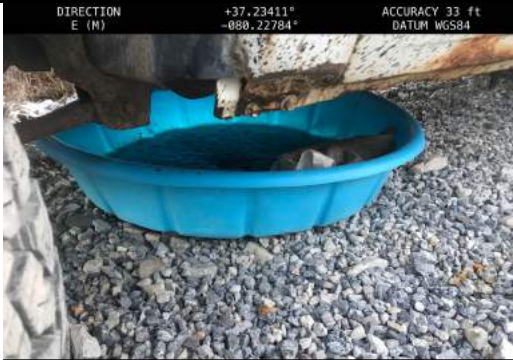
<p>DIRECTION E (N) +37.23411° -080.22784° ACCURACY 33 ft DATUM WGS84</p> <p>MVP-PY-006_090420 Containment under stored vehicle 2020-09-04 07:13:48-04:00</p>

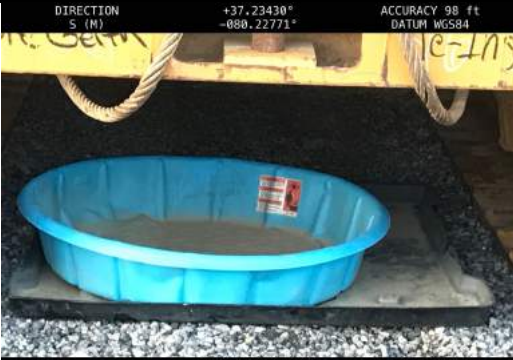
<p>DIRECTION S (N) +37.23430° -080.22771° ACCURACY 98 ft DATUM WGS84</p> <p>MVP-PY-006_090420 Containment under stored equipment 2020-09-04 07:14:34-04:00</p>			
GPS Location	MVP-PY-006 See photo for gps data		GPS Location	MVP-PY-006 See photo for gps data	
Field Station#	+0		Field Station#	+0	
Pic 5 Desc.	Condition of containments under stored vehicle. Looking E.		Pic 6 Desc.	Condition of containment under stored equipment. Looking S.

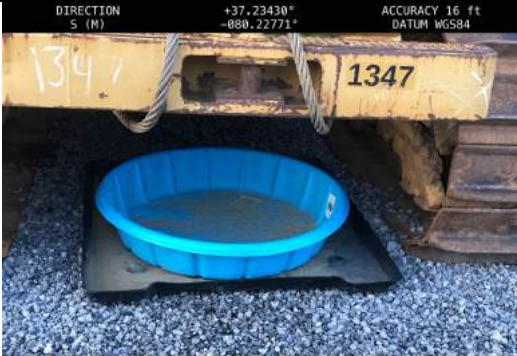
<p>DIRECTION S (N) +37.23430° -080.22771° ACCURACY 16 ft DATUM WGS84</p> <p>MVP-PY-006_090420 Containment under stored equipment 2020-09-04 07:14:43-04:00</p>

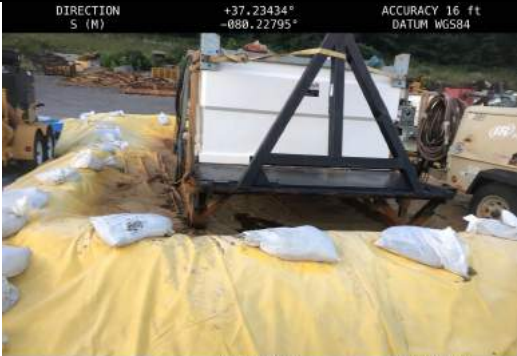
<p>DIRECTION S (N) +37.23434° -080.22795° ACCURACY 16 ft DATUM WGS84</p> <p>MVP-PY-006_090420 Condition of containment 2020-09-04 07:14:59-04:00</p>			
GPS Location	MVP-PY-006 See photo for gps data		GPS Location	MVP-PY-006 See photo for gps data	
Field Station#	+0		Field Station#	+0	
Pic 7 Desc.	Condition of containment under stored equipment. Looking S.		Pic 8 Desc.	Condition of containment under stored equipment. Looking S.

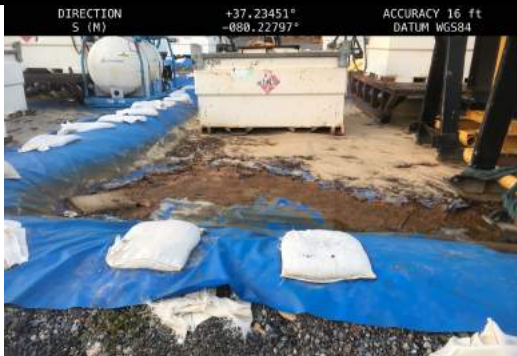
<p>DIRECTION S (N) +37.23451° -080.22797° ACCURACY 16 ft DATUM WGS84</p> <p>MVP-PY-006_090420 Condition of containment 2020-09-04 07:15:43-04:00</p>

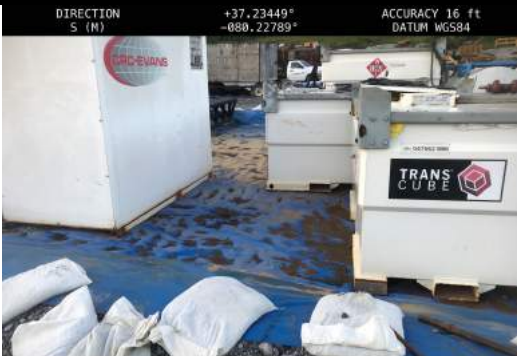
<p>DIRECTION S (N) +37.23449° -080.22789° ACCURACY 16 ft DATUM WGS84</p> <p>MVP-PY-006_090420 Condition of containment 2020-09-04 07:15:54-04:00</p>

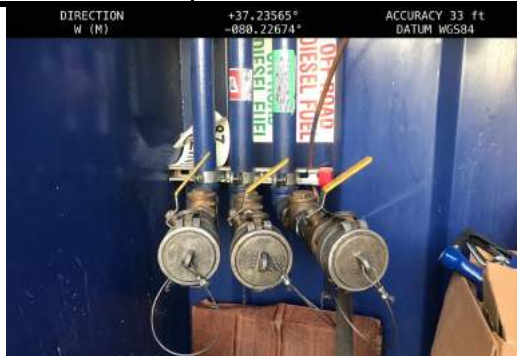
<p>DIRECTION W (N) +37.23565° -080.22674° ACCURACY 33 ft DATUM WGS84</p> <p>MVP-PY-006_090420 No leaky internal fittings 2020-09-04 07:18:22-04:00</p>

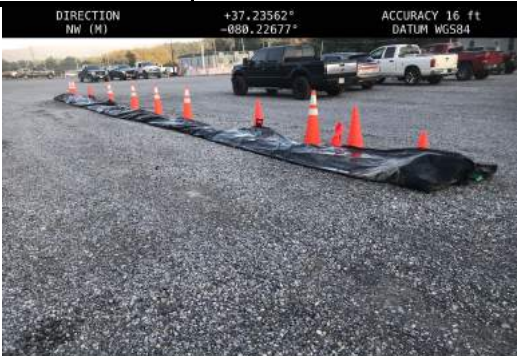
<p>DIRECTION NW (N) +37.23562° -080.22677° ACCURACY 16 ft DATUM WGS84</p> <p>MVP-PY-006_090420 Secondary containment on site for tankers 2020-09-04 07:19:32-04:00</p>			
GPS Location	MVP-PY-006 See photo for gps data		GPS Location	MVP-PY-006 See photo for gps data	
Field Station#	+0		Field Station#	+0	
Pic 11 Desc.	Blue Bulk Fuel tanks no leaky internal fittings. Looking W.		Pic 12 Desc.	Secondary containment on site for tankers offloading fuel into Blue Bulk fuel tanks. Looking NW.

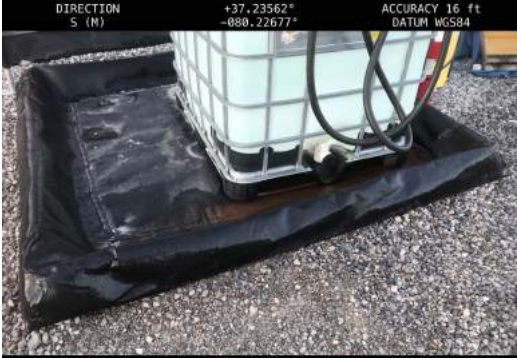
<p>DIRECTION S (M) +37.23562° -080.22677° ACCURACY 16 ft DATUM WGS84</p> <p>MVP-PY-006_090420 Condition of containment 2020-09-04 07:19:34-04:00</p>

<p>DIRECTION NE (M) +37.23582° -080.22720° ACCURACY 213 ft DATUM WGS84</p> <p>MVP-PY-006_090420 No leaky internal fittings 2020-09-04 07:20:30-04:00</p>			
GPS Location	MVP-PY-006 See photo for gps data		GPS Location	MVP-PY-006 See photo for gps data	
Field Station#	+0		Field Station#	+0	
Pic 13 Desc.	Condition of containment under DEF container. Looking S.		Pic 14 Desc.	Off Road Fuel unit no leaky internal fittings. Looking NE.

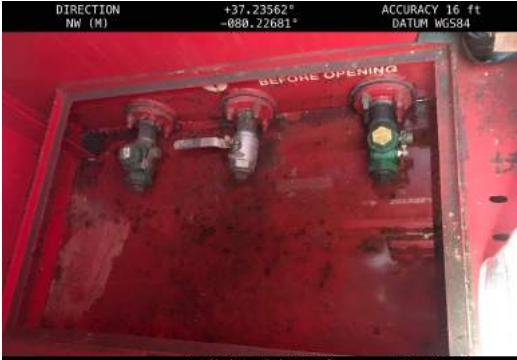
<p>DIRECTION NW (M) +37.23562° -080.22681° ACCURACY 16 ft DATUM WGS84</p> <p>MVP-PY-006_090420 Condition of internal drip pan 2020-09-04 07:20:36-04:00</p>

GPS Location	MVP-PY-006 See photo for gps data		GPS Location	MVP-PY-006 See photo for gps data	
Field Station#	+0		Field Station#	+0	
Pic 15 Desc.	Off Road Fuel unit internal drip pan empty. Looking NW.		Pic 16 Desc.	No loose trash around dumpsters. Looking SE.

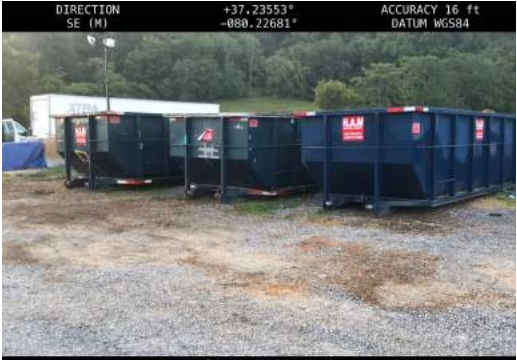
<p>DIRECTION SE (M) +37.23553° -080.22681° ACCURACY 16 ft DATUM WGS84</p> <p>MVP-PY-006_090420 No loose trash around dumpsters 2020-09-04 07:22:06-04:00</p>

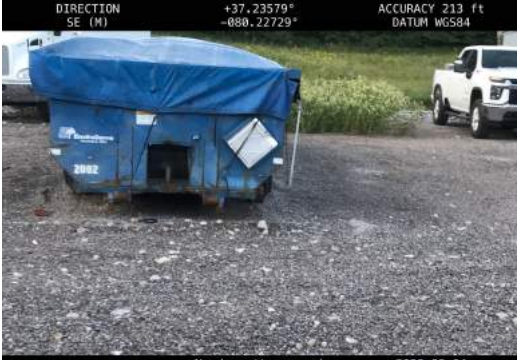
<p>DIRECTION SE (M) +37.23579° -080.22729° ACCURACY 213 ft DATUM WGS84</p> <p>MVP-PY-006_090420 No deposits around hazardous waste 2020-09-04 07:22:41-04:00</p>

<p>DIRECTION SE (M) +37.23450° -080.22577° ACCURACY 16 ft DATUM WGS84</p> <p>MVL-PY-006_090420 Condition of CFS along east LOD 2020-09-04 07:25:05-04:00</p>			
GPS Location	MVP-PY-006 See photo for gps data		GPS Location	MVP-PY-006 See photo for gps data	
Field Station#	+0		Field Station#	+0	
Pic 17 Desc.	No deposits around hazardous waste dumpster. Looking SE.		Pic 18 Desc.	Condition of compost filter sock along east LOD. CFS over grown with vegetation. Looking SE.

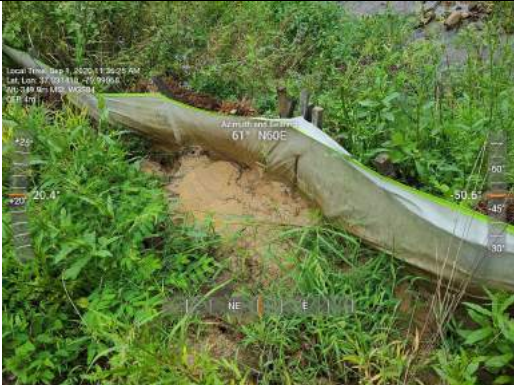
GPS Location	000000	GPS Location	00000		
Field Station#	13542+80	Field Station#	13540+50		
Pic 1 Desc.	P1 undermined above stream crossing, added to the punch list and discussed with the contractor		Pic 2 Desc.	p1 requires maintenance, added to the punch list

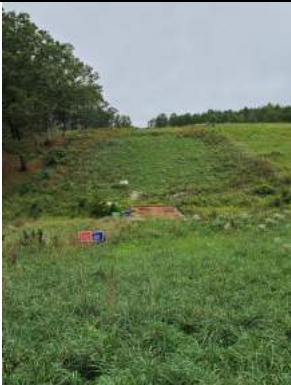
GPS Location	00000	GPS Location	00000		
Field Station#	13529+28	Field Station#	13542+70		
Pic 3 Desc.	Installed new wetland and stream crossing signs		Pic 4 Desc.	Silt fence undermined, talked with environmental crew to make repairs	
Insert image here			Insert image here		
GPS Location		GPS Location			
Field Station#		Field Station#			
Pic 5 Desc.			Pic 6 Desc.

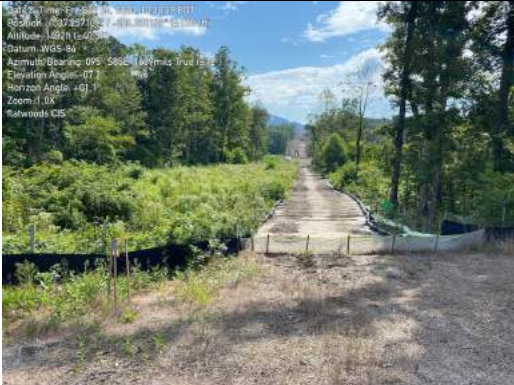
GPS Location	See photo for coordinates.		GPS Location	See photo for coordinates.	
Field Station#	12121+00		Field Station#	12121+29	
Pic 1 Desc.	CIS wetland and stream complex: W-C12, S-C36, S-C33, and W-C11.		Pic 2 Desc.	W-C12, upstream, banks well vegetated.

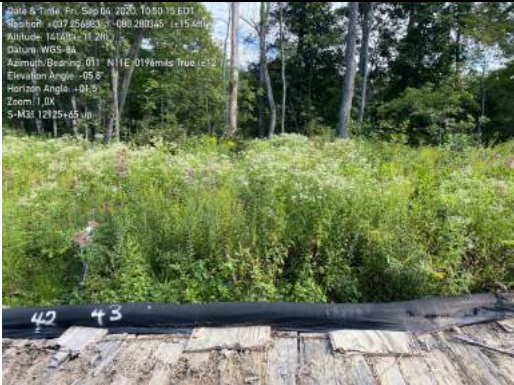
GPS Location	See photo for coordinates.		GPS Location	See photo for coordinates.	
Field Station#	12125+65		Field Station#	12125+65	
Pic 3 Desc.	S-MM31, upstream, well vegetated.		Pic 4 Desc.	S-MM31, downstream, water noted flowing, banks heavily vegetated.

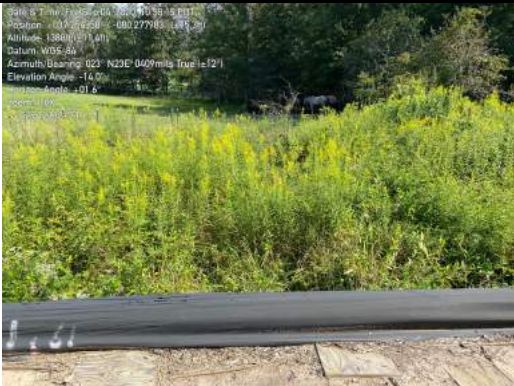
GPS Location	See photo for coordinates.		GPS Location	See photo for coordinates.	
Field Station#	12132+73		Field Station#	12132+73	
Pic 5 Desc.	S-C29, upstream, banks heavily vegetated, no environmental issues noted.		Pic 6 Desc.	Perimeter ECDs in acceptable condition.

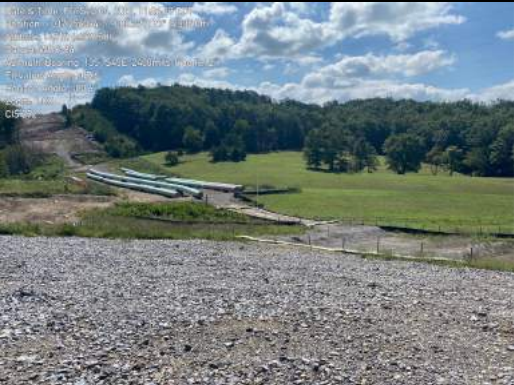
GPS Location	See photo for coordinates.		GPS Location	See photo for coordinates.	
Field Station#	12140+00		Field Station#	12143+59	
Pic 7 Desc.	MVP-MN-272 at ROW, workspace and access road in acceptable condition, ROW stable.		Pic 8 Desc.	W-C5, ECDs in acceptable condition along ROW and wetland.

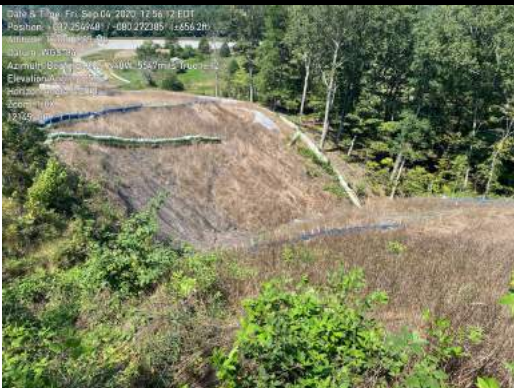
GPS Location	See photo for coordinates.		GPS Location	See photo for coordinates.	
Field Station#	12145+00		Field Station#	12155+00	
Pic 9 Desc.	ROW stable, perimeter controls in acceptable condition.		Pic 10 Desc.	GAS MVP-MN-273, ROW stable, with sparse vegetative cover.

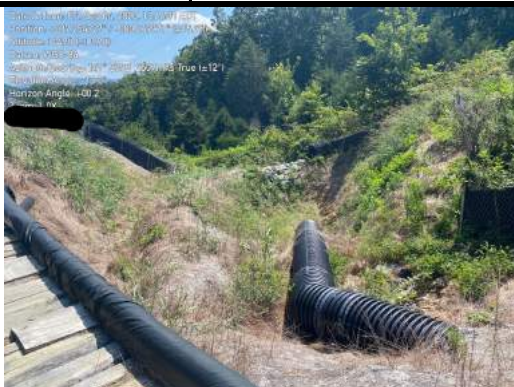
GPS Location	See photo for coordinates.		GPS Location	See photo for coordinates.	
Field Station#	12157+00		Field Station#	12163+05	
Pic 11 Desc.	Plunge pool and clean water conveyance, no water noted.		Pic 12 Desc.	CIS S-C25, waterbars functioning acceptbely, bridge and perimeter controls in acceptable condition.

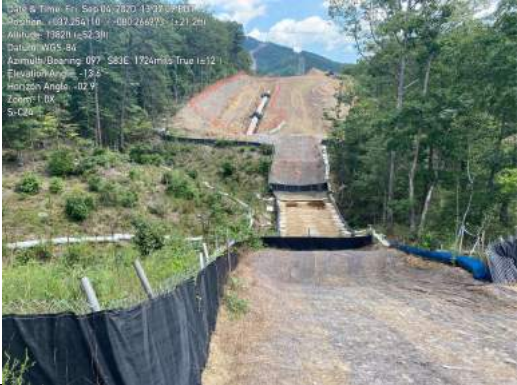
GPS Location	See photo for coordinates.	GPS Location	See photo for coordinates.		
Field Station#	12166+47	Field Station#	12168+00		
Pic 13 Desc.	S-C24, ECDs functioning acceptably.	Pic 14 Desc.	No off ROW impacts noted, waterbars in acceptable condition.

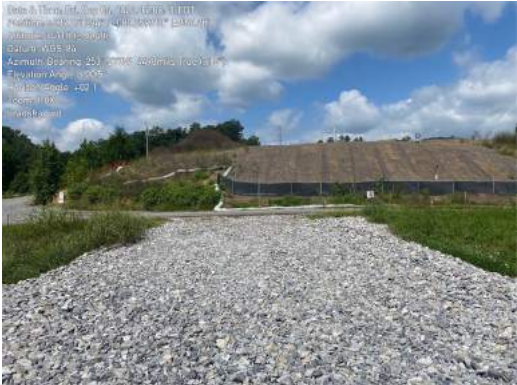
GPS Location	See photo for coordinates.	GPS Location	See photo for coordinates.		
Field Station#	12190+85	Field Station#	12192+50		
Pic 15 Desc.	Bradshaw Road, RCEs in acceptable condition.	Pic 16 Desc.	S-C21, upstream, no ROW impacts noted, no turbidity observed, banks appeared stable.

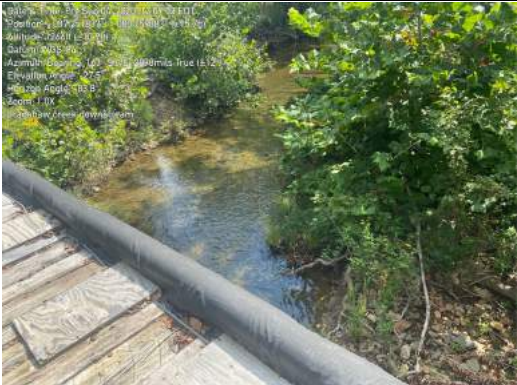
GPS Location	See photo for coordinates.	GPS Location	See photo for coordinates.		
Field Station#	12192+50	Field Station#	12233+00		
Pic 17 Desc.	S-C21, downstream, no environmental concerns noted.	Pic 18 Desc.	ROW stable, perimeter controls functioning acceptably.
