Visual Site Inspection Report

| Project Name | H-600 Pipeline Spread H | AFE | 124300138 | Spread | H-600 Pipeline Spread H |
| Inspector | John Brcic | | | Date/Time | 11/3/2020 1:28 PM |

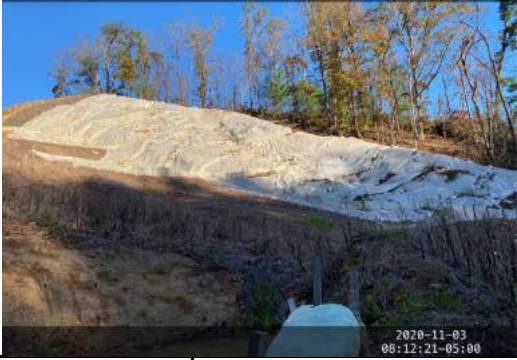
| Pic 7 Desc. | Plastic sheeting on stockpiles nearest to Yellow Finch Road remains intact and secure. | | Pic 8 Desc. | Rilling continues to worsen on the denuded logging road adjacent to MVP ROW. | |

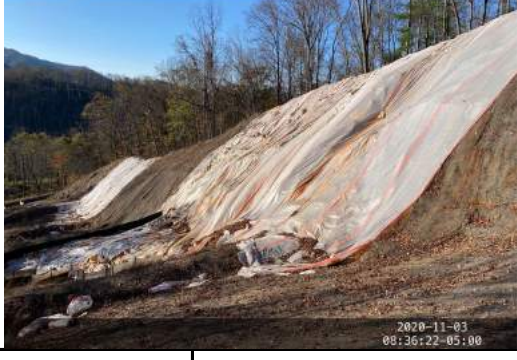
| Pic 9 Desc. | Plastic sheeting approximately 1500 feet from Yellow Finch Road is intact and secure. | | Pic 10 Desc. | Stream S-EF19, facing northeast, upstream | |

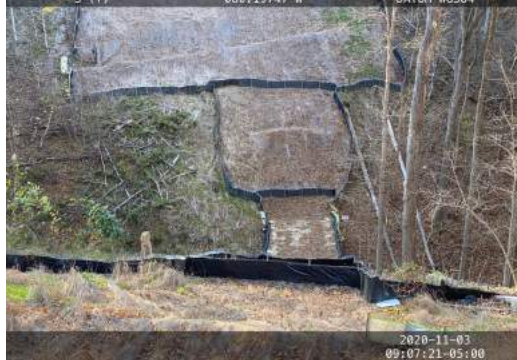
| Pic 11 Desc. | Buffer zone of stream S-EF19 is stable and ECDs are in satisfactory condition. | | Pic 12 Desc. | Super silt fence along the bottom of this fill slope is in good repair. | |

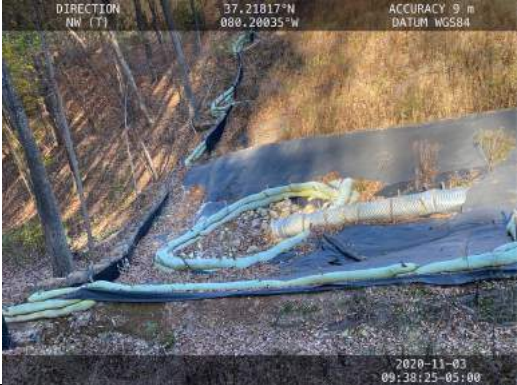
| Pic 13 Desc. | This clean water diversion pipe outlet is in satisfactory condition and free of sediment. | | Pic 14 Desc. | This clean water diversion pipe inlet is in good repair, no maintenance needed. | |

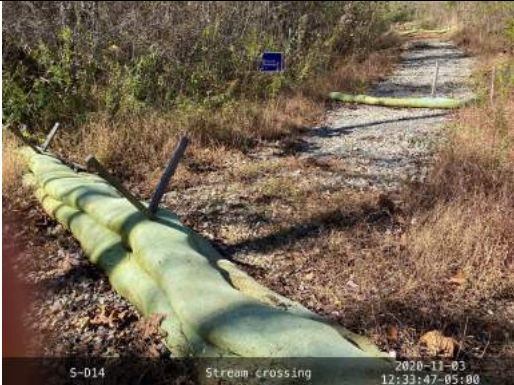
| Pic 1 Desc. | MVP-FR-292 stream crossing. | | Pic 2 Desc. | S-D10 crossing on MVP-MLV-AR-29 | |

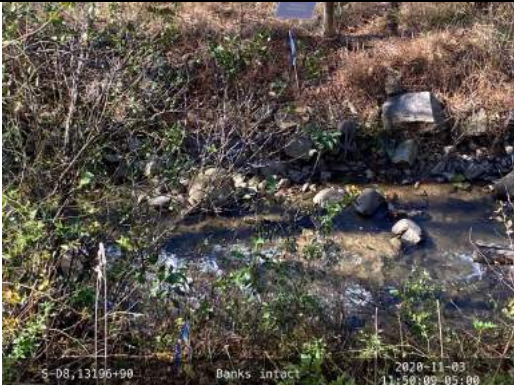
| Pic 3 Desc. | Stream banks are intact. | | Pic 4 Desc. | Permanent restoration is in acceptable condition. | |

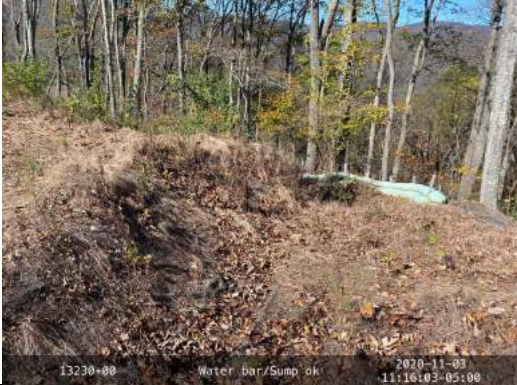
| Pic 7 Desc. | Water bar and sump are in acceptable condition. | | Pic 8 Desc. | Permanent restoration is in acceptable condition. | |

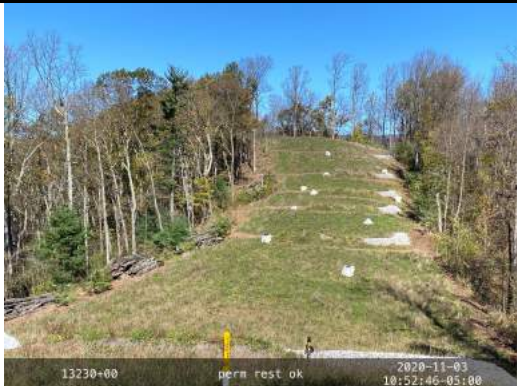
| Pic 9 Desc. | Permanent restoration is in acceptable condition. | | Pic 10 Desc. | Perimeter controls are acceptable. | |

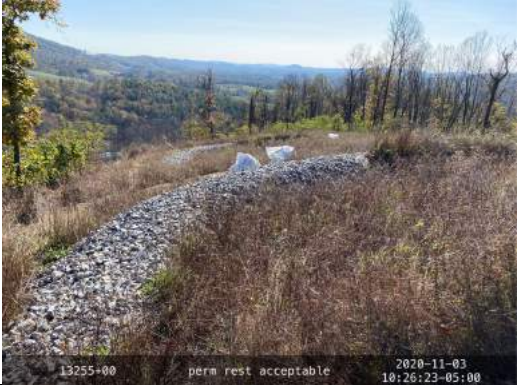
| <p>13255+00 perm rest acceptable 2020-11-03 10:26:23-05:00</p> | | <p>13256+00 perimeter controls acceptable 2020-11-03 10:04:37-05:00</p> | | | |
| Pic 13 Desc. | Permanent restoration is in acceptable condition. | | Pic 14 Desc. | Perimeter controls are acceptable. | |

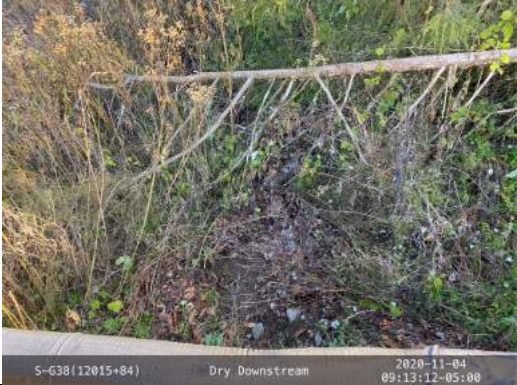
| <small>S-G38(12015+84) Dry Downstream 2020-11-04 09:13:12-05:00</small> | | <small>S-G38(12015+84) Dry Upstream 2020-11-04 09:13:33-05:00</small> | | | |
| Pic 7 Desc. | S-G38 is dry downstream. | | Pic 8 Desc. | S-G38 is dry upstream. | |

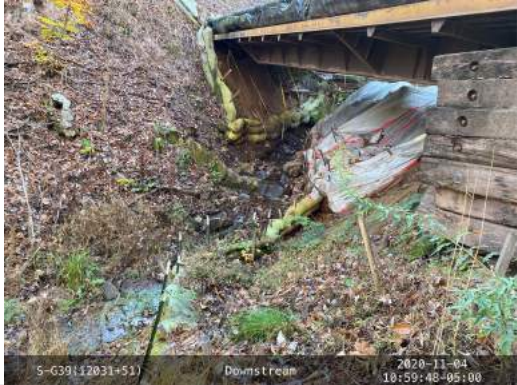
| <small>S-G39(12031+51) Downstream 2020-11-04 10:59:48-05:00</small> | | <small>S-G39(12031+51) GAS 2020-11-04 10:59:57-05:00</small> | | | |
| Pic 9 Desc. | Downstream S-G39 has stable banks and functioning ECDs surrounding it. There is no turbidity. | | Pic 10 Desc. | Downstream S-G39 has functioning ECDs surrounding it. There is no turbidity. | |

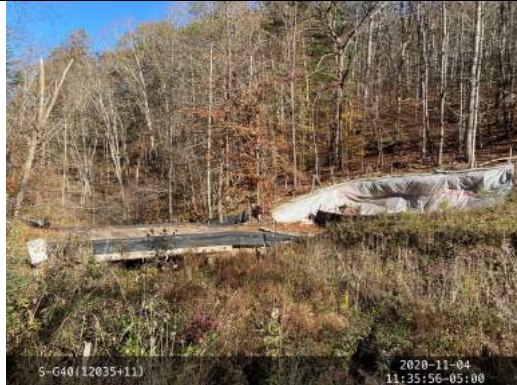
| <small>S-G40(12035+11) 2020-11-04 11:35:56-05:00</small> | | <small>S-MM15(12076+95) All surrounding acceptable 2020-11-04 12:44:40-05:00</small> | | | |

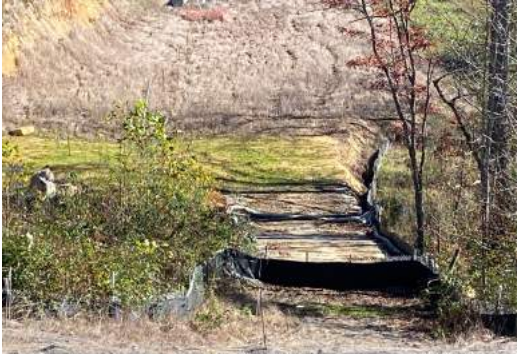
| <small>S-MM14(12086+56) All surrounding acceptable 2020-11-04 12:57:16-05:00</small> | | <small>CWC, 12093+00 All surrounding acceptable 2020-11-04 13:05:08-05:00</small> | | | |
| Pic 13 Desc. | S-MM14 has stable banks and acceptable surrounding ECDs. There is no turbidity. | | Pic 14 Desc. | This clean water crossing is in acceptable condition. | |

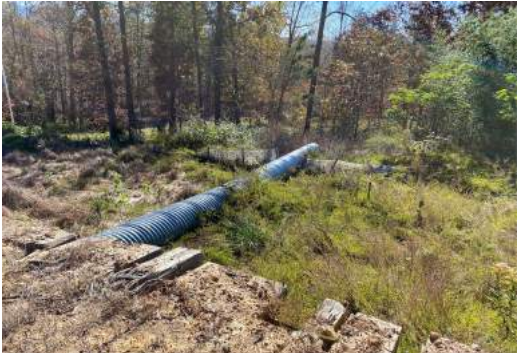
| <small>CWC, 12093+00 All surrounding acceptable 2020-11-04 13:05:12-05:00</small> | | <small>S-MM13(12098+44) All surrounding acceptable 2020-11-04 13:10:16-05:00</small> | | | |
| Pic 15 Desc. | This clean water crossing outlet is in acceptable condition. | | Pic 16 Desc. | S-MM13 has stable banks and acceptable surrounding ECDs. There is no turbidity. | |

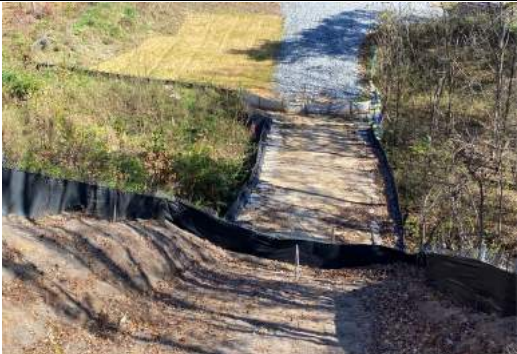
| <small>S-MM11(12101+57) All surrounding acceptable 2020-11-04 13:15:31-05:00</small> | | <small>12119+17, CIS All surrounding acceptable 2020-11-04 13:20:35-05:00</small> | | | |

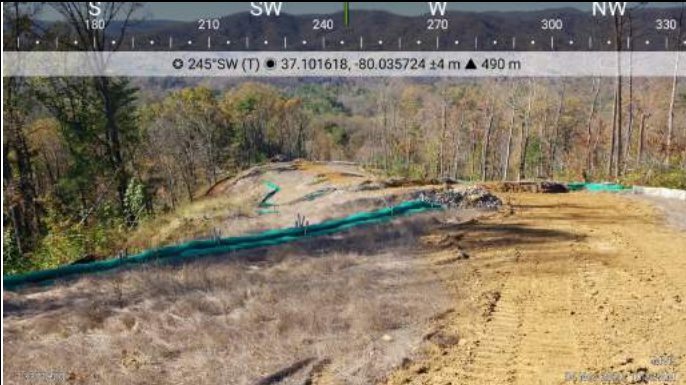
| Pic 13 Desc. | ROW Overview. Travel lane and Temporary Restoration. ECDs are functional. | | Pic 14 Desc. | ROW Overview. Travel lane and Temporary Restoration. ECDs are functional. | |

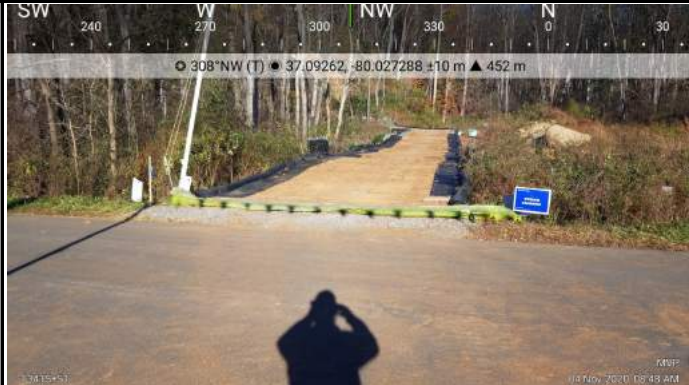
| Pic 15 Desc. | ROW Overview. Travel lane and Temporary Restoration. ECDs are functional. | | Pic 16 Desc. | Overview of Waterbody S-IJ1. ECDs are functional. | |

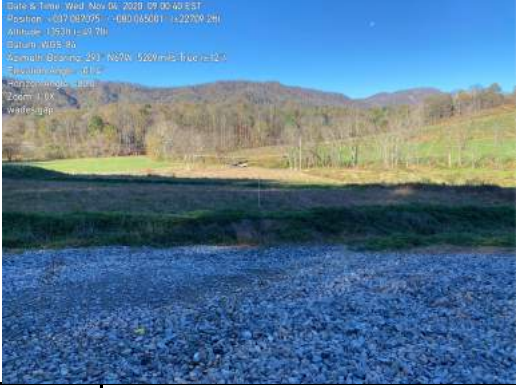
| Field Station# | 13315+00 | | Field Station# | 13310+00 | |

| Pic 1 Desc. | ROW stable with acceptable vegetative cover across LOD.I, temporary waterbars functioning acceptably. | | Pic 2 Desc. | ROW stable with acceptable vegetative cover across LOD. | |

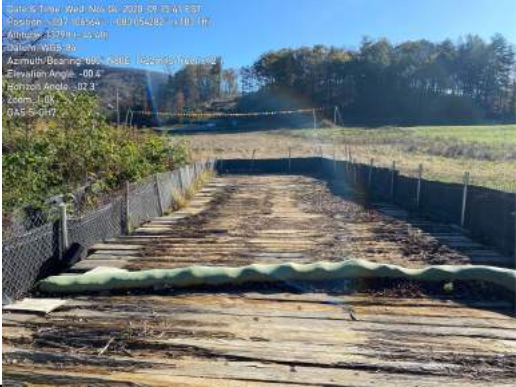
| Field Station# | 13410+50 | | Field Station# | 13309+09 | |

| Pic 3 Desc. | ROW stable with acceptable vegetative cover across LOD, bridge in acceptable condition at S-GH7. | | Pic 4 Desc. | S-GH7, upstream, no ROW impacts or changes noted at stream crossing. | |

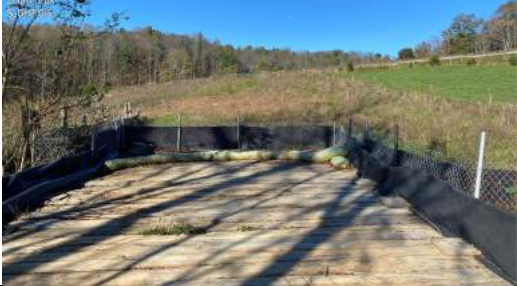
| Field Station# | 13309+09 | | Field Station# | 13306+00 | |

| Pic 7 Desc. | ROW stable with acceptable vegetative cover across LOD, bridge in acceptable condition at S-GH7. | | Pic 8 Desc. | ROW stable with acceptable vegetative cover across LOD. | |

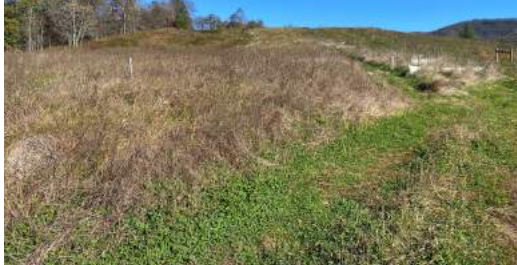
| Field Station# | 13306+00 | | Field Station# | 13300+00 | |

| Pic 9 Desc. | ROW stable with acceptable vegetative cover across LOD. | | Pic 10 Desc. | ROW stable with acceptable vegetative cover across LOD. | |

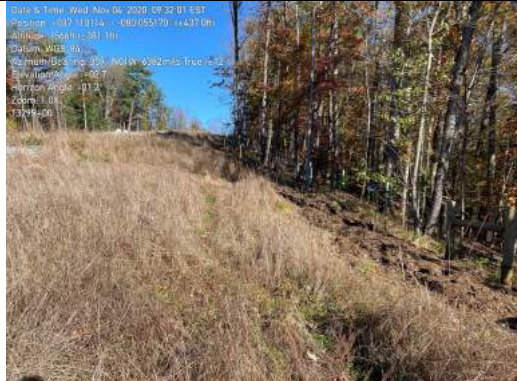
| Field Station# | 13295+00 | | Field Station# | 13290+00 | |

| Pic 11 Desc. | ROW stable with acceptable vegetative cover across LOD. | | Pic 12 Desc. | ROW stable with acceptable vegetative cover across LOD. | |

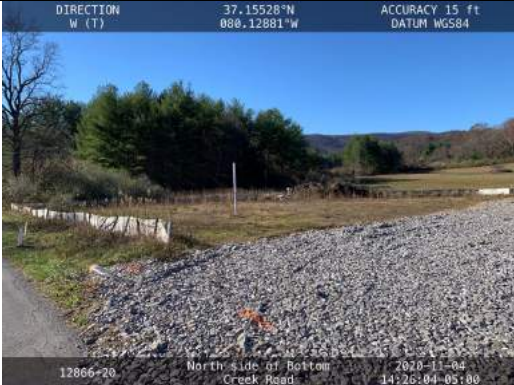
| Field Station# | 12866+20 | | Field Station# | 12866+50 | |

| Pic 1 Desc. | Bottom Creek Road crossing, facing west | | Pic 2 Desc. | Bottom Creek Road crossing, facing south | |

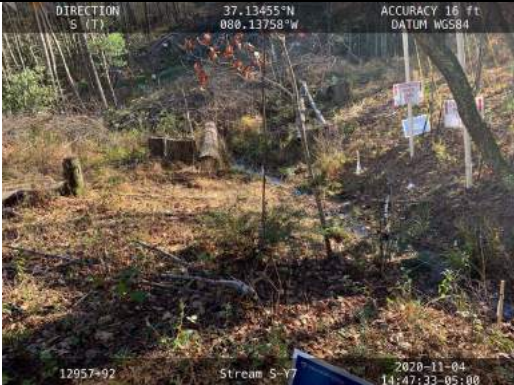
| Field Station# | 12957+92 | | Field Station# | 12958+78 | |

| Pic 3 Desc. | Stream S-Y7, facing south, downstream | | Pic 4 Desc. | Stream S-Y8, facing south, downstream | |

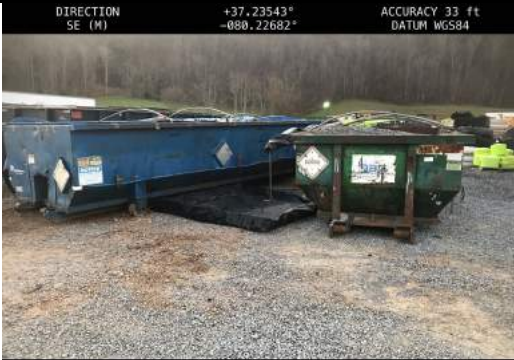
| <p>DIRECTION SE (M) +37.23543° -080.22682° ACCURACY 33 ft DATUM WGS84</p> <p>MVP-PY-006_110520 No deposits around hazardous waste 2020-11-05 06:58:38-05:00</p> | | <p>DIRECTION SE (M) +37.23556° -080.22664° ACCURACY 16 ft DATUM WGS84</p> <p>MVP-PY-006_110520 No loose trash around dumpsters 2020-11-05 06:58:59-05:00</p> | | | |

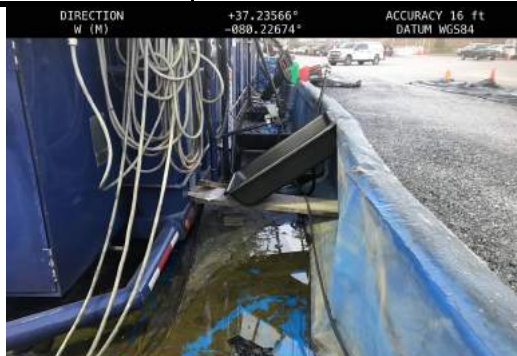
| <p>DIRECTION W (M) +37.23566° -080.22674° ACCURACY 16 ft DATUM WGS84</p> <p>MVP-PY-006_110520 Condition of containment & new ... 2020-11-05 07:00:59-05:00</p> | | <p>DIRECTION W (M) +37.23556° -080.22697° ACCURACY 33 ft DATUM WGS84</p> <p>MVP-PY-006_110520 Condition of containment 2020-11-05 07:01:29-05:00</p> | | | |
| Pic 11 Desc. | Blue Bulk Fuel tanks condition of containment with new drip pans. Looking W. | | Pic 12 Desc. | Off Road Fuel unit condition of containment. Free of stormwater. Looking W. | |

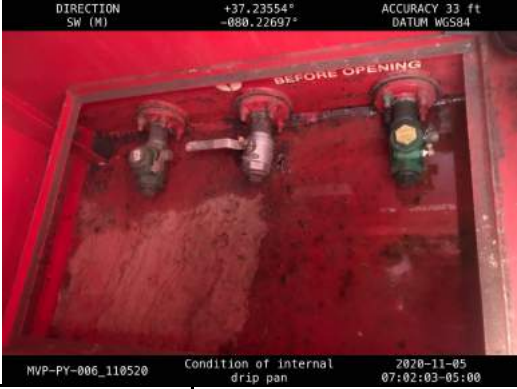
| Pic 13 Desc. | Off Road Fuel unit condition of internal drip pan. Looking SW. | | Pic 14 Desc. | Off Road Fuel unit no leaky internal fittings. Looking SW. | |

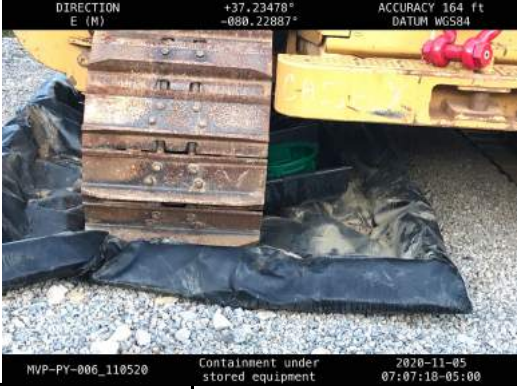
| Pic 15 Desc. | Condition of containment under stored equipment. Looking W. | | Pic 16 Desc. | Condition of containment under stored equipment. Looking SW. | |

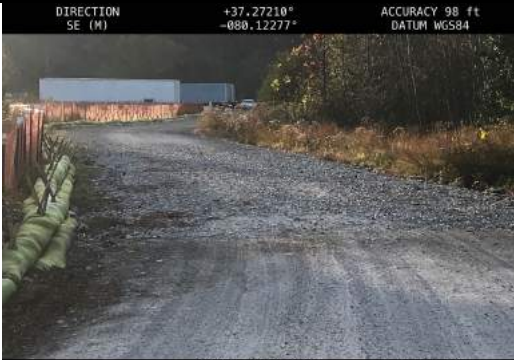
| Pic 1 Desc. | Condition of Rock entrance on center drive. No sediment on stone. Looking SE. | Pic 2 Desc. | Condition of containment under light plant. Free of stormwater. Looking SW. | | |

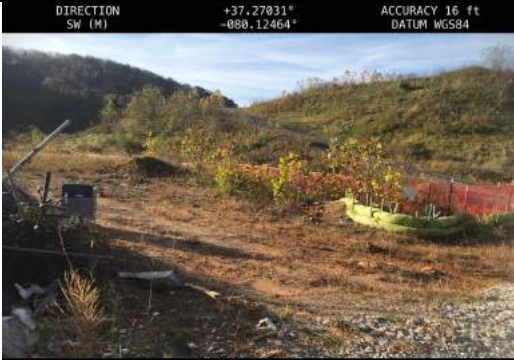
| Pic 3 Desc. | Landowner soil disturbance along compost filter sock and feature W-CV21B. Area not stabilized. No impacts. Looking SW. | Pic 4 Desc. | Landowner soil disturbance within 66' of feature W-CV21B. Area not stabilized. No impacts. Looking SW. | | |

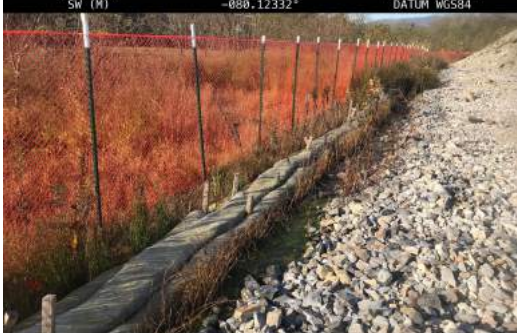
| MVP-LY-049_110520 | | Condition of CFS & safety fence 2020-11-05 08:41:00-05:00 | | MVP-LY-049_110520 | |
| Pic 12 Desc. | | Condition of compost filter sock and safety fence along south LOD. Looking SW. | | | |

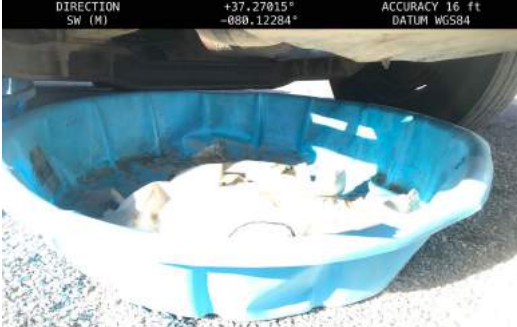
| MVP-LY-049_110520 Containment under stored vehicle 2020-11-05 09:20:36-05:00 | | MVP-LY-049_110520 Fuel can in containment 2020-11-05 09:23:19-05:00 | | | |

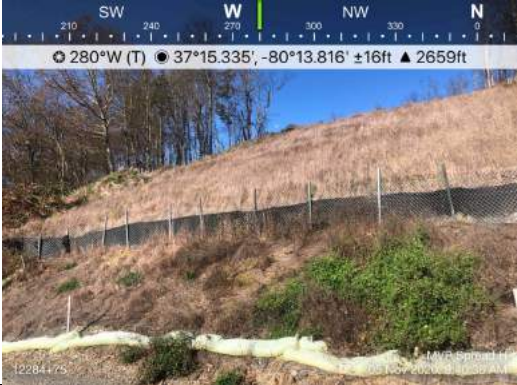
| Field Station# | 12284+75 | | Field Station# | 12296+50 | |

| Pic 7 Desc. | MVP-MN-276.03 crossing controls are installed and no maintenance is necessary. | | Pic 8 Desc. | GAS Reese "V" diversion berm is in good condition. | |

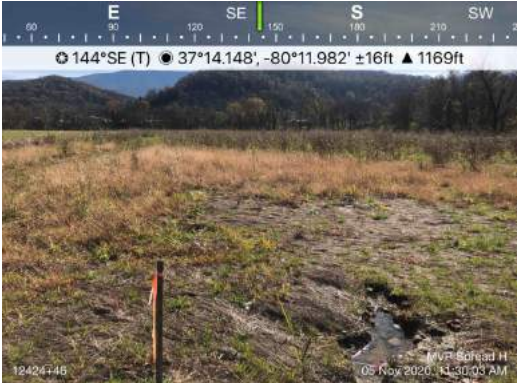
| Field Station# | 12424+46 | | Field Station# | 12438+50 | |

| Pic 15 Desc. | ROW conditions approaching the Roanoke River. ROW is well vegetated and no signs of accelerated erosion were observed. | | Pic 16 Desc. | Roanoke River and buffer area remain undisturbed and in good condition. | |

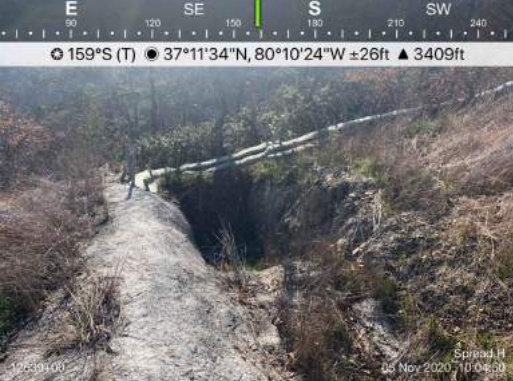
| Field Station# | 12638+99 | | Field Station# | 12639+00 | |

| Pic 1 Desc. | Temporary vegetation and erosion control blankets are in place and the ROW is in acceptable condition. | | Pic 2 Desc. | Waterbars and waterbar end treatments and sumps are in acceptable condition. | |

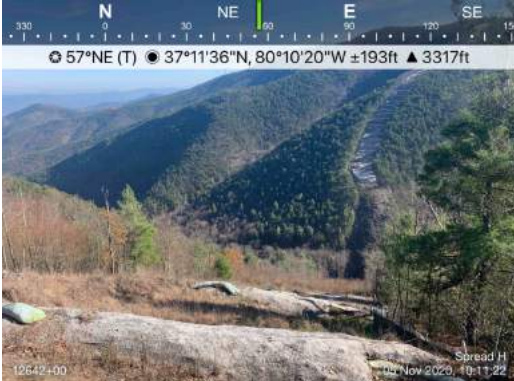
| Field Station# | 12642+00 | | Field Station# | 12681+00 | |

| Pic 3 Desc. | Temporary vegetation and erosion control blankets are in place and the ROW is in acceptable condition. | | Pic 4 Desc. | Super Silt fence is in acceptable condition. | |

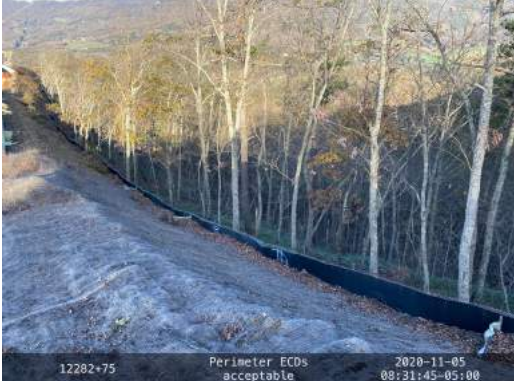
| Pic 1 Desc. | Ditch side perimeter ECDs are in acceptable condition. | | Pic 2 Desc. | Tree fell of SSF. Added to punch list and contractor notified. | |

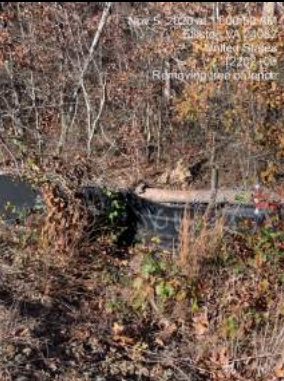
| Pic 3 Desc. | Contractor removed fallen tree and repaired fence. | | Pic 4 Desc. | Overview of stream and wetland bridge bridge and matting. All are in satisfactory condition. | |

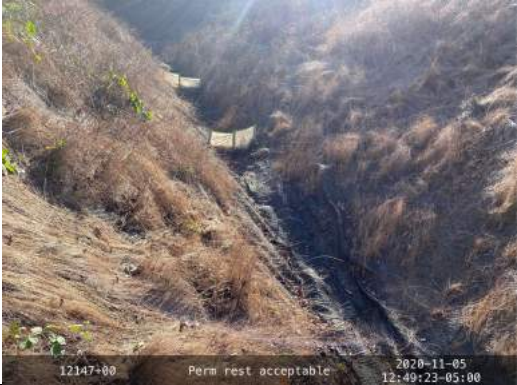
| Pic 7 Desc. | Permanent restoration is stable and ECDs are in satisfactory condition. | | Pic 8 Desc. | Permanent restoration is stable and ECDs are in satisfactory condition. | |

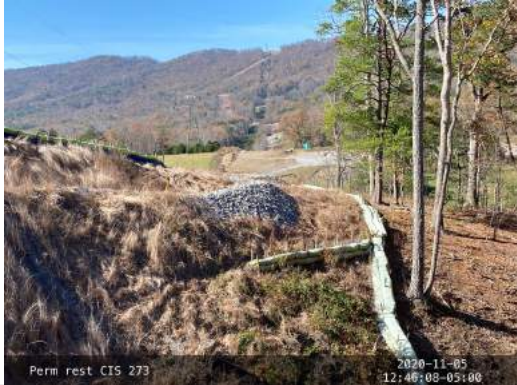
| Pic 9 Desc. | Permanent restoration is stable and ECDs are in satisfactory condition. | | Pic 10 Desc. | Stream banks are intact and streams display no turbidity. | |

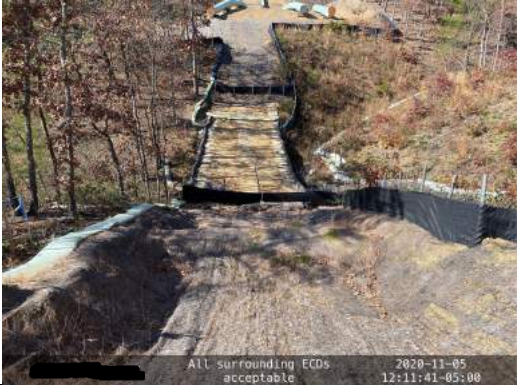
| Pic 13 Desc. | All surrounding ECDs at S-C24 are in acceptable condition. | | Pic 14 Desc. | S-C21 downstream has no turbidity and surrounding ECDs are in satisfactory condition. | |

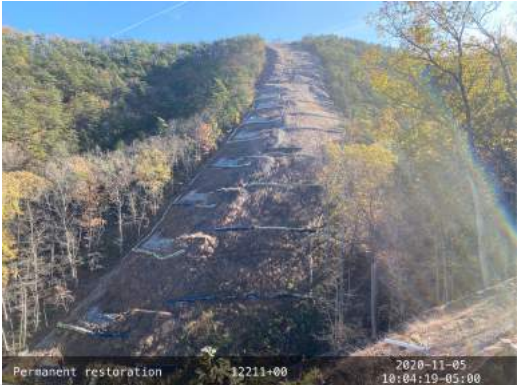
| Pic 15 Desc. | GAS side, permanent restoration rock weirs and earthen berms are in acceptable condition. | | Pic 16 Desc. | CIS, is stable with acceptable perimeter controls. | |
