## Visual Site Inspection Report

<b>Project Name</b>	H-600 Pipeline Spread H	<b>AFE</b>	124300138	<b>Spread</b>	H-600 Pipeline Spread H
<b>Contractor</b>	Precision			<b>Report #</b>	14570
<b>Inspector</b>	John Brcic			<b>Date/Time</b>	9/14/2020 11:57 AM
<b>Permit #</b>	TBD	<b>Inspection Type</b>	VA SWPP	<b>Station Begin</b>	12443+75
<b>State</b>	VA	<b>Inspection Area</b>	Partial	<b>Station End</b>	12544+06
<b>County</b>	Montgomery	<b>Ground</b>	Damp	<b>Temperature (°F)</b>	78.00
<b>Municipality</b>	N/A	<b>Weather</b>	Sunny	<b>Rain Gauge (in)</b>	0.00
				<b>Rain Accumulation Time (days)</b>	3.00

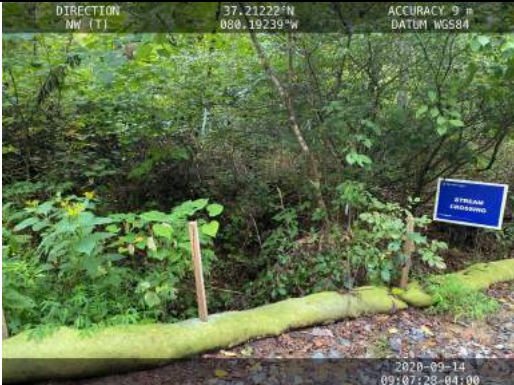
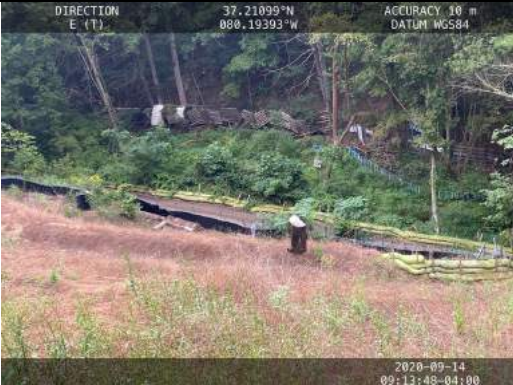
<b>GPS Location</b>	See photo		<b>GPS Location</b>	See photo	
<b>Field Station#</b>	12543+56		<b>Field Station#</b>	12543+00	
<b>Pic 3 Desc.</b>	Stream S-EF54, facing northwest from Yellow Finch Road, upstream		<b>Pic 4 Desc.</b>	Yellow Finch Road as viewed from slope on coming in side of road.

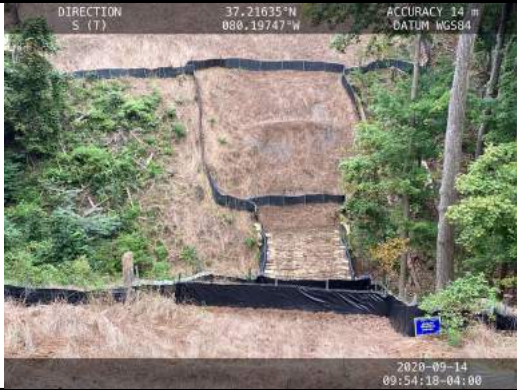
<b>GPS Location</b>	See photo	<b>GPS Location</b>	See photo		
<b>Field Station#</b>	12519+41	<b>Field Station#</b>	12506+00		
<b>Pic 9 Desc.</b>	Buffer zone of stream S-EF19 remains stable, ECDs in good repair.	<b>Pic 10 Desc.</b>	Slope on going away side of clean water diversion pipe remains stable.

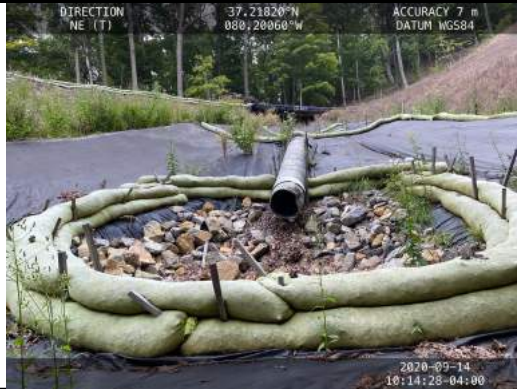
<b>GPS Location</b>	See photo	<b>GPS Location</b>	See photo		
<b>Field Station#</b>	12503+70	<b>Field Station#</b>	12486+00		
<b>Pic 11 Desc.</b>	Clean water diversion pipe outlet plunge pool in satisfactory condition.	<b>Pic 12 Desc.</b>	Perimeter controls in satisfactory condition between "pig parts" excavation site and MLV-28.

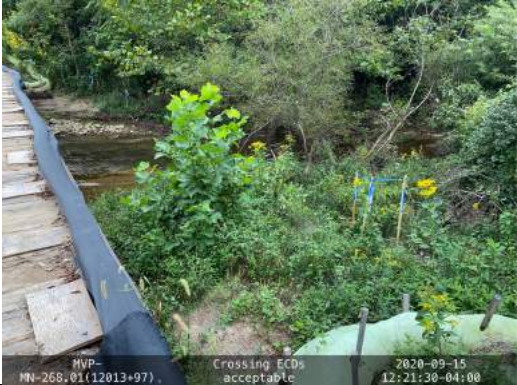
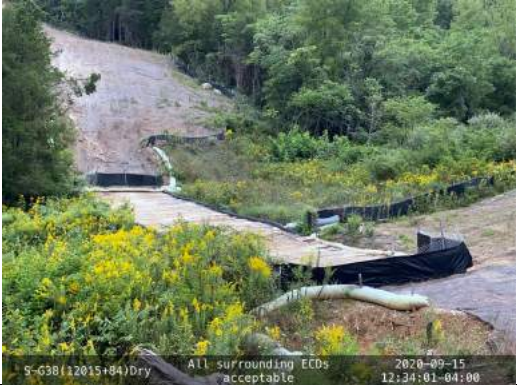
<b>GPS Location</b>	See photo GPS for location		<b>GPS Location</b>	See photo GPS for location	
<b>Field Station#</b>	12013+97		<b>Field Station#</b>	12015+84	
<b>Pic 13 Desc.</b>	All surrounding ECDs are in acceptable condition.		<b>Pic 14 Desc.</b>	All surrounding ECDs are in acceptable condition.

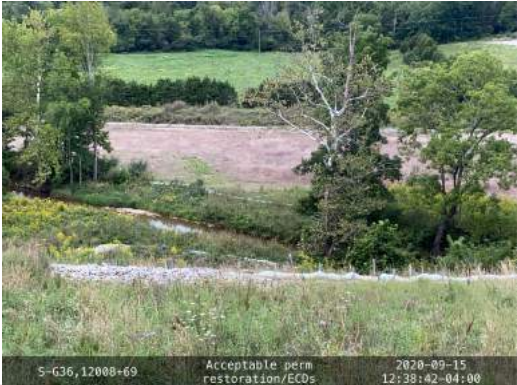
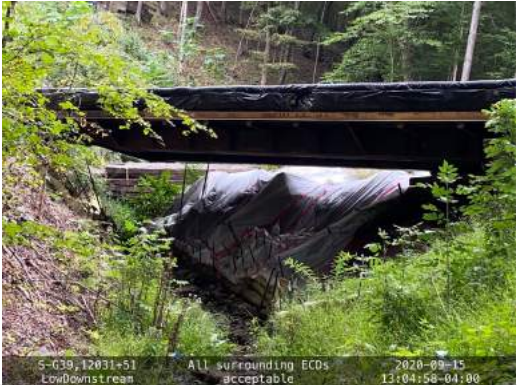
<b>GPS Location</b>	See photo GPS for location		<b>GPS Location</b>	See photo GPS for location	
<b>Field Station#</b>	12008+69		<b>Field Station#</b>	12031+51	
<b>Pic 15 Desc.</b>	Permanent restoration & stream bank ECDs are in acceptable condition.		<b>Pic 16 Desc.</b>	All surrounding ECDs are in acceptable condition.

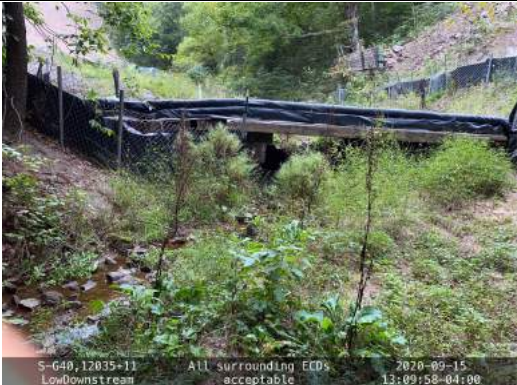
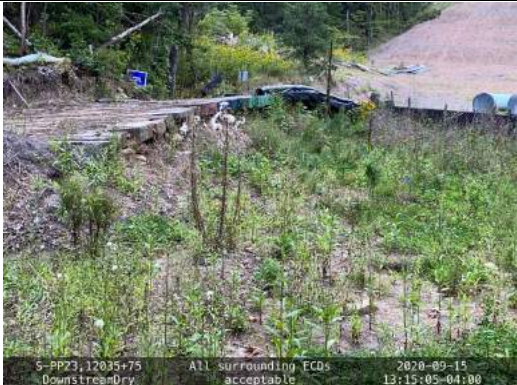
<b>Pic 17 Desc.</b>	All surrounding ECDs are in acceptable condition.		<b>Pic 18 Desc.</b>	All surrounding ECDs are in acceptable condition.

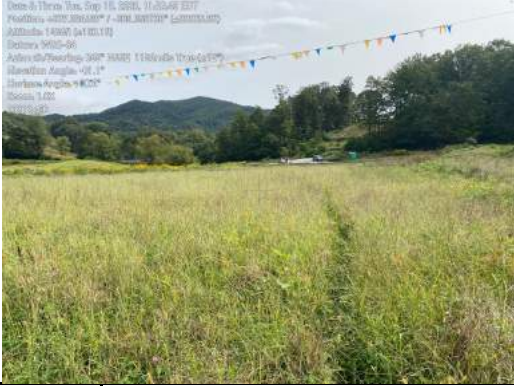
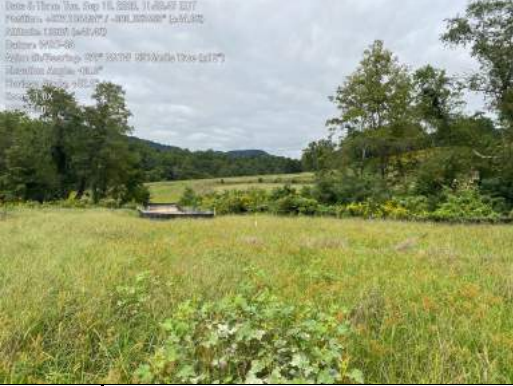
<b>GPS Location</b>	See photo for coordinates.		<b>GPS Location</b>	See photo for coordinates.	
<b>Field Station#</b>	13312+00		<b>Field Station#</b>	13312+00	
<b>Pic 1 Desc.</b>	ROW well vegetated across LOD.		<b>Pic 2 Desc.</b>	ROW well vegetated across LOD.

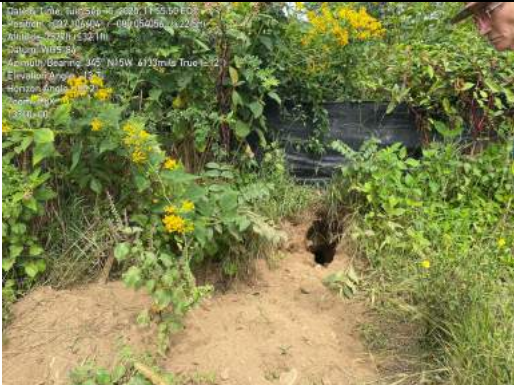
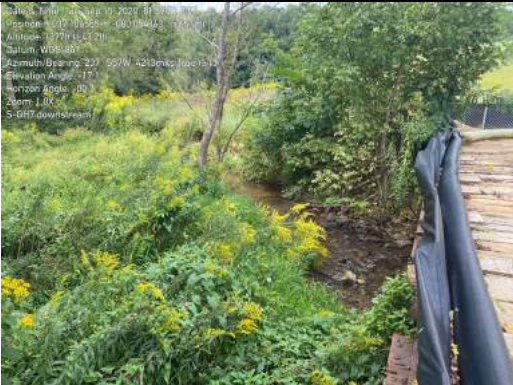
<b>GPS Location</b>	See photo for coordinates.		<b>GPS Location</b>	See photo for coordinates.	
<b>Field Station#</b>	13310+00		<b>Field Station#</b>	13309+15	
<b>Pic 3 Desc.</b>	Animal burrow near stream S-GH7 stream buffer.		<b>Pic 4 Desc.</b>	S-GH7, downstream, no changes noted to stream bed or banks.

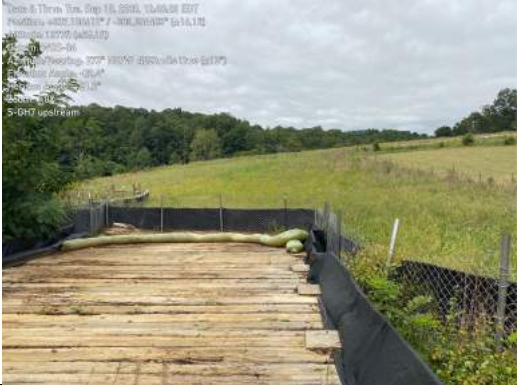
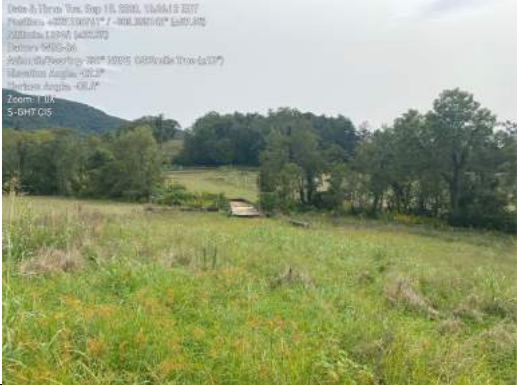
<b>GPS Location</b>	See photo for coordinates.		<b>GPS Location</b>	See photo for coordinates.	
<b>Field Station#</b>	13309+00		<b>Field Station#</b>	13306+00	
<b>Pic 7 Desc.</b>	CIS S-GH7, ROW stable with vegetative coverage noted across LOD.		<b>Pic 8 Desc.</b>	Good vegetative cover noted across LOD.

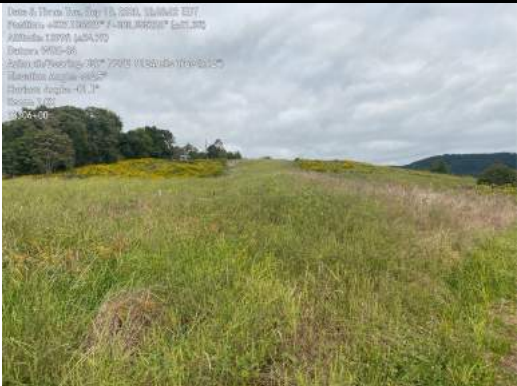
<b>GPS Location</b>	See photo for coordinates.		<b>GPS Location</b>	See photo for coordinates.	
<b>Field Station#</b>	13306+00		<b>Field Station#</b>	13306+00	
<b>Pic 9 Desc.</b>	Landowner crossing, stable and well vegetated.		<b>Pic 10 Desc.</b>	ROW stable with good vegetative cover across LOD.

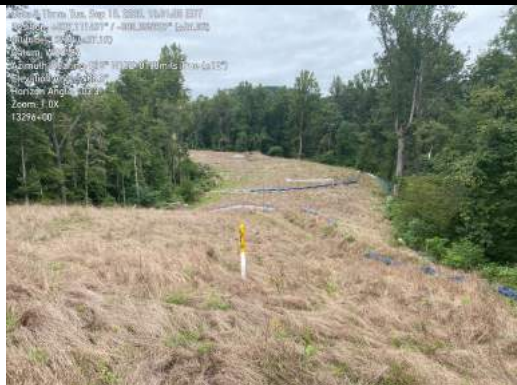
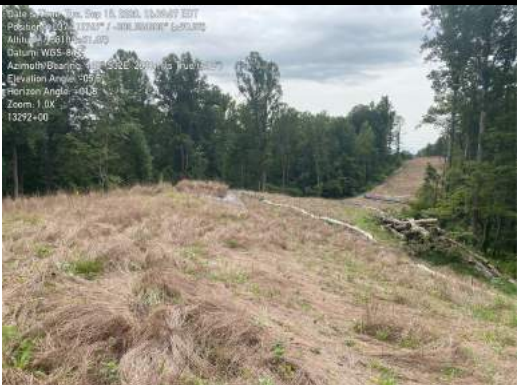
<b>GPS Location</b>	See photo for coordinates.		<b>GPS Location</b>	See photo for coordinates.	
<b>Field Station#</b>	13296+00		<b>Field Station#</b>	13292+00	
<b>Pic 11 Desc.</b>	Vegetative coverage noted across LOD with sparse coverage permanent species noted.		<b>Pic 12 Desc.</b>	Vegetative coverage noted across LOD with sparse coverage permanent species noted.

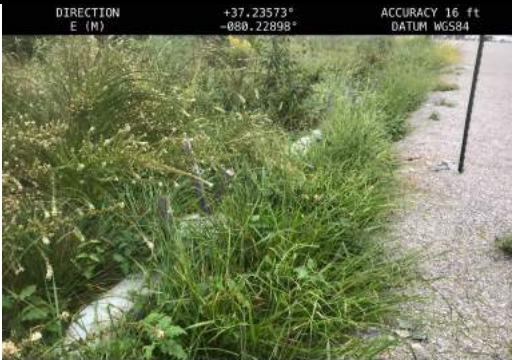
<p>DIRECTION E (M) +37.23573° -080.22898° ACCURACY 16 ft DATUM WGS84</p> <p>MVP-PY-006_091620 Condition of CFS along LOD 2020-09-16 07:53:01-04:00</p>

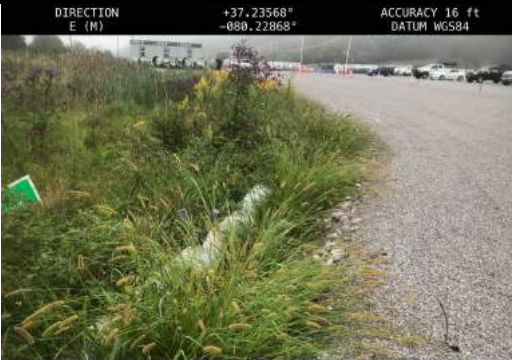
<p>DIRECTION E (M) +37.23568° -080.22868° ACCURACY 16 ft DATUM WGS84</p> <p>MVP-PY-006_091620 Condition of CFS along feature 2020-09-16 07:53:30-04:00</p>

<b>GPS Location</b>	MVP-PY-006 See photo for gps data	<b>GPS Location</b>	MVP-PY-006 See photo for gps data		
<b>Field Station#</b>	+0	<b>Field Station#</b>	+0		
<b>Pic 3 Desc.</b>	Condition of compost filter sock along North LOD. Looking E.	<b>Pic 4 Desc.</b>	Condition of compost filter sock along south edge of feature W-008. Looking E.

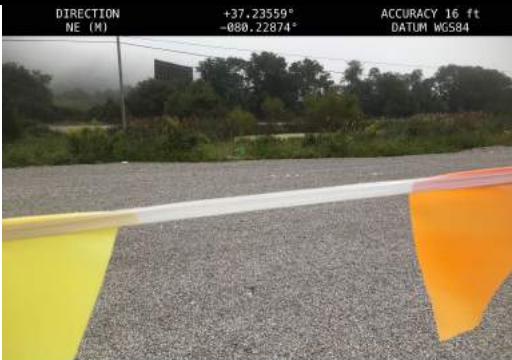
<p>DIRECTION NE (M) +37.23559° -080.22874° ACCURACY 16 ft DATUM WGS84</p> <p>MVP-PY-006_091620 Signage and buffer flagging for feature 2020-09-16 07:53:51-04:00</p>

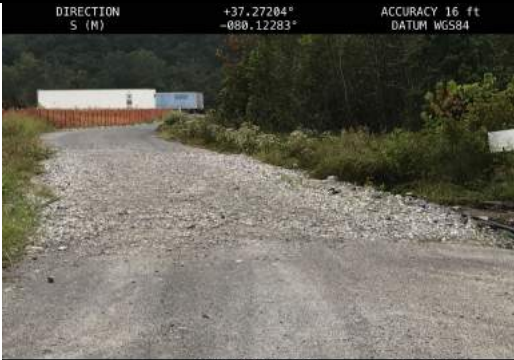
<p>DIRECTION S (N) +37.27284° -080.12283° ACCURACY 16 ft DATUM WGS84</p> <p>MVP-LY-049_091620 Condition of rock entrance 2020-09-16 08:20:27-04:00</p>

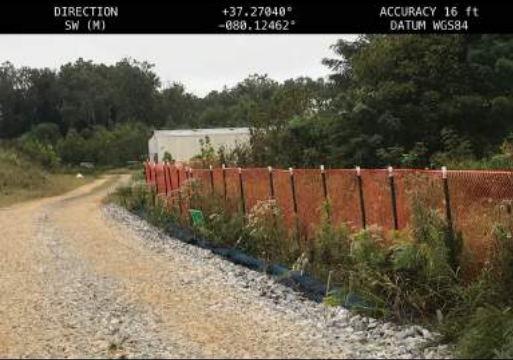
<p>DIRECTION SW (N) +37.27040° -080.12462° ACCURACY 16 ft DATUM WGS84</p> <p>MVP-LY-049_091620 2020-09-16 08:22:10-04:00</p>			
<b>GPS Location</b>	MVP-LY-049 See photo for gps data	<b>GPS Location</b>	MVP-LY-049 See photo for gps data		
<b>Field Station#</b>	+0	<b>Field Station#</b>	+0		
<b>Pic 1 Desc.</b>	Condition of rock entrance on center drive. No sediment on stone surface. Looking S.	<b>Pic 2 Desc.</b>	Condition of compost filter sock and safety fence along feature W-CV21A. Looking SW.

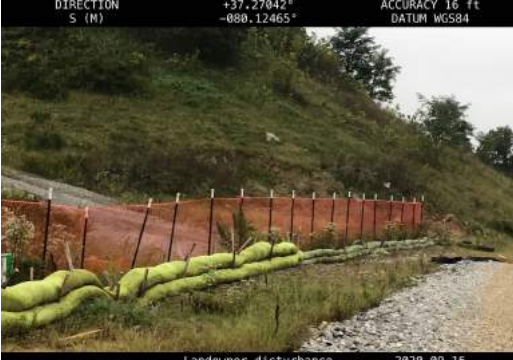
<p>DIRECTION S (N) +37.27042° -080.12465° ACCURACY 16 ft DATUM WGS84</p> <p>MVP-LY-049_091620 Landowner disturbance within 66' of feature 2020-09-16 08:22:30-04:00</p>

<b>GPS Location</b>	MVP-LY-049 See photo for gps data	<b>GPS Location</b>	MVP-LY-049 See photo for gps data		
<b>Field Station#</b>	+0	<b>Field Station#</b>	+0		
<b>Pic 3 Desc.</b>	Landowner disturbance along compost filter sock and feature W-CV21B. No impacts. Looking Sw	<b>Pic 4 Desc.</b>	Landowner disturbance within 66' of feature W-CV21B. No impacts. Looking SW.

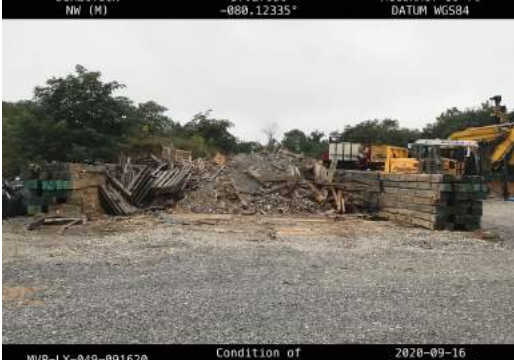
<p>DIRECTION NW (N) +37.27056° -080.12335° ACCURACY 16 ft DATUM WGS84</p> <p>MVP-LY-049-091620 Condition of temporary trash ... 2020-09-16 08:23:35-04:00</p>

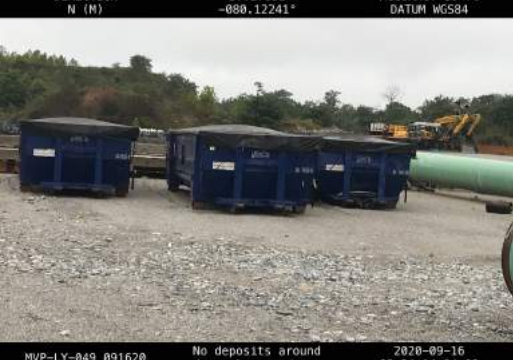
<p>DIRECTION N (N) +37.27052° -080.12241° ACCURACY 16 ft DATUM WGS84</p> <p>MVP-LY-049_091620 No deposits around hazardous waste ... 2020-09-16 08:24:14-04:00</p>			
<b>GPS Location</b>	MVP-LY-049 See photo for gps data	<b>GPS Location</b>	MVP-LY-049 See photo for gps data		
<b>Field Station#</b>	+0	<b>Field Station#</b>	+0		
<b>Pic 5 Desc.</b>	Condition of temporary trash transfer pit. Debris inside boundary of pit. Looking NW.	<b>Pic 6 Desc.</b>	No deposits around hazardous waste dumpsters. Looking NW.

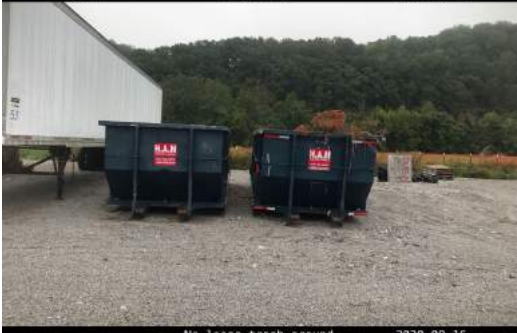
<p>DIRECTION SW (M) +37.27040° -080.12142° ACCURACY 16 ft DATUM WGS84</p> <p>MVP-LY-049_091620 No loose trash around south dumpsters 2020-09-16 08:24:58-04:00</p>

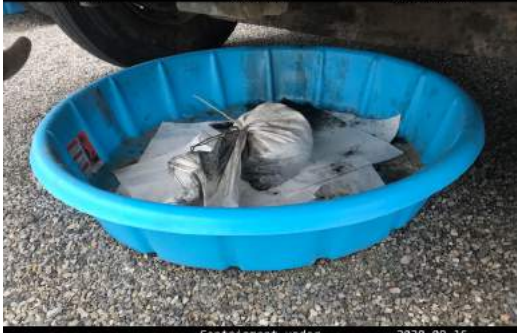
<p>DIRECTION SW (M) +37.27119° -080.12031° ACCURACY 16 ft DATUM WGS84</p> <p>MVP-LY-049_091620 Containment under stored vehicle 2020-09-16 08:26:02-04:00</p>			
<b>GPS Location</b>	MVP-LY-049 See photo for gps data		<b>GPS Location</b>	MVP-LY-049 See photo for gps data	
<b>Field Station#</b>	+0		<b>Field Station#</b>	+0	
<b>Pic 7 Desc.</b>	No loose trash around south dumpsters. Looking SE.		<b>Pic 8 Desc.</b>	Condition of containment under stored vehicle. Looking SE.

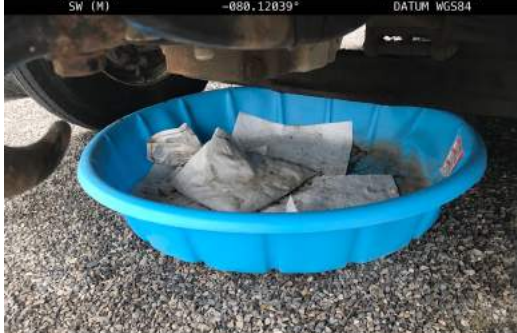
<p>DIRECTION SW (M) +37.27129° -080.12039° ACCURACY 16 ft DATUM WGS84</p> <p>MVP-LY-049_091620 Containment under stored vehicle 2020-09-16 08:26:13-04:00</p>

<b>GPS Location</b>	MVP-LY-049 See photo for gps data		<b>GPS Location</b>	MVP-LY-049 See photo for gps data	
<b>Field Station#</b>	+0		<b>Field Station#</b>	+0	
<b>Pic 9 Desc.</b>	Condition of containment under stored vehicle. Looking SE.		<b>Pic 10 Desc.</b>	Condition of containment under stored vehicle. Looking E.

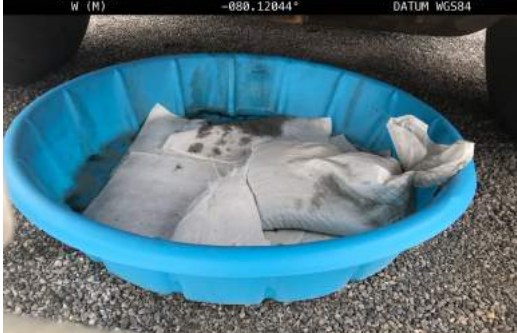
<p>DIRECTION W (M) +37.27141° -080.12044° ACCURACY 16 ft DATUM WGS84</p> <p>MVP-LY-049_091620 Containment under stored vehicle 2020-09-16 08:26:39-04:00</p>

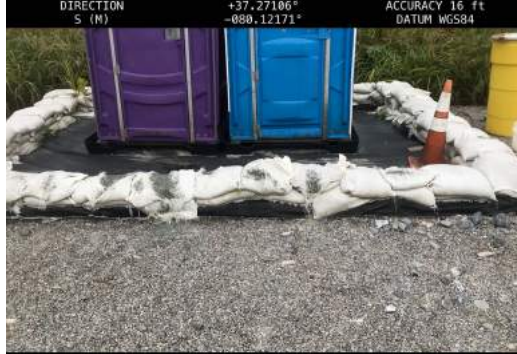
<p>DIRECTION S (M) +37.27106° -080.12171° ACCURACY 16 ft DATUM WGS84</p> <p>MVP-LY-049_091620 Condition of trays and containment 2020-09-16 08:29:29-04:00</p>

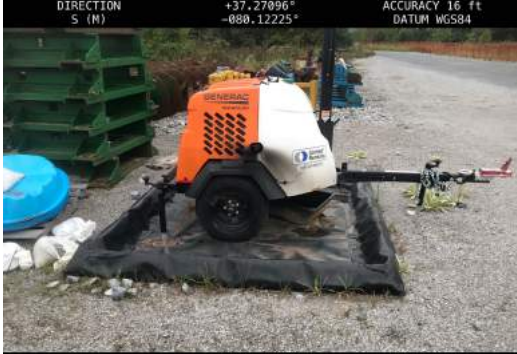
<p>DIRECTION S (M) +37.27096° -080.12225° ACCURACY 16 ft DATUM WGS84</p> <p>MVP-LY-049_091620 Condition of containment 2020-09-16 08:30:14-04:00</p>			
<b>GPS Location</b>	MVP-LY-049 See photo for gps data		<b>GPS Location</b>	MVP-LY-049 See photo for gps data	
<b>Field Station#</b>	+0		<b>Field Station#</b>	+0	
<b>Pic 11 Desc.</b>	Condition of trays and containment under toilets. Looking N.		<b>Pic 12 Desc.</b>	Condition of containment under light plant. Looking N.

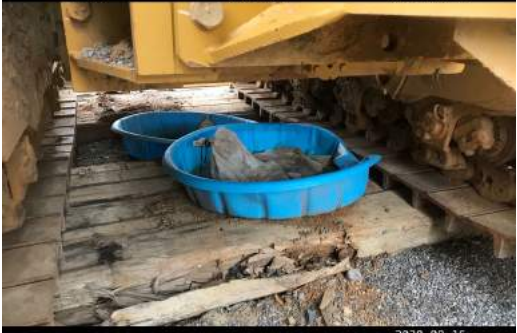
MVP-LY-049_091620 Containment under stored equipment 2020-09-16 08:31:47-04:00			
<b>GPS Location</b>	MVP-LY-049 See photo for gps data		<b>GPS Location</b>	MVP-LY-049 See photo for gps data	
<b>Field Station#</b>	+0		<b>Field Station#</b>	+0	
<b>Pic 13 Desc.</b>	condition of containment under stored equipment. Looking SW.		<b>Pic 14 Desc.</b>	Condition of containments under stored equipment. Looking E.	
DIRECTION SW (M) +37.27022° -080.12224° ACCURACY 16 ft DATUM WGS84   MVP-LY-049_091620 Containment under stored equipment 2020-09-16 08:32:04-04:00		DIRECTION S (M) +37.26989° -080.12307° ACCURACY 16 ft DATUM WGS84   MVP-LY-049_091620 Containments under stored equipment 2020-09-16 08:33:14-04:00

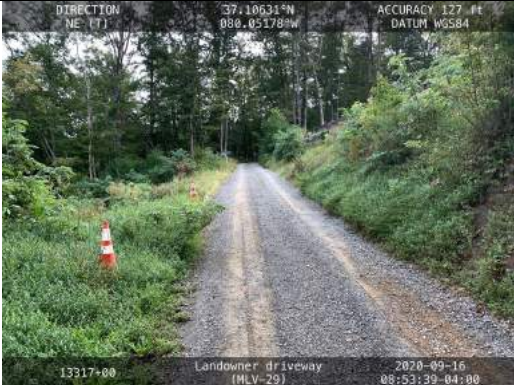
<b>GPS Location</b>	See photo for gps location data.		<b>GPS Location</b>	See photo for gps location data.	
<b>Field Station#</b>	13317+00		<b>Field Station#</b>	13321+47	
<b>Pic 1 Desc.</b>	Photo shows the landowner driveway and proposed MLV-29.		<b>Pic 2 Desc.</b>	Photo shows stream S-GH15 downstream from the bridge.

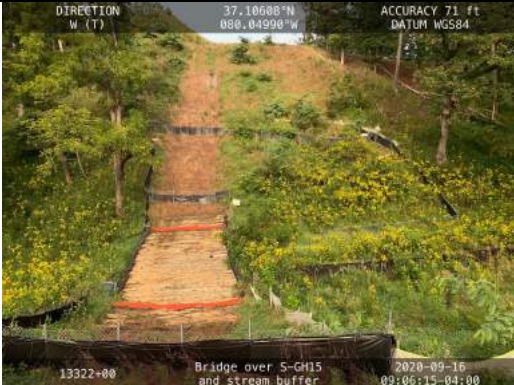
<b>GPS Location</b>	See photo for gps location data.		<b>GPS Location</b>	See photo for gps location data.	
<b>Field Station#</b>	13322+00		<b>Field Station#</b>	13325+20	
<b>Pic 3 Desc.</b>	Photo shows the bridge over stream S-GH15 and adjacent stream buffer.		<b>Pic 4 Desc.</b>	Photo shows the bridge over stream S-GH14.

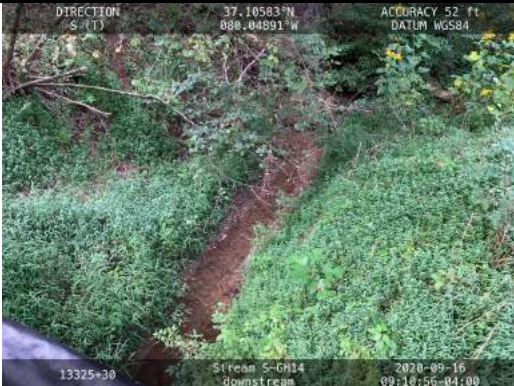
<b>Pic 5 Desc.</b>	Photo shows stream S-GH14 downstream from the bridge.		<b>Pic 6 Desc.</b>	Photo shows the bridge over stream S-GH11 and adjacent stream buffer.

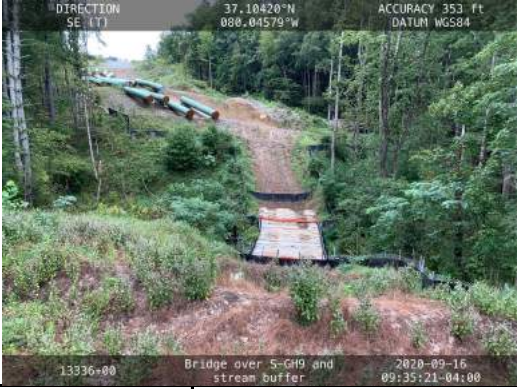
<b>GPS Location</b>	See photo for gps location data.		<b>GPS Location</b>	See photo for gps location data.	
<b>Field Station#</b>	13336+00		<b>Field Station#</b>	13337+00	
<b>Pic 7 Desc.</b>	Photo shows the bridge over stream S-GH9 and adjacent stream buffer.		<b>Pic 8 Desc.</b>	Photo shows the bridge over stream S-GH9.

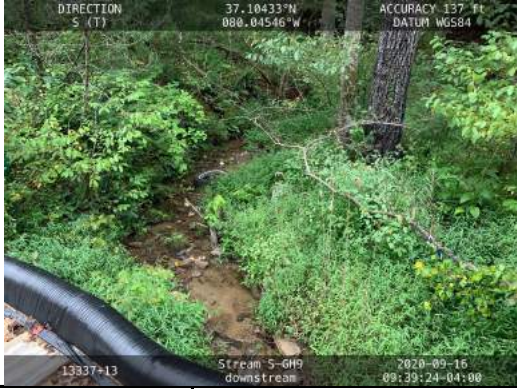
<b>GPS Location</b>	See photo for gps location data.		<b>GPS Location</b>	See photo for gps location data.	
<b>Field Station#</b>	13337+13		<b>Field Station#</b>	13346+00	
<b>Pic 9 Desc.</b>	Photo shows stream S-GH9 downstream from the bridge.		<b>Pic 10 Desc.</b>	Photo shows the clean water outlet structure.

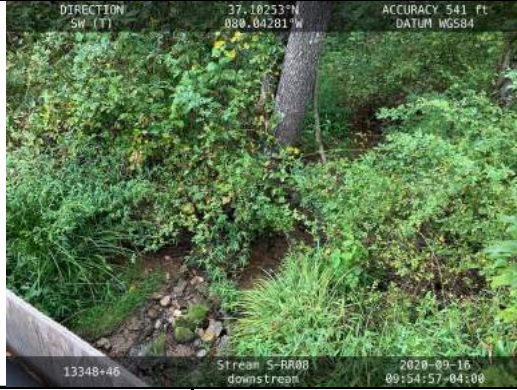
<b>Pic 11 Desc.</b>	Photo shows stream S-RR08 downstream from the bridge.		<b>Pic 12 Desc.</b>	Photo shows the bridge over stream S-RR09 and adjacent stream buffer.

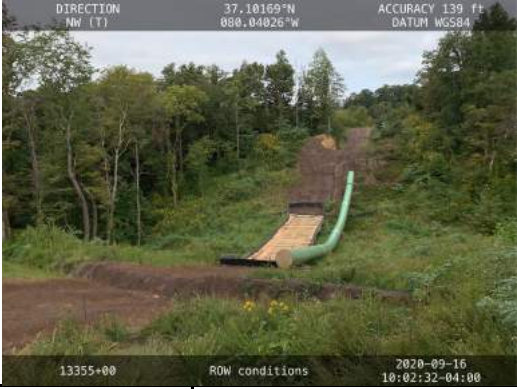
<b>GPS Location</b>	See photo for gps location data.		<b>GPS Location</b>	See photo for gps location data.	
<b>Field Station#</b>	13355+00		<b>Field Station#</b>	13358+00	
<b>Pic 13 Desc.</b>	Photo shows the ROW condition from about 13355+00 to 13353+00.		<b>Pic 14 Desc.</b>	Photo shows the bridge over stream S-RR11 and adjacent stream buffer.

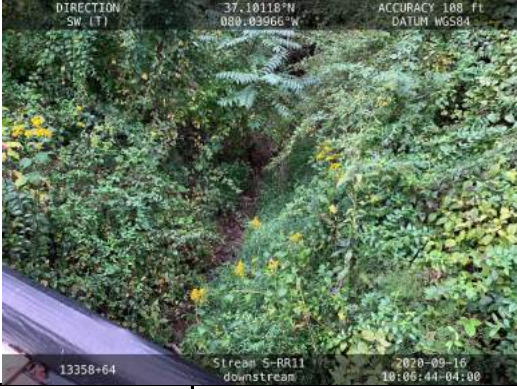
<b>GPS Location</b>	See photo for gps location data.		<b>GPS Location</b>	See photo for gps location data.	
<b>Field Station#</b>	13358+64		<b>Field Station#</b>	13375+00	
<b>Pic 15 Desc.</b>	Photo shows stream S-RR11 downstream from the bridge.		<b>Pic 16 Desc.</b>	Photo shows the ROW condition from about 13375+00 to 13385+00.

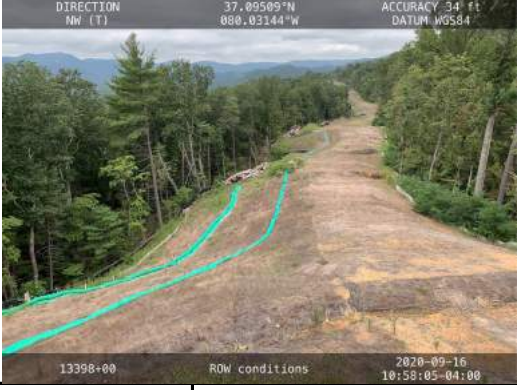
<b>Field Station#</b>	13398+00		<b>Field Station#</b>	13413+00	
<b>Pic 17 Desc.</b>	Photo shows the ROW condition from about 13385+00 to 13398+00.		<b>Pic 18 Desc.</b>	Photo shows stream S-IJ1 downstream from the bridge.

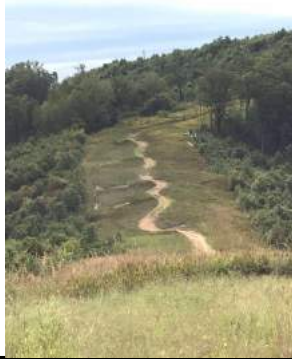
<b>GPS Location</b>	0000		<b>GPS Location</b>	0000	
<b>Field Station#</b>	13436+36		<b>Field Station#</b>	13440+00	
<b>Pic 1 Desc.</b>	Vegetation observation photo		<b>Pic 2 Desc.</b>	Vegetation photo and showing travel lane where land owners continue traveling the row

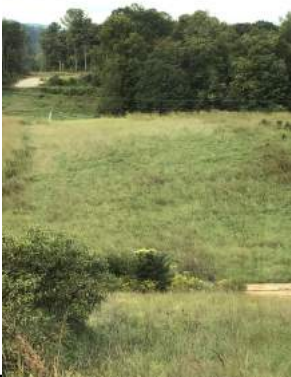
<b>GPS Location</b>	0000		<b>GPS Location</b>	000	
<b>Field Station#</b>	13574+00		<b>Field Station#</b>	13541+89	
<b>Pic 3 Desc.</b>	Vegetation observation photo		<b>Pic 4 Desc.</b>	Photo taken during light rain events Thursday	
Insert image here			Insert image here		
<b>GPS Location</b>			<b>GPS Location</b>		
<b>Field Station#</b>			<b>Field Station#</b>		
<b>Pic 5 Desc.</b>			<b>Pic 6 Desc.</b>

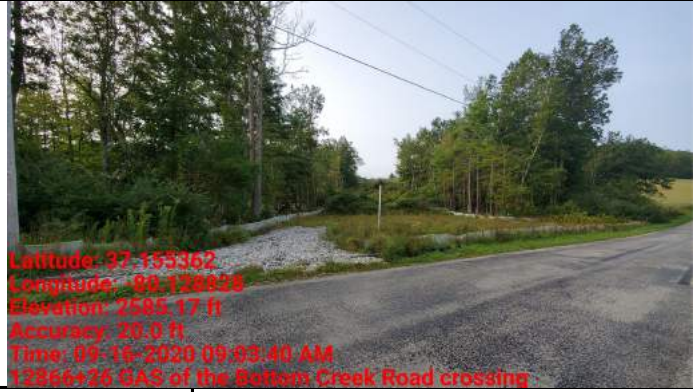
<p>Latitude: 37.155362 Longitude: -80.128826 Elevation: 2585.17 ft Accuracy: 20.0 ft Time: 09-16-2020 09:03:40 AM 12866+26 GAS of the Bottom Creek Road crossing</p>

<p>Latitude: 37.155218 Longitude: -80.128826 Elevation: 2533.3 ft Accuracy: 12.3 ft Time: 09-16-2020 09:04:45 AM 12866+26 CIS of the Bottom Creek Road crossing</p>			
<b>GPS Location</b>	See pic for GPS location		<b>GPS Location</b>	See pic for GPS location	
<b>Field Station#</b>	12866+26		<b>Field Station#</b>	12866+26	
<b>Pic 1 Desc.</b>	GAS of the Bottom Creek Road crossing.		<b>Pic 2 Desc.</b>	CIS of the Bottom Creek Road crossing.

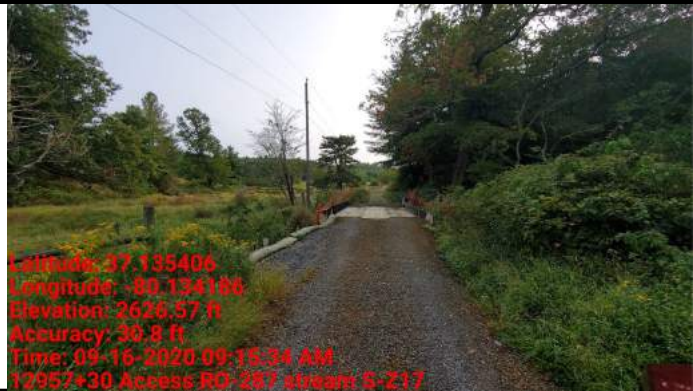
<p>Latitude: 37.135406 Longitude: -80.134186 Elevation: 2626.37 ft Accuracy: 30.8 ft Time: 09-16-2020 09:15:34 AM 12957+30 Access RO-287 stream S-Z17</p>

<b>GPS Location</b>	See pic for GPS location		<b>GPS Location</b>	See pic for GPS location	
<b>Field Station#</b>	12957+30		<b>Field Station#</b>	12957+30	
<b>Pic 3 Desc.</b>	Access road RO-287 at stream crossing S-Z17.		<b>Pic 4 Desc.</b>	Access road RO-287 at stream crossing S-Z16.

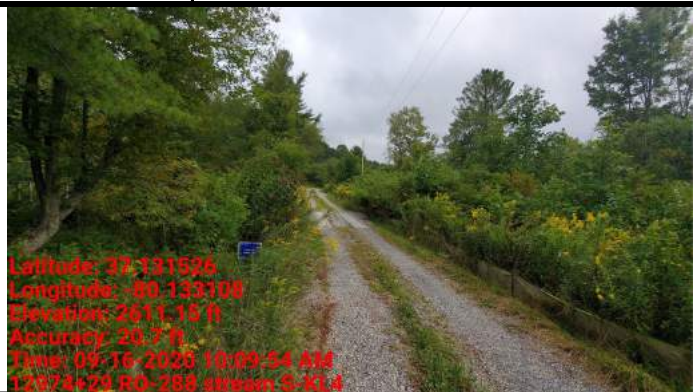
<p>Latitude: 37.131526 Longitude: -80.133108 Elevation: 2611.15 ft Accuracy: 20.7 ft Time: 09-16-2020 10:09:54 AM 12974+29 RO-288 stream S-KL4</p>

<p>Latitude: 37.132473 Longitude: -80.13204 Elevation: 2588.22 ft Accuracy: 19.8 ft Time: 09-16-2020 10:12:43 AM 12974+29 RO-288 stream S-Q20</p>			
<b>GPS Location</b>	See pic for GPS location		<b>GPS Location</b>	See pic for GPS location	
<b>Field Station#</b>	12974+29		<b>Field Station#</b>	12974+29	
<b>Pic 5 Desc.</b>	Access road RO-288 at stream crossing S-KL4		<b>Pic 6 Desc.</b>	Access road RO-288 at stream crossing S-Q20.

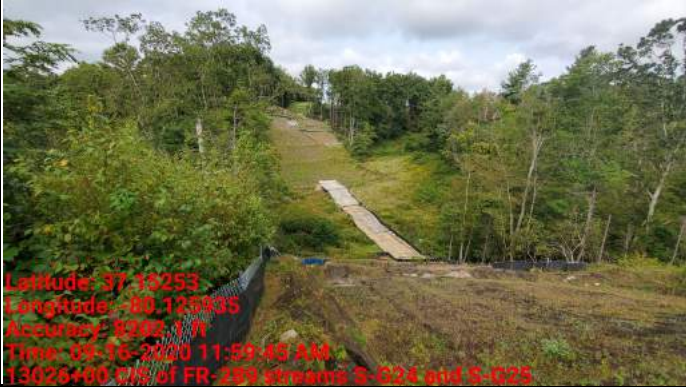
<p>Latitude: 37.18253 Longitude: -80.125935 Accuracy: 8.295 ft Time: 09-16-2020 11:59:49 AM 13026+00 G/L of FR-290 streams S-G24 and S-G25</p>

<p>Latitude: 37.127767 Longitude: -80.117629 Elevation: 2729.56 ft Accuracy: 14.8 ft Time: 09-16-2020 12:11:39 PM 13040+00 GAS of FR-290 stream S-H1</p>		
GPS Location	See pic for GPS location		GPS Location	See pic for GPS location	
Field Station#	13026+00		Field Station#	13040+00	
Pic 13 Desc.	Streams S-G24 and S-G25 from the GAS.		Pic 14 Desc.	Stream S-H1 from the CIS.

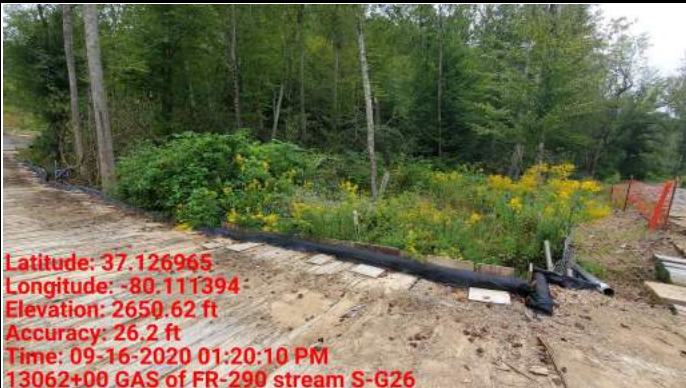
<p>Latitude: 37.126965 Longitude: -80.111394 Elevation: 2650.62 ft Accuracy: 26.2 ft Time: 09-16-2020 01:20:10 PM 13062+00 GAS of FR-290 stream S-G26</p>

GPS Location	See pic for GPS location		GPS Location	See pic for GPS location	
Field Station#	13062+00		Field Station#	13063+00	
Pic 15 Desc.	Stream S-G26 on the GAS of FR-290.		Pic 16 Desc.	Stream S-G27 on the GAS of FR-290.

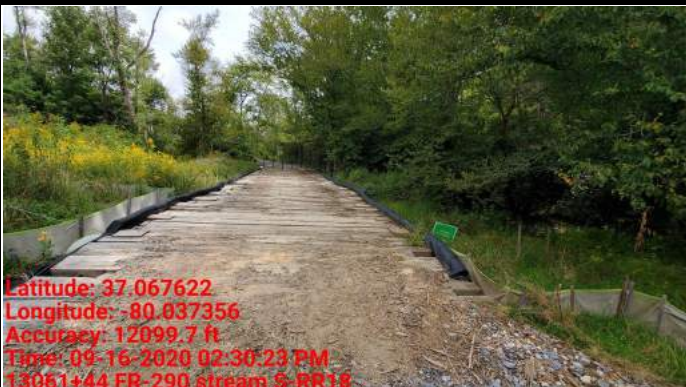
<p>Latitude: 37.067622 Longitude: -80.037356 Accuracy: 12099.7 ft Time: 09-16-2020 02:30:23 PM 13061+44 FR-290 stream S-RR18</p>

<p>Latitude: 37.123892 Longitude: -80.115505 Elevation: 2602.03 ft Accuracy: 21.0 ft Time: 09-16-2020 02:32:08 PM 13061+44 FR-290 stream S-RR16</p>		
GPS Location	See pic for GPS location		GPS Location	See pic for GPS location	
Field Station#	13061+44		Field Station#	13061+44	
Pic 17 Desc.	Stream S-RR18 on access road FR-290		Pic 18 Desc.	Stream S-RR16 on access road FR-290.

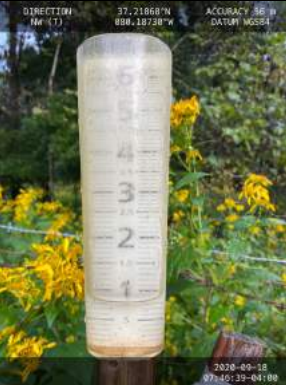
<b>GPS Location</b>	See photo		<b>GPS Location</b>	See photo	
<b>Field Station#</b>	12543+56		<b>Field Station#</b>	12543+56	
<b>Pic 1 Desc.</b>	There was 1.0 inches of precipitation in the rain gauge at Yellow Finch Road this morning.		<b>Pic 2 Desc.</b>	Stream S-KL32, facing northwest Yellow Finch Road, downstream

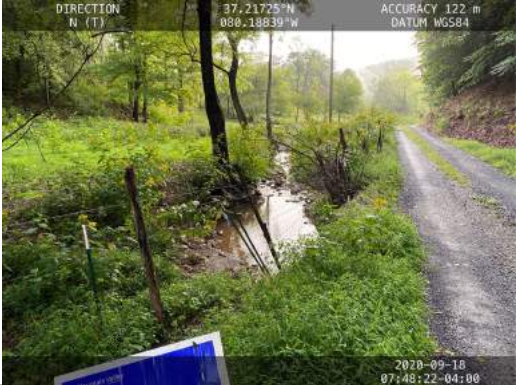
<b>GPS Location</b>	See photo		<b>GPS Location</b>	See photo	
<b>Field Station#</b>	12543+56		<b>Field Station#</b>	12543+56	
<b>Pic 3 Desc.</b>	Stream S-EF20b, facing north from Yellow Finch Road, upstream		<b>Pic 4 Desc.</b>	Stream S-EF54, facing northwest, upstream

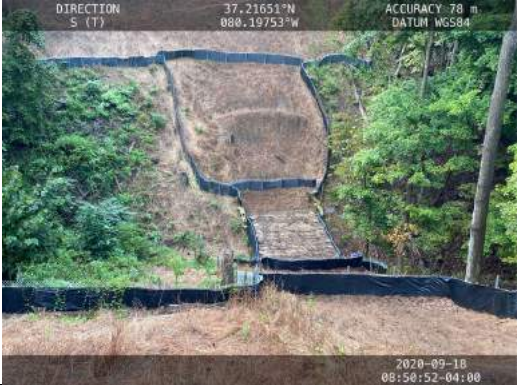
<b>GPS Location</b>	See photo		<b>GPS Location</b>	See photo	
<b>Field Station#</b>	12519+41		<b>Field Station#</b>	12522+00	
<b>Pic 13 Desc.</b>	Buffer zone of stream S-EF19 remains stable, ECDs in satisfactory condition.		<b>Pic 14 Desc.</b>	The slope on the going away side of stream S-EF19 remains stable.

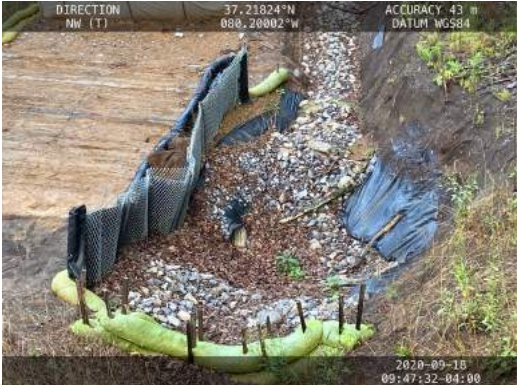
<b>GPS Location</b>	See photo		<b>GPS Location</b>	See photo	
<b>Field Station#</b>	12503+70		<b>Field Station#</b>	12503+70	
<b>Pic 15 Desc.</b>	This clean water diversion pipe inlet is in satisfactory condition and free of sediment.		<b>Pic 16 Desc.</b>	The clean water diversion pipe and outlet are in good repair and functioning properly.

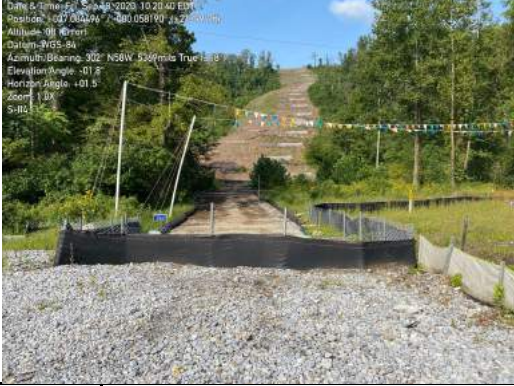
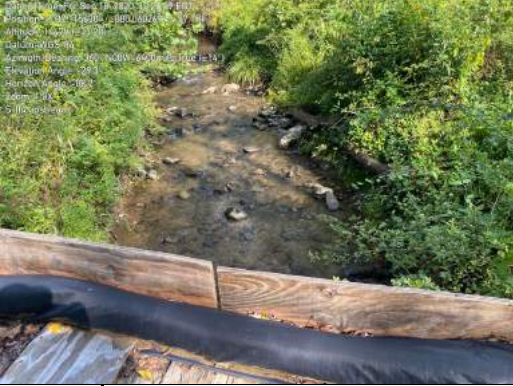
<b>GPS Location</b>	See photo for coordinates		<b>GPS Location</b>	See photo for coordinates	
<b>Field Station#</b>	13261+00		<b>Field Station#</b>	13260+60	
<b>Pic 1 Desc.</b>	S-II4, ECDs functioning acceptably.		<b>Pic 2 Desc.</b>	S-II4, upstream, no changes noted, no impacts noted.

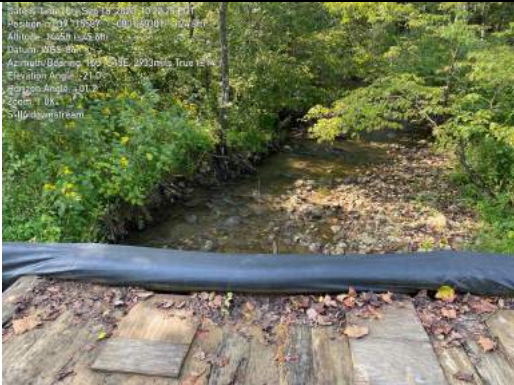
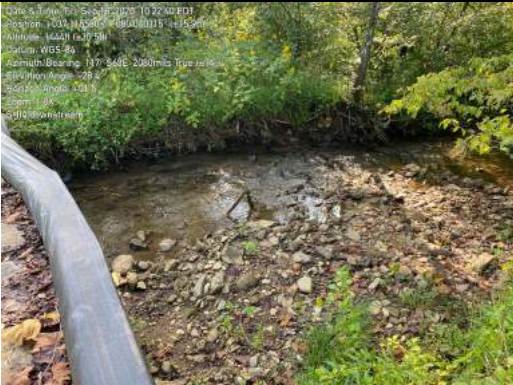
<b>GPS Location</b>	See photo for coordinates		<b>GPS Location</b>	See photo for coordinates	
<b>Field Station#</b>	13260+60		<b>Field Station#</b>	13260+60	
<b>Pic 3 Desc.</b>	S-II4, downstream, no changes noted, no impacts noted.		<b>Pic 4 Desc.</b>	S-II4, downstream, no changes noted, no impacts noted.

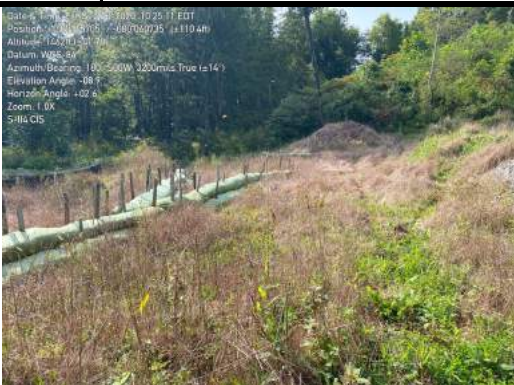
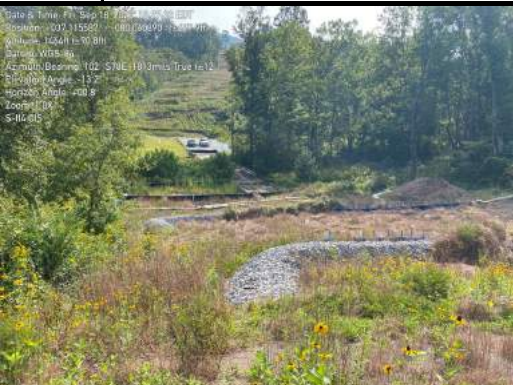
<b>GPS Location</b>	See photo for coordinates		<b>GPS Location</b>	See photo for coordinates	
<b>Field Station#</b>	13258+00		<b>Field Station#</b>	13257+50	
<b>Pic 5 Desc.</b>	ROW stabilized.		<b>Pic 6 Desc.</b>	Restored ROW stable with vegetative cover across LOD.

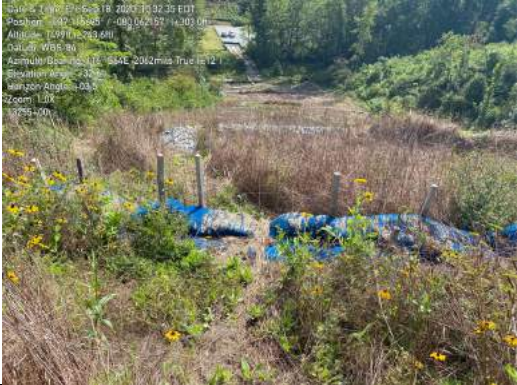
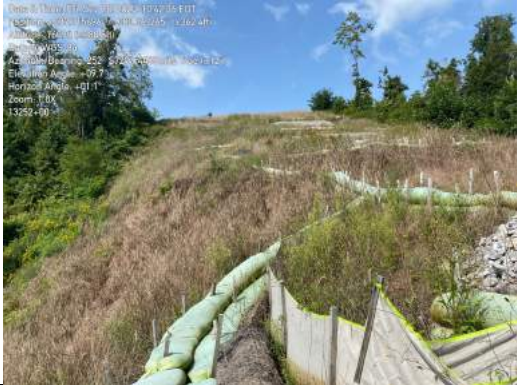
<b>GPS Location</b>	See photo for coordinates	<b>GPS Location</b>	See photo for coordinates		
<b>Field Station#</b>	13255+00	<b>Field Station#</b>	13252+00		
<b>Pic 7 Desc.</b>	Restored ROW stable with vegetative cover across LOD.	<b>Pic 8 Desc.</b>	Restored ROW stable with vegetative cover across LOD.

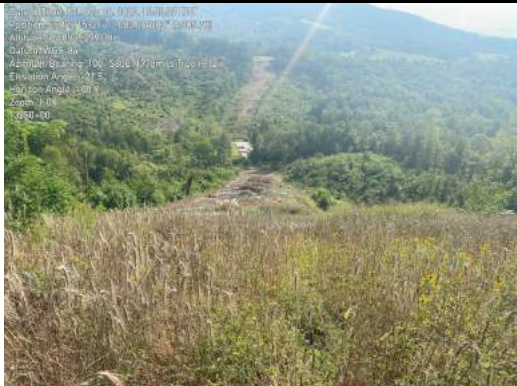
<b>GPS Location</b>	See photo for coordinates	<b>GPS Location</b>	See photo for coordinates		
<b>Field Station#</b>	13250+00	<b>Field Station#</b>	13250+00		
<b>Pic 9 Desc.</b>	Restored ROW stable with vegetative cover across LOD.	<b>Pic 10 Desc.</b>	Restored ROW stable with vegetative cover across LOD.

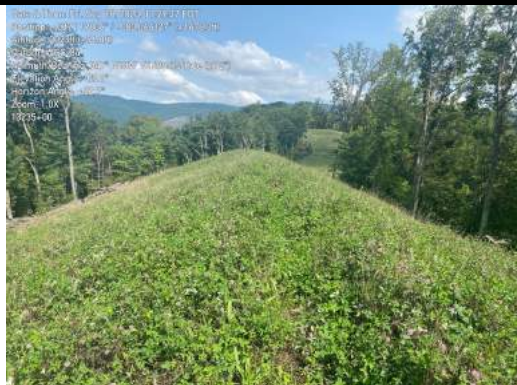
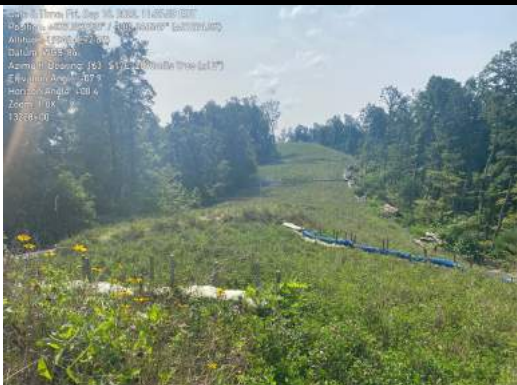
<b>GPS Location</b>	See photo for coordinates	<b>GPS Location</b>	See photo for coordinates		
<b>Field Station#</b>	13235+00	<b>Field Station#</b>	13228+00		
<b>Pic 11 Desc.</b>	Restored ROW stable with vegetative cover across LOD.	<b>Pic 12 Desc.</b>	Restored ROW stable with vegetative cover across LOD.

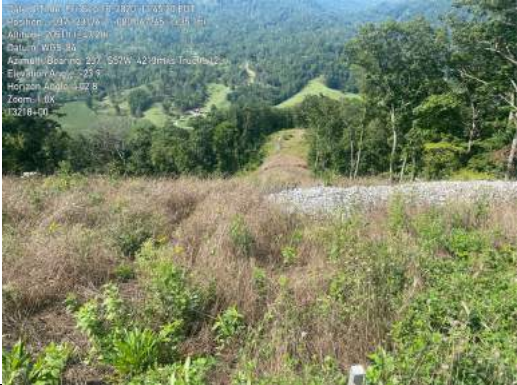
<b>GPS Location</b>	See photo for coordinates		<b>GPS Location</b>	See photo for coordinates	
<b>Field Station#</b>	13218+00		<b>Field Station#</b>	13216+00	
<b>Pic 13 Desc.</b>	Restored ROW stable with vegetative cover across LOD.		<b>Pic 14 Desc.</b>	Restored ROW stable with vegetative cover across LOD.

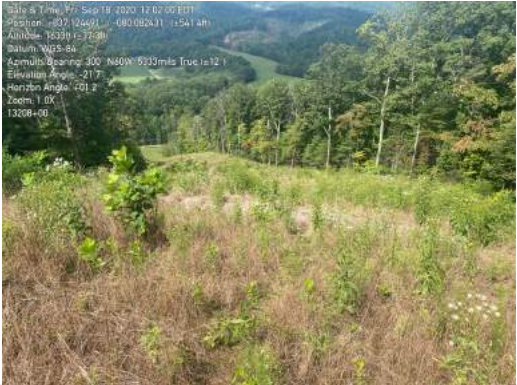
<b>GPS Location</b>	See photo for coordinates		<b>GPS Location</b>	See photo for coordinates	
<b>Field Station#</b>	13213+00		<b>Field Station#</b>	13208+00	
<b>Pic 15 Desc.</b>	Restored and stabilized ROW stable with vegetative cover across LOD.		<b>Pic 16 Desc.</b>	Stabilized ROW stable with vegetative cover across LOD.

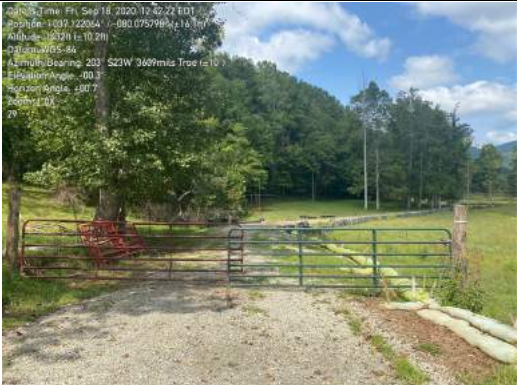
<b>Pic 17 Desc.</b>	MVP-AR-29, no off ROW impacts noted.		<b>Pic 18 Desc.</b>	Andey Gap at MVP-FR-292 entrance.
