## Visual Site Inspection Report

<b>Project Name</b>	H-600 Pipeline Spread H	<b>AFE</b>	124300138	<b>Spread</b>	H-600 Pipeline Spread H
<b>Contractor</b>	Precision			<b>Report #</b>	14983
<b>Inspector</b>	Pat Davis			<b>Date/Time</b>	9/28/2020 4:00 PM
<b>Permit #</b>	TBD	<b>Inspection Type</b>	VA SWPP	<b>Station Begin</b>	+0
<b>State</b>	VA	<b>Inspection Area</b>	Partial	<b>Station End</b>	+0
<b>County</b>	Montgomery	<b>Ground</b>	Damp	<b>Temperature (°F)</b>	78.00
<b>Municipality</b>	N/A	<b>Weather</b>	Cloudy	<b>Rain Gauge (in)</b>	0.00
				<b>Rain Accumulation Time (days)</b>	0.00

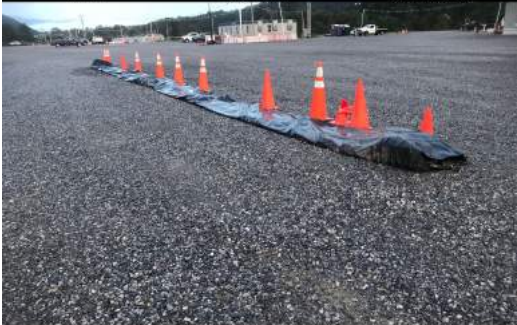
<b>Pic 5 Desc.</b>	Blue Bulk fuel tanks containment holding stormwater. Looking N.	<b>Pic 6 Desc.</b>	Blue Bulk Fuel tanks no leaky internal fittings. Looking W.

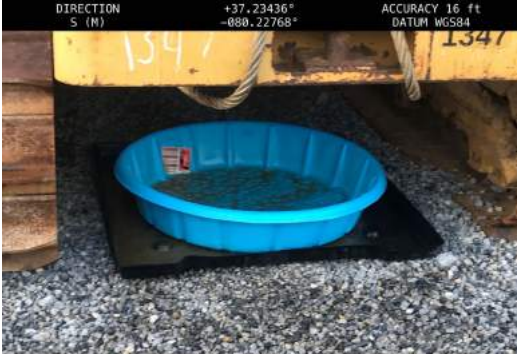
<b>GPS Location</b>	MVP-PY-006 See photo for GPS data		<b>GPS Location</b>	MVP-PY-006 See photo for GPS data	
<b>Field Station#</b>	+0		<b>Field Station#</b>	+0	
<b>Pic 13 Desc.</b>	Condition of containment under stored equipment. Looking S.		<b>Pic 14 Desc.</b>	Condition of containment, holding stormwater. Looking S.

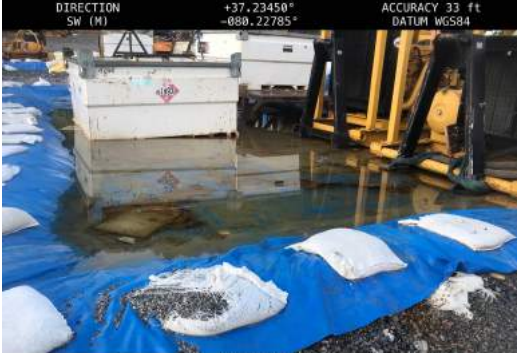
<b>GPS Location</b>	MVP-PY-006 See photo for GPS data		<b>GPS Location</b>	MVP-PY-006 See photo for GPS data	
<b>Field Station#</b>	+0		<b>Field Station#</b>	+0	
<b>Pic 15 Desc.</b>	Condition of containment, holding stormwater. Looking SW.		<b>Pic 16 Desc.</b>	Condition of trays and containment under toilets. Looking NE.

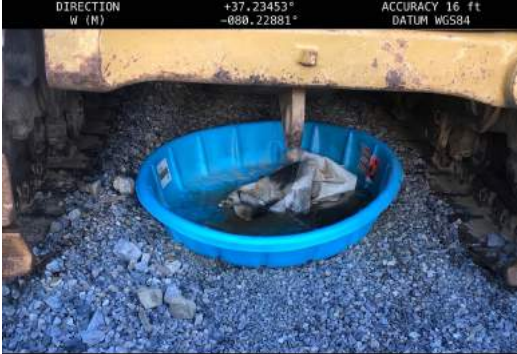
<b>Pic 17 Desc.</b>	Condition of containment under stored equipment. Looking W.		<b>Pic 18 Desc.</b>	Condition of containment under light plant. Looking SW.

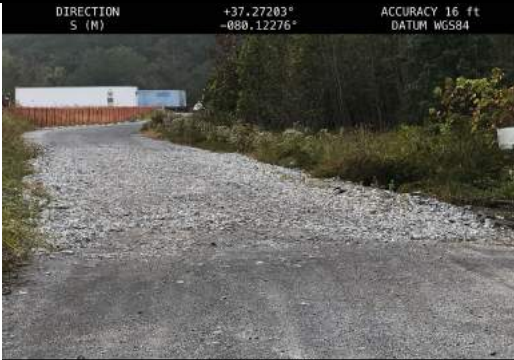
<p>DIRECTION S (N) +37.27283° -080.12276° ACCURACY 16 ft DATUM WGS84</p> <p>MVP-LY-049_092820 Condition of rock entrance 2020-09-28 09:06:48-04:00</p>

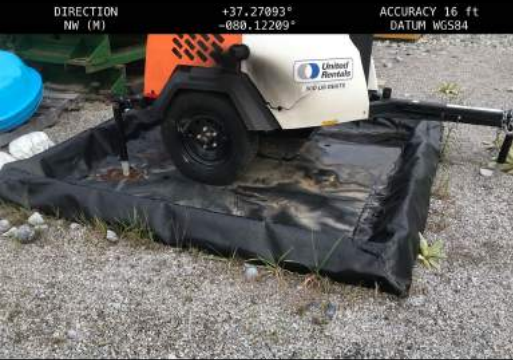
<p>DIRECTION NW (N) +37.27093° -080.12209° ACCURACY 16 ft DATUM WGS84</p> <p>MVP-LY-049_092820 Condition of containment 2020-09-28 09:09:22-04:00</p>			
<b>GPS Location</b>	MVP-LY-049 See photo for GPS data		<b>GPS Location</b>	MVP-LY-049 See photo for GPS data	
<b>Field Station#</b>	+0		<b>Field Station#</b>	+0	
<b>Pic 1 Desc.</b>	Condition of rock entrance on center drive. No sediment on stone surface. Looking S.		<b>Pic 2 Desc.</b>	Condition of containment under light plant. Free of stormwater. Looking NW.

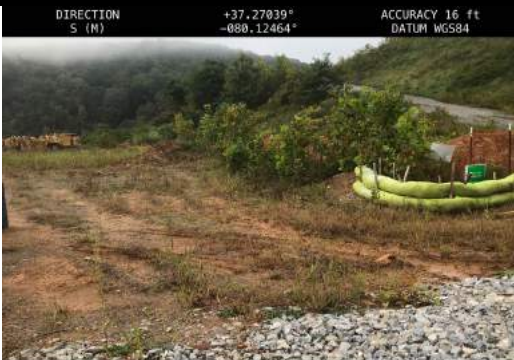
<p>DIRECTION S (N) +37.27039° -080.12464° ACCURACY 16 ft DATUM WGS84</p> <p>MVP-LY-049_092820 Landowner disturbance along CFS &amp; feature 2020-09-28 09:12:59-04:00</p>

<b>GPS Location</b>	MVP-LY-049 See photo for GPS data		<b>GPS Location</b>	MVP-LY-049 See photo for GPS data	
<b>Field Station#</b>	+0		<b>Field Station#</b>	+0	
<b>Pic 3 Desc.</b>	Landowner disturbance along compost filter sock and feature W-CV21B. No impacts. Looking S.		<b>Pic 4 Desc.</b>	Landowner disturbance within 66' of feature W-CV21B. No impacts. Looking SW.

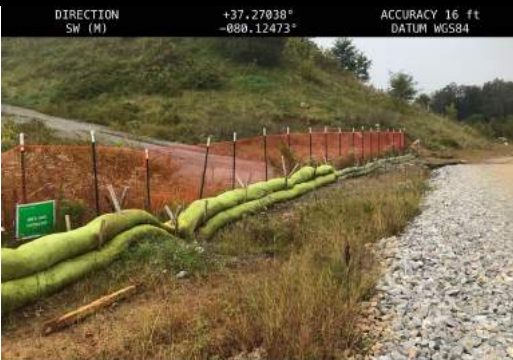
<p>DIRECTION SW (N) +37.27038° -080.12473° ACCURACY 16 ft DATUM WGS84</p> <p>MVP-LY-049_092820 Landowner disturbance within 66' of feature 2020-09-28 09:13:10-04:00</p>

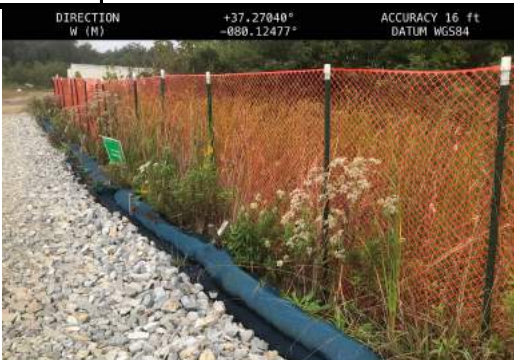
<p>DIRECTION W (N) +37.27040° -080.12477° ACCURACY 16 ft DATUM WGS84</p> <p>MVP-LY-049_092820 Condition of CFS &amp; safety fence 2020-09-28 09:13:23-04:00</p>

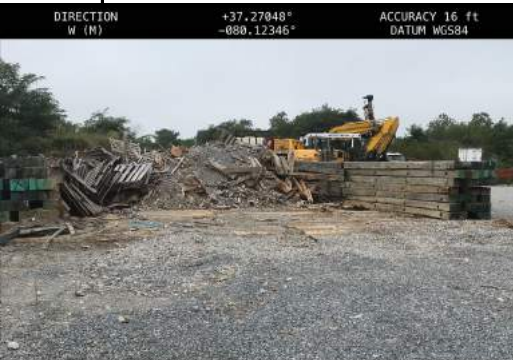
<p>DIRECTION W (N) +37.27048° -080.12346° ACCURACY 16 ft DATUM WGS84</p> <p>MVP-LY-049_092820 Condition of temporary trash ... 2020-09-28 09:24:29-04:00</p>			
<b>GPS Location</b>	MVP-LY-049 See photo for GPS data		<b>GPS Location</b>	MVP-LY-049 See photo for GPS data	
<b>Field Station#</b>	+0		<b>Field Station#</b>	+0	
<b>Pic 5 Desc.</b>	Condition of compost filter sock and safety fence along feature W-CV21A. Looking W.		<b>Pic 6 Desc.</b>	Condition of temporary trash transfer pit. Debris within boundary of temporary trash transfer pit. Looking W.

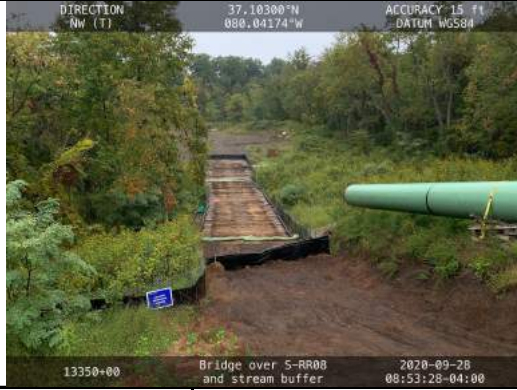
<b>Pic 11 Desc.</b>	Photo shows the bridge over stream S-RR08 and adjacent stream buffer.		<b>Pic 12 Desc.</b>	Photo shows stream S-RR08 downstream from the bridge.

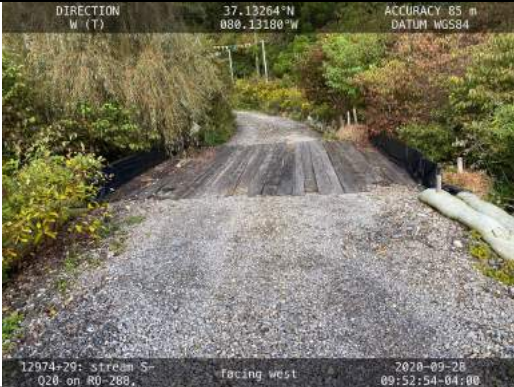
<b>GPS Location</b>	See photo		<b>GPS Location</b>	See photo	
<b>Field Station#</b>	12974+29		<b>Field Station#</b>	12974+29	
<b>Pic 3 Desc.</b>	Stream S-Q20 on access road MVP-RO-288, facing west		<b>Pic 4 Desc.</b>	Stream S-KL4 on access road MVP-ROW-288, facing south

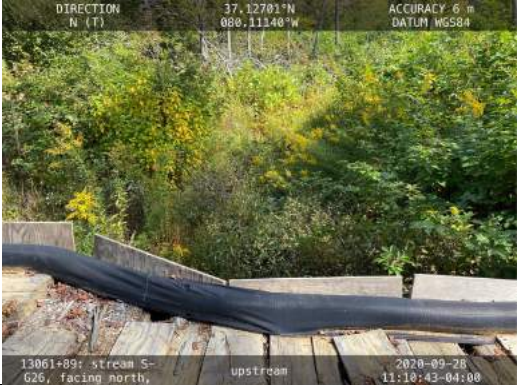
<b>GPS Location</b>	See photo		<b>GPS Location</b>	See photo	
<b>Field Station#</b>	13061+89		<b>Field Station#</b>	13062+96	
<b>Pic 13 Desc.</b>	Stream S-G26, facing north, upstream		<b>Pic 14 Desc.</b>	Stream S-G26, facing southwest, downstream

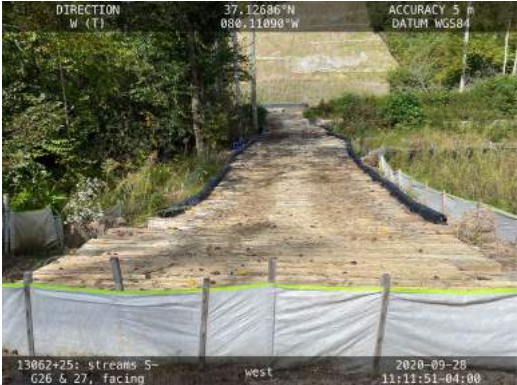
<b>GPS Location</b>	See photo		<b>GPS Location</b>	See photo	
<b>Field Station#</b>	13062+25		<b>Field Station#</b>	123070+00	
<b>Pic 15 Desc.</b>	Streams S-G26 and S-G27, facing west		<b>Pic 16 Desc.</b>	Permanent restoration on the going away side of access road MVP-FR-290 remains stable

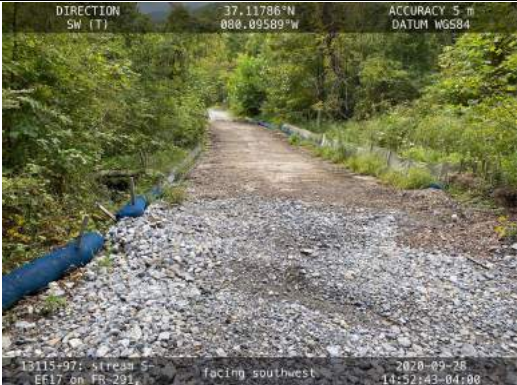
<b>GPS Location</b>	See photo		<b>GPS Location</b>	See photo	
<b>Field Station#</b>	13115+97		<b>Field Station#</b>	13112+00	
<b>Pic 17 Desc.</b>	Stream S-EF17 on access road MVP-FR-290, facing		<b>Pic 18 Desc.</b>	Permanent restoration on the coming in side of access road MVP-FR-271 remains stable.

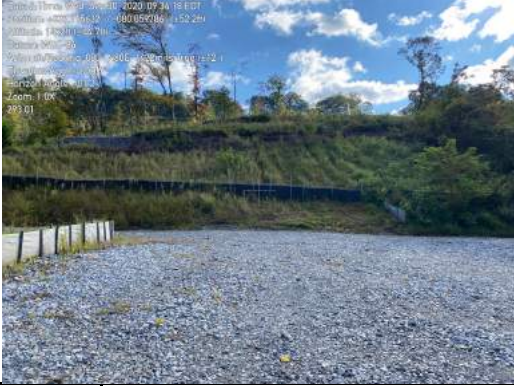
<p> <small> Date &amp; Time: Wed Sep 30, 2020 09:34:18 EDT  Position: 40.1715710, -80.0596780 (152.2m)  Altitude: 1452m (125.3m)  Datum: WGS 84  Azimuth Bearing: 201.7020N 570mils True (12)  Elevation Angle: +01.5  Horizon Angle: 100  Zoom: 1.0x  Pic: 01 </small> </p>

<p> <small> Date &amp; Time: Wed Sep 30, 2020 09:34:18 EDT  Position: 40.1715710, -80.0596780 (152.2m)  Altitude: 1452m (125.3m)  Datum: WGS 84  Azimuth Bearing: 201.7020N 570mils True (12)  Elevation Angle: +01.5  Horizon Angle: 100  Zoom: 1.0x  Pic: 02 </small> </p>			
<b>GPS Location</b>	See photo for coordinates.		<b>GPS Location</b>	See photo for coordinates.	
<b>Field Station#</b>	13262+00		<b>Field Station#</b>	13262+00	
<b>Pic 1 Desc.</b>	MVP-FR-293.01, road crossing in acceptable condition.		<b>Pic 2 Desc.</b>	ATWS-1055, partially restored with acceptable vegetative cover.

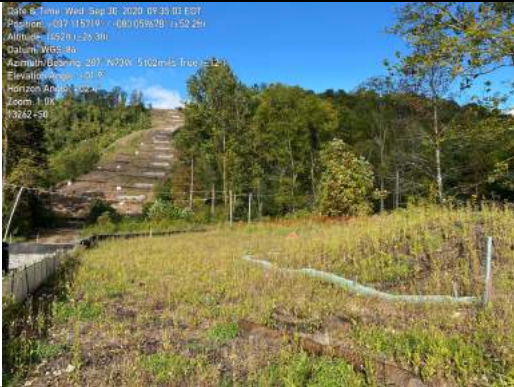
<p> <small> Date &amp; Time: Wed Sep 30, 2020 09:35:01 EDT  Position: 40.1715710, -80.0596780 (152.2m)  Altitude: 1452m (125.3m)  Datum: WGS 84  Azimuth Bearing: 201.7020N 570mils True (12)  Elevation Angle: +01.5  Horizon Angle: 100  Zoom: 1.0x  Pic: 03 </small> </p>

<p> <small> Date &amp; Time: Wed Sep 30, 2020 09:35:15 EDT  Position: 40.1715710, -80.0596780 (152.2m)  Altitude: 1452m (125.3m)  Datum: WGS 84  Azimuth Bearing: 201.7020N 570mils True (12)  Elevation Angle: +01.5  Horizon Angle: 100  Zoom: 1.0x  Pic: 04 </small> </p>			
<b>GPS Location</b>	See photo for coordinates.		<b>GPS Location</b>	See photo for coordinates.	
<b>Field Station#</b>	13262+00		<b>Field Station#</b>	13260+60	
<b>Pic 3 Desc.</b>	ROW temporarily stabilized.		<b>Pic 4 Desc.</b>	S-II4, upstream, no changes noted to stream bed or banks.

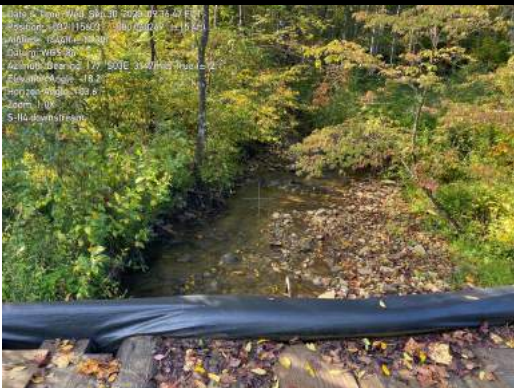
<p> <small> Date &amp; Time: Wed Sep 30, 2020 09:35:29 EDT  Position: 40.1715710, -80.0596780 (152.2m)  Altitude: 1452m (125.3m)  Datum: WGS 84  Azimuth Bearing: 201.7020N 570mils True (12)  Elevation Angle: +01.5  Horizon Angle: 100  Zoom: 1.0x  Pic: 05 </small> </p>

<b>GPS Location</b>	See photo for coordinates.		<b>GPS Location</b>	See photo for coordinates.	
<b>Field Station#</b>	13260+60		<b>Field Station#</b>	13260+60	
<b>Pic 5 Desc.</b>	S-II4, downstream, no changes noted to stream bed or banks.		<b>Pic 6 Desc.</b>	CIS S-II4, ROW stable with vegetative cover across LOD.

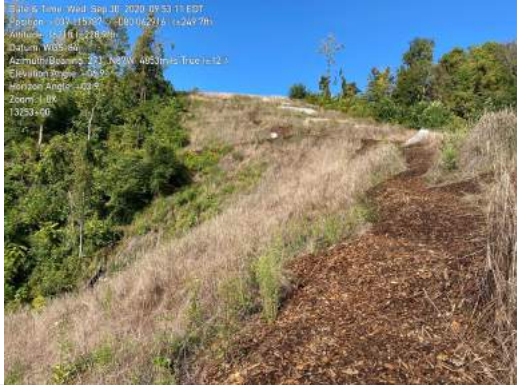
<b>GPS Location</b>	See photo for coordinates.		<b>GPS Location</b>	See photo for coordinates.	
<b>Field Station#</b>	13253+00		<b>Field Station#</b>	13250+00	
<b>Pic 9 Desc.</b>	ROW stable with vegetative cover across LOD.		<b>Pic 10 Desc.</b>	ROW stable with vegetative cover across LOD.

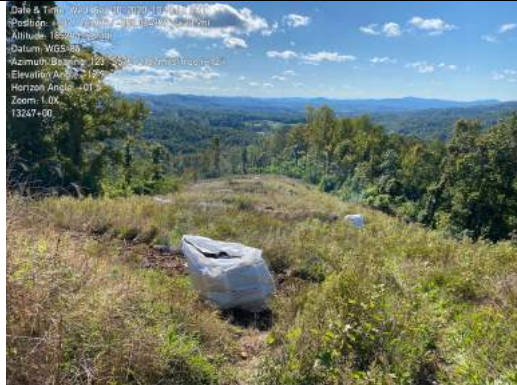
<b>GPS Location</b>	See photo for coordinates.		<b>GPS Location</b>	See photo for coordinates.	
<b>Field Station#</b>	13247+00		<b>Field Station#</b>	13245+00	
<b>Pic 11 Desc.</b>	ROW stable with vegetative cover across LOD.		<b>Pic 12 Desc.</b>	ROW stable with vegetative cover across LOD.

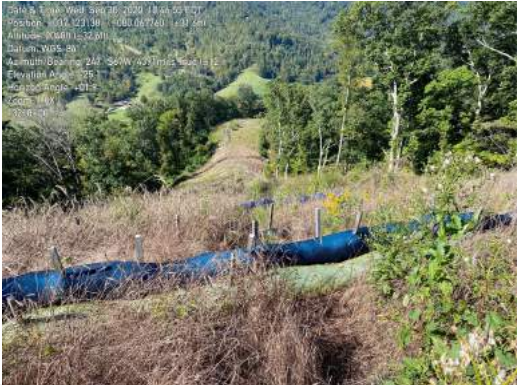
<p>Date &amp; Time: Wed Sep 30, 2020 10:44:55 EDT Position: +037.12213N, -080.06474W (+1317.4m) Altitude: 2000.0 (+1321.0m) Datum: WGS-84 Azimuth/Bearing: 247.184W (+312.8m to tree #2) Elevation Angle: +12.1 Horizon Angle: +00.0 Zoom: F 10X 13218+00</p>

<b>GPS Location</b>	See photo for coordinates.		<b>GPS Location</b>	See photo for coordinates.	
<b>Field Station#</b>	13218+00		<b>Field Station#</b>	13213+00	
<b>Pic 15 Desc.</b>	ROW stable with vegetative cover across LOD.		<b>Pic 16 Desc.</b>	ROW stable with vegetative cover across LOD.

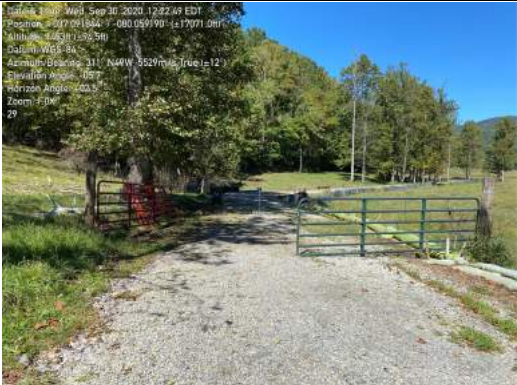
<p>Date &amp; Time: Wed Sep 30, 2020 12:22:49 EDT Position: +037.091844N, -080.059190W (+1709.0m) Altitude: 1557.0 (+1557.0m) Datum: WGS-84 Azimuth/Bearing: 311.1 N4W (+52.9m to tree #12) Elevation Angle: +06.6 Horizon Angle: +00.0 Zoom: F 10X 29</p>

<b>Pic 17 Desc.</b>	MVP-AR-29, gate left open, ATV noted driving out, road in acceptable condition.		<b>Pic 18 Desc.</b>	MVP-FR-292, RCE and access road in acceptable condition.

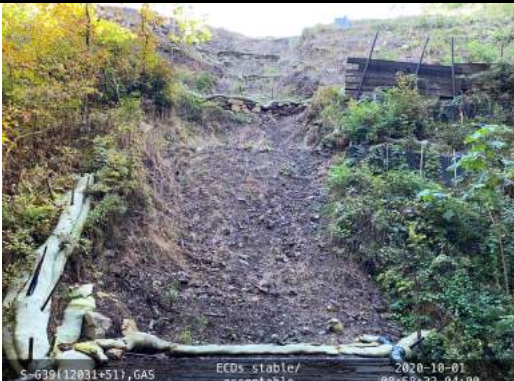
<b>Pic 5 Desc.</b>	All ECDs are in acceptable condition. Sumps and vegetation is in acceptable condition.		<b>Pic 6 Desc.</b>	All ECDs are in acceptable condition. Sumps and vegetation is in acceptable condition.

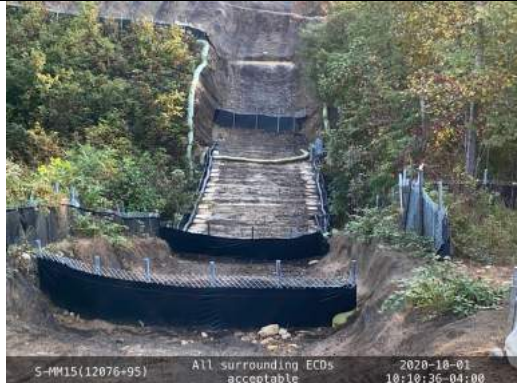
<b>Field Station#</b>	12076+95		<b>Field Station#</b>	12086+56	
<b>Pic 11 Desc.</b>	All surrounding ECDs are in acceptable condition.		<b>Pic 12 Desc.</b>	All surrounding ECDs are in acceptable condition.

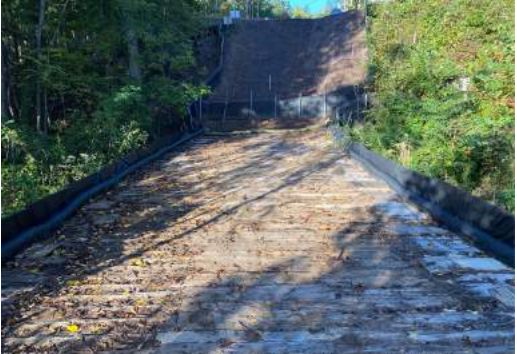
<small>S-MM13, (12098+44) All surrounding ECDs acceptable 2020-10-01 10:35:09-04:00</small>		<small>S-MM11, (12101+57) All surrounding ECDs acceptable 2020-10-01 10:41:40-04:00</small>			
<b>GPS Location</b>	See photo GPS for location		<b>GPS Location</b>	See photo GPS for location	
<b>Field Station#</b>	12098+44		<b>Field Station#</b>	12101+57	
<b>Pic 13 Desc.</b>	All surrounding ECDs are in acceptable condition.		<b>Pic 14 Desc.</b>	All surrounding ECDs are in acceptable condition.

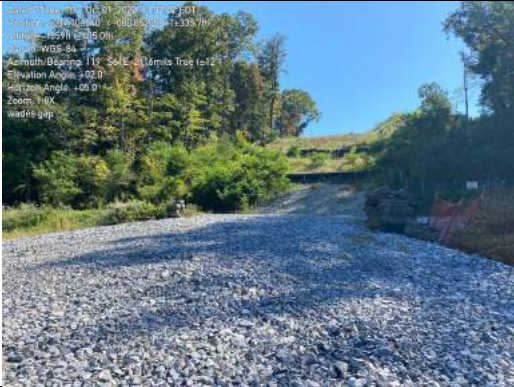
<b>GPS Location</b>	See phot for coordinates.		<b>GPS Location</b>	See phot for coordinates.	
<b>Field Station#</b>	13314+00		<b>Field Station#</b>	13314+00	
<b>Pic 1 Desc.</b>	Wades Gap road crossing.		<b>Pic 2 Desc.</b>	CIS of Wades Gap crossing, ROW stable with acceptable vegetative cover.

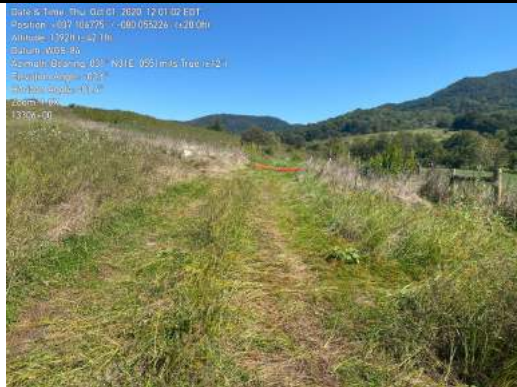
<b>Pic 11 Desc.</b>	ROW stable with acceptable vegetative cover across LOD, landowner crossing.		<b>Pic 12 Desc.</b>	ROW stable with acceptable vegetative cover across LOD, landowner crossing.

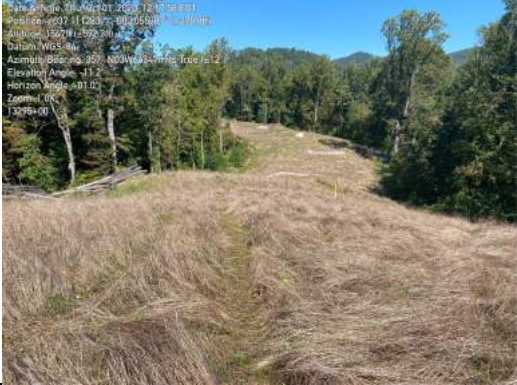
<b>GPS Location</b>	See phot for coordinates.		<b>GPS Location</b>	See phot for coordinates.	
<b>Field Station#</b>	13293+00		<b>Field Station#</b>	13290+00	
<b>Pic 15 Desc.</b>	ROW stable with acceptable vegetative cover across LOD.		<b>Pic 16 Desc.</b>	ROW stable with acceptable vegetative cover across LOD.	
<p>Date &amp; Time: Thu Oct 01, 2020 12:31:11 EDT  Position: +037.108541, -080.055077, +5416.041  Altitude: 1512ft (+595.5m)  Datum: WGS-84  Azimuth Bearing: 295° TN25E, 200Ymils True (121)  Elevation Angle: +21.8°  Horizon Angle: +00.7°  Zoom: 1.0X  13275+00</p>

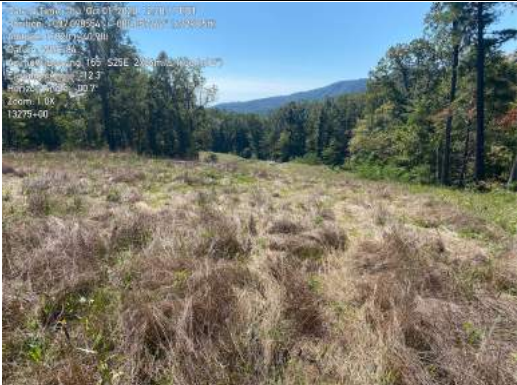
<b>GPS Location</b>	See phot for coordinates.		<b>GPS Location</b>	See phot for coordinates.	
<b>Field Station#</b>	13275+00		<b>Field Station#</b>	13273+00	
<b>Pic 17 Desc.</b>	ROW stable with acceptable vegetative cover across LOD.		<b>Pic 18 Desc.</b>	ROW stable with acceptable vegetative cover across LOD.

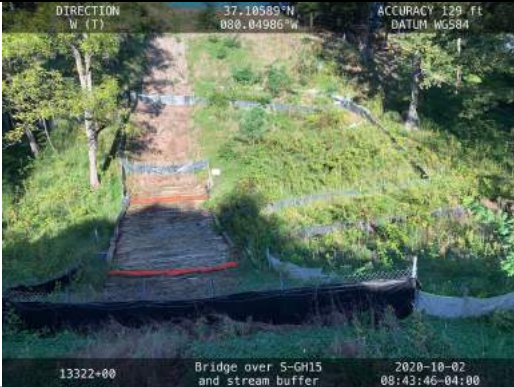
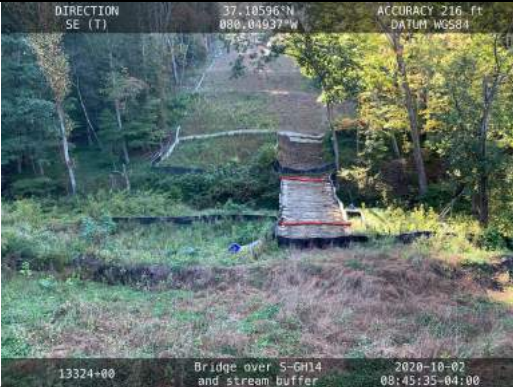
<b>GPS Location</b>	See photo for gps location data.		<b>GPS Location</b>	See photo for gps location data.	
<b>Field Station#</b>	13322+00		<b>Field Station#</b>	13324+00	
<b>Pic 3 Desc.</b>	Photo shows the bridge over stream S-GH15 and adjacent stream buffer.		<b>Pic 4 Desc.</b>	Photo shows the bridge over stream S-GH14 and adjacent stream buffer.

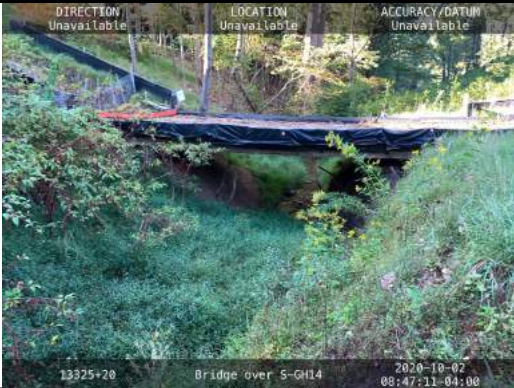
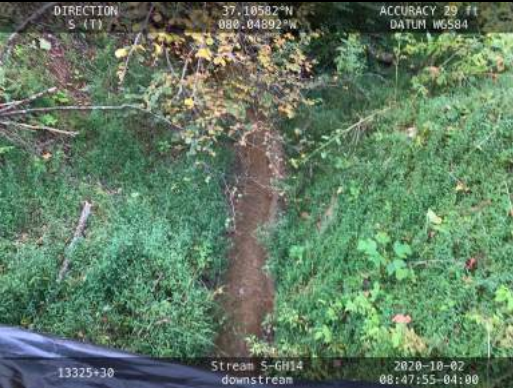
<b>Field Station#</b>	13325+20		<b>Field Station#</b>	13325+30	
<b>Pic 5 Desc.</b>	Photo shows the bridge over stream S-GH14.		<b>Pic 6 Desc.</b>	Photo shows stream S-GH14 downstream from the bridge.

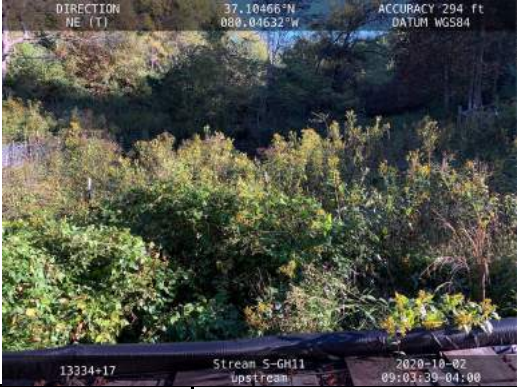
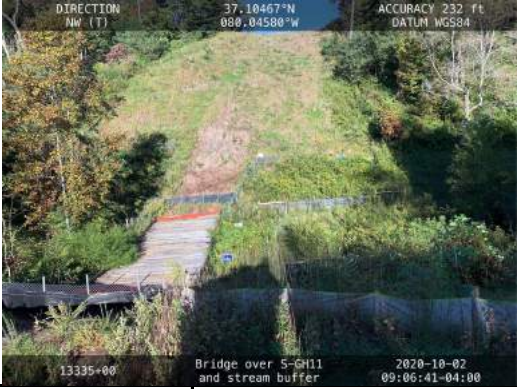
<b>GPS Location</b>	See photo for gps location data.		<b>GPS Location</b>	See photo for gps location data.	
<b>Field Station#</b>	13334+17		<b>Field Station#</b>	13335+00	
<b>Pic 7 Desc.</b>	Photo shows stream S-GH11 upstream from the bridge.		<b>Pic 8 Desc.</b>	Photo shows the bridge over stream S-GH11 and adjacent stream buffer.

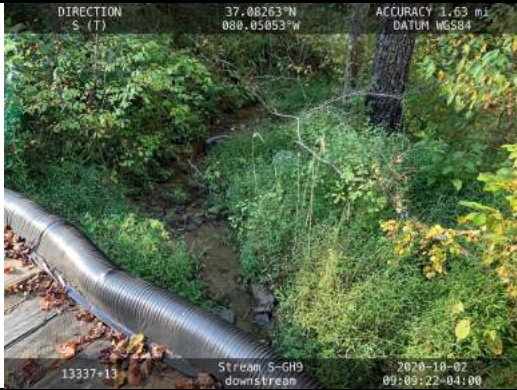
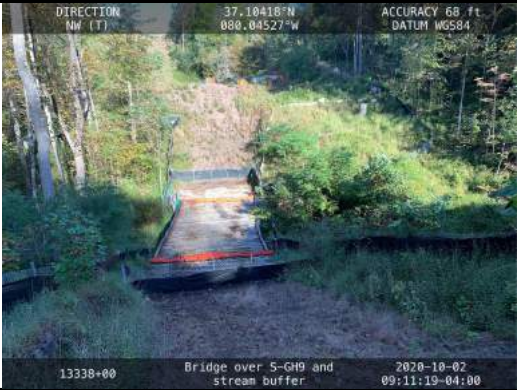
<b>GPS Location</b>	See photo for gps location data.		<b>GPS Location</b>	See photo for gps location data.	
<b>Field Station#</b>	13337+13		<b>Field Station#</b>	13338+00	
<b>Pic 9 Desc.</b>	Photo shows stream S-GH9 downstream from the bridge.		<b>Pic 10 Desc.</b>	Photo shows the bridge over stream S-GH9 and adjacent stream buffer.

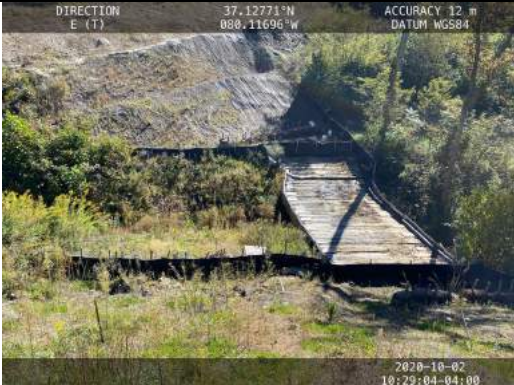
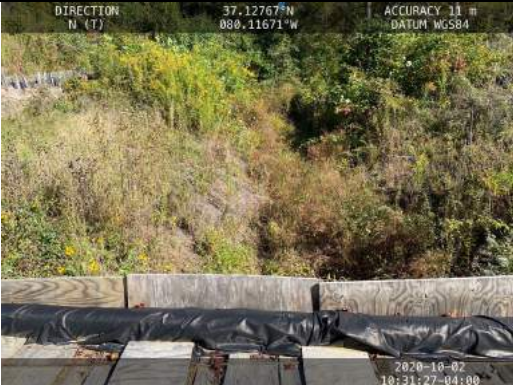
<b>GPS Location</b>	See photo		<b>GPS Location</b>	See photo	
<b>Field Station#</b>	13042+61		<b>Field Station#</b>	13042+61	
<b>Pic 3 Desc.</b>	Stream S-H1, facing east		<b>Pic 4 Desc.</b>	Stream S-H1, facing north, upstream

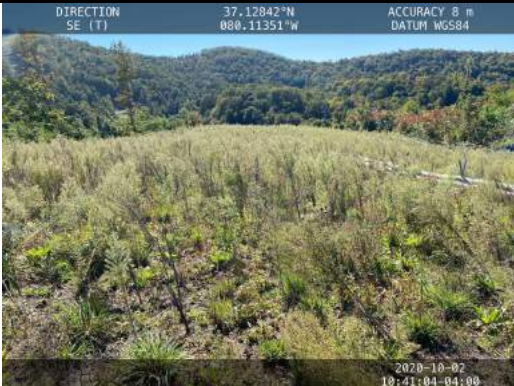
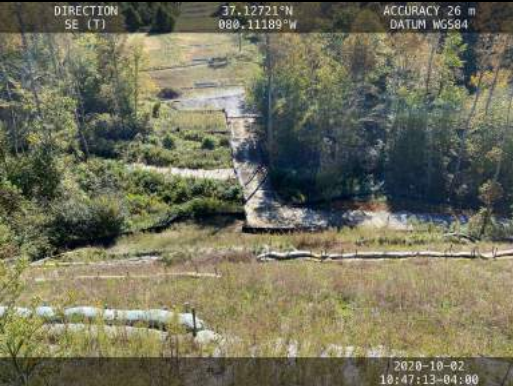
<b>GPS Location</b>	See photo		<b>GPS Location</b>	See photo	
<b>Field Station#</b>	13053+00		<b>Field Station#</b>	13057+00	
<b>Pic 5 Desc.</b>	Permanent restored ROW stable		<b>Pic 6 Desc.</b>	The slope on the coming in side of access road MVP-FR-290 remains stable.

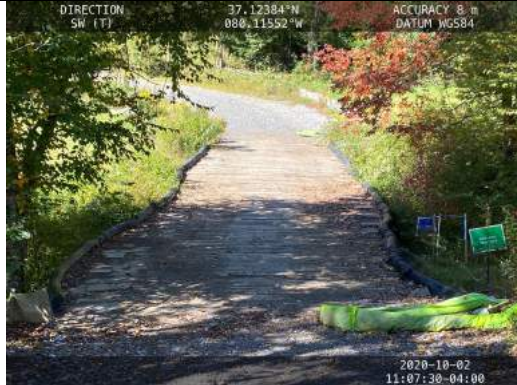
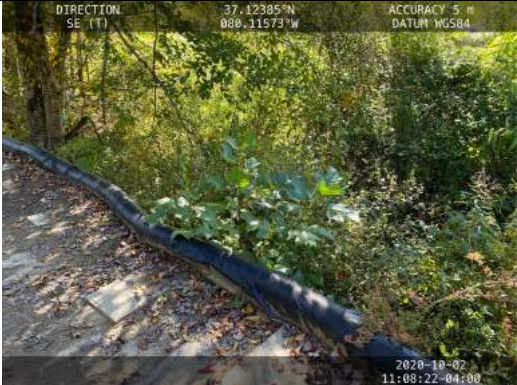
<b>GPS Location</b>	See photo		<b>GPS Location</b>	See photo	
<b>Field Station#</b>	13061+44		<b>Field Station#</b>	13061+44	
<b>Pic 11 Desc.</b>	Stream S-RR16 on access road MVP-FR-290, facing southwest		<b>Pic 12 Desc.</b>	Stream S-RR16 on access road MVP-FR-290, facing southeast, downstream

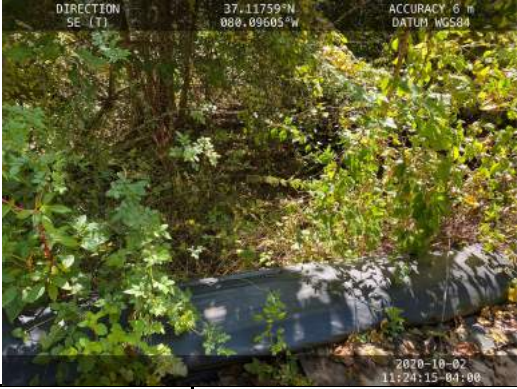
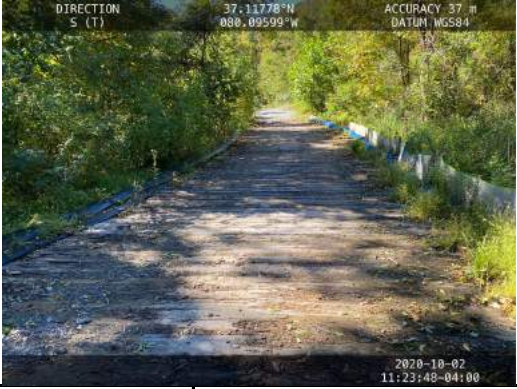
<b>GPS Location</b>	See photo		<b>GPS Location</b>	See photo	
<b>Field Station#</b>	13115+97		<b>Field Station#</b>	13115+97	
<b>Pic 13 Desc.</b>	Stream S-EF17 on access road MVP-FR-291, facing southeast, downstream		<b>Pic 14 Desc.</b>	Stream S-EF17 on access road MVP-FR-291, facing south

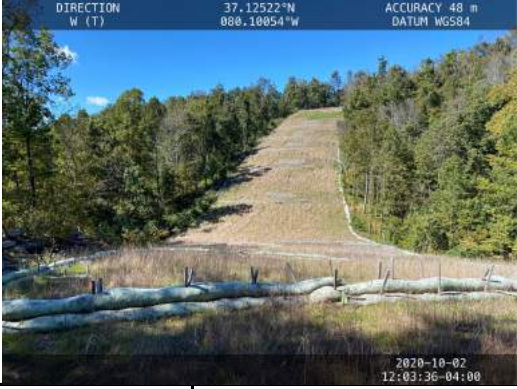
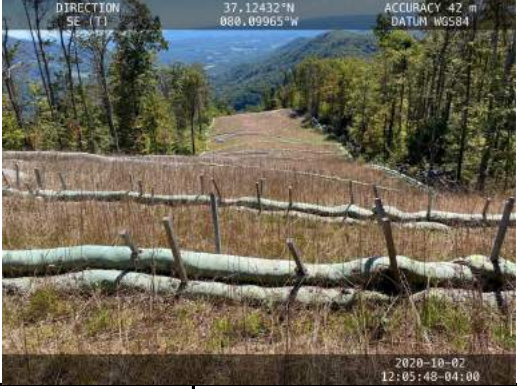
<b>GPS Location</b>	See photo		<b>GPS Location</b>	See photo	
<b>Field Station#</b>	13095+00		<b>Field Station#</b>	13105+00	
<b>Pic 15 Desc.</b>	Permanent restoration well vegetated and stable		<b>Pic 16 Desc.</b>	Permanent restoration well vegetated and stable

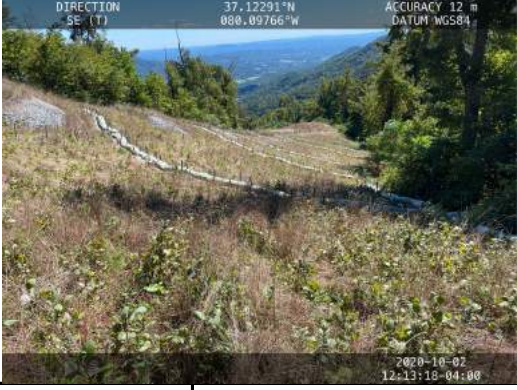
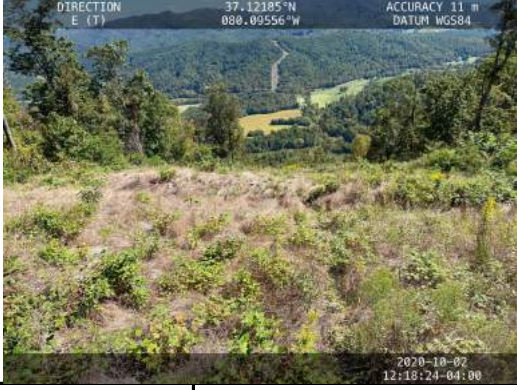
<b>GPS Location</b>	See photo		<b>GPS Location</b>	See photo	
<b>Field Station#</b>	13110+00		<b>Field Station#</b>	13117+00	
<b>Pic 17 Desc.</b>	Permanent restoration well vegetated and stable		<b>Pic 18 Desc.</b>	Temporarily stabilized ROW on the going away side of access road MVP-FR-291 is well vegetated and stable.
