Visual Site Inspection Report

Project Name	H-600 Pipeline Spread H	AFE	124300138	Spread	H-600 Pipeline Spread H
Contractor	Precision			Report #	15207
Inspector	Logan Box			Date/Time	10/5/2020 10:02 AM
Permit #	TBD	Inspection Type	VA SWPP	Station Begin	13415+51
State	VA	Inspection Area	Partial	Station End	13670+00
County	Franklin	Ground	Dry	Temperature (°F)	81.00
Municipality	N/A	Weather	Sunny	Rain Gauge (in)	1.25
				Rain Accumulation Time (days)	6.00

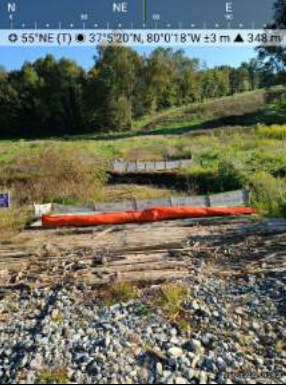
GPS Location	00000	GPS Location	00000		
Field Station#	13497+89	Field Station#	13480+00		
Pic 1 Desc.	The EI monitored stream crossing where equipment mats were removed during maintenance repairs, ECDs were in place and functioning during time of inspection.		Pic 2 Desc.	Vegetation photo observation showing permanent vegetation growth

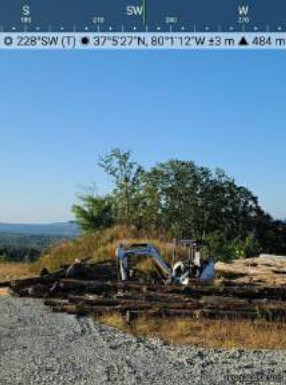
GPS Location	000000	GPS Location	00000		
Field Station#	13437+75	Field Station#	13420+77		
Pic 3 Desc.	The EI noticed a land owner has been loading out logs from the access rd MVP-FR-293.03, checked for leaks and documented that it was not project related.		Pic 4 Desc.	The EI monitored a work space where clean up activities took place removing old supplies and trash, documented good house keeping.

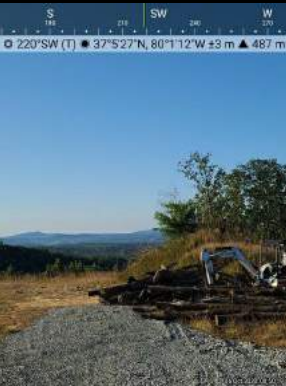
Pic 5 Desc.	The EI noticed a land owner has been loading out logs from the access rd MVP-FR-293.03, checked for leaks and documented that it was not project related.		Pic 6 Desc.	Vegetation observation in permanent area of row, showing good coverage over the row

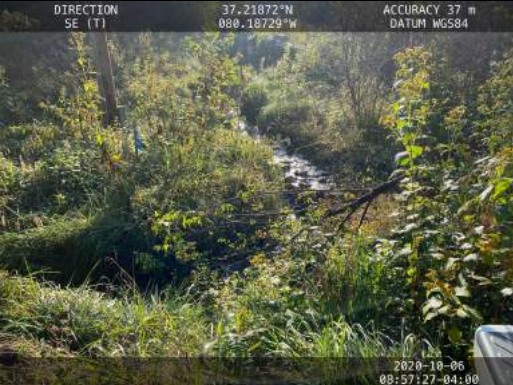
GPS Location	See photo		GPS Location	See photo	
Field Station#	12543+56		Field Station#	12543+56	
Pic 1 Desc.	Stream S-EF20b on Yellow Finch Road, facing north, downstream		Pic 2 Desc.	Stream S-KL32 on Yellow Finch Road, facing southeast, upstream

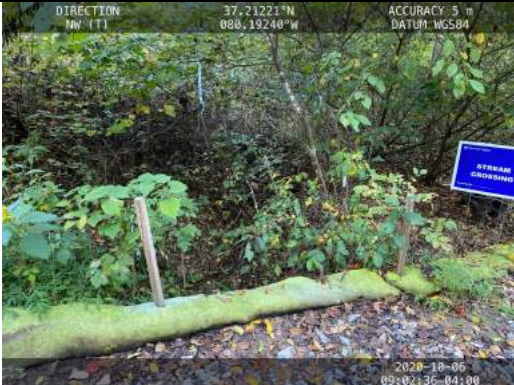
GPS Location	See photo		GPS Location	See photo	
Field Station#	12543+56		Field Station#	12543+56	
Pic 3 Desc.	Stream S-EF54 on Yellow Finch Road, facing northwest, upstream		Pic 4 Desc.	Protester activity has resulted in a denuded road bank where a new shelter was recently erected in close proximity to stream S-EF54.

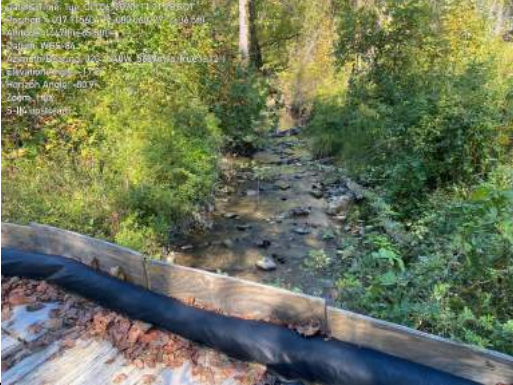
GPS Location	See photo for coordinates.		GPS Location	See photo for coordinates.	
Field Station#	13262+50		Field Station#	13260+60	
Pic 3 Desc.	ROW temporarily stabilized, perimeter ECDs in acceptable condition.		Pic 4 Desc.	S-II4, upstream, no changes noted to stream bed or banks.

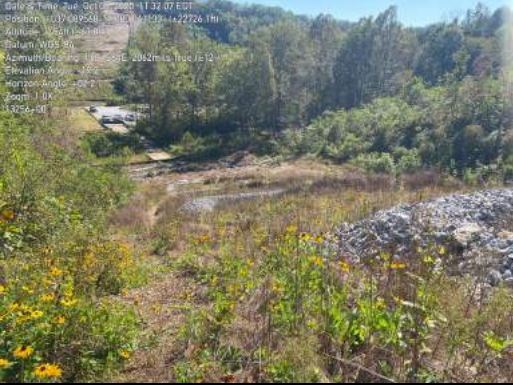
GPS Location	See photo for coordinates.		GPS Location	See photo for coordinates.	
Field Station#	13260+60		Field Station#	13256+00	
Pic 5 Desc.	S-II4, downstream, no changes noted to stream bed or banks.		Pic 6 Desc.	ROW stable with acceptable vegetative cover.

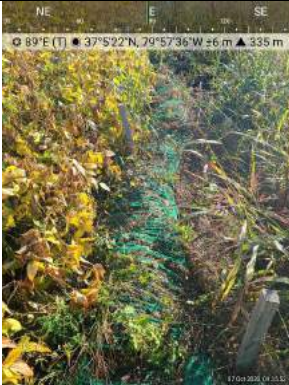
GPS Location	00000	GPS Location	00000		
Field Station#	13646+70	Field Station#	13655+50		
Pic 1 Desc.	CFS needs replaced added to the punch list	Pic 2 Desc.	P1 requires maintenance, added to the punch list

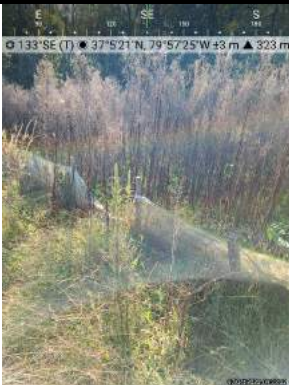
GPS Location	0000	GPS Location	0000		
Field Station#	13656+90	Field Station#	13656+00		
Pic 3 Desc.	P1 requires maintenance, added to the punch list for repairs.	Pic 4 Desc.	P1 requires maintenance, added to the punch list

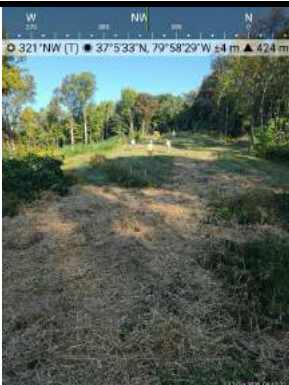
GPS Location	00000	GPS Location	00000		
Field Station#	13591+30	Field Station#	13630+00		
Pic 5 Desc.	Breaker repaired from land owner disturbance, stabilized area after repair made	Pic 6 Desc.	Vegetation photo showing good coverage.

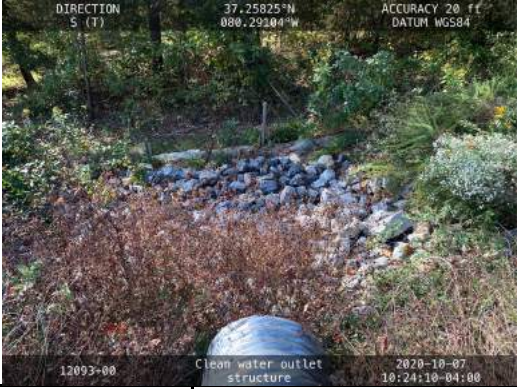
GPS Location	See photo for gps location data.		GPS Location	See photo for gps location data.	
Field Station#	12093+00		Field Station#	12098+44	
Pic 13 Desc.	Photo shows the clean water outlet structure.		Pic 14 Desc.	Photo shows stream S-MM13 downstream from the bridge.

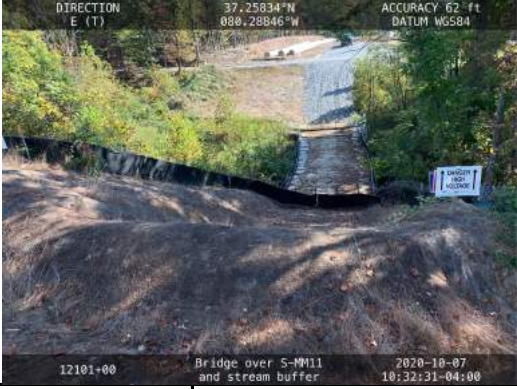
GPS Location	See photo for gps location data.		GPS Location	See photo for gps location data.	
Field Station#	12101+00		Field Station#	12108+50	
Pic 15 Desc.	Photo shows the bridge over stream S-M11 and adjacent stream buffer.		Pic 16 Desc.	Photo shows the bridge over stream S-F15 and adjacent stream buffer.

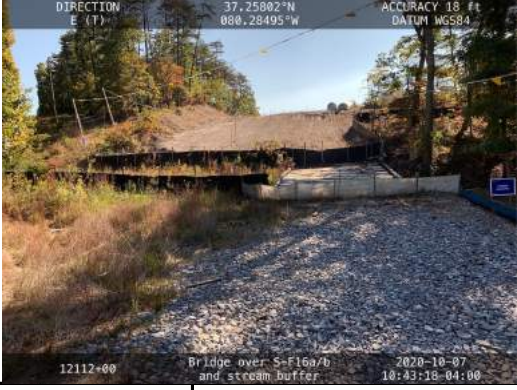
GPS Location	See photo for gps location data.		GPS Location	See photo for gps location data.	
Field Station#	12112+00		Field Station#	12073+00	
Pic 17 Desc.	Photo shows the bridge over stream S-F16 A/B and adjacent stream buffer.		Pic 18 Desc.	Photo shows the the re-stabilized section of ROW from 12073+00 to 12076+00.

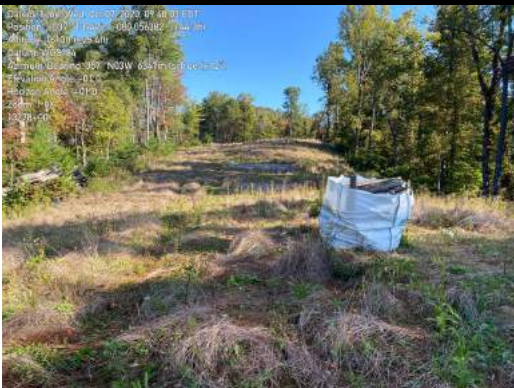
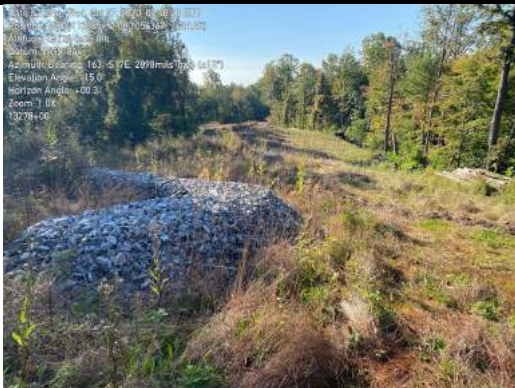
GPS Location	See photo for coordinates.		GPS Location	See photo for coordinates.	
Field Station#	13278+00		Field Station#	13278+00	
Pic 5 Desc.	ROW stable with acceptable vegetative cover across LOD.		Pic 6 Desc.	ROW stable with acceptable vegetative cover across LOD.

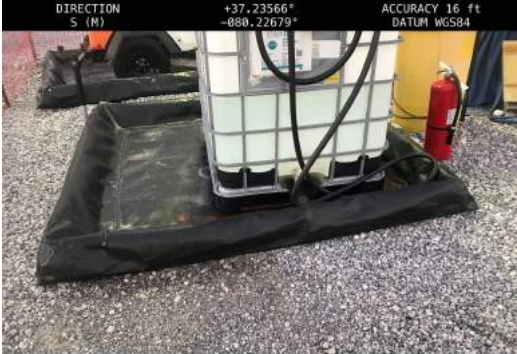
GPS Location	MVP-PY-006 See photo for gps data	GPS Location	MVP-PY-006 See photo for gps data		
Field Station#	+0	Field Station#	+0		
Pic 7 Desc.	Condition of containment under DEF tank. Free of fluid. Looking S.	Pic 8 Desc.	Secondary containment on site for tankers offloading fuel into Blue Bulk fuel tanks. Looking NW.

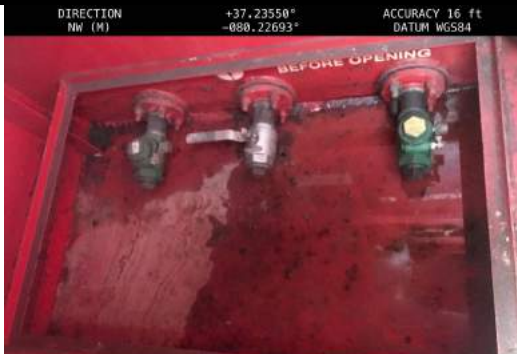
GPS Location	MVP-PY-006 See photo for gps data	GPS Location	MVP-PY-006 See photo for gps data		
Field Station#	+0	Field Station#	+0		
Pic 9 Desc.	Off Road Fuel unit condition of internal drip pan. Holding some stormwater. Looking NW.	Pic 10 Desc.	Off Road Fuel unit no leaky internal fittings. Looking NW.

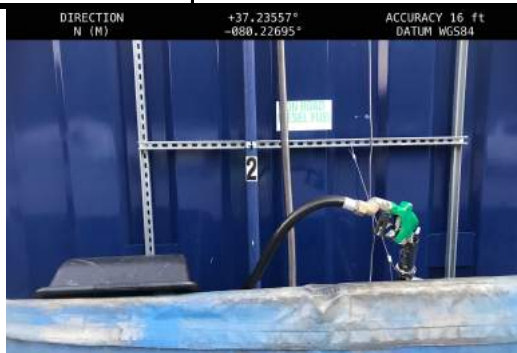
GPS Location	MVP-PY-006 See photo for gps data	GPS Location	MVP-PY-006 See photo for gps data		
Field Station#	+0	Field Station#	+0		
Pic 11 Desc.	Blue Bulk Fuel tanks no leaky fittings or nozzles. Looking N.	Pic 12 Desc.	No loose trash around dumpsters. Looking SE.

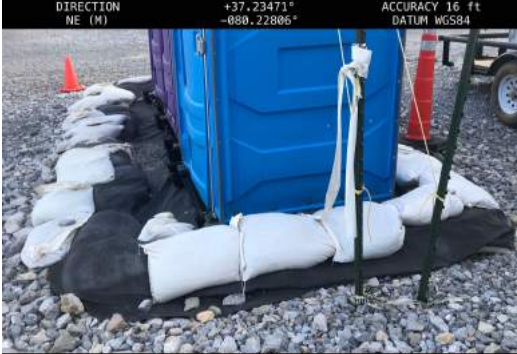
GPS Location	MVP-PY-006 See photo for gps data		GPS Location	MVP-PY-006 See photo for gps data	
Field Station#	+0		Field Station#	+0	
Pic 15 Desc.	Condition of containments under stored equipment. Looking E.		Pic 16 Desc.	Condition of containment under stored equipment. Looking NW.	
DIRECTION NE (M) +37.23471° -080.22806° ACCURACY 16 ft DATUM WGS84

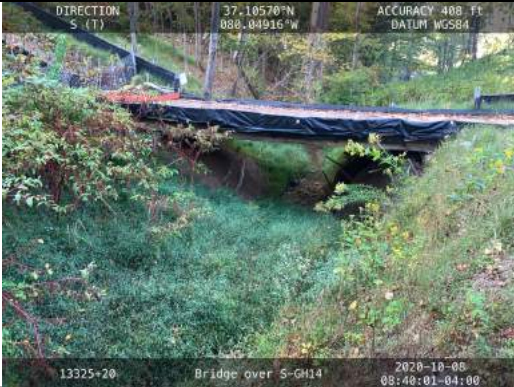
GPS Location	See photo for gps location data.		GPS Location	See photo for gps location data.	
Field Station#	13322+00		Field Station#	13324+00	
Pic 1 Desc.	Photo shows the bridge over stream S-GH15 and adjacent stream buffer.		Pic 2 Desc.	Photo shows the bridge over stream S-GH14 and adjacent stream buffer.

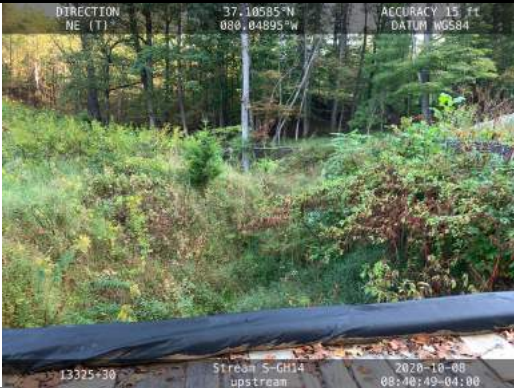
GPS Location	See photo for gps location data.		GPS Location	See photo for gps location data.	
Field Station#	13325+20		Field Station#	13325+30	
Pic 3 Desc.	Photo shows the bridge over stream S-GH14.		Pic 4 Desc.	Photo shows stream S-GH14 downstream from the bridge.

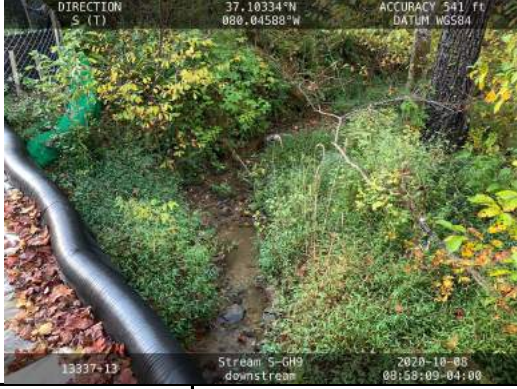
GPS Location	See photo for gps location data.		GPS Location	See photo for gps location data.	
Field Station#	13335+00		Field Station#	13337+00	
Pic 7 Desc.	Photo shows the bridge over stream S-GH11 and adjacent stream buffer.		Pic 8 Desc.	Photo shows the bridge over stream S-GH9.

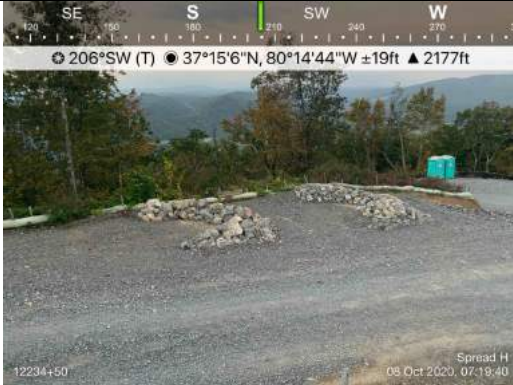
GPS Location	See Photograph.		GPS Location	See Photograph.	
Field Station#	12234+50		Field Station#	12234+50	
Pic 1 Desc.	ROW is in acceptable condition.		Pic 2 Desc.	Rock Check dams are in acceptable condition.

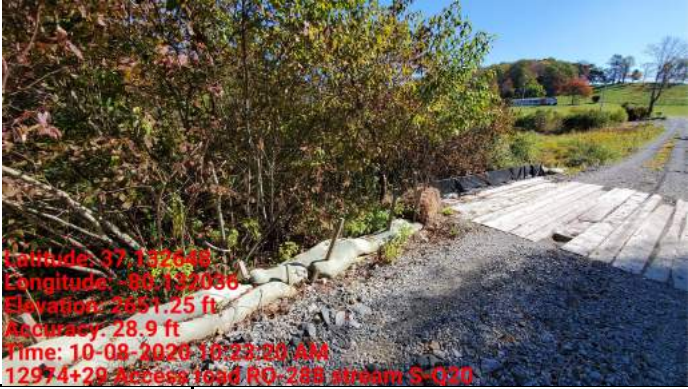
<p>Latitude: 37.132648 Longitude: -80.134086 Elevation: 2661.25 ft Accuracy: 28.9 ft Time: 10-08-2020 10:23:29 AM 12974+29 Access road RO-288 stream S-Q20</p>

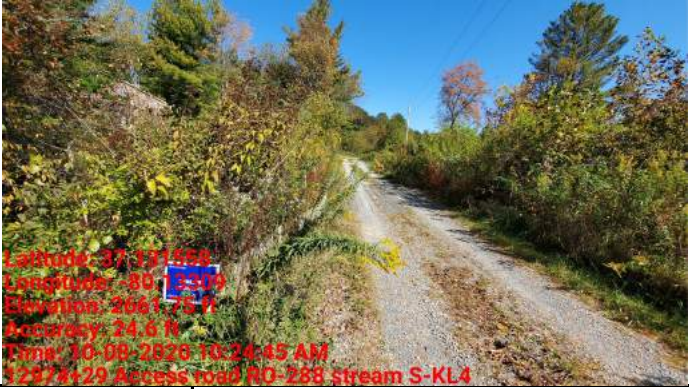
<p>Latitude: 37.131858 Longitude: -80.13309 Elevation: 2661.75 ft Accuracy: 24.6 ft Time: 10-08-2020 10:24:45 AM 12974+29 Access road RO-288 stream S-KL4</p>			
GPS Location	See pic for GPS location		GPS Location	See pic for GPS location	
Field Station#	12974+29		Field Station#	12974+29	
Pic 7 Desc.	Downstream side of stream S-Q20.		Pic 8 Desc.	Stream crossing S-KL4 on access road RO-288.

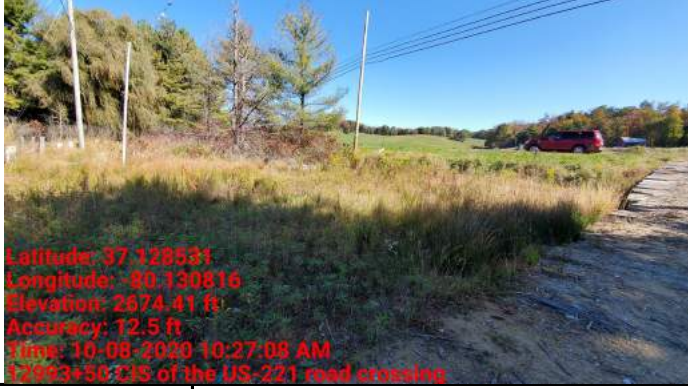
<p>Latitude: 37.128531 Longitude: -80.130816 Elevation: 2674.41 ft Accuracy: 12.5 ft Time: 10-08-2020 10:27:08 AM 12993+50 CIS of the US-221 road crossing</p>

GPS Location	See pic for GPS location		GPS Location	See pic for GPS location	
Field Station#	12993+50		Field Station#	12994+40	
Pic 9 Desc.	CIS of the US-221 road crossing.		Pic 10 Desc.	GAS of the US-221 road crossing.

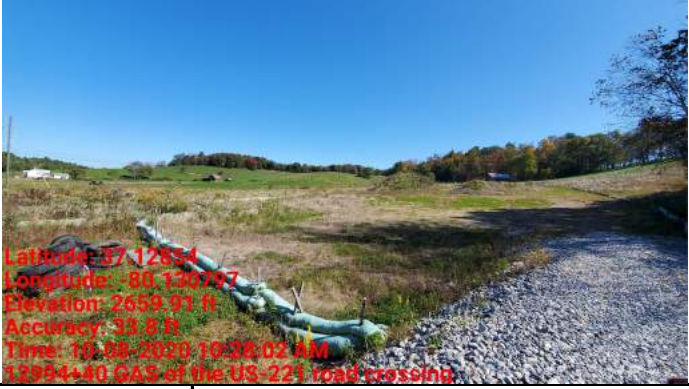
<p>Latitude: 37.128531 Longitude: -80.130797 Elevation: 2659.91 ft Accuracy: 33.8 ft Time: 10-08-2020 10:38:02 AM 12994+40 GAS of the US-221 road crossing</p>

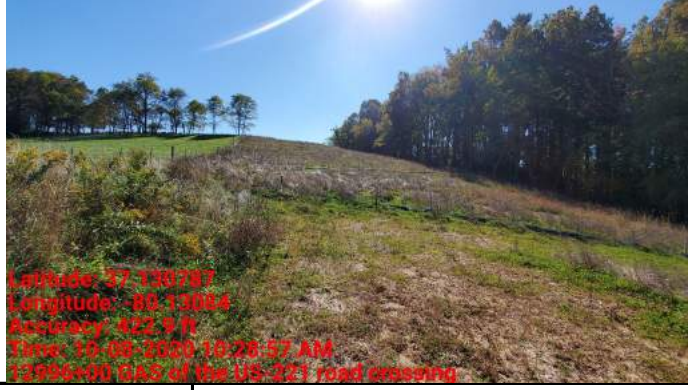
<p>Latitude: 37.130787 Longitude: -80.13084 Elevation: 2723.5 ft Accuracy: 22.5 ft Time: 10-08-2020 10:28:57 AM 12996+00 GAS of the US-221 road crossing</p>

<p>Latitude: 37.125929 Longitude: -80.12542 Elevation: 2718.7 ft Accuracy: 21.3 ft Time: 10-08-2020 11:02:44 AM 13012+40 CIS of the BRP motorway</p>			
GPS Location	See pic for GPS location		GPS Location	See pic for GPS location	
Field Station#	12996+00		Field Station#	13012+40	
Pic 11 Desc.	GAS of the US-221 road crossing up to the CIS of the BRP.		Pic 12 Desc.	CIS of the BRP motorway.
