# Visual Site Inspection Report

<b>Project Name</b>	H-600 Pipeline Spread I	<b>AFE</b>	124300139	<b>Spread</b>	H-600 Pipeline Spread I
<b>Contractor</b>	Precision			<b>Report #</b>	15747
<b>Inspector</b>	Justin Burch			<b>Date/Time</b>	10/19/2020 12:48 PM
<b>Permit #</b>	TBD	<b>Inspection Type</b>	VA SWPP	<b>Station Begin</b>	14802+19
<b>State</b>	VA	<b>Inspection Area</b>	Full	<b>Station End</b>	14928+52
<b>County</b>	Franklin	<b>Ground</b>	Damp	<b>Temperature (°F)</b>	70.00
<b>Municipality</b>	N/A	<b>Weather</b>	Sunny	<b>Rain Gauge (in)</b>	0.00
				<b>Rain Accumulation Time (days)</b>	6.00

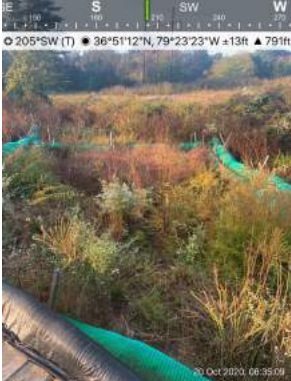
<p>Insert image here</p>			
<b>GPS Location</b>	O	<b>GPS Location</b>			
<b>Field Station#</b>	15839+50	<b>Field Station#</b>			
<b>Pic 7 Desc.</b>	Observing temporary vegetation and ECD's performing as they should.	<b>Pic 8 Desc.</b>			
<p>Insert image here</p>		<p>Insert image here</p>			
<b>GPS Location</b>		<b>GPS Location</b>			
<b>Field Station#</b>		<b>Field Station#</b>			
<b>Pic 9 Desc.</b>		<b>Pic 10 Desc.</b>			
<p>Insert image here</p>		<p>Insert image here</p>			
<b>GPS Location</b>		<b>GPS Location</b>			
<b>Field Station#</b>		<b>Field Station#</b>			
<b>Pic 11 Desc.</b>		<b>Pic 12 Desc.</b>

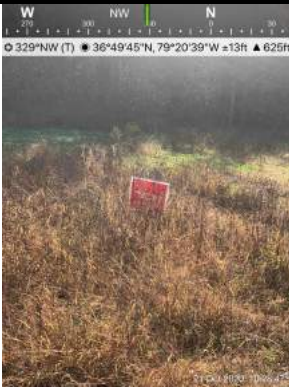
<b>GPS Location</b>	O	<b>GPS Location</b>	O		
<b>Field Station#</b>	11+00	<b>Field Station#</b>	12+65		
<b>Pic 3 Desc.</b>	Observing temporary vegetation and signage.	<b>Pic 4 Desc.</b>	Observing equipment crossing.		
Insert image here			Insert image here		
<b>GPS Location</b>		<b>GPS Location</b>			
<b>Field Station#</b>		<b>Field Station#</b>			
<b>Pic 5 Desc.</b>		<b>Pic 6 Desc.</b>

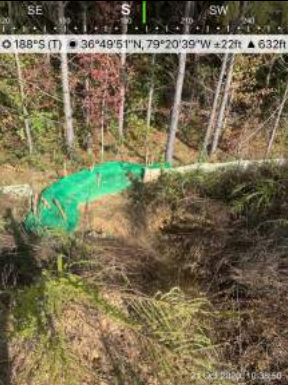
<b>GPS Location</b>	O	<b>GPS Location</b>	O		
<b>Field Station#</b>	16021+00	<b>Field Station#</b>	16022+00		
<b>Pic 1 Desc.</b>	Observing sump and end treatment.	<b>Pic 2 Desc.</b>	Observing water bar and CFS check.

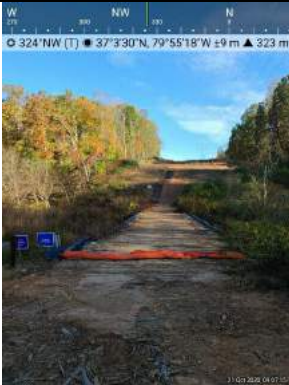
<b>GPS Location</b>	00000	<b>GPS Location</b>	00000		
<b>Field Station#</b>	13834+79	<b>Field Station#</b>	13805+60		
<b>Pic 3 Desc.</b>	Ecds in place at stream crossing along with signs		<b>Pic 4 Desc.</b>	Photo showing equipment bridge in place with ECDs function to protect.

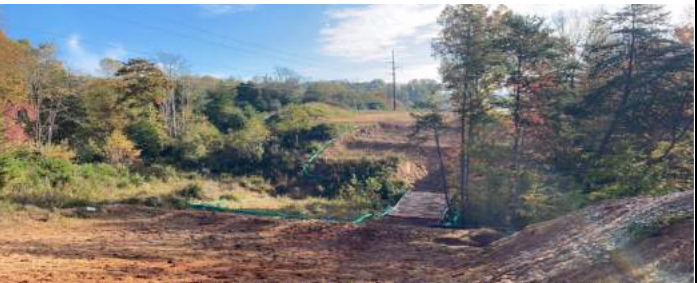
GPS Location	3		GPS Location	4	
Field Station#	14657+00		Field Station#	14675+00	
Pic 3 Desc.	Bridge crossing and surrounding ECD's in place and functional.		Pic 4 Desc.	ROW stable in temporary area. Limited vegetative growth observed. All ECD's in place and functional at stream crossing.

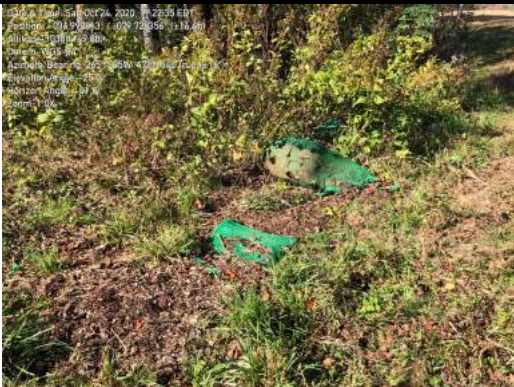
<b>GPS Location</b>	0	<b>GPS Location</b>	0		
<b>Field Station#</b>	14636+75	<b>Field Station#</b>	14570+75		
<b>Pic 3 Desc.</b>	CFS needs maintenance	<b>Pic 4 Desc.</b>	ROW temporary stabilization very little vegetative growth

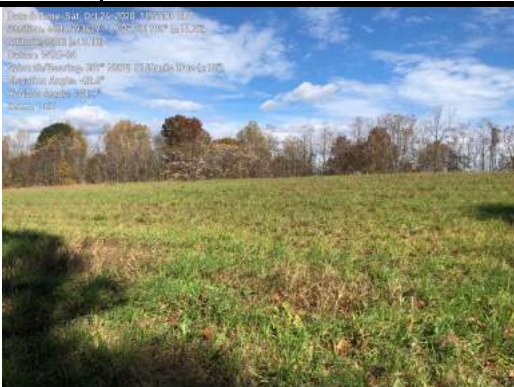
<b>GPS Location</b>	0	<b>GPS Location</b>	0		
<b>Field Station#</b>	14626+00	<b>Field Station#</b>	14649+67		
<b>Pic 5 Desc.</b>	ROW permanently stabilized good vegetative growth	<b>Pic 6 Desc.</b>	RCE in need of maintenance.
