# Visual Site Inspection Report

| <b>Project Name</b> | H-600 Pipeline Spread I | <b>AFE</b> | 124300139 | <b>Spread</b> | H-600 Pipeline Spread I |
| <b>Inspector</b> | John White | | | <b>Date/Time</b> | 10/26/2020 10:40 AM |

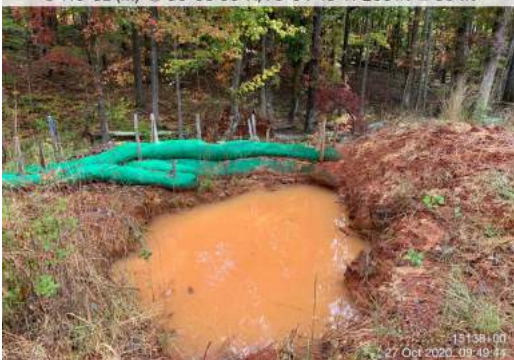
| <b>Pic 3 Desc.</b> | Super silt fence was damaged by a fallen tree | <b>Pic 4 Desc.</b> | Super silt fence in acceptable condition with tree removed and SSF repaired | | |

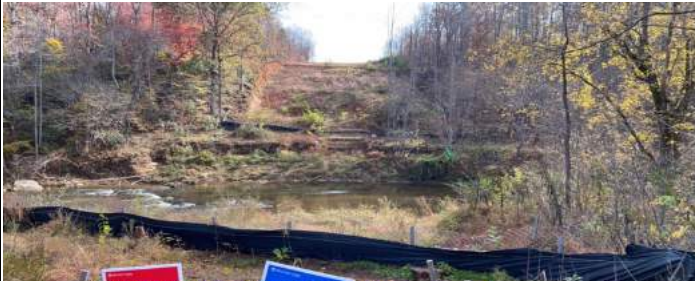
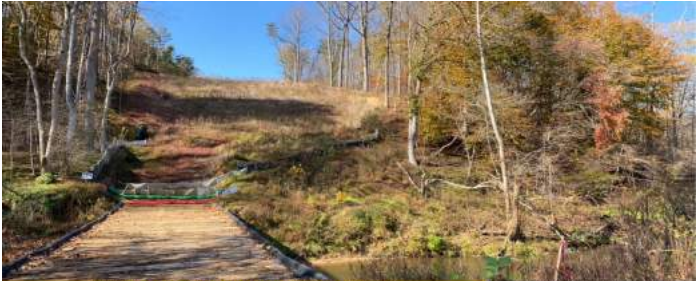
| Pic 3 Desc. | ROW stabilized in temporary area. Equipment bridge and surrounding ECD's in place and functional at stream crossing. | | Pic 4 Desc. | ROW stabilized in temporary area. Equipment bridge and surrounding ECD's in place and functional at stream crossing. | |

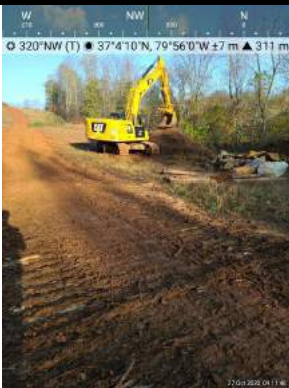
| <b>Pic 3 Desc.</b> | Row photo taken during routine inspection throughout | | <b>Pic 4 Desc.</b> | Stream observation photo facing downstream, no environmental issues observed at the time of inspection. | |

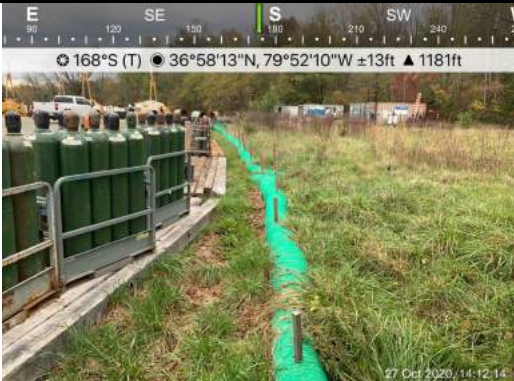
| <b>Pic 3 Desc.</b> | Perimeter ECD's on south end of paved yard in good condition | | <b>Pic 4 Desc.</b> | Secondary containment structure for fuel cell in compliance. | |

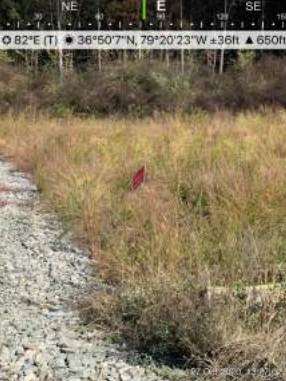
| <b>Pic 1 Desc.</b> | Observing storm water pond and ECD's.(clicked on the wrong picture) | <b>Pic 2 Desc.</b> | Observing RCE, temporary vegetation and signage. | | |

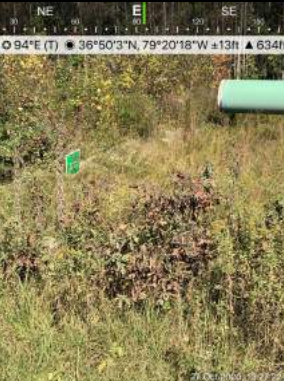
| <b>Pic 3 Desc.</b> | Observing temporary vegetation and signage. | <b>Pic 4 Desc.</b> | Observing temporary vegetation and signage. | | |

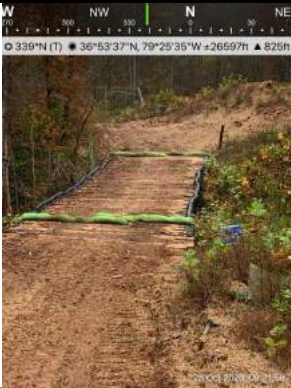
| <b>Pic 3 Desc.</b> | Observing equipment crossing, temporary stabilization and signage. | <b>Pic 4 Desc.</b> | Observing temporary stabilization and signage. | | |

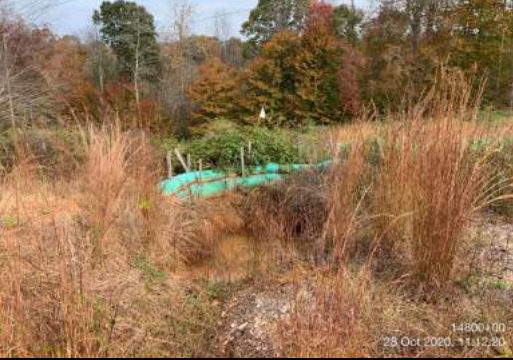
| <b>Pic 3 Desc.</b> | P1 silt fence has a broken stake | <b>Pic 4 Desc.</b> | P1 silt fence in acceptable condition; P1 silt fence was repaired with new stake installed | | |

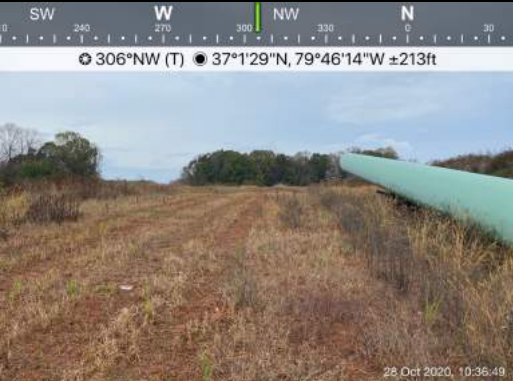
| <b>Pic 3 Desc.</b> | Approximately 14330+00. Overview of ROW and ECDs. ROW temporarily stabilized and has temporary vegetation growing. | | <b>Pic 4 Desc.</b> | Approximately 14391+53. Overview of stream crossing, equipment bridge and ECDs at stream S-A41. | |

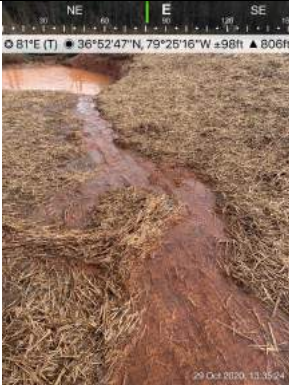
| <b>Pic 1 Desc.</b> | Observing water flowing into sump after the rain event. | <b>Pic 2 Desc.</b> | Observing undermined end treatment that requires maintenance. | | |

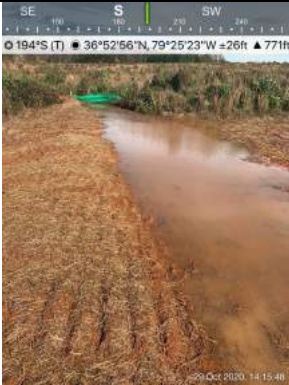
| <b>Pic 3 Desc.</b> | Observing water bar that is dNot discharging water off row. | <b>Pic 4 Desc.</b> | Observing wattle that requires maintenance. | | |

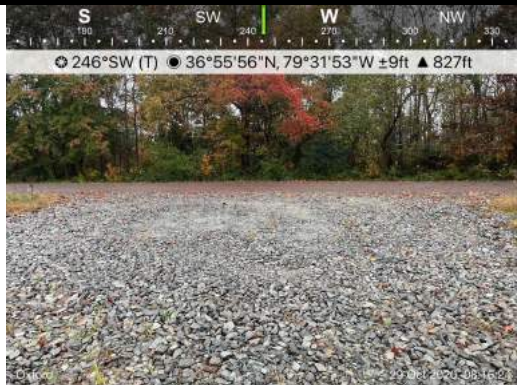
| <b>Pic 9 Desc.</b> | Waterbar flow path is obstructed. | | <b>Pic 10 Desc.</b> | Sediment and straw have been removed from flow path. | |

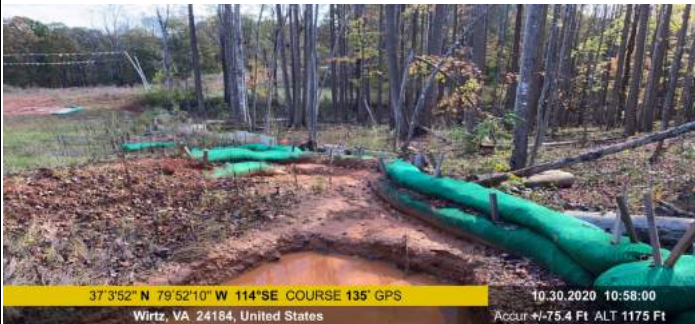
| Pic 3 Desc. | Routine maintenance. Rill erosion across ROW needs repaired and stabilized. | Pic 4 Desc. | Routine maintenance. Throat of water bar eroding away from heavy water flow. Repair and stabilize area. | | |

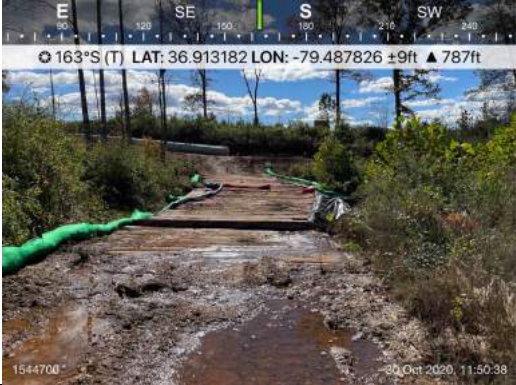
| <b>Pic 7 Desc.</b> | Equipment bridge at stream S-CC16 has shifted during flooding. Sideboards and CFS have been displaced. Crew repairing these | <b>Pic 8 Desc.</b> | | | |

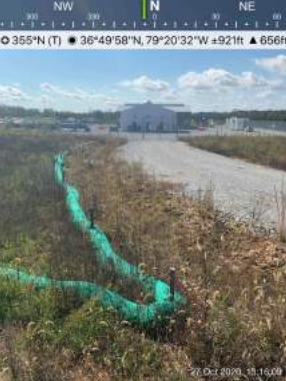
| <b>Pic 1 Desc.</b> | Observing storm water pond and ECD's performing as they should. | | <b>Pic 2 Desc.</b> | Observing temporary vegetation, rock check dam and ECD's performing as they should. | |
