# Visual Site Inspection Report

<b>Project Name</b>	H-603 Pipeline Spread I	<b>AFE</b>	124300139	<b>Spread</b>	H-603 Pipeline Spread I	
<b>Contractor</b>	Precision			<b>Report #</b>	16311	
<b>Inspector</b>	John White			<b>Date/Time</b>	11/2/2020 10:31 AM	
<b>Permit #</b>	TBD	<b>Inspection Type</b>	VA SWPP	<b>Station Begin</b>	00+00	
<b>State</b>	VA	<b>Inspection Area</b>	Full	<b>Station End</b>	24+53	
<b>County</b>	Pittsylvania	<b>Ground</b>	Wet	<b>Temperature (°F)</b>	47.00	
<b>Municipality</b>	Chatham	<b>Weather</b>	Sunny	<b>Rain Gauge (in)</b>	2.60	
				<b>Rain Accumulation Time (days)</b>	6.00

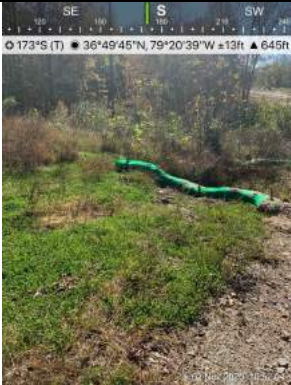
<b>GPS Location</b>	O	<b>GPS Location</b>	O		
<b>Field Station#</b>	12+00	<b>Field Station#</b>	12+65		
<b>Pic 3 Desc.</b>	Observing ECD's and buffer performing as they should.		<b>Pic 4 Desc.</b>	Observing equipment crossing and ECD's performing as they should.	
Insert image here			Insert image here		
<b>GPS Location</b>		<b>GPS Location</b>			
<b>Field Station#</b>		<b>Field Station#</b>			
<b>Pic 5 Desc.</b>			<b>Pic 6 Desc.</b>

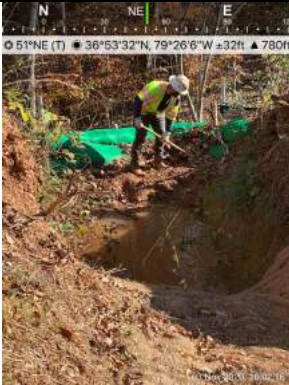
<b>GPS Location</b>	O	<b>GPS Location</b>	O		
<b>Field Station#</b>	15634+00	<b>Field Station#</b>	15634+00		
<b>Pic 3 Desc.</b>	Observing contractor performing maintenance.	<b>Pic 4 Desc.</b>	Observing end treatment that required maintenance

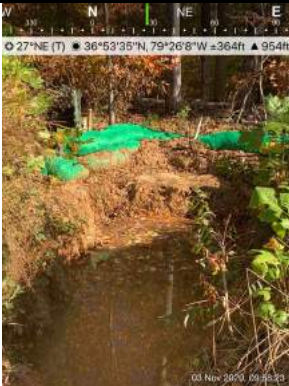
<b>GPS Location</b>	O	<b>GPS Location</b>	O		
<b>Field Station#</b>	15632+00	<b>Field Station#</b>	1563+20		
<b>Pic 5 Desc.</b>	Observing end treatment that required maintenance.	<b>Pic 6 Desc.</b>	Observing contractor performing maintenance.

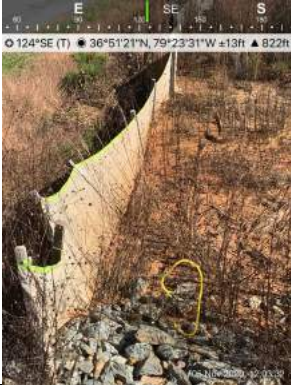
<b>GPS Location</b>	O	<b>GPS Location</b>	O		
<b>Field Station#</b>	15827+00	<b>Field Station#</b>	15827+00		
<b>Pic 7 Desc.</b>	Observing p1 that requires maintenance.	<b>Pic 8 Desc.</b>	Observing p1 that requires maintenance.		
Insert image here		Insert image here			
<b>GPS Location</b>		<b>GPS Location</b>			
<b>Field Station#</b>		<b>Field Station#</b>			
<b>Pic 9 Desc.</b>		<b>Pic 10 Desc.</b>			
Insert image here		Insert image here			
<b>GPS Location</b>		<b>GPS Location</b>			
<b>Field Station#</b>		<b>Field Station#</b>			
<b>Pic 11 Desc.</b>		<b>Pic 12 Desc.</b>

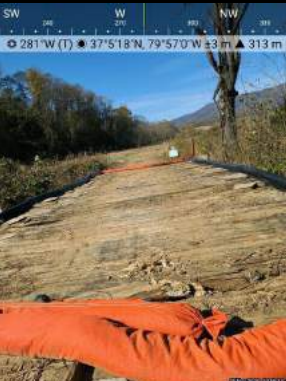
<b>Field Station#</b>	13678+71	<b>Field Station#</b>	13730+00		
<b>Pic 5 Desc.</b>	Ecds in place over a stream crossing on a problem land owner area.		<b>Pic 6 Desc.</b>	Photo taken by the EI during routine SWPPP inspection showing the contractor backfilling a ditch in a upland area., no environmental issues observed at the time of inspection.

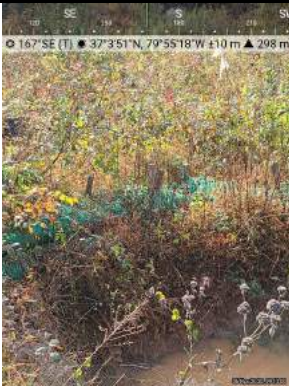
<b>Pic 5 Desc.</b>	CFS end treatment needs replaced due to being weathered, EI Documented and sent in to be added to the punch list.		<b>Pic 6 Desc.</b>	Ecds in place and hill side above stream crossing stabilized

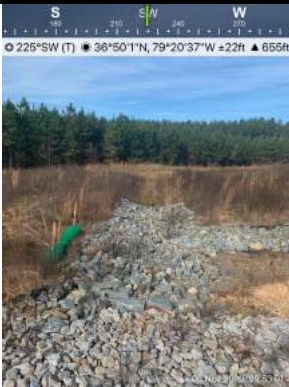
<b>GPS Location</b>	O	<b>GPS Location</b>	O		
<b>Field Station#</b>	00+00	<b>Field Station#</b>	00+00		
<b>Pic 3 Desc.</b>	Observing rock drain.	<b>Pic 4 Desc.</b>	Observing materials that have been dumped on the Transco RCE.		
Insert image here		Insert image here			
<b>GPS Location</b>		<b>GPS Location</b>			
<b>Field Station#</b>		<b>Field Station#</b>			
<b>Pic 5 Desc.</b>		<b>Pic 6 Desc.</b>
