Visual Site Inspection Report

Project Name	H-600 Pipeline Spread I	AFE	124300139	Spread	H-600 Pipeline Spread I
Contractor	Precision			Report #	16592
Inspector	Ben Davenport			Date/Time	11/9/2020 9:09 AM
Permit #	TBD	Inspection Type	VA SWPP	Station Begin	13853+45
State	VA	Inspection Area	Partial	Station End	13958+31
County	Franklin	Ground	Dry	Temperature (°F)	74.00
Municipality	N/A	Weather	Sunny	Rain Gauge (in)	0.00
				Rain Accumulation Time (days)	0.00

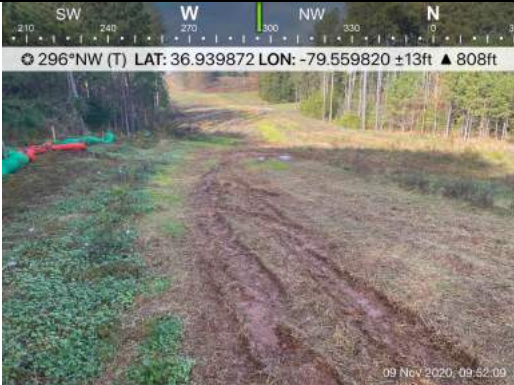
GPS Location	3	GPS Location	4		
Field Station#	15207+00	Field Station#	15207+00		
Pic 3 Desc.	Rill erosion on this slope needs to be regraded and stabilized.		Pic 4 Desc.	Environmental crew on site has regraded and stabilized this area.

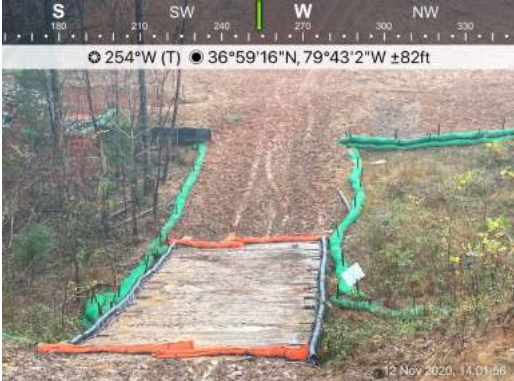
GPS Location	0	GPS Location	0		
Field Station#	14673+10	Field Station#	14675+00		
Pic 3 Desc.	Approximately 14673+10. Overview of stream crossing, equipment bridge and ECDs at stream S-H37.		Pic 4 Desc.	Approximately 14675+00. Overview of ROW. ROW temporarily stabilized and has temporary vegetation growing.

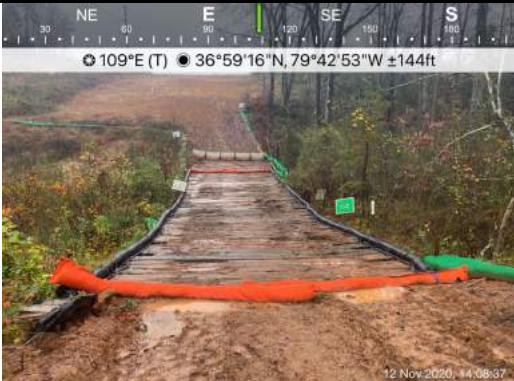
GPS Location	0	GPS Location	0		
Field Station#	14680+37	Field Station#	14689+36		
Pic 5 Desc.	Approximately 14680+37. Overview of stream crossing, equipment bridge and ECDs at stream S-H36.		Pic 6 Desc.	Approximately 14689+36. Overview of stream crossing, equipment bridge and ECDs at stream S-H34.

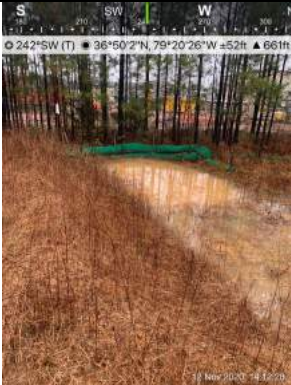
GPS Location	O	GPS Location	O		
Field Station#	10+00	Field Station#	13+00		
Pic 3 Desc.	Observing water bar, sump and end treatment.	Pic 4 Desc.	Observing sump and end treatment.		
Insert image here		Insert image here			
GPS Location		GPS Location			
Field Station#		Field Station#			
Pic 5 Desc.		Pic 6 Desc.

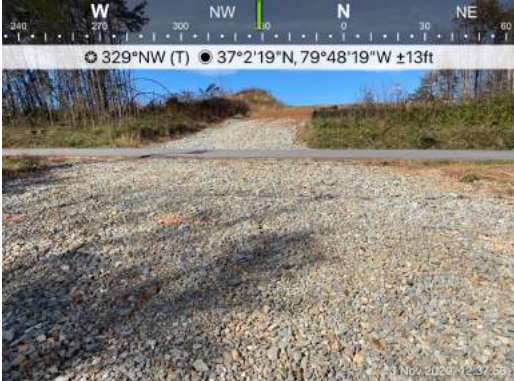
GPS Location	0	GPS Location	0		
Field Station#	14333+50	Field Station#	14375+00		
Pic 3 Desc.	Approximately 14333+50. Overview of road crossing and RCEs. RCEs installed and appears to be functioning correctly at time of inspection.		Pic 4 Desc.	Approximately 14375+00. Overview of ROW. ROW temporarily stabilized and has temporary vegetation growing.

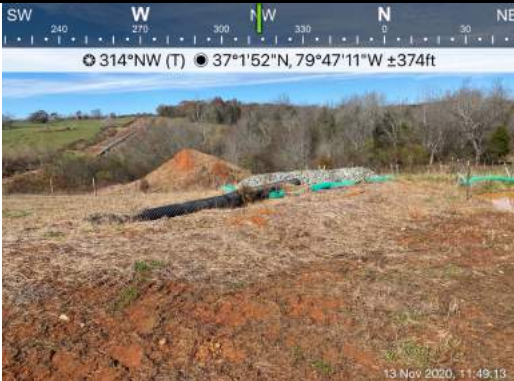
GPS Location	0	GPS Location	0		
Field Station#	14398+00	Field Station#	14438+49		
Pic 5 Desc.	Approximately 14398+00. Overview of CWD piping and level spreader. CWD piping installed and appears to be functioning correctly at time of inspection.		Pic 6 Desc.	Approximately 14438+49. Overview of stream crossing, equipment bridge and ECDs at stream S-IJ47.
