# Visual Site Inspection Report

<b>Project Name</b>	H-600 Pipeline Spread I	<b>AFE</b>	124300139	<b>Spread</b>	H-600 Pipeline Spread I
<b>Contractor</b>	Precision			<b>Report #</b>	15213
<b>Inspector</b>	Justin Burch			<b>Date/Time</b>	10/5/2020 11:30 AM
<b>Permit #</b>	TBD	<b>Inspection Type</b>	VA SWPP	<b>Station Begin</b>	14694+77
<b>State</b>	VA	<b>Inspection Area</b>	Full	<b>Station End</b>	15142+66
<b>County</b>	Franklin/Pittsylvania	<b>Ground</b>	Damp	<b>Temperature (°F)</b>	68.00
<b>Municipality</b>	Chatham	<b>Weather</b>	Sunny	<b>Rain Gauge (in)</b>	1.20
				<b>Rain Accumulation Time (days)</b>	6.00

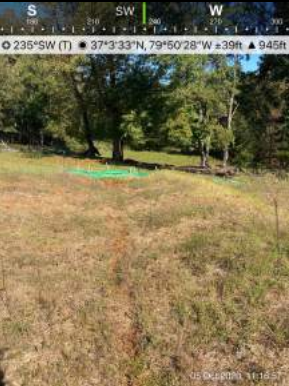
<b>GPS Location</b>	0	<b>GPS Location</b>	0		
<b>Field Station#</b>	13925+00	<b>Field Station#</b>	13915+82		
<b>Pic 3 Desc.</b>	Approximately 13925+00. Overview of ROW. ROW temporarily stabilized and has temporary vegetation growing.		<b>Pic 4 Desc.</b>	Approximately 13915+82. Overview of stream crossing, equipment bridge and ECDs at stream S-II2.

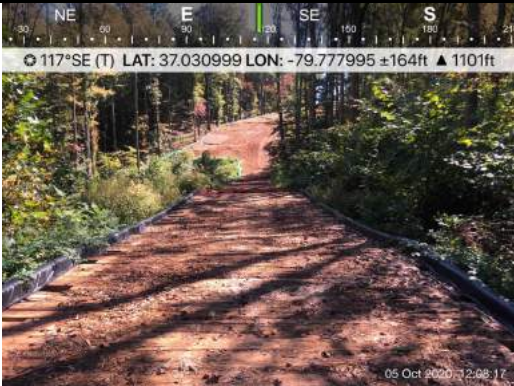
<b>GPS Location</b>	0	<b>GPS Location</b>	0		
<b>Field Station#</b>	14353+53	<b>Field Station#</b>	14405+00		
<b>Pic 3 Desc.</b>	Equipment bridge clean at stream S-A38	<b>Pic 4 Desc.</b>	Temporary stabilization on the GAS of Golden View Road

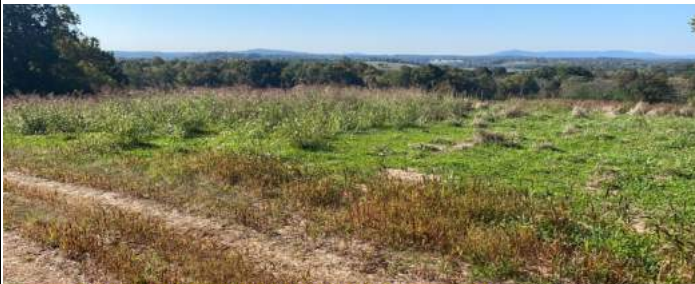
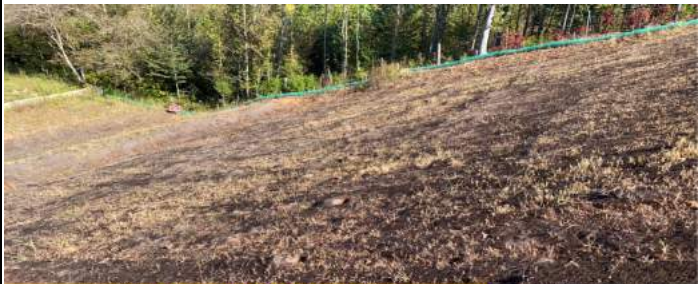
36°56'50" N 79°34'40" W 222°SW COURSE 339' GPS Sandy Level, VA 24161, United States 10.06.2020 10:29:40 Accur +/-15.4 Ft ALT 916 Ft			36°56'37" N 79°34'15" W 358°N COURSE 9' GPS Sandy Level, VA 24161, United States 10.06.2020 10:41:56 Accur +/-22.4 Ft ALT 754 Ft		
<b>GPS Location</b>	1	<b>GPS Location</b>	2		
<b>Field Station#</b>	15146+00	<b>Field Station#</b>	15170+00		
<b>Pic 1 Desc.</b>	View of permanent vegetation growing along ROW. Noticeable travel lane use. No erosion issues observed.		<b>Pic 2 Desc.</b>	Slope in temporary vegetated area GAS Rock Creek Rd. Entire slope had Curlex installed but limited vegetative growth observed.

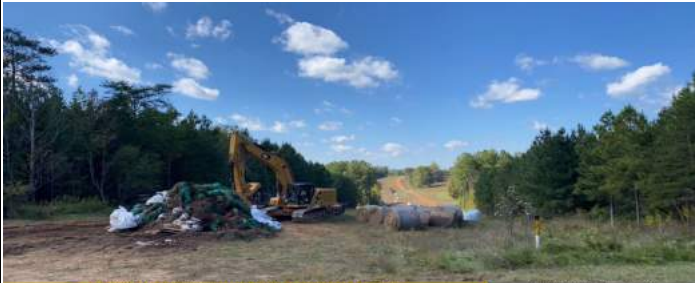
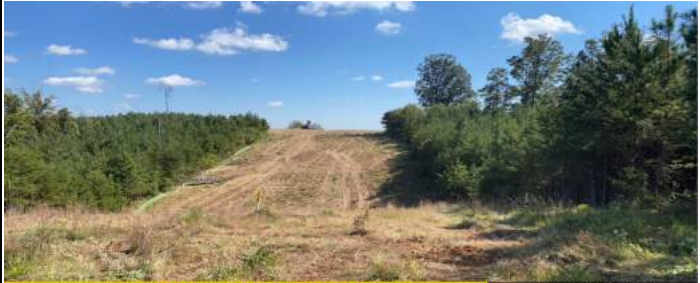
36°56'23" N 79°33'30" W 312°NW COURSE 332' GPS 3400-3480 Grassland Dr, Sandy Level, VA 24161, United States 10.06.2020 13:26:39 Accur +/-90.0 Ft ALT 838 Ft			36°56'18" N 79°33'18" W 60°E COURSE 0' GPS 3400-3480 Grassland Dr, Sandy Level, VA 24161, United States 10.06.2020 13:25:19 Accur +/-80.7 Ft ALT 0 Ft		
<b>GPS Location</b>	5	<b>GPS Location</b>	6		
<b>Field Station#</b>	15209+50	<b>Field Station#</b>	15222+00		
<b>Pic 5 Desc.</b>	Contractor removing worn/damaged CFS and garbage and piling material to be taken off-site.		<b>Pic 6 Desc.</b>	Contractor stabilized ROW with straw mulch after replacing perimeter CFS.

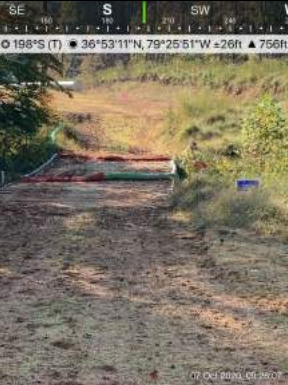
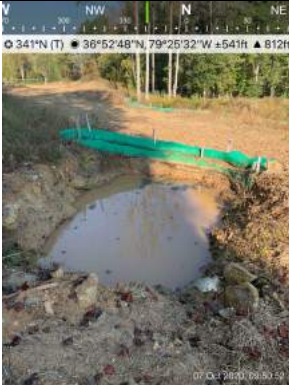
<b>GPS Location</b>	O	<b>GPS Location</b>	O		
<b>Field Station#</b>	15658+43	<b>Field Station#</b>	15678+57		
<b>Pic 1 Desc.</b>	Observing equipment crossing, signage and ECD's performing as they should.	<b>Pic 2 Desc.</b>	Observing sump and end treatment performing as they should.

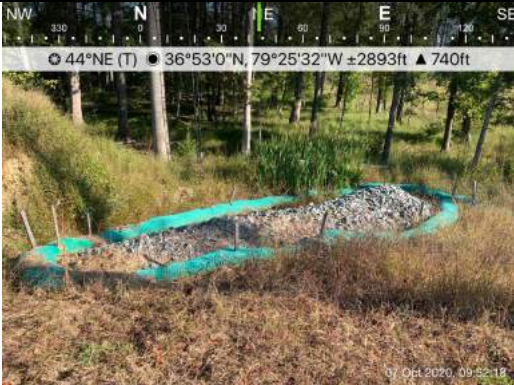
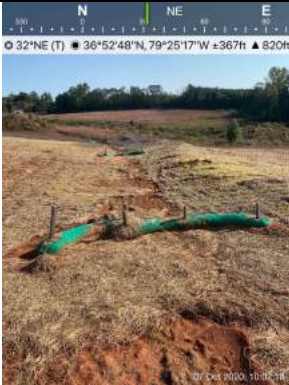
<b>GPS Location</b>	O	<b>GPS Location</b>	O		
<b>Field Station#</b>	15677+00	<b>Field Station#</b>	15696+00		
<b>Pic 3 Desc.</b>	Observing CWD outlet and ECD's performing as they should.	<b>Pic 4 Desc.</b>	Observing water bar and CFS checks performing as they should.

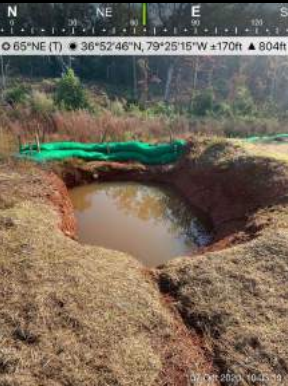
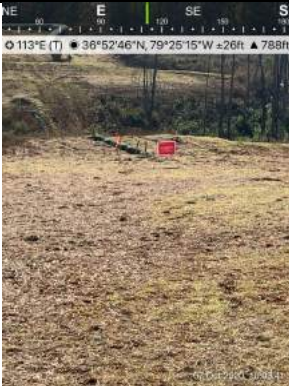
<b>GPS Location</b>	O	<b>GPS Location</b>	O		
<b>Field Station#</b>	15697+00	<b>Field Station#</b>	156850+00		
<b>Pic 5 Desc.</b>	Observing sump and end treatment performing as they should.	<b>Pic 6 Desc.</b>	Observing temporary stabilization, signage and ECD's performing as they should.

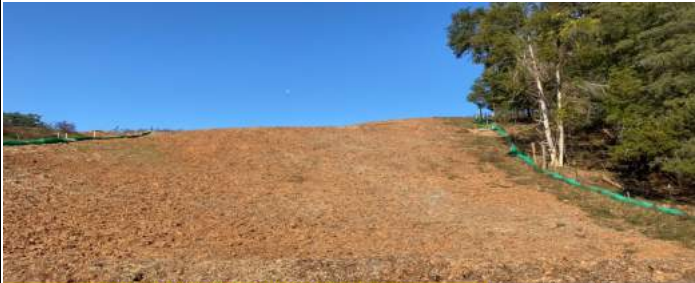
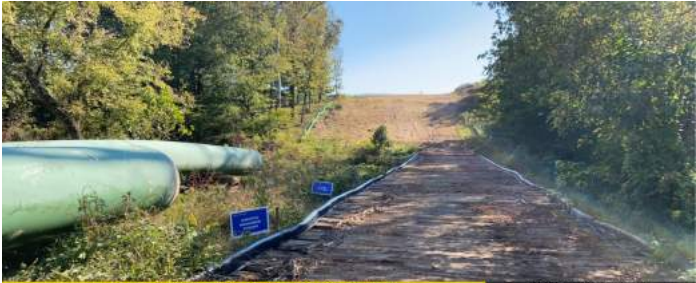
36°55'47" N 79°31'36" W 280°W COURSE 113' GPS 1624 Lark Dr, Chatham, VA 24531, United States 10.07.2020 10:41:50 Accur +/-30.6 Ft ALT 673 Ft			36°55'47" N 79°31'35" W 107°E COURSE 80' GPS Chatham, VA 24531, United States 10.07.2020 10:42:53 Accur +/-25.9 Ft ALT 665 Ft		
<b>GPS Location</b>	5	<b>GPS Location</b>	6		
<b>Field Station#</b>	15304+00	<b>Field Station#</b>	15314+19		
<b>Pic 5 Desc.</b>	Limited to no vegetation growing in temporary area. This section of ROW is accessible by cattle.		<b>Pic 6 Desc.</b>	Updated signage at stream crossing of S-C3

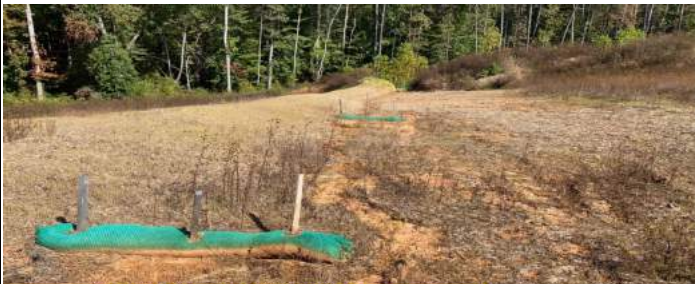
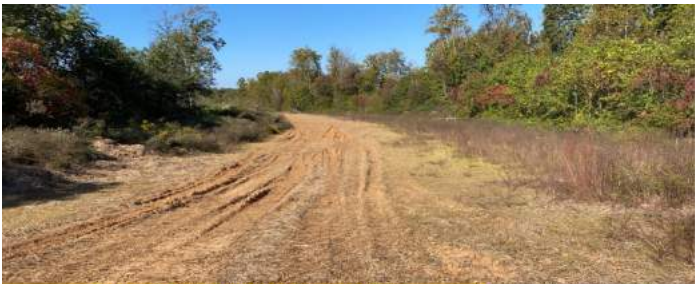
36°54'55" N 79°29'21" W 10°N COURSE 304° GPS Chatham, VA 24531, United States 10.08.2020 11:32:30 Accur +/-33.9 Ft ALT 813 Ft			36°54'45" N 79°28'59" W 273°W COURSE 0° GPS Chatham, VA 24531, United States 10.08.2020 11:19:08 Accur +/-71.7 Ft ALT 0 Ft		
GPS Location	1	GPS Location	2		
Field Station#	15437+00	Field Station#	15461+00		
Pic 1 Desc.	Ineffective ESC measure. CFS check dams not filtering causing water/sediment to channel around checks. Replace.		Pic 2 Desc.	Rutting caused by third party vehicle observed along ROW CIS Toshes Rd. Will monitor area for erosion issues that might occur.

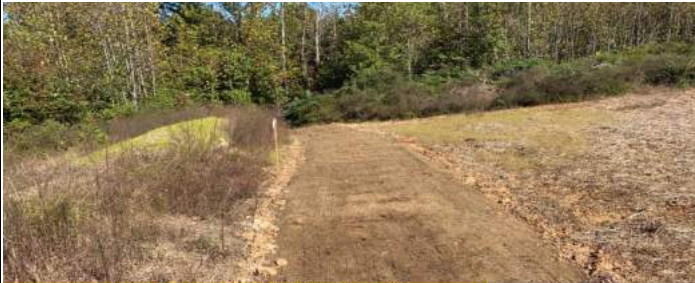
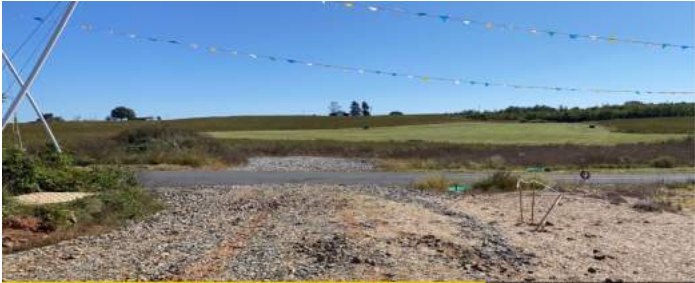
36°54'45" N 79°28'59" W 342°N COURSE 35° GPS Chatham, VA 24531, United States 10.08.2020 11:19:27 Accur +/-20.0 Ft ALT 859 Ft			36°54'37" N 79°28'39" W 151°SE COURSE 264° GPS 1535-2357 Toshes Rd, Chatham, VA 24531, United States 10.08.2020 11:10:50 Accur +/-22.2 Ft ALT 905 Ft		
GPS Location	5	GPS Location	6		
Field Station#	15460+00	Field Station#	15480+67		
Pic 5 Desc.	Erosion control blanket installed in throats of water bar per previous punch list identification. No erosion observed during inspection.		Pic 6 Desc.	RCE at Toshes Rd observed to be in good condition during inspection.

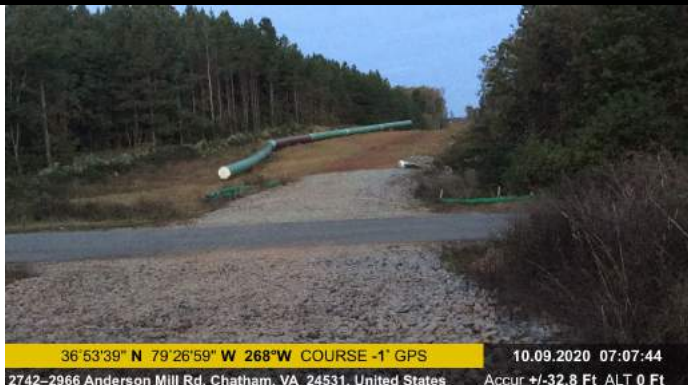
<b>GPS Location</b>	3	<b>GPS Location</b>	4		
<b>Field Station#</b>	15488+00	<b>Field Station#</b>	15495+00		
<b>Pic 3 Desc.</b>	Vegetation growing uniformly in final cleanup area between Toshes Rd and Climax Rd. Travel lane has been utilized by contractor and load/unloaders.		<b>Pic 4 Desc.</b>	Spoil pile where section turns from permanent to temporary stabilization CIS Toshes Rd. Spoil pile is stabilized per specifications.

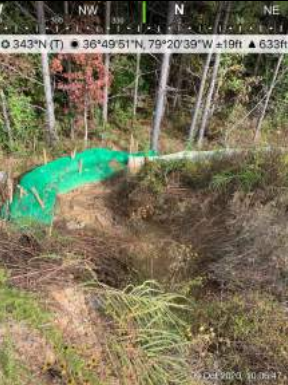
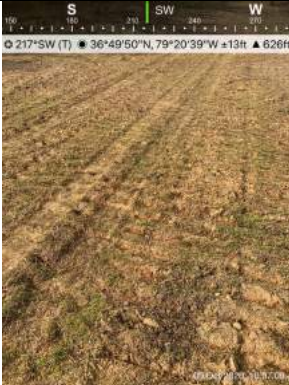
<b>GPS Location</b>	O	<b>GPS Location</b>	O		
<b>Field Station#</b>	16022+00	<b>Field Station#</b>	16021+50		
<b>Pic 1 Desc.</b>	Observing sump and end treatment performing as they should.	<b>Pic 2 Desc.</b>	Observing temporary vegetation/stabilization.

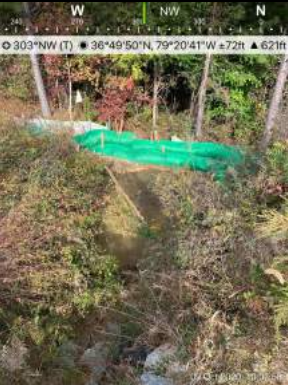
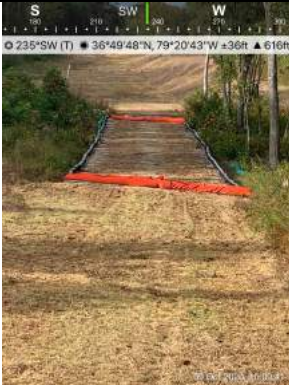
<b>GPS Location</b>	O	<b>GPS Location</b>	O		
<b>Field Station#</b>	16020+00	<b>Field Station#</b>	16016+36		
<b>Pic 3 Desc.</b>	Observing sump and end treatment performing as they should.	<b>Pic 4 Desc.</b>	Observing equipment crossing and ECD's performing as they should.

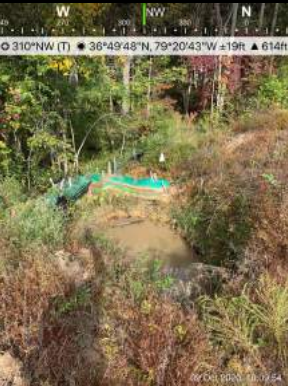
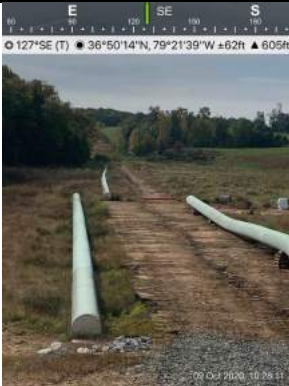
<b>GPS Location</b>	O	<b>GPS Location</b>	O		
<b>Field Station#</b>	16017+50	<b>Field Station#</b>	15952+00		
<b>Pic 5 Desc.</b>	Observing sump and end treatment performing as they should.	<b>Pic 6 Desc.</b>	Observing equipment crossing and ECD's performing as they should.

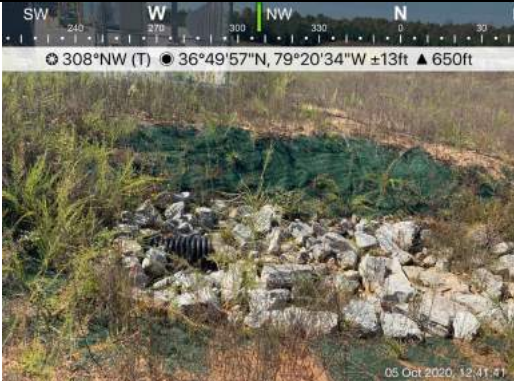
<b>GPS Location</b>	O	<b>GPS Location</b>	O		
<b>Field Station#</b>	00+00	<b>Field Station#</b>	00+00		
<b>Pic 3 Desc.</b>	Observing outlet and outlet protection.		<b>Pic 4 Desc.</b>	Observing rock drain and ECD's performing as they should.	
Insert image here			Insert image here		
<b>GPS Location</b>		<b>GPS Location</b>			
<b>Field Station#</b>		<b>Field Station#</b>			
<b>Pic 5 Desc.</b>			<b>Pic 6 Desc.</b>
