Visual Site Inspection Report

Project Name	H-600 Pipeline Spread G	AFE	124300137	Spread	H-600 Pipeline Spread G
Contractor	Precision			Report #	18704
Inspector	Len Kruizenga			Date/Time	1/4/2021 12:45 PM
Permit #	TBD	Inspection Type	VA SWPP	Station Begin	11254+99
State	VA	Inspection Area	Full	Station End	11158+27
County	Giles	Ground	Muddy	Temperature (°F)	32.00
Municipality	N/A	Weather	Cloudy	Rain Gauge (in)	0.05
				Rain Accumulation Time (days)	1.00

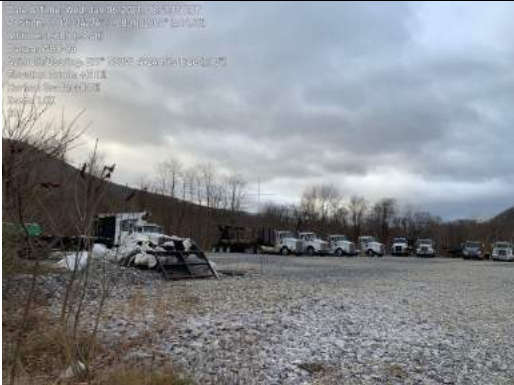
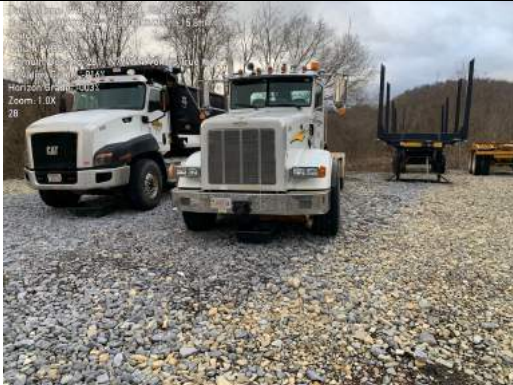
GPS Location	See pictures above for gps locations		GPS Location	See pictures above for gps locations	
Field Station#	12005+00		Field Station#	12005+00	
Pic 1 Desc.	ECDs and ROW conditions		Pic 2 Desc.	ECDs and ROW conditions

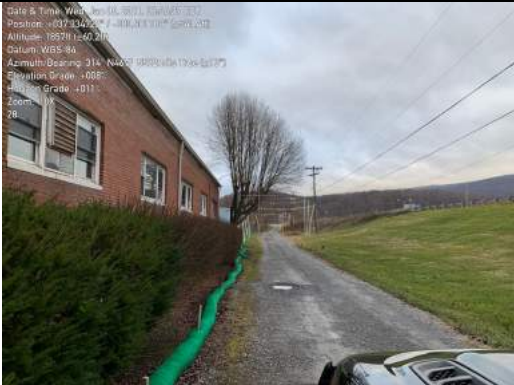
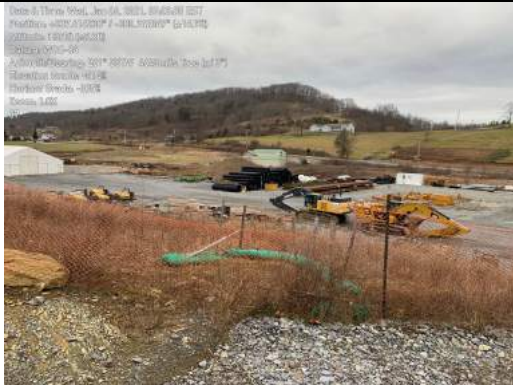
GPS Location	See pictures above for gps coordinate		GPS Location	See pictures above for gps locations	
Field Station#	12005+00		Field Station#	12005+00	
Pic 3 Desc.	ECDs and ROW conditions		Pic 4 Desc.	ECDs and ROW conditions

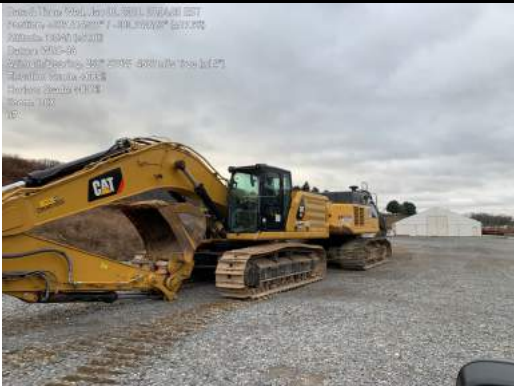
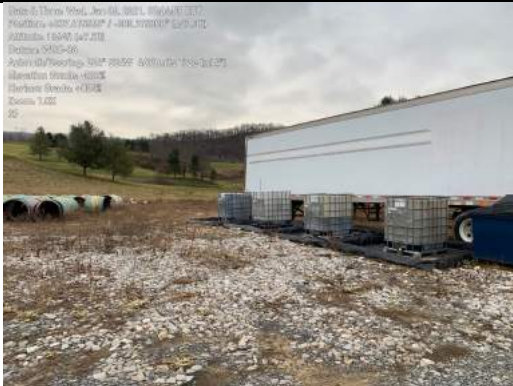
GPS Location	See pictures above for gps locations		GPS Location	See pictures above for gps locations	
Field Station#	12005+00		Field Station#	12005+00	
Pic 5 Desc.	ECDs and ROW conditions		Pic 6 Desc.	ECDs and ROW conditions

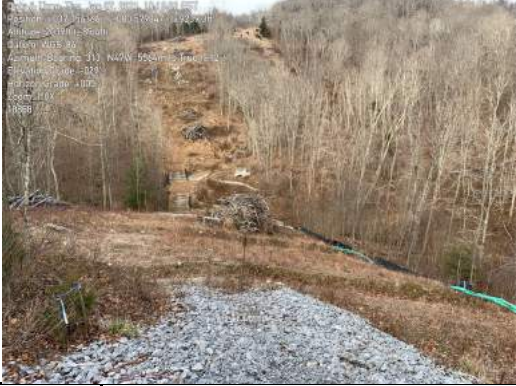
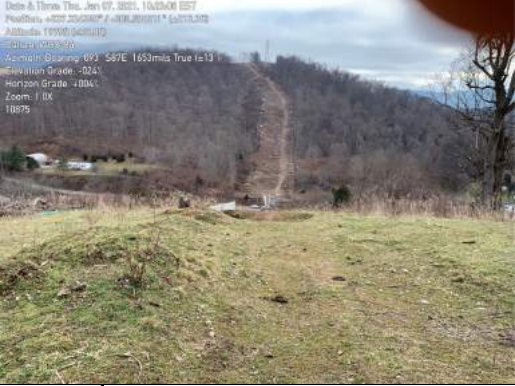
GPS Location	See picture above for GPS coordinates		GPS Location	See picture above for GPS coordinates	
Field Station#	10858+00		Field Station#	10875+00	
Pic 1 Desc.	ECD's and row conditions		Pic 2 Desc.	ECD's and row conditions

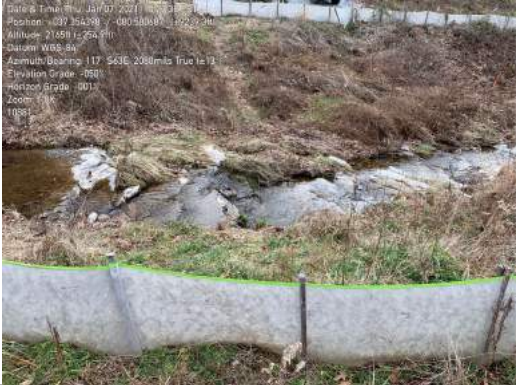
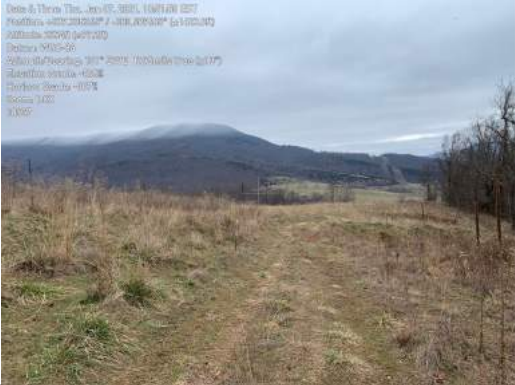
GPS Location	See picture above for GPS coordinates		GPS Location	See picture above for GPS coordinates	
Field Station#	10881+00		Field Station#	10907+00	
Pic 3 Desc.	ECD's and row conditions		Pic 4 Desc.	ECD's and row conditions

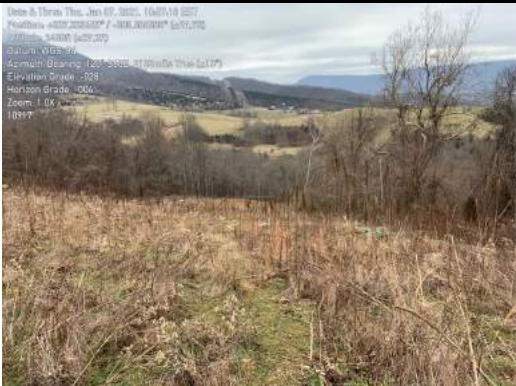
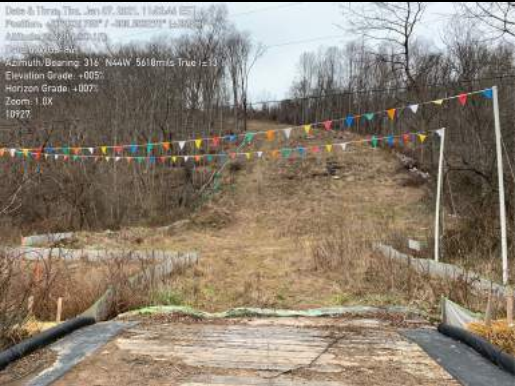
GPS Location	See picture above for GPS coordinates		GPS Location	See picture above for GPS coordinates	
Field Station#	10917+00		Field Station#	10927+00	
Pic 5 Desc.	ECD's and row conditions		Pic 6 Desc.	ECD's and row conditions

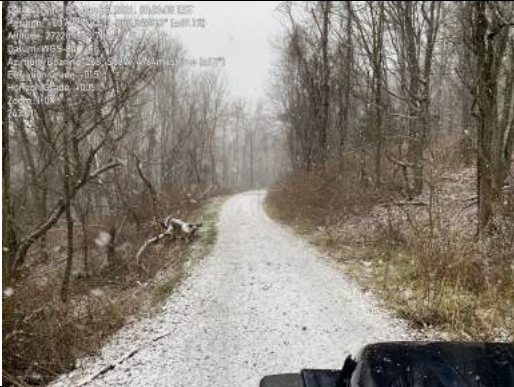
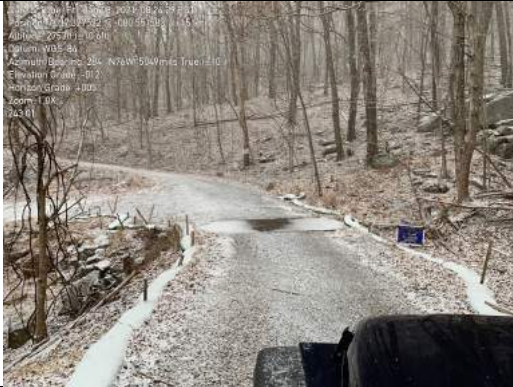
GPS Location	See picture above for GPS coordinates		GPS Location	See picture above for GPS coordinates	
Field Station#	+1		Field Station#	+1	
Pic 1 Desc.	ECD's and row conditions 243.01		Pic 2 Desc.	ECD's and row conditions AR 243.01

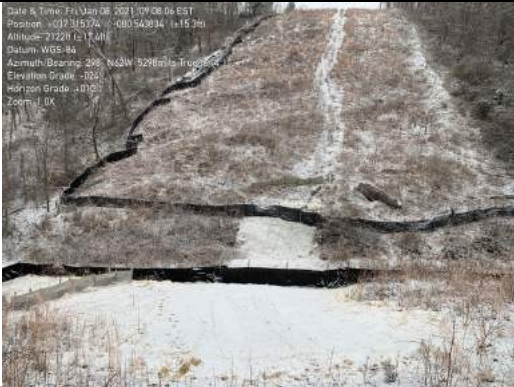
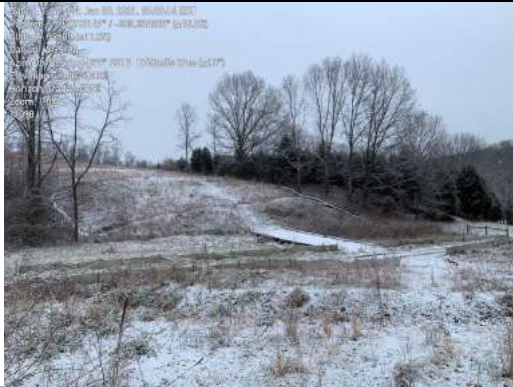
GPS Location	See picture above for GPS coordinates		GPS Location	See picture above for GPS coordinates	
Field Station#	11064+53		Field Station#	11098+00	
Pic 3 Desc.	ECD's and row conditions		Pic 4 Desc.	ECD's and row conditions

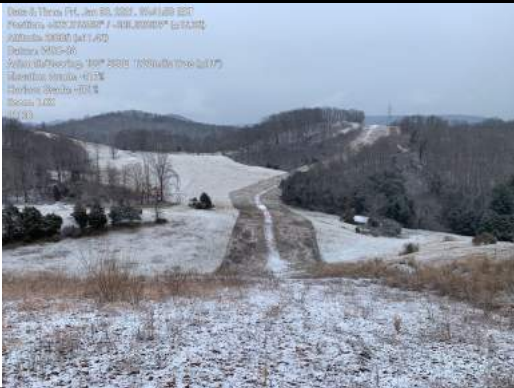
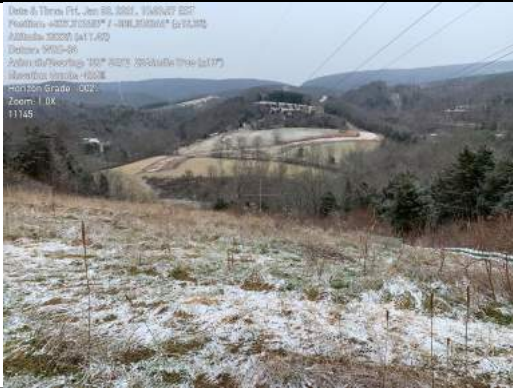
GPS Location	See picture above for GPS coordinates		GPS Location	See picture above for GPS coordinates	
Field Station#	11120+00		Field Station#	11145+00	
Pic 5 Desc.	ECD's and row conditions		Pic 6 Desc.	ECD's and row conditions
