Visual Site Inspection Report

Project Name	H-600 Pipeline Spread G	AFE	124300137	Spread	H-600 Pipeline Spread G
Contractor	Precision			Report #	18926
Inspector	Garrett Barclay			Date/Time	1/11/2021 12:29 PM
Permit #	TBD	Inspection Type	VA SWPP	Station Begin	11524+16
State	VA	Inspection Area	Partial	Station End	11600+01
County	Giles	Ground	Frozen	Temperature (°F)	26.00
Municipality	N/A	Weather	Snow/Sleet	Rain Gauge (in)	0.00
				Rain Accumulation Time (days)	1.00

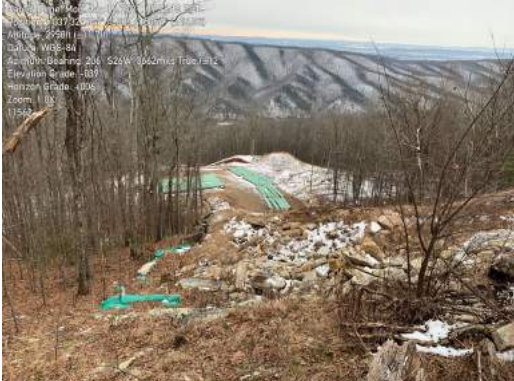
GPS Location	See picture above for GPS coordinates		GPS Location	See picture above for GPS coordinates	
Field Station#	11562+00		Field Station#	11568+00	
Pic 3 Desc.	ECD's and row conditions		Pic 4 Desc.	ECD's and row conditions

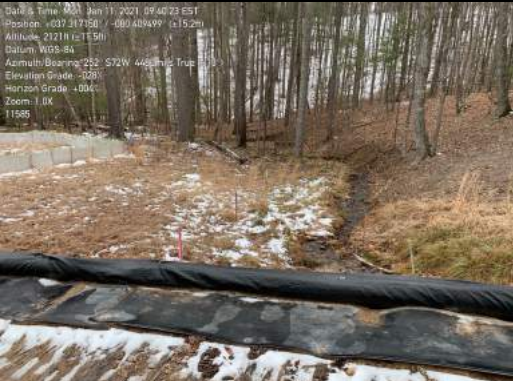
GPS Location	See picture above for GPS coordinates		GPS Location	See picture above for GPS coordinates	
Field Station#	11568+00		Field Station#	11585+00	
Pic 5 Desc.	Sediment build up on CFS		Pic 6 Desc.	ECD's and row conditions

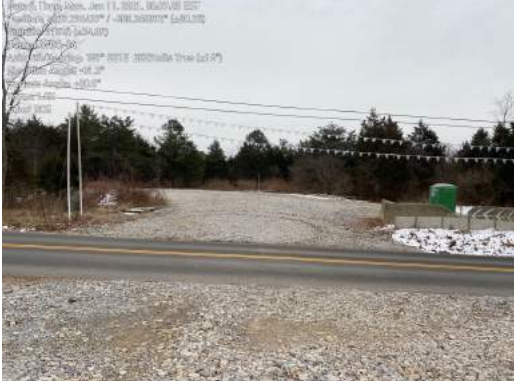
GPS Location	See photo GPS		GPS Location	See photo GPS	
Field Station#	11788+52		Field Station#	11800+00	
Pic 1 Desc.	Tabor RCE		Pic 2 Desc.	Row and level spreaders.

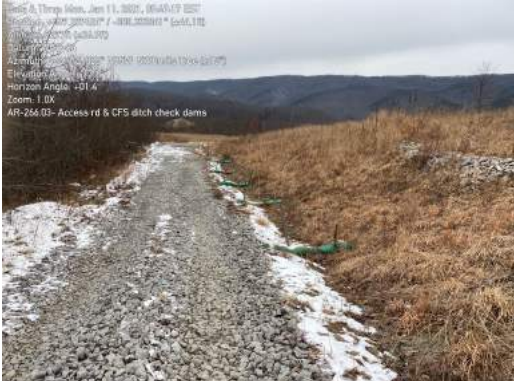
GPS Location	See photo GPS		GPS Location	See photo GPS	
Field Station#	11901+00		Field Station#	11935+00	
Pic 3 Desc.	AR- 266.03 - Access road and CFS ditch check dams.		Pic 4 Desc.	Row and ECD's

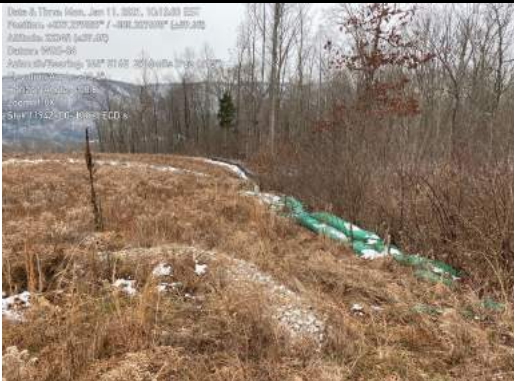
GPS Location	See photo GPS		GPS Location	See photo GPS	
Field Station#	11942+00		Field Station#	11977+00	
Pic 5 Desc.	Karst ECD's		Pic 6 Desc.	Row & Karst ECD's.

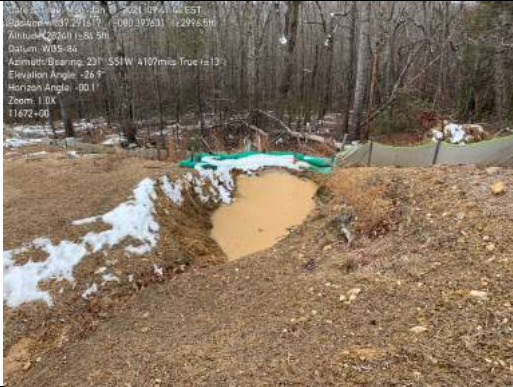
GPS Location	See photo for GPS location.		GPS Location	See photo for GPS location.	
Field Station#	11670+00		Field Station#	11672+00	
Pic 1 Desc.	CFS and priority one silt fence in place along LOD.		Pic 2 Desc.	Waterbar, sump pit, and end treatment in place.

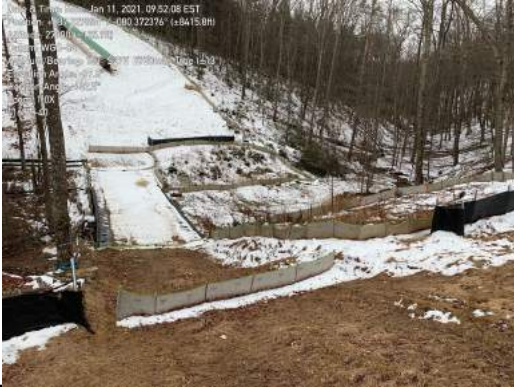
GPS Location	See photo for GPS location.		GPS Location	See photo for GPS location.	
Field Station#	11687+40		Field Station#	11732+00	
Pic 3 Desc.	Sensitive resource buffer in place at stream S-MN21.		Pic 4 Desc.	ROW snow cover and frozen.

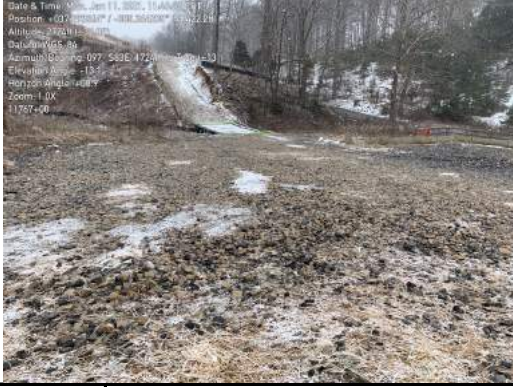
GPS Location	See photo for GPS location.		GPS Location	See photo for GPS location.	
Field Station#	11742+00		Field Station#	11767+00	
Pic 5 Desc.	Broken priority one silt fence stake.		Pic 6 Desc.	RCE in place at Main Line Valve 26.

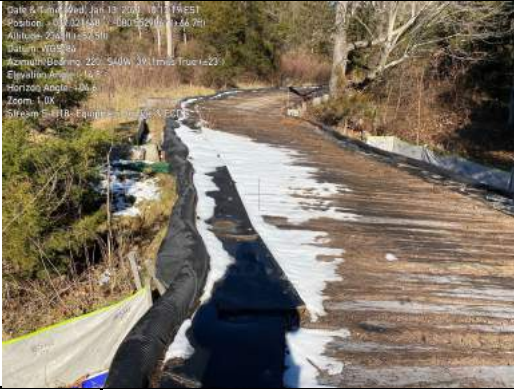
GPS Location	See photo GPS		GPS Location	See photo GPS	
Field Station#	11023+88		Field Station#	11019+00	
Pic 1 Desc.	Stream S- IJ18- Equipment Bridge and ECD's		Pic 2 Desc.	Row, and stream S- RR5

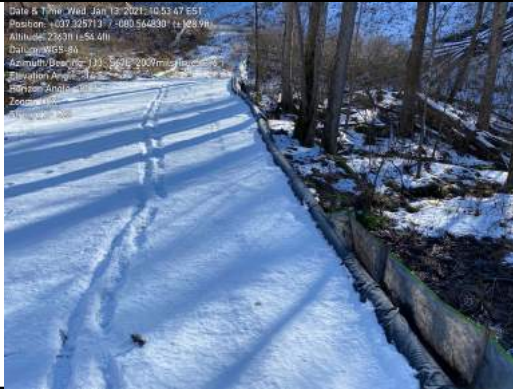
GPS Location	See photo GPS		GPS Location	See photo GPS	
Field Station#	10993+00		Field Station#	10986+00	
Pic 3 Desc.	Steep slope, water bars and controls.		Pic 4 Desc.	Stream S-E25- Equipment bridge and ECD's

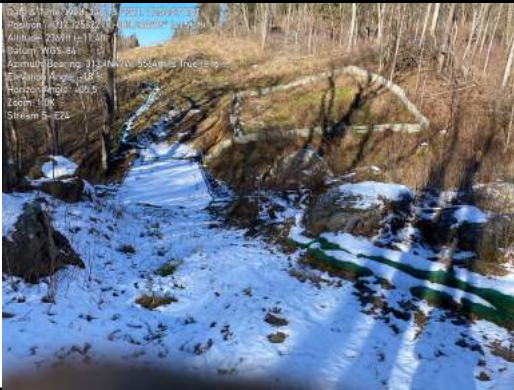
GPS Location	See photo GPS		GPS Location	See photo GPS	
Field Station#	10985+00		Field Station#	10964+00	
Pic 5 Desc.	Stream S-E24- Equipment bridge, buffers and controls.		Pic 6 Desc.	Drainage feature and ECD's

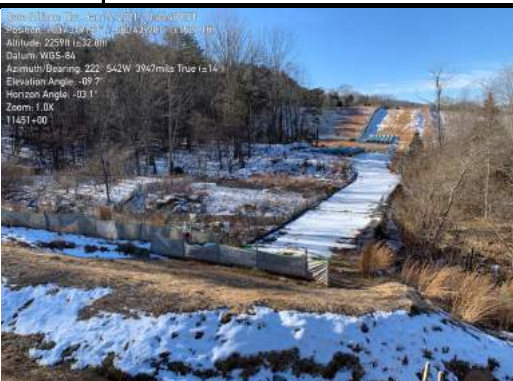
GPS Location				See photo for GPS location.				GPS Location				See photo for GPS location.			
Field Station#				11476+00				Field Station#				11451+00			
Pic 5 Desc.				Slope drain in place over two-tone.				Pic 6 Desc.				Sensitive resource buffer in place at stream S-0012 and S-0013.

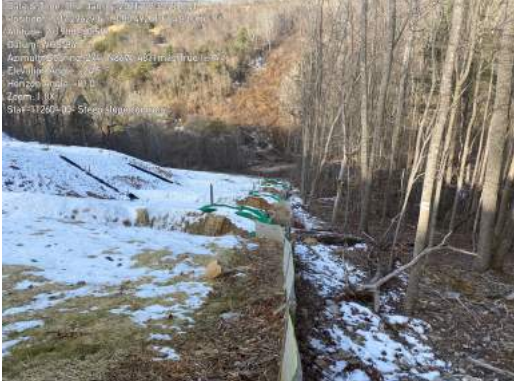
GPS Location	See photo GPS		GPS Location	See photo GPS	
Field Station#	11260+00		Field Station#	11270+00	
Pic 1 Desc.	Steep slope controls.		Pic 2 Desc.	CWD pipe and plunge pool, slope drain pipe

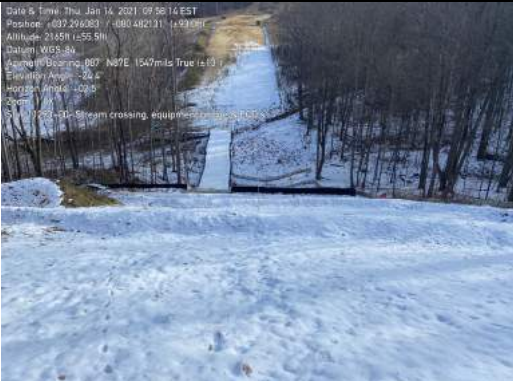
GPS Location	See photo GPS		GPS Location	See photo GPS	
Field Station#	11284+00		Field Station#	11293+00	
Pic 3 Desc.	Slope is covered in snow in this area.		Pic 4 Desc.	Stream crossing, equipment bridge, ECD's

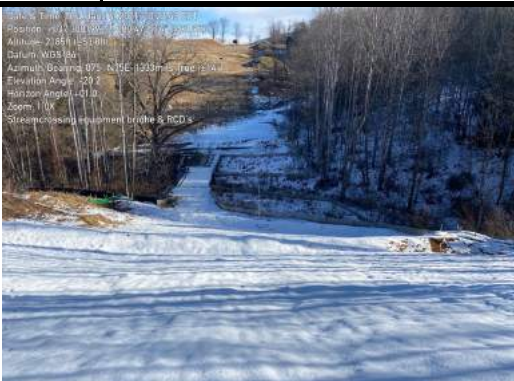
GPS Location	See photo GPS		GPS Location	See photo GPS	
Field Station#	11328+00		Field Station#	11353+00	
Pic 5 Desc.	Stream crossing and equipment bridge, stream ECD's.		Pic 6 Desc.	Stream crossing bridge and ECD's

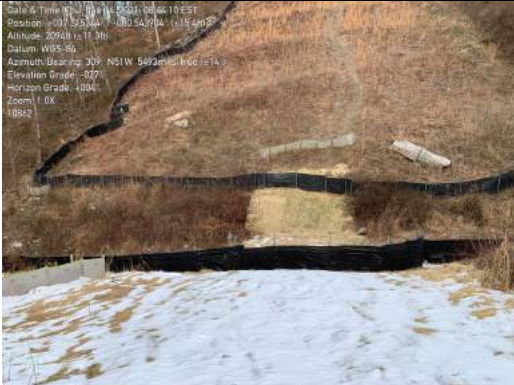
GPS Location	See picture above for GPS coordinates		GPS Location	See picture above for GPS coordinates	
Field Station#	11065+00		Field Station#	11069+00	
Pic 1 Desc.	ECD's and row conditions		Pic 2 Desc.	ECD's and row conditions

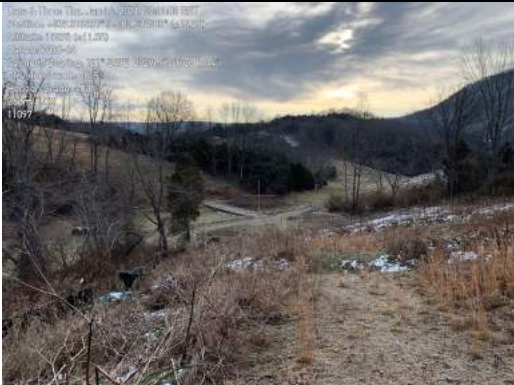
GPS Location	See picture above for GPS coordinates		GPS Location	See picture above for GPS coordinates	
Field Station#	11097+00		Field Station#	11107+00	
Pic 3 Desc.	ECD's and row conditions		Pic 4 Desc.	ECD's and row conditions

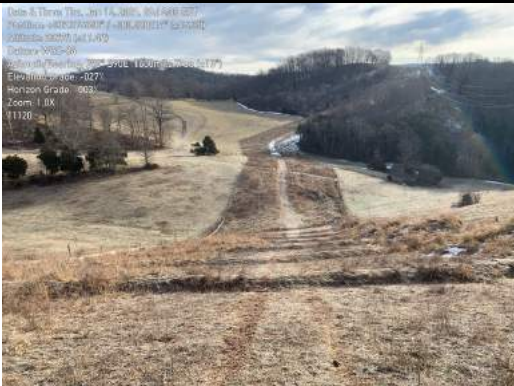
GPS Location	See picture above for GPS coordinates		GPS Location	See picture above for GPS coordinates	
Field Station#	11120+00		Field Station#	+1	
Pic 5 Desc.	ECD's and row conditions		Pic 6 Desc.	ECD's and row conditions

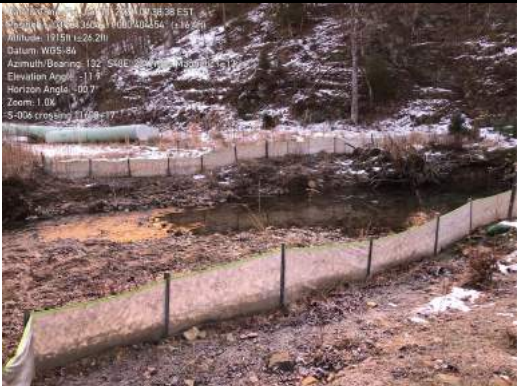
GPS Location	On photo	GPS Location	On photo		
Field Station#	11613+69	Field Station#	11608+17		
Pic 9 Desc.	The S-RR13 crossing on access road MN-258.04 is stable.	Pic 10 Desc.	The S-006 crossing is currently stable with ECDs in place.		
Insert image here		Insert image here			
GPS Location		GPS Location			
Field Station#		Field Station#			
Pic 11 Desc.		Pic 12 Desc.
