Visual Site Inspection Report

Project Name	H-600 Pipeline Spread G	AFE	124300137	Spread	H-600 Pipeline Spread G
Contractor	Precision			Report #	18031
Inspector	Len Kruizenga			Date/Time	12/14/2020 8:16 AM
Permit #	TBD	Inspection Type	VA SWPP	Station Begin	11023+88
State	VA	Inspection Area	Full	Station End	10930+00
County	Giles	Ground	Muddy	Temperature (°F)	41.00
Municipality	N/A	Weather	Heavy Rain	Rain Gauge (in)	1.10
				Rain Accumulation Time (days)	1.00

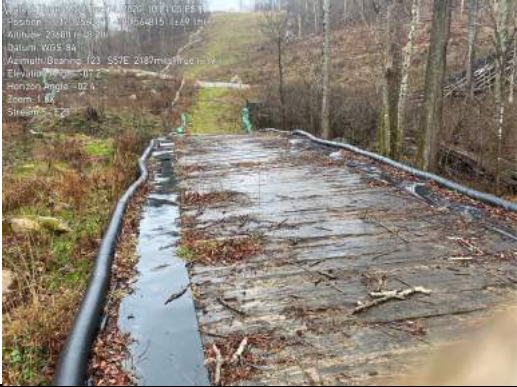
GPS Location	See photo GPS	GPS Location	See photo GPS		
Field Station#	10987+00	Field Station#	10986+00		
Pic 7 Desc.	Stream S-E25	Pic 8 Desc.	Stream S- E24

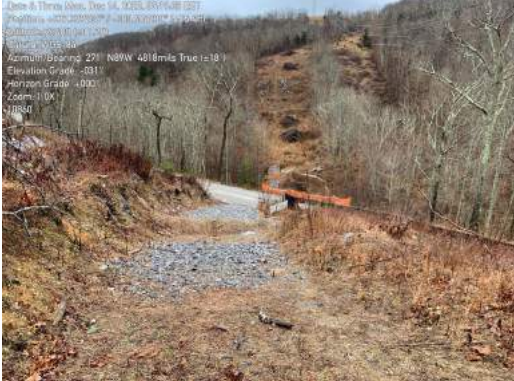
GPS Location	See picture above for GPS coordinates		GPS Location	See picture above for GPS coordinates	
Field Station#	10860+00		Field Station#	10866+00	
Pic 1 Desc.	ECD's and row conditions		Pic 2 Desc.	ECD's and row conditions

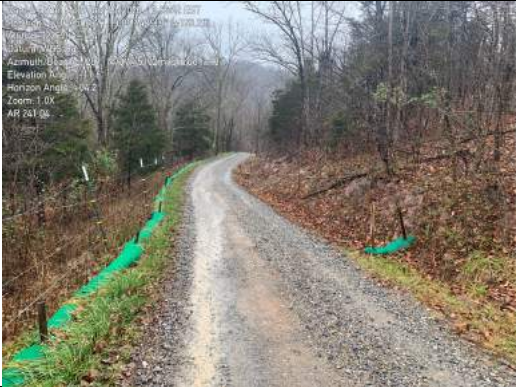
GPS Location	See photo for GPS location.		GPS Location	See photo for GPS location.	
Field Station#	10711+00		Field Station#	10712+50	
Pic 1 Desc.	CFS in place along access road 241.04.		Pic 2 Desc.	Sensitive resource buffer in place at stream S-G33.

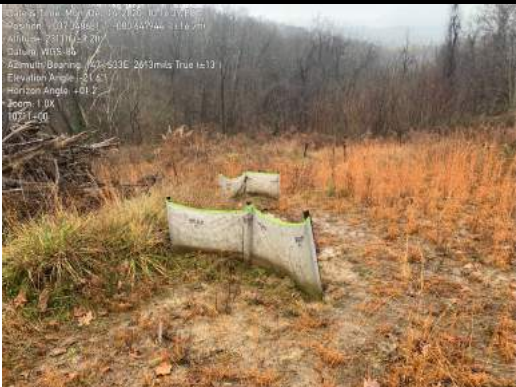
GPS Location	See photo for GPS location.		GPS Location	See photo for GPS location.	
Field Station#	10711+00		Field Station#	10710+00	
Pic 3 Desc.	Priority one silt fence checks in place.		Pic 4 Desc.	ROW stabilized with natural vegetation growth.

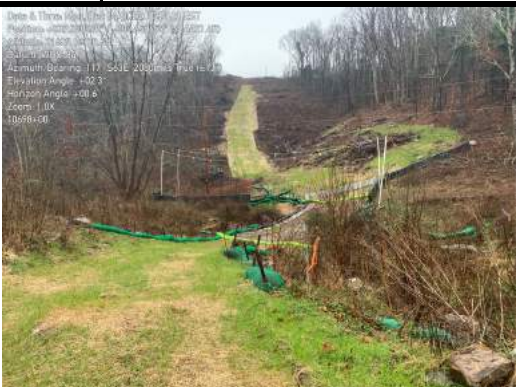
GPS Location	See photo for GPS location.		GPS Location	See photo for GPS location.	
Field Station#	10698+00		Field Station#	11696+00	
Pic 5 Desc.	Sensitive resource buffer in place at stream S-G32.		Pic 6 Desc.	RCE in place at Buffalo Anklets Road.

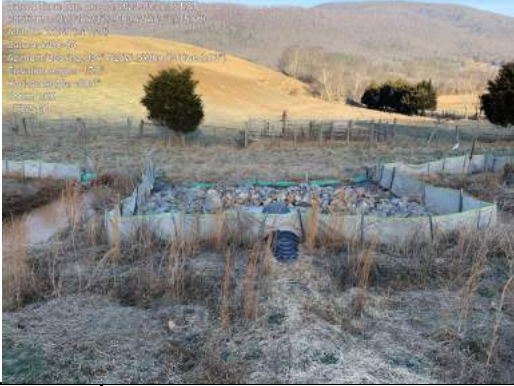
GPS Location	See photo for GPS location.		GPS Location	See photo for GPS location.	
Field Station#	11507+00		Field Station#	11489+00	
Pic 1 Desc.	Clean water diversion pipe and plunge pool in place.		Pic 2 Desc.	Rain gauge at Stevers Gap Road reads 0.5 inches.

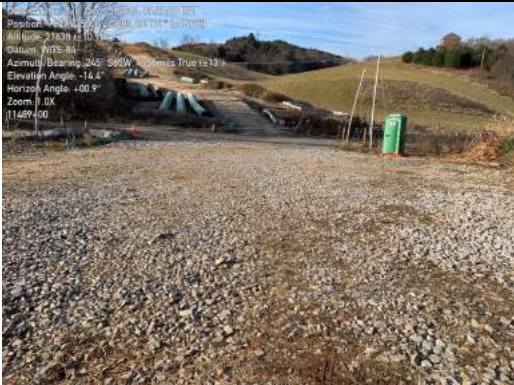
GPS Location	See photo for GPS location.		GPS Location	See photo for GPS location.	
Field Station#	11489+00		Field Station#	11475+00	
Pic 3 Desc.	RCE in place at Stevers Gap Road.		Pic 4 Desc.	Two-tone stabilized with ECB. Slope drains in place.

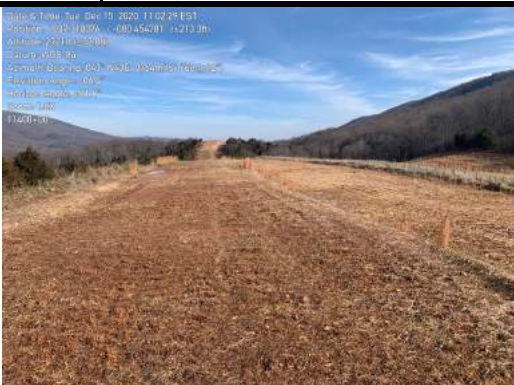
GPS Location	See photo for GPS location.		GPS Location	See photo for GPS location.	
Field Station#	11400+00		Field Station#	11451+00	
Pic 5 Desc.	ROW stabilized with seed and mulch.		Pic 6 Desc.	Sensitive resource buffer in place at stream S-0012 and S-0013.

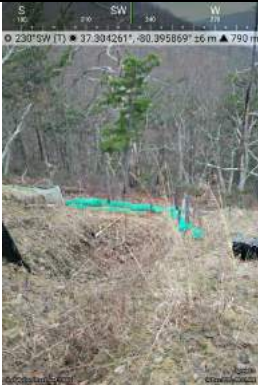
GPS Location	see photo		GPS Location	see photo	
Field Station#	11665+00		Field Station#	11632+00	
Pic 3 Desc.	sump and end treatment.		Pic 4 Desc.	sump and end treatment

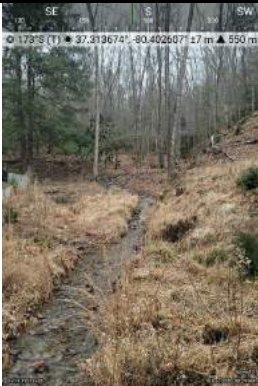
GPS Location	see photo		GPS Location	see photo	
Field Station#	11613+85		Field Station#	11613+85	
Pic 5 Desc.	s-rr14 flowing above timer mat bridge.		Pic 6 Desc.	creek bed of s-rr14 dry beyond row crossing.

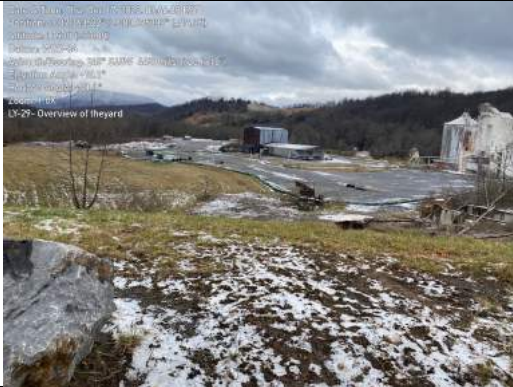
<p>Date & Time: Thu, Dec 17, 2020, 08:59:11 (EST) Position: +4037.36272N / -80.188888W (Elev: 1205) Datum: WGS-84 Altitude: 1205.00 Azimuth/Bearing: 256.57W 442mils True (±10°) Elevation Angle: -08.0° Horizon Angle: -12.4° Zoom: 1.0x LY-29- Overview of the yard</p>			
GPS Location	See photo GPS	GPS Location	See photo GPS		
Field Station#	12005+00	Field Station#	12005+00		
Pic 1 Desc.	AR-238.00- Access road serving LY-29	Pic 2 Desc.	LY-29- Overview of the yard.

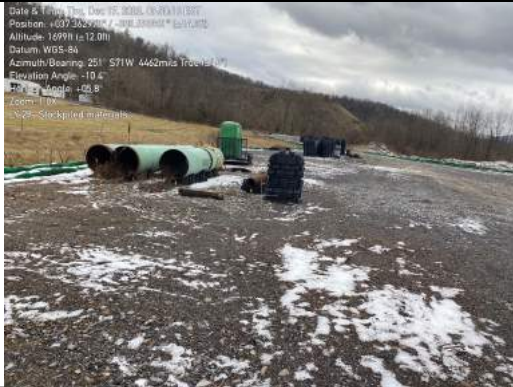
<p>Date & Time: Thu, Dec 17, 2020, 08:59:11 (EST) Position: +4037.36272N / -80.188888W (Elev: 1205) Datum: WGS-84 Altitude: 1205.00 Azimuth/Bearing: 256.57W 442mils True (±10°) Elevation Angle: -08.0° Horizon Angle: -12.4° Zoom: 1.0x LY-29- Stockpiled materials</p>

GPS Location	See photo GPS	GPS Location	See photo GPS		
Field Station#	12005+00	Field Station#	12005+00		
Pic 3 Desc.	CFS triple stack perimeter controls.	Pic 4 Desc.	LY- 29- Materials storage

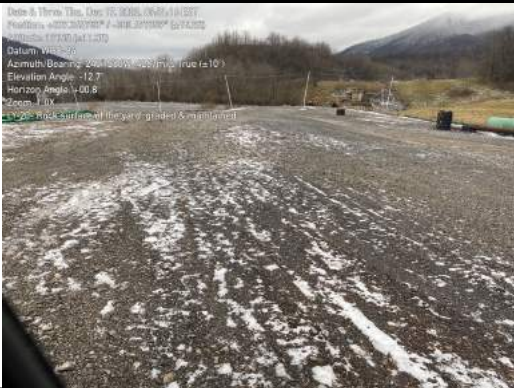
<p>Date & Time: Thu, Dec 17, 2020, 08:59:11 (EST) Position: +4037.36272N / -80.188888W (Elev: 1205) Datum: WGS-84 Altitude: 1205.00 Azimuth/Bearing: 256.57W 442mils True (±10°) Elevation Angle: -12.7° Horizon Angle: -10.8° Zoom: 1.0x LY-29- Rock surface of the yard is graded & maintained</p>

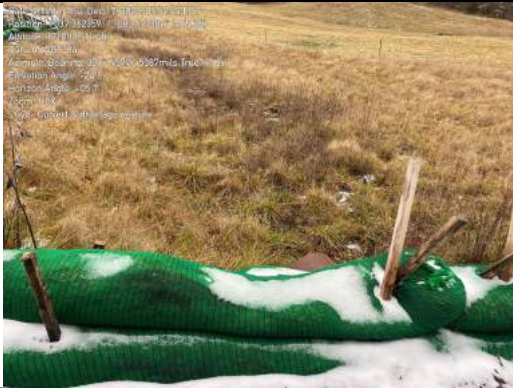
<p>Date & Time: Thu, Dec 17, 2020, 08:59:11 (EST) Position: +4037.36272N / -80.188888W (Elev: 1205) Datum: WGS-84 Altitude: 1205.00 Azimuth/Bearing: 256.57W 442mils True (±10°) Elevation Angle: -12.7° Horizon Angle: -10.8° Zoom: 1.0x LY-29- Culvert & drainage feature</p>			
GPS Location	See photo GPS	GPS Location	See photo GPS		
Field Station#	12005+00	Field Station#	12005+00		
Pic 5 Desc.	LY- 29 - Rock surface of the yard is maintained in acceptable condition.	Pic 6 Desc.	LY29- Culvert and drainage feature.

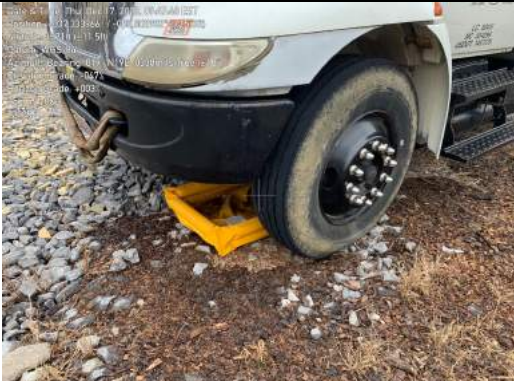
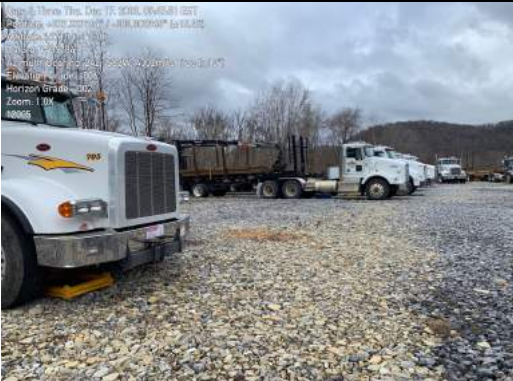
GPS Location	See picture above for GPS coordinates		GPS Location	See picture above for GPS coordinates	
Field Station#	12005+00		Field Station#	12005+00	
Pic 1 Desc.	ECD's and row conditions		Pic 2 Desc.	ECD's and row conditions

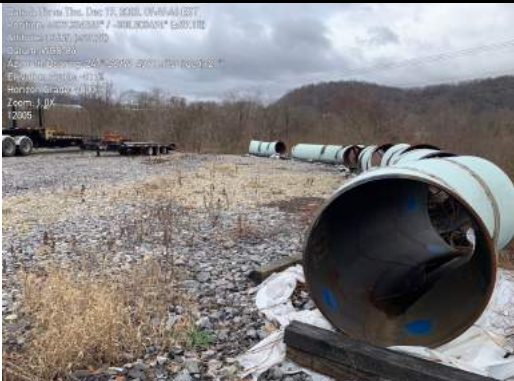
GPS Location	See picture above for GPS coordinates		GPS Location	See picture above for GPS coordinates	
Field Station#	12005+00		Field Station#	12005+00	
Pic 3 Desc.	ECD's and row conditions		Pic 4 Desc.	ECD's and row conditions

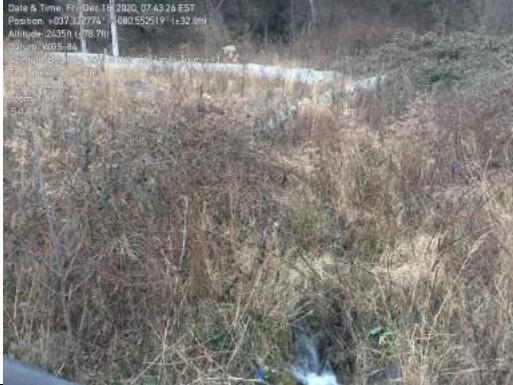
GPS Location	1		GPS Location	2	
Field Station#	11025+50		Field Station#	11034+00	
Pic 1 Desc.	S-IJ18 and controls.		Pic 2 Desc.	Section of RoW showing conditions and controls.

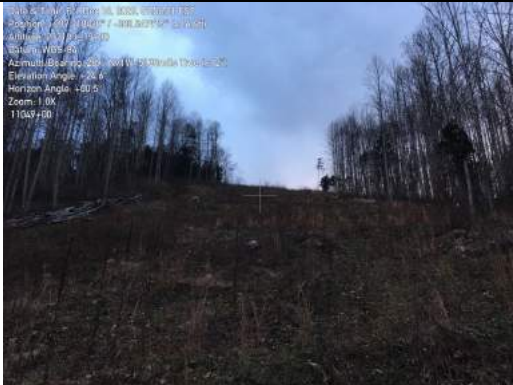
GPS Location	3		GPS Location	4	
Field Station#	11049+00		Field Station#	11050+10	
Pic 3 Desc.	Section of RoW showing conditions and controls.		Pic 4 Desc.	S-IJ16B/S-IJ17.

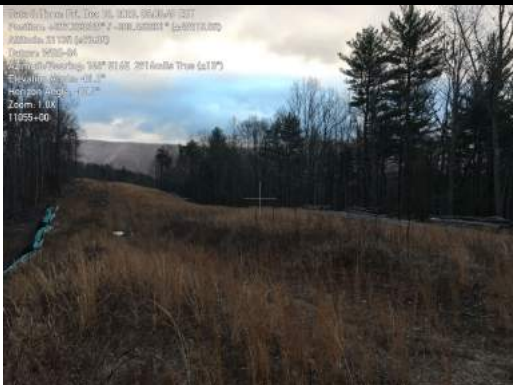
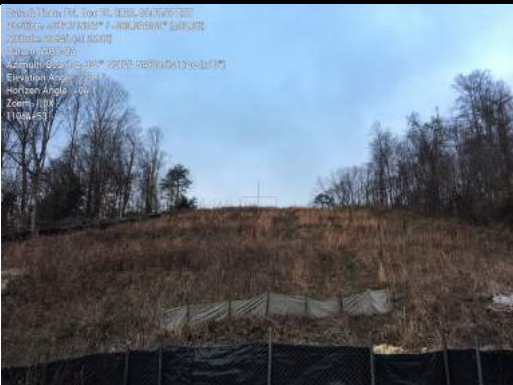
GPS Location	5		GPS Location	6	
Field Station#	11055+00		Field Station#	11064+53	
Pic 5 Desc.	Section of RoW showing conditions and controls.		Pic 6 Desc.	Section of RoW showing conditions and controls.

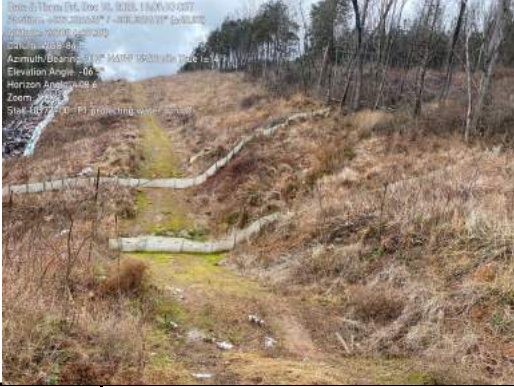
GPS Location	See photo GPS	GPS Location	See photo GPS		
Field Station#	10987+00	Field Station#	10986+00		
Pic 3 Desc.	Stream S- E25 equipment bridge and ECD's.	Pic 4 Desc.	Stream S- E24- Stream ECD's

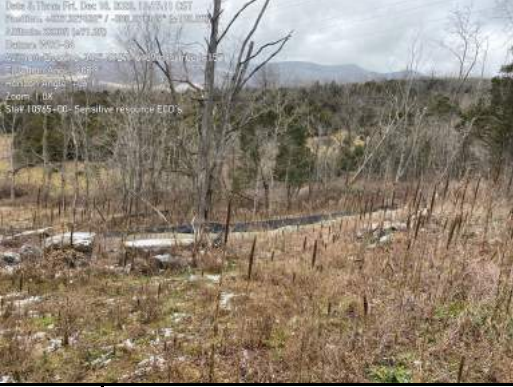
<p>Date & Time: Fri, Dec 18, 2020, 09:28:39 CST Position: 4027.2214147, -88.532845 (e64.18) Altitude: 2511 ft (769 m) Datum: WGS-84 Azimuth/Bearing: 305° N55W 5422mils True (±15°) Elevation Angle: -22.4° Horizon Angle: -04.8° Zoom: 1.0X Still 11023+88 Stream S- IJ18</p>			
GPS Location	See photo GPS	GPS Location	See photo GPS		
Field Station#	10977+00	Field Station#	10965+00		
Pic 5 Desc.	P1 protection for water run off	Pic 6 Desc.	Sensitive resource ECD's.

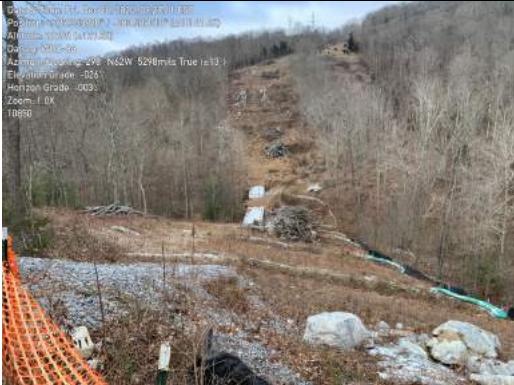
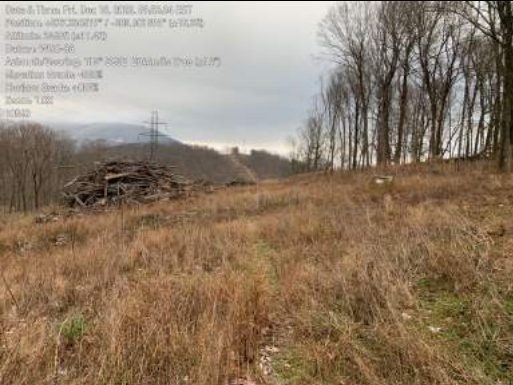
GPS Location	See picture above for GPS coordinates		GPS Location	See picture above for GPS coordinates	
Field Station#	10850+00		Field Station#	10863+00	
Pic 1 Desc.	ECD's and row conditions		Pic 2 Desc.	ECD's and row conditions

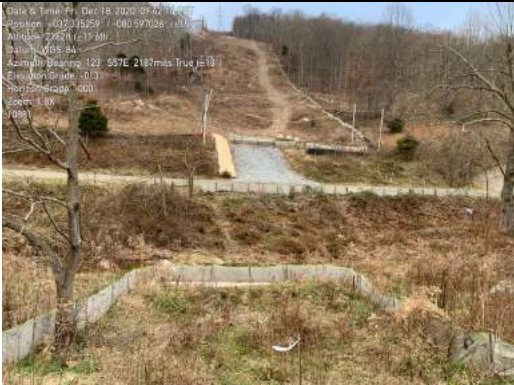
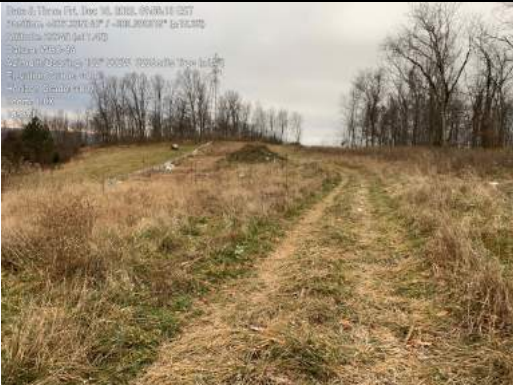
GPS Location	See picture above for GPS coordinates		GPS Location	See picture above for GPS coordinates	
Field Station#	10881+00		Field Station#	10891+00	
Pic 3 Desc.	ECD's and row conditions		Pic 4 Desc.	ECD's and row conditions

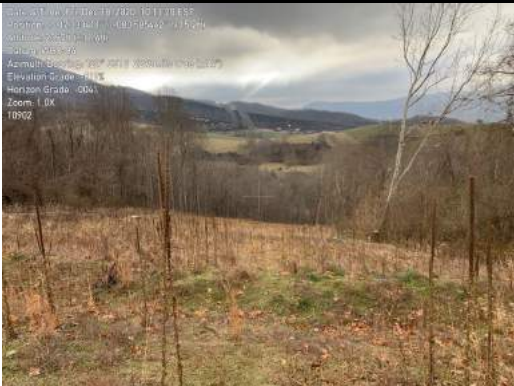
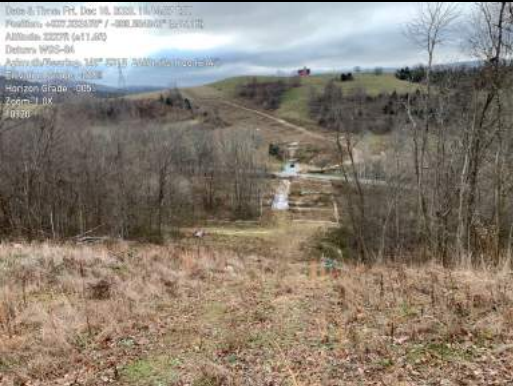
GPS Location	See picture above for GPS coordinates		GPS Location	See picture above for GPS coordinates	
Field Station#	10902+00		Field Station#	10920+00	
Pic 5 Desc.	ECD's and row conditions		Pic 6 Desc.	ECD's and row conditions
