Visual Site Inspection Report

Project Name	H-600 Pipeline Spread H	AFE	124300138	Spread	H-600 Pipeline Spread H
Contractor	Precision			Report #	19154
Inspector	John Brcic			Date/Time	1/18/2021 1:27 PM
Permit #	TBD	Inspection Type	VA SWPP	Station Begin	12284+75
State	VA	Inspection Area	Partial	Station End	12443+75
County	Montgomery	Ground	Damp	Temperature (°F)	0.00
Municipality	N/A	Weather	Cloudy	Rain Gauge (in)	34.00
				Rain Accumulation Time (days)	2.00

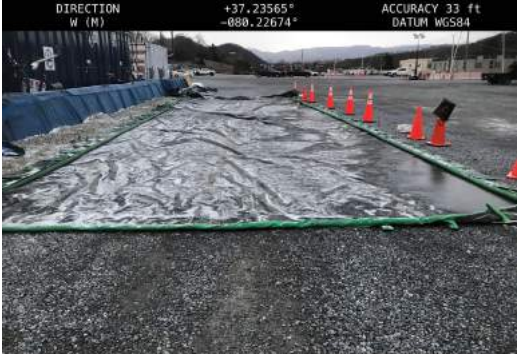
<p>DIRECTION W (M) +37.23565° -080.22674° ACCURACY 33 ft DATUM WGS84</p> <p>MVP-PY-006_011821 Secondary containment on site for tankers 2021-01-18 07:53:54-05:00</p>

<p>DIRECTION S (M) +37.23565° -080.22671° ACCURACY 16 ft DATUM WGS84</p> <p>MVP-PY-006_011821 Condition of containment 2021-01-18 07:53:59-05:00</p>			
GPS Location	MVP-PY-006 See photo for gps data		GPS Location	MVP-PY-006 See photo for gps data	
Field Station#	+0		Field Station#	+0	
Pic 7 Desc.	Secondary containment on site for tankers offloading fuel. Looking W.		Pic 8 Desc.	Condition of containment under DEF container. Free of stormwater. Looking S.

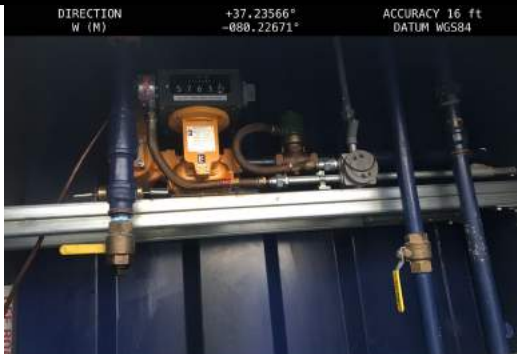
<p>DIRECTION W (M) +37.23566° -080.22671° ACCURACY 16 ft DATUM WGS84</p> <p>MVP-PY-006_010821 No leaky internal fittings 2021-01-18 07:54:46-05:00</p>

GPS Location	MVP-PY-006 See photo for gps data		GPS Location	MVP-PY-006 See photo for gps data	
Field Station#	+0		Field Station#	+0	
Pic 9 Desc.	Blue Bulk Fuel tanks no leaky internal fittings. Looking W.		Pic 10 Desc.	Off Road Fuel unit condition of internal drip pan. Looking W.

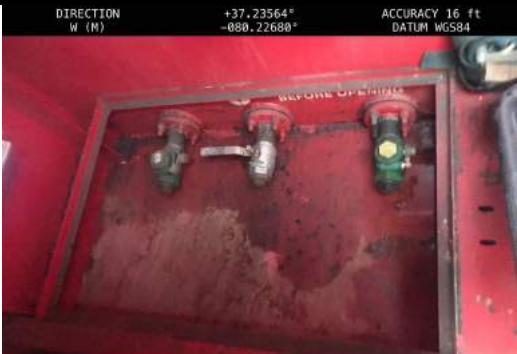
<p>DIRECTION W (M) +37.23564° -080.22680° ACCURACY 16 ft DATUM WGS84</p> <p>MVP-PY-006_011821 Condition of internal drip pan 2021-01-18 07:57:00-05:00</p>

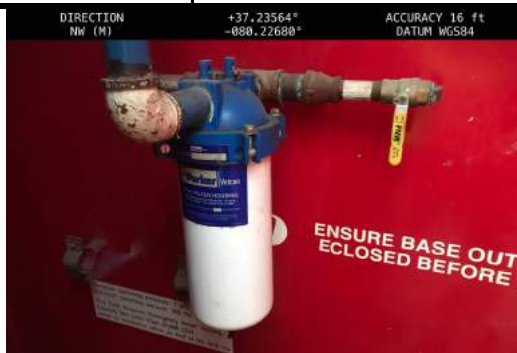
<p>DIRECTION NW (M) +37.23564° -080.22680° ACCURACY 16 ft DATUM WGS84</p> <p>MVP-PY-006_011821 No leaky internal fittings 2021-01-18 07:57:03-05:00</p>

<p>DIRECTION NE (M) +37.23562° -080.22681° ACCURACY 16 ft DATUM WGS84</p> <p>MVP-PY-006_011821 No fuel spills south of tanks 2021-01-18 07:57:50-05:00</p>			
GPS Location	MVP-PY-006 See photo for gps data		GPS Location	MVP-PY-006 See photo for gps data	
Field Station#	+0		Field Station#	+0	
Pic 11 Desc.	Off Road Fuel unit no leaky internal fittings. Looking NW.		Pic 12 Desc.	Blue Bulk Fuel tanks no fuel spills south of the tanks. Looking NE.

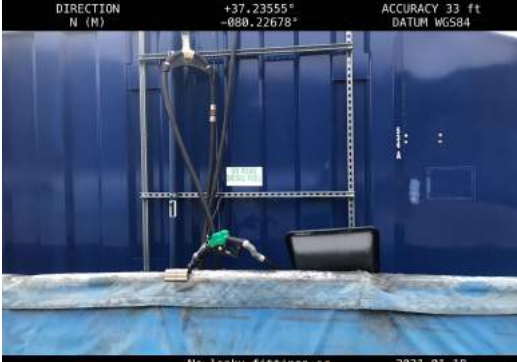
<p>DIRECTION N (M) +37.23555° -080.22678° ACCURACY 33 ft DATUM WGS84</p> <p>MVP-PY-006_011821 No leaky fittings or nozzles 2021-01-18 07:58:15-05:00</p>

<p>DIRECTION S (M) +37.23553° -080.22673° ACCURACY 16 ft DATUM WGS84</p> <p>MVP-PY-006_011821 No deposits around hazardous waste 2021-01-18 07:58:24-05:00</p>			
GPS Location	MVP-PY-006 See photo for gps data	GPS Location	MVP-PY-006 See photo for gps data		
Field Station#	+0	Field Station#	+0		
Pic 13 Desc.	Blue Bulk Fuel tanks no leaky fittings or nozzles. Looking N.	Pic 14 Desc.	No fluids or deposits around hazardous waste dumpsters. Looking S.

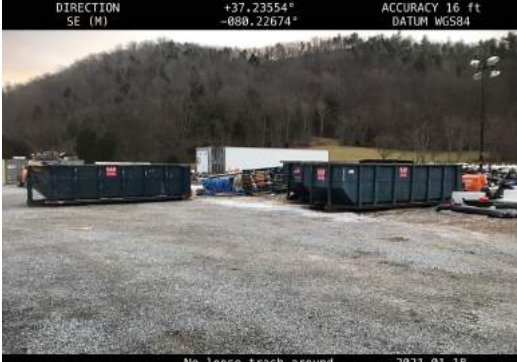
<p>DIRECTION SE (M) +37.23554° -080.22674° ACCURACY 16 ft DATUM WGS84</p> <p>MVP-PY-006_011821 No loose trash around dumpsters 2021-01-18 07:58:40-05:00</p>

GPS Location	MVP-PY-006 See photo for gps data	GPS Location	MVP-PY-006 See photo for gps data		
Field Station#	+0	Field Station#	+0		
Pic 15 Desc.	No loose trash around dumpsters. Looking SE.	Pic 16 Desc.	Restoration supplies covered and protected from the elements. Looking E.

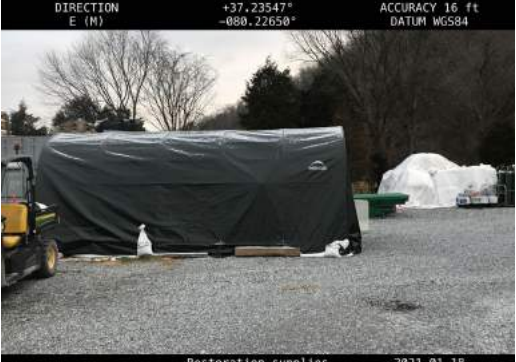
<p>DIRECTION E (M) +37.23547° -080.22650° ACCURACY 16 ft DATUM WGS84</p> <p>MVP-PY-006_011821 Restoration supplies covered 2021-01-18 07:59:29-05:00</p>

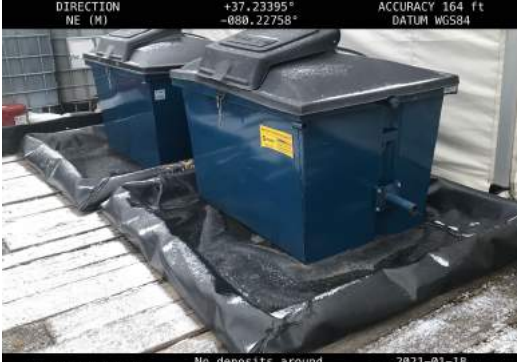
<p>DIRECTION NE (M) +37.23395° -080.22758° ACCURACY 164 ft DATUM WGS84</p> <p>MVP-PY-006_011821 No deposits around hazardous waste 2021-01-18 08:06:44-05:00</p>

<p>DIRECTION SE (M) +37.23457° -080.22807° ACCURACY 16 ft DATUM WGS84</p> <p>MVP-PY-006_011821 Condition of containment 2021-01-18 08:09:15-05:00</p>			
GPS Location	MVP-PY-006 See photo for gps data	GPS Location	MVP-PY-006 See photo for gps data		
Field Station#	+0	Field Station#	+0		
Pic 17 Desc.	No fluids or deposits around hazardous waste dumpsters west of the mechanics building. Looking NE.	Pic 18 Desc.	Condition of containments. Holding stormwater now frozen. Looking SE.

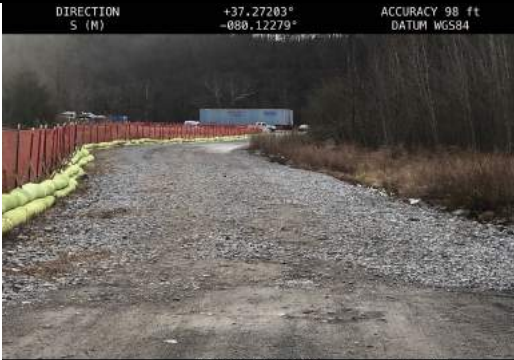
<p>DIRECTION S (N) +37.27283° -080.12279° ACCURACY 98 ft DATUM WGS84</p> <p>MVP-LY-049_011821 Condition of rock entrance 2021-01-18 08:53:24-05:00</p>

<p>DIRECTION S (N) +37.27097° -080.12213° ACCURACY 16 ft DATUM WGS84</p> <p>MVP-LY-049_011821 Condition of containment 2021-01-18 08:55:06-05:00</p>			
GPS Location	MVP-LY-049 See photo for gps data		GPS Location	MVP-LY-049 See photo for gps data	
Field Station#	+0		Field Station#	+0	
Pic 1 Desc.	Condition of rock entrance. No sediment on stone. Looking S.		Pic 2 Desc.	Condition of containment under light plant. Free of stormwater. Looking S.	
  <p>DIRECTION NE (N) +37.27102° -080.12176° ACCURACY 16 ft DATUM WGS84</p> <p>MVP-LY-049_011821 Condition of trays & containment 2021-01-18 08:55:48-05:00</p>

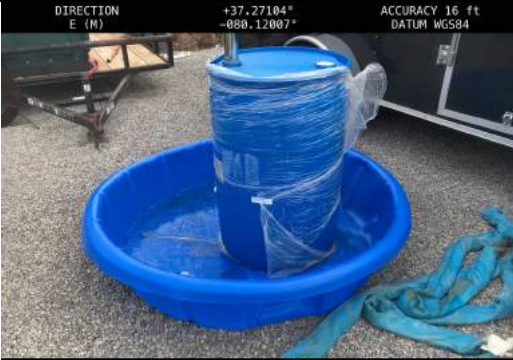
<p>DIRECTION E (N) +37.27104° -080.12007° ACCURACY 16 ft DATUM WGS84</p> <p>MVP-LY-049_011821 Barrel of toilet chemical in 2021-01-18 08:57:22-05:00</p>

GPS Location	MVP-LY-049 See photo for gps data		GPS Location	MVP-LY-049 See photo for gps data	
Field Station#	+0		Field Station#	+0	
Pic 3 Desc.	Condition of trays and containment under toilets. Looking NE.		Pic 4 Desc.	Condition of containment holding barrel of toilet chemical. Looking E.

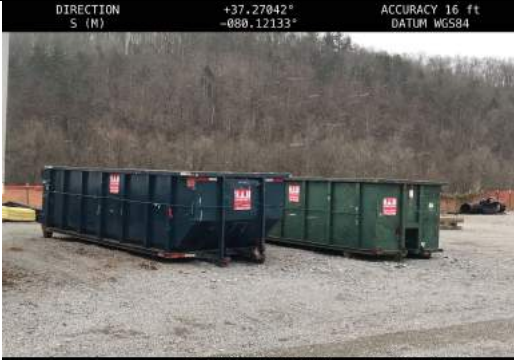
<p>DIRECTION S (N) +37.27042° -080.12133° ACCURACY 16 ft DATUM WGS84</p> <p>MVP-LY-049_011821 No loose trash around south dumpsters 2021-01-18 09:22:15-05:00</p>		  <p>DIRECTION S (N) +37.27021° -080.12171° ACCURACY 16 ft DATUM WGS84</p> <p>MVP-LY-049_011821 Restoration supplies covered 2021-01-18 09:22:40-05:00</p>			
GPS Location	MVP-LY-049 See photo for gps data		GPS Location	MVP-LY-049 See photo for gps data	
Field Station#	+0		Field Station#	+0	
Pic 5 Desc.	No loose trash around south dumpsters. Looking S.		Pic 6 Desc.	Restoration supplies covered and protected from the elements. Looking S.

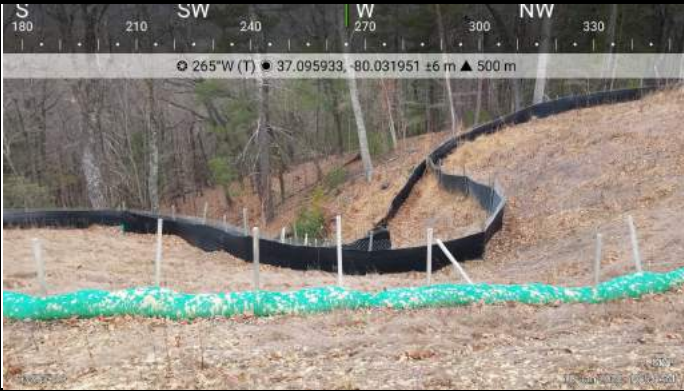
GPS Location	See Above		GPS Location	See Above	
Field Station#	13393+00		Field Station#	13397+00	
Pic 13 Desc.	ROW Overview. ECDs are functional and ROW is stable.		Pic 14 Desc.	ROW Overview. ECDs are functional and ROW is stable.

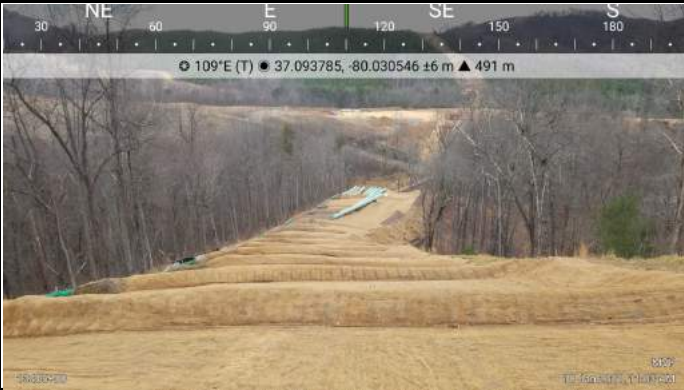
GPS Location	See Above		GPS Location	See Above	
Field Station#	13405+00		Field Station#	13413+01	
Pic 15 Desc.	ROW Overview. ECDs are functional and ROW is stable.		Pic 16 Desc.	Overview of Waterbody S-IJ1. ECDs are functional and ROW is stable.

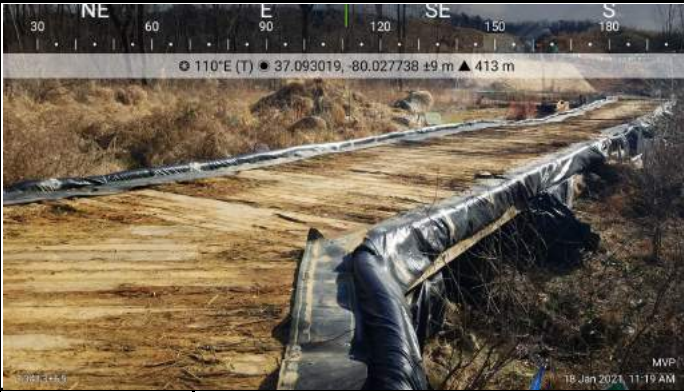
GPS Location	See Above		GPS Location	See Above	
Field Station#	13413+65		Field Station#	13422+00	
Pic 17 Desc.	Overview of Waterbody S-IJ2. ECDs are functional and ROW is stable.		Pic 18 Desc.	ROW Overview. ECDs are functional and ROW is stable.

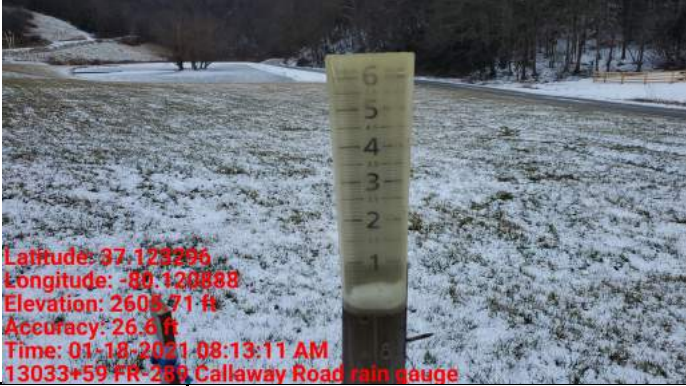
<p>Latitude: 37.123296 Longitude: -80.120888 Elevation: 2605.71 ft Accuracy: 26.6 ft Time: 01-18-2021 08:13:11 AM 13033+59 FR-289 Callaway Road rain gauge</p>

<p>Latitude: 37.125232 Longitude: -80.120875 Elevation: 2690.91 ft Accuracy: 12.5 ft Time: 01-18-2021 09:30:35 AM 13026+00 CIS of FR-289 streams S-G24 and S-G25</p>			
GPS Location	See pic for GPS location		GPS Location	See pic for GPS location	
Field Station#	13033+59		Field Station#	13026+00	
Pic 1 Desc.	Snow and ice accumulation in rain gauge at Callaway Road.		Pic 2 Desc.	Streams S-G24 and S-G25 on the GAS of the BRP.

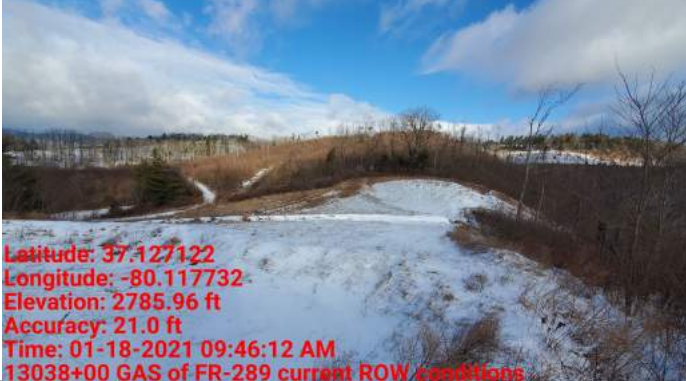
<p>Latitude: 37.127122 Longitude: -80.117732 Elevation: 2785.96 ft Accuracy: 21.0 ft Time: 01-18-2021 09:46:12 AM 13038+00 GAS of FR-289 current ROW conditions</p>

GPS Location	See pic for GPS location		GPS Location	See pic for GPS location	
Field Station#	13038+00		Field Station#	13040+00	
Pic 3 Desc.	Temporary stabilization remains in compliance on the GAS of FR-289.		Pic 4 Desc.	Stream S-H1 on the GAS of FR-289.

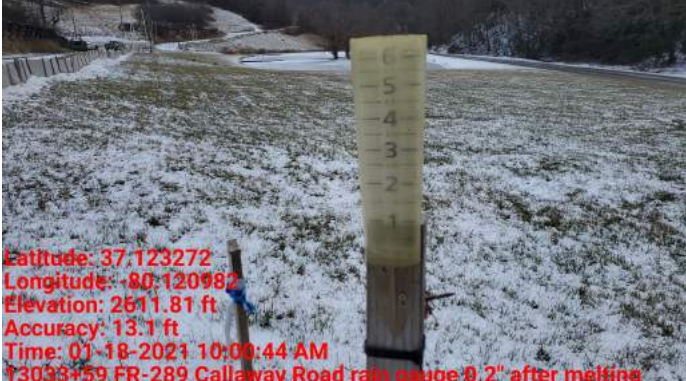
<p>Latitude: 37.123272 Longitude: -80.120982 Elevation: 2611.81 ft Accuracy: 13.1 ft Time: 01-18-2021 10:09:44 AM 13033+59 FR-289 Callaway Road rain gauge 0.2" after melting</p>

<p>Latitude: 37.133047 Longitude: -80.111465 Elevation: 2682.43 ft Accuracy: 22.0 ft Time: 01-18-2021 11:38:24 AM 13061+00 CIS of FR-290</p>			
GPS Location	See pic for GPS location		GPS Location	See pic for GPS location	
Field Station#	13033+59		Field Station#	13061+00	
Pic 5 Desc.	0.2" total precipitation accumulation after melting snow and ice.		Pic 6 Desc.	Slope on the CIS of FR-290.

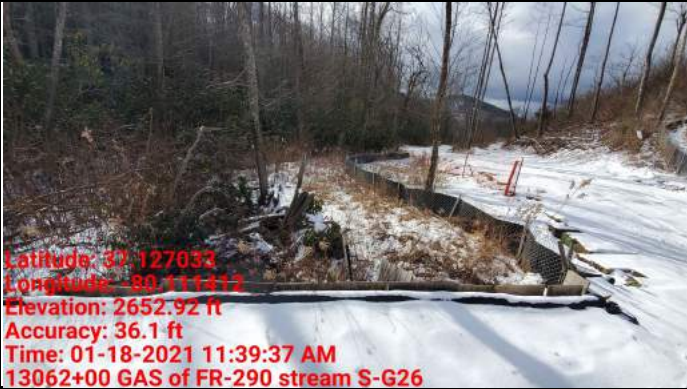
<p>Latitude: 37.127033 Longitude: -80.111412 Elevation: 2652.92 ft Accuracy: 36.1 ft Time: 01-18-2021 11:39:37 AM 13062+00 GAS of FR-290 stream S-G26</p>

<p>Latitude: 37.127046 Longitude: -80.111425 Elevation: 2659.22 ft Accuracy: 18.7 ft Time: 01-18-2021 11:39:10 AM 13062+00 GAS of FR-290 stream S-G26</p>		
GPS Location	See pic for GPS location		GPS Location	See pic for GPS location	
Field Station#	13062+00		Field Station#	13062+00	
Pic 7 Desc.	Downstream side of stream S-G26.		Pic 8 Desc.	Upstream side of stream S-G26 on GAS of FR-290.

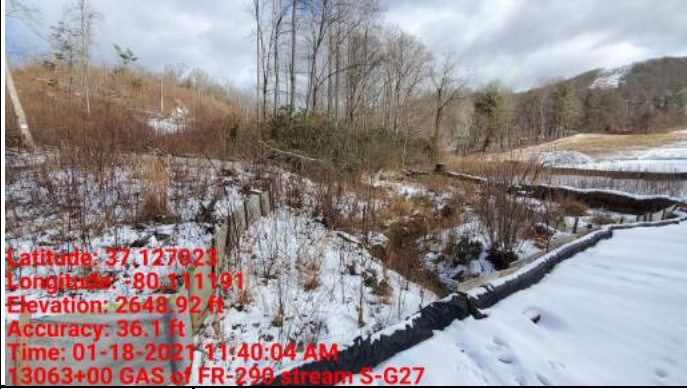
<p>Latitude: 37.127023 Longitude: -80.111191 Elevation: 2648.92 ft Accuracy: 36.1 ft Time: 01-18-2021 11:40:04 AM 13063+00 GAS of FR-290 stream S-G27</p>

GPS Location	See pic for GPS location		GPS Location	See pic for GPS location	
Field Station#	13063+00		Field Station#	13063+00	
Pic 9 Desc.	Upstream side of stream S-G27.		Pic 10 Desc.	Downstream side of stream S-G27 on the GAS of FR-290.

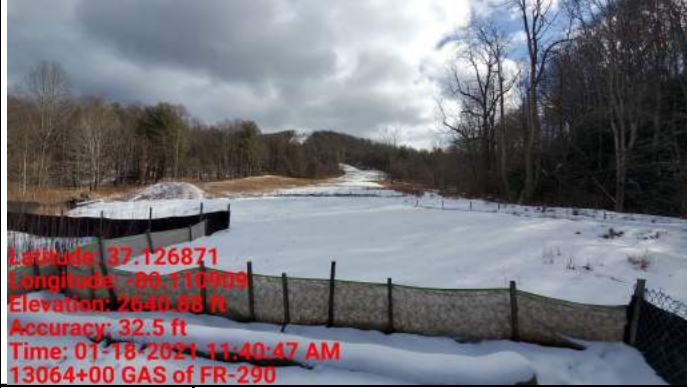
<p>Latitude: 37.126871 Longitude: -80.110909 Elevation: 2640.88 ft Accuracy: 32.5 ft Time: 01-18-2021 11:40:47 AM 13064+00 GAS of FR-290</p>

<p>Latitude: 37.068713 Longitude: -80.0369 Accuracy: 11154.9 ft Time: 01-18-2021 11:43:58 AM 13061+44 access road FR-290 streams S-G26 and S-G27 adjacent</p>		
GPS Location	See pic for GPS location		GPS Location	See pic for GPS location	
Field Station#	13064+00		Field Station#	13061+44	
Pic 11 Desc.	ROW conditions are acceptable on the GAS of FR-290		Pic 12 Desc.	Streams S-G26 and S-G27 merge along access FR-290.

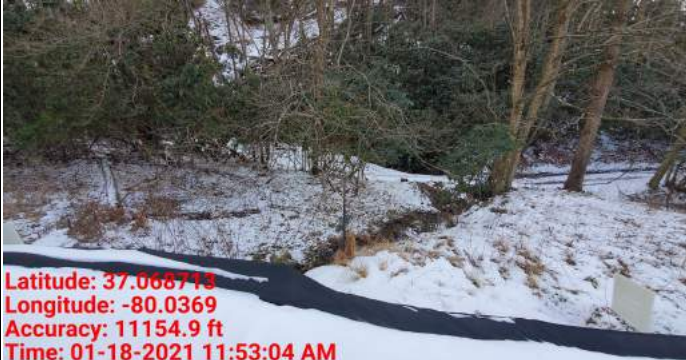
<p>Latitude: 37.068713 Longitude: -80.0369 Accuracy: 11154.9 ft Time: 01-18-2021 11:53:04 AM 13061+44 access road FR-290 stream S-RR18</p>

<p>Latitude: 37.11387 Longitude: -80.11564 Elevation: 2613.98 ft Accuracy: 25.3 ft Time: 01-18-2021 11:55:10 AM 13061+44 access road FR-290 stream S-RR16</p>		
GPS Location	See pic for GPS location		GPS Location	See pic for GPS location	
Field Station#	13061+44		Field Station#	13061+44	
Pic 13 Desc.	Downstream side of stream S-RR18.		Pic 14 Desc.	Downstream side of stream S-RR16

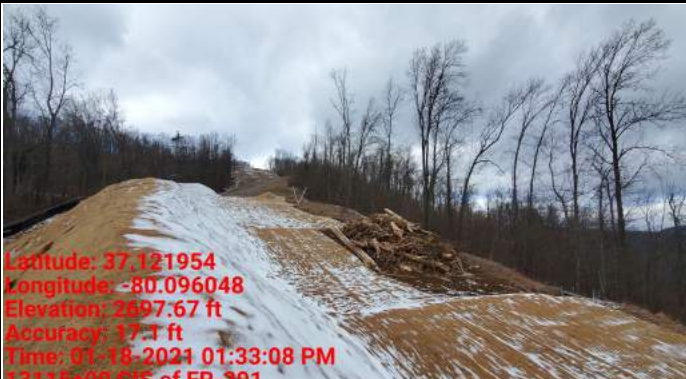
<p>Latitude: 37.121954 Longitude: -80.096048 Elevation: 2697.67 ft Accuracy: 17.1 ft Time: 01-18-2021 01:33:08 PM 13115+00 CIS of FR-291</p>			  <p>Latitude: 37.117596 Longitude: -80.096033 Elevation: 2331.23 ft Accuracy: 23.6 ft Time: 01-18-2021 01:45:19 PM 13115+97 FR-291 stream S-EF17</p>		
GPS Location	See pic for GPS location		GPS Location	See pic for GPS location

Field Station#	13115+00		Field Station#	13115+97	
Pic 15 Desc.	Recently disturbed soils on the CIS of FR-291 have been seeded and stabilized with curlex and straw mulch. No issues or impacts found.		Pic 16 Desc.	Stream crossing S-EF17 on downstream side of the access road.	
  <p>Latitude: 37.1176 Longitude: -80.096065 Elevation: 2310.63 ft Accuracy: 17.3 ft Time: 01-18-2021 01:45:46 PM 13115+97 FR-291 stream S-EF17</p>

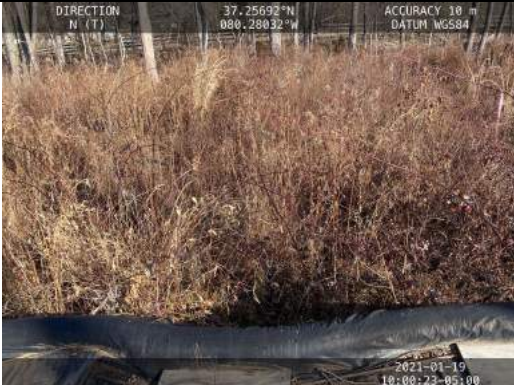
GPS Location	See photo		GPS Location	See photo	
Field Station#	12125+65		Field Station#	12132+73	
Pic 3 Desc.	Stream S-MM31, facing north, upstream		Pic 4 Desc.	Labeling on some signs refreshed today where needed.

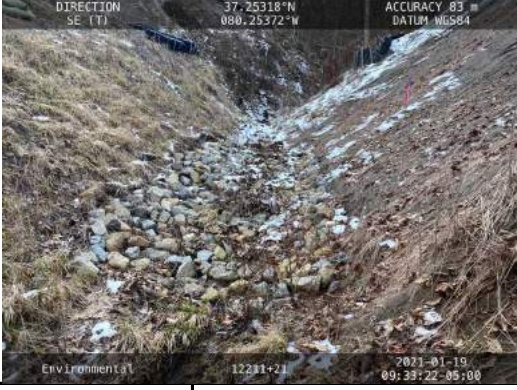
GPS Location	See photo		GPS Location	See photo	
Field Station#	12211+00		Field Station#	12213+00	
Pic 17 Desc.	The drainage feature in the bottom of the ravine between Bradshaw Road and Reese Mountain remains stable.		Pic 18 Desc.	Permanent restoration between Bradshaw Road and Reese Mountain remains stable.

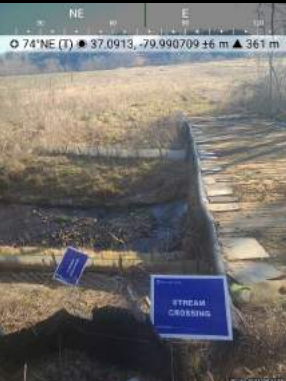
GPS Location	0000	GPS Location	0000		
Field Station#	13543+11	Field Station#	13543+11		
Pic 3 Desc.	During the EI's travel today the EI noticed debris that needs removed from flume pipes at stream crossing, documented and sent in to be added to the punch list.		Pic 4 Desc.	Stream observation photo facing downstream during row inspection today .

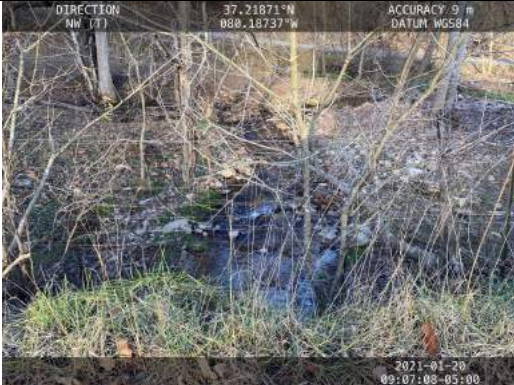
GPS Location	See photo		GPS Location	See photo	
Field Station#	12544+06		Field Station#	12544+06	
Pic 1 Desc.	Stream S-KL32, facing northwest, downstream from Yellow Finch Lane		Pic 2 Desc.	Stream S-EF20b, facing north, downstream from Yellow Finch Lane

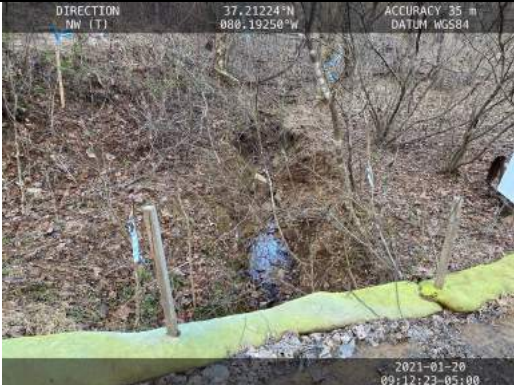
GPS Location	See photo		GPS Location	See photo	
Field Station#	12544+06		Field Station#	12544+06	
Pic 3 Desc.	Stream S-EF54, facing northwest, upstream from Yellow Finch Lane		Pic 4 Desc.	Access road MVP-MN-278.01, Yellow Finch Lane

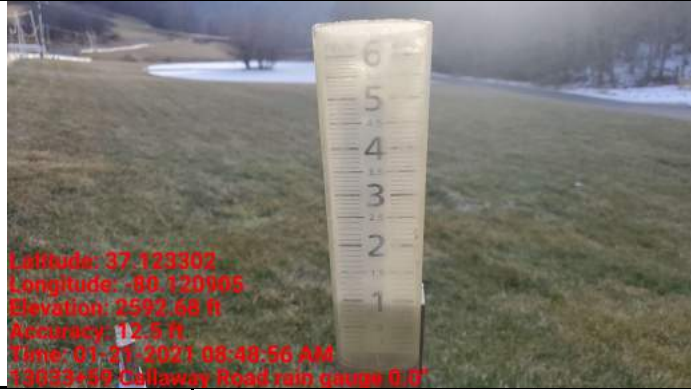
<p>Latitude: 37.123302 Longitude: -80.120905 Elevation: 2593.68 ft Accuracy: 11.5 ft Time: 01-21-2021 08:49:56 AM 13033+59 Callaway Road rain gauge 0.0"</p>

<p>Latitude: 37.123182 Longitude: -80.122326 Elevation: 2583.53 ft Accuracy: 19.0 ft Time: 01-21-2021 09:34:28 AM 13021+77 GAS of the BRP</p>		GPS Location See pic for GPS location	
Field Station# 13033+59		Field Station# 13021+77		Pic 1 Desc. 0.0" precipitation at Callaway Road.

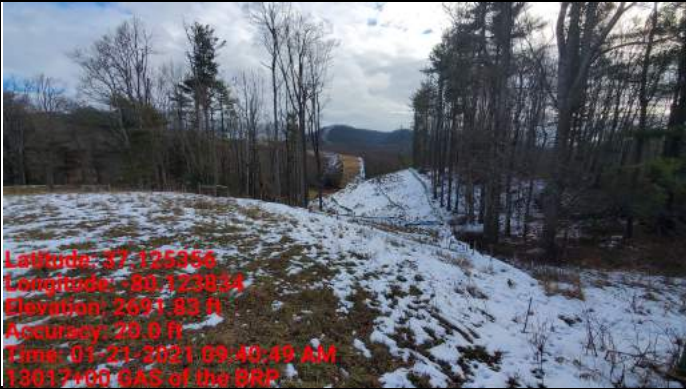
GPS Location	See pic for GPS location		GPS Location	See pic for GPS location	
Field Station#	13017+00		Field Station#	13012+40	
Pic 7 Desc.	Necked down portion of the ROW from the pasture to the wooded portion of the BRP.		Pic 8 Desc.	CIS of the BRP motorway.

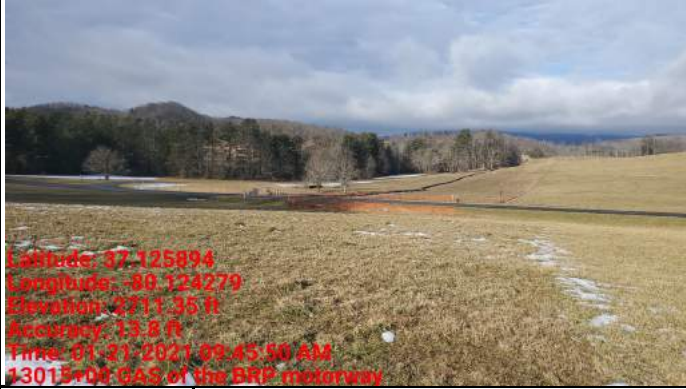
GPS Location	See pic for GPS location		GPS Location	See pic for GPS location	
Field Station#	13015+00		Field Station#	12994+20	
Pic 9 Desc.	GAS of BRP motorway.		Pic 10 Desc.	GAS of the US-221 road crossing.

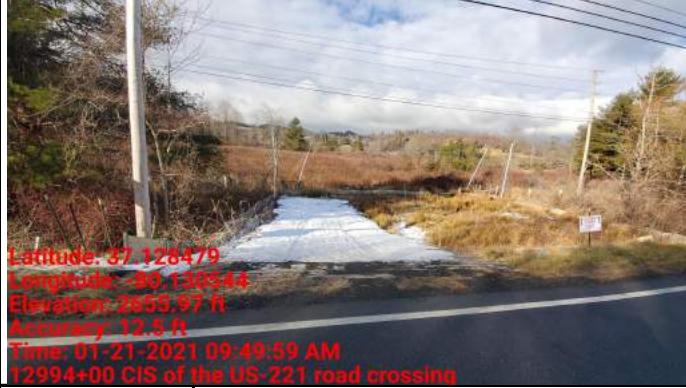
GPS Location	See pic for GPS location		GPS Location	See pic for GPS location	
Field Station#	12994+00		Field Station#	12974+50	
Pic 11 Desc.	CIS of the US-221 road crossing		Pic 12 Desc.	GAS of RO-288 remain stabilized with hydromulch and curlex.

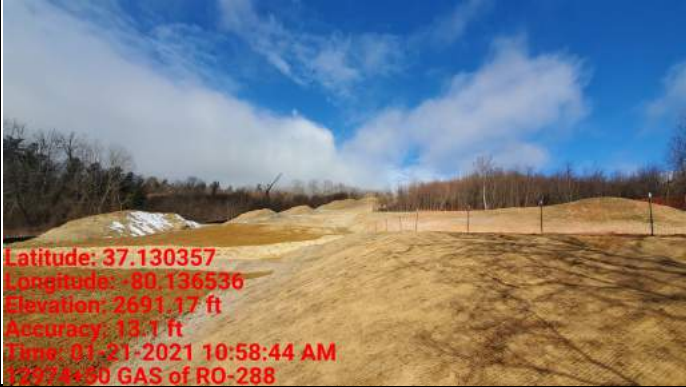
<p>Latitude: 37.130357 Longitude: -80.136536 Elevation: 2691.17 ft Accuracy: 13.1 ft Time: 01-21-2021 10:58:44 AM 12974+50 GAS of RO-288</p>

<p>Latitude: 37.131806 Longitude: -80.131966 Elevation: 2672.24 ft Accuracy: 42.7 ft Time: 01-21-2021 11:04:45 AM 12974+29 RO-288 stream S-Q20</p>		
GPS Location	See pic for GPS location		GPS Location	See pic for GPS location	
Field Station#	12974+50		Field Station#	12974+29	
Pic 13 Desc.	CIS of RO-288 remain in compliance and stabilized with EarthGuard hydromulch.		Pic 14 Desc.	No impacts observed at the stream crossing S-Q20.

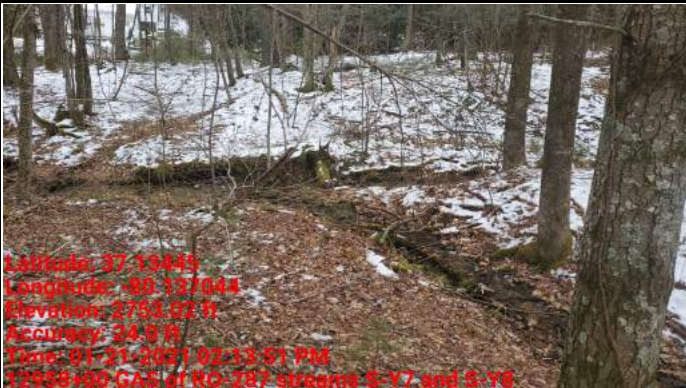
<p>Latitude: 37.13449 Longitude: -80.137644 Elevation: 2753.02 ft Accuracy: 34.0 ft Time: 01-21-2021 02:13:51 PM 12958+00 GAS of RO-287 streams S-Y7 and S-Y8</p>

GPS Location	See pic for GPS location		GPS Location	See pic for GPS location	
Field Station#	12958+00		Field Station#	12956+93	
Pic 15 Desc.	Streams S-Y7 and S-Y8 where the merge on the downstream side of ROW.		Pic 16 Desc.	Landowner's spring box at RO-287 and streams S-Y7 and S-Y9.

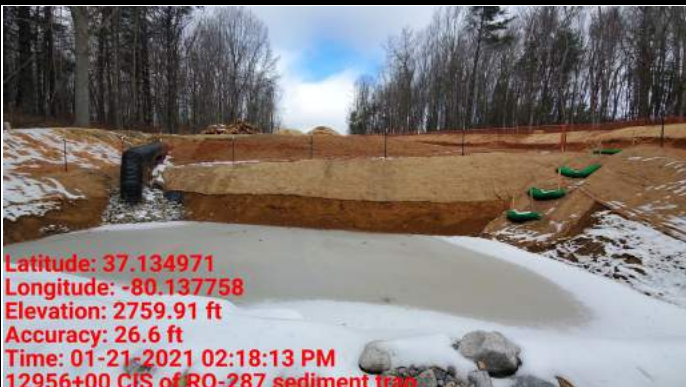
<p>Latitude: 37.134971 Longitude: -80.137758 Elevation: 2759.91 ft Accuracy: 26.6 ft Time: 01-21-2021 02:18:13 PM 12956+00 CIS of RO-287 sediment trap</p>

<p>Latitude: 37.135393 Longitude: -80.134667 Elevation: 3887.5 ft Accuracy: 26.2 ft Time: 01-21-2021 02:49:32 PM 12957+30 Access road RO-287 at stream S-Z17</p>		
GPS Location	See pic for GPS location		GPS Location	See pic for GPS location	
Field Station#	12956+00		Field Station#	12957+30	
Pic 17 Desc.	Sediment trap on the CIS of RO-287.		Pic 18 Desc.	Access road RO-287 at stream crossing S-Z17.

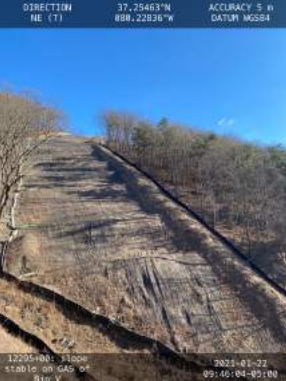
GPS Location	See photo		GPS Location	See photo	
Field Station#	12295+00		Field Station#	12291+64	
Pic 1 Desc.	Slope stable on going away side of the "Big V" on Reese Mountain.		Pic 2 Desc.	Clean water diversion channel in the bottom of the "Big V" is well vegetated and stable and ECDs are in satisfactory condition.

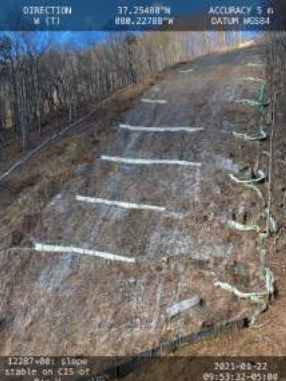
GPS Location	See photo		GPS Location	See photo	
Field Station#	12287+00		Field Station#	12294+00	
Pic 3 Desc.	Slope stable on coming in side of the "Big V" on Reese Mountain.		Pic 4 Desc.	Perimeter controls in good repair in the "Big V" on Reese Mountain.

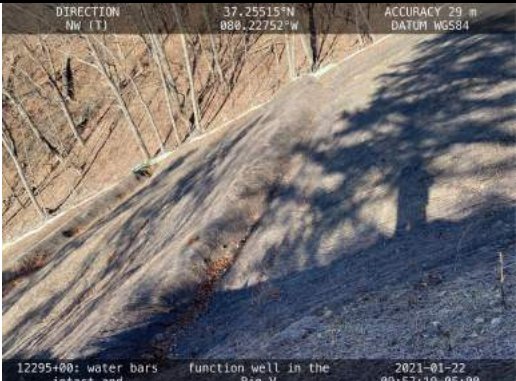
GPS Location	See photo		GPS Location	See photo	
Field Station#	12295+00		Field Station#	12300+00	
Pic 5 Desc.	Water bars are in good condition and functioning properly through the "Big V".		Pic 6 Desc.	ROW stable

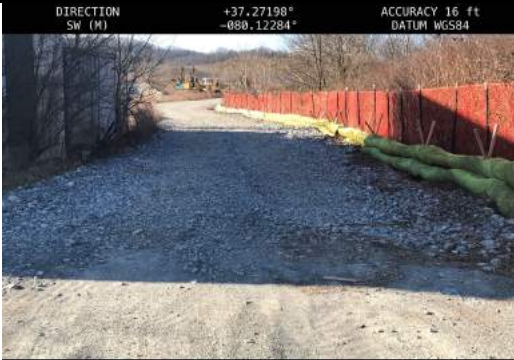
<p>DIRECTION SW (M) +37.27198° -080.12284° ACCURACY 16 ft DATUM WGS84</p> <p>MVP-LY-049_012221 Condition of rock entrance 2021-01-22 09:36:21-05:00</p>

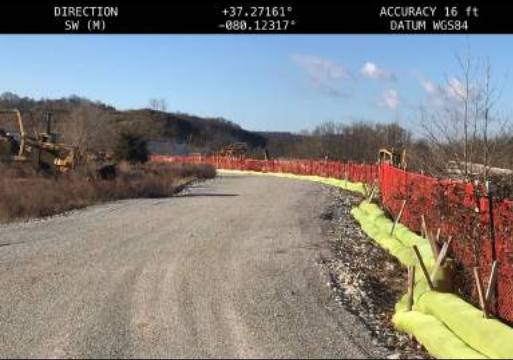
<p>DIRECTION SW (M) +37.27161° -080.12317° ACCURACY 16 ft DATUM WGS84</p> <p>MVP-LY-049_012221 Condition of CFS & safety fence LOD 2021-01-22 09:37:35-05:00</p>			
GPS Location	MVP-LY-049 See photo for gps data		GPS Location	MVP-LY-049 See photo for gps data	
Field Station#	+0		Field Station#	+0	
Pic 1 Desc.	Condition of rock entrance on north drive. No sediment on stone. Looking SW.		Pic 2 Desc.	Condition of compost filter sock and safety fence along north LOD. Looking SW.

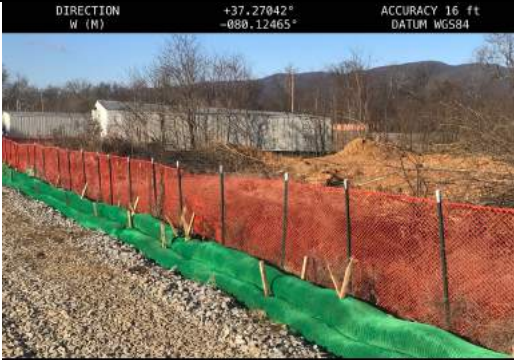
<p>DIRECTION W (M) +37.27042° -080.12465° ACCURACY 16 ft DATUM WGS84</p> <p>MVP-LY-049_012221 Landowner disturbance along feature 2021-01-22 09:39:07-05:00</p>

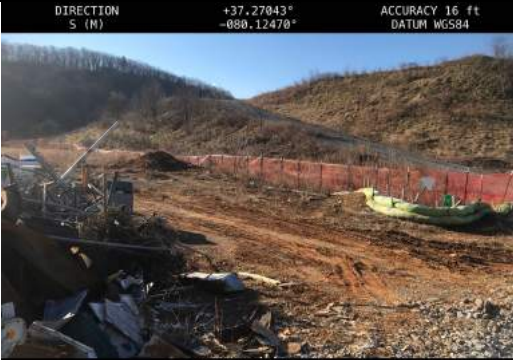
GPS Location	MVP-LY-049 See photo for gps data		GPS Location	MVP-LY-049 See photo for gps data	
Field Station#	+0		Field Station#	+0	
Pic 3 Desc.	Landowner soil disturbance along north edge of feature W-CV21A. Looking W.		Pic 4 Desc.	Landowner soil disturbance along compost filter sock and feature W-CV21B. Area not stabilized. No impacts. Looking S.

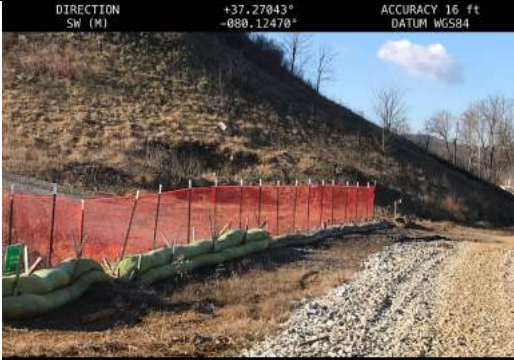
<p>DIRECTION S (M) +37.27043° -080.12470° ACCURACY 16 ft DATUM WGS84</p> <p>MVP-LY-049_012221 Landowner disturbance along CFS & feature 2021-01-22 09:39:27-05:00</p>

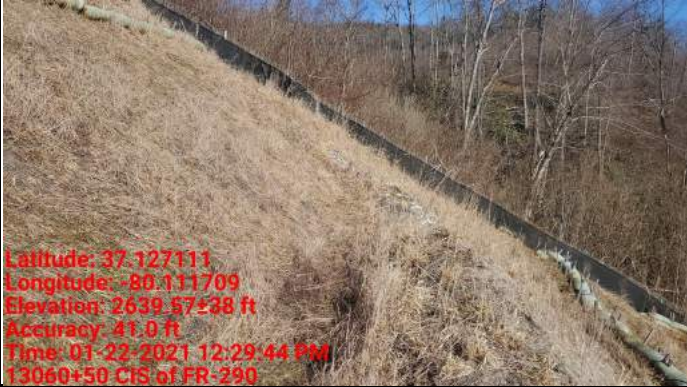
<p>Latitude: 37.127111 Longitude: -80.111709 Elevation: 2639.57±38 ft Accuracy: 41.0 ft Time: 01-22-2021 12:29:44 PM 13060+50 CIS of FR-290</p>

<p>Latitude: 37.127018 Longitude: -80.111404 Elevation: 2659.32±71 ft Accuracy: 63.6 ft Time: 01-22-2021 12:32:36 PM 13063+00 GAS of FR-290 stream S-G27</p>		
GPS Location	See pic for GPS location		GPS Location	See pic for GPS location	
Field Station#	13060+50		Field Station#	13063+00	
Pic 7 Desc.	Vegetative stabilization on the CIS of FR-290.		Pic 8 Desc.	Downstream side of S-G27

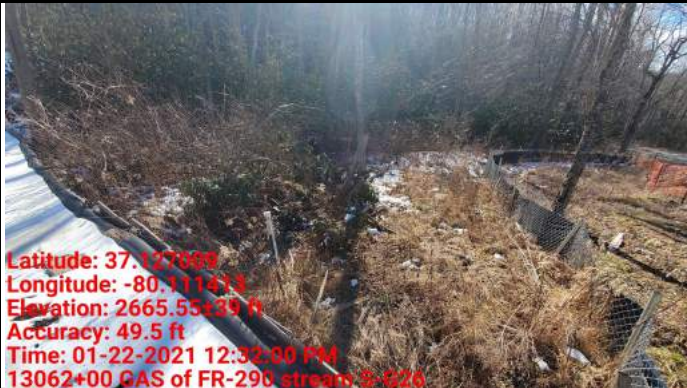
<p>Latitude: 37.127839 Longitude: -80.111413 Elevation: 2665.55±39 ft Accuracy: 49.5 ft Time: 01-22-2021 12:32:30 PM 13062+00 GAS of FR-290 stream S-G26</p>

GPS Location	See pic for GPS location		GPS Location	See pic for GPS location	
Field Station#	13062+00		Field Station#	13064+00	
Pic 9 Desc.	Downstream side of S-G26.		Pic 10 Desc.	Current conditions of the GAS of FR-290.

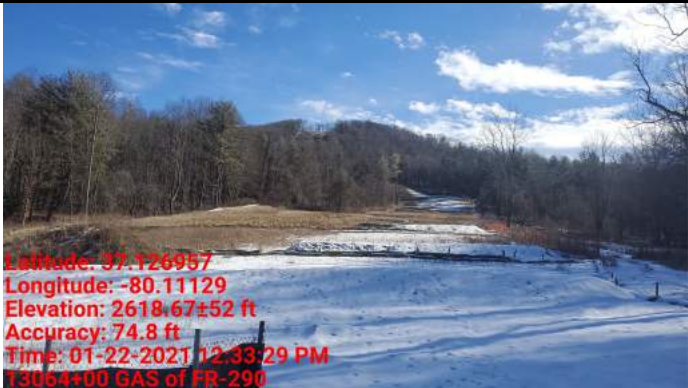
<p>Latitude: 37.126957 Longitude: -80.11129 Elevation: 2618.67±52 ft Accuracy: 74.8 ft Time: 01-22-2021 12:33:29 PM 13064+00 GAS of FR-290</p>

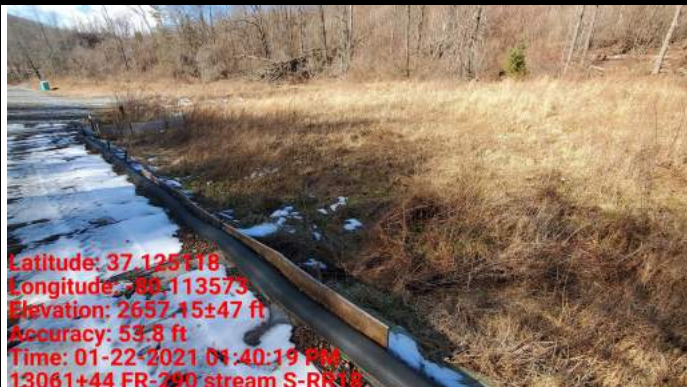
<p>Latitude: 37.125118 Longitude: -80.113573 Elevation: 2657.15±47 ft Accuracy: 53.8 ft Time: 01-22-2021 01:40:19 PM 13061+44 FR-290 stream S-RR18</p>

<p>Latitude: 37.125154 Longitude: -80.113653 Elevation: 2587.5±28 ft Accuracy: 31.5 ft Time: 01-22-2021 01:40:48 PM 13061+44 FR-290 stream S-RR18</p>		
GPS Location	See pic for GPS location		GPS Location	See pic for GPS location	
Field Station#	13061+44		Field Station#	13061+44	
Pic 11 Desc.	Upstream side of stream S-RR18 along FR-290.		Pic 12 Desc.	Downstream side of stream S-RR18 along FR-290.
