Visual Site Inspection Report

| Project Name | H-600 Pipeline Spread H | AFE | 124300138 | Spread | H-600 Pipeline Spread H |
| Contractor | Precision | | | Report # | 18710 |
| Inspector | John Brcic | | | Date/Time | 1/4/2021 12:00 PM |

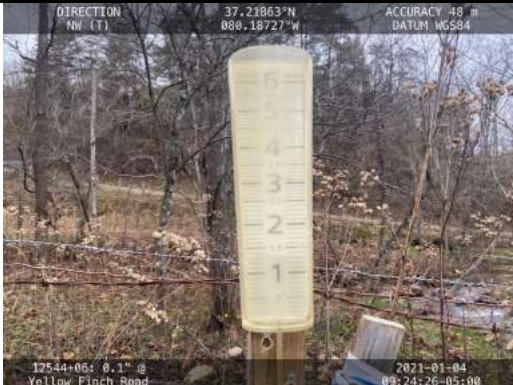
| Field Station# | 12544+06 | | Field Station# | 12544+06 | |

| Pic 1 Desc. | 0.1 inches in the rain gauge at Yellow Finch Road this morning. | | Pic 2 Desc. | Stream S-EF54, facing east, downstream from Yellow Finch Road | |

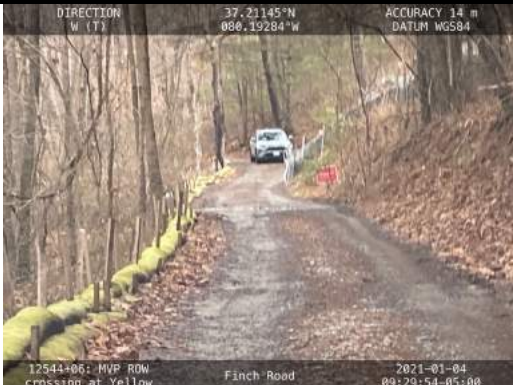
| Field Station# | 12544+06 | | Field Station# | 12544+54 | |

| Pic 3 Desc. | MVP ROW crossing on Yellow Finch Road. | | Pic 4 Desc. | Stream S-EF20a, facing northeast , downstream | |

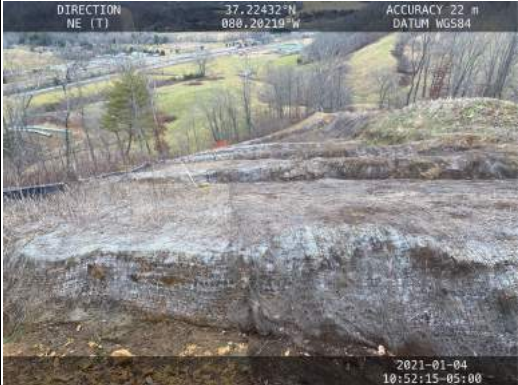
| Field Station# | 12486+00 | | Field Station# | 12482+00 | |

| Pic 15 Desc. | ROW stable | | Pic 16 Desc. | Plastic sheeting over the site of the "pig parts" excavation site remains intact. | |

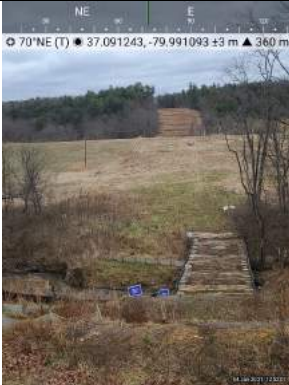
| Field Station# | 13541+82 | Field Station# | 13644+73 | | |

| Pic 1 Desc. | The EI monitored slope breakers and ECDs above stream crossing, no environmental issues observed at the time of inspection | | Pic 2 Desc. | The EI inspected P1 along road crossing at Leaning Oak rd, no environmental issues observed at the time of inspection | |

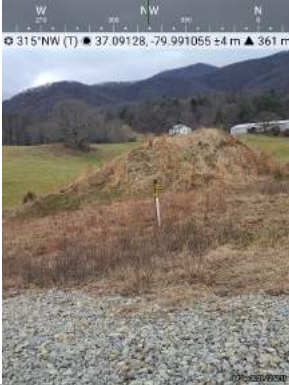
| Field Station# | 13541+60 | Field Station# | 13541+73 | | |

| Pic 3 Desc. | Vegetation stabilization on spoil pile monitored | | Pic 4 Desc. | EI checked RCEs and monitored vegetation growth throughout row inspections today. | |

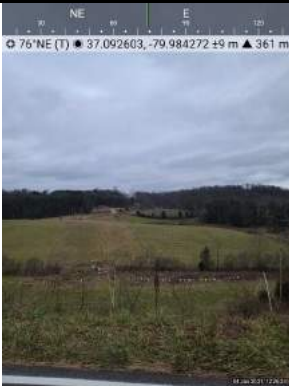
| Field Station# | 13562+73 | Field Station# | 13644+90 | | |

| Pic 5 Desc. | Row photo taken by the EI above stream crossing showing equipment bridge along with ECDs and vegetation coverage being good in this area | | Pic 6 Desc. | Photo showing vegetation on the going away side of Leaning Oak , vegetation coverage was good and no environmental issues observed. | |

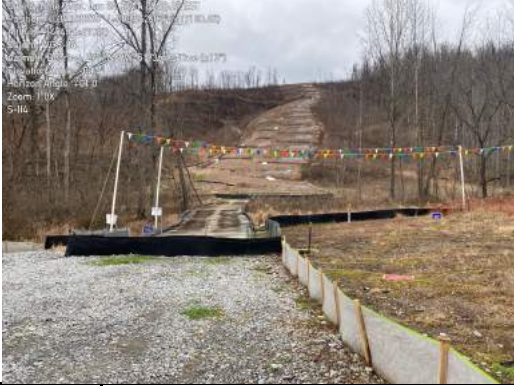
| Field Station# | 13262+00 | | Field Station# | 13262+00 | |

| Pic 1 Desc. | S-II4, GAS, ECDs in acceptable condition. | | Pic 2 Desc. | ATWS-1055, workspace in acceptable condition, perimeter ECDs functioning acceptably. | |

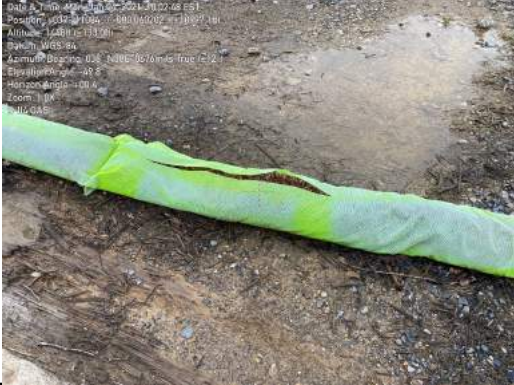
| Field Station# | 13261+00 | | Field Station# | 13261+00 | |

| Pic 3 Desc. | Waddle on bridge damaged. | | Pic 4 Desc. | Ridge over S-II4 in acceptable condition. | |

| E&S BMPs | Compliance Level | Corrective Action | Corrective Time Frame | Date Repaired |
|---|---|---|---|---|
| Compost Filter Sock | Communication | Repair waddle; 3 day maintenance | | |

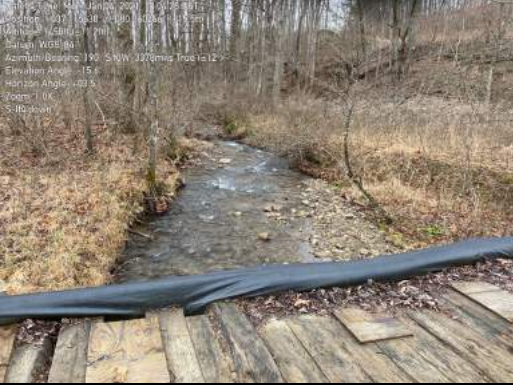
| Field Station# | 13260+60 | | Field Station# | 13260+60 | |

| Pic 5 Desc. | S-II4, upstream, water clear, no changes noted to stream bed or banks. | | Pic 6 Desc. | S-II4, downstream, water clear, no changes noted to stream bed or banks. | |

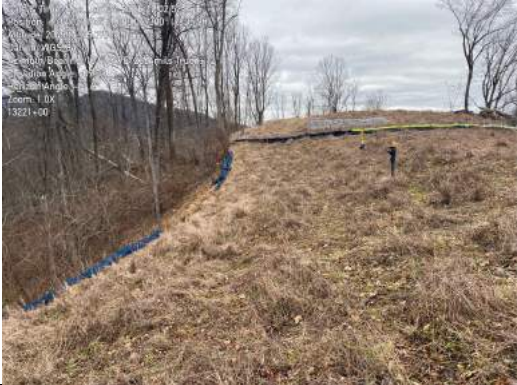
| Field Station# | 13221+00 | | Field Station# | 13218+00 | |

| Pic 13 Desc. | ROW stable, no movement noted upslope of documented slip. | | Pic 14 Desc. | ROW stable with vegetative cover noted across LOD. | |

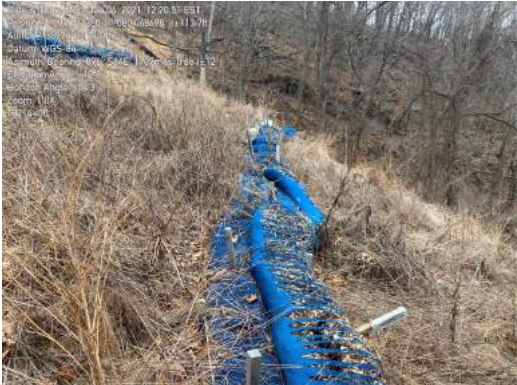
| Field Station# | 13214+00 | | Field Station# | 13208+00 | |

| Pic 15 Desc. | Bright blue CFS in poor condition, restored portion of ROW. | | Pic 16 Desc. | ROW stabilized, acceptable vegetative cover across ROW, waterbars in acceptable condition. | |

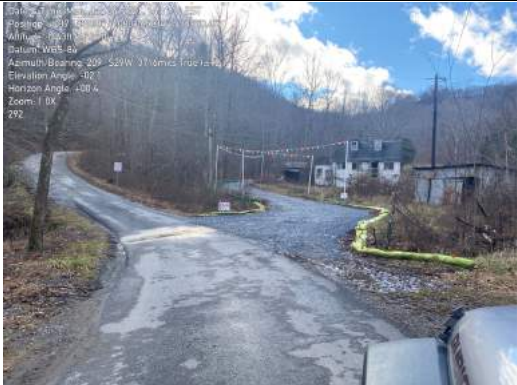
| Field Station# | 13160+00 | | Field Station# | 13148+00 | |

| Pic 17 Desc. | ROW stabilized, no ECDs in area. | | Pic 18 Desc. | MVP-FR-292, access road in acceptable condition. | |

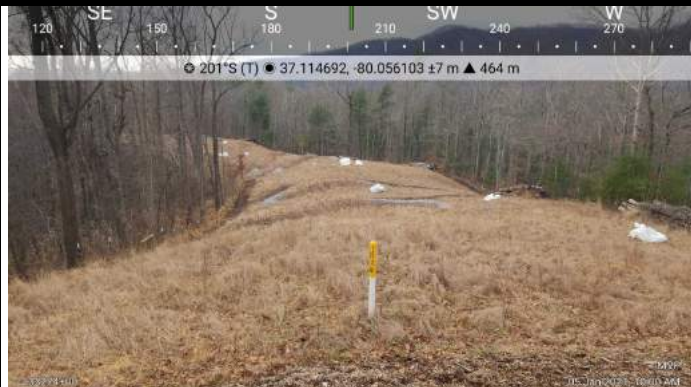
| Field Station# | 13274+00 | | Field Station# | 13286+00 | |

| Pic 3 Desc. | ROW Overview (permanent stabilization). ECDs are functional and ROW is stable. | | Pic 4 Desc. | ROW Overview (permanent stabilization). ECDs are functional and ROW is stable. | |

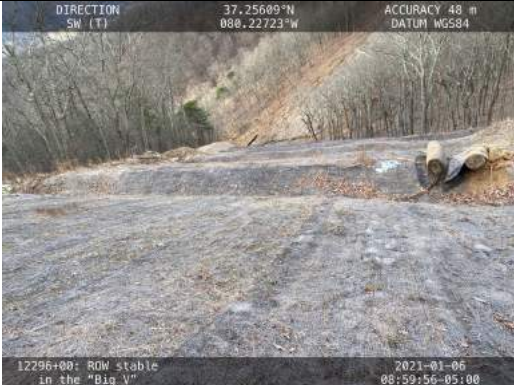
| Field Station# | 12296+00 | | Field Station# | 12301+00 | |

| Pic 1 Desc. | ROW stable in the "Big V". | | Pic 2 Desc. | ROW stable | |

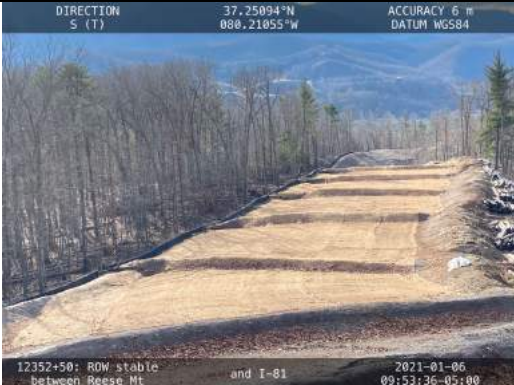
| Field Station# | 12352+50 | | Field Station# | 12361+02 | |

| Pic 3 Desc. | ROW stable | | Pic 4 Desc. | ECDs in satisfactory condition at landowner crossing near I-81. | |

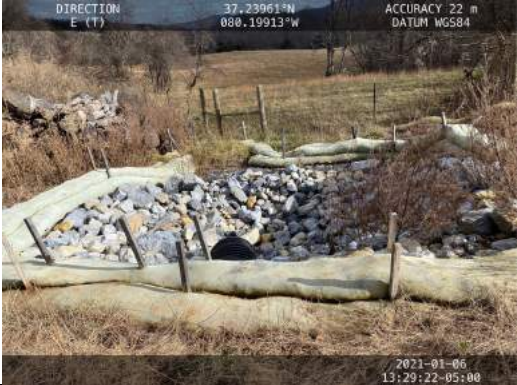
| Field Station# | 12410+50 | | Field Station# | 12435+50 | |

| Pic 13 Desc. | Clean water diversion pipe outlet plunge pool is in satisfactory condition, free of sediment. | | Pic 14 Desc. | Stream S-NN16, Roanoke River, facing northeast from Lafayette Road. | |

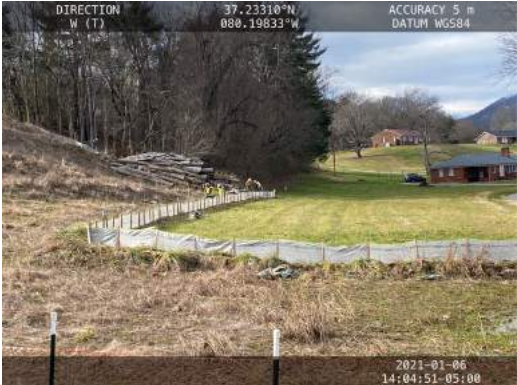
| Field Station# | 12437+00 | | Field Station# | 12424+00 | |

| Pic 15 Desc. | An environmental crew was replacing old ECDs on the going away side of Lafayette Road. | | Pic 16 Desc. | The rock construction entrance on the going away side of access road MVP-MN-279 is in good condition. | |

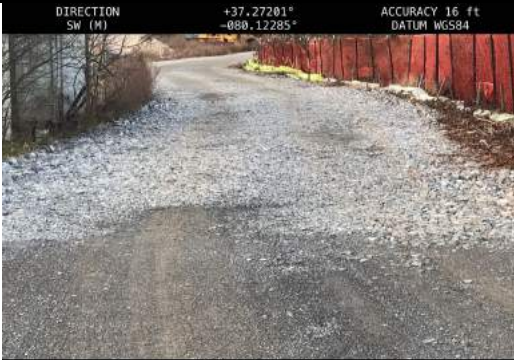
| Pic 1 Desc. | Condition of north rock entrance. No sediment on stone. Looking Sw. | Pic 2 Desc. | Condition of compost filter sock and safety fence along north LOD. Looking W. | | |

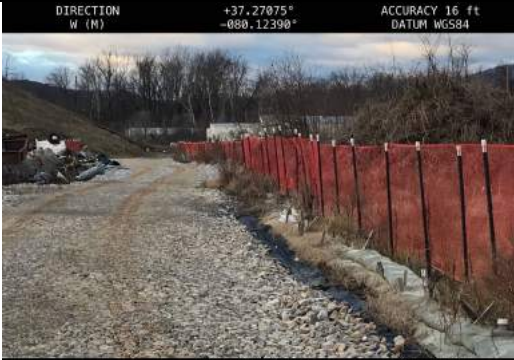
| Pic 3 Desc. | Condition of compost filter sock and safety fence along north LOD. Looking W. | Pic 4 Desc. | Landowner soil disturbance along compost filter sock and feature W-CV21B. Area not stabilized. No impacts. Looking SW. | | |

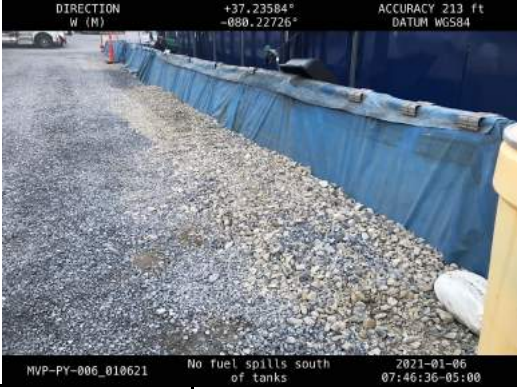
| Pic 7 Desc. | No fuel spills south of the Blue Bulk fuel tanks. Looking W. | | Pic 8 Desc. | Blue Bulk Fuel tanks no leaky internal fittings. Looking W. | |

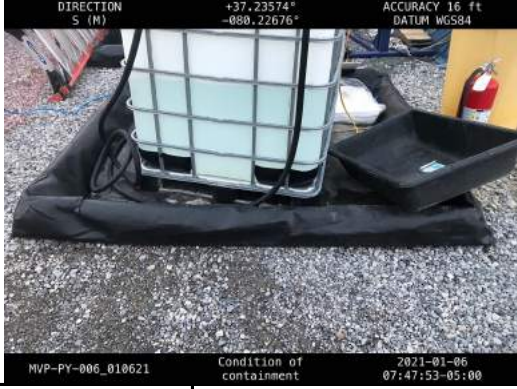
| Pic 9 Desc. | Condition of containment under DEF container. Looking S. | | Pic 10 Desc. | Secondary containment on site for tankers offloading fuel into Blue Bulk fuel tanks. Looking W. | |

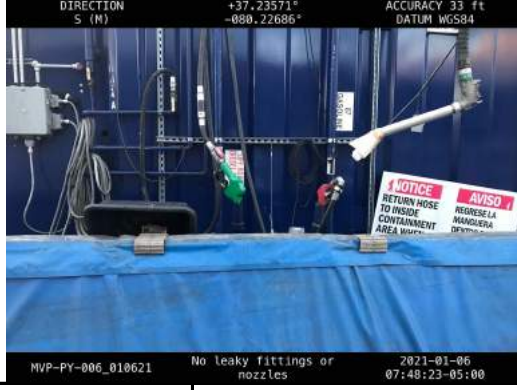
| Pic 11 Desc. | Blue Bulk Fuel tanks no leaky fittings or nozzles. Looking S. | | Pic 12 Desc. | Off Road Fuel unit containment holding stormwater. Looking N. | |

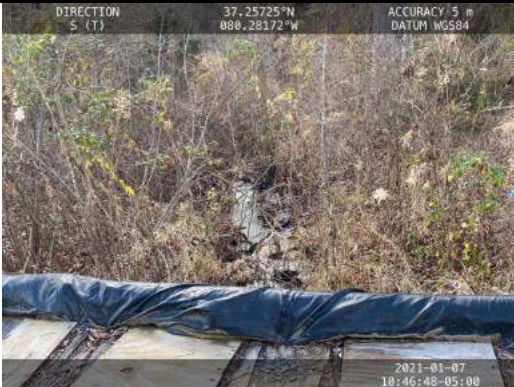
| Field Station# | 12121+33 | | Field Station# | 12121+83 | |

| Pic 1 Desc. | Stream S-C33, facing south, downstream | | Pic 2 Desc. | Stream S-C36, facing south, downstream | |

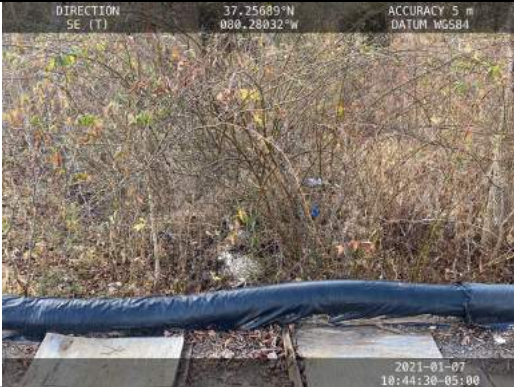
| Field Station# | 12125+65 | | Field Station# | 12130+90 | |

| Pic 3 Desc. | Stream S-MM31, facing southeast, downstream | | Pic 4 Desc. | P1 silt fence replaced per DEQ action item. | |

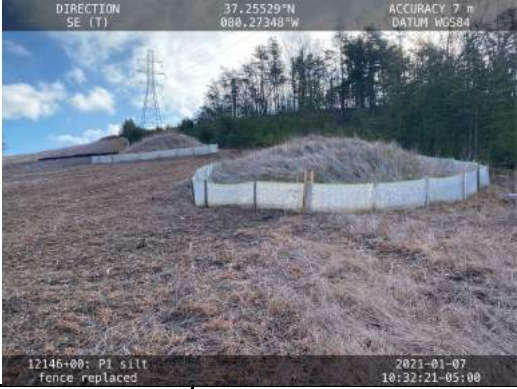
| Field Station# | 12146+00 | | Field Station# | 12148+00 | |

| Pic 7 Desc. | P1 silt fence replaced per DEQ action item. | | Pic 8 Desc. | Ravine between access roads MVP-MN-272 and 273 remains stable. | |

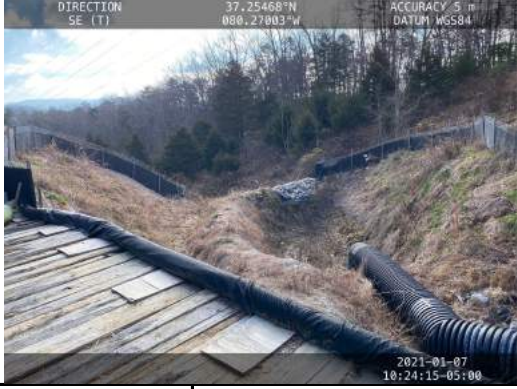
| Field Station# | 12157+00 | | Field Station# | 12163+05 | |

| Pic 9 Desc. | The clean water diversion channel and temporary sediment trap are in good condition and functioning properly. | | Pic 10 Desc. | Bridge, buffer zone and ECDs in satisfactory condition at stream S-C25. | |

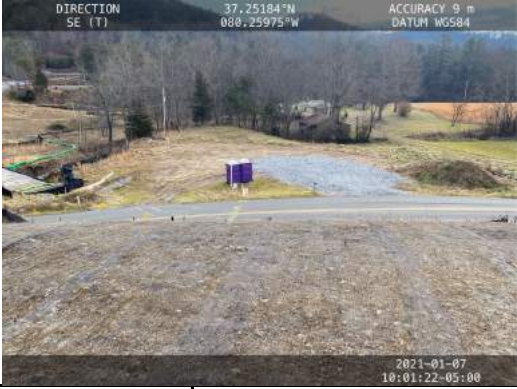
| Field Station# | 12190+85 | Field Station# | 12192+50 | | |

| Pic 13 Desc. | Bradshaw Road crossing in satisfactory condition, free of sediment or any other debris. | Pic 14 Desc. | Stream S-C21, Bradshaw Creek, facing east, downstream | | |

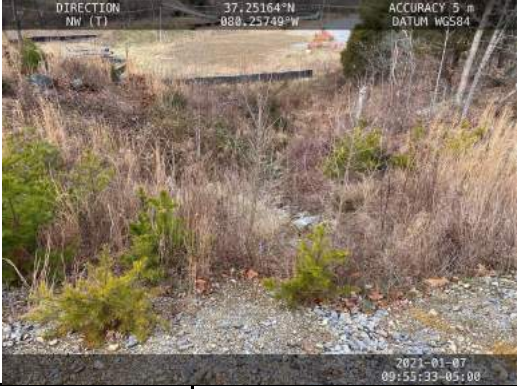
| Field Station# | 12197+37 | Field Station# | 12215+00 | | |

| Pic 15 Desc. | Stream S-0011, facing northwest, downstream | Pic 16 Desc. | Permanent restoration on slope below the switchback on Reese Mountain remains stable. | | |

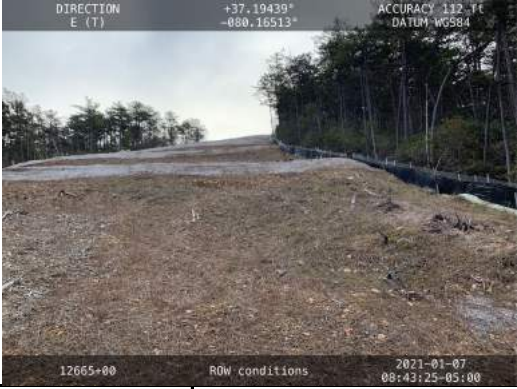
| Field Station# | 12671+00 | | Field Station# | 12665+00 | |

| Pic 7 Desc. | Photo shows the ROW condition from about 12671+00 to 12675+00. | | Pic 8 Desc. | Photo shows the ROW condition from about 12665+00 to 12670+00. | |

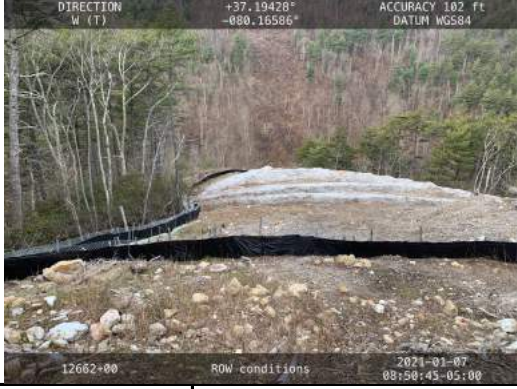
| Field Station# | 12661+00 | | Field Station# | 12690+50 | |

| Pic 9 Desc. | Photo shows the ROW condition from about 12661+00 to 12662+00. | | Pic 10 Desc. | Photo shows the RCE on the east side of Honeysuckle Road. | |

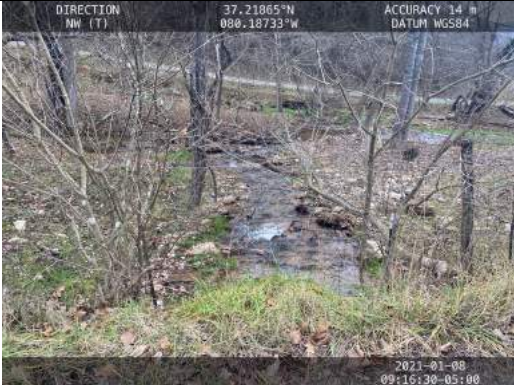
| Field Station# | 12544+06 | | Field Station# | 12544+06 | |

| Pic 1 Desc. | Stream S-KL32, facing northwest, downstream from Yellow Finch Lane | | Pic 2 Desc. | Stream S-EF20b, facing north, downstream from Yellow Finch Lane | |

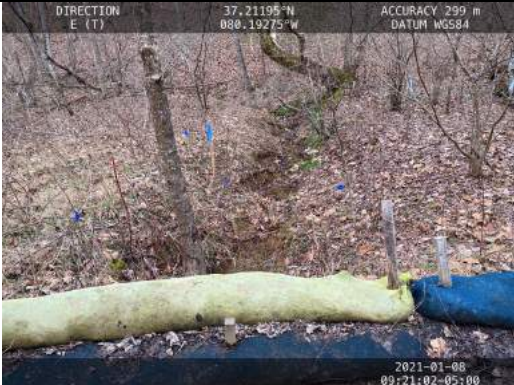
| Field Station# | 12544+06 | | Field Station# | 12543+50 | |

| Pic 3 Desc. | Stream S-EF54, facing east, downstream from Yellow Finch Lane | | Pic 4 Desc. | ECDs in the on slope leading down to Yellow Finch Lane. | |

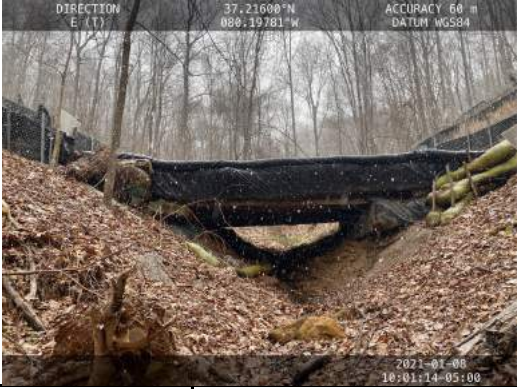
| Field Station# | 12519+41 | | Field Station# | 12519+41 | |

| Pic 13 Desc. | Stream S-EF19, facing east, upstream | | Pic 14 Desc. | Buffer zone, bridge and ECDs in satisfactory condition at stream S-EF19. | |

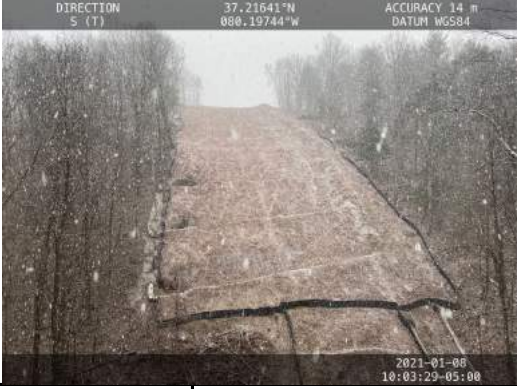
| Field Station# | 12523+00 | | Field Station# | 12496+00 | |

| Pic 15 Desc. | Slope remains stable on the going away side of stream S-EF19. | | Pic 16 Desc. | ROW stable | |

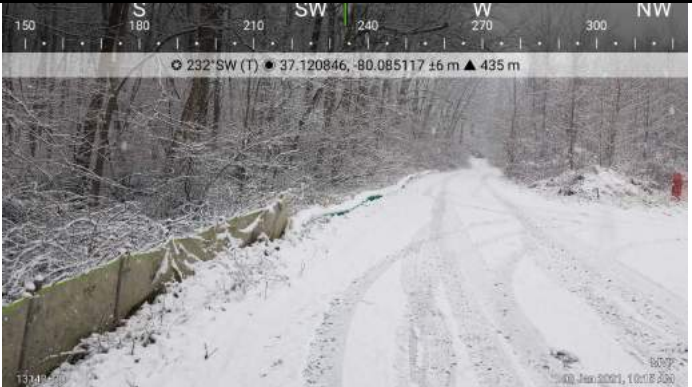
| Field Station# | 13142+00 | Field Station# | 13142+00 | | |

| Pic 1 Desc. | Access Road 292 Overview. ECDs are functional and ROW is stable. | Pic 2 Desc. | Access Road 292 Overview. ECDs are functional and ROW is stable. | | |
