Visual Site Inspection Report

Project Name	H-600 Pipeline Spread H	AFE	124300138	Spread	H-600 Pipeline Spread H
Contractor	Precision			Report #	18940
Inspector	John Brcic			Date/Time	1/11/2021 9:57 AM
Permit #	TBD	Inspection Type	VA SWPP	Station Begin	12005+00
State	VA	Inspection Area	Partial	Station End	12119+17
County	Montgomery	Ground	Frozen	Temperature (°F)	32.00
Municipality	N/A	Weather	Snow/Sleet	Rain Gauge (in)	0.30
				Rain Accumulation Time (days)	3.00

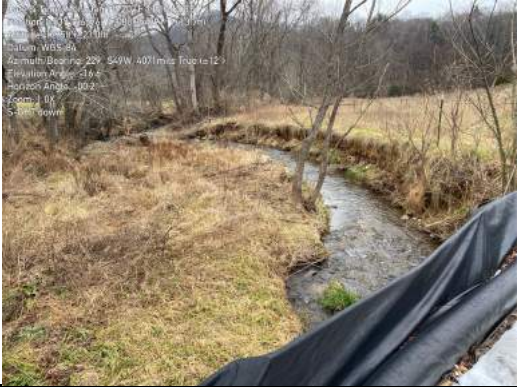
<p>Date & Time: 1/11/2021 5:55 PM Position: 42°51'10.00"N 76°50'00.00"W Altitude: 1241.00 ft Datum: WGS 84 Azimuth Bearing: 229.54°W Elevation Angle: 51.4° Horizon Angle: -10.3° Zoom: 1.0x S-GH7 down</p>

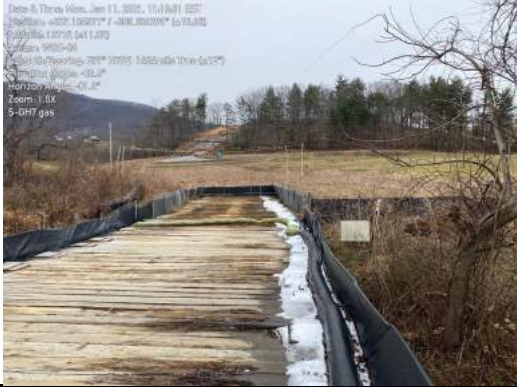
<p>Date & Time: 1/11/2021 5:55 PM Position: 42°51'10.00"N 76°50'00.00"W Altitude: 1241.00 ft Datum: WGS 84 Azimuth Bearing: 229.54°W Elevation Angle: 51.4° Horizon Angle: -10.3° Zoom: 1.0x S-GH7 gas</p>			
GPS Location	See photo for coordinates.		GPS Location	See photo for coordinates.	
Field Station#	13309+09		Field Station#	13309+09	
Pic 7 Desc.	S-GH7, downstream, no changes noted to bed or banks, no turbidity observed.		Pic 8 Desc.	S-GH7, bridge clean and in acceptable confrontation. ROW stable.

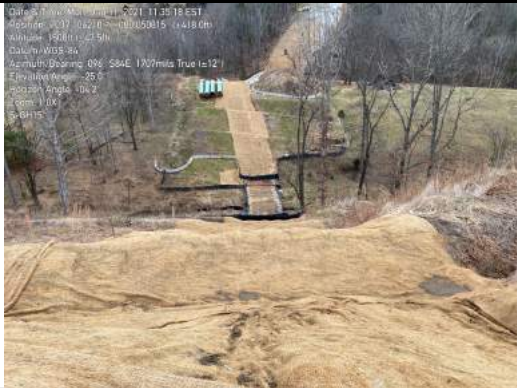
<p>Date & Time: 1/11/2021 11:35:18 EST Position: 42°51'10.00"N 76°50'00.00"W Altitude: 1241.00 ft Datum: WGS 84 Azimuth Bearing: 096.58°E Elevation Angle: 25.0° Horizon Angle: -10.2° Zoom: 1.0x S-GH15</p>

GPS Location	See photo for coordinates.		GPS Location	See photo for coordinates.	
Field Station#	13319+00		Field Station#	13321+47	
Pic 9 Desc.	S-GH15, ROW stable, waterbars functioning acceptably.		Pic 10 Desc.	S-GH15, downstream, no ROW impacts observed at steam crossing.

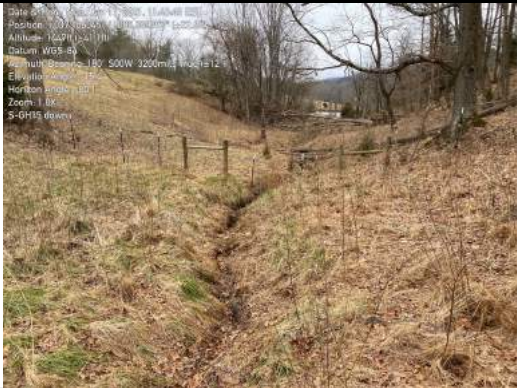
<p>Date & Time: 1/11/2021 11:40:48 EST Position: 42°51'10.00"N 76°50'00.00"W Altitude: 1241.00 ft Datum: WGS 84 Azimuth Bearing: 180.50°W Elevation Angle: 12.1° Horizon Angle: -10.2° Zoom: 1.0x S-GH15 down</p>

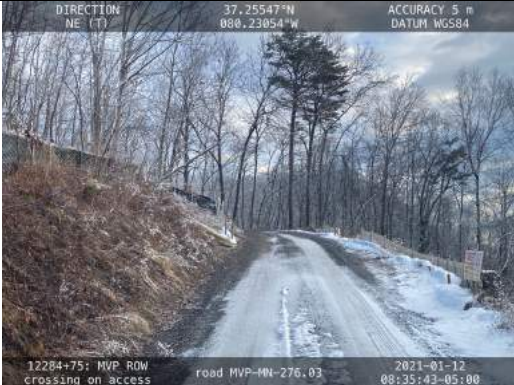
GPS Location	See photo		GPS Location	See photo	
Field Station#	12284+75		Field Station#	12287+00	
Pic 1 Desc.	MVP ROW crossing on access road MVP-MN-276.03.		Pic 2 Desc.	Slope on coming in side of the "Big V" remains stable.

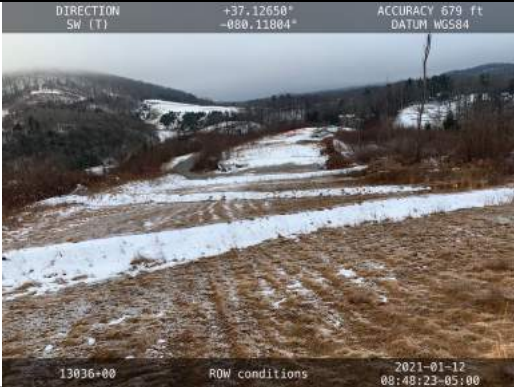
GPS Location	See pic for GPS location		GPS Location	See pic for GPS location	
Field Station#	13036+00		Field Station#	13042+61	
Pic 3 Desc.	Temporary stabilization at access FR-289.		Pic 4 Desc.	Mat equipment bridge over stream S-H1.

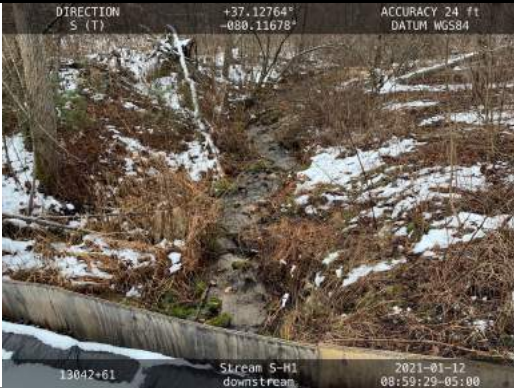
GPS Location	See pic for GPS location		GPS Location	See pic for GPS location	
Field Station#	13042+61		Field Station#	13054+00	
Pic 5 Desc.	Stream S-H1 on the downstream side of equipment bridge.		Pic 6 Desc.	Permanent restoration performed on the CIS of FR-290.

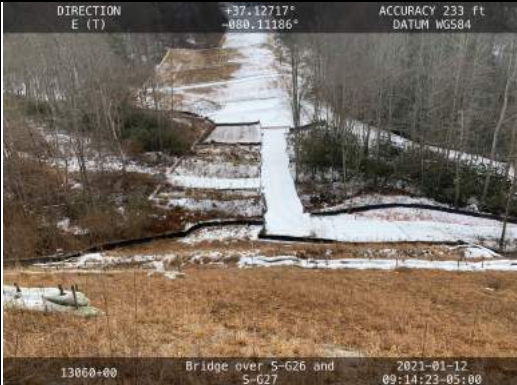
GPS Location	See pic for GPS location		GPS Location	See pic for GPS location	
Field Station#	13060+00		Field Station#	13062+00	
Pic 7 Desc.	Streams S-G26 and S-G27 from the slope on the CIS of access FR-290.		Pic 8 Desc.	Downstream side of stream S-G26.

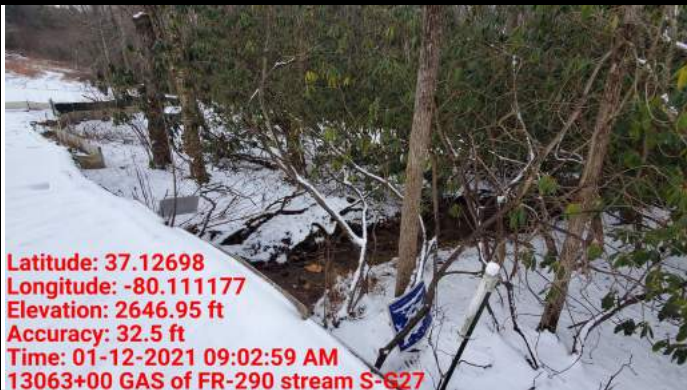
GPS Location	See pic for GPS location		GPS Location	See pic for GPS location	
Field Station#	13063+00		Field Station#	13064+00	
Pic 9 Desc.	Downstream side of stream S-G27		Pic 10 Desc.	Streams S-G26 and S-G27 from the GAS.

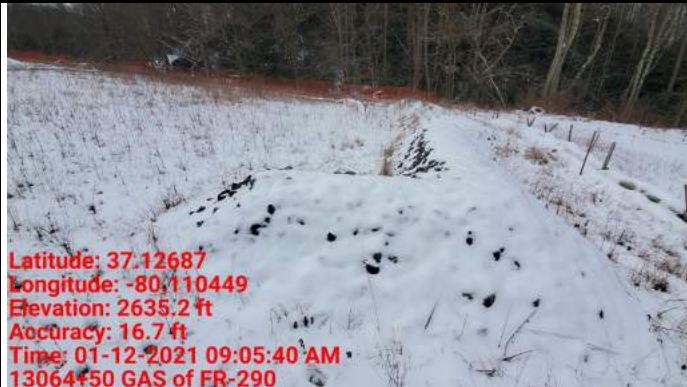
GPS Location	See pic for GPS location		GPS Location	See pic for GPS location	
Field Station#	13064+50		Field Station#	13033+59	
Pic 11 Desc.	Permanent Slope Breaker and Rock Level Spreader.		Pic 12 Desc.	0.0" at Callaway Road

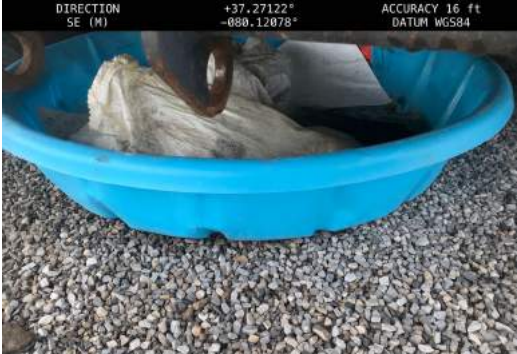
GPS Location	MVP-LY-049 See photo for gps data	GPS Location	MVP-LY-049 See photo for gps data		
Field Station#	+0	Field Station#	+0		
Pic 7 Desc.	Condition of containment under stored vehicle. Looking SE.	Pic 8 Desc.	Condition of containment under stored vehicle. Looking SW.

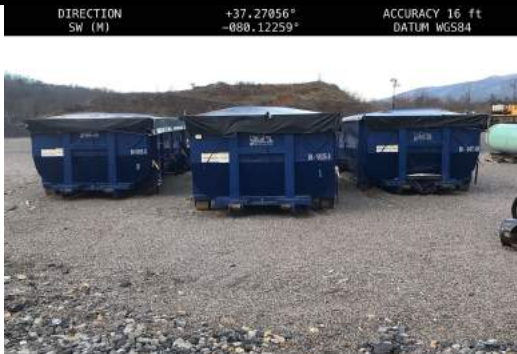
GPS Location	MVP-LY-049 See photo for gps data	GPS Location	MVP-LY-049 See photo for gps data		
Field Station#	+0	Field Station#	+0		
Pic 9 Desc.	No deposits and fluids around hazardous waste dumpsters. Looking NW.	Pic 10 Desc.	No loose trash around south dumpsters. Looking SE.

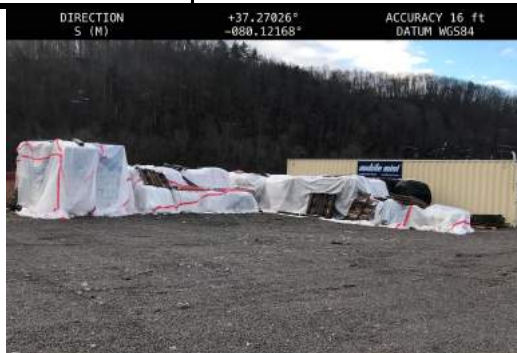
GPS Location	MVP-LY-049 See photo for gps data	GPS Location	MVP-LY-049 See photo for gps data		
Field Station#	+0	Field Station#	+0		
Pic 11 Desc.	Restoration supplies covered and protected from the elements. Looking SW.	Pic 12 Desc.	Condition of temporary trash transfer pit. Debris inside boundary of pit. Looking W.

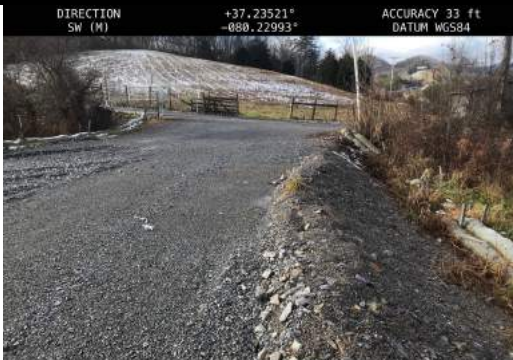
<p>DIRECTION SW (M) +37.23521° -880.22993° ACCURACY 33 ft DATUM WGS84</p> <p>MVP-PY-006_011221 Condition of west rock entrance 2021-01-12 10:15:08-05:00</p>			  <p>DIRECTION N (M) +37.23541° -880.22966° ACCURACY 16 ft DATUM WGS84</p> <p>MVP-PY-006_011221 Condition of trays and containment 2021-01-12 10:15:59-05:00</p>	
GPS Location	MVP-PY-006 See photo for gps data		GPS Location	MVP-PY-006 See photo for gps data	
Field Station#	+0		Field Station#	+0	
Pic 1 Desc.	Condition of west rock entrance. No sediment on stone surface. Looking SW.		Pic 2 Desc.	Condition of trays and containment under toilets. Looking N.

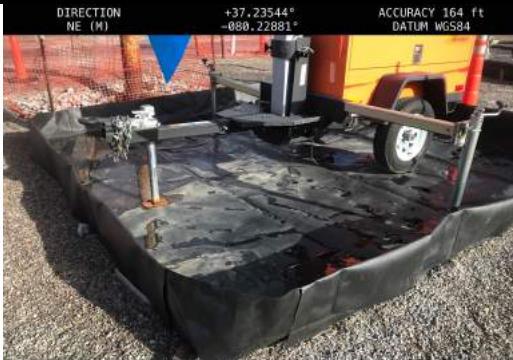
<p>DIRECTION NE (M) +37.23544° -880.22881° ACCURACY 164 ft DATUM WGS84</p> <p>MVP-PY-006_011221 Condition of containment 2021-01-12 10:18:38-05:00</p>

GPS Location	MVP-PY-006 See photo for gps data		GPS Location	MVP-PY-006 See photo for gps data	
Field Station#	+0		Field Station#	+0	
Pic 3 Desc.	Condition of containment under light plant. Free of stormwater. Looking NE.		Pic 4 Desc.	Condition of of buffer flagging for feature W-008. Looking E.	
	  <p>DIRECTION E (M) +37.23571° -880.22871° ACCURACY 16 ft DATUM WGS84</p> <p>MVP-PY-006_011221 Condition of signage and CFS at feature 2021-01-12 11:39:39-05:00</p>

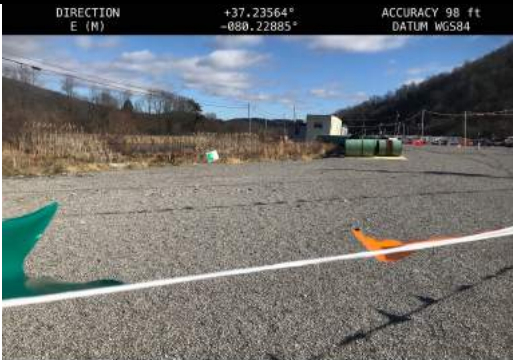
<p>DIRECTION E (M) +37.23564° -880.22885° ACCURACY 98 ft DATUM WGS84</p> <p>MVP-PY-006_011221 Buffer flagging for feature 2021-01-12 11:39:28-05:00</p>

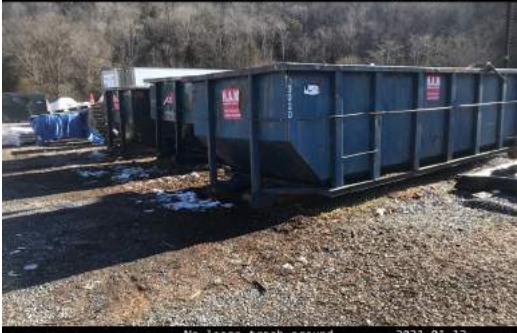
MVP-PY-006_011221 No loose trash around dumpsters 2021-01-12 11:44:01-05:00				MVP-PY-006_011221 No fuel spills south of tanks 2021-01-12 11:44:10-05:00	
GPS Location	MVP-PY-006 See photo for gps data		GPS Location	MVP-PY-006 See photo for gps data	
Field Station#	+0		Field Station#	+0	
Pic 7 Desc.	No loose trash around dumpsters. Looking SE.		Pic 8 Desc.	No fuel spills south of Blue Bulk fuel tanks. Looking W.	
DIRECTION W (M) +37.23561° -080.22673° ACCURACY 16 ft DATUM WGS84

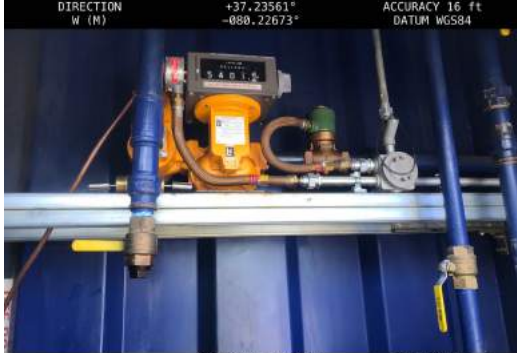
MVP-PY-006_011221 No leaky internal fittings 2021-01-12 11:44:36-05:00				MVP-PY-006_011221 Condition of containment 2021-01-12 11:45:12-05:00

GPS Location	MVP-PY-006 See photo for gps data		GPS Location	MVP-PY-006 See photo for gps data	
Field Station#	+0		Field Station#	+0	
Pic 9 Desc.	Blue Bulk Fuel tanks no leaky internal fittings. Looking W.		Pic 10 Desc.	Condition of containment under DEF container. Free of stormwater. Looking SW.	
DIRECTION W (M) +37.23566° -080.22680° ACCURACY 16 ft DATUM WGS84

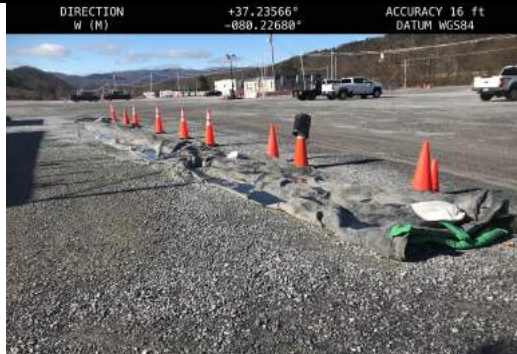
MVP-PY-006_011221 Secondary containment on site for tankers 2021-01-12 11:45:18-05:00				MVP-PY-006_011221 Condition of internal drip pan 2021-01-12 11:46:25-05:00	
GPS Location	MVP-PY-006 See photo for gps data		GPS Location	MVP-PY-006 See photo for gps data	
Field Station#	+0		Field Station#	+0	
Pic 11 Desc.	Secondary containment on site for tankers offloading fuel into Blue Bulk fuel tanks. Looking W.		Pic 12 Desc.	Off Road Fuel unit condition of internal drip pan. Looking W.

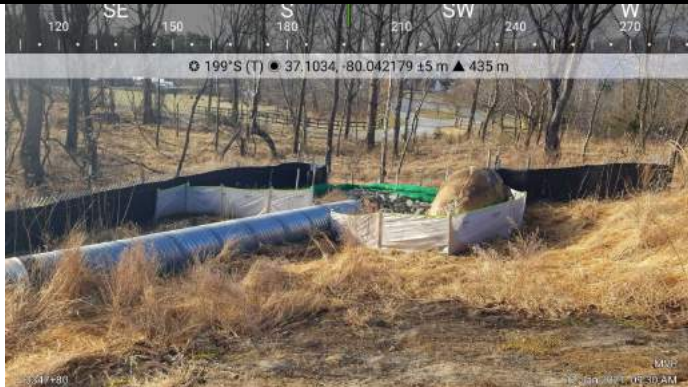
GPS Location	See Above		GPS Location	See Above	
Field Station#	13347+80		Field Station#	13348+46	
Pic 3 Desc.	ROW Overview. ECDs are functional and ROW is stable.		Pic 4 Desc.	Waterbody S-RR08. ECDs are functional and ROW is stable.

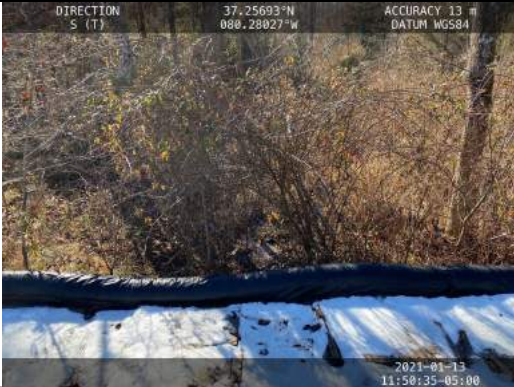
GPS Location	See photo		GPS Location	See photo	
Field Station#	12121+33		Field Station#	12121+83	
Pic 1 Desc.	Stream S-C33, facing south, downstream		Pic 2 Desc.	Stream S-C36, facing south, downstream

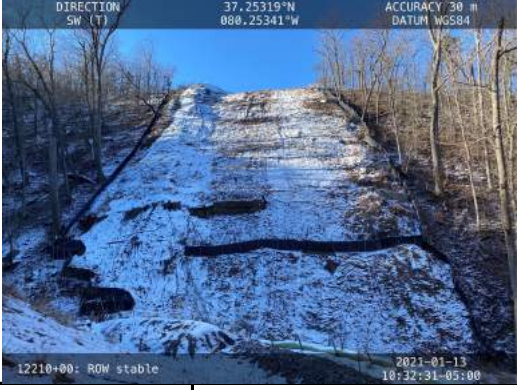
GPS Location	See photo		GPS Location	See photo	
Field Station#	12215+00		Field Station#	12211+00	
Pic 15 Desc.	Permanent restoration remains stable between Bradshaw Road and the switchback on Reese Mountain.		Pic 16 Desc.	The drainage feature in the ravine between Bradshaw Road and Reese Mountain remains stable.

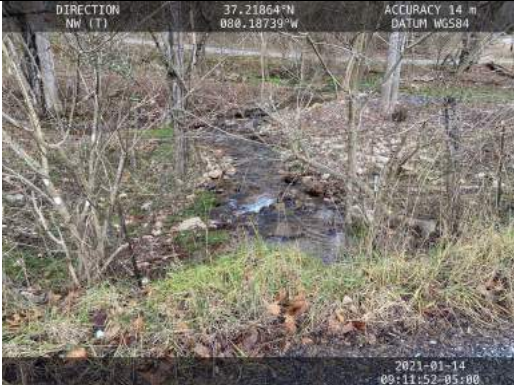
GPS Location	See photo		GPS Location	See photo	
Field Station#	12544+06		Field Station#	12544+06	
Pic 1 Desc.	Stream S-KL32, facing northwest, downstream from Yellow Finch Lane		Pic 2 Desc.	Stream S-EF20b, facing north, downstream from Yellow Finch Lane

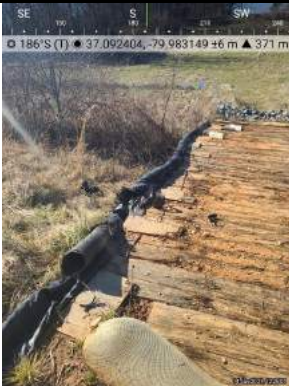
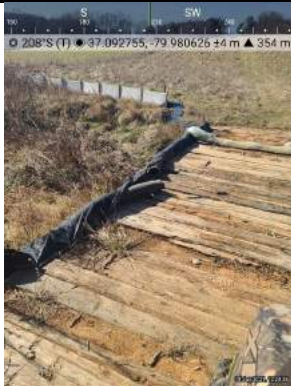
GPS Location	00000	GPS Location	00000		
Field Station#	13565+30	Field Station#	13572+83		
Pic 5 Desc.	EI noticed splash protection on equipment bridge was damaged from wildlife and required maintenance, documented and sent in to be added to the punch list		Pic 6 Desc.	EI noticed splash protection on equipment bridge was damaged from wildlife and required maintenance, documented and sent in to be added to the punch list

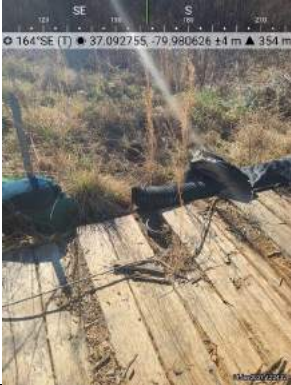
Insert image here		Insert image here	
GPS Location	00000	GPS Location			
Field Station#	13572+83	Field Station#			
Pic 7 Desc.	El noticed splash protection on equipment bridge was damaged from wildlife and required maintenance, documented and sent in to be replaced by the manufacturer.		Pic 8 Desc.		
Insert image here		Insert image here			
GPS Location		GPS Location			
Field Station#		Field Station#			
Pic 9 Desc.			Pic 10 Desc.		
Insert image here		Insert image here			
GPS Location		GPS Location			
Field Station#		Field Station#			
Pic 11 Desc.			Pic 12 Desc.

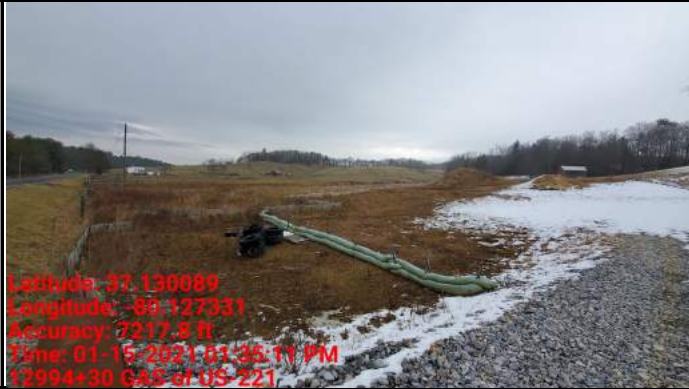
<p>Latitude: 37.13844 Longitude: -89.136639 Elevation: 2707.87 ft Accuracy: 12.5 ft Time: 01-15-2021 11:51:55 AM 12975+00 GAS of RO-288 punch list item completed</p>

<p>Latitude: 37.138089 Longitude: -89.127331 Elevation: 2717.8 ft Accuracy: 7217.8 ft Time: 01-15-2021 01:35:11 PM 12994+30 GAS of US-221</p>		
GPS Location	See pic for GPS location		GPS Location	See pic for GPS location	
Field Station#	12975+00		Field Station#	12994+30	
Pic 13 Desc.	Erosion rills raked out and stabilized with Curbex then removed from punch list.		Pic 14 Desc.	GAS of US-221 remains in compliance

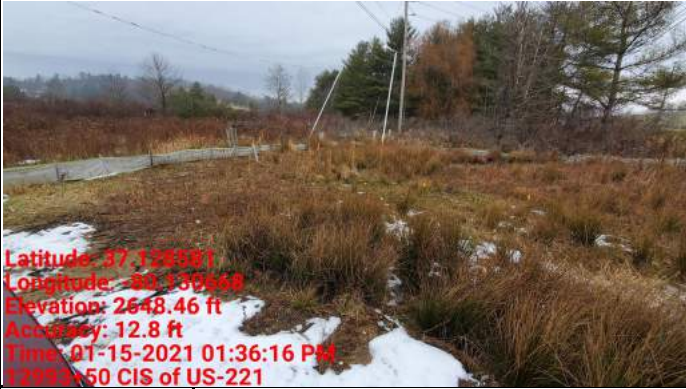
<p>Latitude: 37.128381 Longitude: -89.139658 Elevation: 2648.46 ft Accuracy: 12.8 ft Time: 01-15-2021 01:36:16 PM 12993+50 CIS of US-221</p>

GPS Location	See pic for GPS location		GPS Location	See pic for GPS location	
Field Station#	12993+50		Field Station#	13012+40	
Pic 15 Desc.	No maintenance issues or impacts found on the CIS of US-221		Pic 16 Desc.	CIS of the BRP motorway
